# **Trewhella Barn, Trewhella Lane, Relubbus, Cornwall**

## **Historic Building Record and Archaeological Watching Brief**

<b>Client</b>	<b>Alan and Tristan Brown</b>
<b>Report Number</b>	2021R078
<b>Date</b>	<b>06/12/21</b>
<b>Status</b>	Final
<b>Report author(s)</b>	<b>Connor Motley</b>
<b>Checked by</b>	<b>Jo Sturgess</b>
<b>Approved by</b>	<b>Andy Jones</b>
<b>Project number</b>	147129
<b>Site code</b>	TWL21
<b>Data location</b>	\\CAU\Archive\Sites\R\Relubbus, Trewhella Lane HBR & WB
<b>Historic England / ADS OASIS online reference</b>	cornwall2-427987
<b>Planning reference</b>	PA19/08625

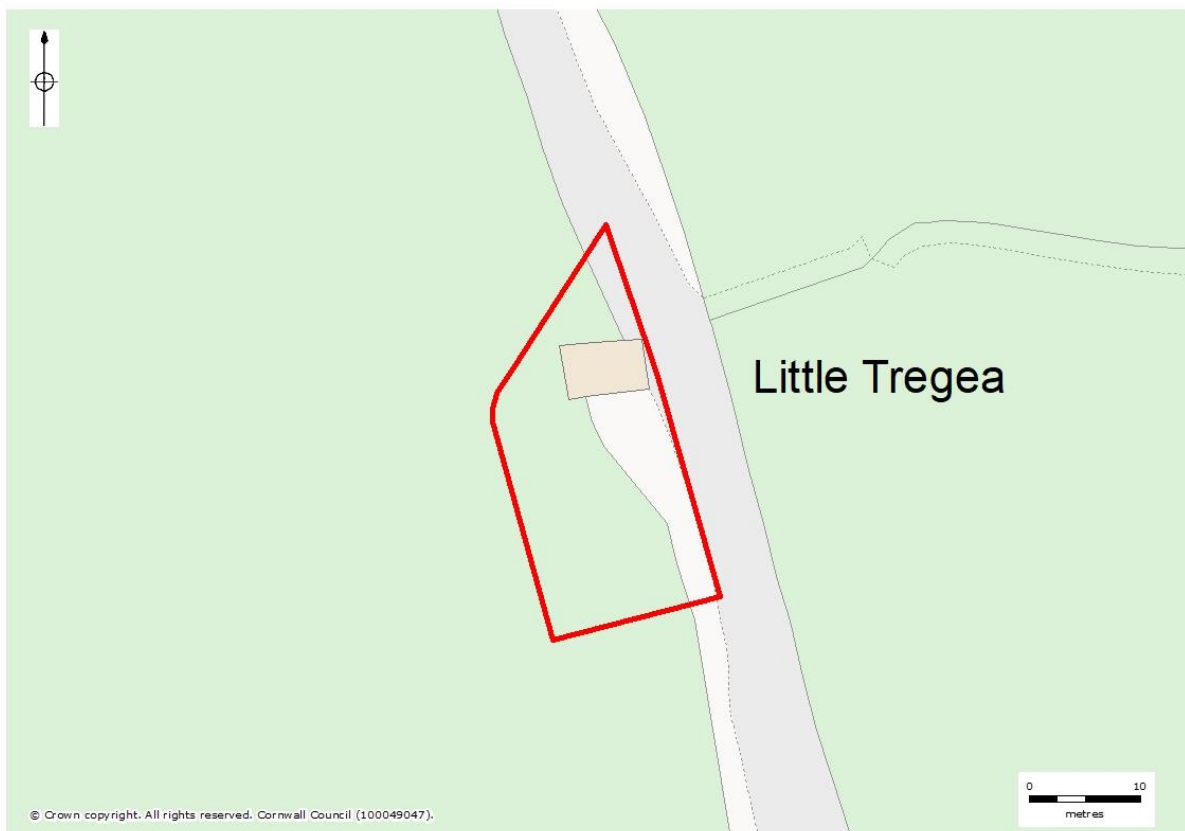
Fig 2 Site extent.

A watching brief was undertaken during topsoil stripping and ground reduction within the whole of the site extent shown on Fig 2. See watching brief plan (Fig 27) for feature locations.

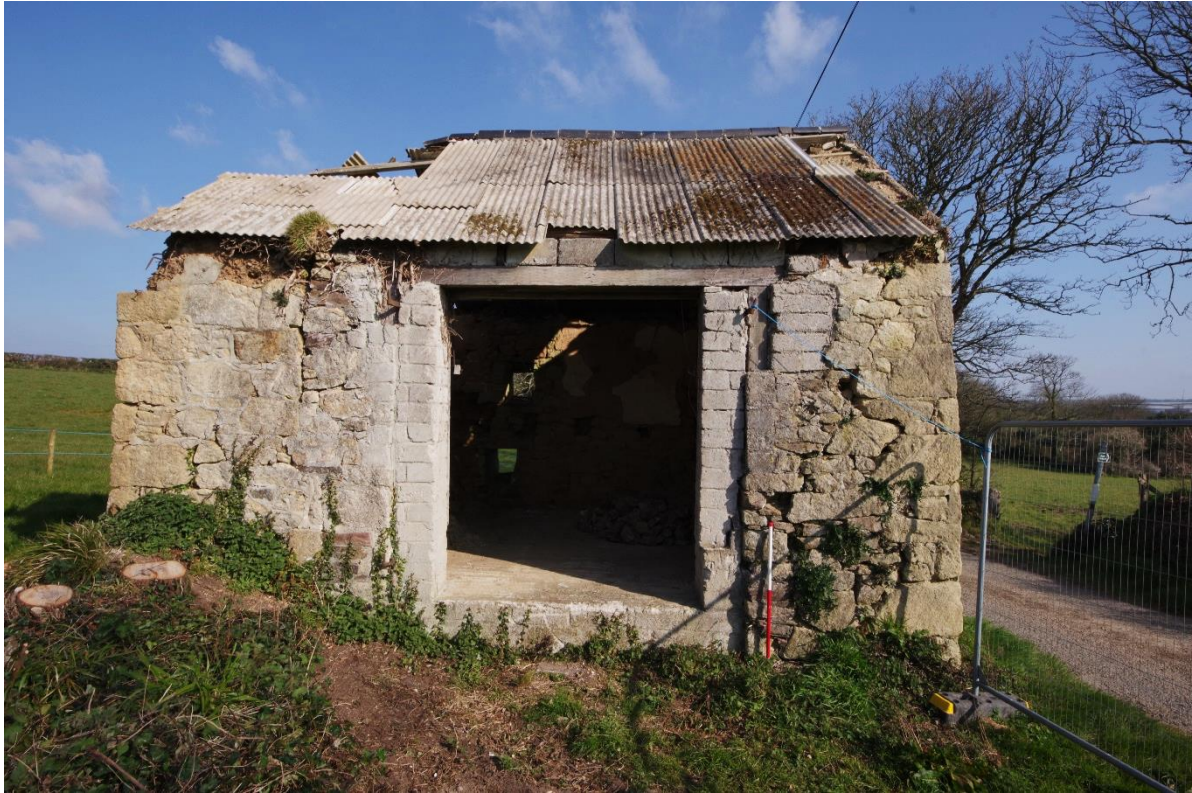
*Fig 3 South elevation.*

There is a large, inserted, phase 5 double door opening in the south elevation (Fig 3). It has concrete blockwork jambs, a modern timber lintel and concrete threshold. There are two iron pintles in the western jamb and one in the eastern jamb indicating that there were once double doors in the opening. The eastern jamb is built up against an earlier concrete blockwork jamb possibly dating to the early/mid 20<sup>th</sup> century. The granite rubble-built walls either side of the opening have been partially rebuilt and there are granite block quoins at each end. Immediately west of the inserted door opening there appears to be part of a blocked window opening at first floor level. There is a large hand forged iron nail in the western quoin. Areas of the stone rubble-built wall have been repointed with cement mortar.

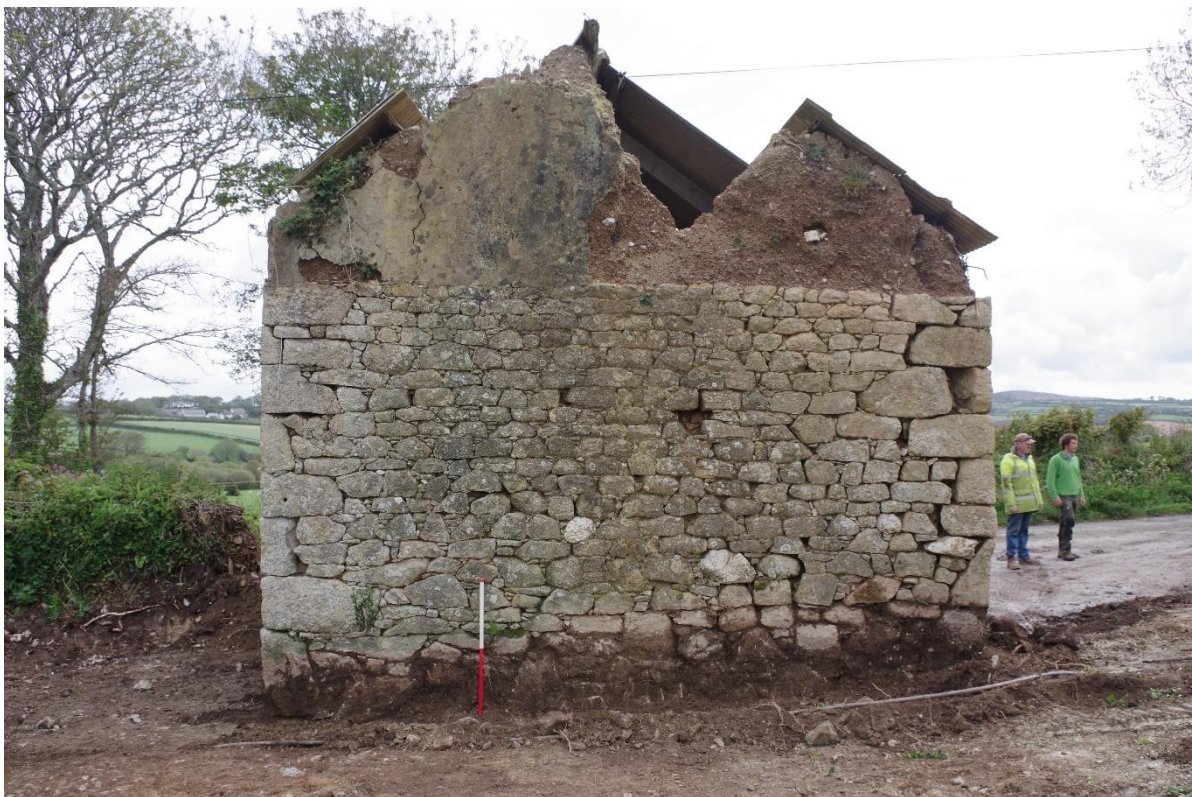
*Fig 4 West elevation.*

The lower part of the wall up to just below eaves level (Figs 4 and 26) is constructed from coursed granite rubble with snecking between stones, bonded with earth mortar. Above this the gable is constructed from cob which has been rendered at a later date with cement. A large portion of the cob has collapsed. In the walling below the cob there are what appear to be three small joist sockets for a lean-to which has since been removed. There are large granite quoins at either end of the wall. In the northern quoin the sixth stone up from the ground appears to be a reused kneeler stone of possible 17<sup>th</sup> century date, the fourth stone up contains a drilled hole (possible for a bolted door to the removed lean-to) and the basal quoin also appears reused with a chamfered corner at the base (Fig 25).

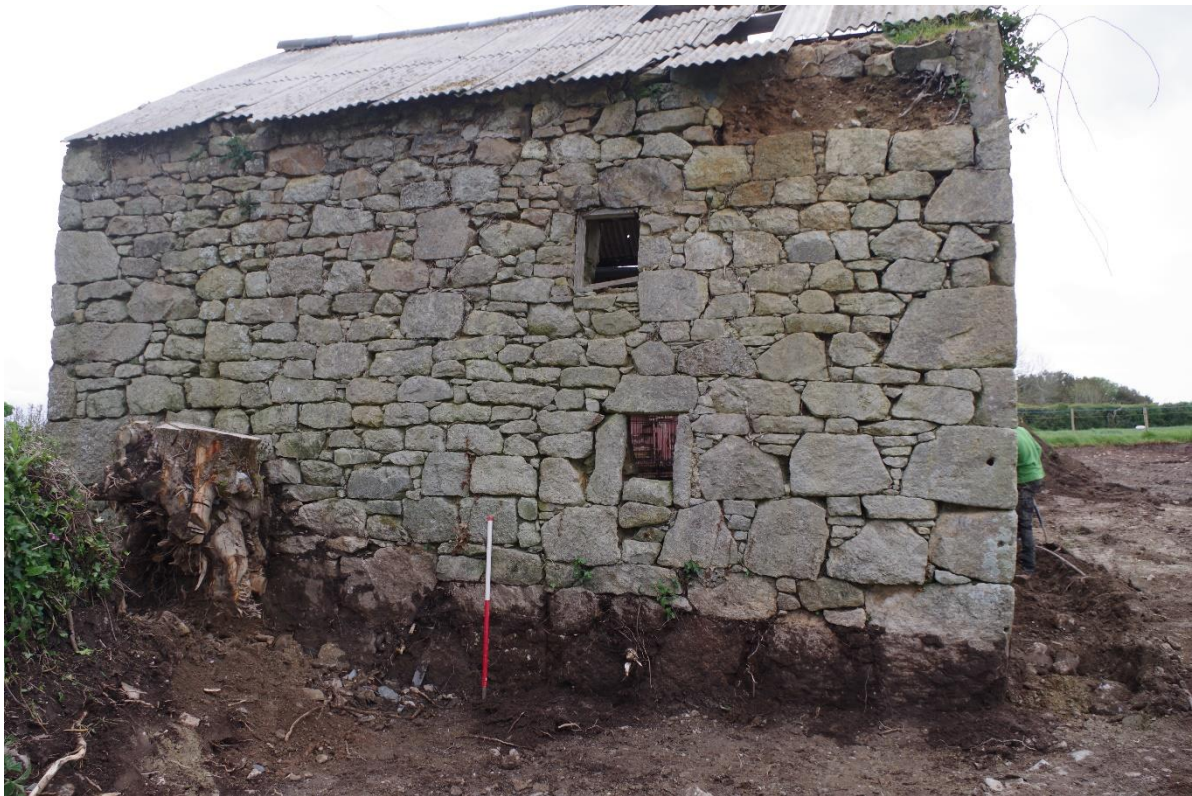
*Fig 5 North elevation.*

The wall (Fig 5) is constructed from randomly coursed granite rubble with snecking between stones, bonded with earth mortar and has some areas of lime repointing. There are two small offset windows within the western half of the wall, one at ground floor level and the other at first floor level. The ground floor window opening is constructed of a few large granite blocks and there is no remaining evidence of the window itself. The first floor window is constructed from a number of smaller stones and there is a detached

probably 19th century fixed timber window inside the opening. To the east of the ground floor window opening there is a straight joint (possibly once the jamb of a door opening here). This joint indicates that the walling to the east and above has been rebuilt at some point. At either end of the wall there are granite block-built quoins. There are two drilled holes in the western quoin (possibly where a former gate was attached) and the basal quoin stone is a reused chamfered granite block (Fig 34). At the top of the wall, towards the west end there is an area of cob walling.

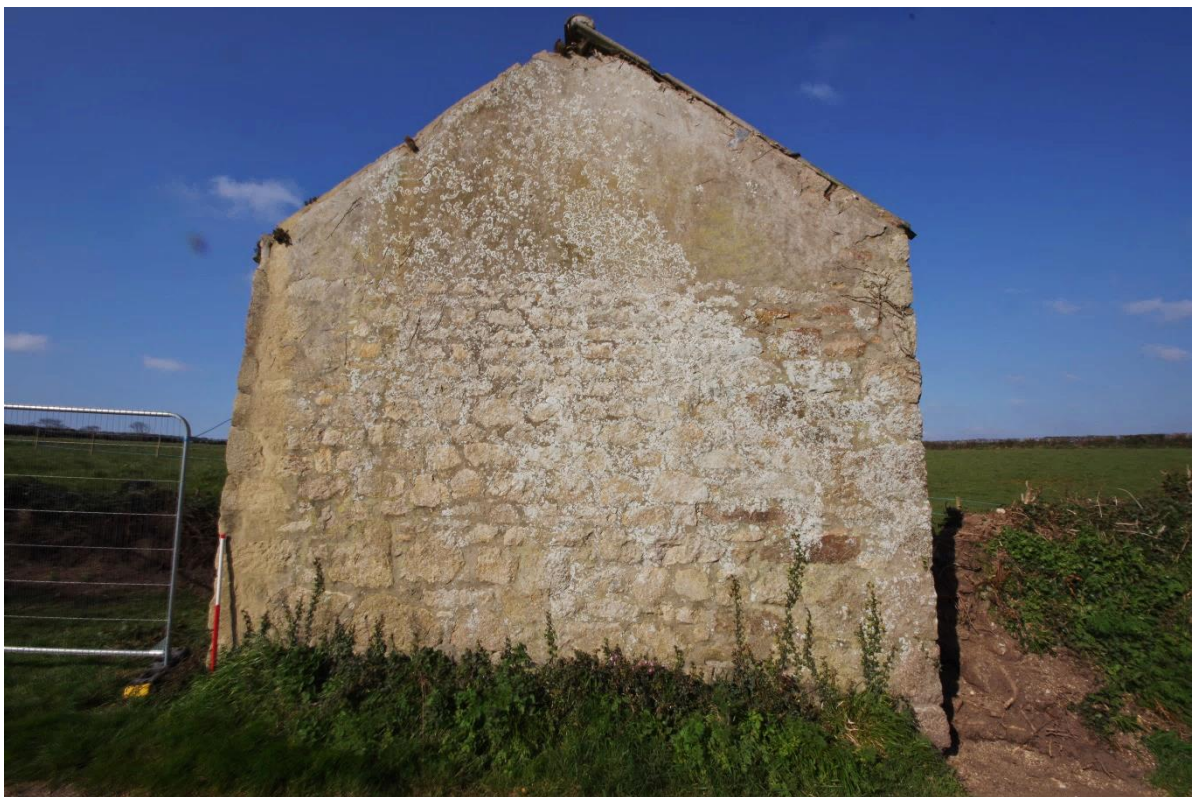
*Fig 6 East elevation.*

The east elevation (Fig 6) is constructed from coursed granite rubble in the lower half of the wall up to just below eaves level, which has been repointed with cement mortar. The upper half of the wall forming the gable is constructed from cob which has been rendered at a later date with cement. There are granite block quoins at either end. The remains of a stile over a Cornish hedge adjoin the northern quoin.

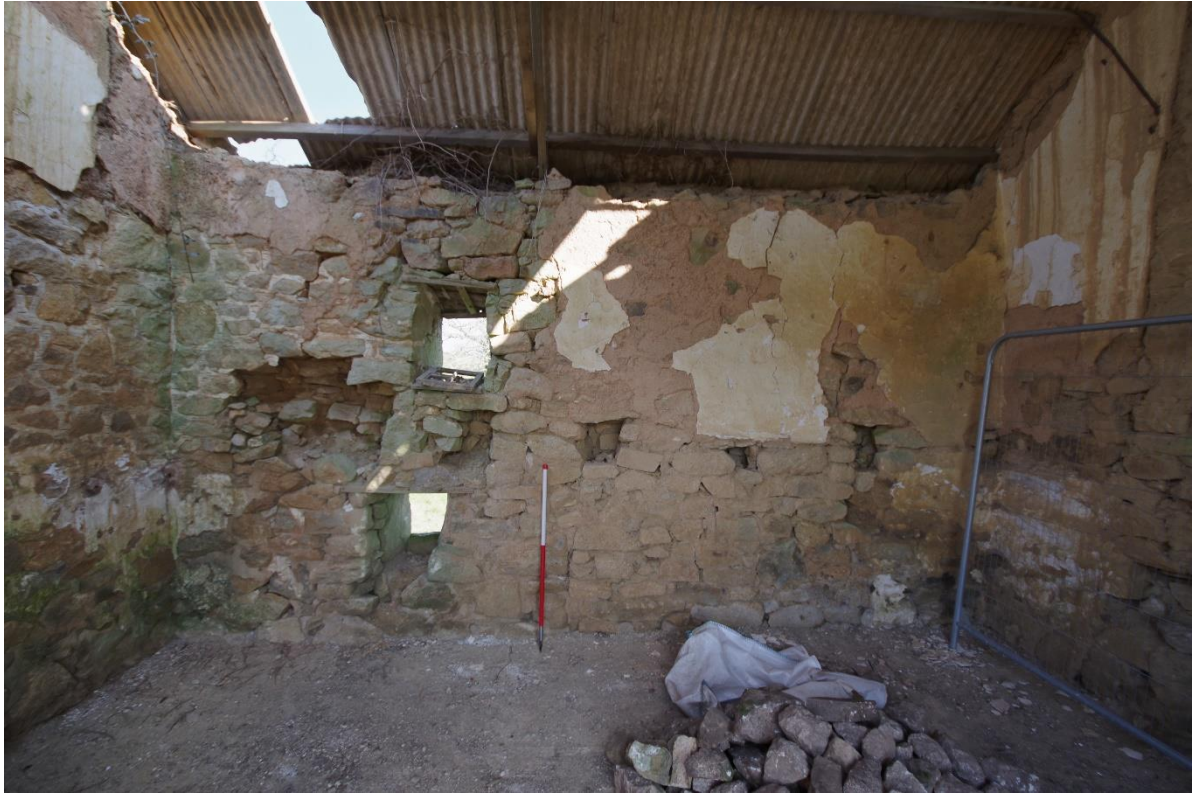
Fig 7 Interior north wall.

The north wall (Fig 7) is constructed from granite rubble bonded with earth mortar, and there is an area of cob walling at the top of the western end. The eastern half of the wall retains areas of earth plaster with a later lime plaster over. There are two small, splayed window openings; one at ground floor level and the other at first floor level. The first floor opening contains a 19<sup>th</sup> or early 20<sup>th</sup> century timber four-pane fixed window which is missing its glass. Halfway up the wall and running the full length, are a series of square sockets for the removed timber first floor joists.

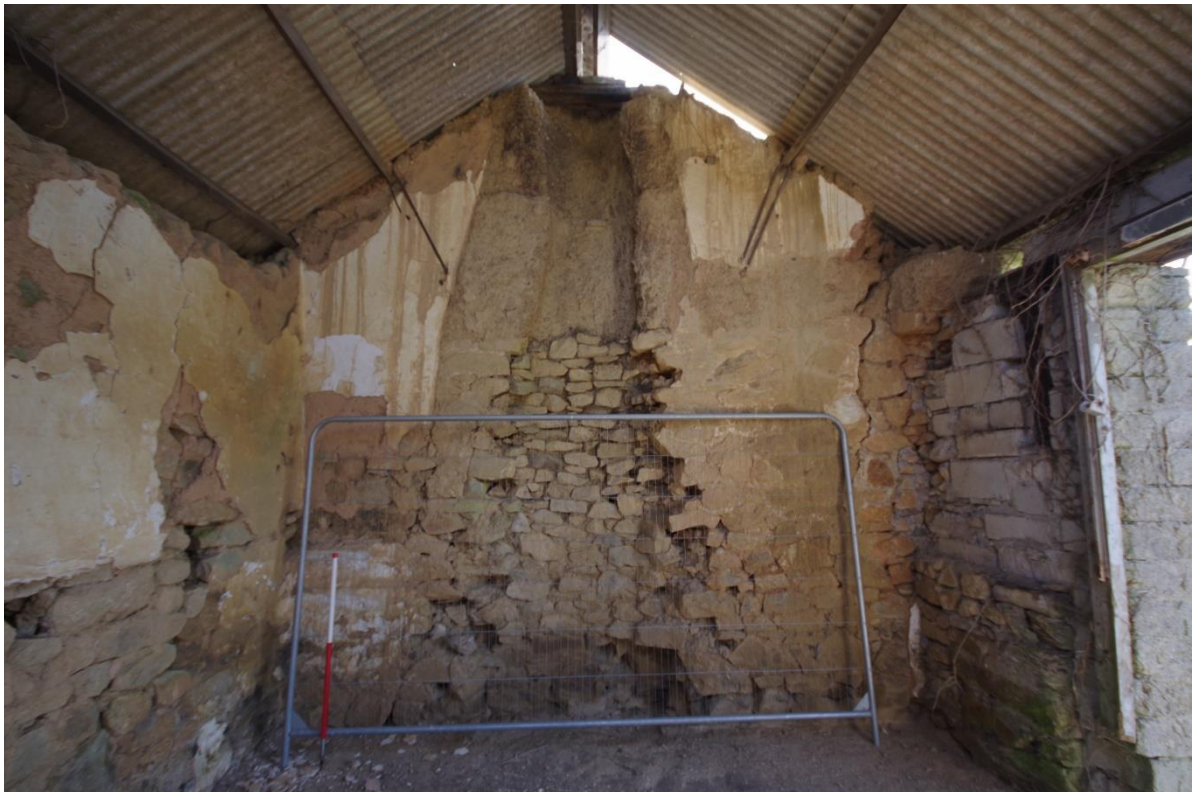
Fig 8 Interior east wall.

The lower part of the east wall (Fig 8) is constructed from small granite rubble bonded with earth mortar and the upper part, forming the gable is constructed from cob. There is an exposed centrally set chimney flue recessed into the wall which extends from the ground floor upwards. The fireplace(s) have been removed. A scar can be seen at the top of the wall where the external chimney stack at the top of the gable has been removed. At first floor level there are remaining areas of earth plaster which has been painted white. There is an area of lime plaster at the south end of the wall at ground floor level which is abutted by the south wall, indicating that the south wall has been rebuilt.

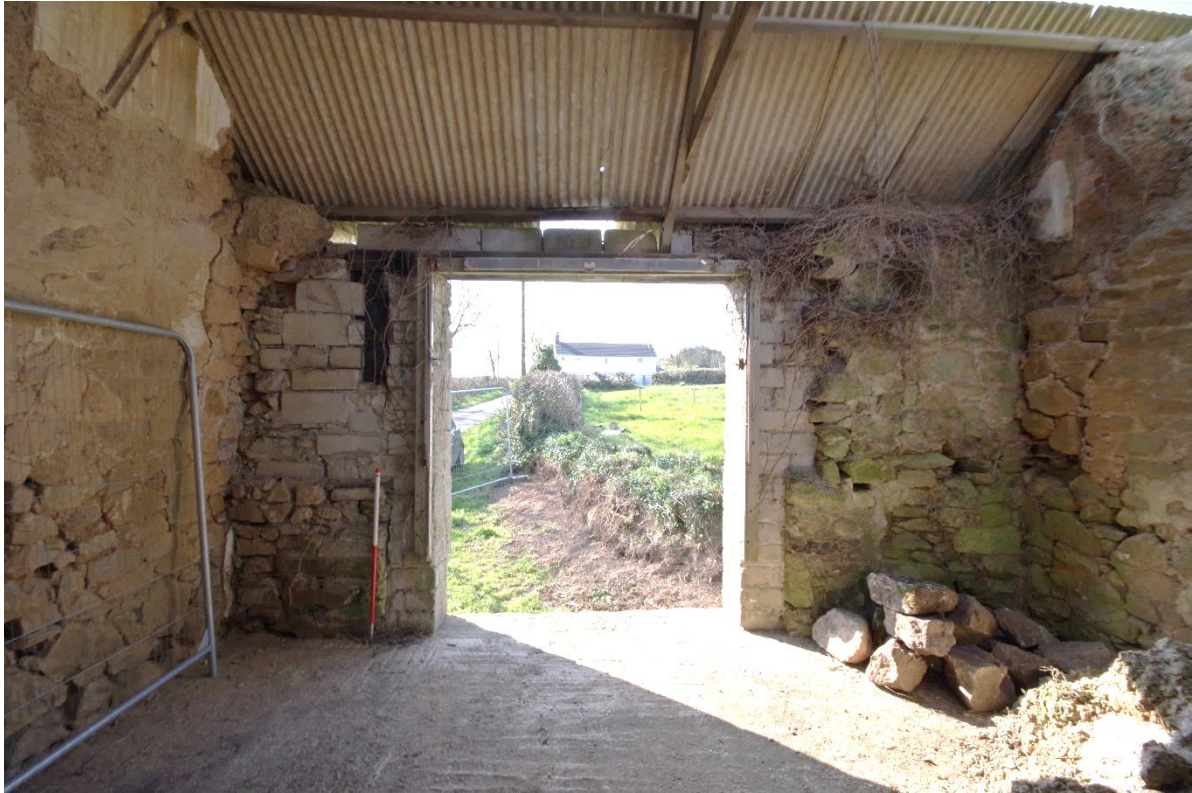
Fig 9 Interior south wall.

The south wall (Fig 9) has undergone a variety of alterations. There is a wide, inserted, modern double door opening offset from the centre slightly to the east, with a timber frame and inserted concrete blockwork around it. To the east of the door opening some earlier stone masonry bonded with earth mortar survives up to approximately 1m from the modern raised floor level. However, this section of surviving wall can clearly be seen to post-date the east wall as it abuts the earth plaster finish of the east wall. To the west of the door opening its jamb has been rebuilt with concrete blockwork, but beyond this, the earlier stone masonry wall survives. Up against the lower half of the concrete blockwork jamb is what appears to be an earlier stone jamb which is almost certainly the remains of an earlier door opening at ground floor level. To the west of the top of this jamb there is a joist socket indicating the original first floor level. Above this, but slightly to the east is the jamb of a first floor window opening and stone masonry used to block it has been inserted to the east of it.

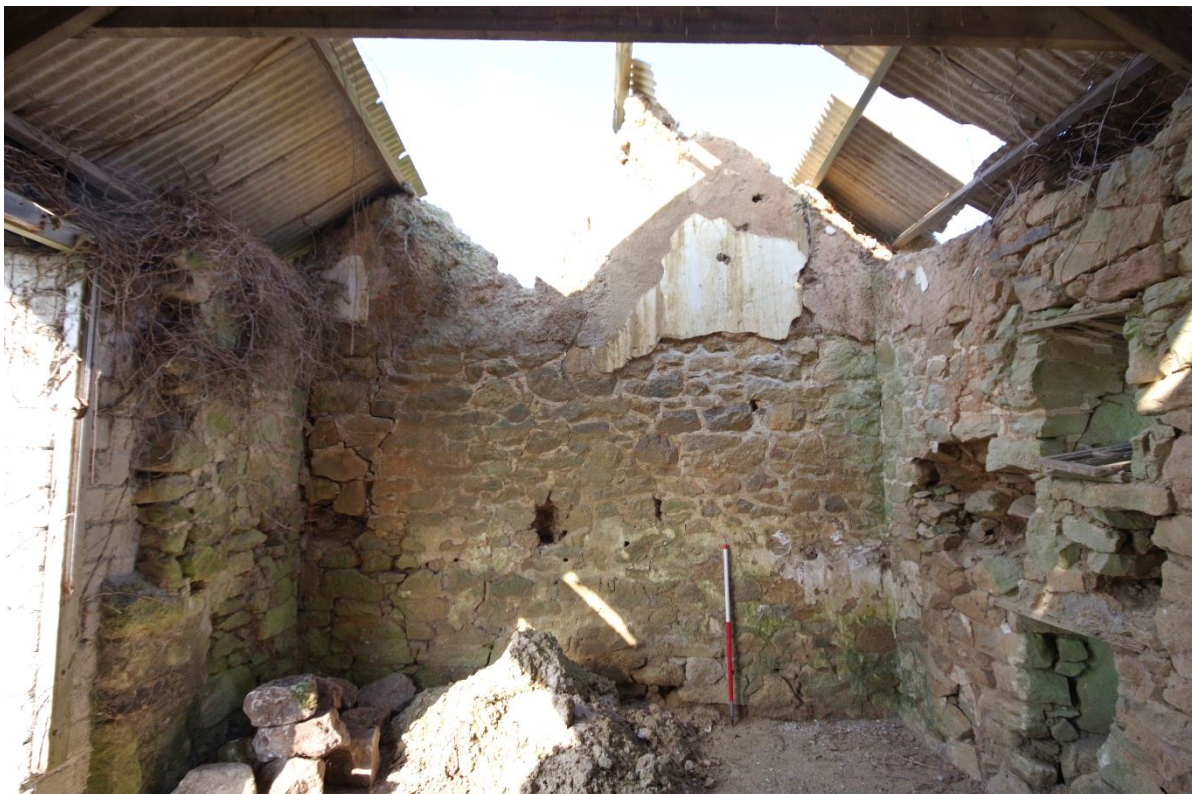
Fig 10 Interior west wall.

The lower part of the west wall (Fig 10) is constructed from uncoursed granite rubble bonded with earth mortar. The upper part of the wall within the gable is constructed from cob. A large portion of the cob wall has collapsed, but where it survives there are areas of earth plaster with lime plaster over which remain *in situ*. The lower, masonry, part of the wall has been repointed with a cement mortar. At the height of the former first floor there are two sockets (one at the south end and one in the centre) which presumably once held support beams for the first floor structure.

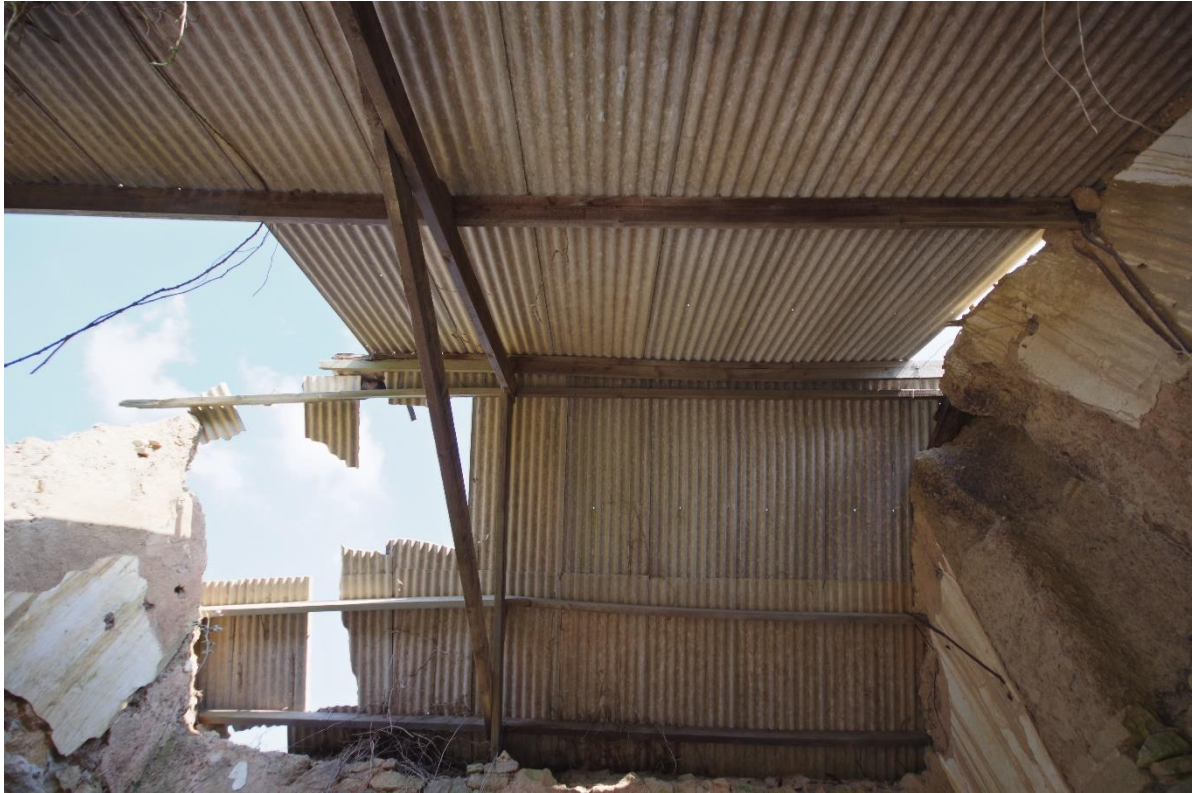
The roof structure comprises a single collar truss which is lap-jointed at the apex with two purlins on either side and ridge timber which probably dates to the early/mid 20<sup>th</sup> century. It has mid/late 20<sup>th</sup> century corrugated cement roof covering (collapsed towards the west) with terracotta ridge tiles, fixed to the ridge with cement mortar.

There is no ceiling and no evidence that there ever was one at first floor level, since the walls are plastered up to the apex of the roof (Fig 11). The roof structure is a 20<sup>th</sup> century replacement. It has a single timber collar truss which is lap jointed at the apex and nailed together, two purlins on each side and a ridge timber. The modern corrugated cement roof covering is exposed.

*Fig 11 Modern roof structure and corrugated covering.*

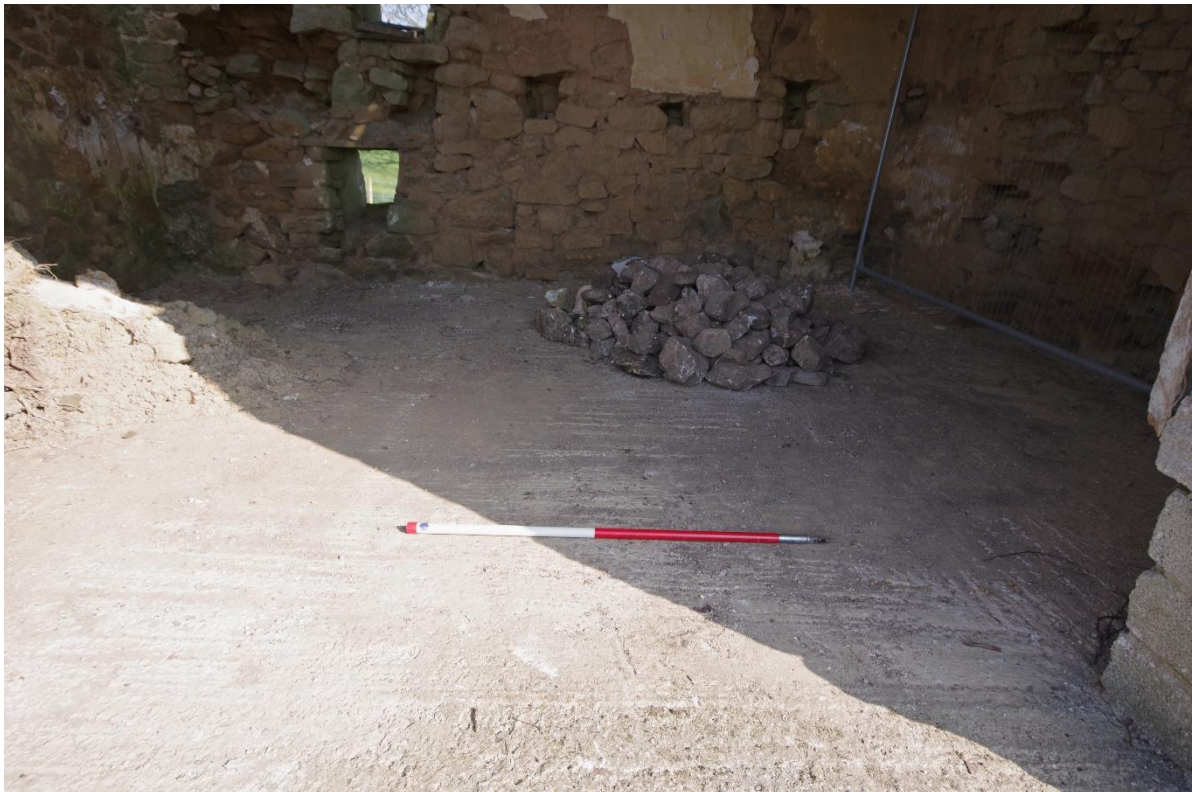
When the present, modern concrete floor was inserted the level was raised significantly (probably c0.5m) from the original ground floor level (see Figs 3 and 12). The first floor structure has been completely removed (probably at some point during the 20<sup>th</sup> century). However, surviving joist sockets show its former location.

*Fig 12 Modern raised concrete floor.*

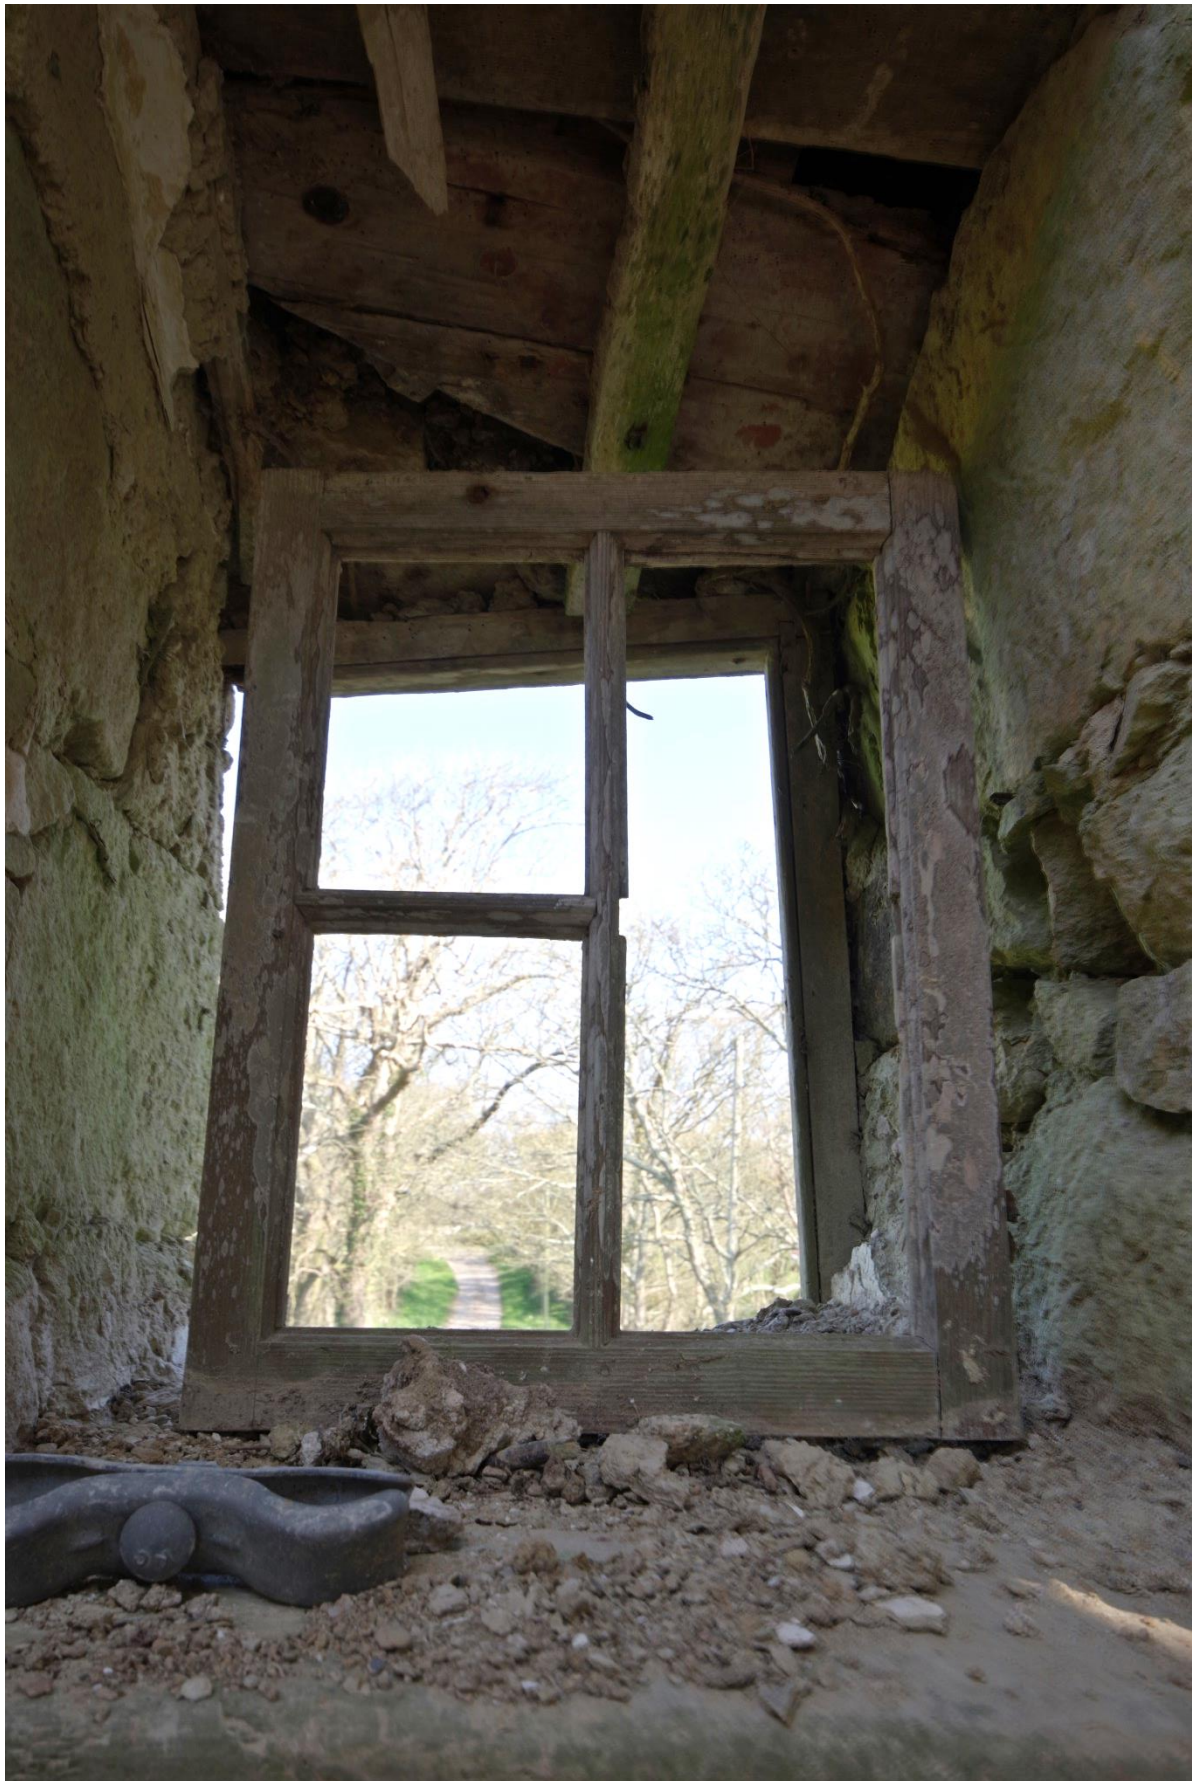
*Fig 13 Remains of timber four-pane, fixed window at first floor level in north wall.*

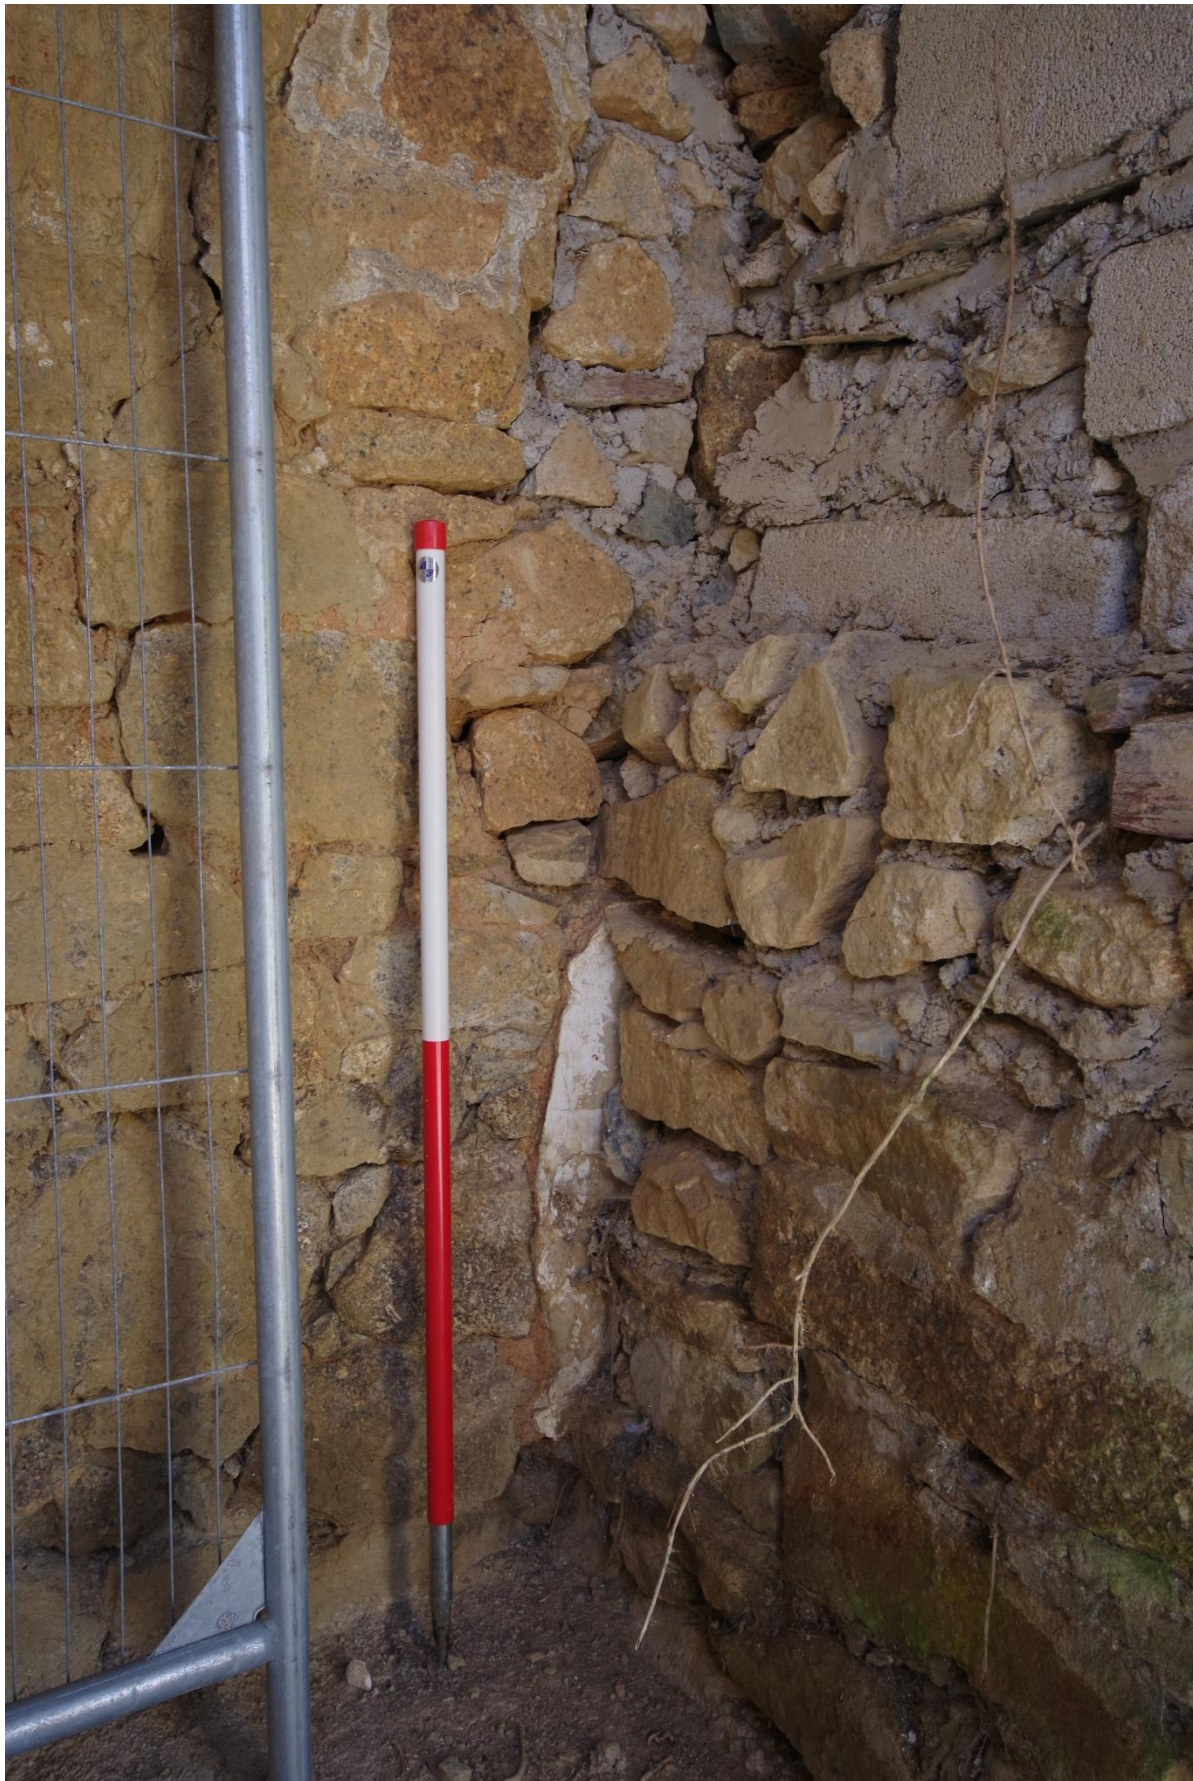
The south wall appears to have been taken down and rebuilt in the 19th century. The remains of this wall are constructed from stone rubble bonded with earth mortar and at its east end, it can clearly be seen to abut the earlier internal plastered surface of the east wall.

*Fig 14 Showing the south wall (right) abutting the east wall (left) and covering the earlier plastered face of the east wall.*

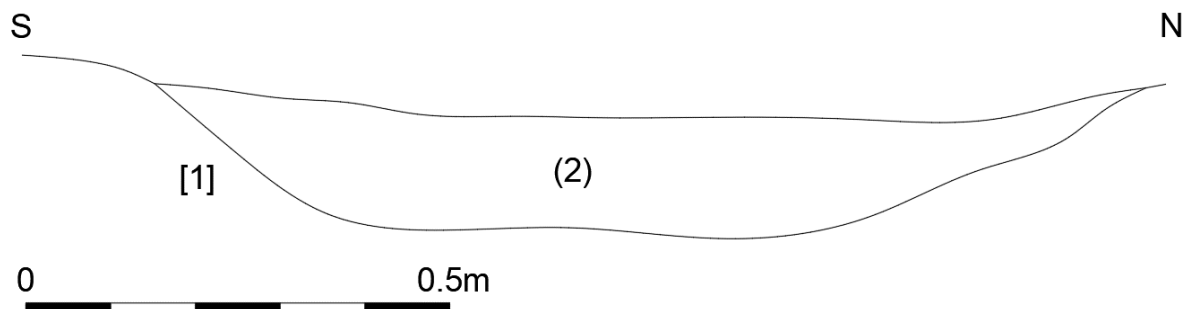
Fig 20 East facing section of garden boundary [1] (2)

A small shallow ditch was identified in the southwest corner of the site (see Fig 28) which was in a similar position to, and probably represents the remains of, the garden boundary shown on the c1840 tithe map (Fig 36) and c1880 OS map (Fig 37). The ditch measured 1.15m wide and 0.14m at its deepest. The ditch extended beyond the extent of the site in both directions. The fill (2) of the ditch was a midgreyish brown silty clay containing occasional pieces of charcoal, bone, pottery and china sherds and a large piece of iron.

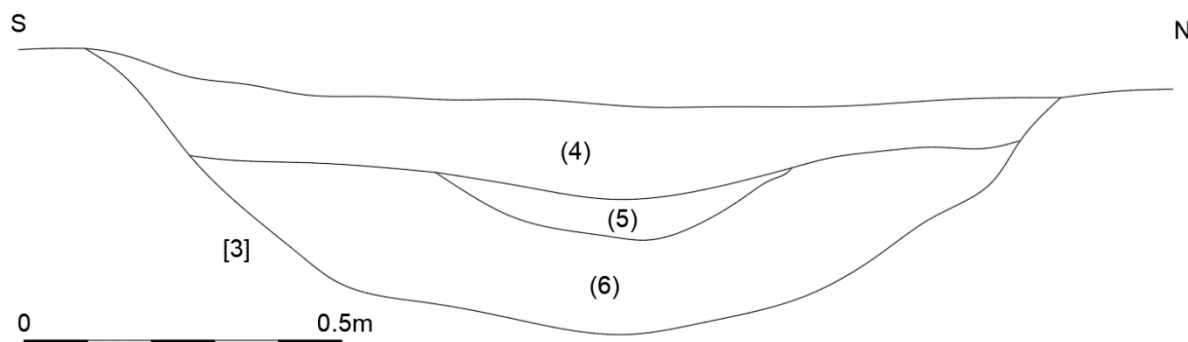
Fig 21 East facing section of pit [3] (4) (5) (6)

A pit was identified to the northeast of the ditch [1]. The pit was ovoid in plan, measuring 1.40m wide, 2.20m long and 0.35m deep. Within the pit there were three fills of dumped material. The primary fill (6) consisted of re-deposited topsoil; mid greyish brown silty clay, containing frequent stones and 19th century pottery and china. Overlying this fill (5) comprised a large quantity of lime. The upper fill (4) was also redeposited topsoil; a mid greyish brown silty clay containing various 19th century metalwork, china a pottery sherds. The finds included a broken pair of brass sugar tongs, an 1861 Queen Victoria Half Penny, a number of glazed and unglazed potsherds, including a patterned piece of china and an inkwell, several fragments of sea shell and a fragment of glass (see Fig 29).

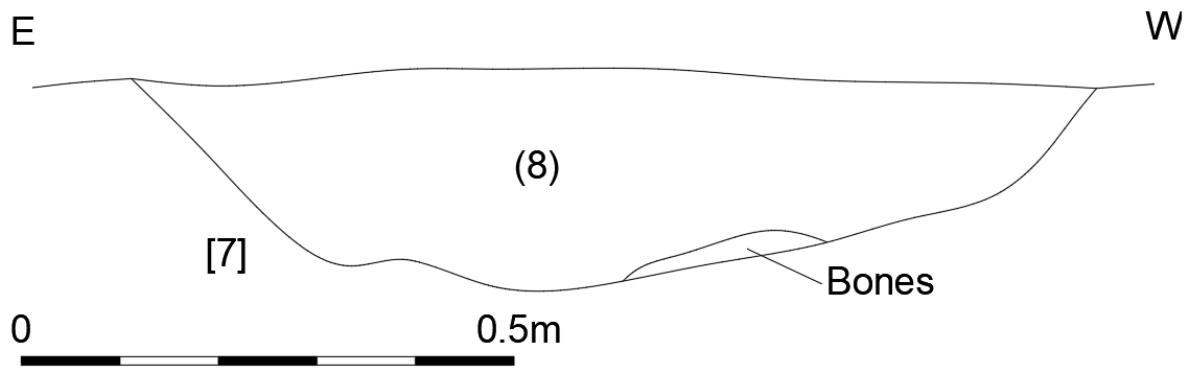
Fig 22 North facing section of animal burial [7] (8)

An animal burial (Fig 31), possibly that of a cat, was identified to the west of the barn. The burial pit was circular in plan and measured 0.95m in diameter and 0.20m deep. The fill (8) of the pit was redeposited topsoil; a mid greyish brown silty clay containing occasional late 19th century pottery and china sherds, a small piece of iron and around twenty small animal bones at the base.

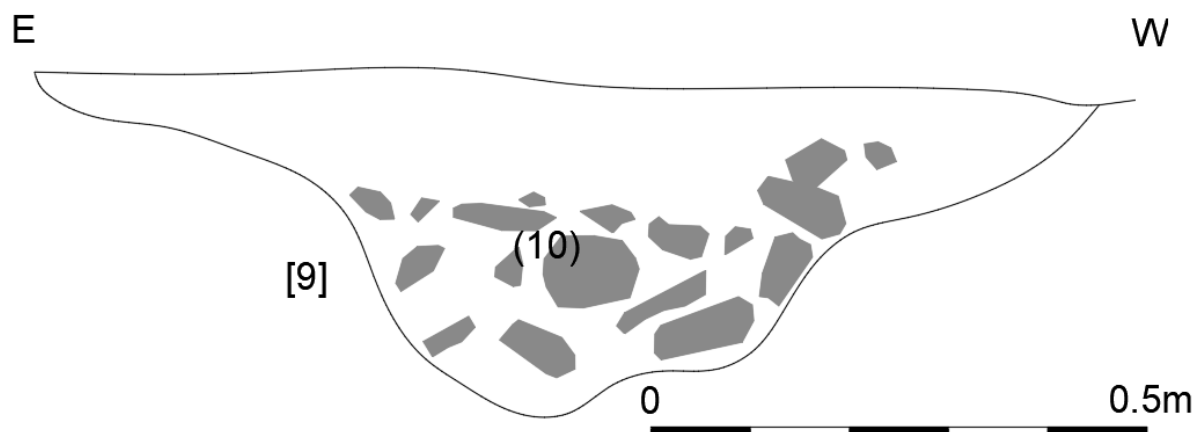
Fig 23 North facing section of house foundation trench [9] (10)

The southern foundation trench of a former house shown on the Tithe map and c1880 OS map (Figs 36 and 37) located directly northwest of the barn was uncovered. The lower 0.20m of the cut [9] had steeply sloping sides and measured 0.5m wide, above this the sides were more gently sloped, reaching a width of 1.05m at the top. The total depth of the construction cut was 0.35m and it could be traced for at least 7.00m running east-west. The eastern end was not clear in the stripped area, and the western end extended beyond the site extent. The fill of the construction cut was a mid brown greyish silty clay with frequent stone demolition material in the lower half. Finds from the fill included late 19th century pottery and china sherds, a limpet shell and an iron nail.

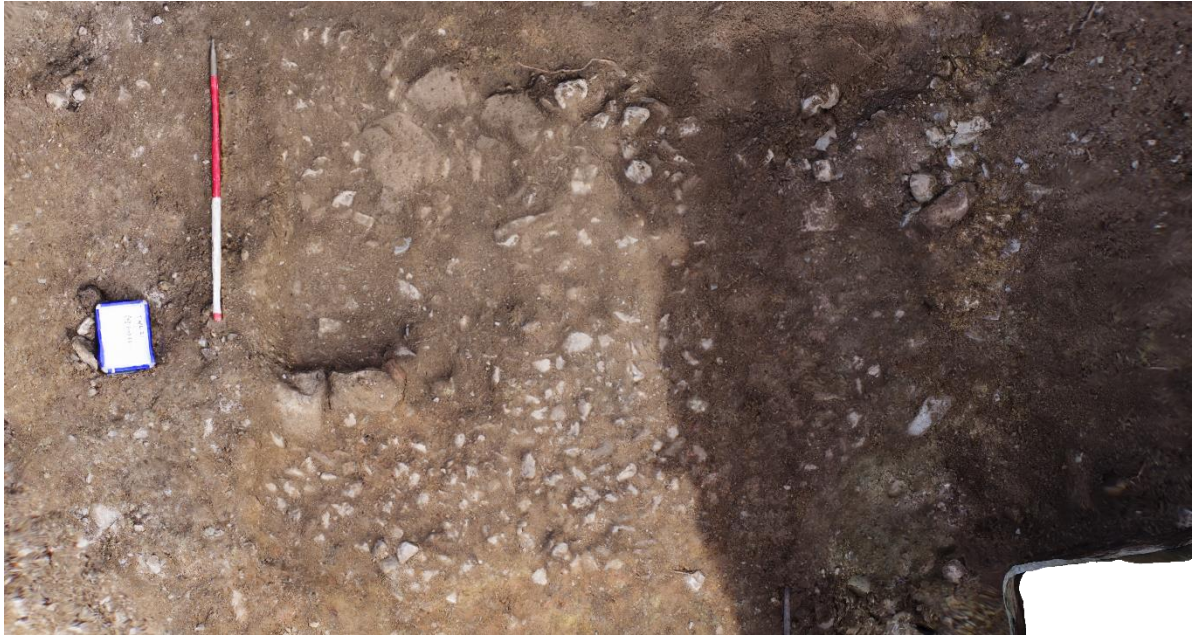
Fig 24 Orthophoto of cobbled surface 11

The remains of a cobbled surface made from slatestone and quartz cobbles and occasional larger stones was exposed between the extant barn and the former house [9]. The full extent of this surface terminated with a straight edge running parallel with the north side of the barn which appears to equate to what appears to be a path shown aligned east-west on the south side of the demolished house to the west of the barn on the Tithe map (Fig 36). By c1880 this path appears to have been covered with a lean-to extension along the south side of the house (Fig 37). The revealed extent of the surface measured 3.20m (east-west) by 2.45m (north-south), but was not fully excavated to the west, where it likely extended beyond the site extent. The soil immediately overlying the surface contained several sherds of thick 19th century pottery.

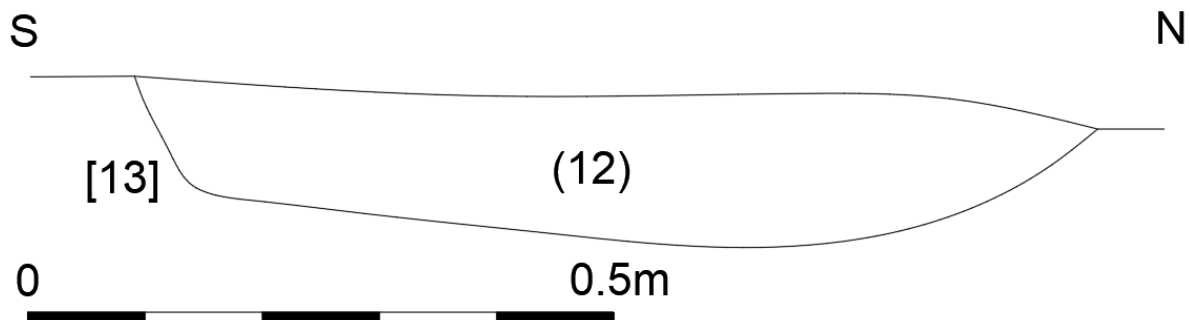
Fig 25 East facing section of pit (12) [13]

A small circular pit was identified towards the western edge of the site, measuring 0.80m in diameter and 0.12m deep. The pit contained redeposited topsoil; a mid greyish brown silty clay with occasional stones and 19<sup>th</sup> century pottery sherds.

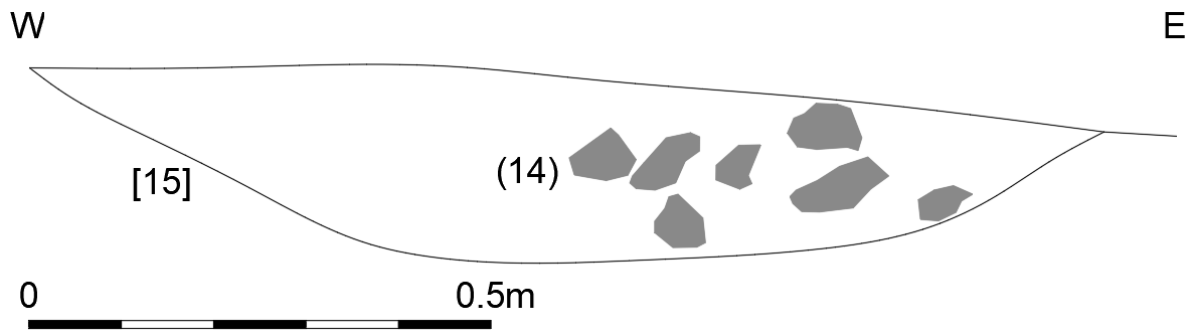
Fig 26 South facing section of ditch (14) [15]

A ditch aligned north-south was identified in the southern half of the site which is not shown on any of the historic mapping, although is likely to have been part of an earlier boundary. The ditch measured 16.20m long, 1.15m wide and 0.20m deep. The southern end of the ditch extended beyond the site extent and the northern end terminated opposite the western gable end of the barn. The fill of the ditch (14) was a mid orangey brown silty clay containing moderate small stones and occasional fragments of charcoal and slate.

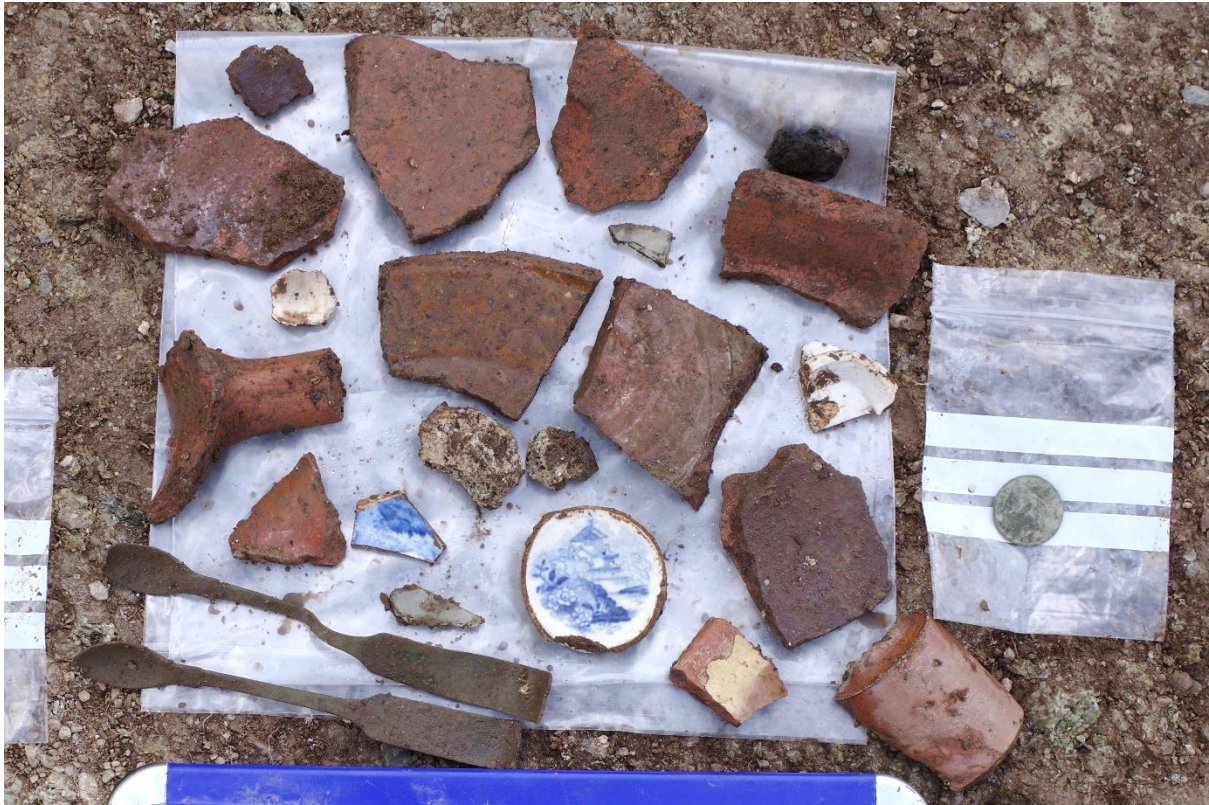
*Fig 29 Finds from pit [3] (4).*
