# **Trewhella Barn, Trewhella Lane, Relubbus, Cornwall**

## **Historic Building Record and Archaeological Watching Brief**

<b>Client</b>	<b>Alan and Tristan Brown</b>
<b>Report Number</b>	2021R078
<b>Date</b>	<b>06/12/21</b>
<b>Status</b>	Final
<b>Report author(s)</b>	<b>Connor Motley</b>
<b>Checked by</b>	<b>Jo Sturgess</b>
<b>Approved by</b>	<b>Andy Jones</b>
<b>Project number</b>	147129
<b>Site code</b>	TWL21
<b>Data location</b>	\\CAU\Archive\Sites\R\Relubbus, Trewhella Lane HBR & WB
<b>Historic England / ADS OASIS online reference</b>	cornwall2-427987
<b>Planning reference</b>	PA19/08625

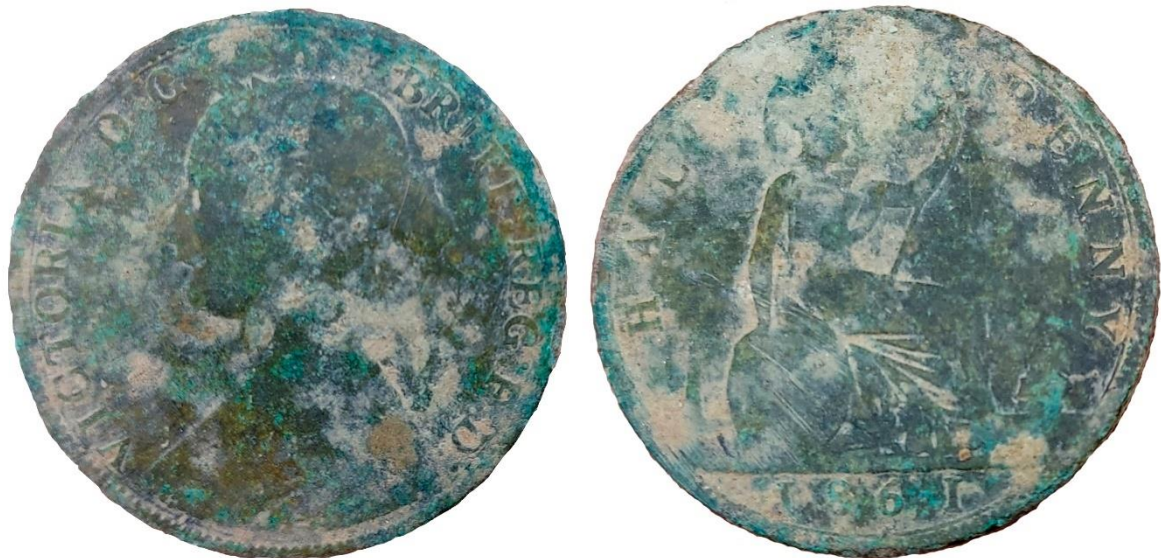
*Fig 30 Victoria 1861 Halfpenny found in waste dump (4)*

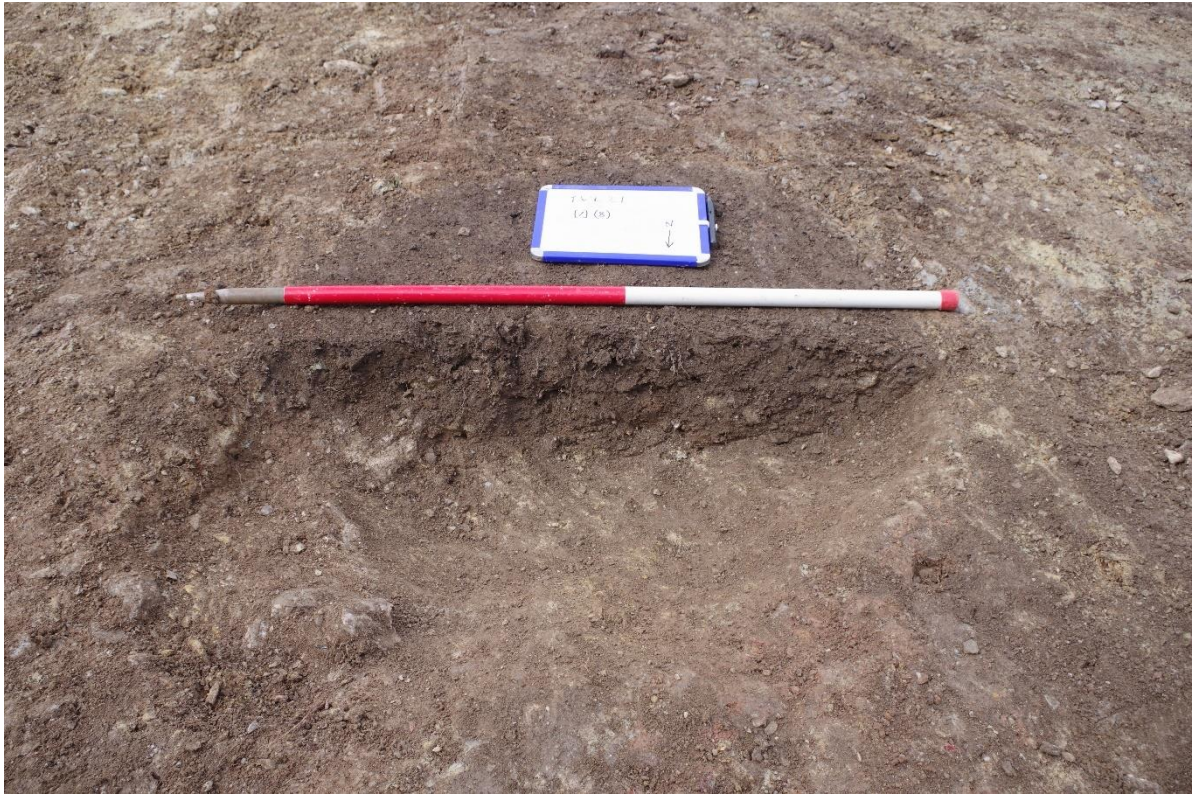
Fig 31 Sectioned animal burial [7] (8)

An animal burial (Fig 31), possibly that of a cat, was identified to the west of the barn. The burial pit was circular in plan and measured 0.95m in diameter and 0.20m deep. The fill (8) of the pit was redeposited topsoil; a mid greyish brown silty clay containing occasional late 19th century pottery and china sherds, a small piece of iron and around twenty small animal bones at the base.

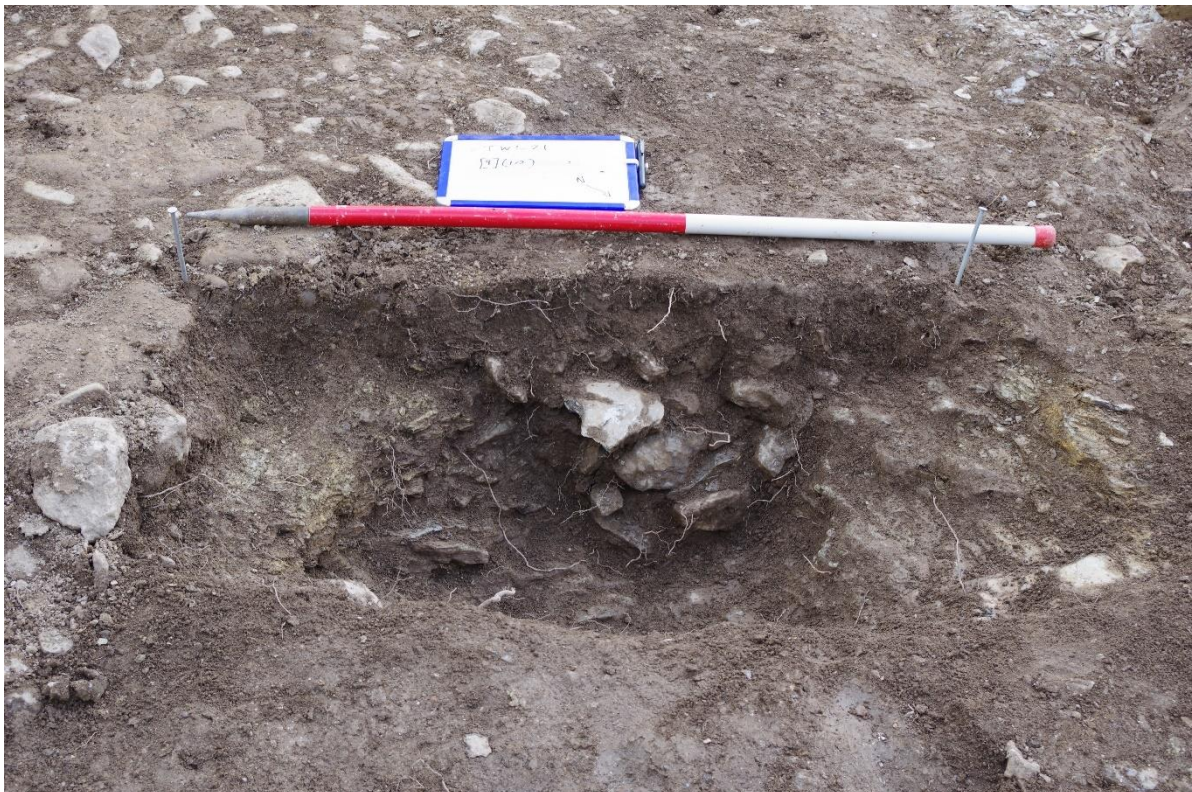
Fig 32 Section of building foundation [9] (10)

The southern foundation trench of a former house shown on the Tithe map and c1880 OS map (Figs 36 and 37) located directly northwest of the barn was uncovered. The lower 0.20m of the cut [9] had steeply sloping sides and measured 0.5m wide, above this the sides were more gently sloped, reaching a width of 1.05m at the top. The total depth of the construction cut was 0.35m and it could be traced for at least 7.00m running east-west. The eastern end was not clear in the stripped area, and the western end extended beyond the site extent. The fill of the construction cut was a mid brown greyish silty clay with frequent stone demolition material in the lower half. Finds from the fill included late 19th century pottery and china sherds, a limpet shell and an iron nail.

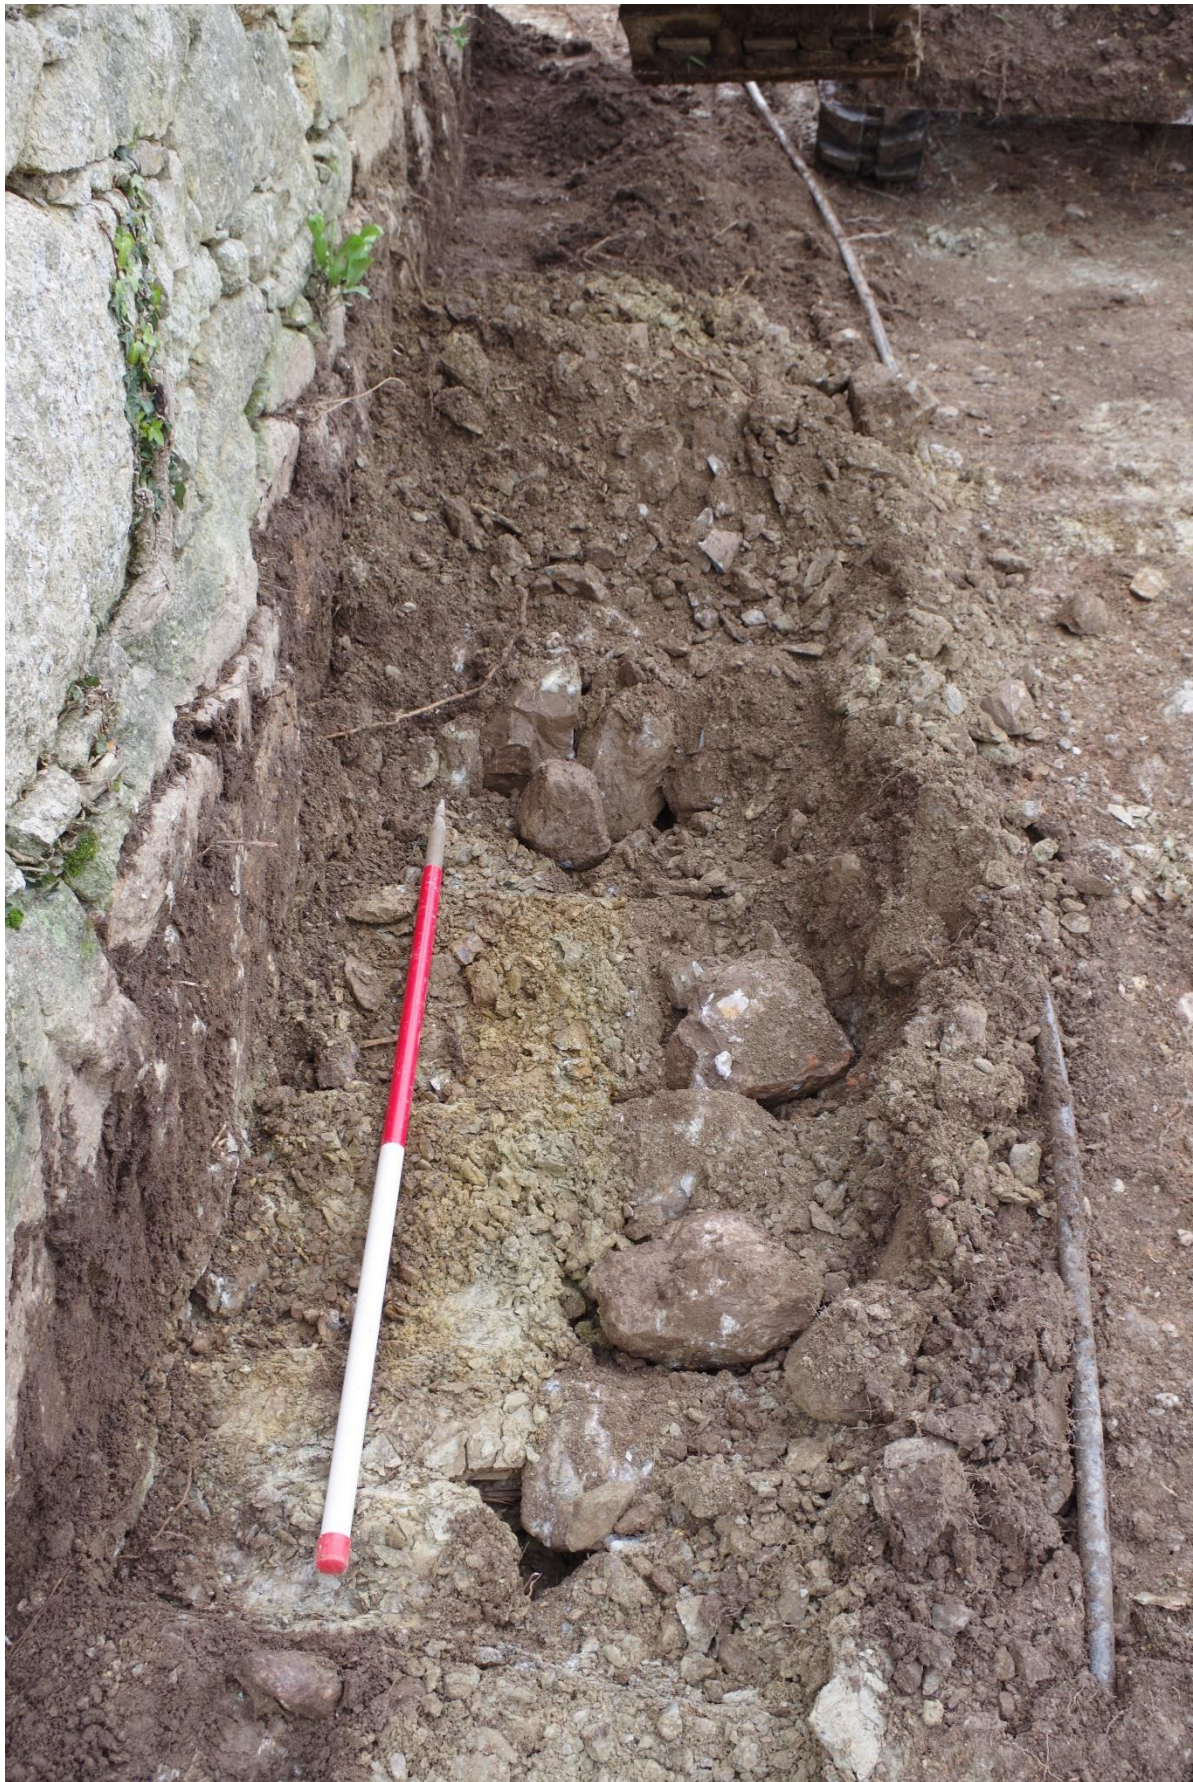
A possible stone wall (Fig 33) measuring 1.30m long was found immediately to the west of and aligned with the west elevation of the barn. The feature was one stone's width and a single course deep. It is possible that this was part of a former lean-to or flowerbed boarder as it was surrounded by demolition rubble.

*Fig 33 Possible wall 18 looking east*

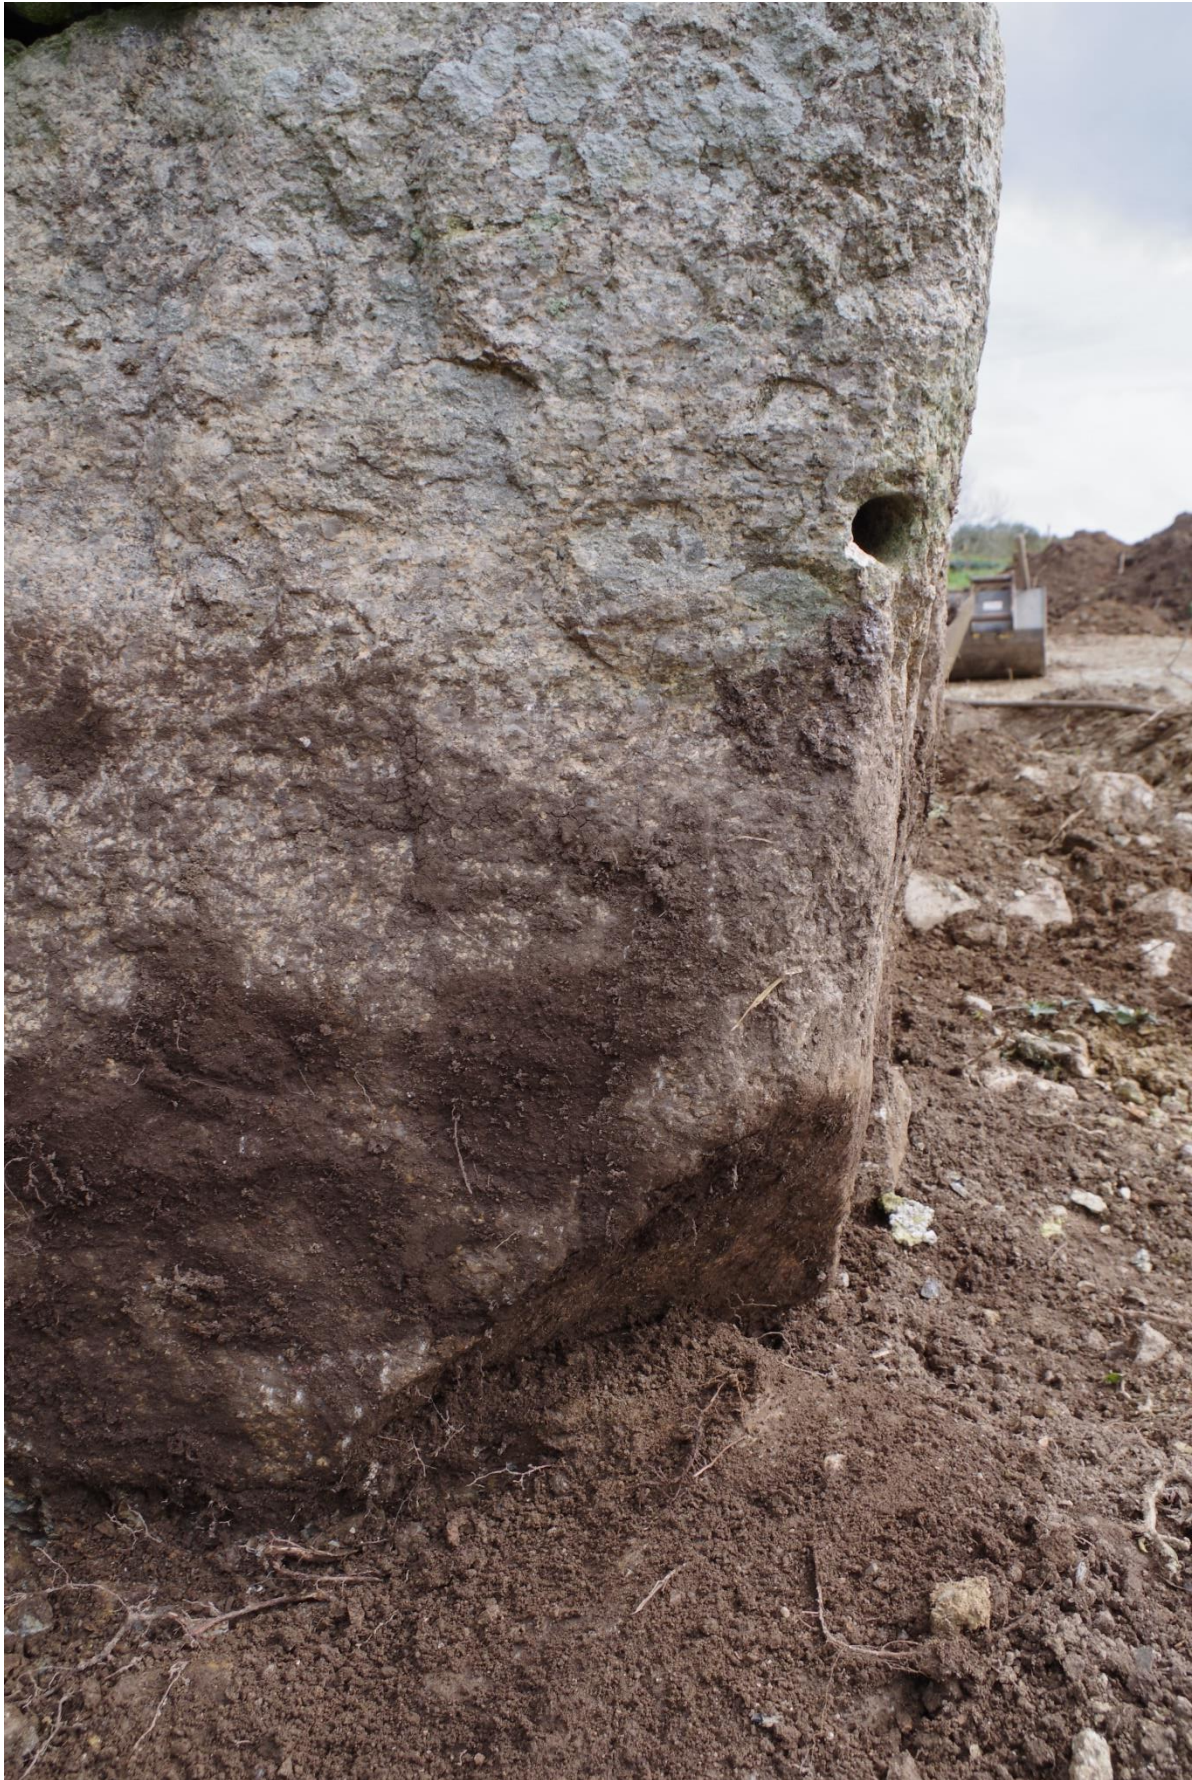
The lower part of the wall up to just below eaves level (Figs 4 and 26) is constructed from coursed granite rubble with snecking between stones, bonded with earth mortar. Above this the gable is constructed from cob which has been rendered at a later date with cement. A large portion of the cob has collapsed. In the walling below the cob there are what appear to be three small joist sockets for a lean-to which has since been removed. There are large granite quoins at either end of the wall. In the northern quoin the sixth stone up from the ground appears to be a reused kneeler stone of possible 17<sup>th</sup> century date, the fourth stone up contains a drilled hole (possible for a bolted door to the removed lean-to) and the basal quoin also appears reused with a chamfered corner at the base (Fig 25).

*Fig 34 Reused chamfered stone to northwest corner*

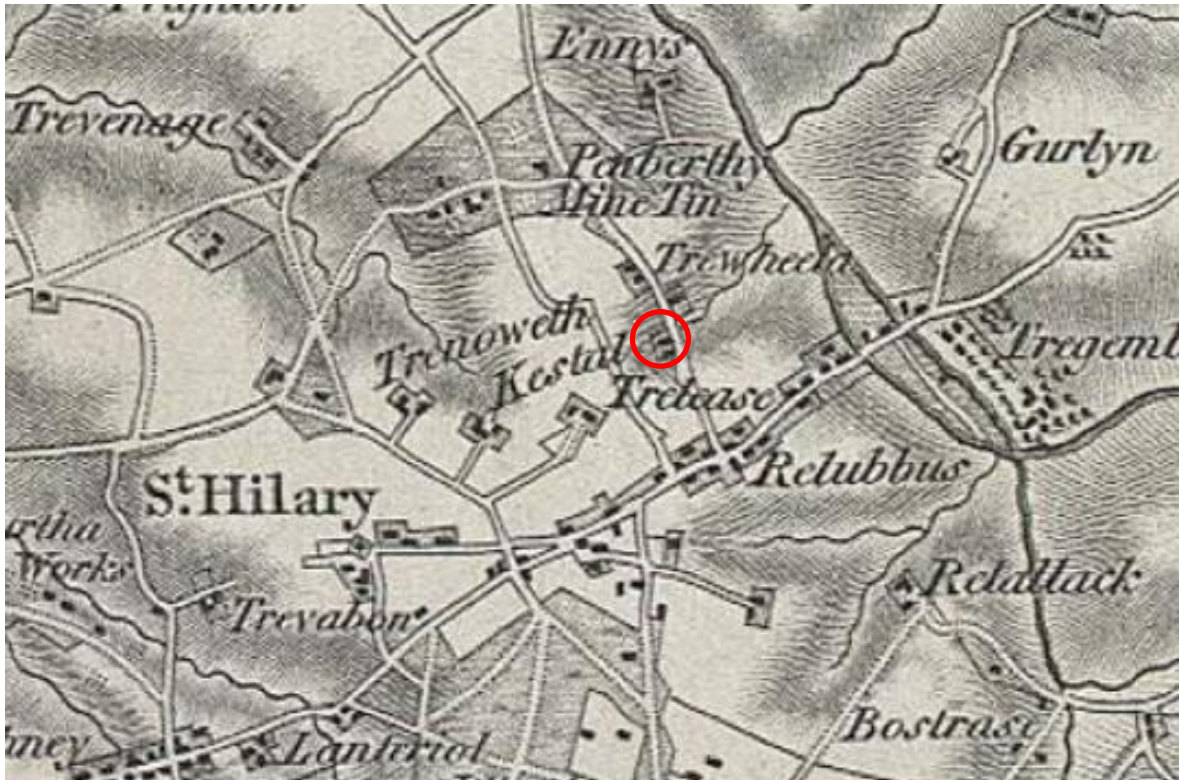
Fig 35 Ordnance Survey, Old Series Surveyor's drawing c1809 (Lower Trewheela circled in red)

The first map available to show the settlement of 'Lower Trewehela' is the OS Surveyor's Drawing of c1809 (Fig 35). The building, along with several others now demolished, is shown on the c1840 St Hillary Tithe Map (Fig 36). It is depicted as a house at this date. The plot is listed in the Tithe Apportionment as being part of Lower Trewehela tenement, owned by Christopher Hawkins and occupied by William Berryman. The plot (460) is described as 'Two Houses and Two Gardens'. In the 1851 census records William Berryman was recorded as a 41 year old farmer of 10 acres, living at Trewhella. The building is shown on all subsequent maps. On the c1880 OS map (Fig 37) there are two buildings shown immediately northwest of the extant building and another immediately to the southeast. These buildings had been demolished by c1907 (Fig 38).

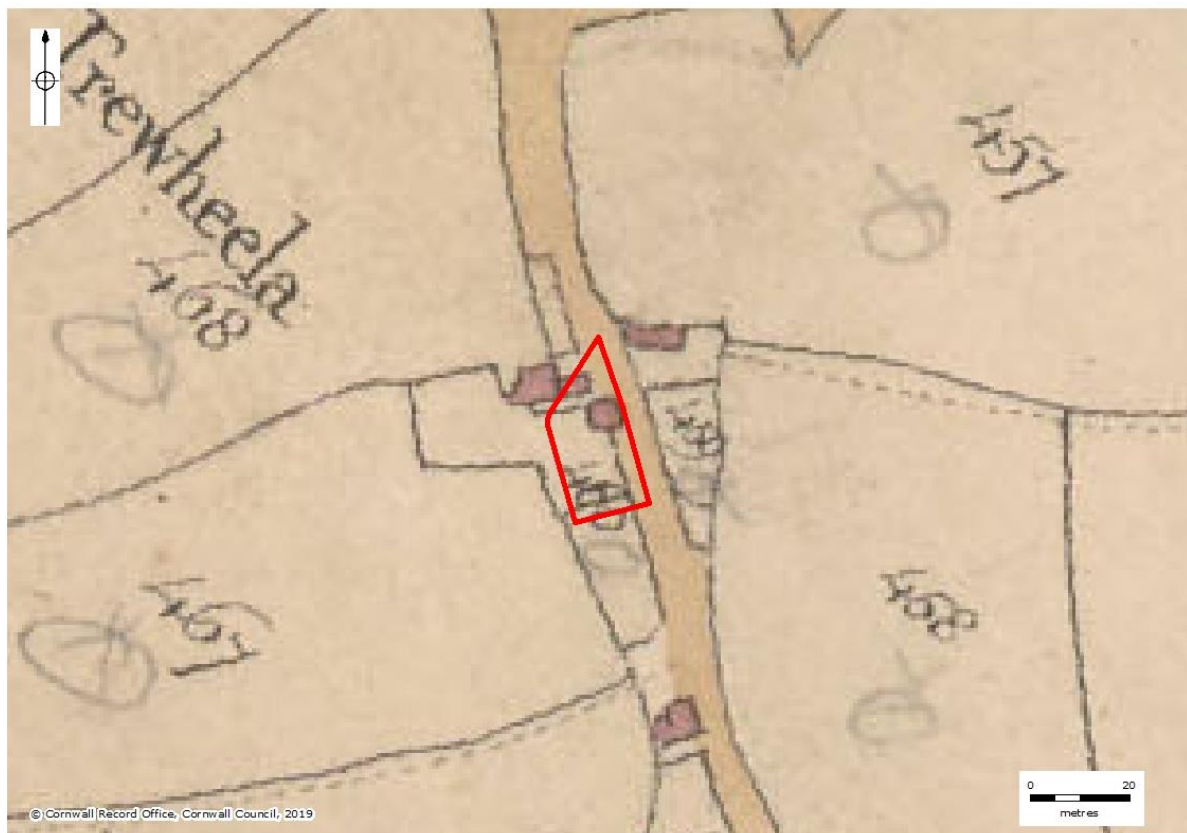
Fig 36 Tithe Map c1840

A small shallow ditch was identified in the southwest corner of the site (see Fig 28) which was in a similar position to, and probably represents the remains of, the garden boundary shown on the c1840 tithe map (Fig 36) and c1880 OS map (Fig 37). The ditch measured 1.15m wide and 0.14m at its deepest. The ditch extended beyond the extent of the site in both directions. The fill (2) of the ditch was a midgreyish brown silty clay containing occasional pieces of charcoal, bone, pottery and china sherds and a large piece of iron.

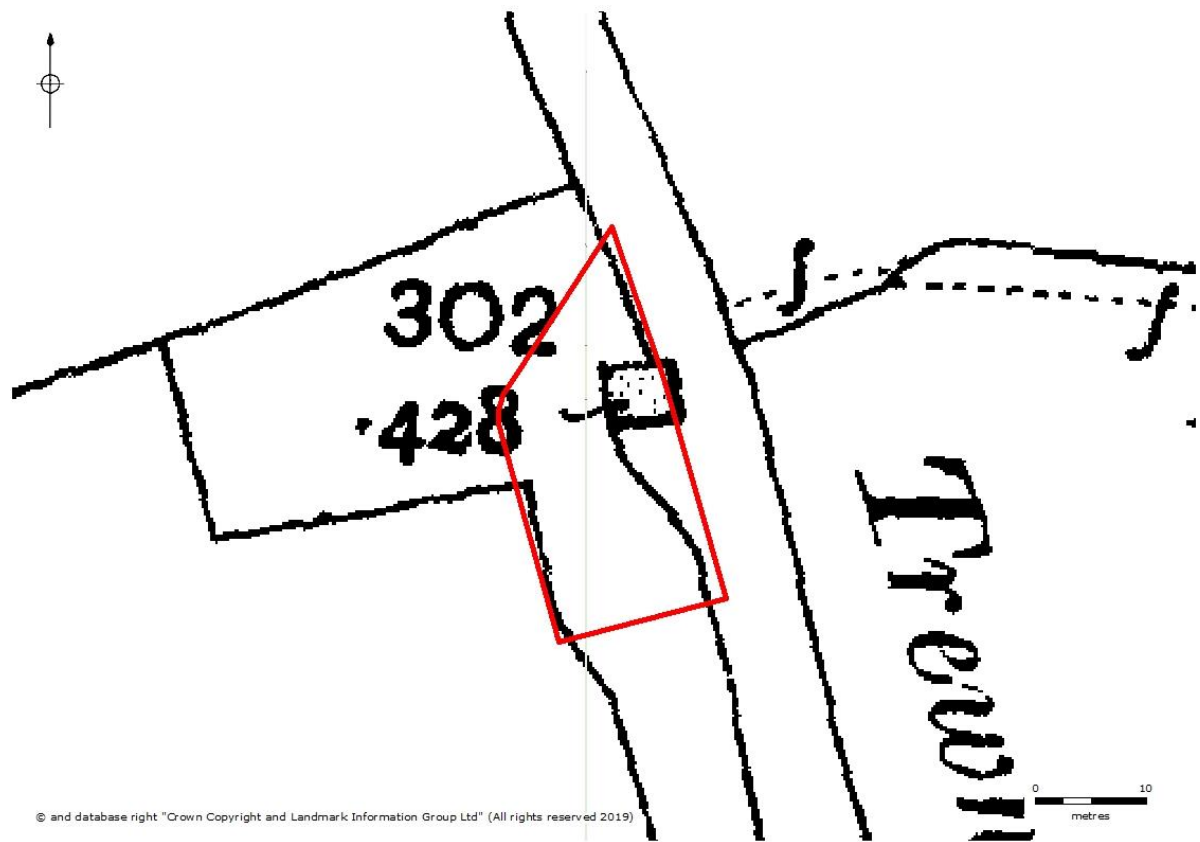
Fig 38 Second Edition of the Ordnance Survey 25 Inch Map, c1907.
