Piggery at Rooke Farm, Chapel Amble,
Cornwall
Historic building record and archaeological
watching brief

Report No: 2022R029

Client	Duchy of Cornwall
Report Number	2022R029
Date	September 2022
Status	Final
Report author(s)	Connor Motley and Jo Sturgess
Checked by	Jo Sturgess
Approved by	Andy Jones
Project number	147178
Site code	RFP22
Data location	\\CAU\Archive\Sites\R\Rooke Farm Piggery, Chapel Amble HBR and WB
Historic England / ADS OASIS online reference	cornwall2-505174
Planning references	PA20/05033, PA20/05034

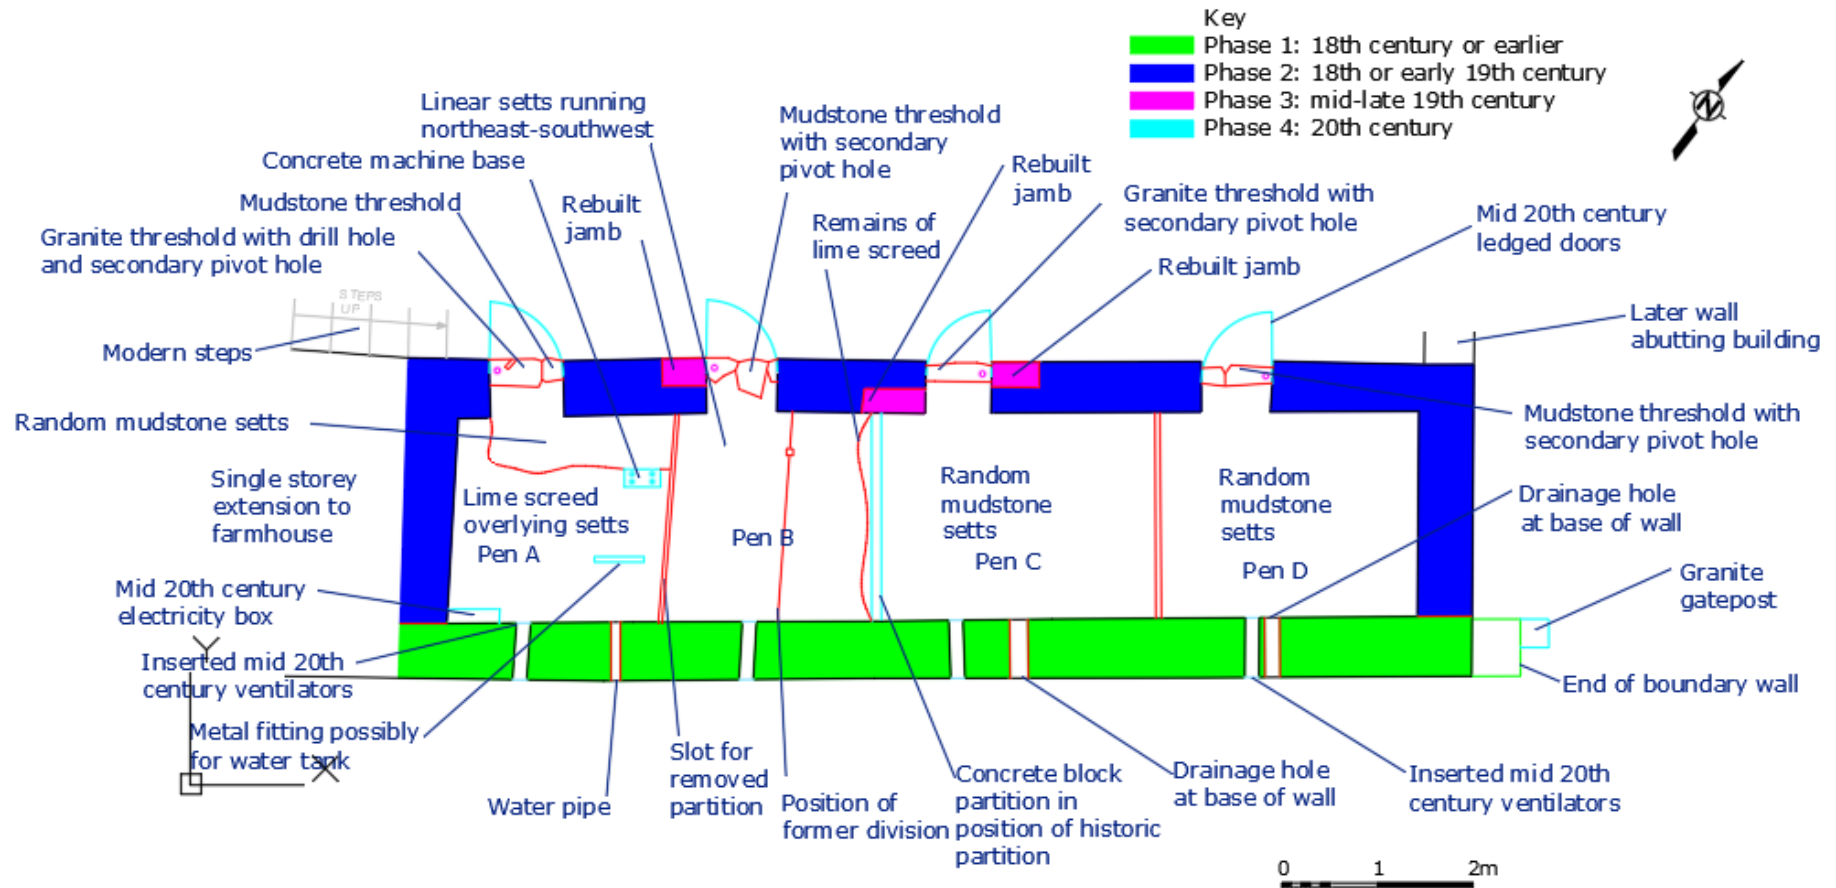
Fig 8 Phase plan of the piggery.

Phase 3: mid-late 19th century repairs

The piggery underwent a phase of repair work in the mid-late 19th century, probably when the new piggery was built opposite it on the northwest side of the yard (at some point between c1840 and c1880). At this time there is evidence that all the original doors were replaced, and new horseshoe shaped hinges added which pivoted in a socket in the threshold and another in the lintel. These replaced the original pintles for the earlier doors. Patch repairs of different masonry that match the masonry in the secondary piggery opposite were also undertaken at this time

Phase 4: 20th century alterations

Further alterations and repairs were made to the piggery in the 20th century, including the insertion of an internal concrete block partition wall, the replacement of the 19th century doors (but reusing the horseshoe shaped pivot hinges), the removal of the former vertically set slate partitions separating the pens, the insertion of ceramic ventilator pipes in the rear wall and the insertion of machine bases and electrics inside at the southwest end of the building. In addition, the rag slate roof covering was removed and reset.

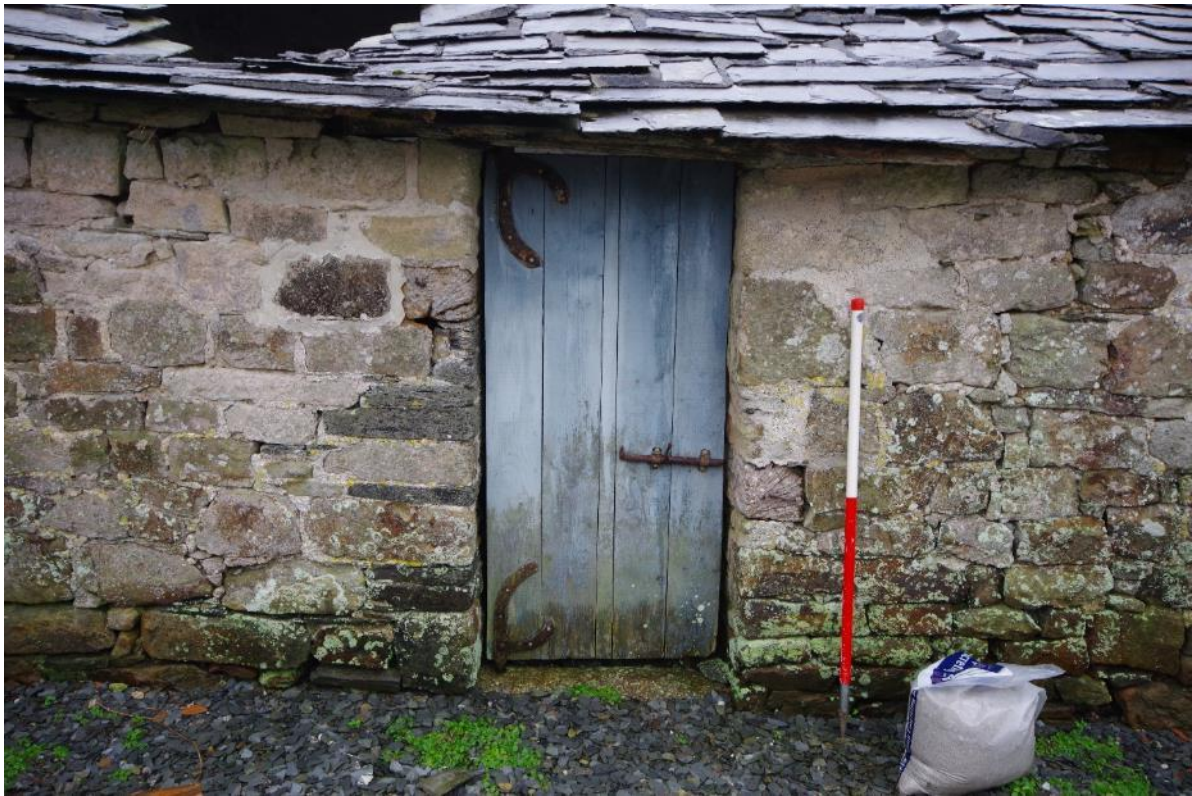
Fig 14 Door C.

Door C (Fig 14) has a reused 19th century (phase 3) iron bolt. The west jamb of the opening contains a single horizontally set timber with an original (phase 2) rectangular bolt hole and also a later round bolt hole. The east jamb contains a single horizontally set timber which is missing its original pintle. The lower timber and pintle are missing as this part of the jamb was repaired in the mid/late 19th century (phase 3).

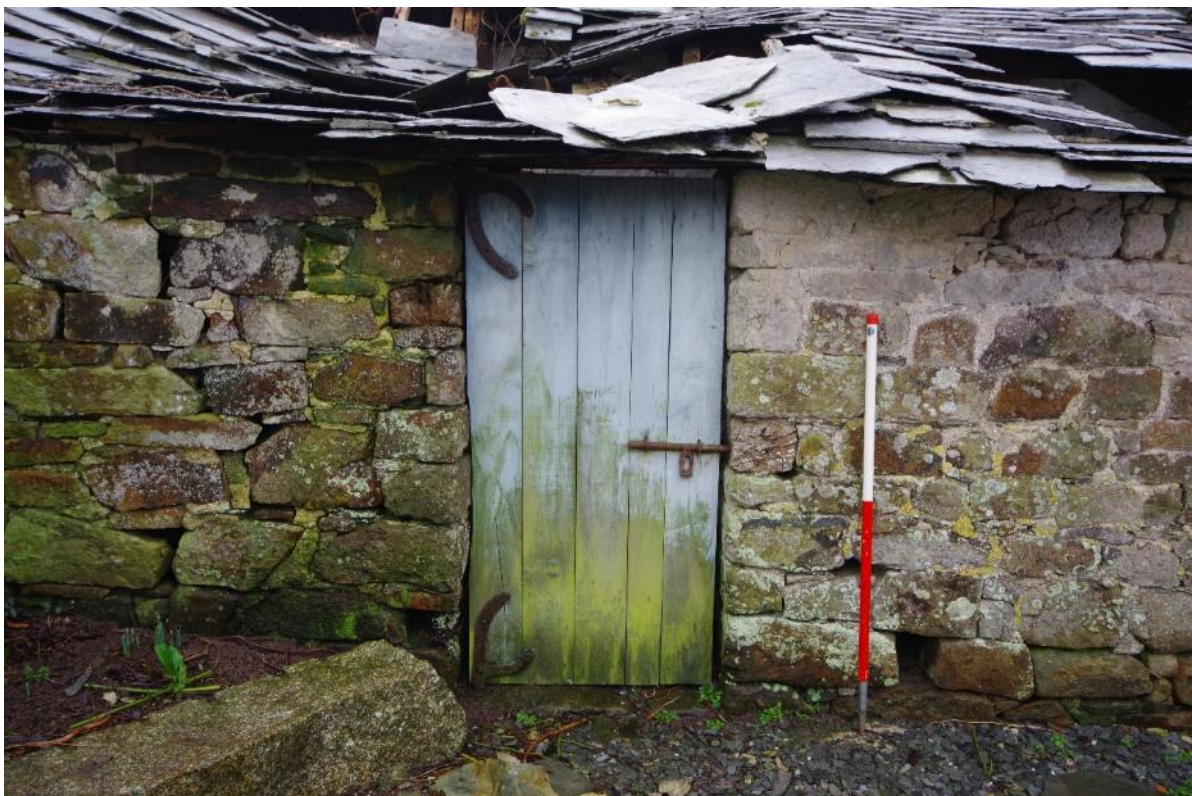
Fig 15 Door D.

Door D (Fig 15) to the east has a reused 19th century (phase 3) bolt. The west jamb of the opening contains a single phase 2 horizontally set timber with an original rectangular bolt hole and also a later round bolt hole. The east jamb contains two horizontally set timbers, the lower timber contains a phase 2 iron pintle and in the upper timber the pintle has been removed. The east end of the elevation is abutted by a later stone-built yard wall (Fig 16).

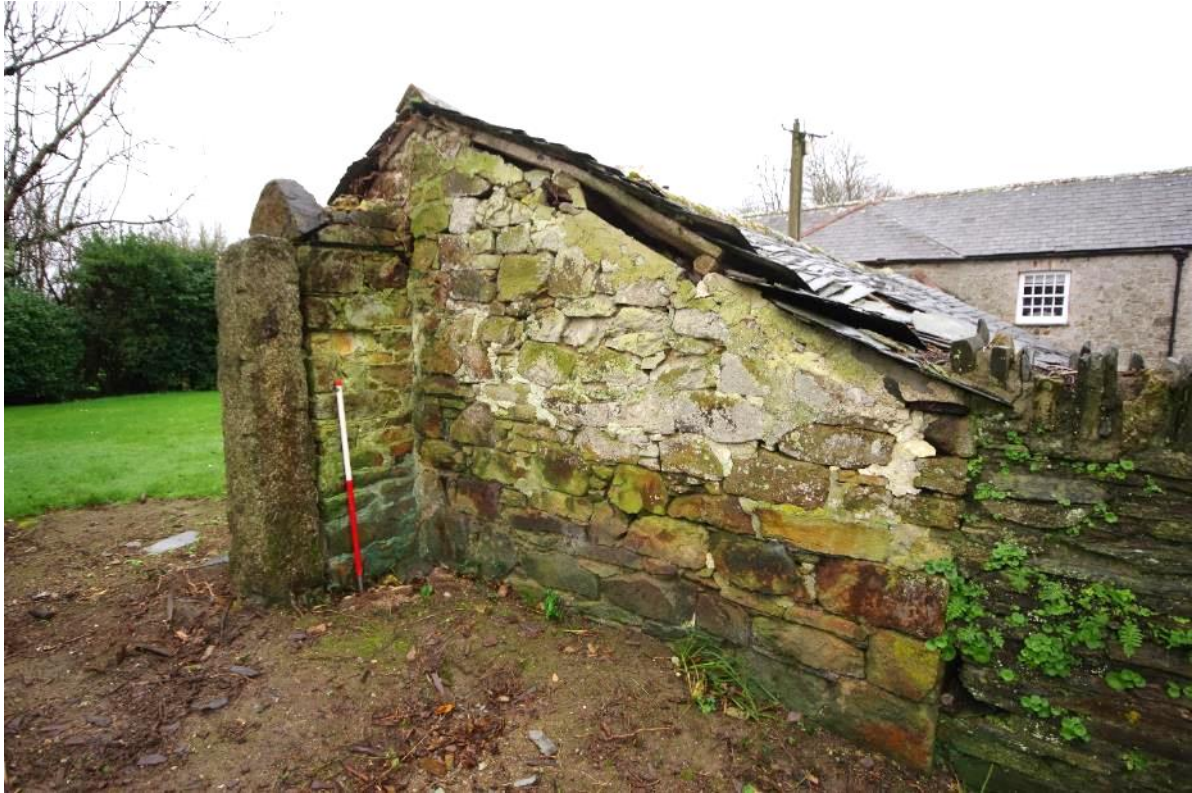
Fig 17 Northeast elevation.

The northeast elevation (Figs 9 and 17) is constructed from randomly coursed mudstone/siltstone bonded with earth mortar and repointed in places with lime mortar and cement mortar. The southeast end of this wall has been built up against the phase 1 southeast boundary wall which extends approximately 0.4m further to the northeast. Here, a 19th century granite gatepost has been added at the end of the boundary wall. At the northwest end of the elevation a later stone-built yard wall with soldier coping stones abuts the quoin.

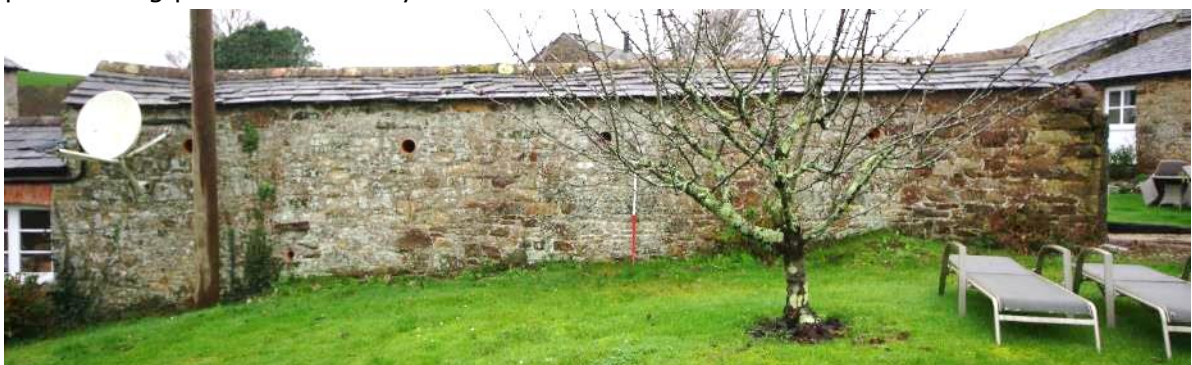
Fig 18 Southeast elevation.

The southeast elevation is a boundary wall which continues beyond the extent of the piggery in both directions (Figs 9 and 18). It is constructed from roughly coursed mudstone/siltstone rubble bonded with lime mortar and repointed in places with lime mortar and cement mortar. The northeast end of the wall (Fig 19) extends by 0.4m beyond the building and there is a 19th century granite gatepost set against the end. This section of the wall has a modern domed coping comprising mudstone/siltstone bonded with cement. Within the section of the wall that forms the rear wall of the piggery four evenly spaced 20th century ceramic pipes have been inserted horizontally through the upper part of the wall for use as ventilators (Figs 9 and 20-22). Towards the southwestern end of the wall, near the base a small modern ceramic pipe has been inserted. There is an iron plate fitting above the pipe, possibly for a water butt. A modern satellite dish has been fixed to the southwestern end of the wall and here. The base of the wall drops to a lower level and forms the rear of an adjoining late 19th or early 20th century building. The window opening of the adjoining building has been inserted in the pre-existing phase 1 boundary wall.

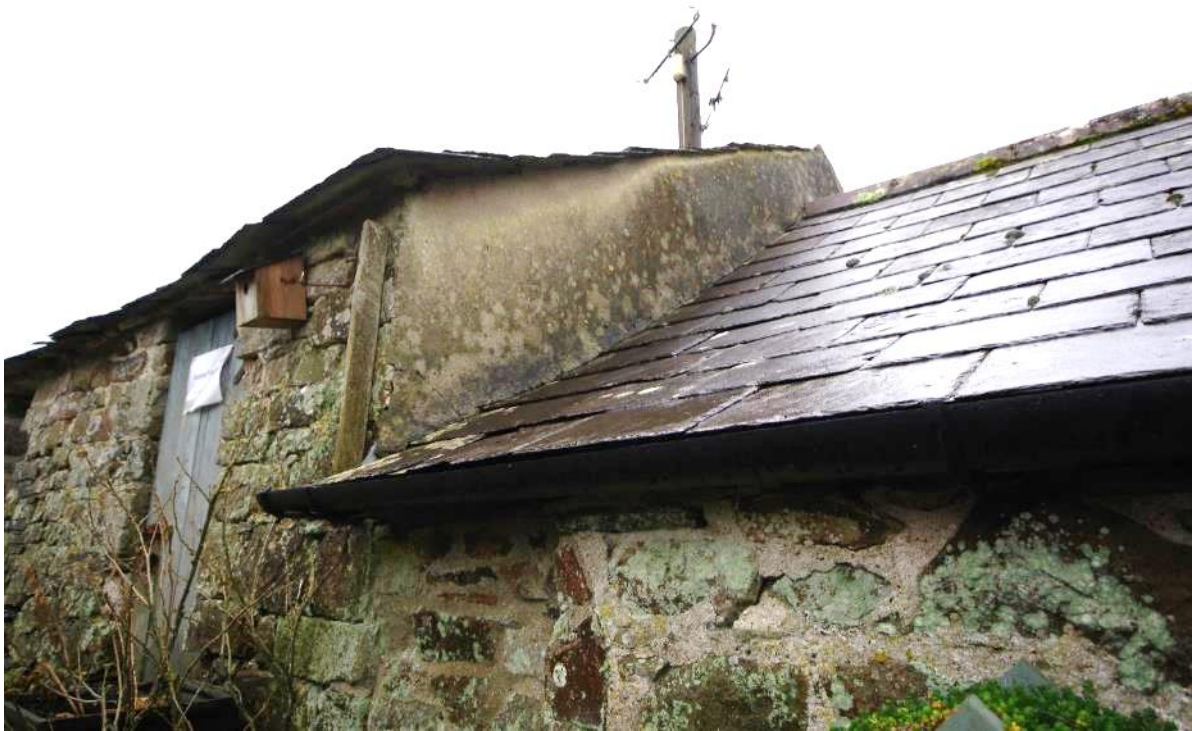
Fig 23 Southwest elevation.

Only the top part of the southwest elevation is visible above the adjoining late 19th/early 20th century building (Fig 23). It has been covered with a modern cement render.

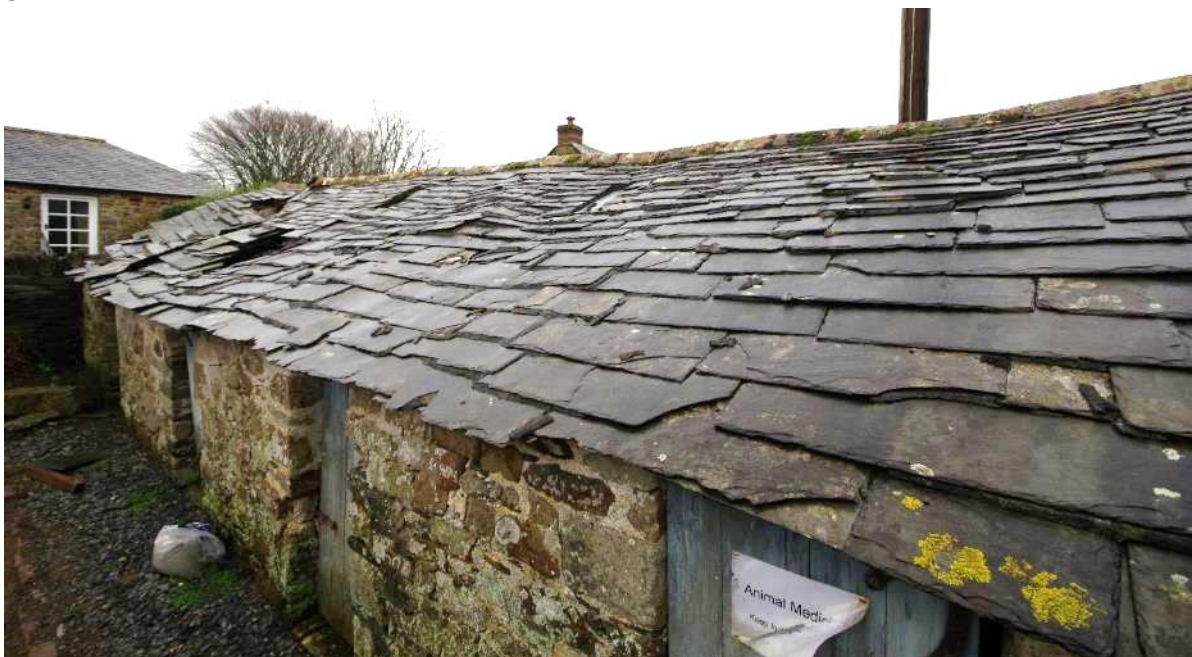
Fig 24 Roof looking east.

The roof appears as a lean-to roof but has a ridge close to the rear, southeast wall and a narrow pitch on that side. The roof covering (Fig 24) comprises original but re-laid rag slates which have been fixed in position with cement mortar rather than pegged as they were originally. Along the ridge of the roof there are historic terracotta ridge tiles (phase 2 or 3). The roof structure is set on timber wall plates which are partially missing and there are the remains of three inserted late 20th century roof lights containing reinforced glass.

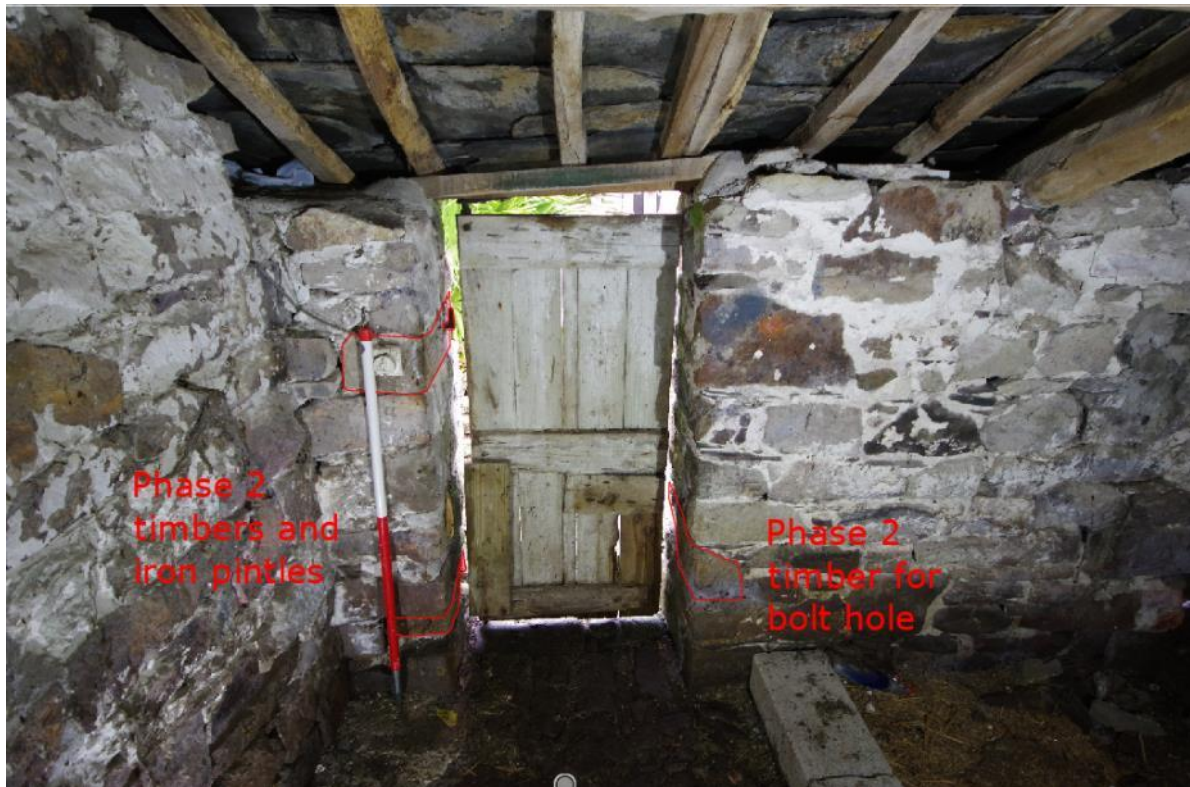
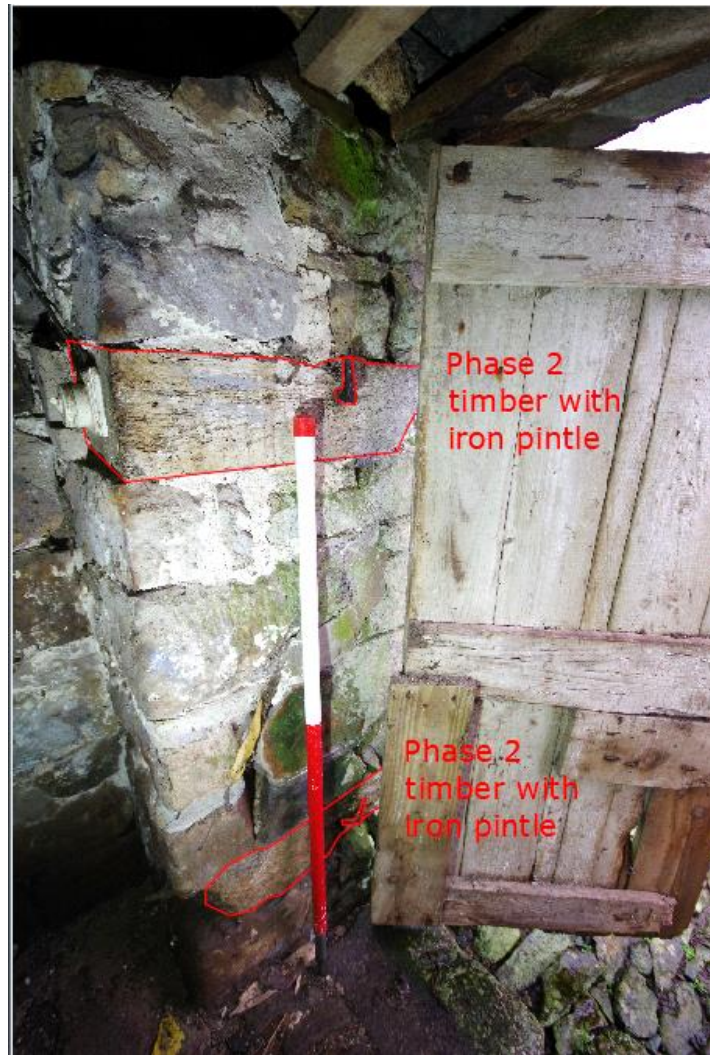
At the southwest end of the wall the southwest jamb of door A (Figs 25 and 26) contains two original timbers set horizontally in the masonry. Both timbers contain phase 2 iron pintles for the original door. Next to this jamb is a mid 20th century light switch. In the northeast jamb there is a phase 2 horizontally set timber containing a rectangular bolt hole for the original door bolt. There is a phase 3 patch repair in lime mortar on the wall next to the jamb. The door has a threshold comprising mudstone/siltstone and granite, one of which contains a socket for the mid/late 19th century (phase 3) pivot hinge.

Fig 25 Northwest wall of the piggery, showing door A.

Fig 26 Southwest jamb of door A.

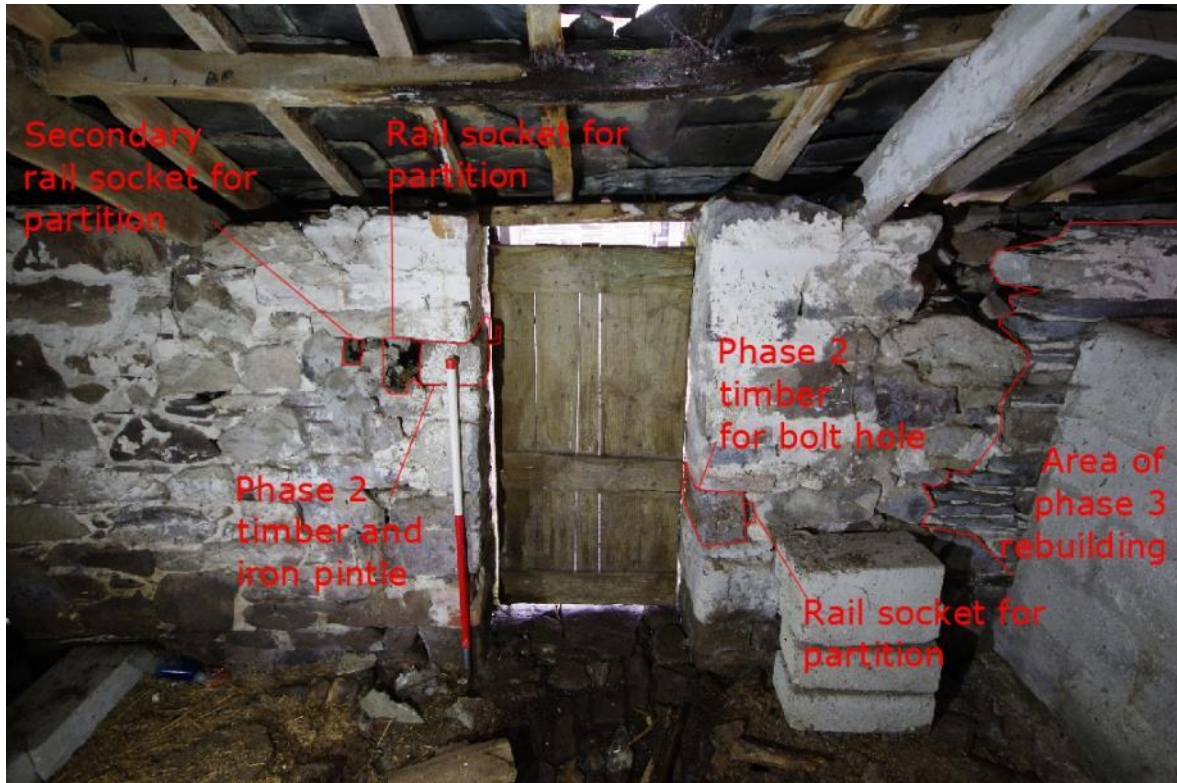
Fig 27 Northwest wall of the piggery showing door B.

In the southwest jamb of door B (Fig 27) there is a single surviving original timber containing an iron pintle for the original door. The lower timber for a second pintle has been lost when this part of the wall was repaired in the mid/late 19th century (phase 3). In the wall directly adjacent to the timber to the southwest are two sockets for removed timber rails for pen partitions. The partitions would have been aligned northwest-southeast. The larger hole closest to the door is the original, and there is a smaller hole relating to a later replacement. Parts of the jamb have been rebuilt during phase 3 with mid/late 19th century perforated bricks bonded with lime mortar. The threshold is mudstone/slatestone. There is one original horizontally set timber in the northeast jamb containing an original rectangular bolt hole and also a later round bolt hole. Next to the timber is a small socket possibly for a removed, low-level dividing rail, perhaps relating to a feeding passage. Between doors B and C there is a 20th century, inserted, northwest-southeast oriented concrete block partition wall with rounded cement capping (Figs 28 and 29). The wall is located in the position of a historic partition (see watching brief section). The area of the northwest wall that the concrete partition abuts has been rebuilt in slate bonded with lime mortar in the mid/late 19th century (phase 3).

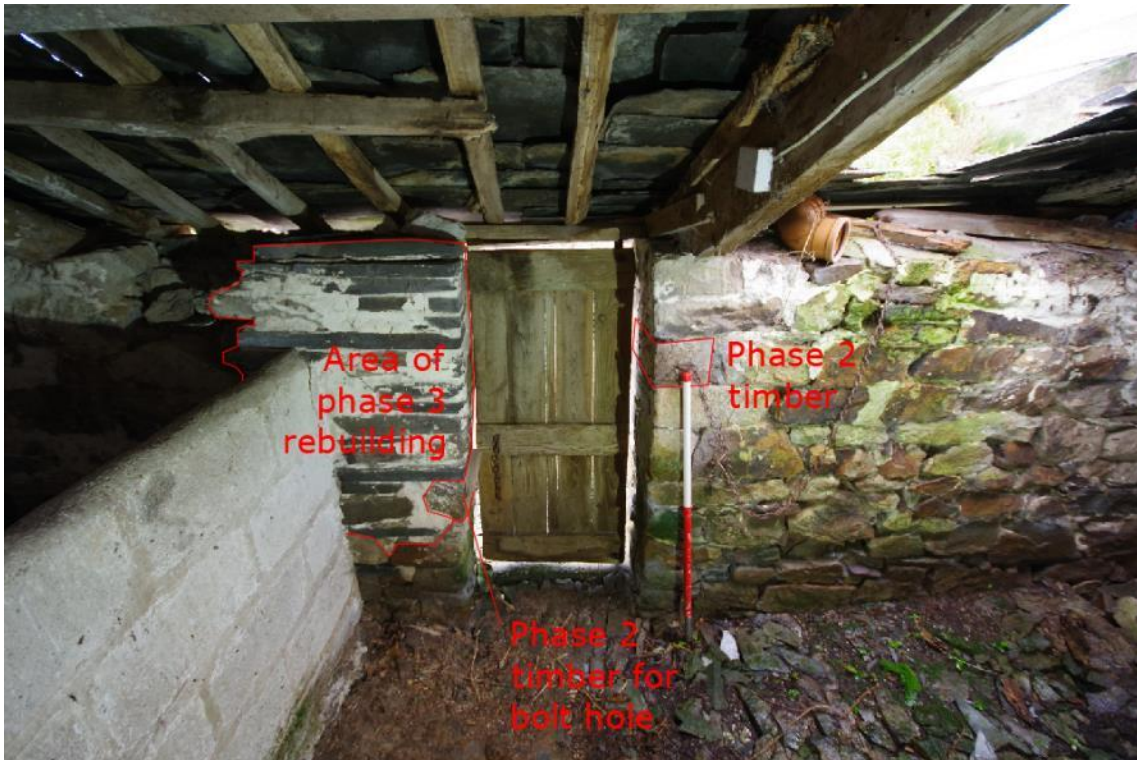
Fig 30 Northwest wall of the piggery showing door C.

Below the rebuilt area of walling, in the southwest jamb of door C there is an original horizontally set timber containing a rectangular bolt hole and later round bolt hole. The door opening (Fig 30) has a granite threshold and the northeast jamb of the opening only retains the original upper timber for a pintle, though the pintle is now missing. Internally there is part of an iron chain attached to the end of the timber. The lower timber and pintle were removed when this area of the wall was rebuilt in the mid/late 19th century (phase 3).

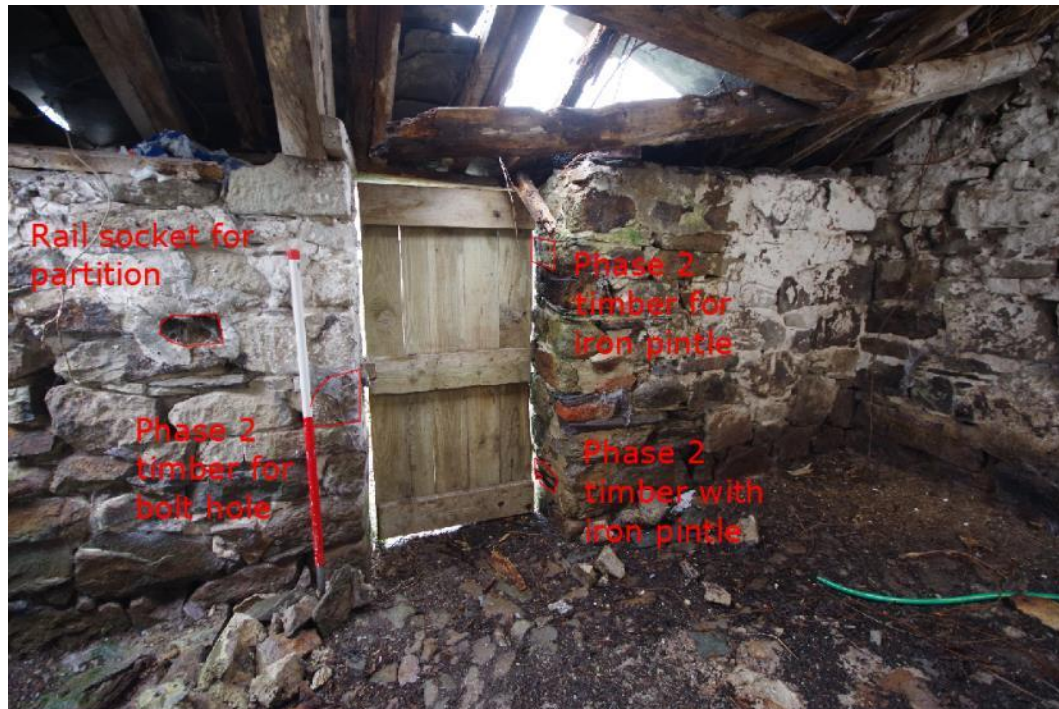
Fig 31 Northwest wall of the piggery showing door D.

To the southwest of the southwest jamb of door D (Fig 31) there is a socket for a timber rail for a pen partition. In the southwest door jamb is an original horizontally set timber containing a rectangular bolt hole and also a later round bolt hole. The threshold of the doorway is mudstone/siltstone. The northeast jamb of door D contains two original timbers for iron pintles, however, only the lower pintle survives. There are phase 3 patch repairs to this jamb containing 19th century handmade bricks. At the northeast end of the wall there are remnants of whitewash.

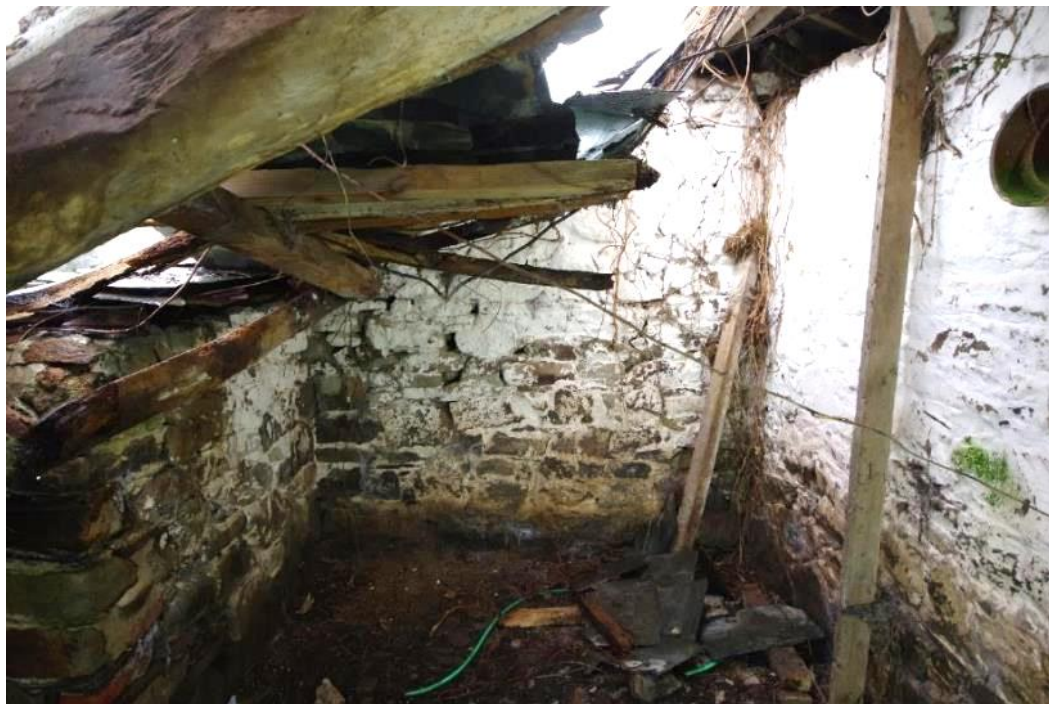
Fig 32 Northeast wall of the piggery.

The northeast wall (Fig 32) is constructed from roughly coursed mudstone/siltstone bonded with earth mortar. There are remains of whitewash on the wall.

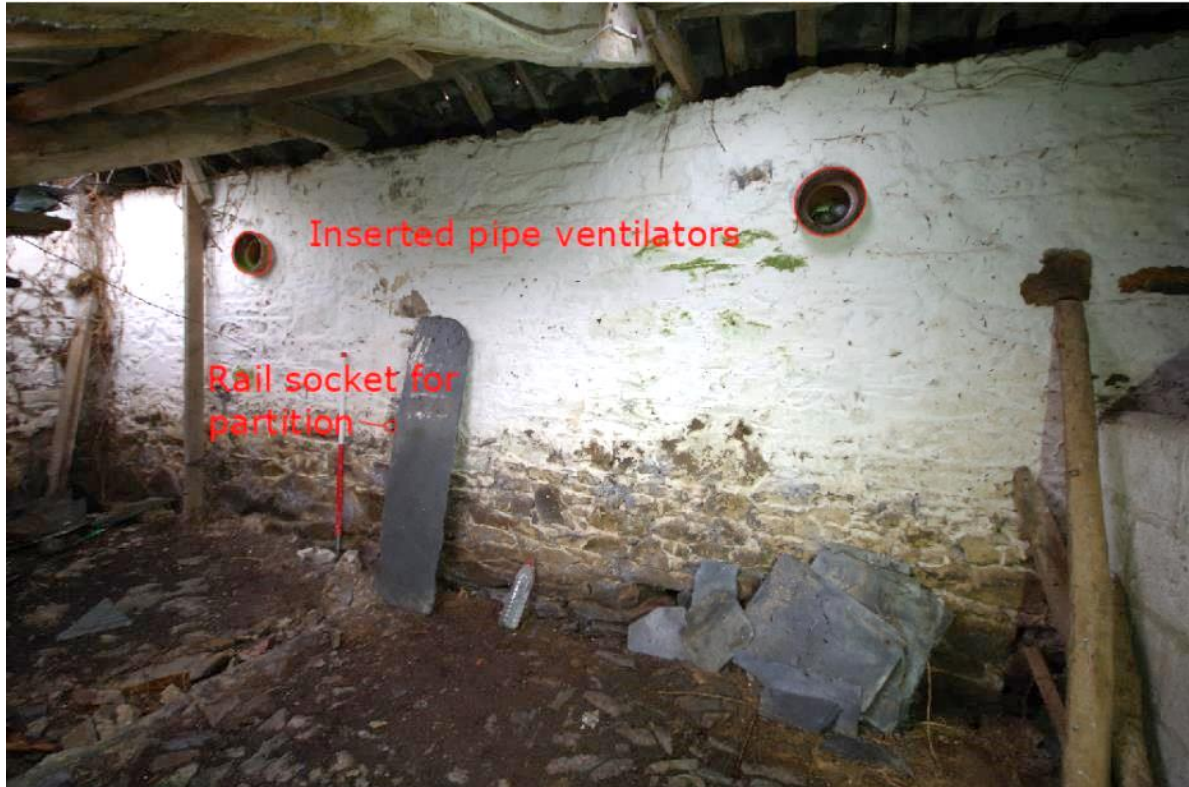
Fig 33 Southeast wall of the piggery, northeast end.

The southeast wall (Fig 33) is constructed from randomly coursed mudstone/siltstone rubble bonded with lime mortar with whitewash/ white paint over. There are four 20th century ceramic pipe ventilators which have been inserted horizontally through the upper part of the wall. These are evenly spaced along the length of the wall. In the north-eastern half (Fig 33) there are two small, rectangular drainage holes at the base of the wall. There is a socket for a former timber rail for a pen partition between the two north-eastern ventilators. Towards the centre of the wall a 20th century concrete block-built partition with rounded concrete coping has been inserted, abutting the rear wall. This replaces an original pen partition in the same location (see watching brief results). One of the historic, slate slabs, which would have been set upright with others to form a pen partition wall, is now lent up against the southeast wall (see Fig 33).

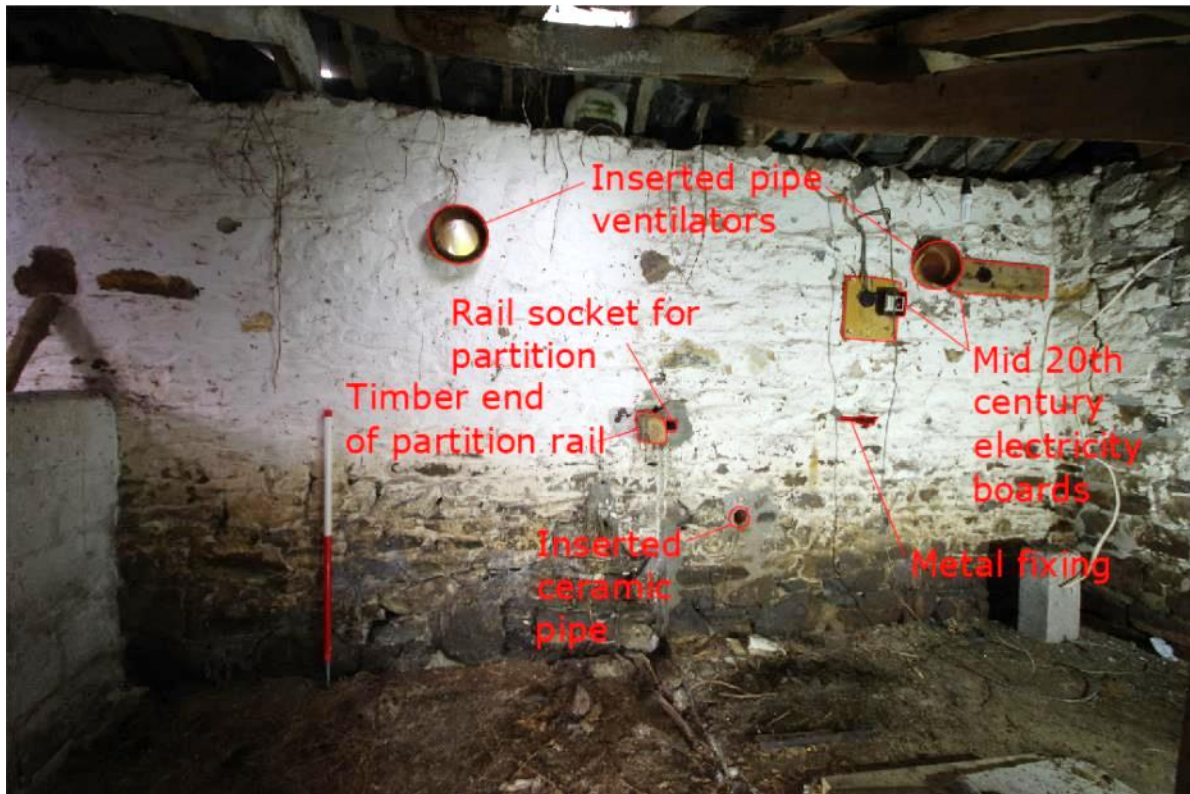
Fig 34 Southeast wall of the piggery, southwest end.

The south-western half of the southeast wall (Fig 34) contains two 20th century ceramic pipe ventilators inserted in the upper part. Between and below the two inserted ventilators the end of a sawn off timber is visible. This appears to have been a rail of a removed pen partition. Directly southwest of this there is a small socket for a secondary rail. Southwest of this socket and lower down the wall there is an inserted ceramic pipe, possibly for water. At the south-western end of the wall there are two early/mid 20th century electricity boards, one with ceramic insulators and Bakelite switch. There is also a metal fitting below this board which may relate to associated cables.

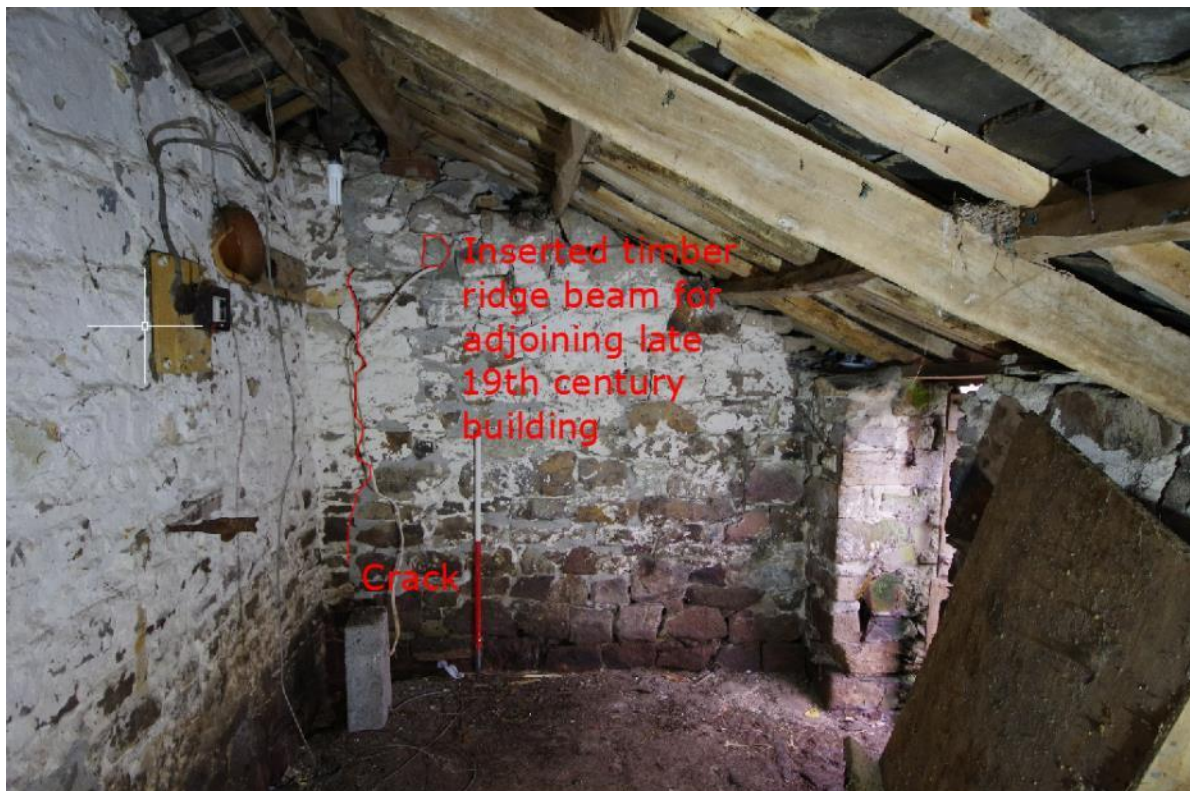
*Fig 35 Southwest wall of the piggery.***Floor**

The southwest wall (Fig 35) is constructed from randomly coursed mudstone/siltstone bonded with earth mortar. There are remnants of whitewash on the wall and the end of an inserted timber associated with the roof of the adjoining late 19th century building is visible towards the top of the wall. There is a long vertical crack towards the southeast end.

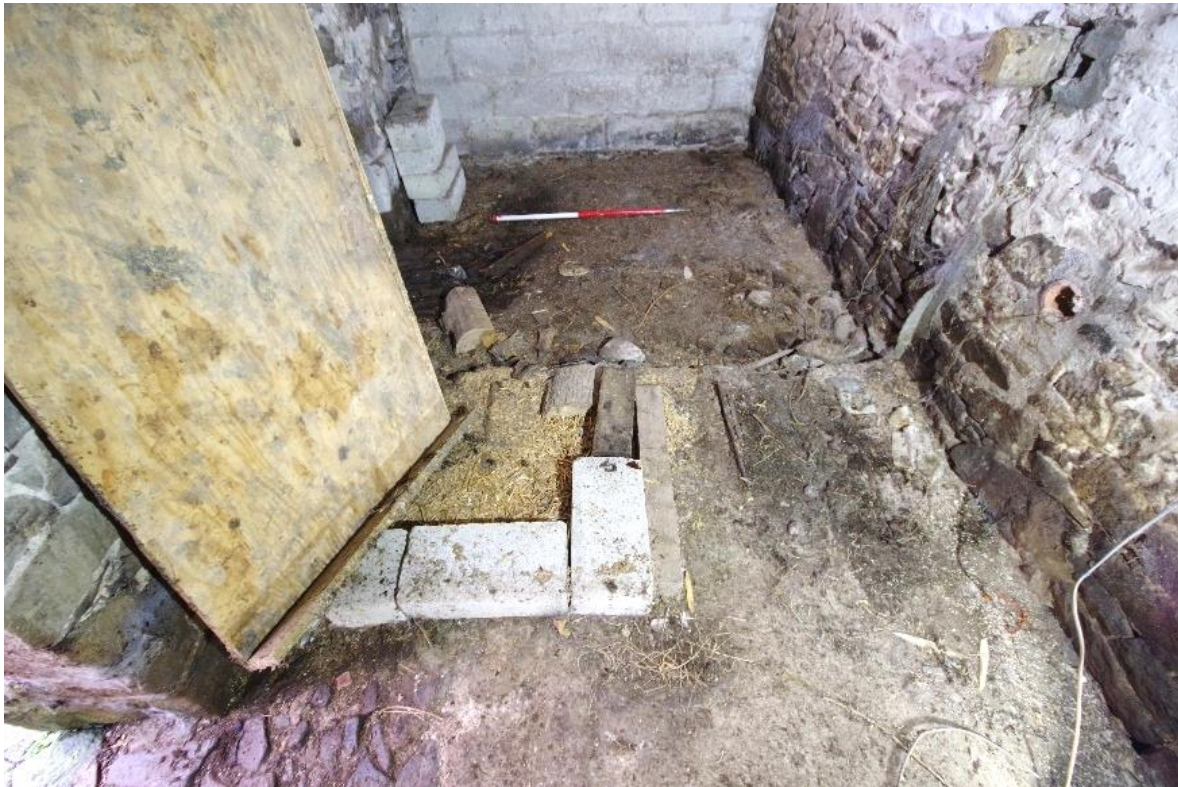
*Fig 36 The floors of pens A and B looking northeast.*

The floor of pen A (Fig 36) at the southwest end of the building is covered mainly with a lime screed which overlies an original (phase 2) floor surface of stone setts. At the north corner of the former pen there is an inserted 20th century concrete and timber machine base containing four bolts. Directly opposite a small low-level inserted ceramic pipe in the southeast wall there is a metal fitting in the floor, possibly the base for a water feed. Between pens A and B is a narrow slot in the floor, indicating the position of the removed original slate pen partition wall. The floor of pen B comprises stone setts with the remains of a later lime screed over it along the northeast edge. The setts near the door are aligned northwest-southeast, however, the setts in the rest of the room are randomly laid suggesting that the floor has been repaired. To the northeast of the door in pen B there is a square socket containing a rotten, upright timber (former post for the removed partition wall). Close to the southeast wall there is a straight edged stone aligned with the square socket in the floor to the northwest and another socket for a rail in the northwest wall, indicating the position of the former half height pen partition wall.

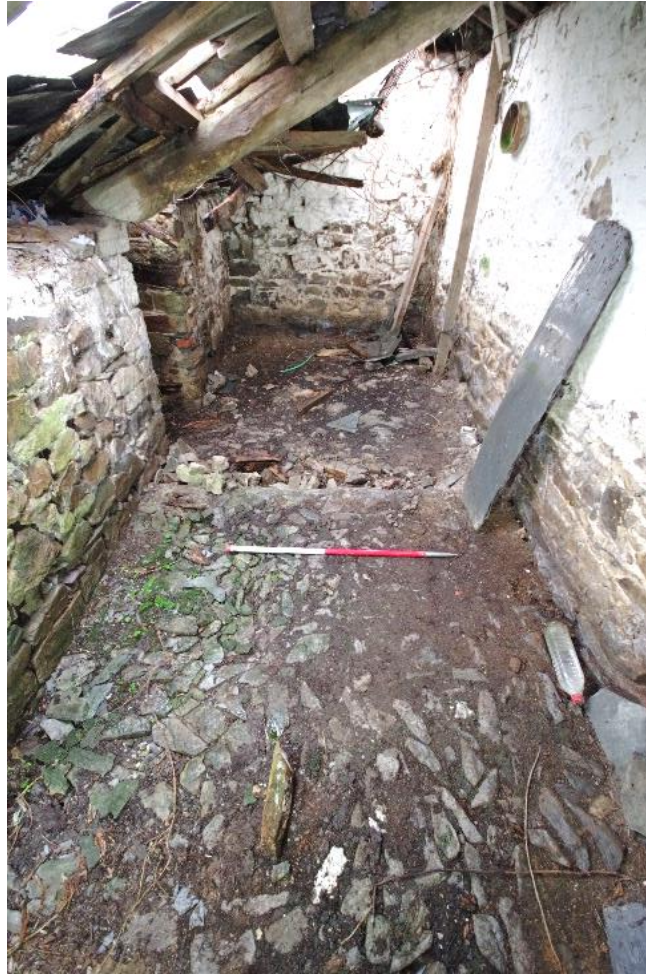
Fig 37 The floors of pens C and D looking northeast.

Between pens B and C there is a 20th century inserted concrete block partition wall with rounded cement capping which has replaced the earlier pen partition in this location. The floors of bay C and D both comprise randomly laid mudstone setts with no indication of a later lime screed. The two pens are divided by a linear slot in the floor indicating the position of a removed slate partition wall. One of the slate slab which once formed this partition is leant up next to it against the southeast wall (Fig 37).

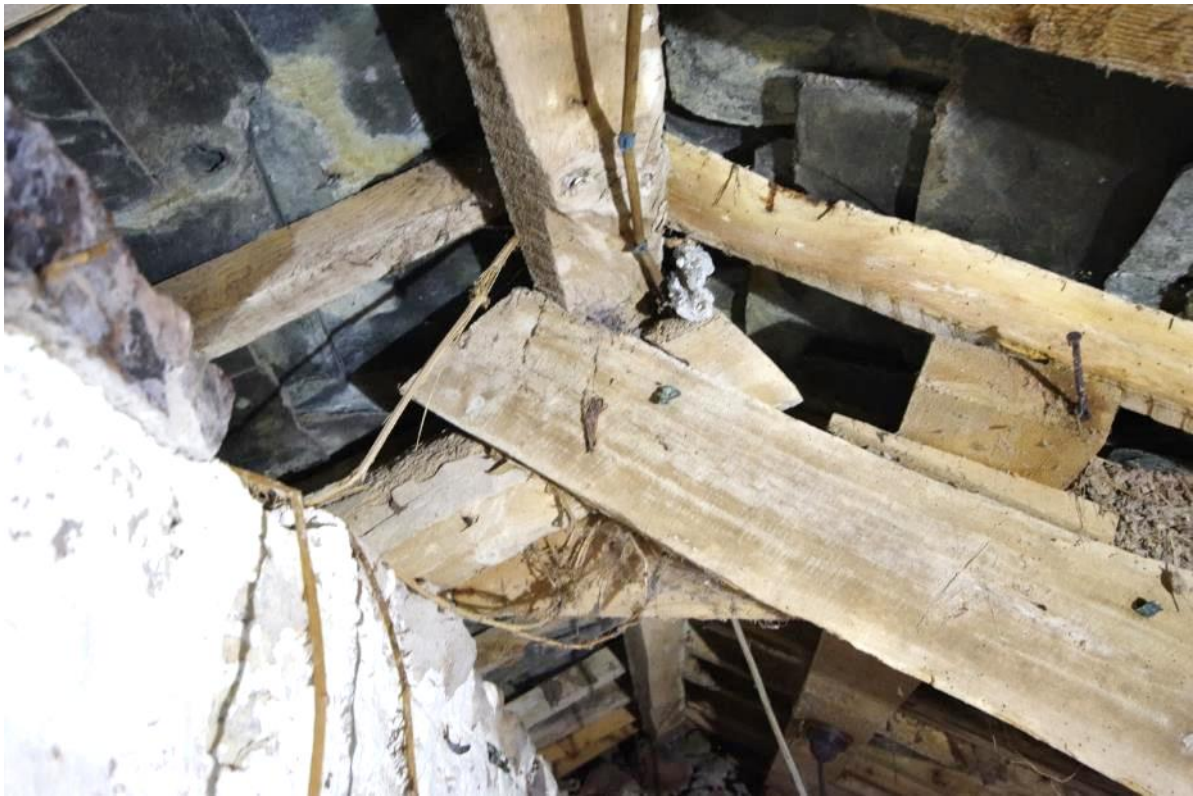
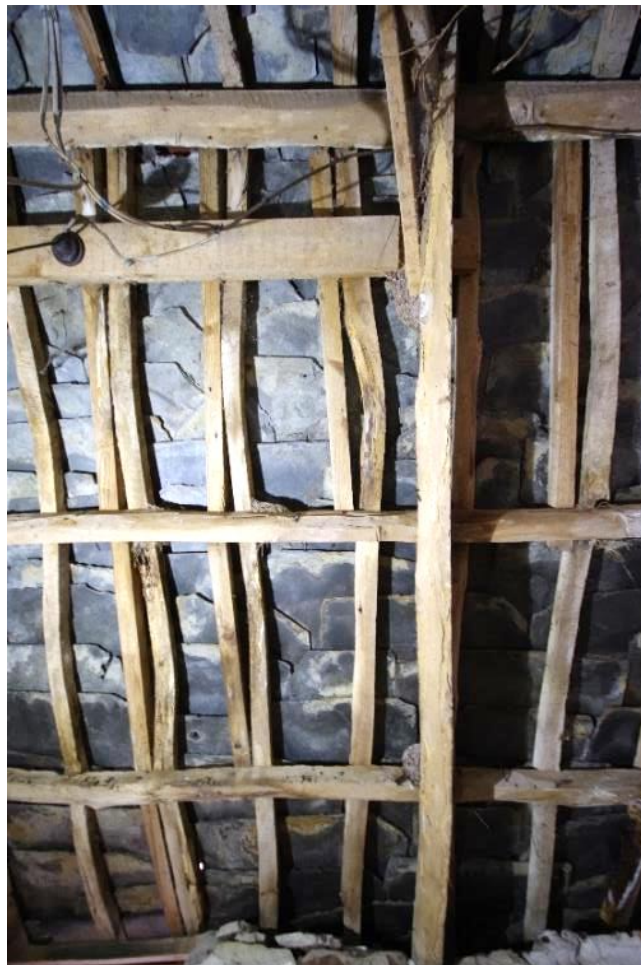
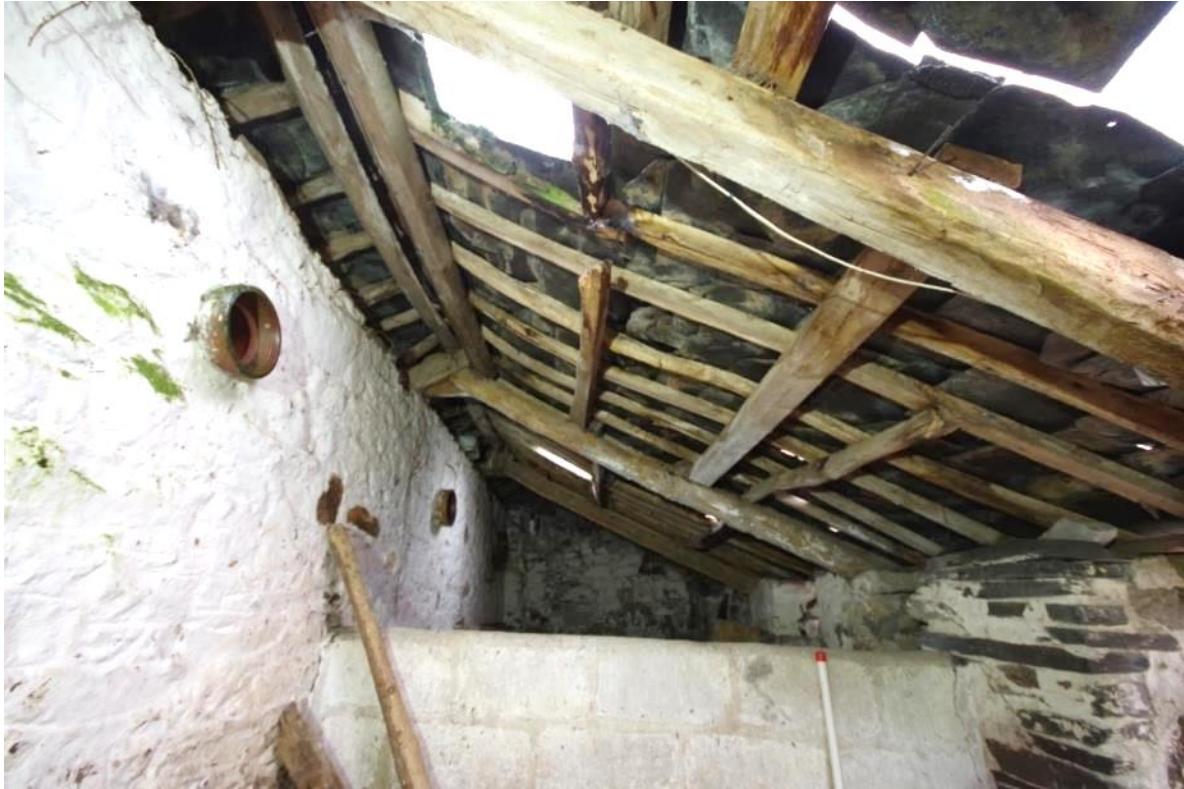
The roof structure has five bays and four simple collar trusses with very short principal rafters to the southeast (Figs 38-41). The trusses are lap jointed and held together with hand forged nails. The ridge timber, rafters and two sets of purlins to the northwest are all roughly hewn and some retain traces of whitewash. The roof structure appears to be largely original except for several additional modern purlins in the south-western bay and three in the north-eastern bays. The rag slate roof covering is not attached to the roof structure by any visible means and the slates have clearly been re-laid as the peg holes in the slates are not pegged and are not in their correct positions. There are three modern, inserted roof lights containing reinforced glass.

Fig 38 Example of the small collar trusses.

Fig 39 Roof structure at the southwest end of the building.

Fig 40 The roof structure looking southwest.

Fig 41 Phase plan including the trusses and purlins of the roof structure.
