Piggery at Rooke Farm, Chapel Amble,
Cornwall
Historic building record and archaeological
watching brief

Report No: 2022R029

Client	Duchy of Cornwall
Report Number	2022R029
Date	September 2022
Status	Final
Report author(s)	Connor Motley and Jo Sturgess
Checked by	Jo Sturgess
Approved by	Andy Jones
Project number	147178
Site code	RFP22
Data location	\\CAU\Archive\Sites\R\Rooke Farm Piggery, Chapel Amble HBR and WB
Historic England / ADS OASIS online reference	cornwall2-505174
Planning references	PA20/05033, PA20/05034

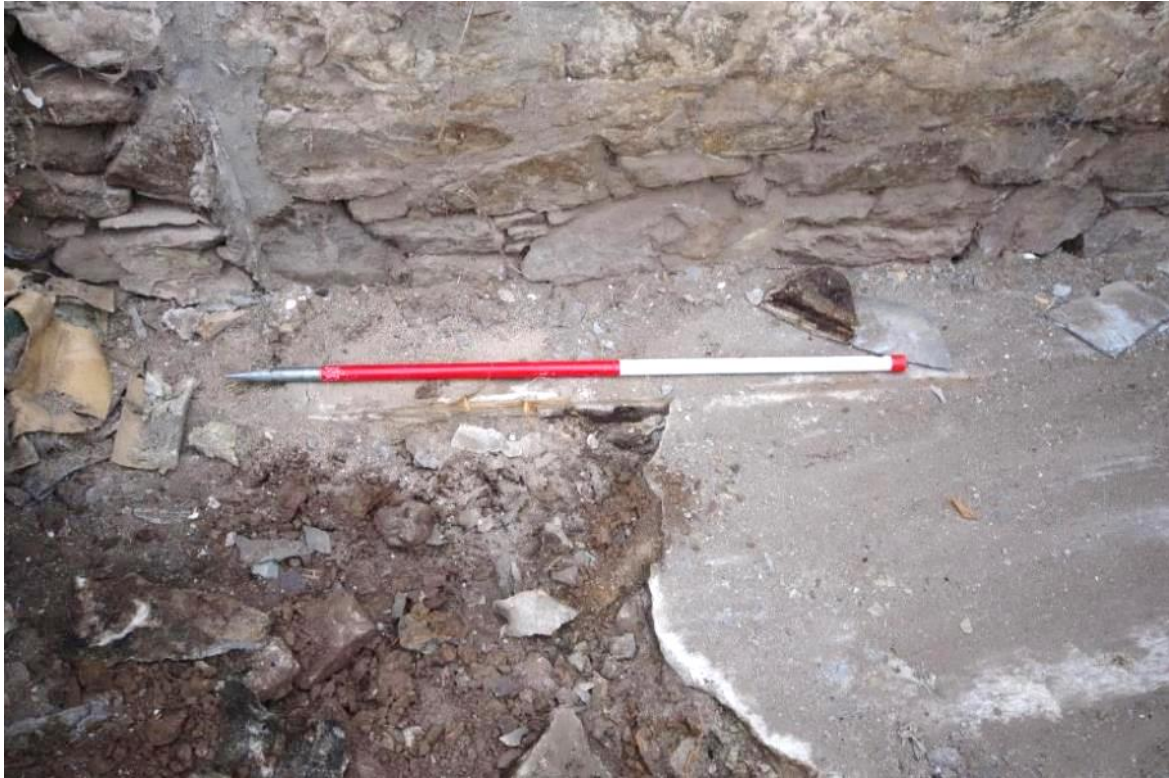
Fig 43 The timber revealed embedded in the lime screed (102).

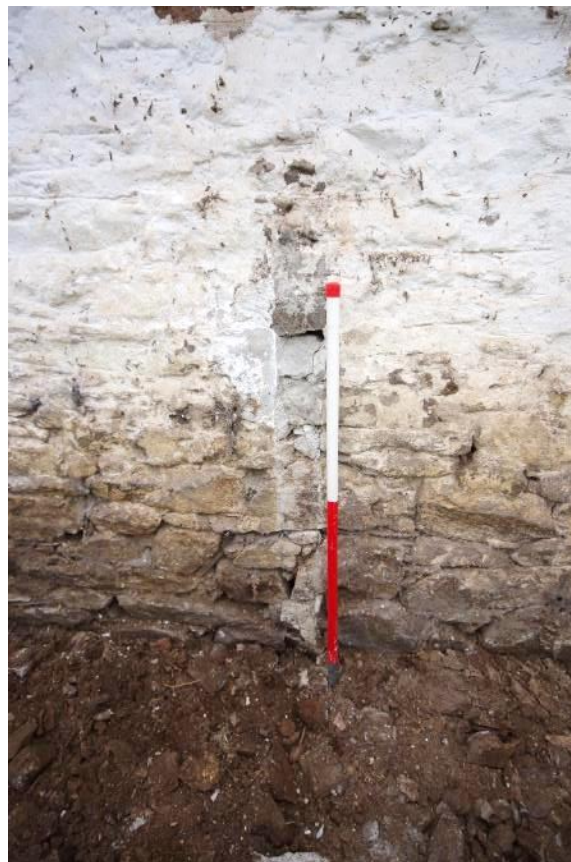
Fig 44 Southeast wall showing the position of the removed concrete block-built partition wall and an earlier rail socket (blocked with cement mortar).
