Trelissick House, Feock, Cornwall
Archaeological Watching Brief

Trelissick House, Feock, Cornwall, Archaeological Watching Brief

Client	National Trust
Report Number	2022R015
Date	April 2022
Status	Final
Report author(s)	Fiona Fleming
Checked by	Jo Sturgess
Approved by	Andy Jones
Project number	147158
Site code	TRE21
Data location	\\CAU\Archive\Sites\T\X:\Live Projects\Trelissick House WB 2021 147158
Historic England / ADS OASIS online reference	cornwall2-505785
Planning reference	PA20/01945

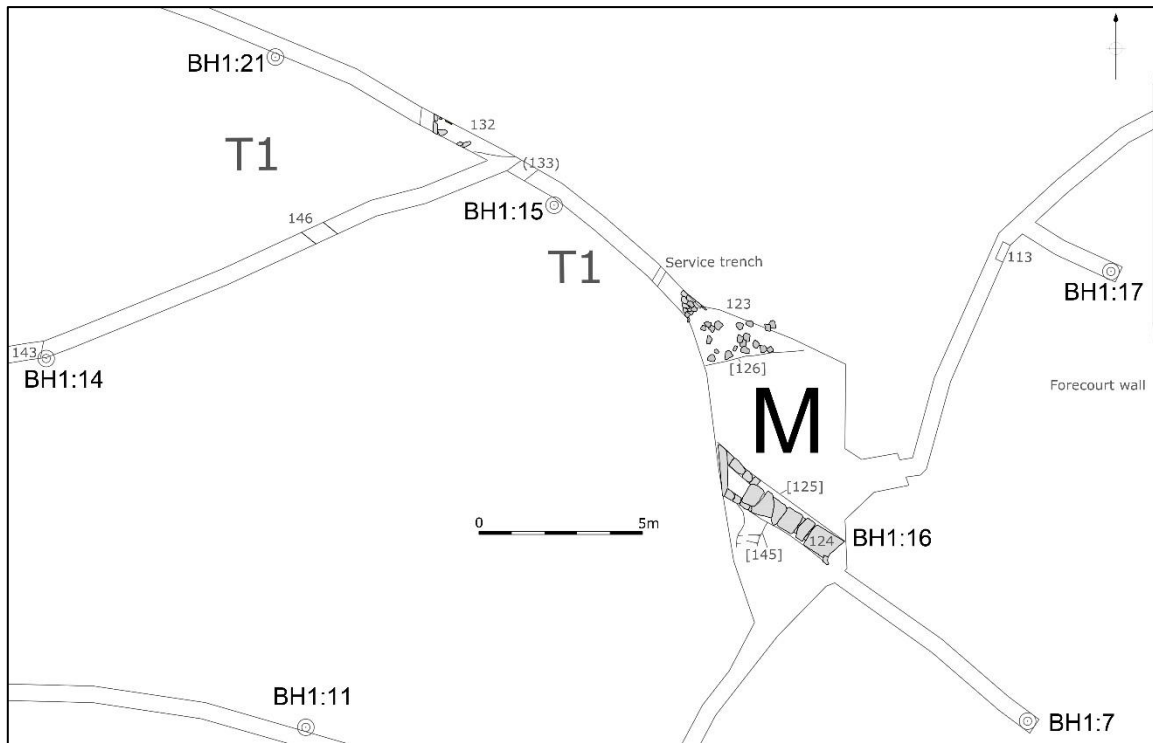
Fig 4 Location of features within Trench 1, east.

Part of a NE-SW aligned slatestone-built culvert, 1m wide and 0.4m deep, was identified on the south side of trench 1, within the area excavated for the manifolds (see Figure 4). The culvert was constructed of coursed slatestones with loose earth bonding, with large slatestone capping stones. The culvert was cut [125] into natural (108) and sat below several layers of subsoil and redeposited material (117), (118), (120), (121), (122). No dating material was recovered from this feature.

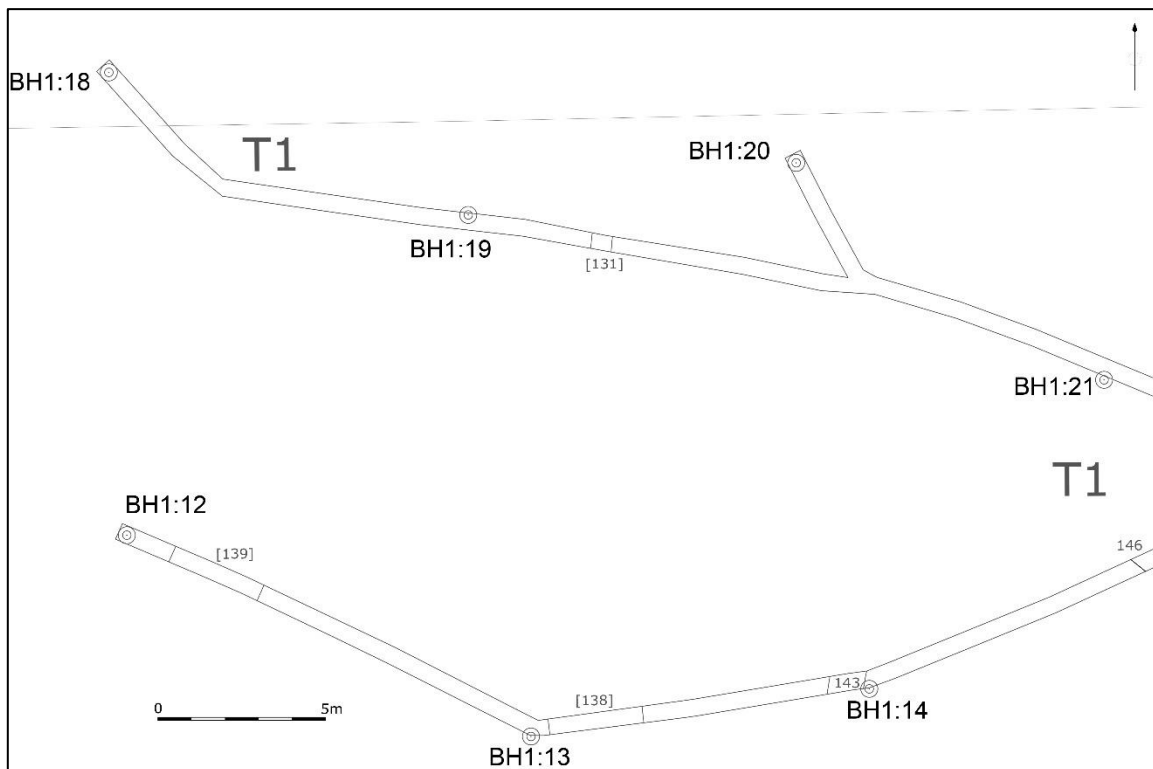
Fig 5 Location of features within Trench 1, west.

Location Figure 5; Section drawing Figure 53; section photograph Figure 22.

A pit 0.7m in diameter and 0.7m deep with a single fill of greyish brown loose silty sand and shillet (130) and a U-shaped profile was identified within the northern arm of trench 1, 3.7m east of Borehole 1:19. No dating material was recovered from the feature.

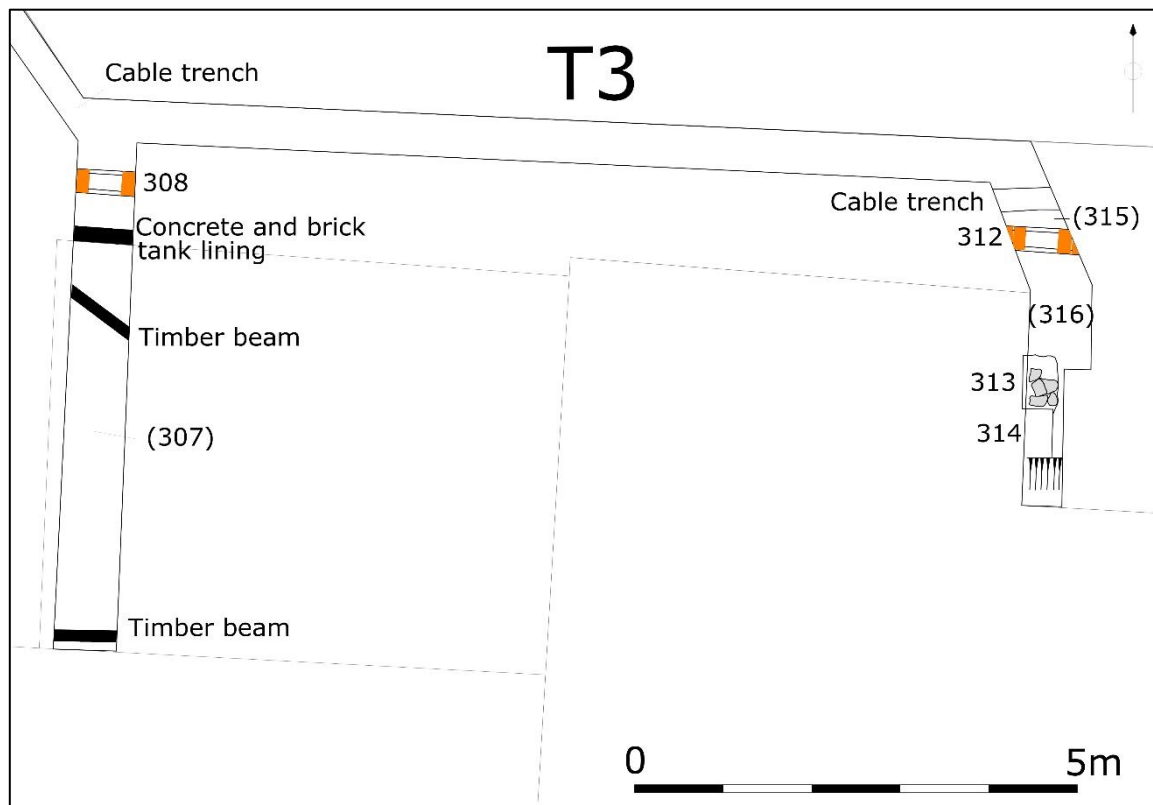
Fig 6 Location of features within Trench 3.

Location Figure 3. Location of features Figure 6.

Trench 3 ran through part of the garden on the north side of the Mansion, turning towards the house and then following the concrete path along the north side of the house. Two arms ran south from the trench to access the boiler and service rooms at the eastern and western ends of the house (Figs 3 and 6).

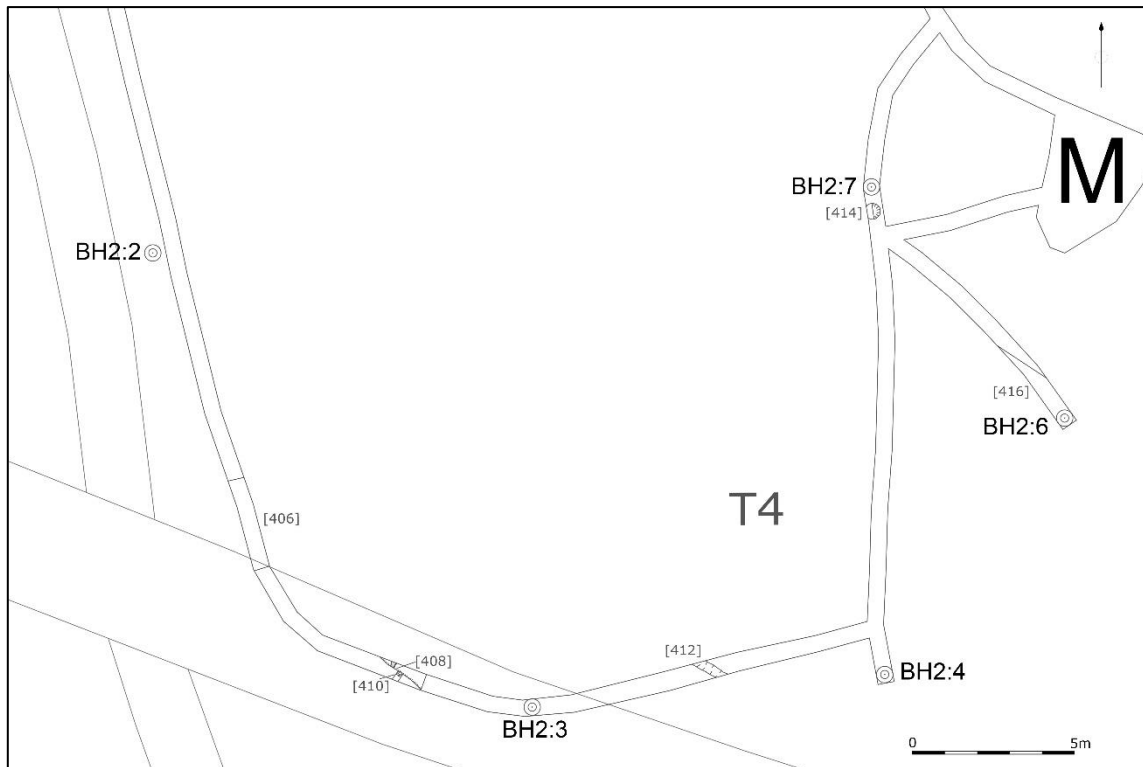
Fig 7 Location of features within Trench 4, south.

Location plan Figure 7; Plan and section drawings Figure 56; plan and half-section photograph Figure 33.

A sub-circular pit or posthole, 0.48m in diameter and 0.1m deep was identified within the eastern arm of trench 4, 0.5m south of borehole 2:7. Feature [414] had concave sides and a concave base and was cut into the natural (403) at a depth of 0.9m below ground surface and below topsoil (401) and subsoil (404). The single fill of feature [414] consisted of a dark reddish grey silty clay (413), with frequent charcoal and small stone fragments. The edges of the fill were scorched as if burnt *in situ*. No dating material was recovered from this feature.

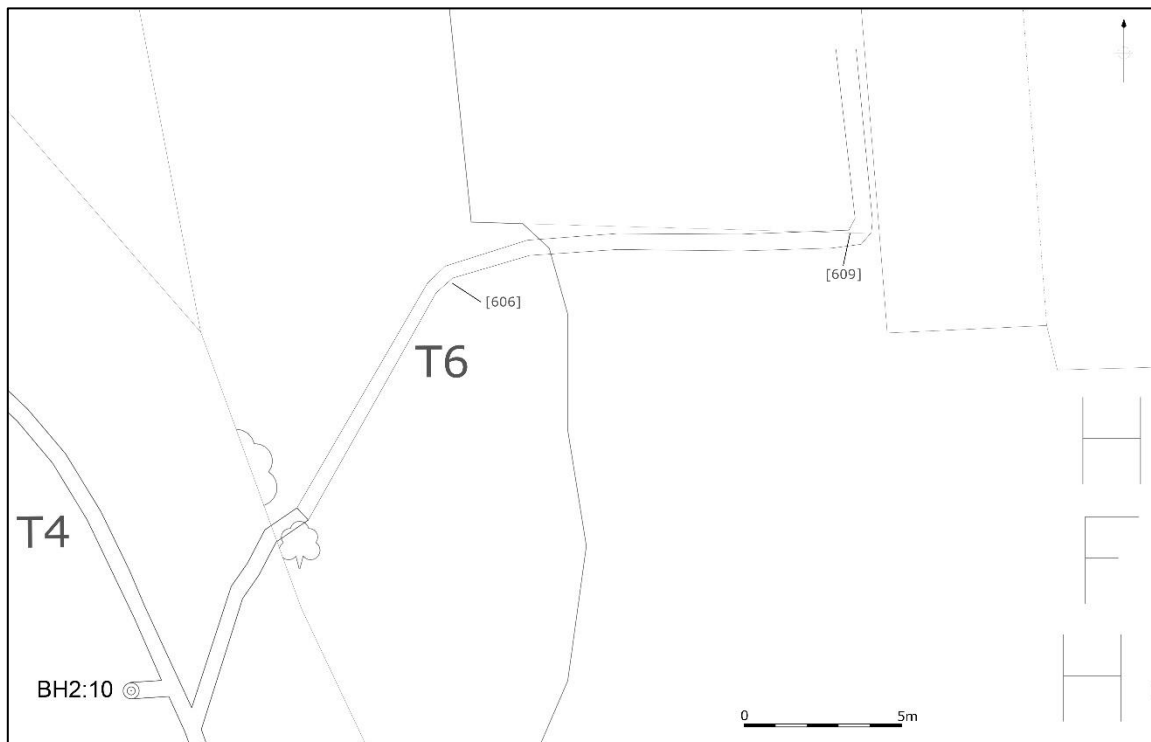
Fig 11 Approximate location of features within Trench 6.

Location Figure 3. Location of features Figure 11.

Trench 6 extended north from trench 4, curving east and then north through the service area on the west side of Home Farm (Figs 3 and 11). The first section of the trench was excavated using a vacuum to clear soil from around the tree roots, with the base of the trench being excavated by machine (see Figure 43). The northern end of the trench was excavated by machine but was dug prior to an archaeologist being on site. The trench was inspected visually once excavation was complete.

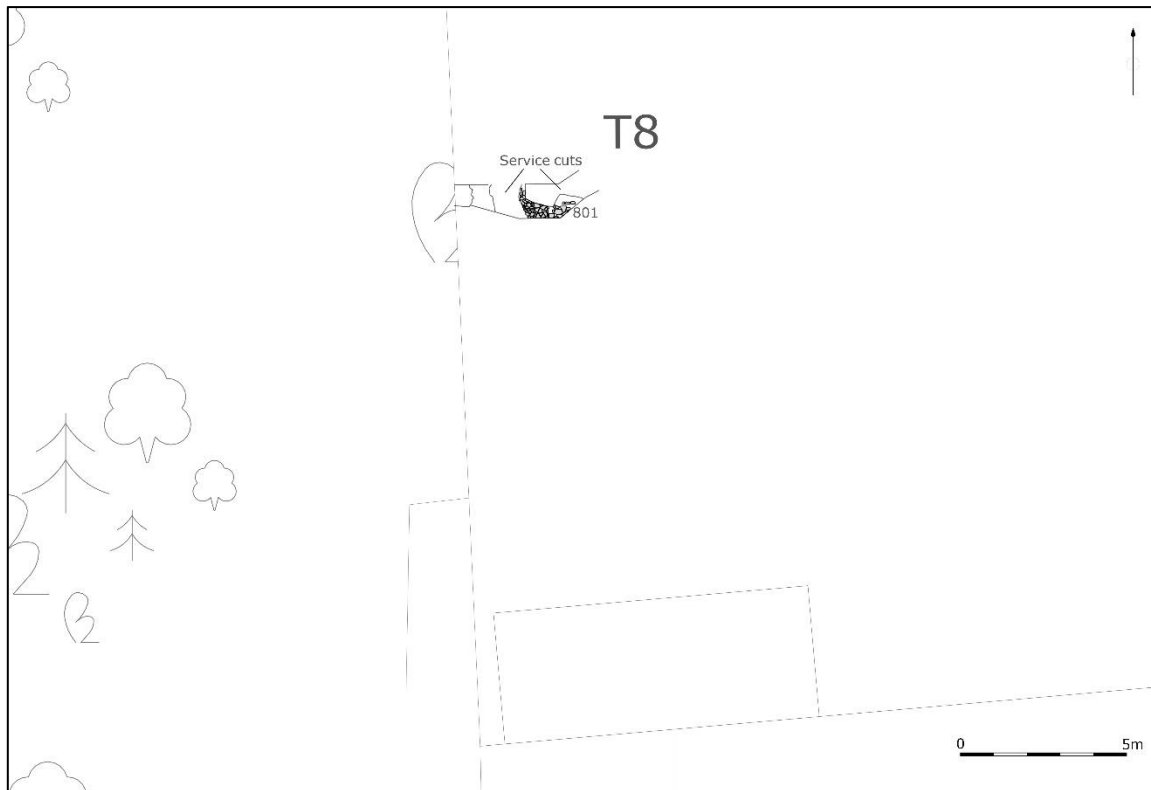
Fig 14 Location of features within Trench 8. Location of trench 8 approximated.

Location Figure 3. Location of features Figure 14.

Trench 8 was located within the car park on the north side of Home Farm. It was positioned against the west wall of the car park, approximately 16m from the northwest corner of the barn (Figs 3 and 14). Excavation of trench 8 exposed the cuts for several service trenches within a layer of rubble and clay, and part of a concrete pad. A stone and cobble surface 801, approximately 0.5m wide and 2m long, was also identified in trench 8, 0.08m below the tarmac and truncated by modern service trenches on its west and north sides (*Plan drawing Fig 55; plan photograph Fig 52*). Surface 801 appears to be part of a former farmyard surface.

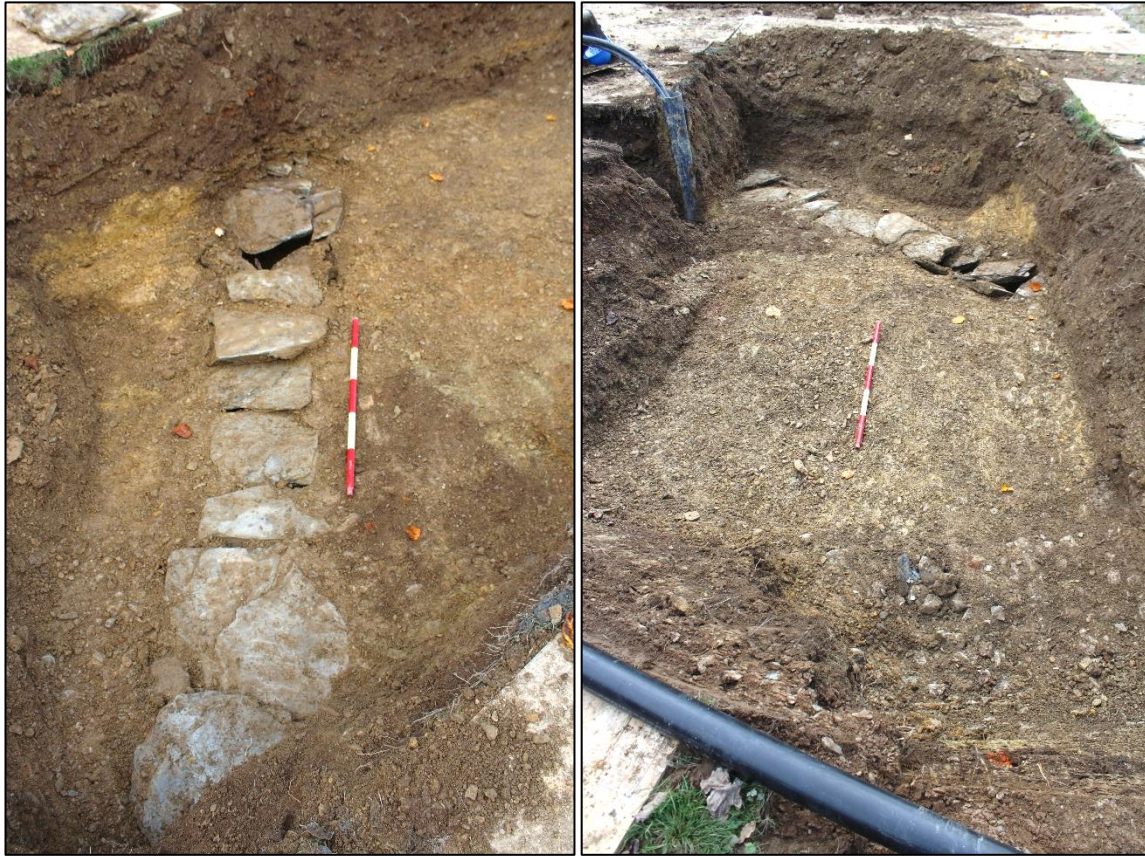
Fig 19 Plan shot of culvert 124 and deposit/surface (123), looking west and south.

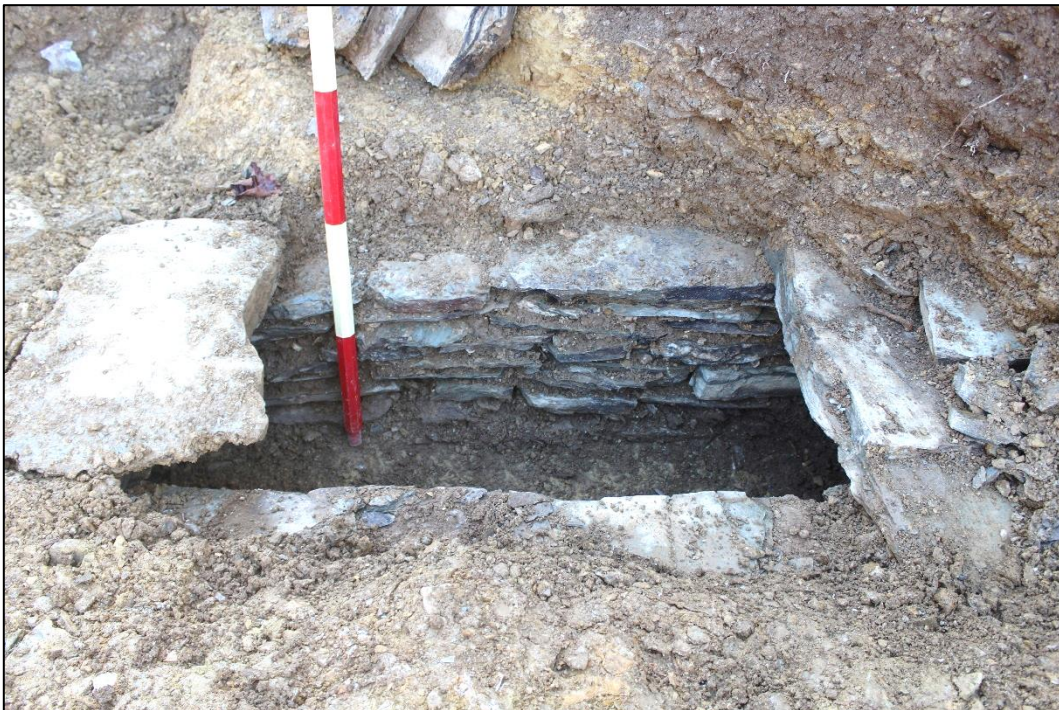
Fig 20 North facing side of culvert 124, looking south.

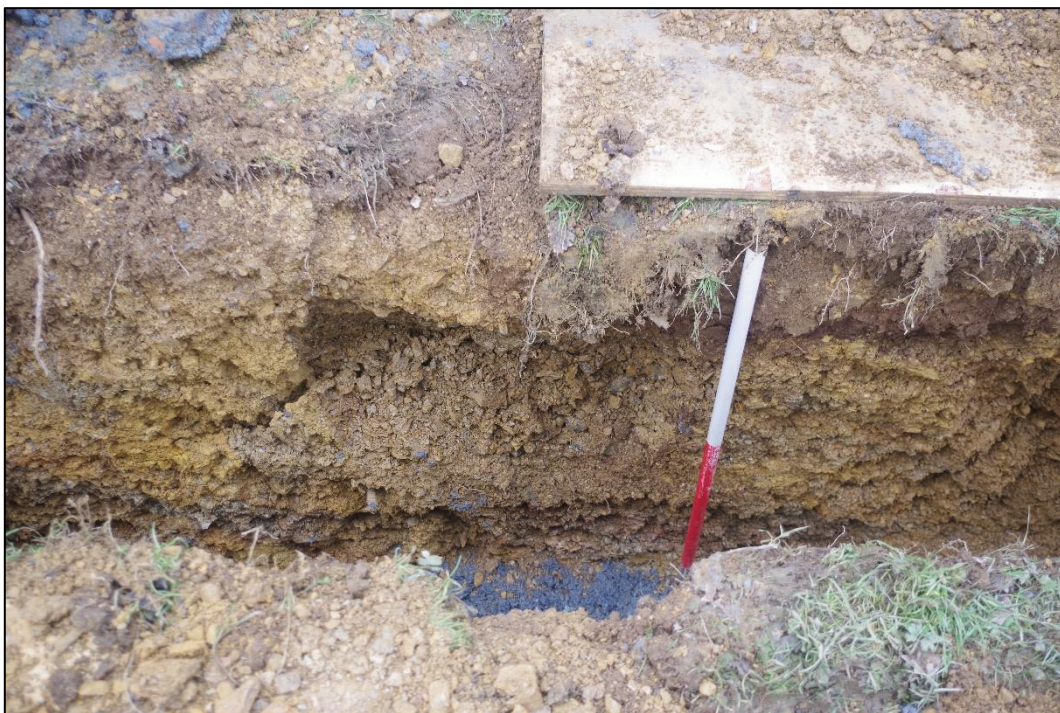
Fig 22 South facing section of pit [131].

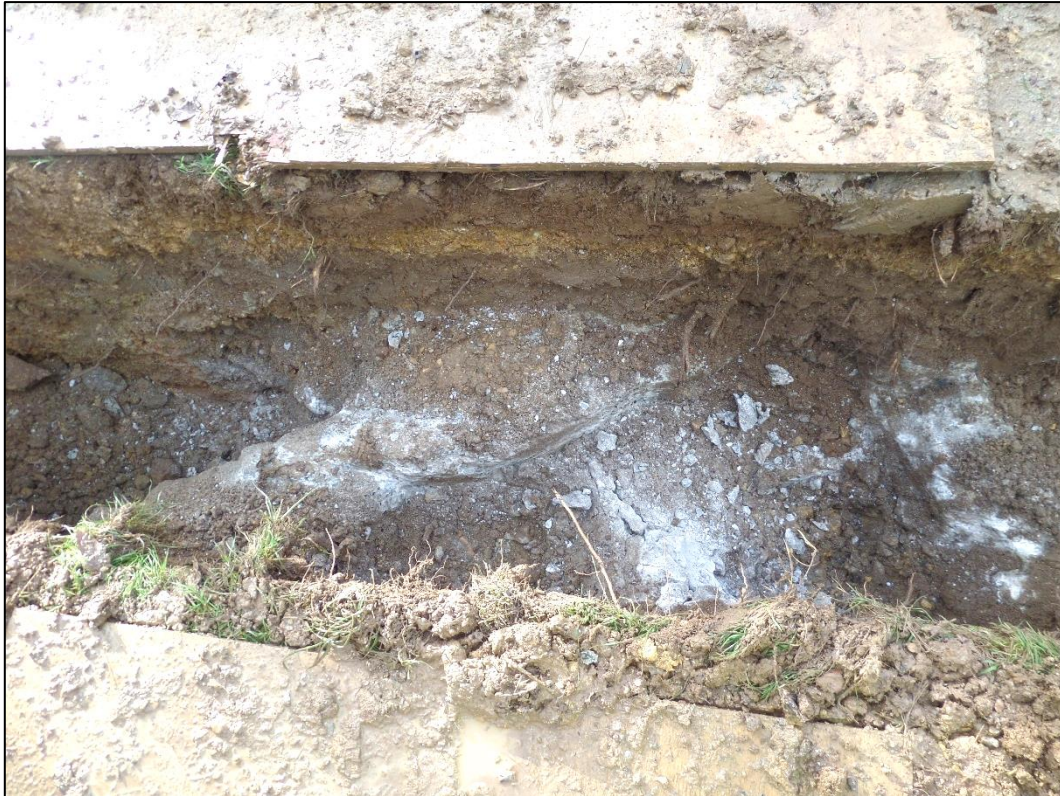
Fig 23 Plan shot of concrete pad 132, looking south.

borehole 1:15. It extended along the trench for a distance of approximately 2m. The concrete pad was not solid but had voids/open spaces within it and in places had slatestones overlying it. The pad was set within a layer of redeposited natural (128), which also overlay it. Above deposit (128) was a shallow layer of loose silty clay (102), also probably redeposited, below topsoil (101). On the east side of the concrete pad 132 was a poorly defined linear band of redeposited stony silty clay (133).

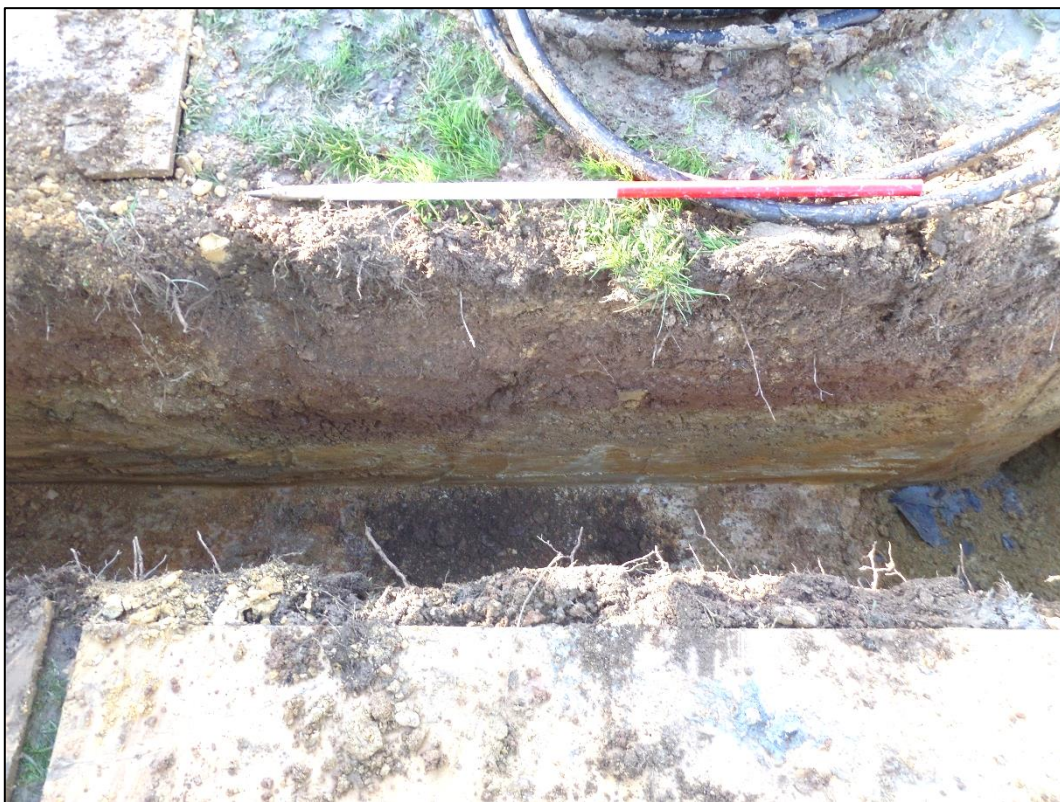
Fig 24 North facing section of ditch [138].

An irregular linear feature [138], probably a ditch, up to 2.7m wide and up to 0.7m deep, with concave sides and base and poorly defined edges, was identified within the southern arm of trench 1, to the east of borehole 1:13. Ditch [138] had a basal fill of loose mottled greyish yellow silty clay (137) below an upper fill of dark greyish red stony silty clay (136). Overlying ditch [138] was a band of redeposited natural (102) between 0.2m and 0.4m deep, below topsoil (101).

Ditch [138] was cut into a mottled reddish yellow wet silty clay (134), over 0.8m deep to base of trench, not fully excavated. Deposit (134) extended west along this arm of the trench and at its western end overlay a dark greyish red homogenous silty clay (135), over 0.9m deep to base of trench, not fully excavated. A stepped edge on the east side of deposit (135) may represent a cut [139] into deposit (135), with deposit (134) being a fill of this possible feature, perhaps also a ditch. Deposit (135) may be an area of degraded natural, and (134) a redeposited subsoil or natural resulting from landscaping work. Alternatively, deposits (134) or (135) may both be anthropogenic in origin, possibly the result of landscaping, or possibly, particularly in the case of deposit (135), the result of infilling that has happened naturally over time.

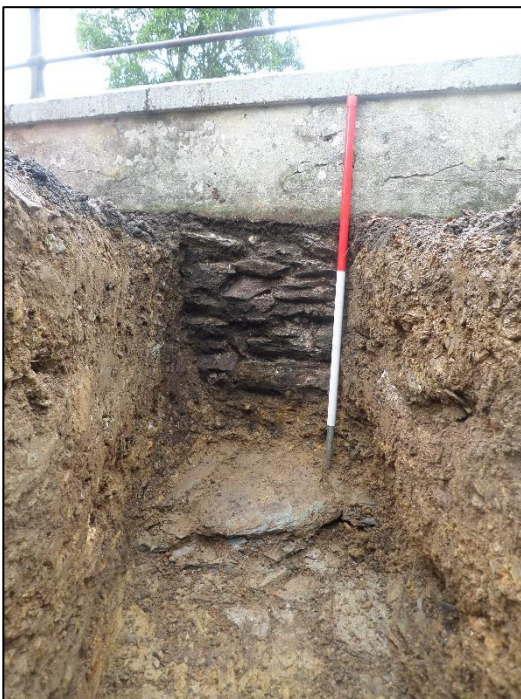
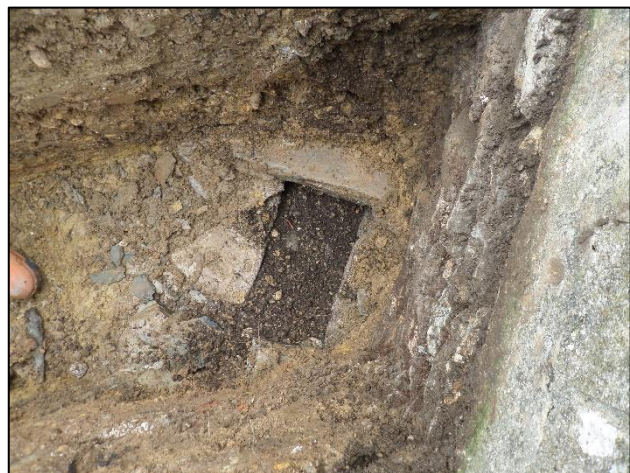
Fig 28 Section and plan shot of culvert 206, looking west and southwest.

The stone-built culverts identified within trenches 1, 2, 5 and 7 are likely to be of post-medieval origin, possibly constructed in the 18th and 19th centuries. The culverts, in particular 124 and 206, were found at depths directly below levelling layers, suggesting they may pre-date, or be contemporary with, some of the earliest landscaping of the grounds to the west of the Mansion house. The brick-built culvert 113, identified in trench 1, was located at a higher level than the stone-built culverts and was cut into existing levelling layers, indicating that it post-dated, or was contemporary with, a later phase of landscaping, possibly carried out during the later 19th century. Surfaces directly below the topsoil in places, and overlying features such as the concrete pad 132, may date to the early 20th century, and were perhaps laid down following the decommission of the Second World War anti-aircraft battery.

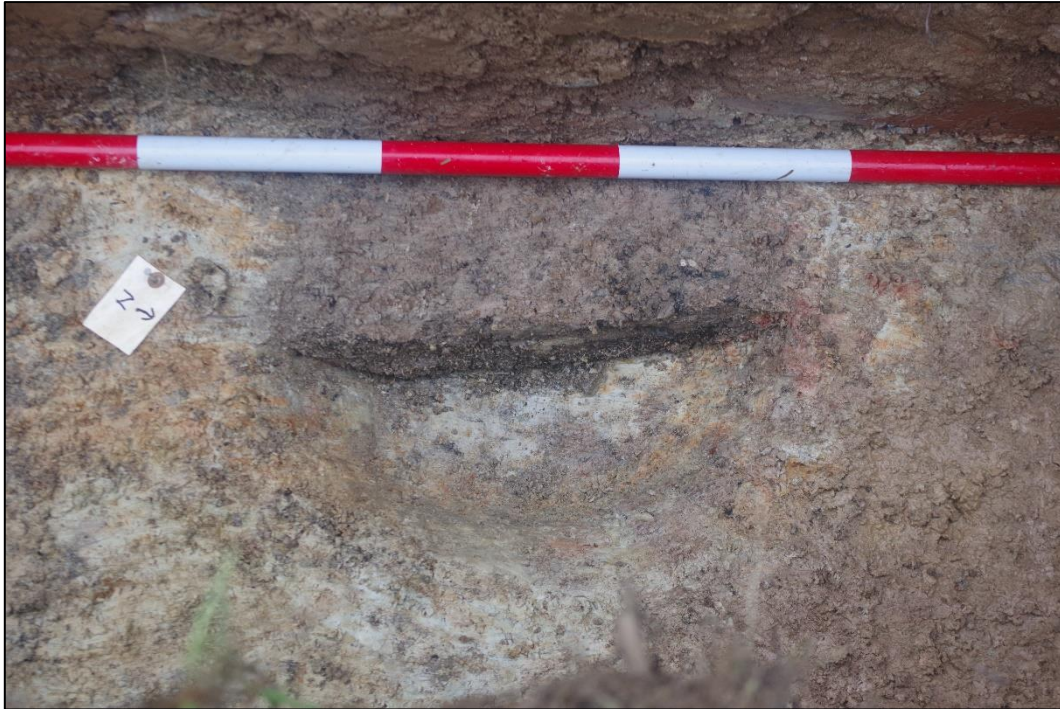
Fig 33 North East facing section of posthole [414].

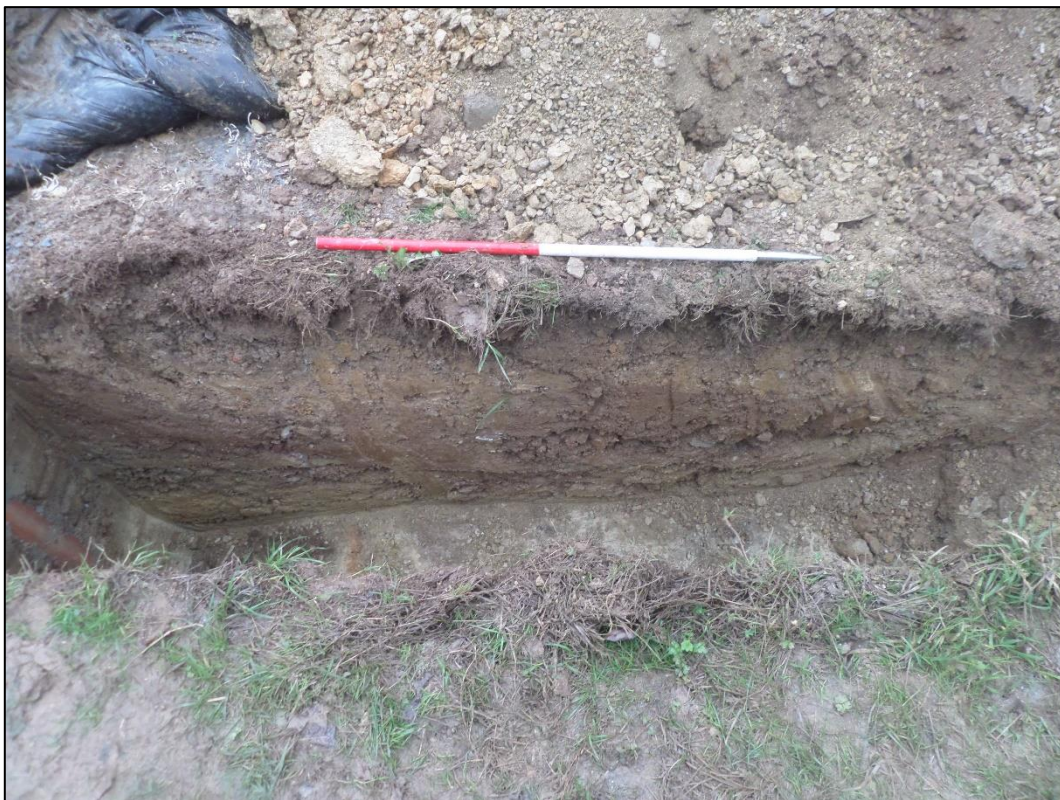
Fig 34 North facing section of ditch [416].

A discrete concentration of pottery sherds, several of which were oxidised, were recovered from the upper level of the primary fill (415). The pottery sherds sat directly above a similarly discrete concentration of small burnt stones. The pottery derived from two separate vessels of Romano-Cornish gabbroic ware, Trethurgy Types 4 and 16, dating from between the 2nd to 3rd centuries AD, although known to continue in use into the 5th century AD (see Appendix 3 and for discussion see Quinnell 2004, 108-126).

T4	416	C	Ditch	Cut of U-shaped profile linear ditch. Oblique in trench and east side not seen. Probable SW-NE alignment, possibly up to 3m wide and up to 0.7m deep. Gently sloping west side and concave base, cut into natural. Corresponds with sub-linear anomaly on geophysical survey, possibly part of an enclosure boundary.		Romano-British
T4	417	D		Mid bright reddish red friable silty clay, moderately stony, possibly heat affected. Fractured slate stones at top and base of fill, with heat affected pottery sherds within. Fill of shallow pit/hollow [418], 0.15m deep.	Gabbroic pottery sherds 2nd-5th centuries AD	Romano-British
T4	418	C	Pit/hollow	Cut of 0.15m deep sub-oval pit/hollow between 0.6m and 1m wide. Concave sides and base. Against and disappearing under north side of trench, cut into natural (403). SE side poorly defined.		Romano-British
T4	419	D		Light bright greyish reddish yellow plastic silty clay, possibly heat affected closer to [418]. Extends NW and SE from (418) in narrow band. 0.02-0.15m deep below (402). Possibly heat affected surface of natural (403).	Gabbroic pottery sherds 2nd-5th centuries AD	Romano-British

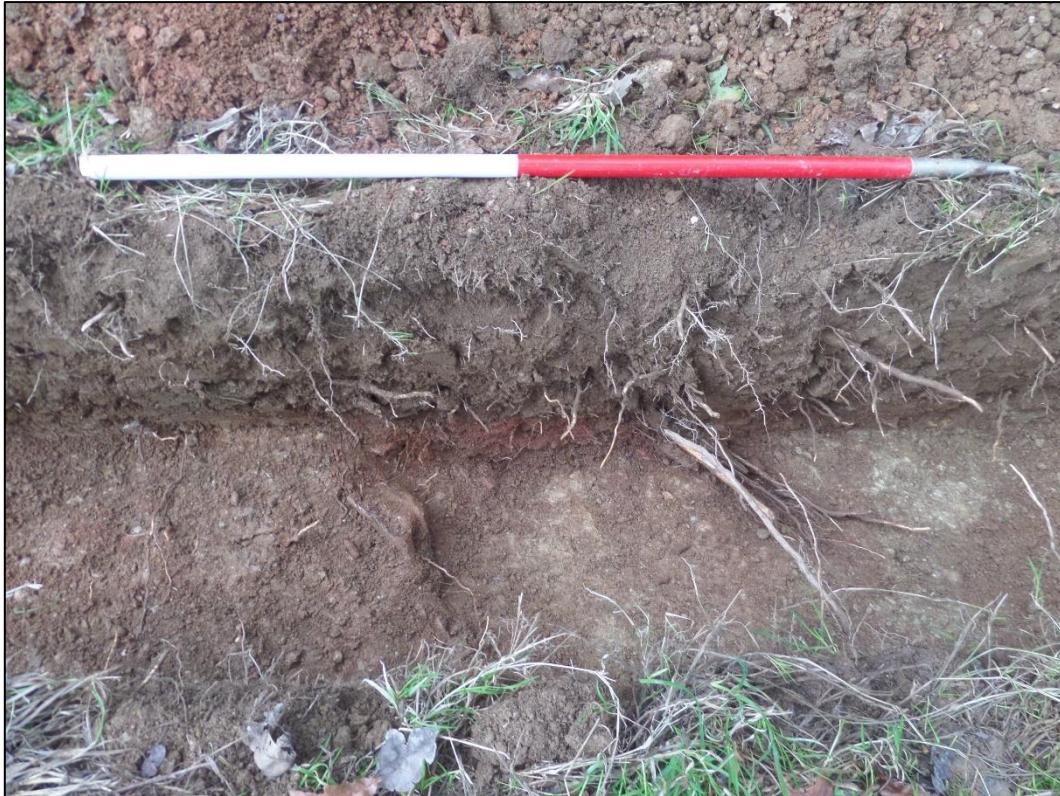
Fig 35 South facing section of pit [418].

A sub-oval pit between 0.6m and 1m wide with concave sides and base was identified within the northern arm of trench 4, against and disappearing under the north side of the trench, just over 3.5m east of borehole 2:11. The feature was cut into the natural (403) 0.4m to 0.6m below ground surface and below topsoil (401) and deposit (402) and was 0.15m deep, with poorly defined edges, particularly on its southeast side. Pit [418] had a single fill of bright pinkish red, stony silty clay (417), slightly stony, with angular fractured slate within the fill. The fill was heat-reddened and there was a further spread of heat-reddened soil (419) either side of pit [418] that suggests a wider area of burning. Feature [418] may have been a deliberately cut pit, or alternatively a naturally formed hollow. Several oxidised pottery sherds were recovered from fill (417), also identified as Romano-Cornish ware, Trethurgy Type 4, dating from around the 2nd to century AD (see Appendix 3 and for discussion see Quinnell 2004, 108-126).

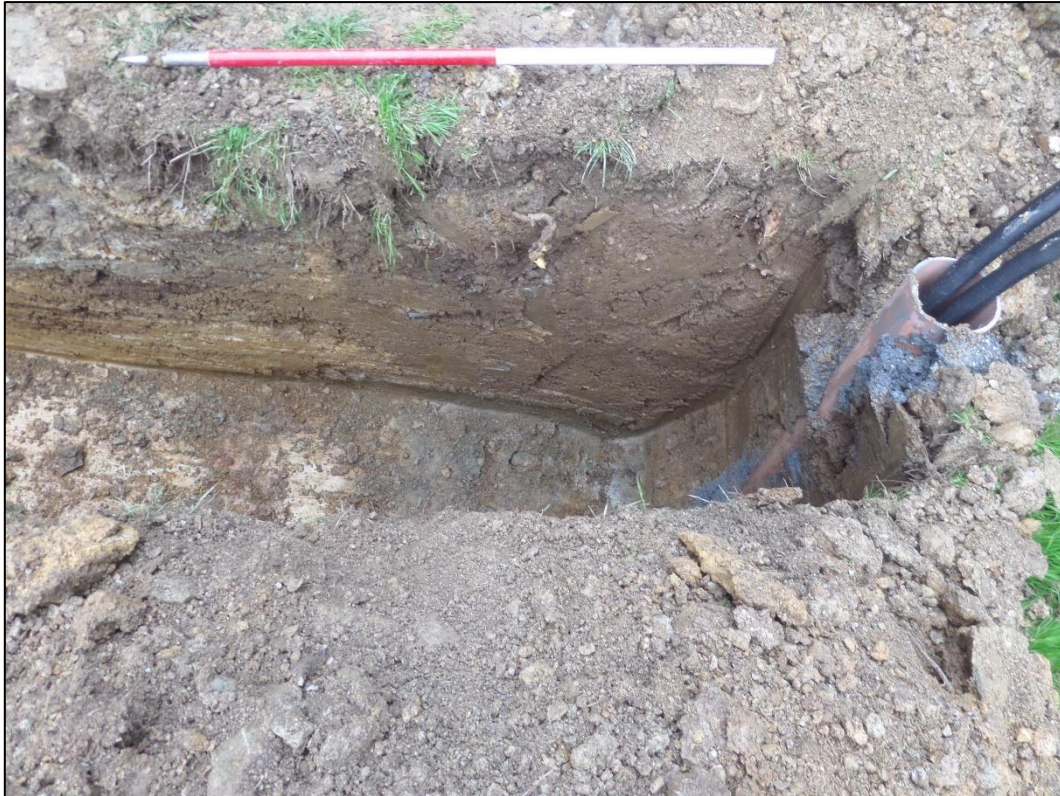
Fig 37 South facing section of possible ditch [509].

Location Figure 9; Section drawing Figure 57; section photograph Figure 37.

Part of a linear feature, U-shaped in profile, was identified immediately west of borehole 2:9, running obliquely across the trench on a broadly SW-NE alignment. The feature had a moderately well-defined and gently sloping northwest side, the southeast side was not seen. The linear feature was estimated at approximately 1m wide and began to bottom out at a depth of around 1.4m from ground surface. The basal fill of feature [509] was a very dark reddish grey, wet silty clay (508), 0.5m deep, with some large slate stones at its base. The upper fill of feature [509] consisted of a 0.9m deep dark greyish red stone-free silty clay (507) – similar to deposits (404) and (415). Above fill (507) was a layer of redeposited natural (503) below topsoil (501). Feature [509] may be part of a linear ditch of uncertain date. No dating material was recovered from this feature.

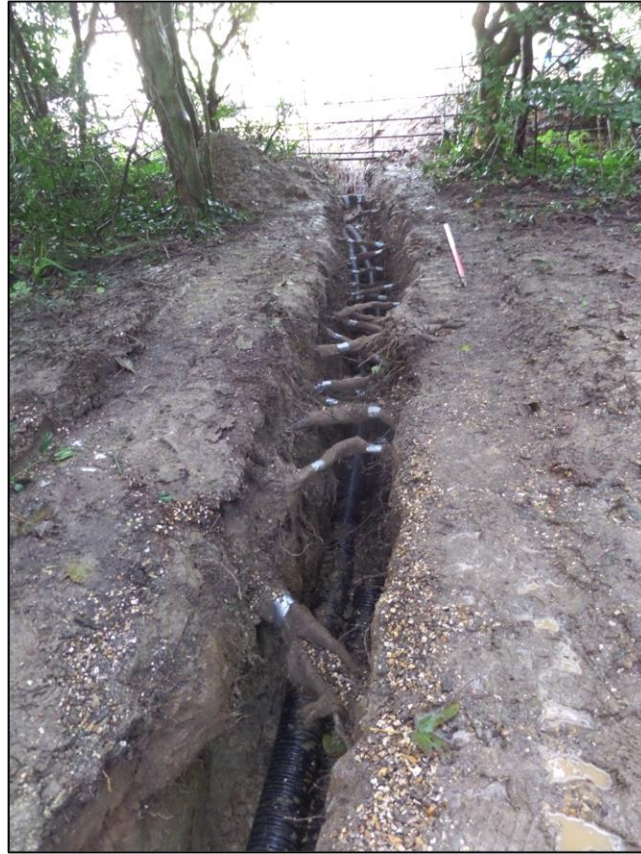
Fig 43 Trench 6, vac-ex section, post-ex, looking south.

One trench (trench 6) within the car park/service area on the west side of Home Farm was partially excavated using a vac ex process to protect tree roots. The soil horizons within trench 6 were loosened and vacuumed out by air driven suction before being dug to 1.2m depth by hand and/or machine where this was possible. Trench 6 was excavated without an archaeologist being notified to attend but was subsequently inspected, photographed and recorded.

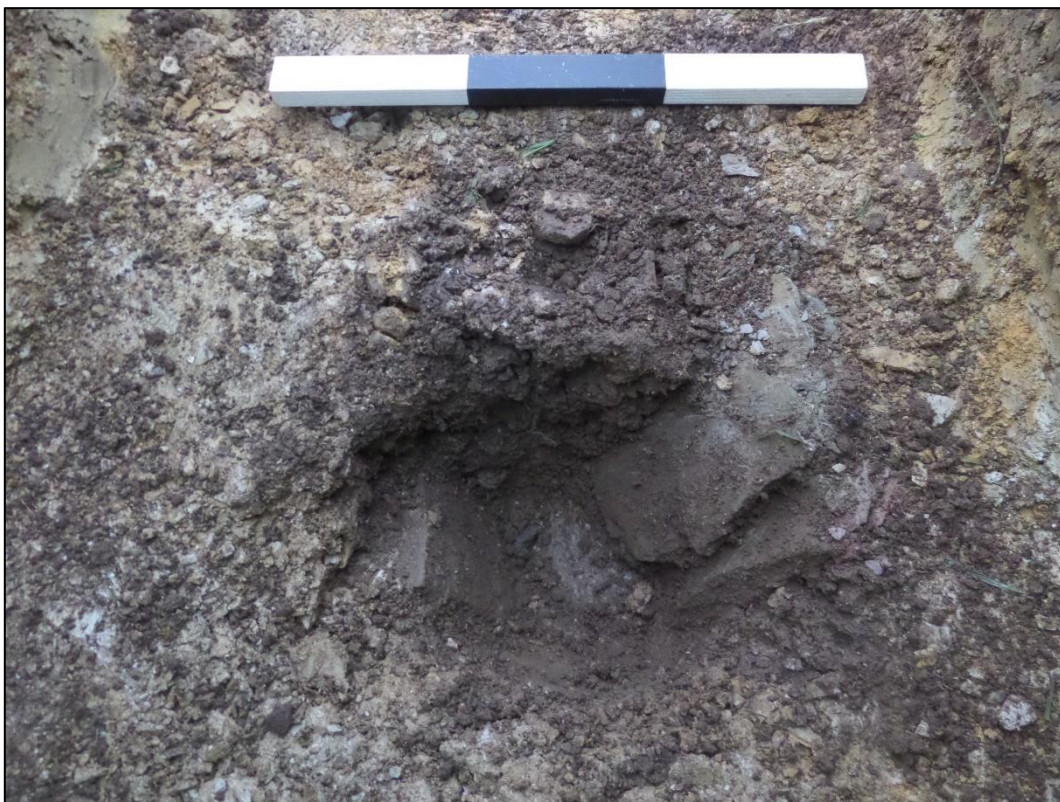
Fig 48 East facing section of posthole [711].

T7	710	D		A dark blackish reddish grey friable silty clay with moderate slate stones and occasional charcoal. Fill of posthole [711]. Pottery sherds within fill.	Pottery sherds of 13th Century Lostwithiel ware	Medieval
T7	711	C	Posthole	A very neat near circular posthole, 0.24m to 0.28 in diameter and 0.16m deep to top of stone at base, very clean edge definition and neatly slate lined on sides and base.		Medieval
T7	712	D		Variable depth of probable degraded natural, varying from mid-greyish yellow to a darker reddish greyish yellow, loose, silty, sometimes sandy, clay with much fractured and weathered slates within and towards base. Ranges from very homogenous and 'clean' to more stony and loose.		
	713	D		Dark greyish grey friable ashy demolition deposit with mixed stone, slate and brick. May be the same as 104 and 118. Very loose and widespread demolition layer. Probably part of the same spread as 104 and 118. Overlies what appears to be a degraded natural, possibly redeposited – the stratigraphy in this E end of T7 and into the manifold trench at E end of T1 is very mixed, loose, with deep deposits.

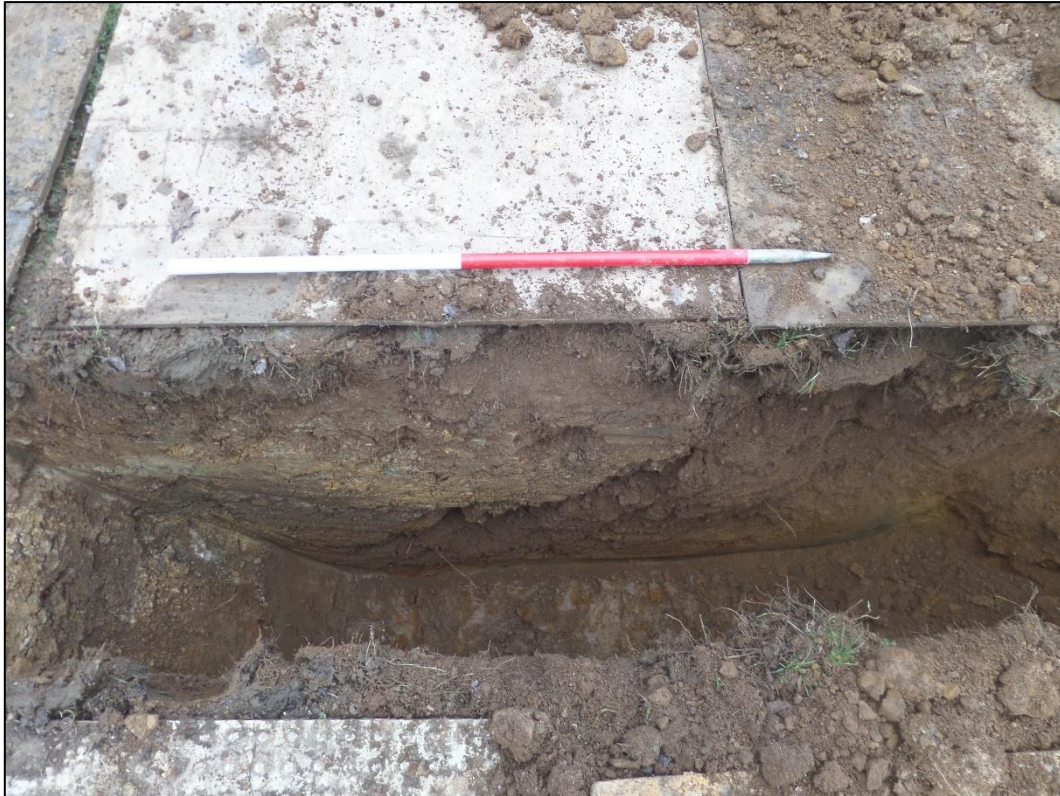
Fig 51 South facing section of possible ditch [715].

A possible linear ditch was identified towards the west end of the southern arm of trench 7, just under 4m east of borehole 1:1. The feature was 1.1m wide and 0.7m deep with concave sides and base. The extent of the feature was clear, but edge definition was poor. It appeared to cut into, or interface with, deposit (712) and was filled with loose reddish grey silty clay (714). The upper western section of fill (714) was mixed with redeposited natural (703), which also overlay feature [715], and may have formed its upper fill. A large stone void was present within deposit (703), above the eastern end of feature [715]. No dating material was recovered from the feature.

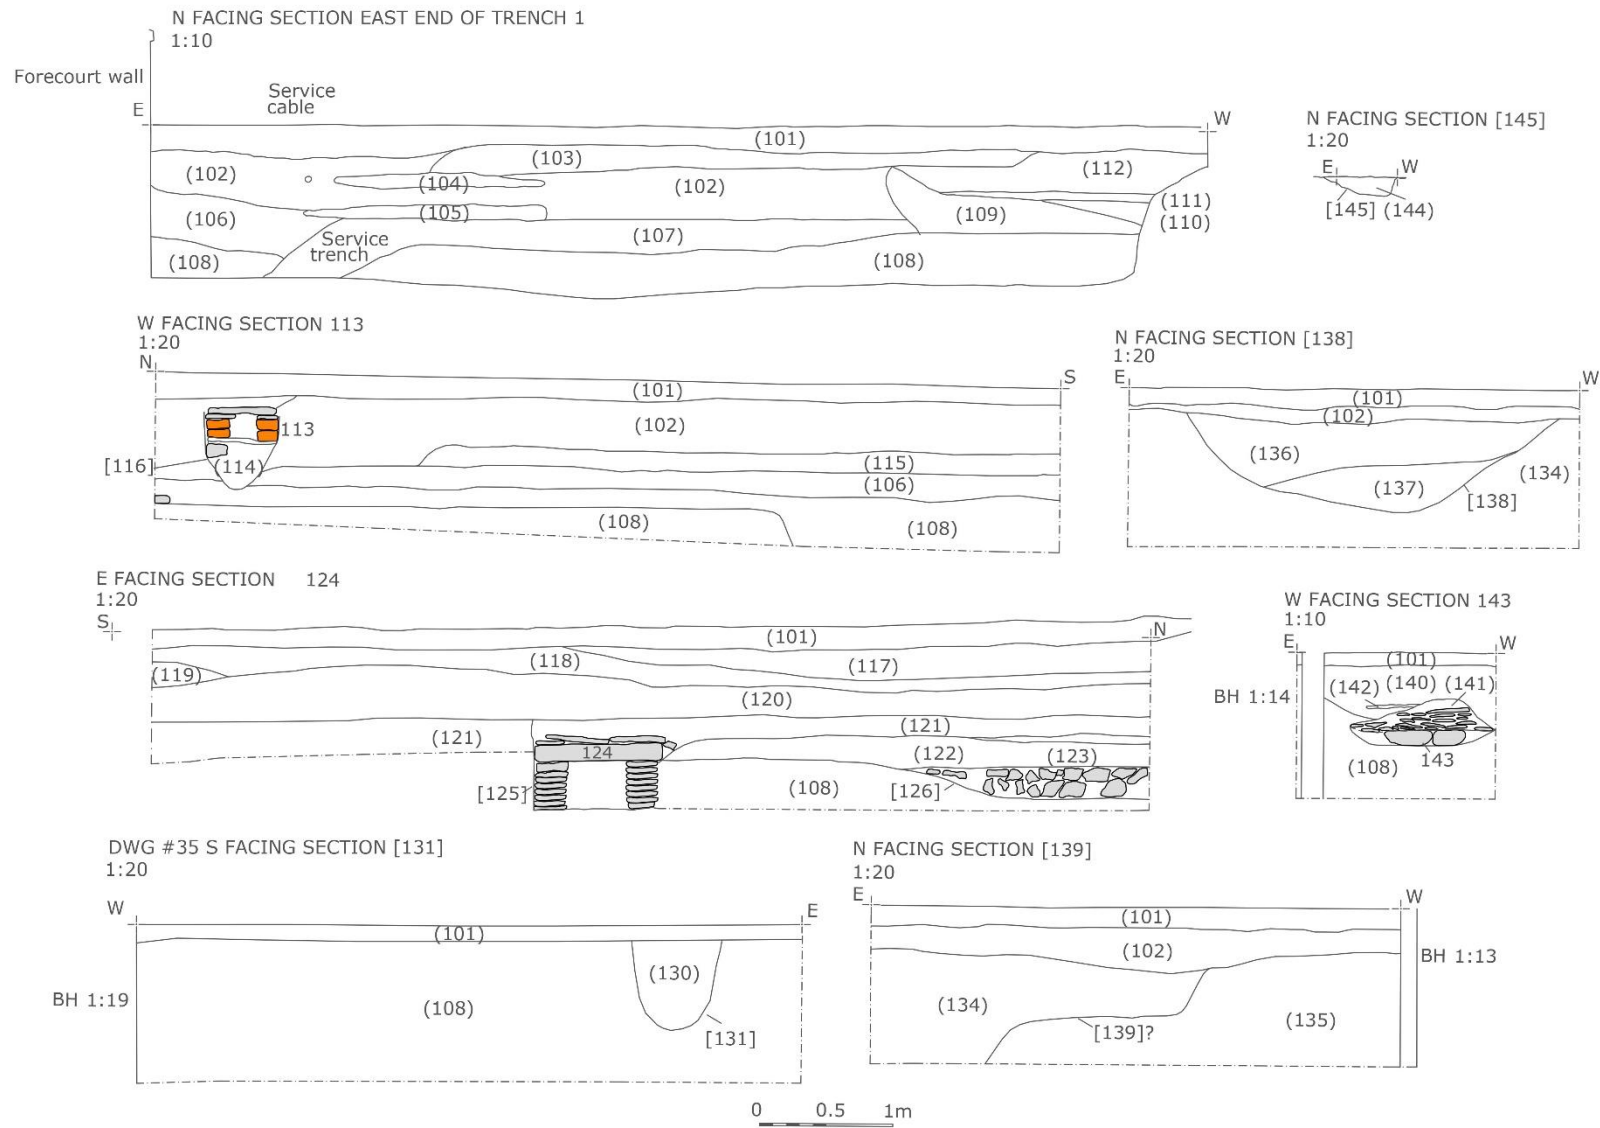
Fig 53 Trench 1, selected section drawings.
