John Harvey House, Hayle Cornwall Archaeological Watching Brief

Archaeological Watching Brief

| Report Number | 2022R019 |
| Date | June 2022 |

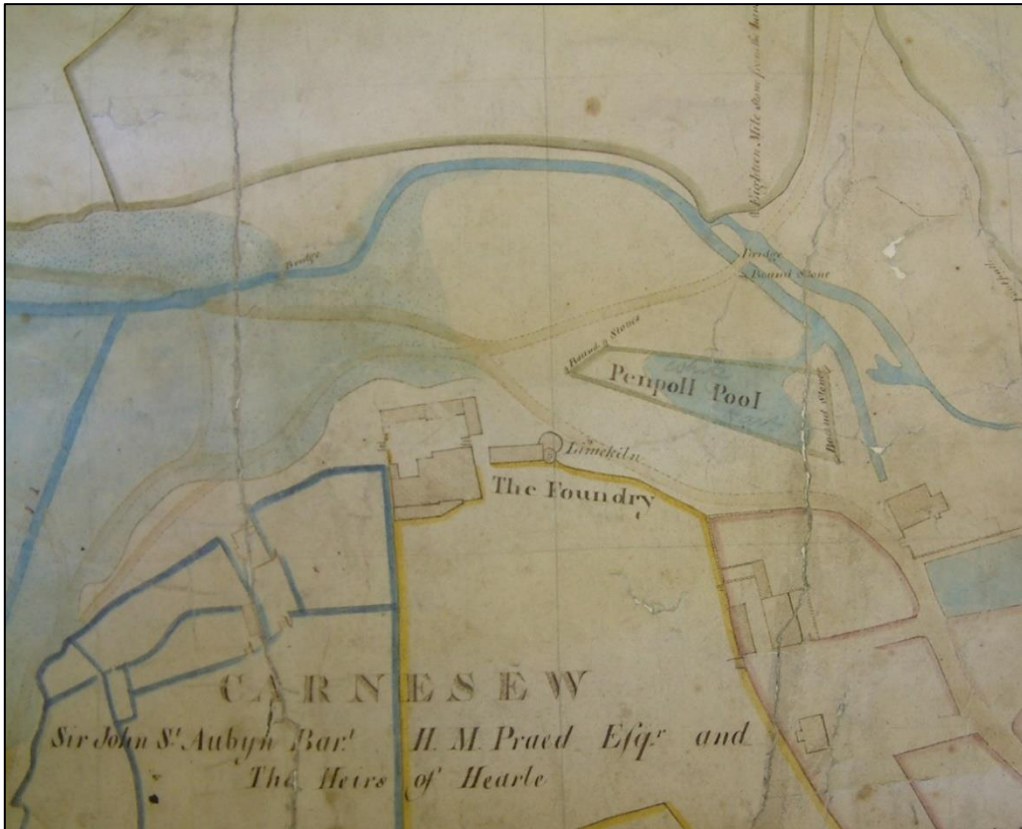
Fig 3 Extract from a map of Hayle, c1790.

The c1790 map of Hayle first shows the site in detail, with foundry buildings, gated yard and offices on the site of 24 Foundry Square (Fig 3).

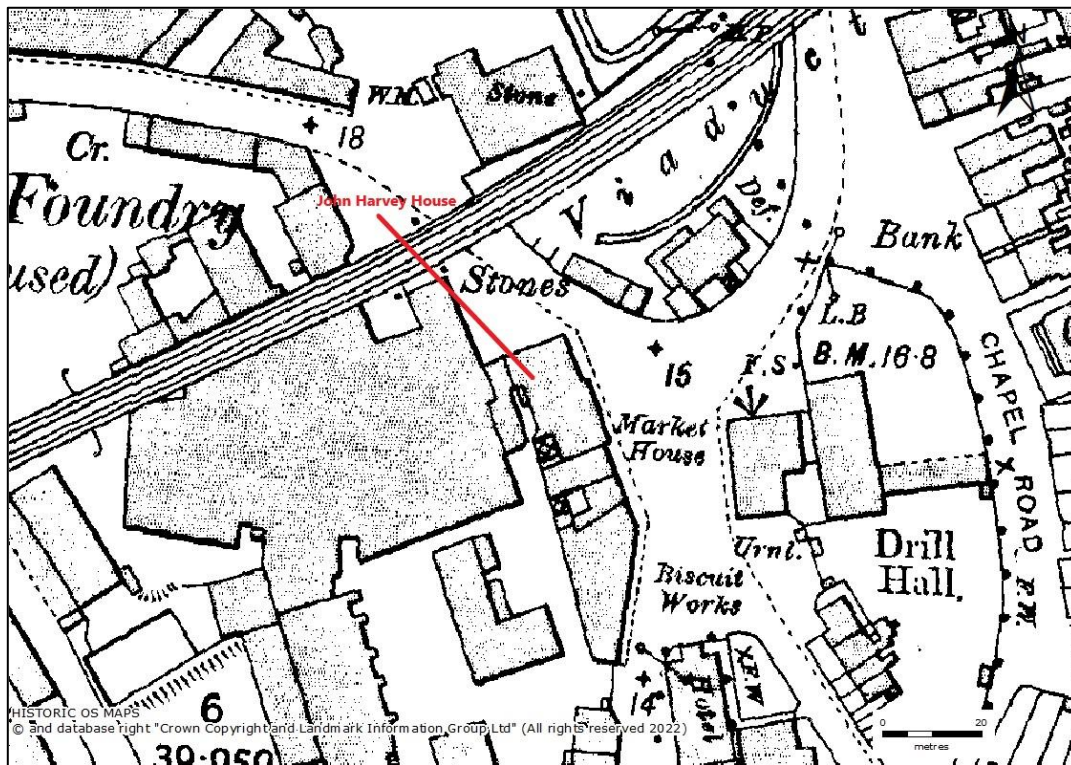
The 1907 OS map (Fig 10) shows the Foundry as disused, with the majority of the buildings still extant. However, by the time of the 1936 OS map substantial demolition had been undertaken to the foundry site, which is most apparent to the casting shops to the rear of 24 Foundry Square (Thomas 2004).

Fig 10 Second Edition of the Ordnance Survey 25 Inch Map, c1907.

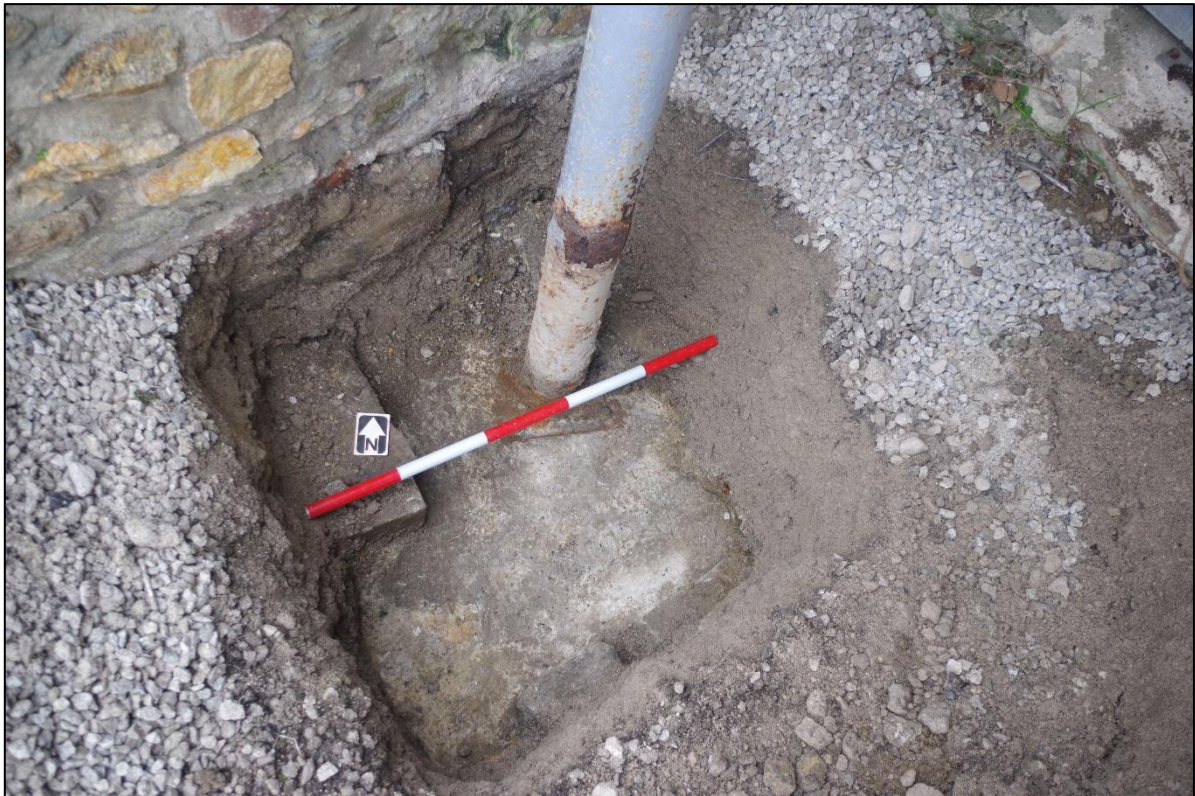
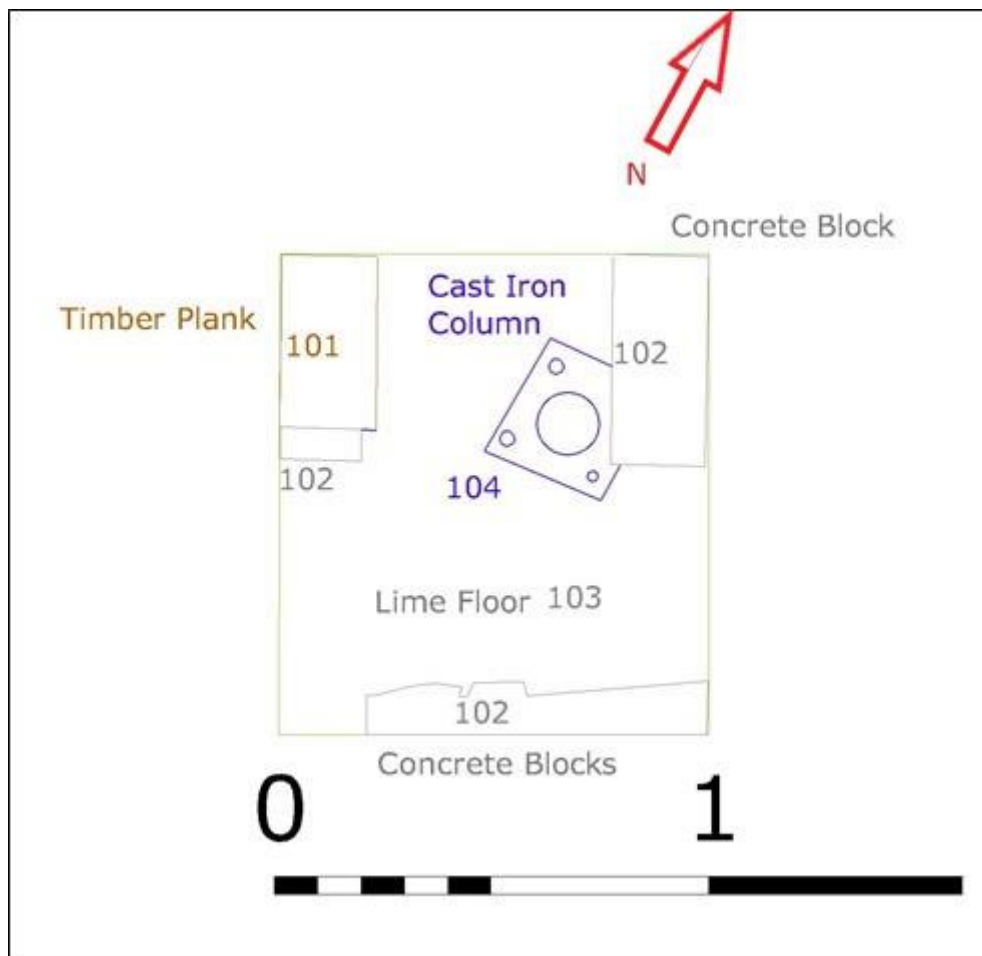
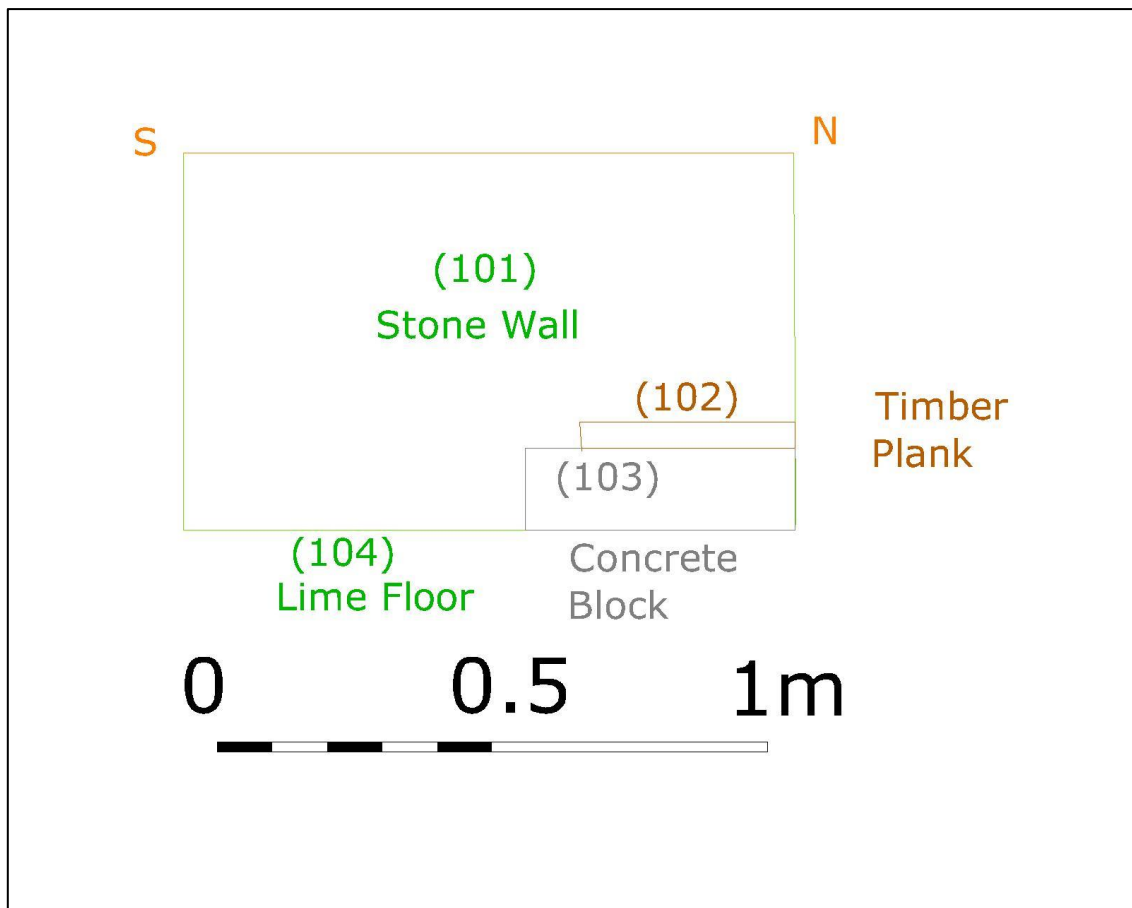
| Test pit | Dimensions of test pit (Length x width x depth) | Description |
|---|---|---|
| TP-1 | 1m x 1.1m x 0.68m | <p>TP-1 adjoined an external stone wall associated with the foundry complex (101). This area had been previously disturbed by the 2004 works and contained two modern timber planks (102) and modern concrete blocks (103) in the redeposited overburden. At the base of the test pit a cast iron rising main was reused as a column to support the drawing office at first floor level. The column was positioned directly on top of an undisturbed lime floor surface (104) associated with the foundry buildings at a depth of 0.68m from the present ground surface.</p> |

Fig 12 TP-1 (showing lime floor at base).

Fig 13 TP-1 plan.

Fig 14 TP-1 section facing east.

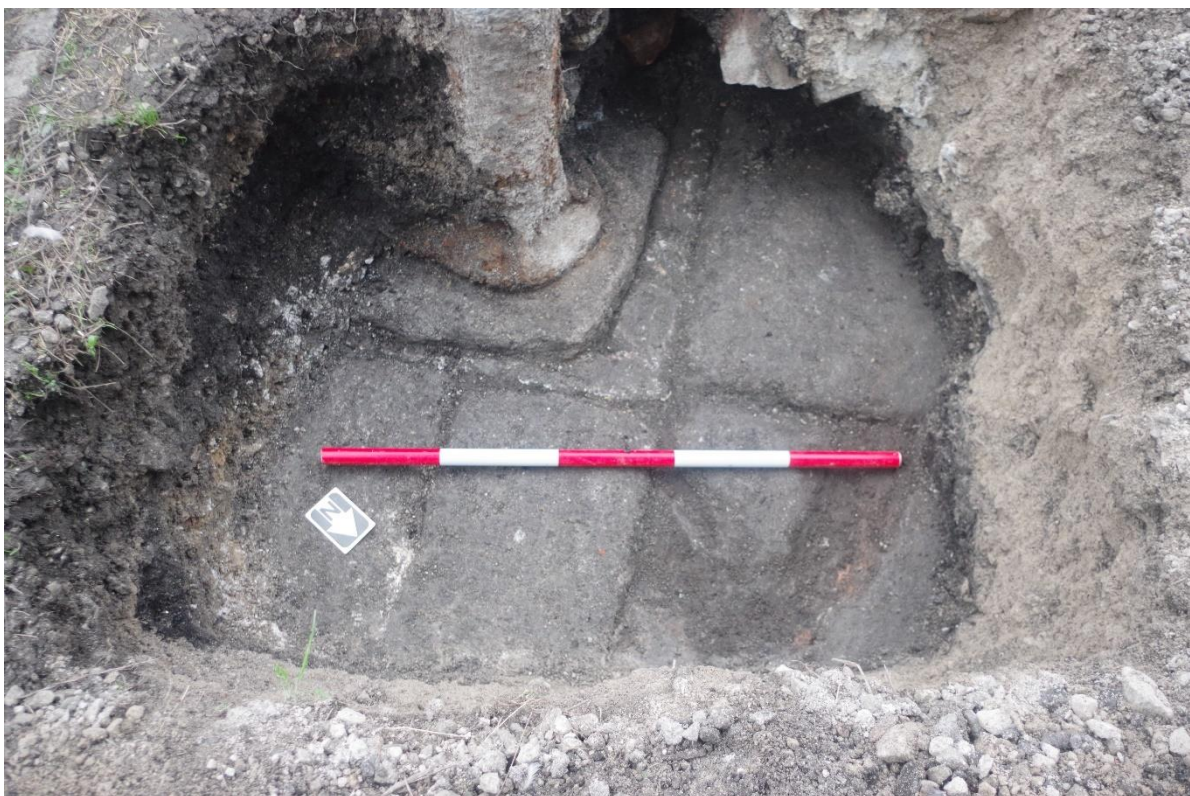
| Test pit | Dimensions of test pit (Length x width x depth) | Description |
|---|---|---|
| TP-2 | 1m x 1.1m x 0.56m | <p>TP-2 was excavated down to the top of a granite flagstone floor (205) associated with the foundry complex. This was present at a depth of 0.56m below the present ground surface. Within the floor a granite pad (206) edged with bricks supported a cast iron rising main (204) that had been reused as a column to support the drawing office at first floor level. The granite floor was overlain by a layer of orangey brown clay silt containing frequent fragments of lime (203) approximated 0.15m deep.</p> <p>This was overlain by a dumped deposit of dark greyish black coal, silt and stone fragments (202) approximately 0.2m deep, which in turn was overlain by a modern mid greyish brown topsoil and gravel (201) (0.3m deep).</p> |

Fig 15 TP-2.

Fig 16 TP-2 plan.

Fig 17 TP-2 section facing south.

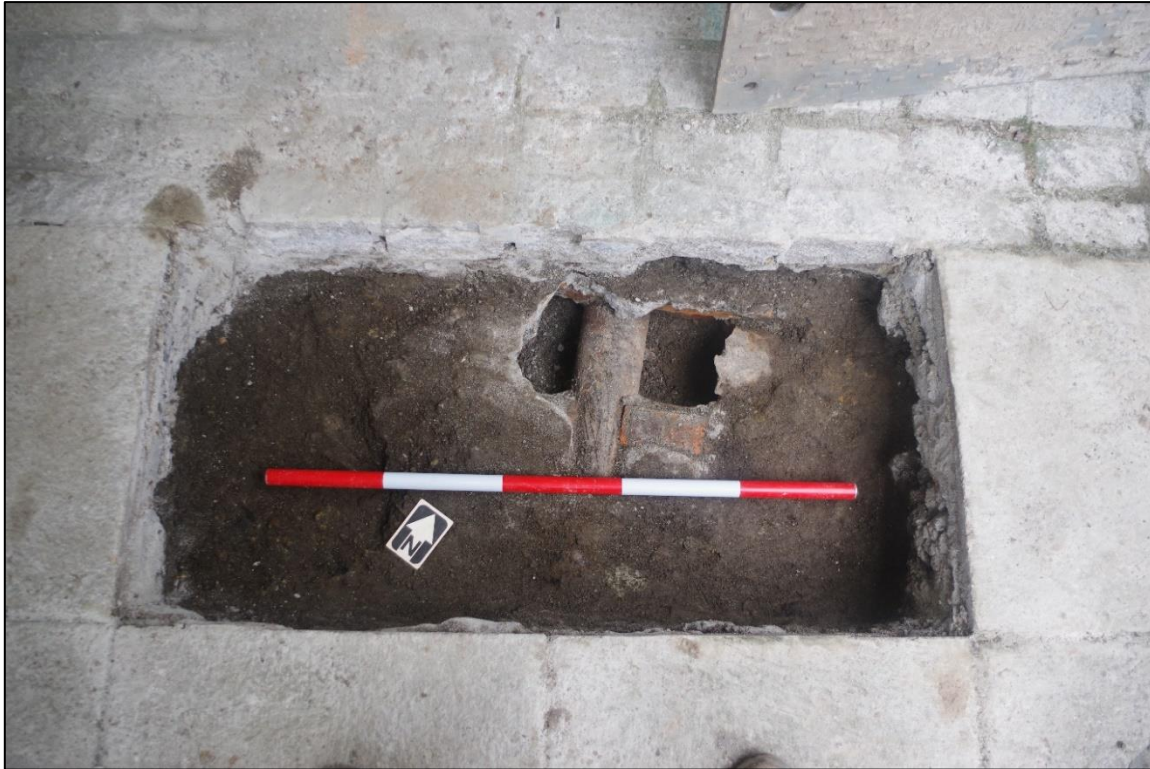
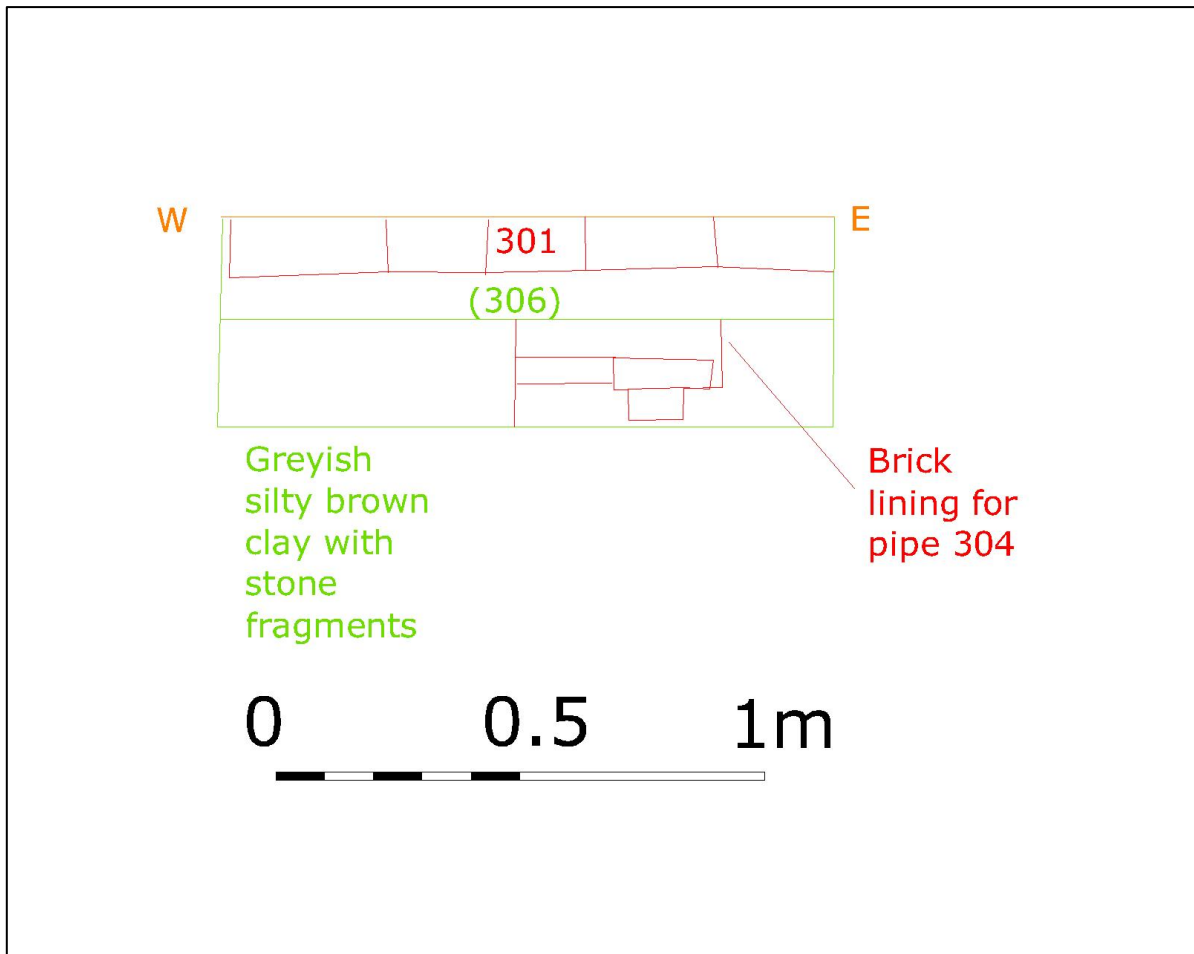
| Test pit | Dimensions of test pit (Length x width x depth) | Description |
|---|---|---|
| TP-3 | 1.6m x 0.59m x 0.42m | <p>TP-3 was excavated within the former gated yard at the running through the building where the 19th century tramway had once been located. It was excavated down to a depth of 0.42m where two cast iron water pipes were visible overlain by a layer of concrete. The pipe aligned east west (304) clearly predated that aligned north south (303) since it had been truncated when (303) was inserted. Pipe (304) was set in a brick sided trench and pipe (303) was overlain by a thin layer of concrete (302).</p> <p>A layer of greyish brown silty clay containing fragments of stone approximately 0.1m deep (306) overlay concrete (302) and above this were modern paving slabs (301). Running along the north side of the trench is a modern surface drainage gully built from granite setts (305).</p> |

Fig 18 TP-3.

Fig 19 TP-3 plan.

Fig 20 TP-3 section facing south.

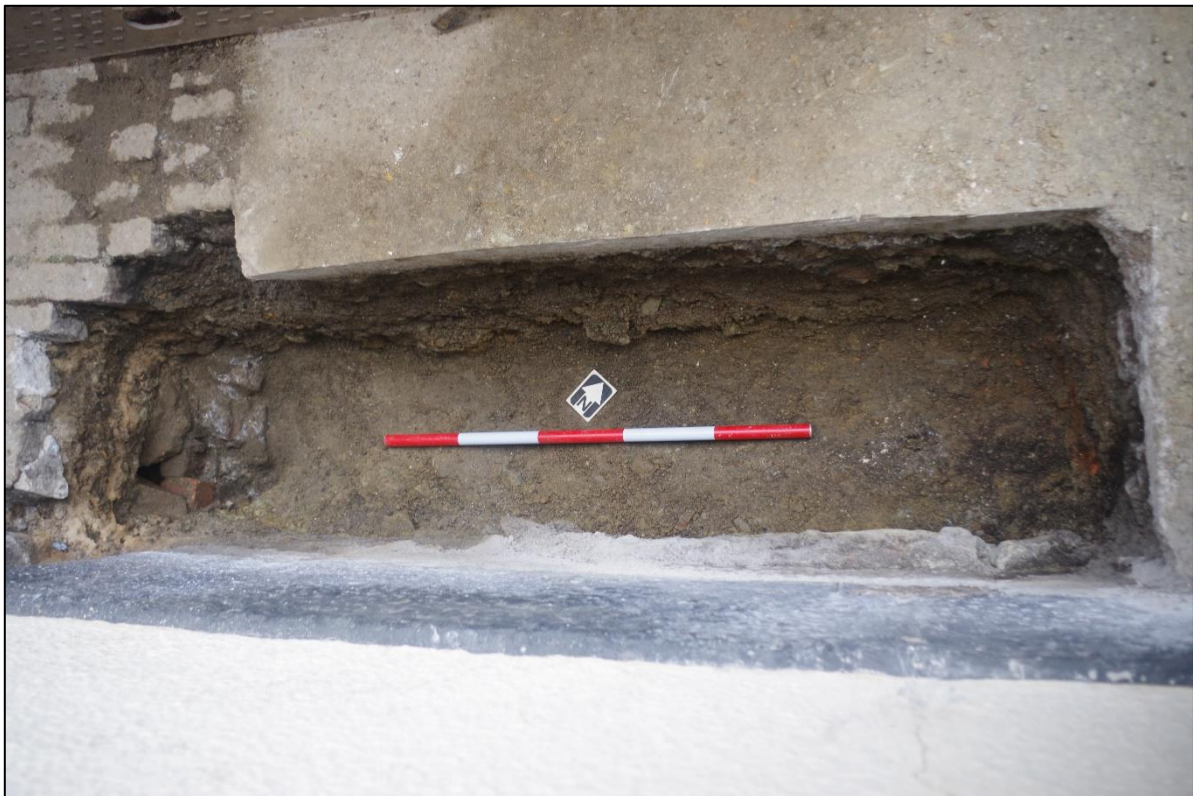
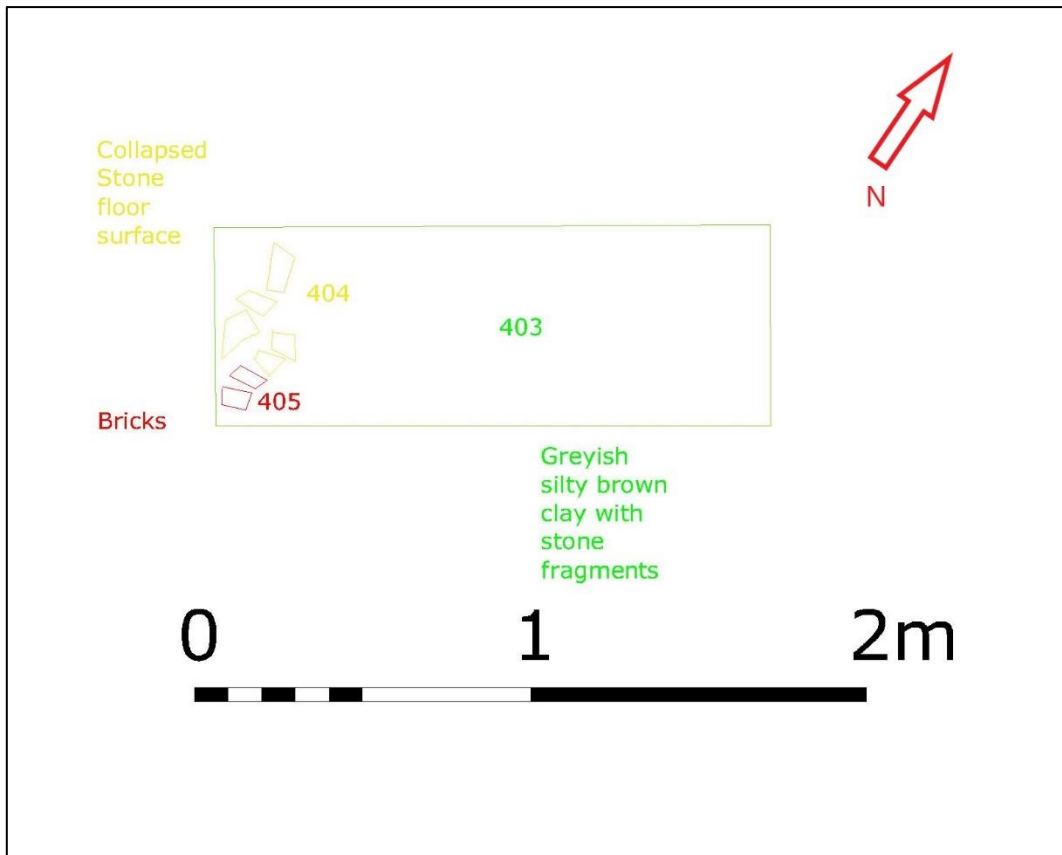
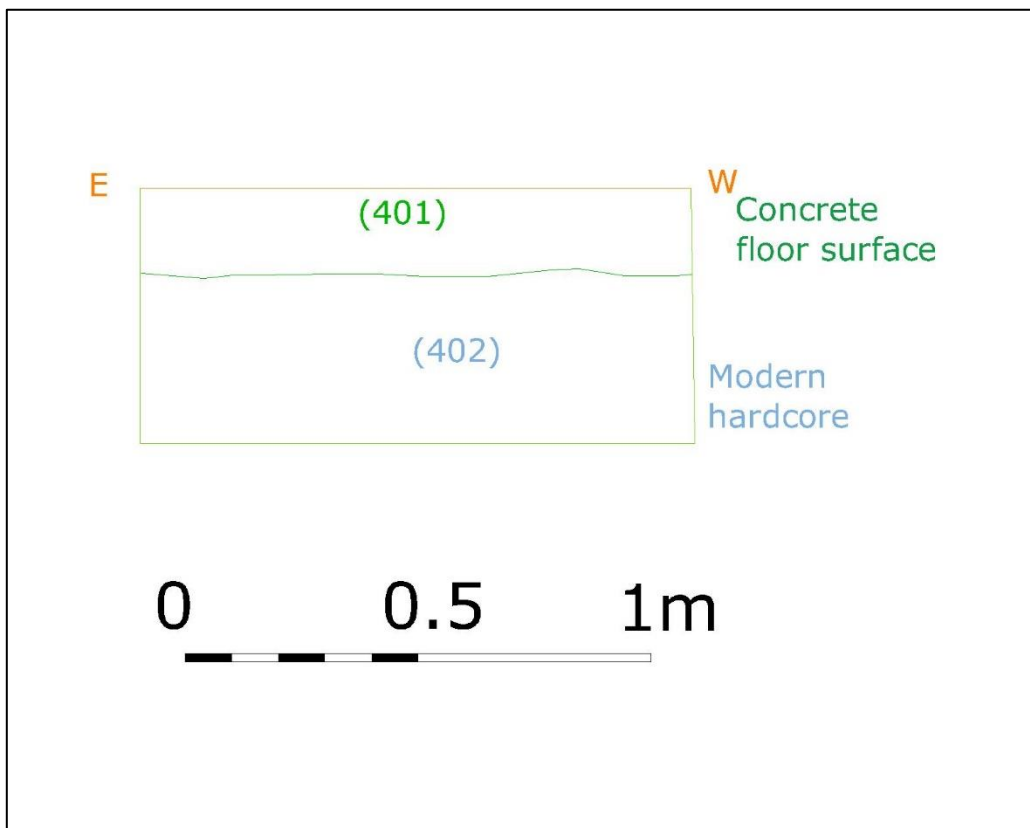
| Test pit | Dimensions of test pit (Length x width x depth) | Description |
|---|---|---|
| TP-4 | 2m x 0.56m x 0.42m | <p>TP-4 was excavated against the north west elevation of the building. It was excavated down to a mid-greyish brown natural (404) at a depth of 0.42m.</p> <p>This was overlain by light brown silty clay (403) which contained stone and brick rubble (404 and 405) at the</p> |

| | | south west end of the trench. Above this was a light brown sand levelling layer (402) which was overlain by concrete surface (401). |

Fig 21 TP-4.

Fig 22 TP-4 plan.

Fig 23 TP-4 section facing south.

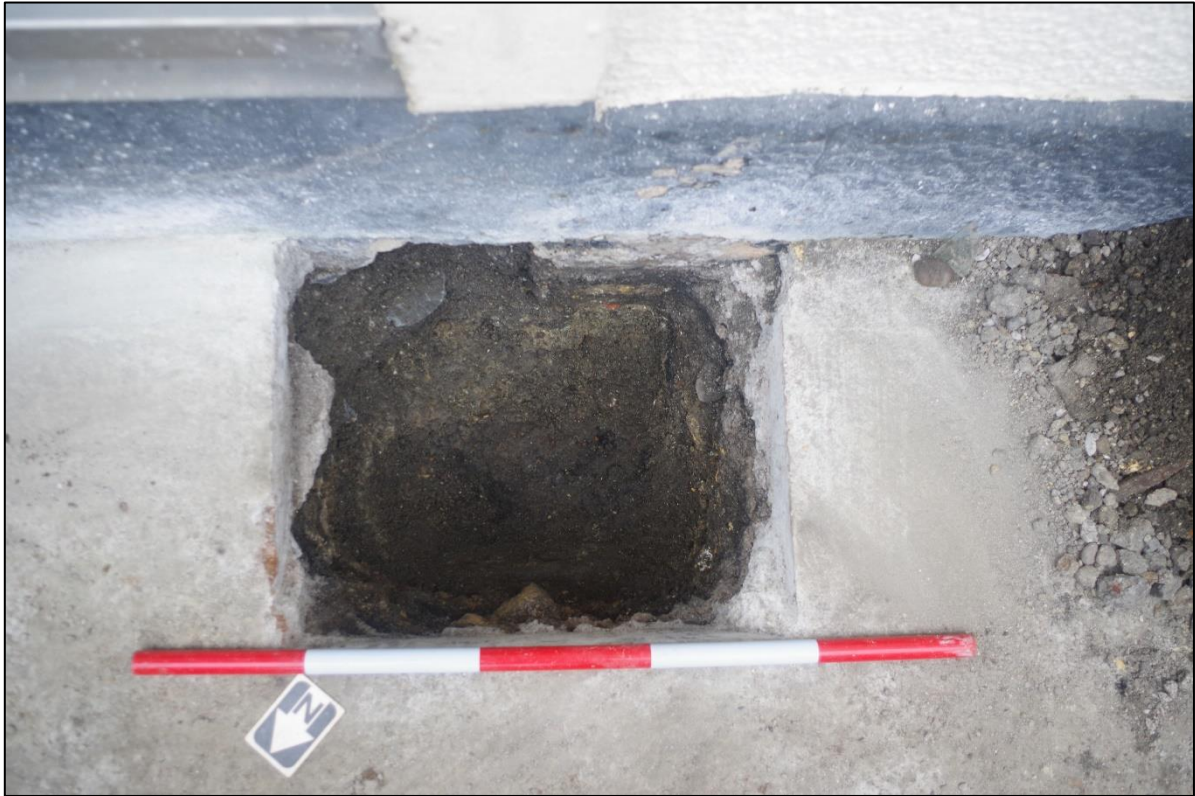
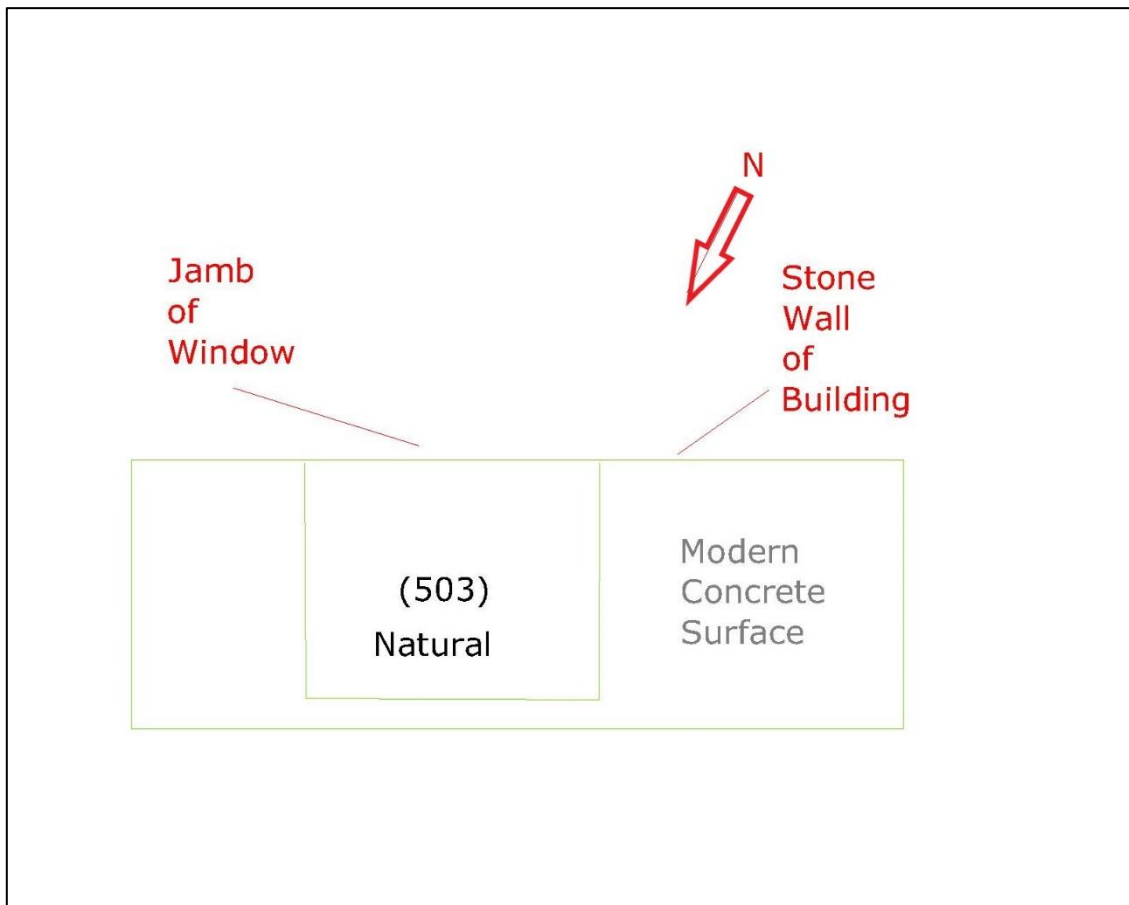
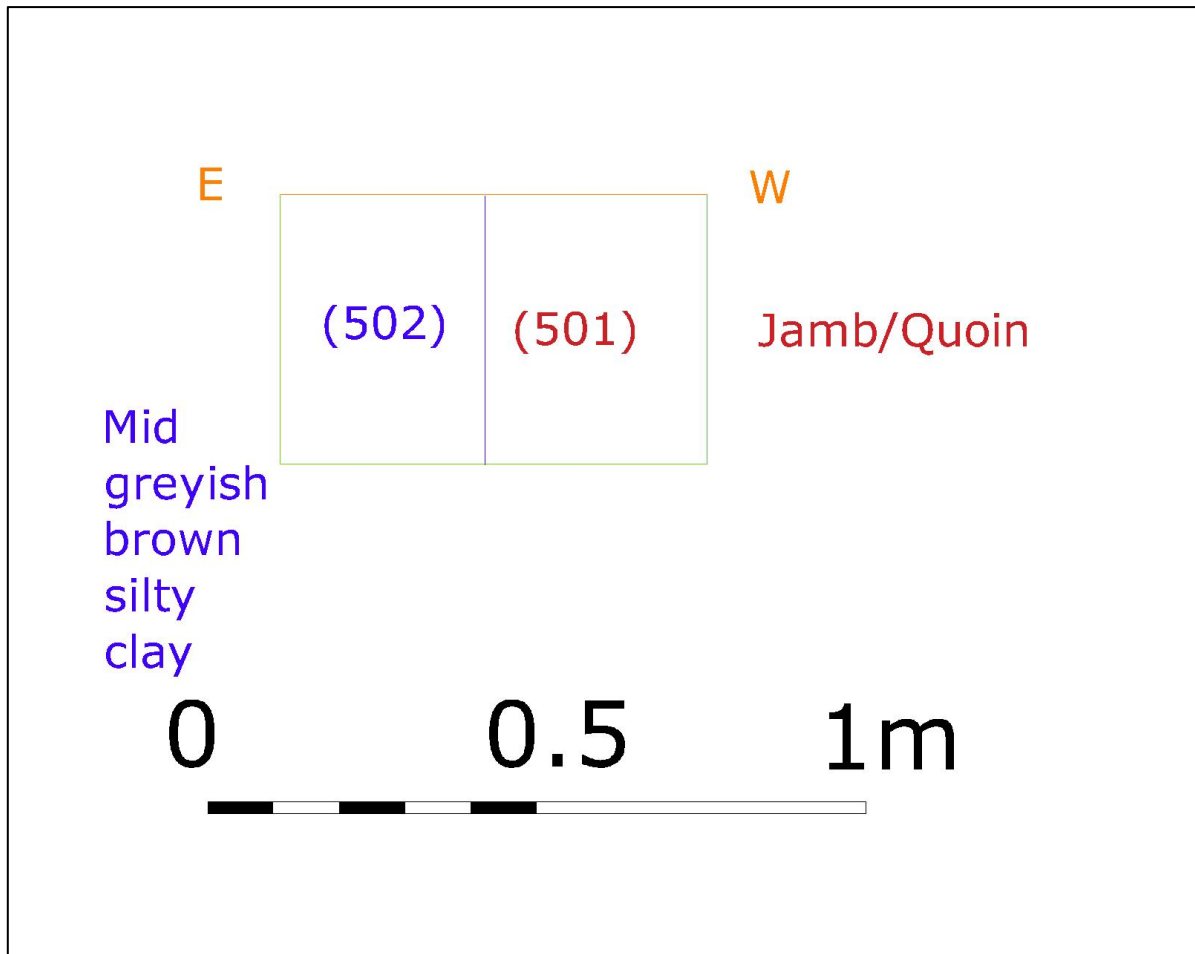
| TP-5 | 0.6m x 0.56m x 0.41m | TP-5 was excavated against the north west elevation of the building below a window jamb. It was excavated down to a natural layer, a yellowish-brown silty clay at a depth of 0.41m (503). In the north-west facing section was a former jamb or quoin (501) occupying the western half of the section and associated with an earlier element of the building. Above the natural (503) elsewhere and seen in the eastern half of the section was a layer of mid greyish brown silty clay with moderate stone and slate fragments (502). Overlying this was a modern concrete surface. |

Fig 24 TP-5.

Fig 25 TP-5 plan.

Fig 26 TP-5 section facing north.

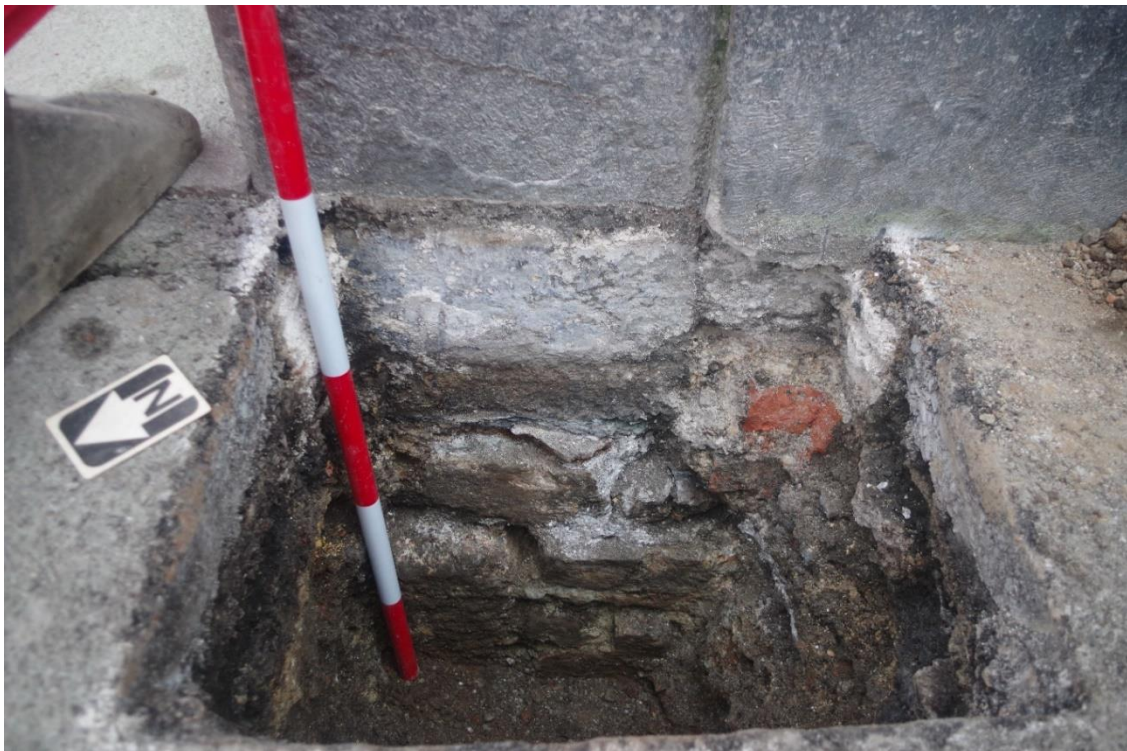
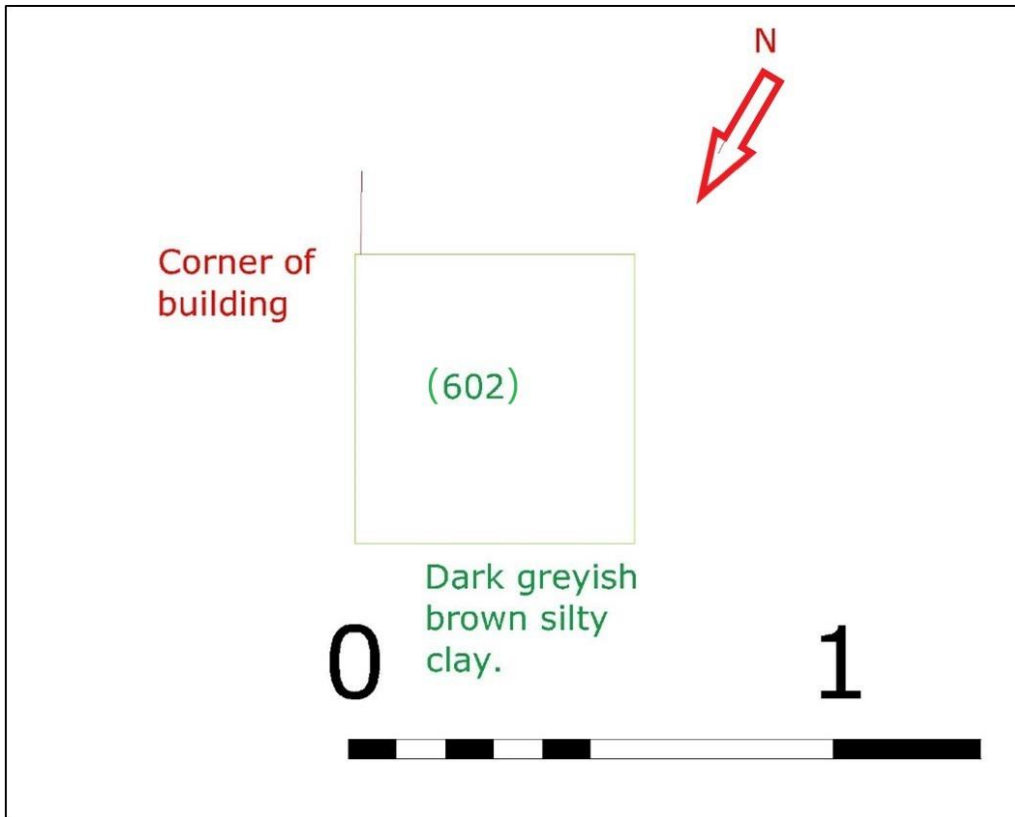
| TP-6 | 0.59m x 0.57m x 0.76m | TP-6 was located at the north east corner of the building. It contained a dark greyish brown silty clay with moderate stone and slate fragments and was excavated down to a depth of 0.76m (602). This was overlain by a modern concrete surface. The footings of the building were revealed in the north facing section and were visible reaching to the base of the trench. |

Fig 27 TP-6

Fig 28 TP-6 plan.

Fig 29 TP-6 section facing north.

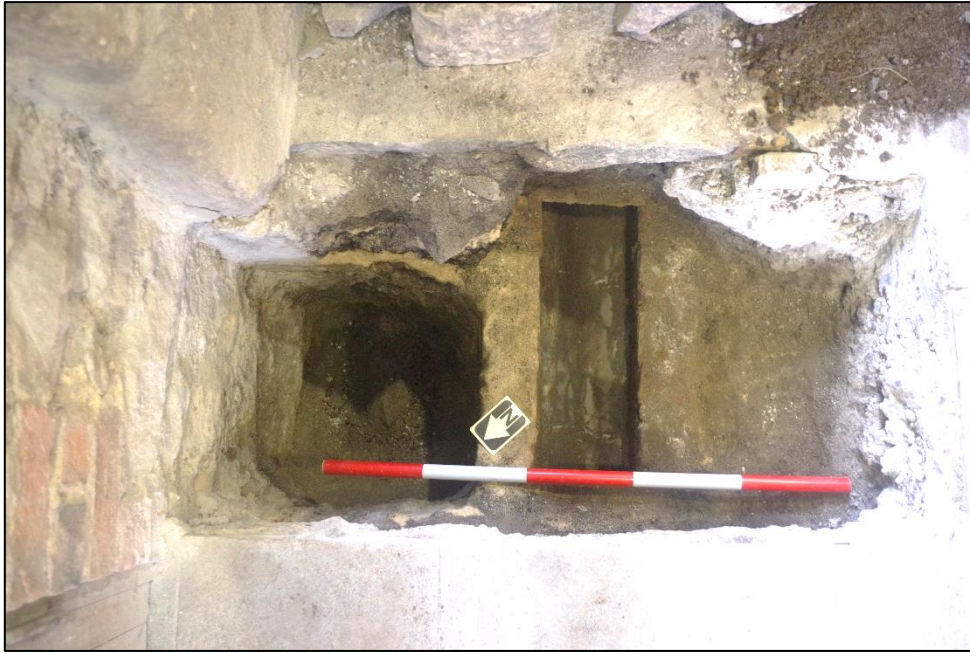
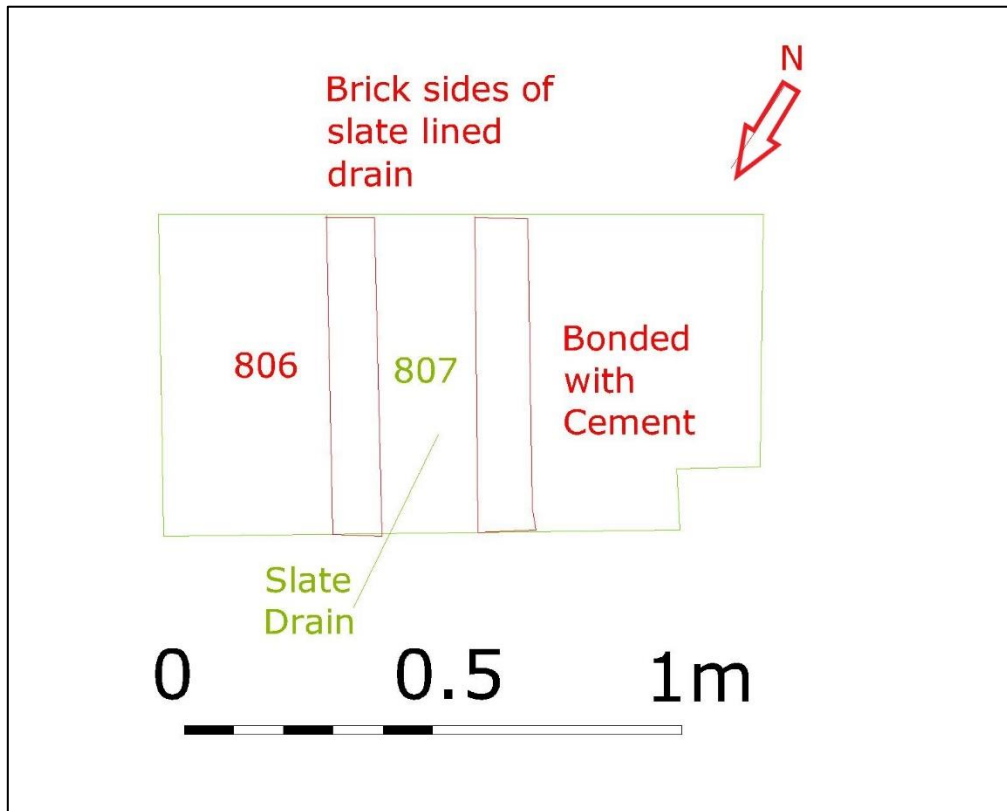
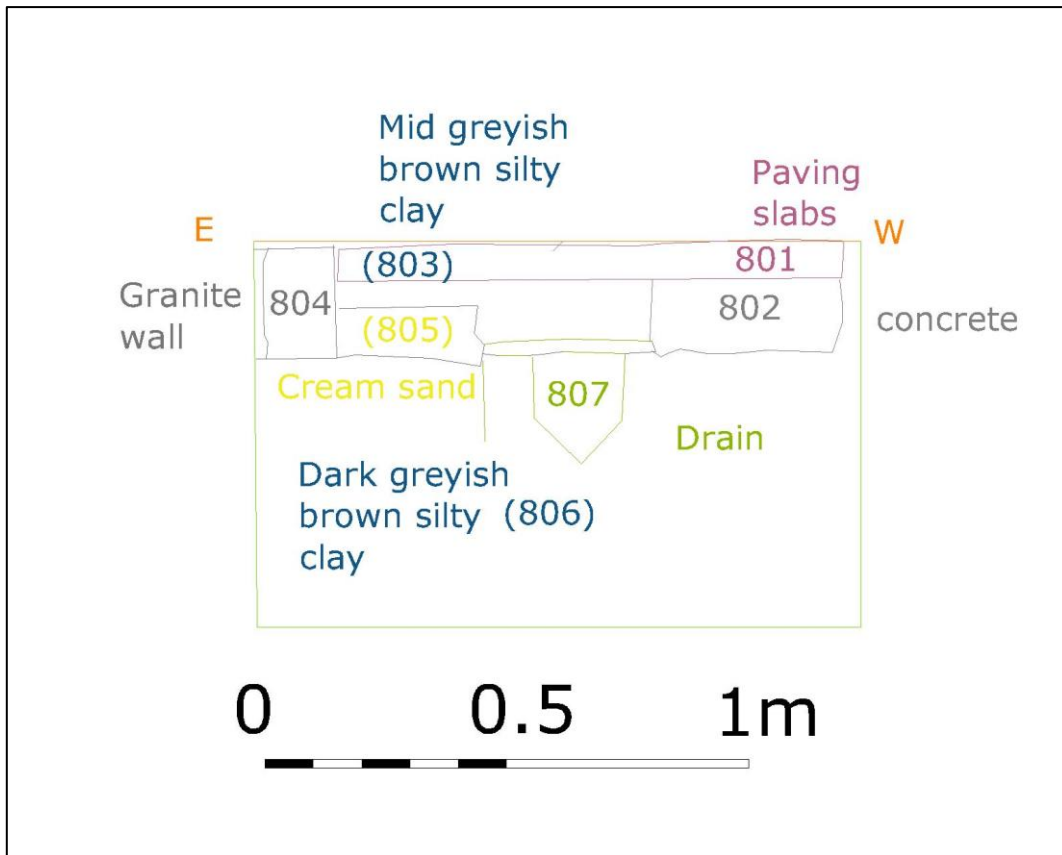
| TP-8 | 1.2m x 0.64m x 0.76m | TP-8 was located in the covered passage. The eastern half of the test pit was excavated down to dark greyish brown clay silt at a depth of 0.76m (806). This was overlain by a thin layer of cream coloured sand (805) which in turn was overlain by a thin layer of coal dust (804). The western half of the test pit was taken down to a slate-lined drain (807), aligned north-south. This had a V-shaped base lined with slate and brick sides bonded with a cement mortar. The drain was covered with iron plates and above this was a layer of mid greyish brown silty clay (803). Adjoining this layer to the west was a layer of concrete (802). Modern paving slabs (801) overlay the entire test pit. |

Fig 30 TP-8

Fig 31 TP-8 plan.

Fig 32 TP-8 section facing north.

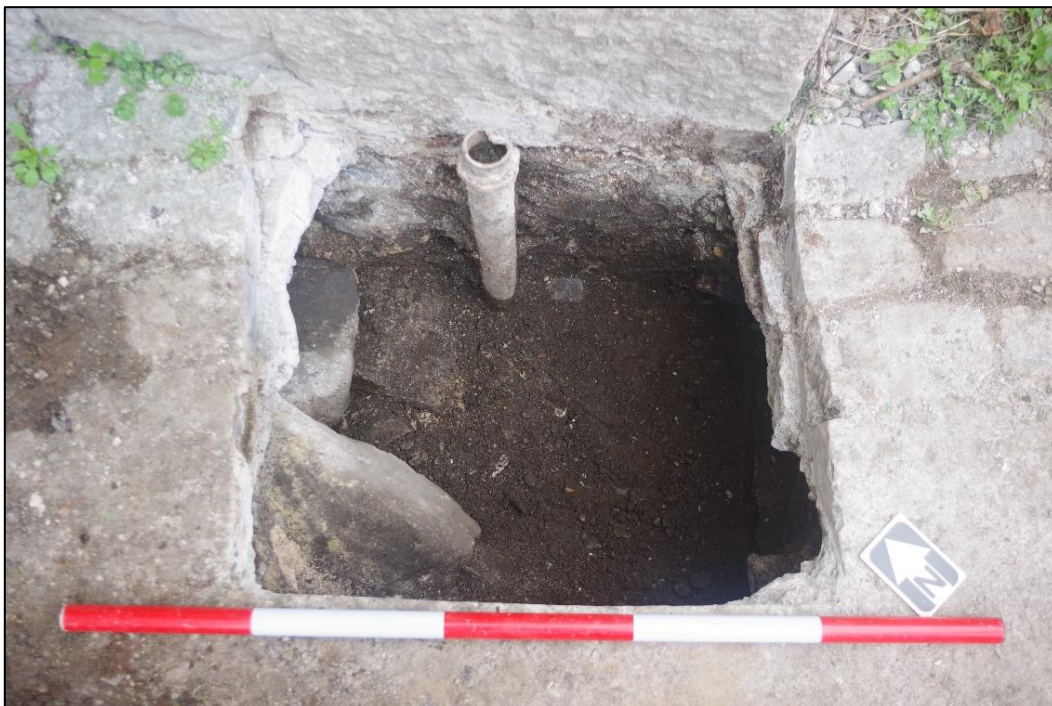
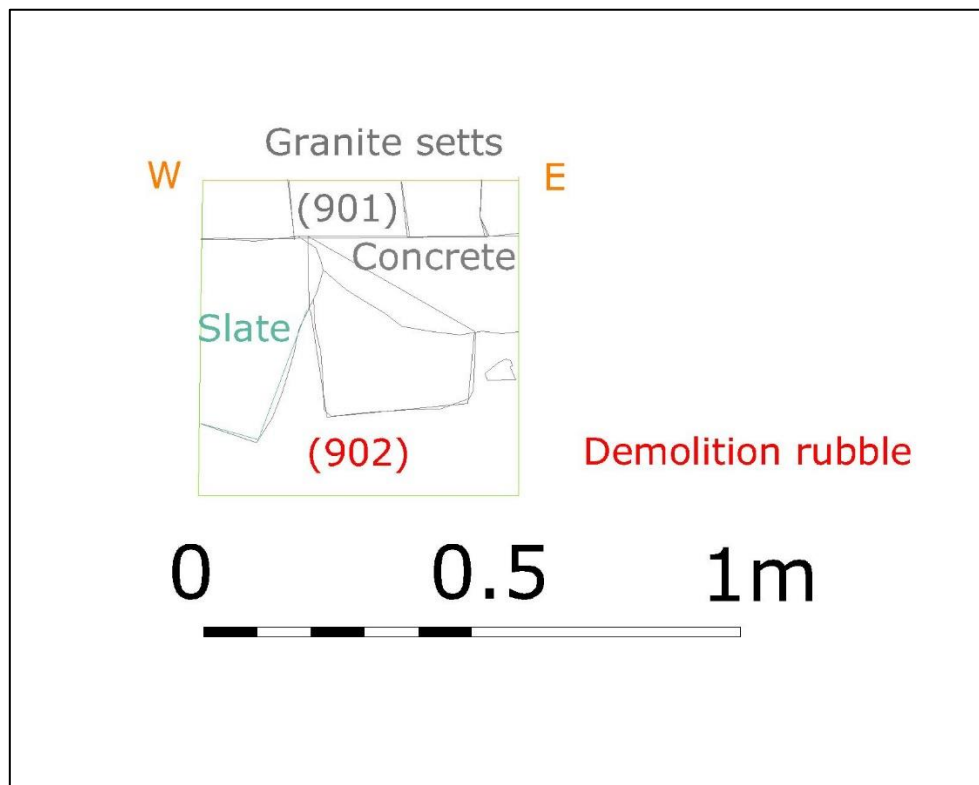
| TP-9 | 0.63m x 0.59m x 0.58m | TP-9 was excavated down through a surface of granite setts (901) which overlay demolition rubble (902) containing some large granite and slate stones. It reached a depth of 0.58m. The test pit contained an iron pipe (903) set vertically against an east wall of the building. |

Fig 33 TP-9.

Fig 34 TP-9 plan.

Fig 35 TP-9 section facing north.

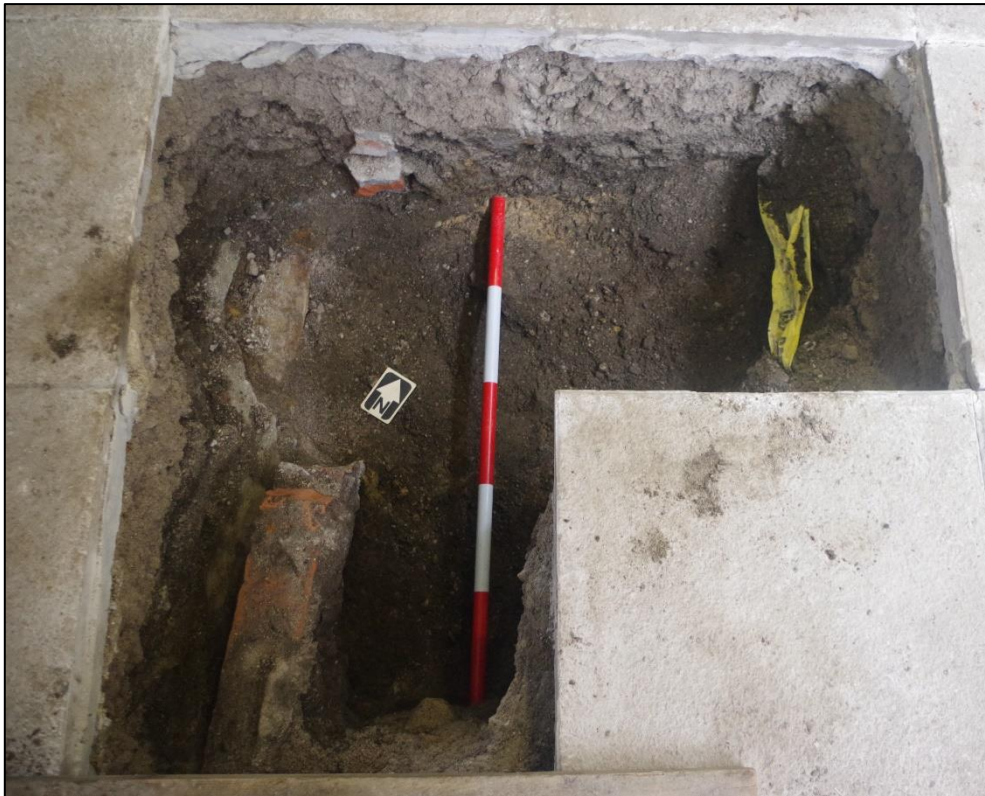
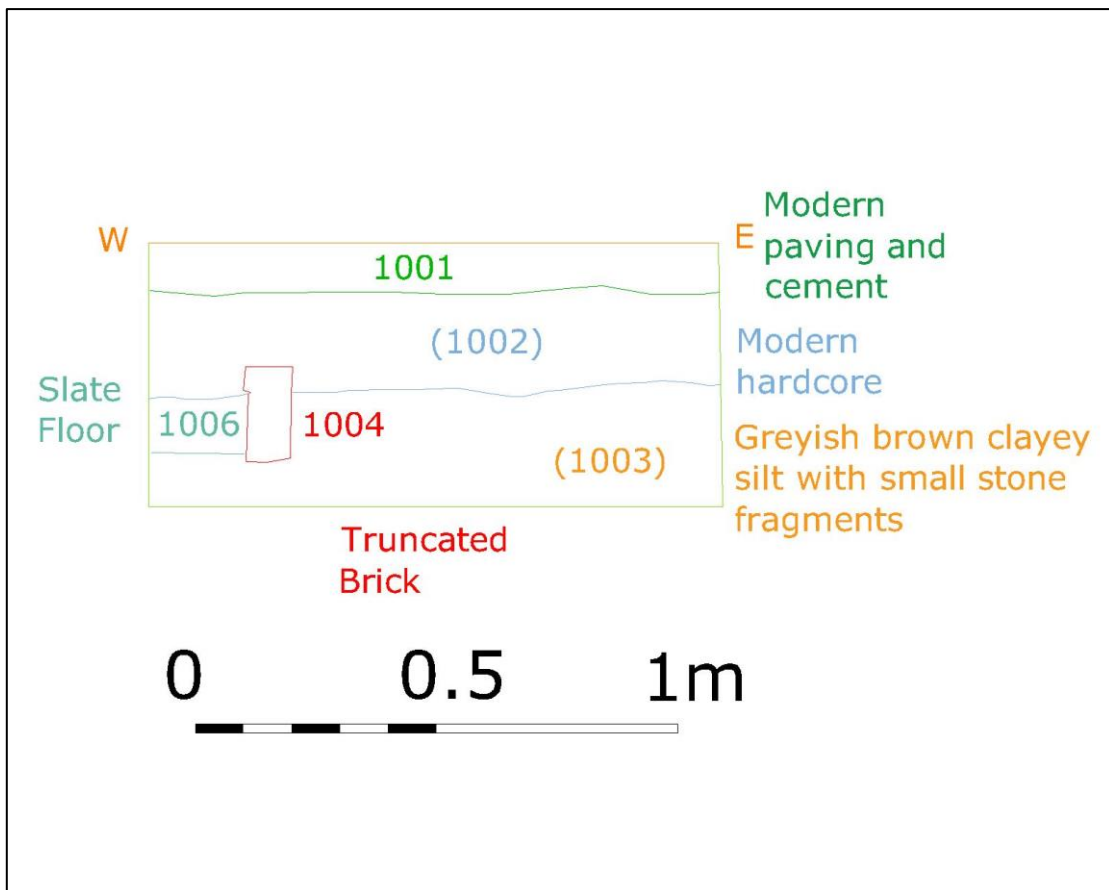
| TP-10 | 1.3m x 1.1m x 0.54m | TP-10 was L-shaped in plan, excavated down to a depth of 0.54m in the eastern part of the test pit. Running north-south along the western side was an iron pipe (1005), with a possibly associated brick wall bonded with cement mortar (1004) running parallel with it on its eastern side which had been truncated towards the north. A slate floor (or base of the pipe trench) (1006) adjoined the western side of the brick wall. The slate floor and the area to the east of the wall were overlain by a layer of greyish brown silty clay with small fragments of stone (1003). This was overlain by a layer of modern hardcore (1002) which in turn was overlain by modern paving and cement (1001). |

Fig 36 TP-10.

Fig 37 TP-10 plan.

Fig 38 TP-10 section facing north.
