John Harvey House, Hayle Cornwall Archaeological Watching Brief

Archaeological Watching Brief

| Report Number | 2022R019 |
| Date | June 2022 |

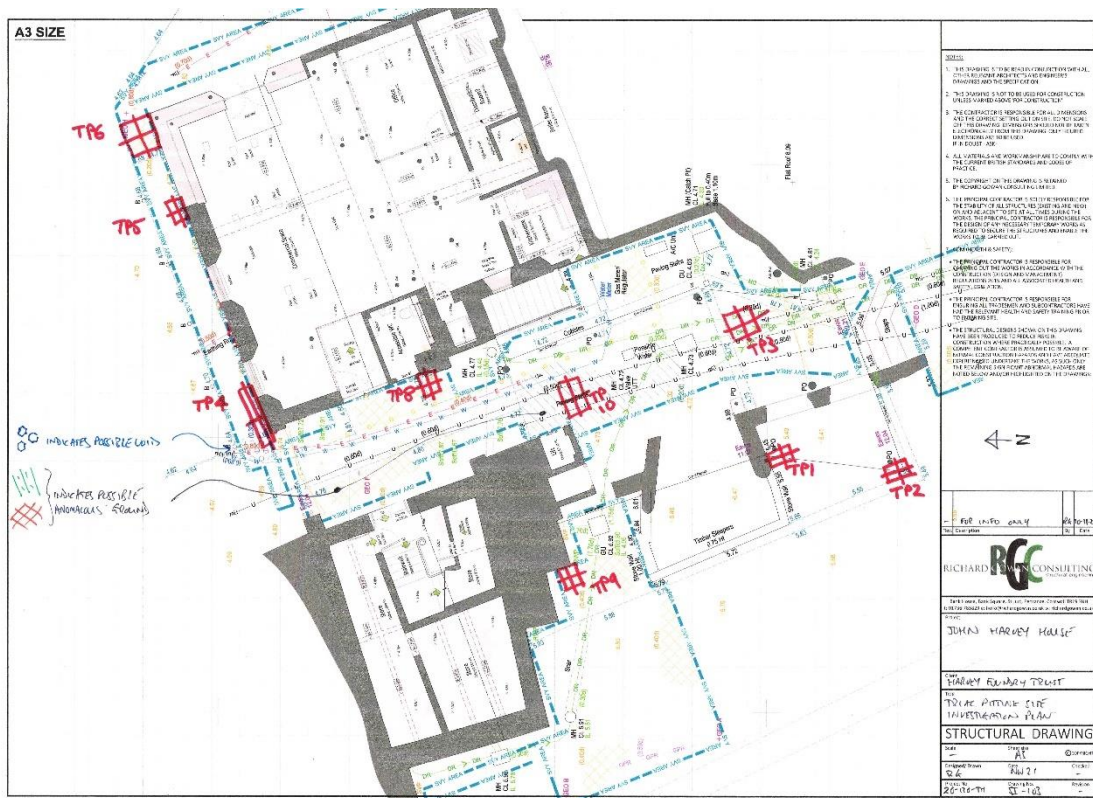
Fig 3 Trial pits proposal plan of locations.

There are ten trial pits which are located both inside and outside of the building. The approximate locations of each are shown on Figure 3. Trial pits 3, 8 and 10 are located inside the building.

In order to investigate signs of subsidence, trial pits have been excavated in various locations around the building (see Fig 3). These pits have been left open to ensure that an archaeological record is made prior to reinstatement. The Harvey's Foundry Trust have now commissioned Cornwall Archaeological Unit to undertake the archaeological work.
