Truro Northern Access Road, Cornwall;

West Langarth phase: Hedge Breaks Report

Client	Cormac Solutions
Report Number	2023R010
Date	March 2023
Status	Final
Report author(s)	Richard Mikulski
Checked by	Fiona Fleming
Approved by	Andy Jones
Project number	147186
Site code	TNAR22
Data location	\\CAU\Archive\Sites\T\ Truro NAR WSI and works 2021 147186\Report\Hedge Breaks Report
ADS OASIS online reference	cornwall2-513606
Planning reference	PA20/09631

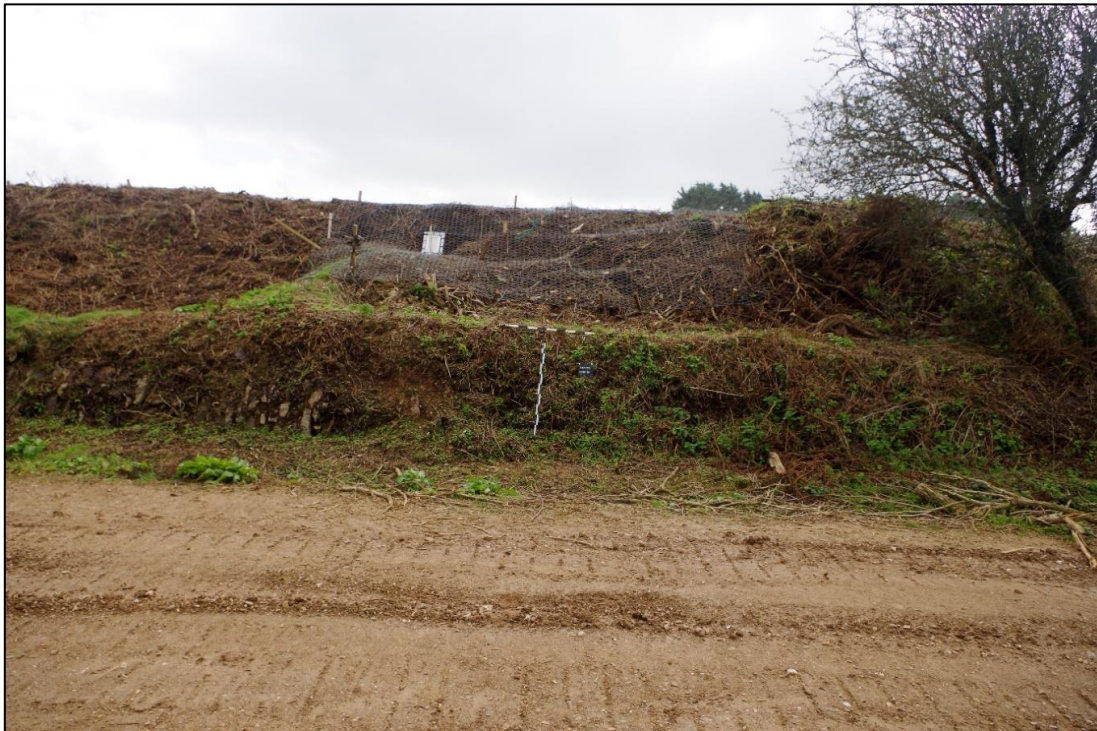
Stone facing to north-facing elevation consists of large basal quartz and killas slabs or blocks vertically laid and irregularly coursed; these were overlain towards the top by smaller rough-hewn angular quartz cobbles, loosely coursed. Southern elevation was not visible as the A390 road embankment immediately abuts the southern side of hedge.

Fig 3 HE-01-01. North-facing elevation in area of hedge-break HE-01-01A, with badger sett visible behind. 1m Scale.

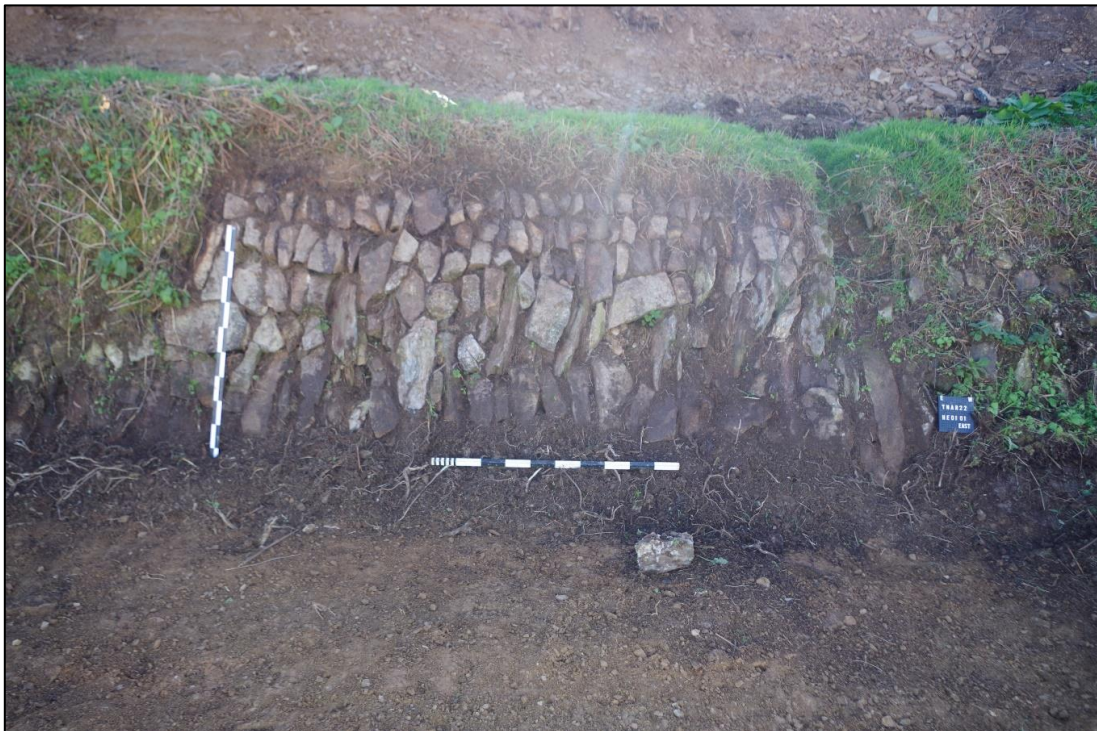
Figure 4 HE-01-01. North-facing elevation to east of hedge-break HE-01-01A (vegetation removed). 1m scale.

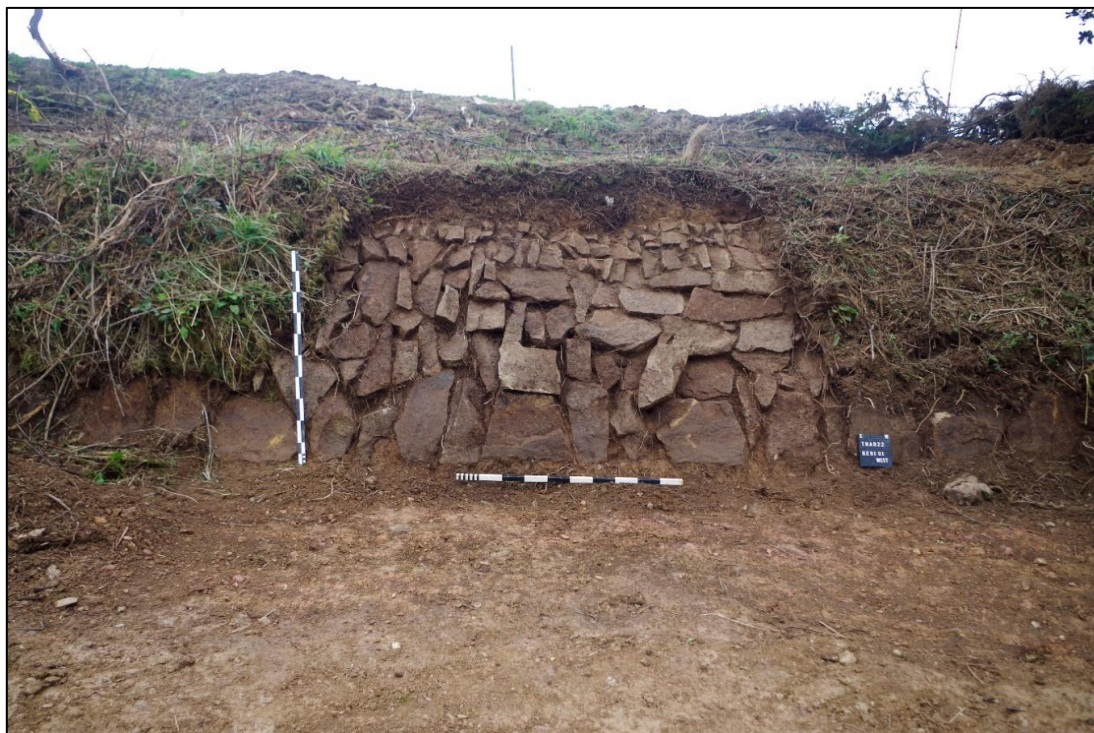
The stone facing to north-facing elevation consisted of rough-hewn angular killas/shale blocks, vertically and horizontally set in loose horizontal coursing (see Fig 5). It was uncertain whether there was any dressing to the southern elevation as that side was under heavy vegetation.

Figure 5 HE-01-01. North-facing elevation to west of hedge-break HE-01-01A and east of hedge-break HE-01-01B (vegetation removed). 1m scale.

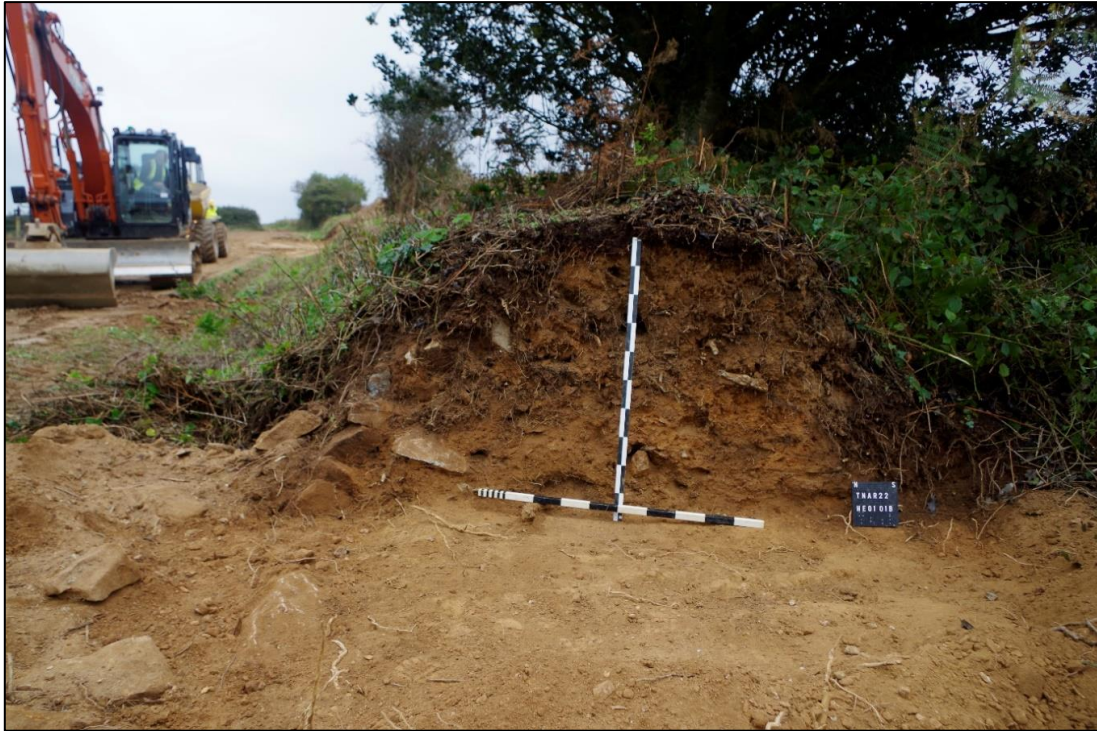
Figure 6 HE-01-01. Post-excavation photograph of west-facing section of hedge-break HE-01-01B. 1m scale.

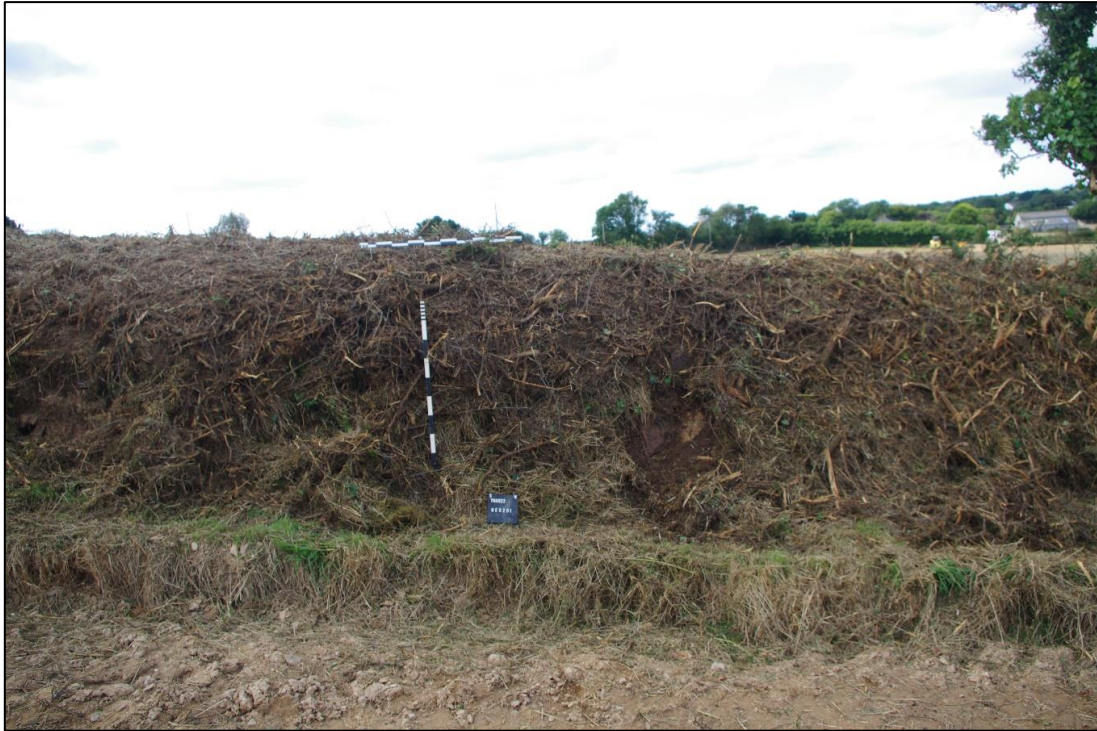
Figure 7 HE-02-01. Pre-excitation photograph of east-facing elevation. 1m scale.

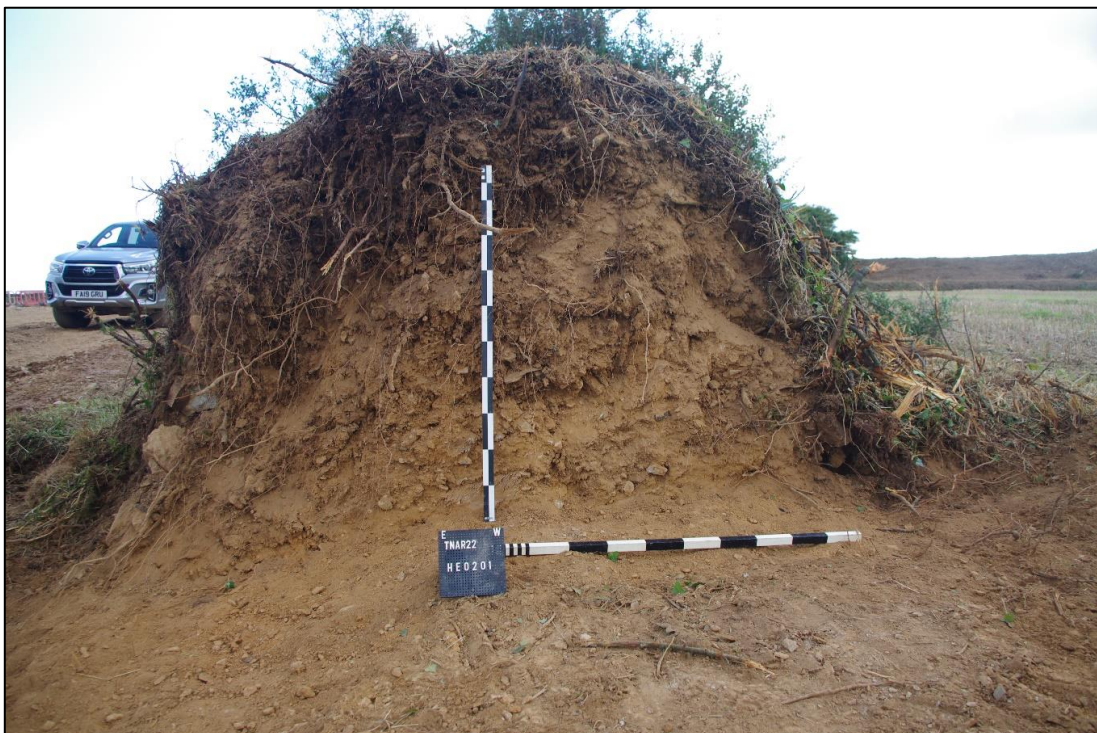
Single ditches were evident on both the east and west sides but were not visible following the break. The level between fields was noted as fairly even. The earthen bank was roughly symmetrical and appeared to be of single-phase construction, consisting of a light reddish brown silty clay with moderate large angular shale/killas pebbles. The uppermost part of the bank was heavily rooted (Figs 8 and 9).

Figure 8 HE-02-01. Post-excitation photograph of north-facing section of hedge-break. 1m scale.

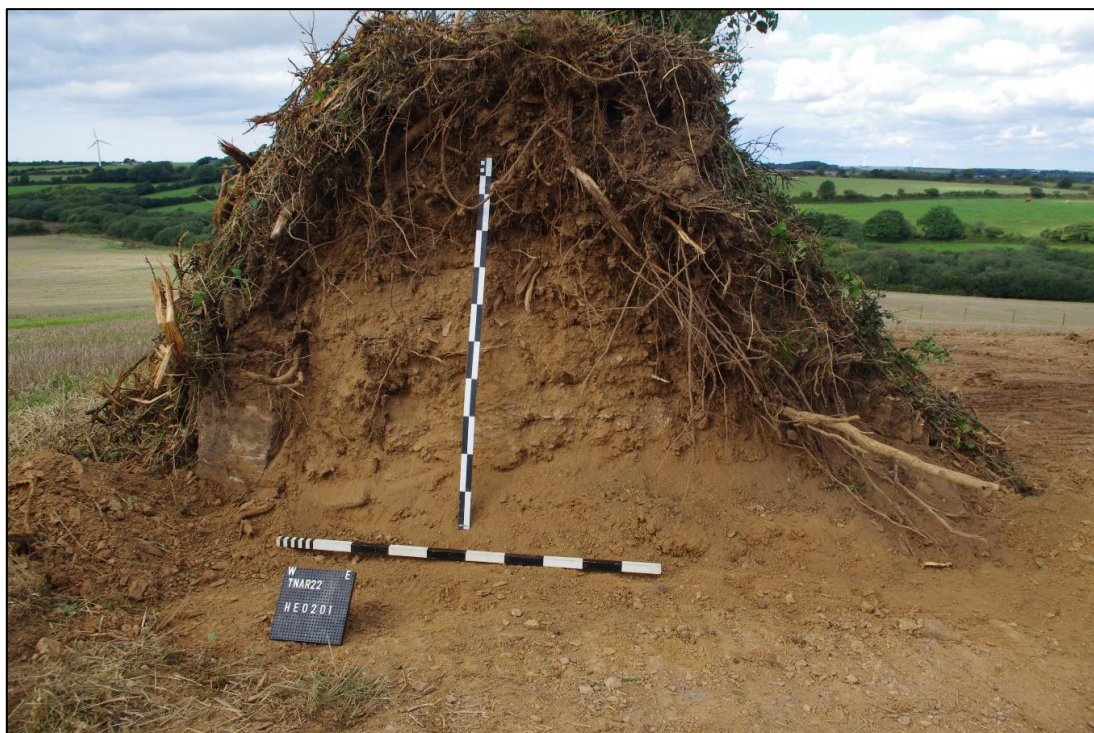
Figure 9 HE-02-01. Post-excavation photograph of south-facing section of hedge-break. 1m scale.

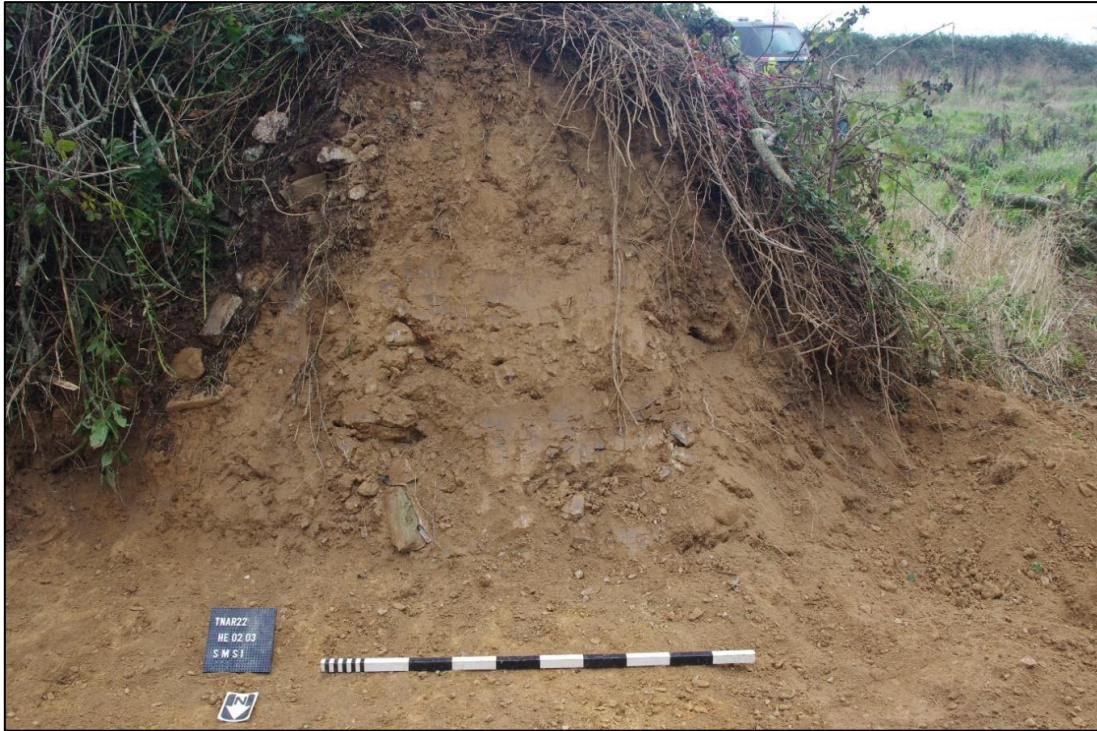
The level between fields was noted as fairly even. The internal earthen bank was considered to be symmetrical and of single-phase construction, consisting of mid yellowish brown silty clay with occasional shale/killas (angular pebbles and small angular cobbles). Animal burrowing (rabbits) had impacted the eastern side, resulting in slumping (Figs 10 and 11).

Figure 10 HE-02-03. Post-excavation photograph of north-facing section of hedge-break HE-02-03A. 1m scale.

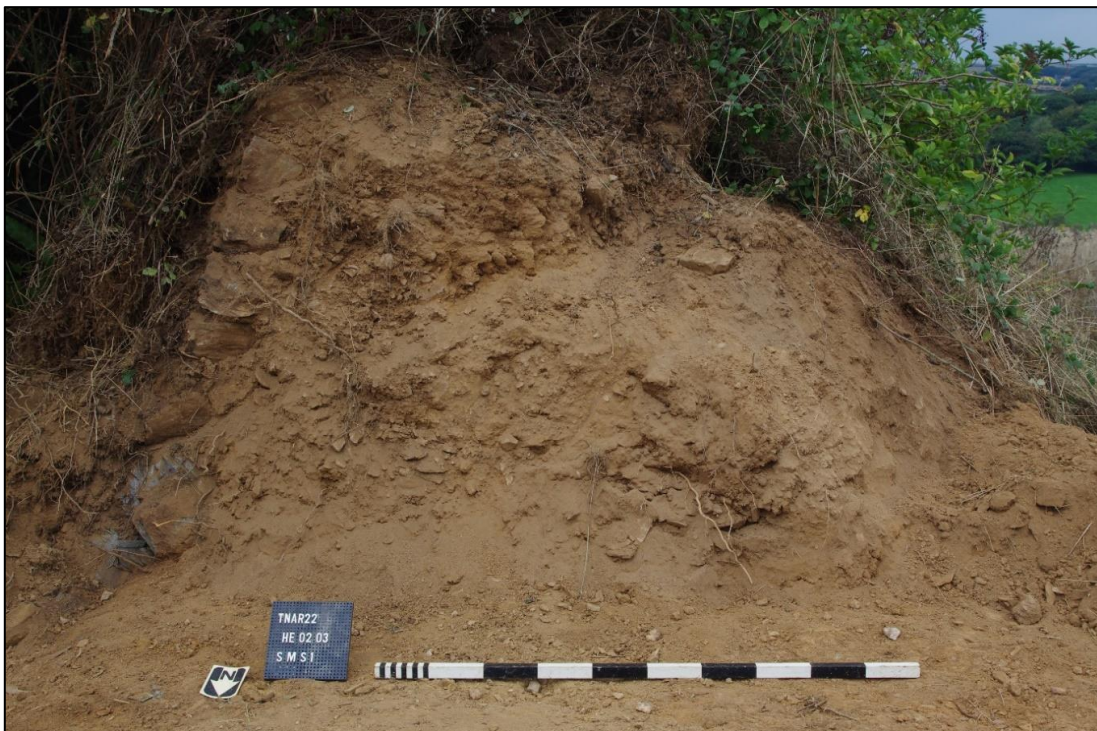
Figure 11 HE-02-03. Post-excavation photograph of south-facing section of hedge-break HE-02-03A. 1m scale.

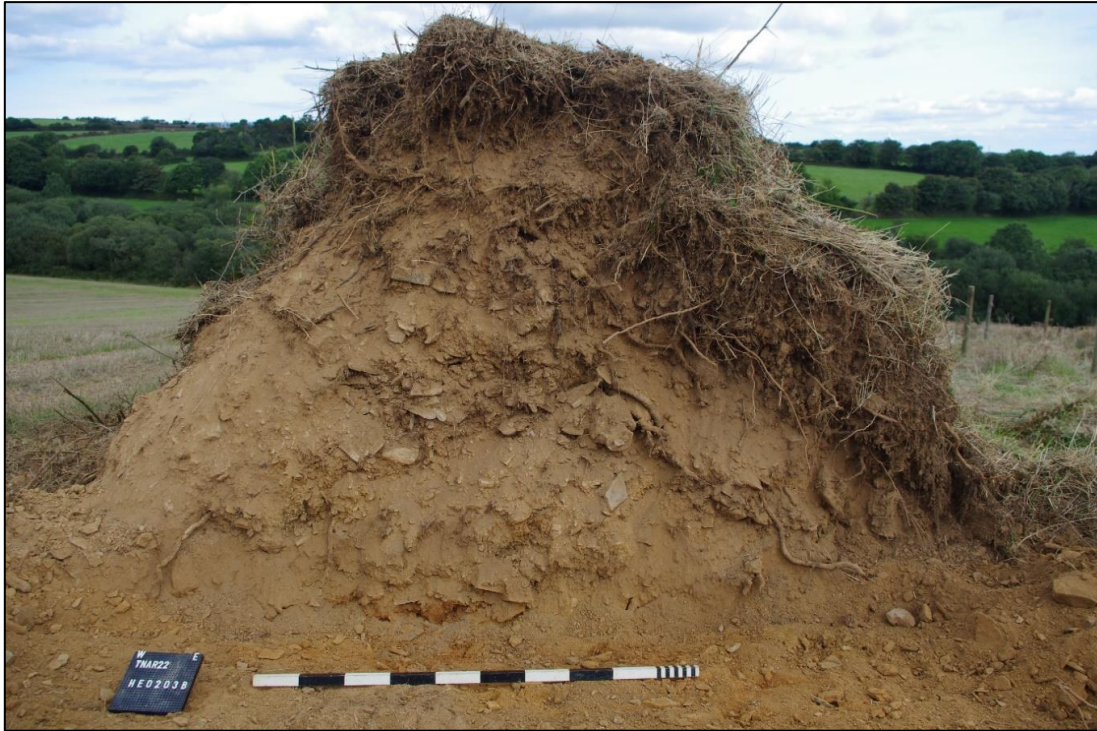
The level between fields was again fairly even. The internal earthen wall core appeared near symmetrical and of possible multi-phase construction with tip lines in mounded curves, representing banked earth with pockets of redeposited material, evident in the north-facing section (Fig 14 and see Fig 80). The upper part of the wall core consisted of looser mid brown heavily rooted silty clay with moderate shale/killas angular pebbles. This overlay a deposit of mid yellowish brown silty clay with moderate shale/killas (angular pebbles and small angular cobbles). Beneath this was a mid reddish brown silty clay layer with moderate shale/killas, possibly an old land surface. Slumping to both sides of the bank was noted, particularly evident on the western side (see Figs 13-14 and 80).

Figure 13 HE-02-03. Post-excitation photograph of south-facing section of hedge-break HE-02-03B. 1m scale.

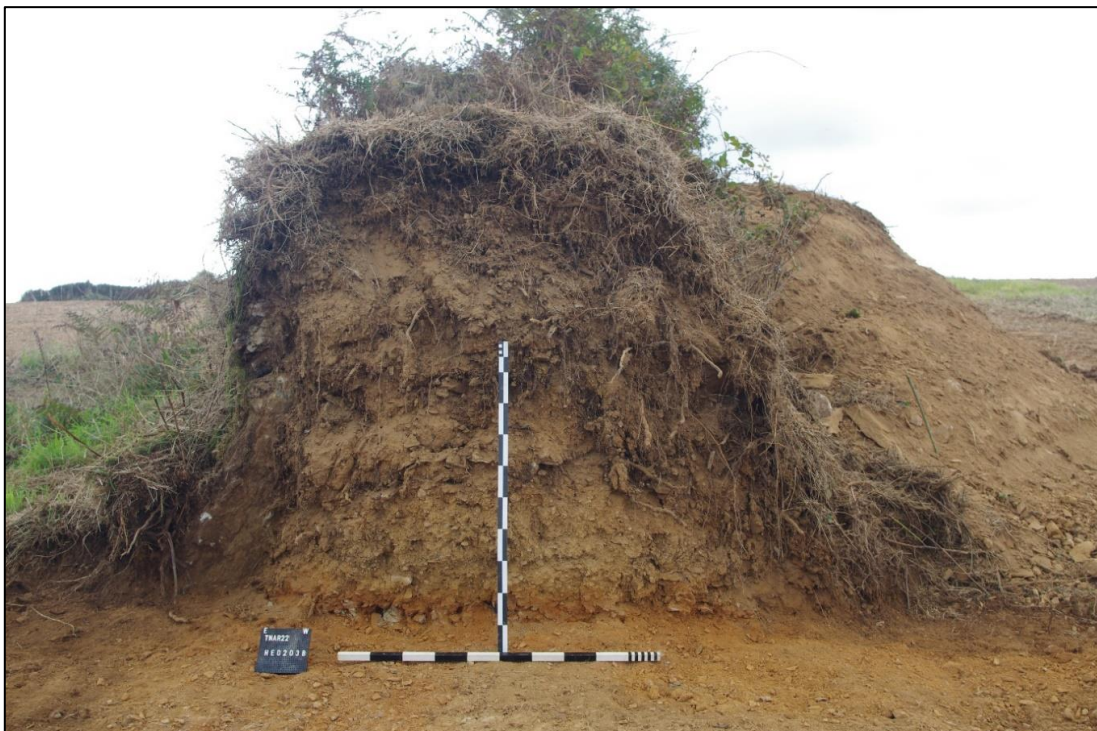
Figure 14 HE-02-03. Post-excitation photograph of north-facing section of hedge-break HE-02-03B. 1m scale.

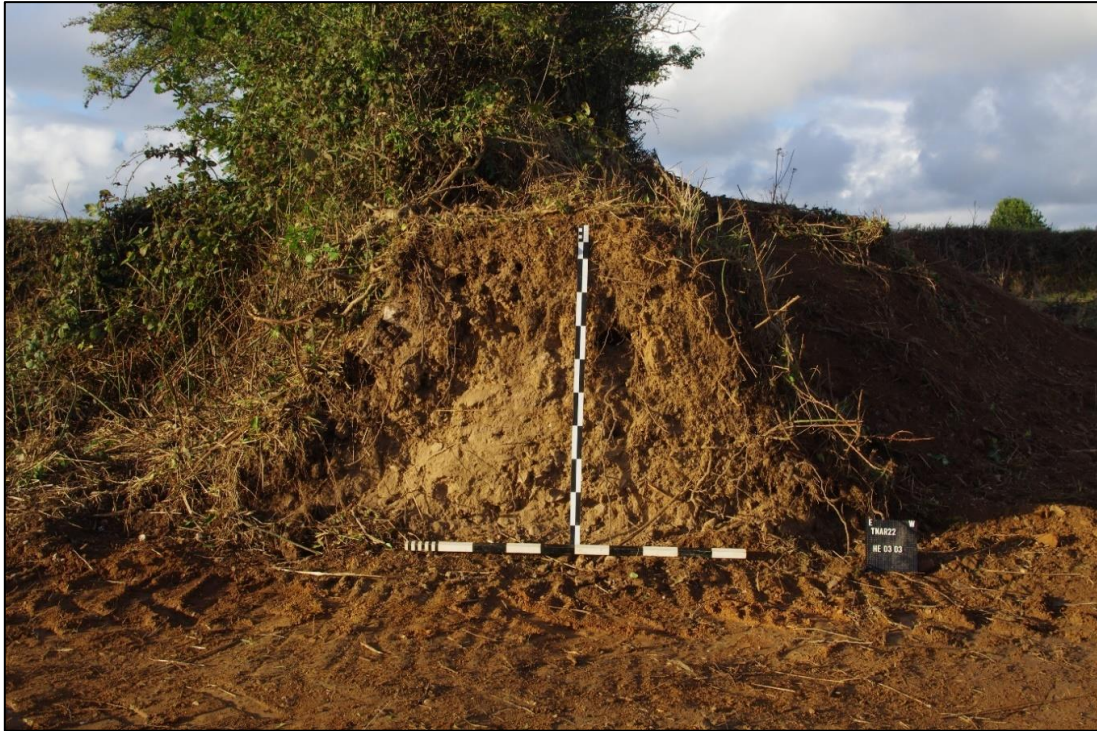
The earthen wall core consisted of two layers suggestive of a phased construction. A loose mid slightly reddish brown friable silty clay sat over a more compact darker mid reddish brown silty clay with frequent small shillet and quartz pebbles. The bank had been subject to heavy root activity (see Figs 22 and 23).

Figure 22 HE-03-03. Post-excavation photograph of north-facing section of hedge-break. 1m scale.

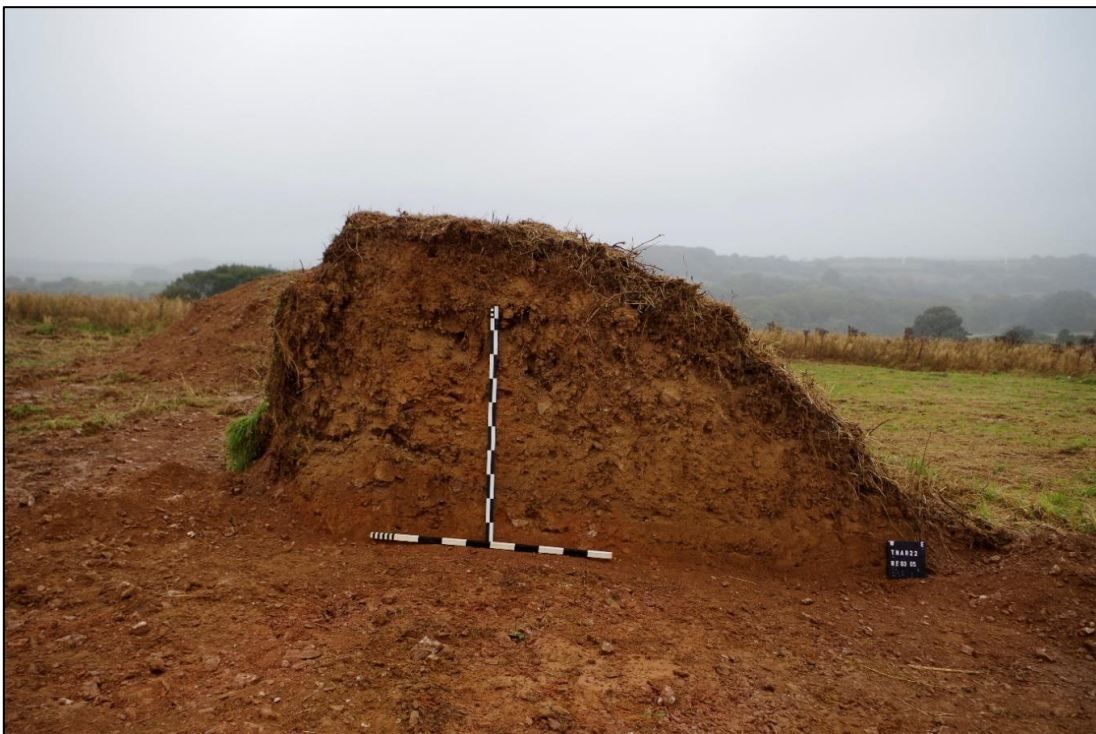
The earthen wall core was relatively stone-free at the top (except for extant facing), where the soil was loose, possibly the result of casting up and consisted of a mid brown silty clay; lower down the bank consisted of a more compact, mixed matrix, but still appeared to have been of single-phase construction, consisting of a mid reddish brown silty clay, mottled with mid yellowish brown silty clay (suggesting the incorporation of redeposited material) with occasional small angular quartz. There was also the suggestion of an old land surface beneath the bank indicated by a slightly darker reddish brown silty clay with frequent small angular quartz (see Figs 27 and 28).

Figure 28 HE-03-05. Post-excavation photograph of south-facing section of hedge-break. 1m scale.

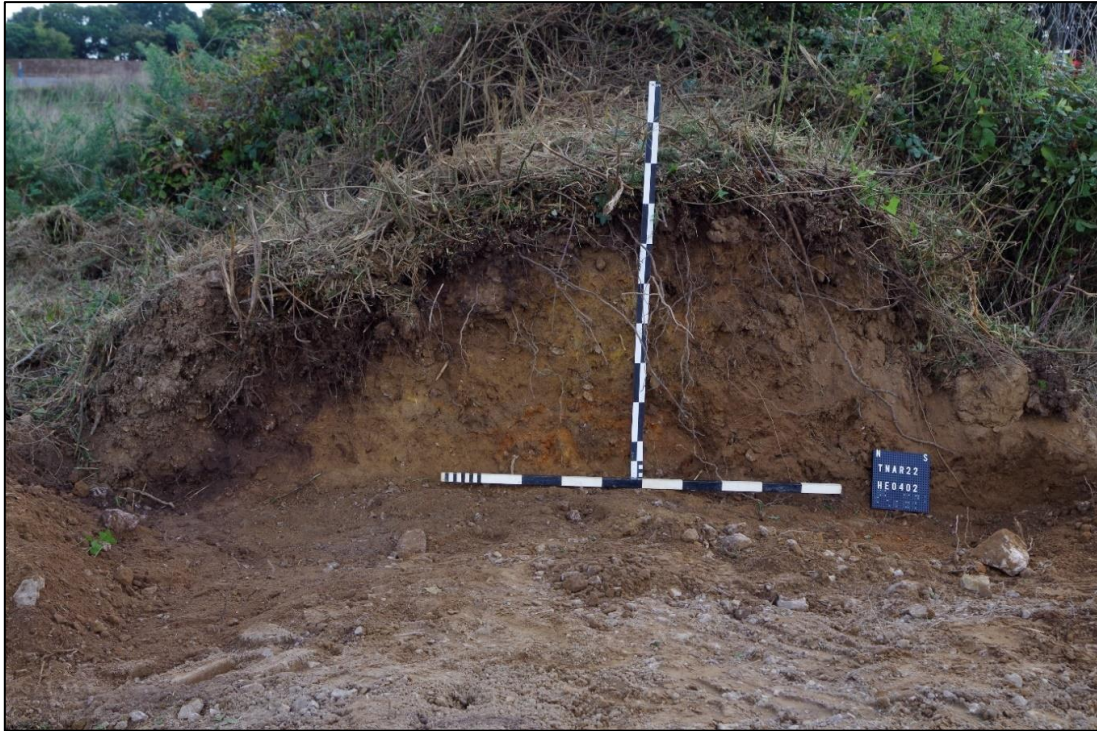
Figure 37 HE-04-02. Post-excavation photograph of west-facing section of hedge-break. N.B. southern side had been subject to severe animal burrowing. 1m scale.

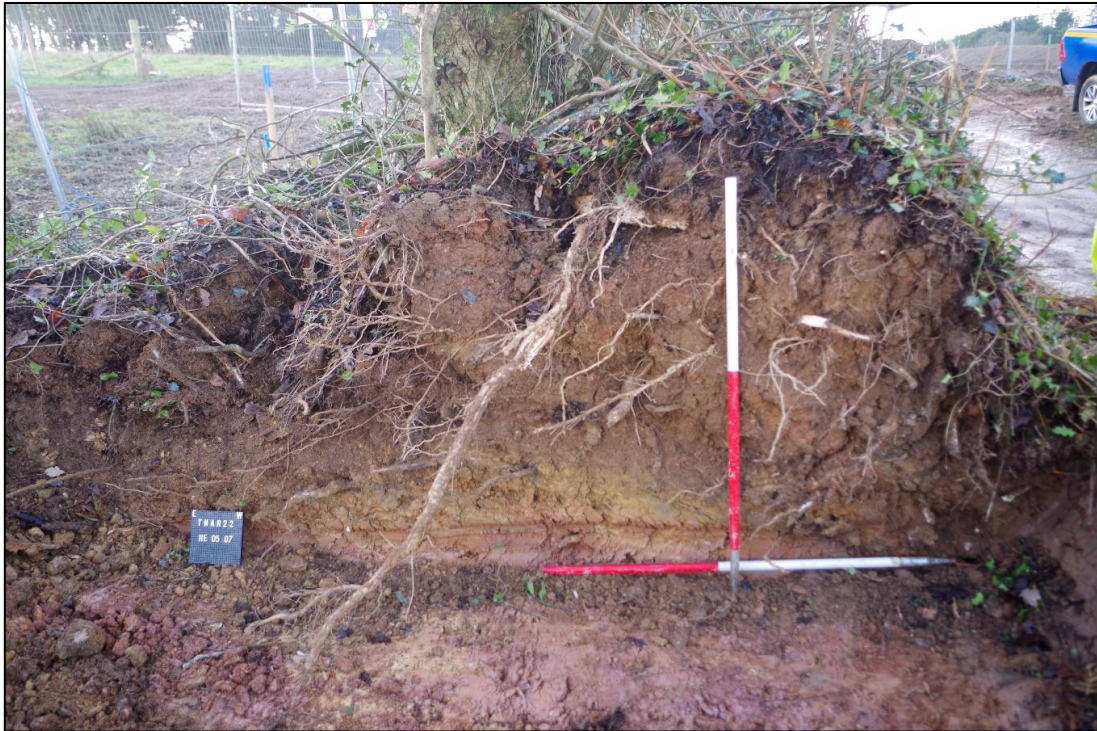
The main bank overlay what may have been an old land surface at the base of the hedge, or possibly the base of an earlier earth bank (see Fig 41). Below this former surface/bank there were a further two earlier deposits. The uppermost of those comprised a light yellow clay focussed towards the eastern (upslope) side of the section, possibly a redeposited natural. This thinned out towards the western side. Beneath was a mottled reddish brown clay layer, possibly degraded natural (see Fig 41).

Figure 41 HE-05-07. Post-excitation photograph of north-facing section of hedge-break. 1m scale.

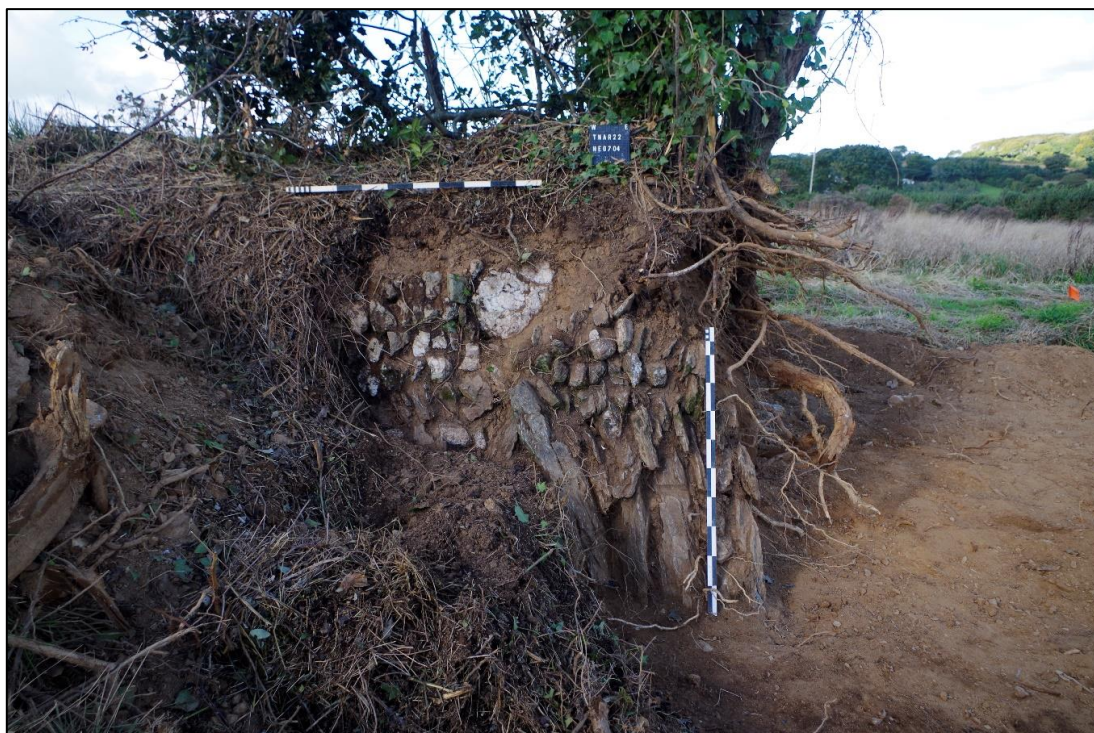
Figure 55 HE-07-04. Post-excavation photograph of south-facing elevation immediately west of hedge-break, showing two possible phases of construction. 1m scale.

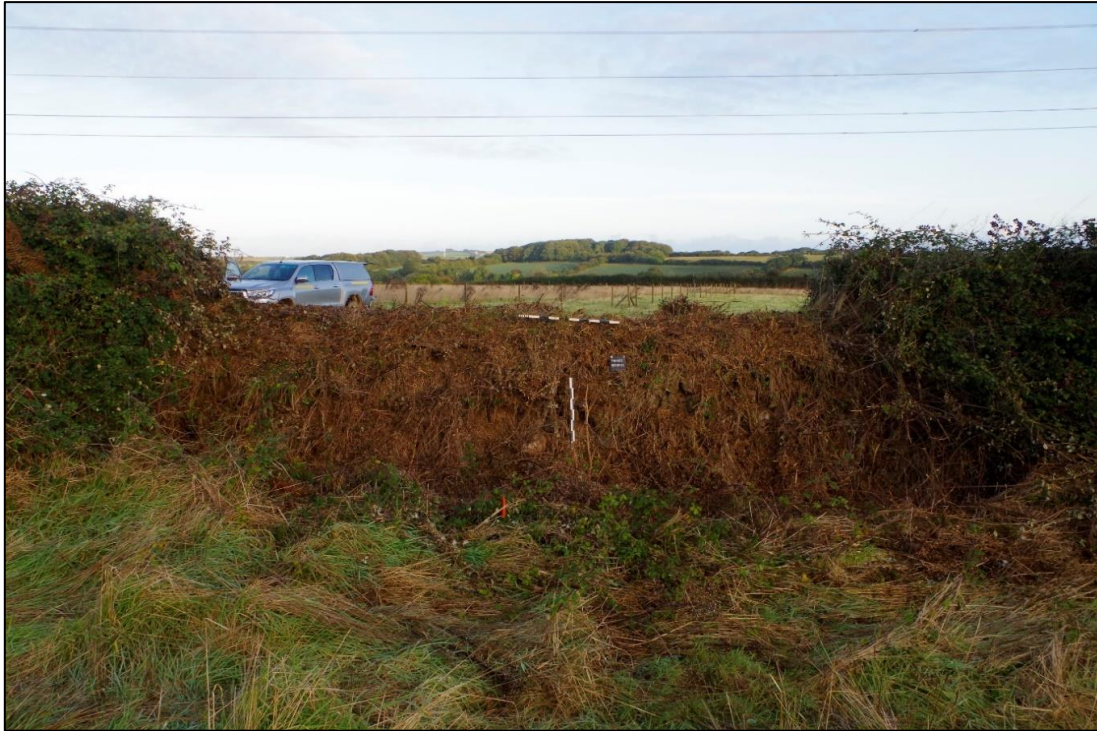
There was evidence of stone facing to both the north-facing and south-facing elevations – more evident/better preserved on the south-facing elevation (Fig 56). The foundations to the stone facing appeared to have slumped into the ditch in places, suggesting the stone dressing was a secondary addition to the original bank.

Figure 56 HE-08-01. Pre-excitation photograph of south-facing elevation in area of hedge-break HE-08-01A. 1m scale.

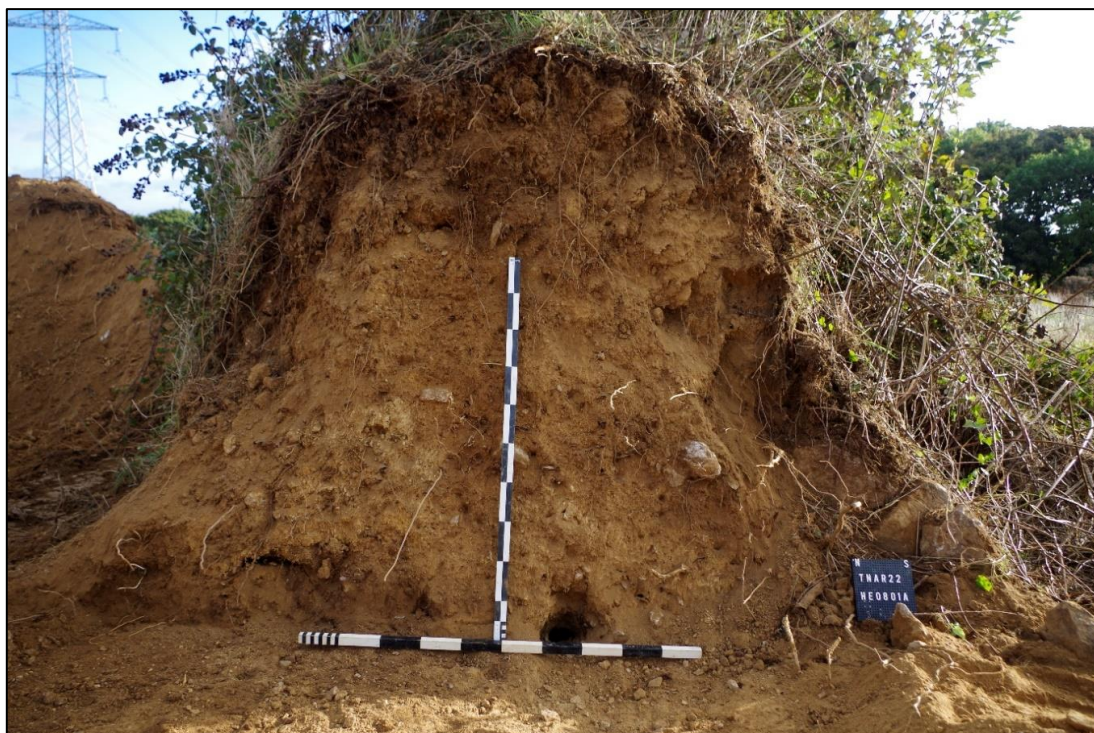
The earthen wall core showed evidence of multi-phase construction. The upper half of the bank consisted of a mid slightly reddish brown friable silty clay, relatively stone-free. The lower half consisted of a mid brown relatively compact silty clay mottled with light yellowish brown and mid reddish brown silty clay (likely incorporated redeposited material) with occasional small angular quartz. A possible stone tip line was suggested between the upper and lower parts of the bank. There was also an indication of an old land surface comprising mid brown looser friable silty clay beneath the bank (more evident on the northern aspect of the section), although this was obscured by animal burrowing at this level (Fig 58).

Figure 58 HE-08-01A. Post-excavation photograph of east-facing section of hedge-break HE-08-01A. 1m scale.

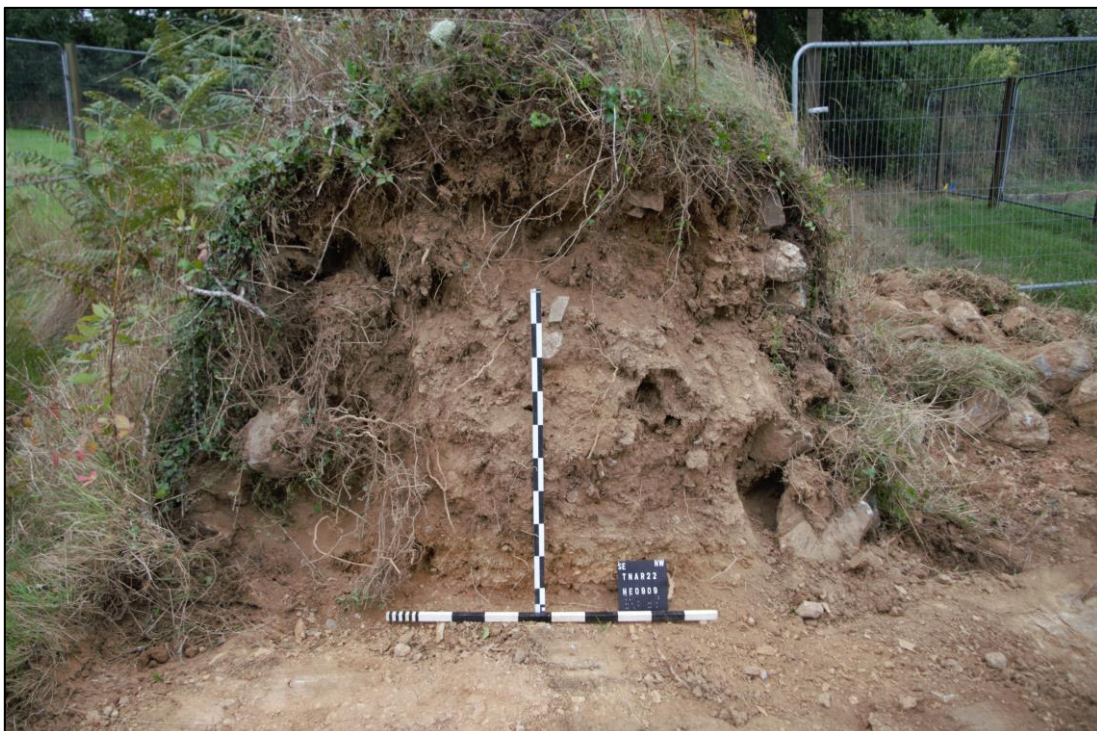
The Cornish hedge was faced on both sides with horizontal coursed quartz blocks and other metamorphic slabs. The earthen wall core was likely of phased construction, with a very loose, relatively stone-free mid brown friable silty clay above a more compact light slightly reddish brown silty clay with occasional large angular shale and quartz pebbles. There was also evidence of an old land surface beneath the earthen bank comprising a compact lighter slightly yellowish brown friable silty clay with frequent small angular quartz and shillet pebbles (see Figs 76 and 82).

The ditches to either side were cut into compact stony silty clay natural. Both ditches had large angular killas blocks in them; potentially a foundation for the coursed quartz stones above; in that case, the stone facing may be a later repair/refacing post-dating the initial construction.

Figure 76 HE-09-09. Post-excitation photograph of northeast-facing section of hedge-break, following removal of granite gatepost. 1m scale.
