Redruth Buttermarket Historic Building Record and Watching Brief

Historic Building Record and Watching Brief

Client	Redruth Revival Community Interest Company
Report Number	2025R037
Date	July 2025
Status	Final
Report author(s)	Jo Sturgess and Connor Motley
Checked by	Jo Sturgess
Approved by	Andy Jones
Project number	147224
Data location	\\CAU\Archive\Sites\R\Redruth Buttermarket HBR and WB
Historic England / ADS OASIS online reference	cornwall2-535700 ADS number: 20036509
Planning references	PA21/09197

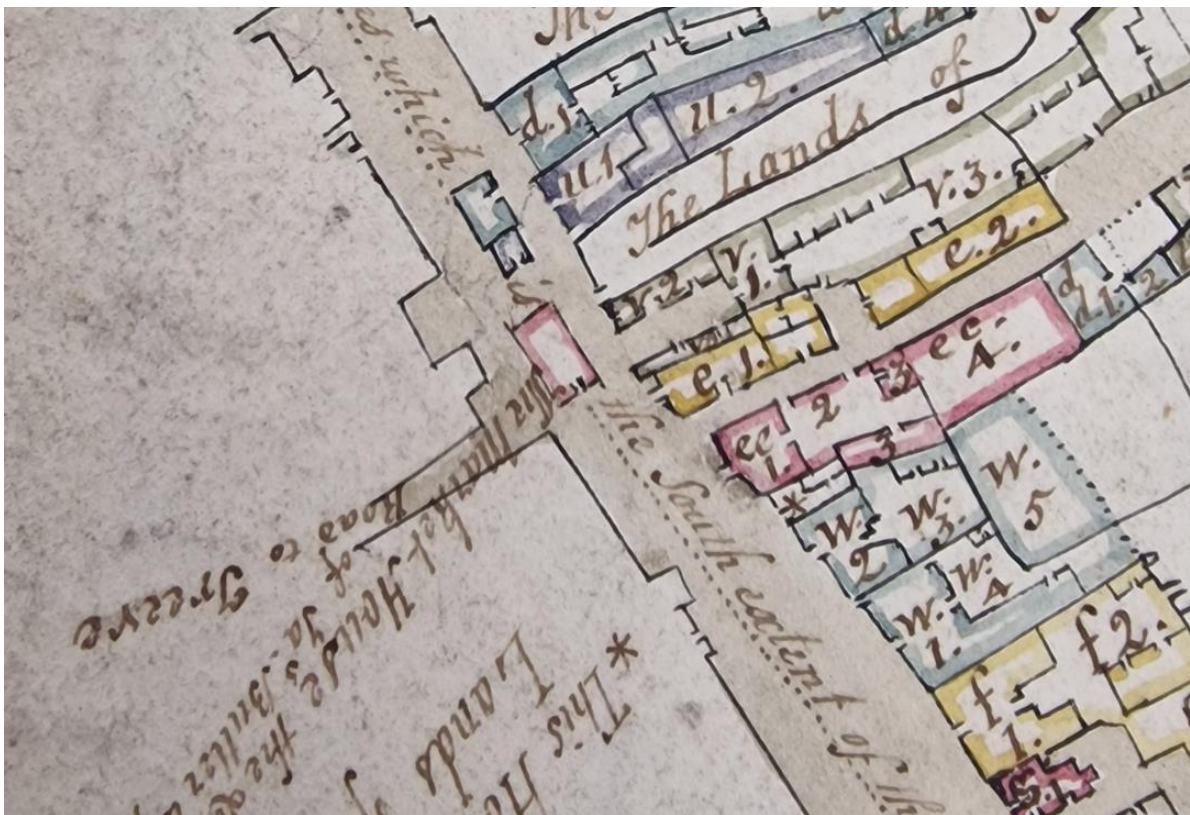
Fig 4 Extract from the Plans of the Manor of Redruth 1794, drawn by Robert Ballment showing the location of the early market house in the centre of Fore Street (Kresen Kernow, X293/18).

The earliest known market house in Redruth was a timber-framed building with a steeply pitched, thatched roof, probably of post-medieval date (Roethe 2021, 4). It was located in Middle Row which comprised a cluster of buildings in the centre of Fore Street, close to the junction with Alma Place (see Fig 4 for location). The market house along with Middle Row were demolished in 1795 to allow a better flow of traffic in Fore Street (Market lease of 2 March 1795 quoted in Michell 1978, 61). The historian CS Gilbert stated in 1817: 'Redruth town was greatly improved about twenty years ago, when the Market House, which greatly interrupted the traffic, together with several other old buildings, were taken down, and the principal street, being laid open, is now very commodious. It contains several inns and shops, which enjoy an excellent trade' (Michell 1978, 61).

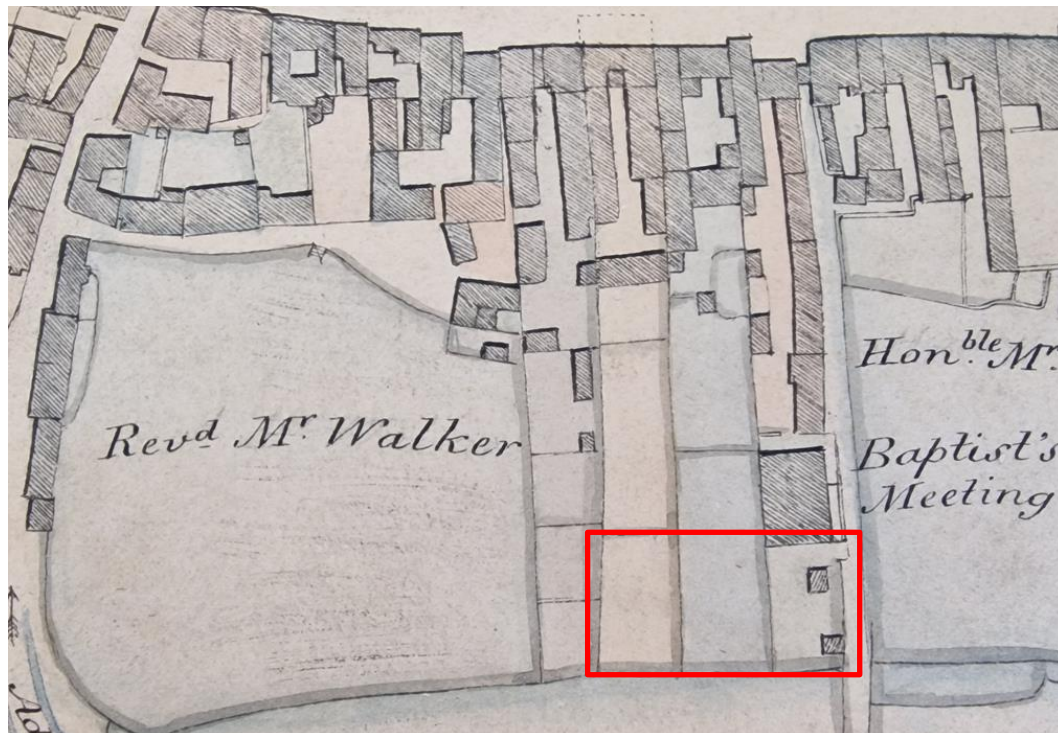
Fig 5 1825 plan of Pedn-an-drea and Wheal Sparnon Mine Sett, surveyed by Richard Thomas of Falmouth. The approximate site of the present market courtyard is outlined in red (Kresen Kernow, MRO/R119B).

Following the demolition of the old market house, the market is said to have moved to Market Strand and to a new building on the site of the later meat market building (Michell 1978, 61). According to Linda Beskeen, John Buller leased the market in 1795 to James Jenkins and a note of 1801 certified that he had rebuilt the market in the agreed time and manner: 'to pull down and remove all part of the market house which now stands in the Fore Street of the town of Redruth...and erect and rebuild the same in and upon the Receps [recess?] next thereto according to the full dimensions of the building so to be pulled down...' (Information from Linda Beskeen, 21 November 2020). The new building had glazed windows, as the churchwardens were paying for setting glass in the market house in March 1805 (Michell 1978, 61). No further details are known about this market house (Roethe 2021, 4), but it was clearly built to similar dimensions of the old market house and on a nearby spot possibly adjoining the clock tower on the south side of Fore Street. An 1825 plan (Fig 5) shows the site prior to the construction of the later (1825-6) market buildings.

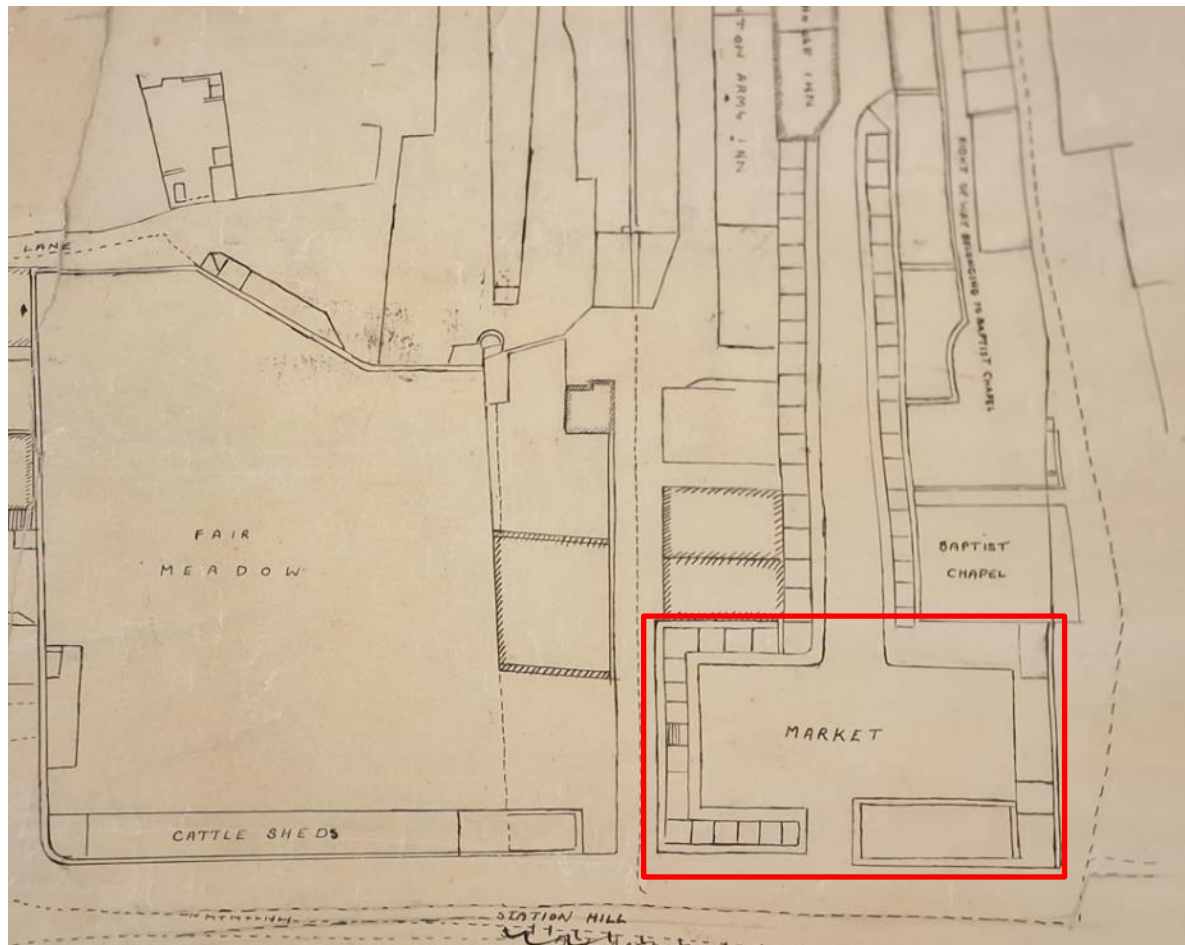
Fig 9 Undated, mid 19th century plan of the market and Fair Meadow stamped 'F MICHELL, 18 FORE STREET, REDRUTH, CORNWALL' (Kresen Kernow, AD2753/P/137). The site of the market courtyard is outlined in red.

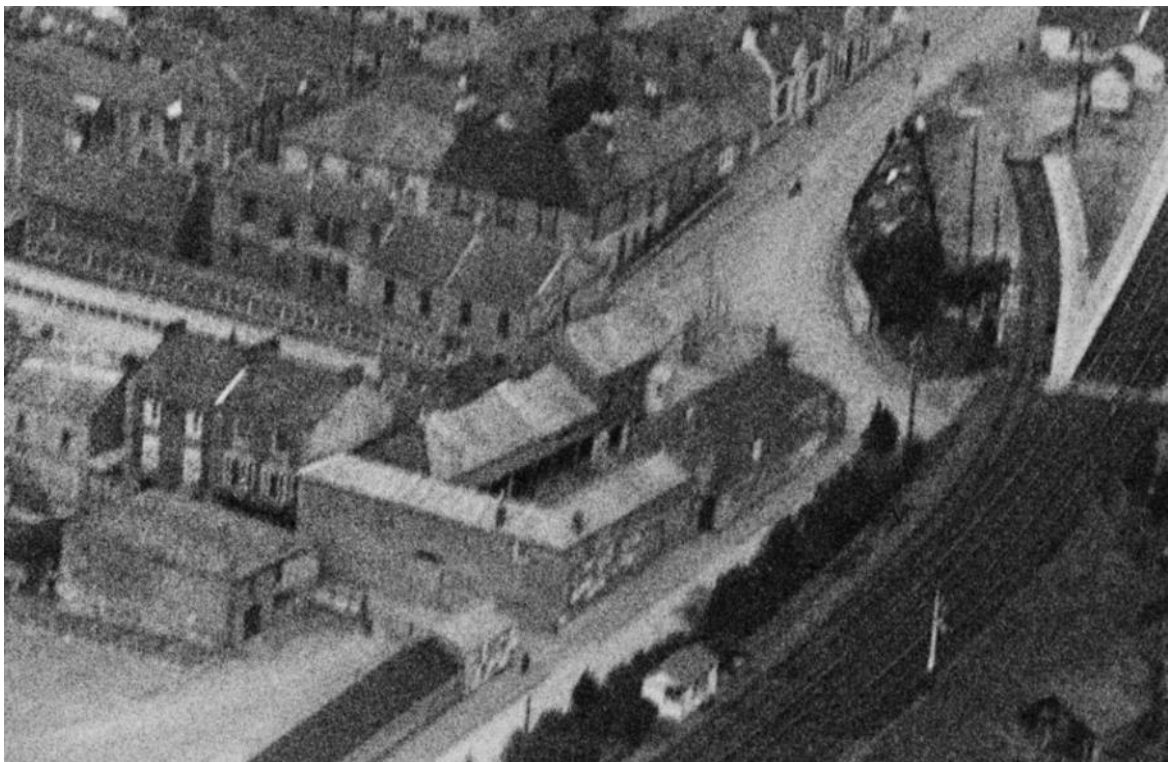
Fig 19 Aerial photograph taken in 1924 (www.britainfromabove.org.uk EPW009905).

Another plan of the manor of Tehidy dated 1889 (Fig 14) shows the internal layout of the new meat market. It had a rectangular plan with two internal aisles lined with stalls along the outer walls and along a central block. Later aerial photos (Figs 18-21) show that as constructed its roof consisted of two hipped and clerestoried ranges, which were supported on a central spine of cast-iron columns (Johns, Berry and Gossip 2001, figure 19). It was entered from Market Strand to the north through one arched opening; two arched openings led into the market courtyard to the south. The new north west range of the southern courtyard is shown as two separate sections on either side of the entrances. Earlier maps had presumably shown them as one continuous structure because of the continuous roof over the two sections. According to this 1889 plan, the westernmost arches in the north west elevation of the two-storey market house of 1825-6 had been blocked. The plan also shows a short internal subdivision at the eastern end of the market house building and a narrow entrance in the north east elevation. The plan also appears to show a row of additional stalls north of the meat market building, on the east side of Market Strand, but it is not clear if they were formally part of the market complex.

On aerial photos of 1924 and 1928 the market buildings appear largely unaltered in their external form and footprint since the 1880s (Figs 18-21). One notable change is the insertion of first-floor rooms at the north east end of the north west courtyard range, adjoining the rear of the Mining Exchange (see Figs 18-20). These first floor rooms were added in 1922 following the acquisition of the market by the Redruth Market Company. Another is the hipped roof on the market house added in the 1880s and an inserted chimneystack for the printer's added in c1900, (Figs 20 and 21). By the time the aerial photograph of 1928 was taken, the replacement 1880s roof of the market house was painted with lettering to advertise 'Moons Pianos, Plymouth & Truro' to passing railway passengers. The photograph also shows the open lower ground floor under the Mining Exchange, which was still used as part of the market (Roethe 2021, 21).

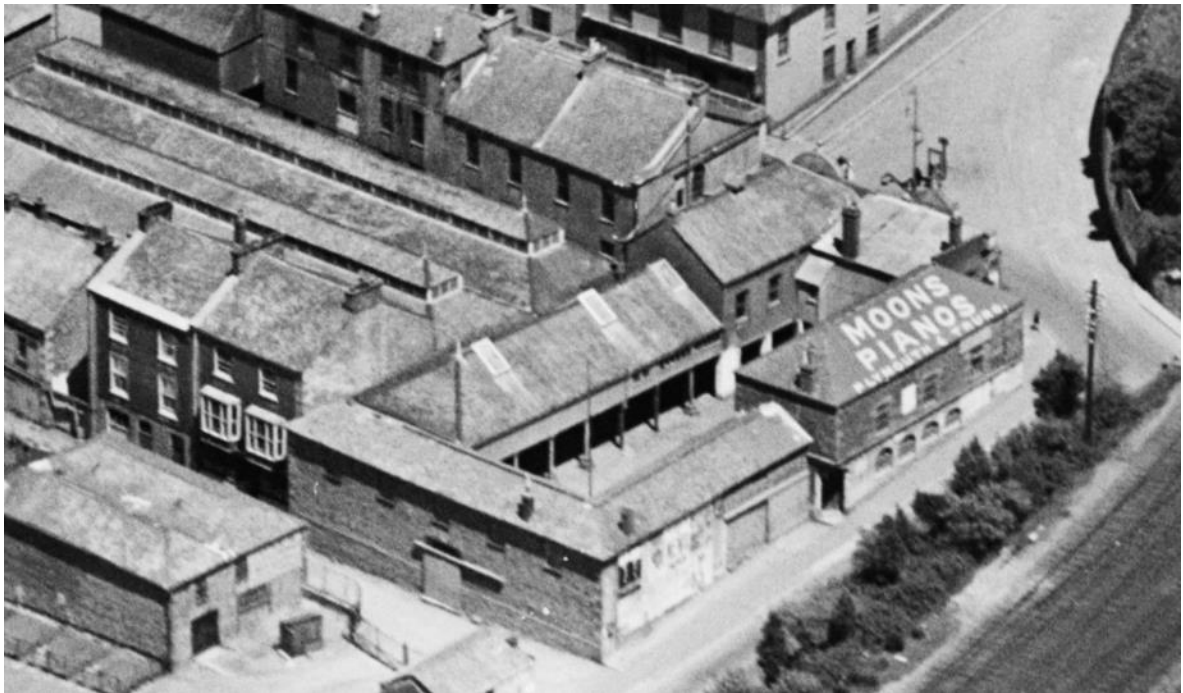
Fig 20 Aerial photograph taken in 1928 (www.britainfromabove.org.uk EPW021734).

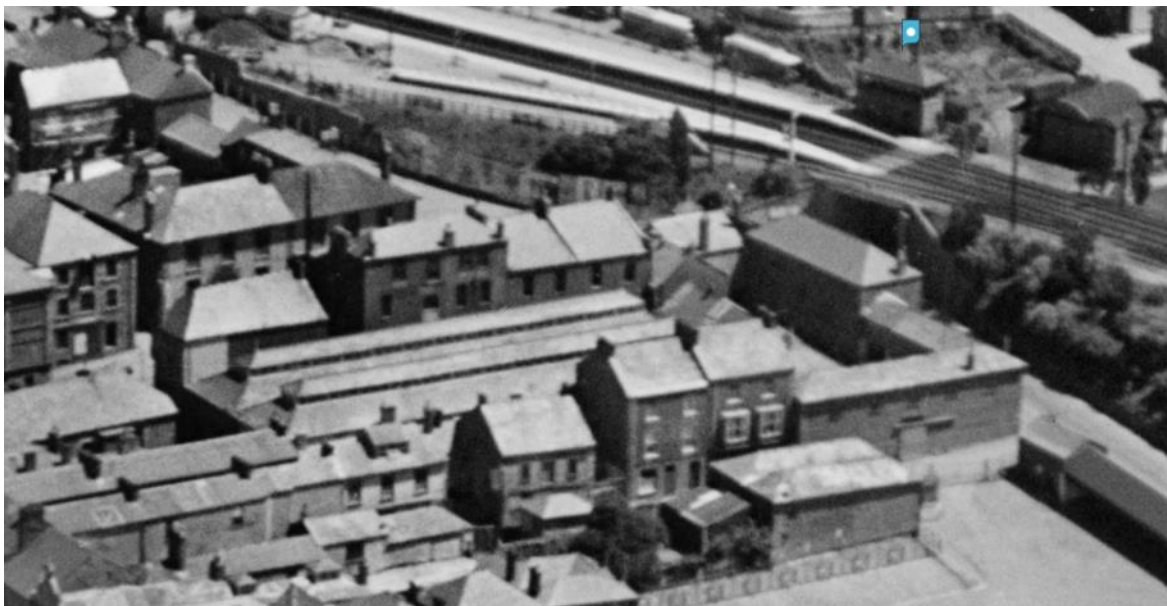
Fig 21 Aerial photograph taken in 1928 (www.britainfromabove.org.uk EPW021733).

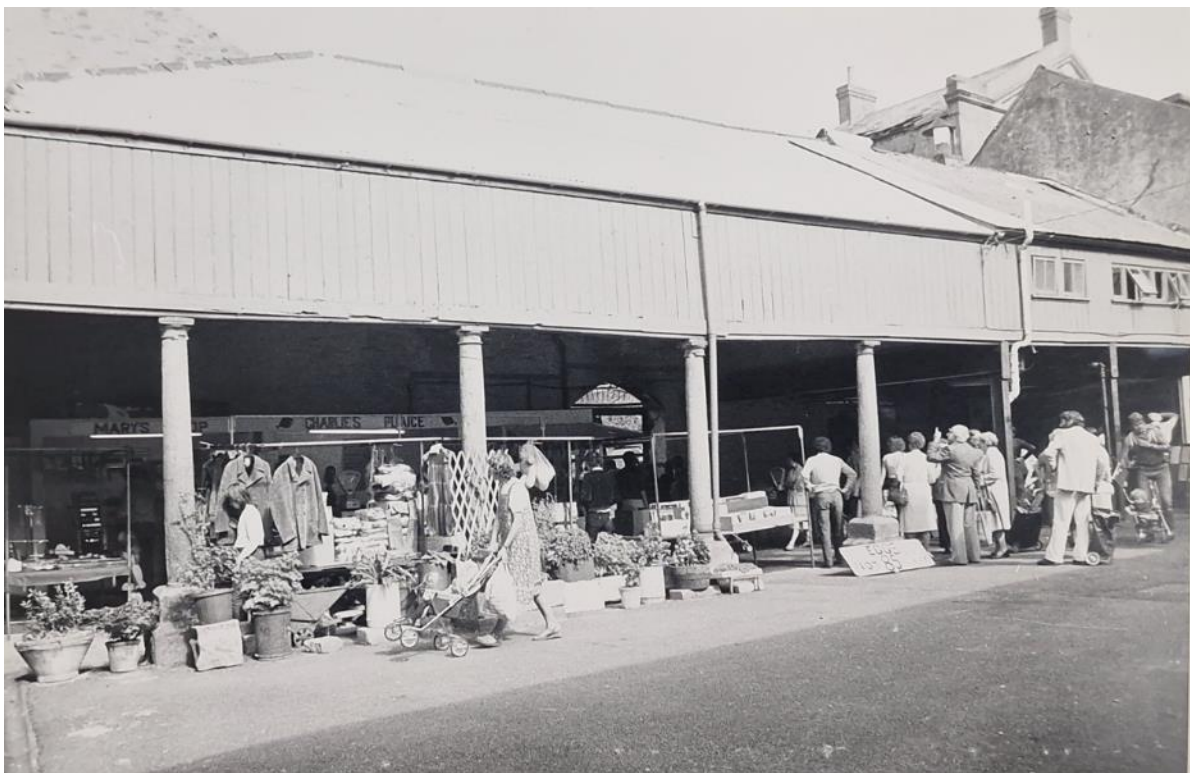
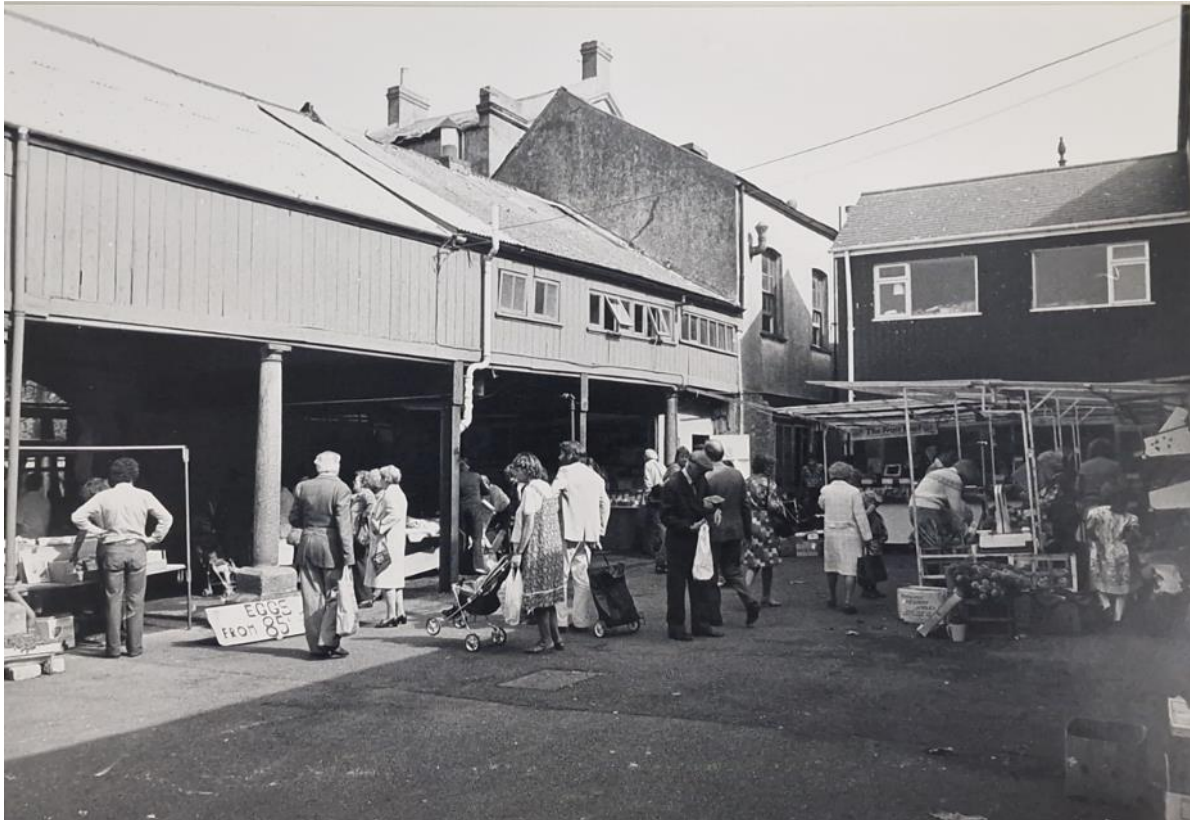
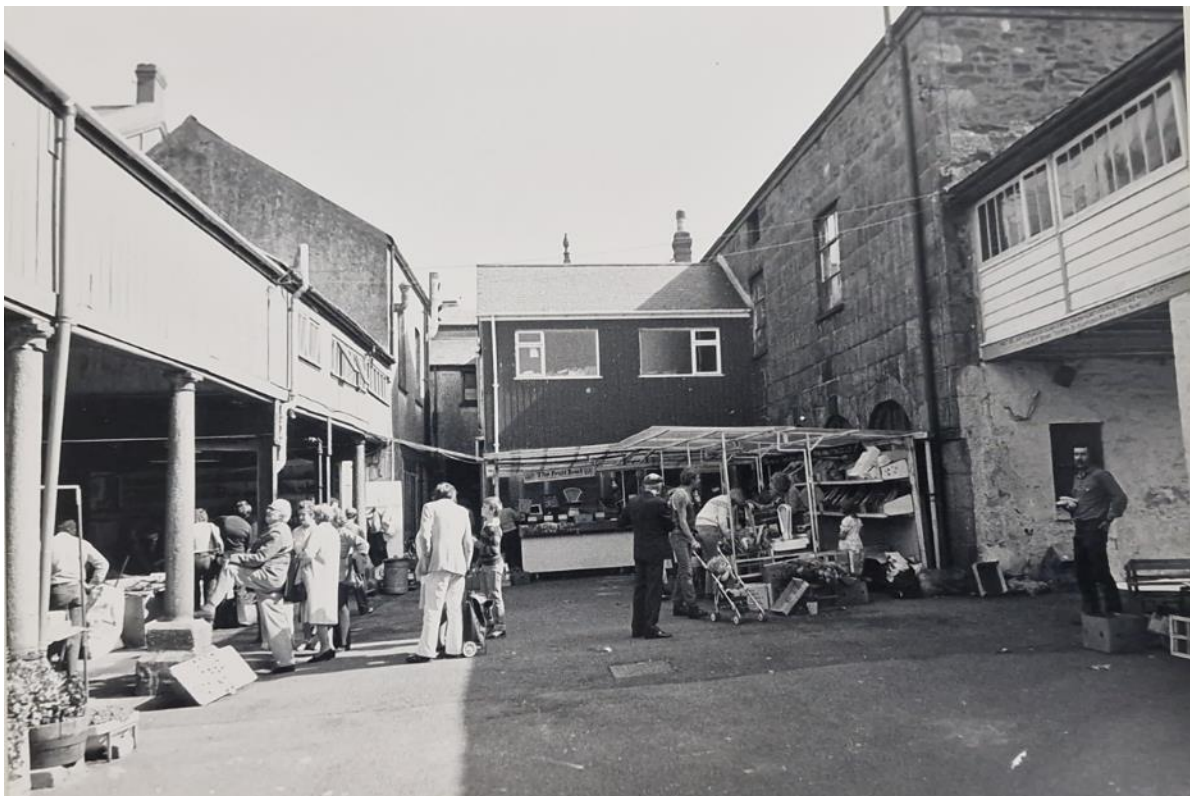
During this time, concrete pillars were inserted below the 1920s Mining Exchange extension in the north west range. These pillars either replaced or encased the 1922 steel support girders (shown in photographs of c1980, Figs 25-27). At the same time the beams and area on the underside of this extension were also encased in concrete and a staircase was inserted giving access to the rooms above. The concrete pillars and staircase are shown as existing on a 1996 elevation drawing associated with Planning Application W2/PA96/C0028. The modern shop unit under the 1922 first floor extension of the Mining Exchange may also have been inserted at this time.

Fig 25 Photograph of the covered market area taken in c1980 (Kresen Kernow ref: AD2828/B/70 153-9).

Fig 26 Photograph of the covered market area, the Mining Exchange and 1977 extension to Wheal Peevor purser's office taken in c1980 (Kresen Kernow ref: AD2828/B/70 153-10).

Fig 27 Photograph of the covered market area, the Mining Exchange, the 1977 extension to Wheal Peevor purser's office and the Market House taken in c1980 (Kresen Kernow ref: AD2828/B/70 153-11).

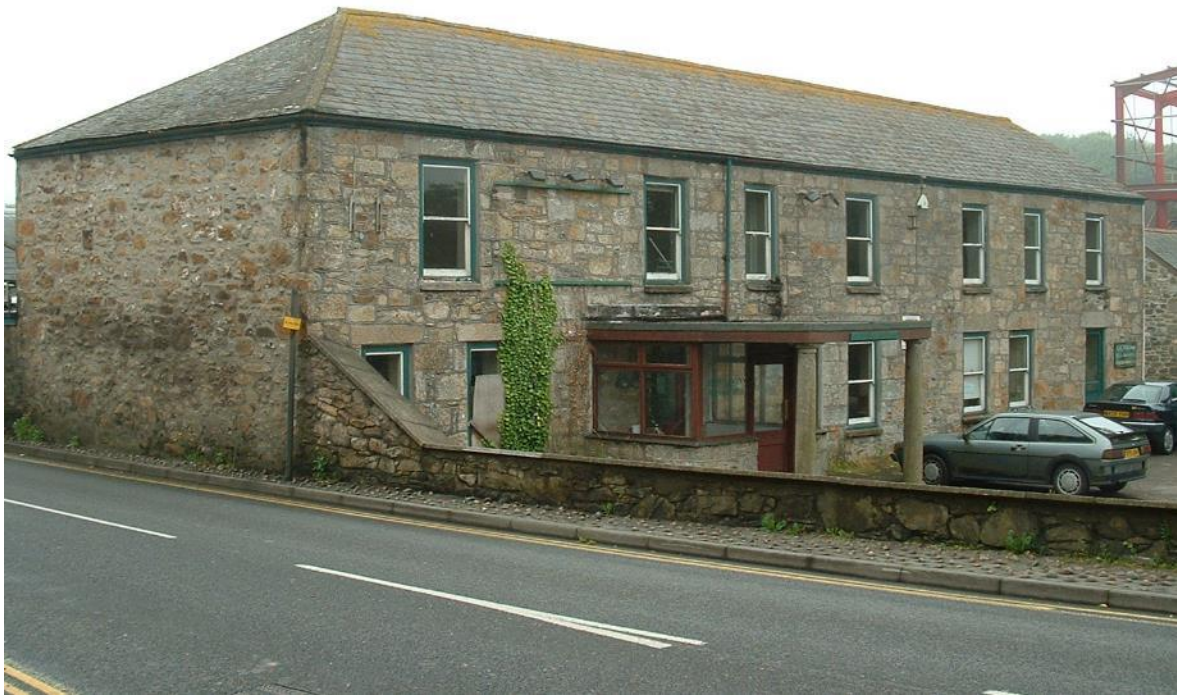
Fig 28 Chymbbla House to the north of Kresen Kernow (former 19th century safety fuse works owned by Alfred Lanyon) taken in 2005, showing two granite Tuscan columns taken from the market in the c1930s and reused in the portico.

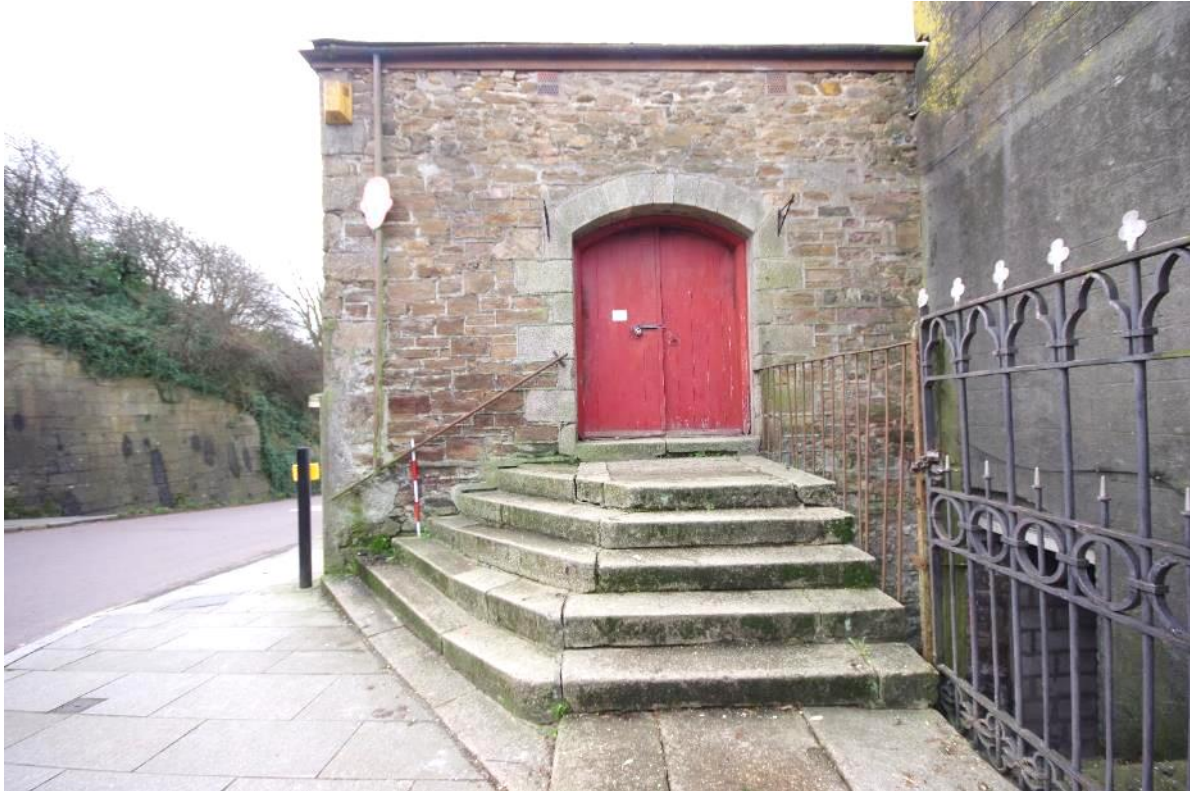
been located on the site of the office. The steps dog-leg where they butt up against the north west end of the north east elevation of the market house. Here there is a phase 1 blocked door opening with granite segmental arch and jambs which originally led through to the arcade on the ground floor of the market house. The stone rubble blocking material was clearly inserted along with the steps in c1883. The north west quoin of the market house is also constructed from granite. The blocked, arched door opening is directly opposite another identical blocked door opening in the south west elevation of the market house. The elevation of the market house has remnants of whitewash in this area at ground floor level.

Fig 33 North east elevation of the market house facing Alma Place with entrance to first floor.

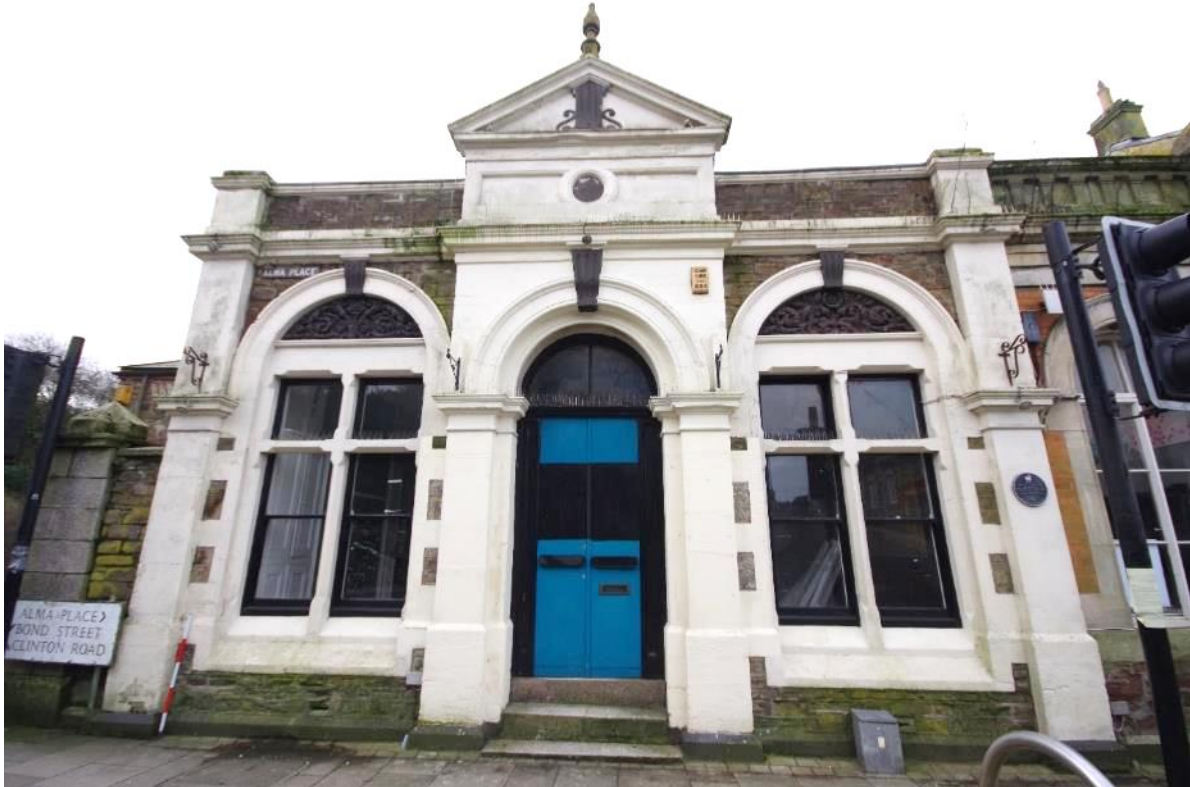
The frontage of Wheal Peevor purser's office is constructed from randomly coursed slatestone rubble with ashlar granite pointed with cement mortar. The elevation is symmetrical and has three bays and a stone rubble plinth. In the centre of the elevation is a round arched door opening with a fluted keystone painted black, pilasters on either side, and granite steps leading up to it. The door opening contains modern, replacement double doors in a timber frame and there is a round two light transom light above them. At the top of the elevation is a parapet wall which hides a mono-pitch roof behind it. Above the middle bay is a panelled entablature with a central roundel and above this again a pediment with scrolled and fluted decoration painted black and topped with a granite finial. The outer bays of the front elevation have granite corner pilasters and are filled with large mullion and transom windows. The windows each have four lights, the taller lower lights containing one over one sash windows with horns, and the upper lights

having square fixed panes. Both openings have sloped granite sills. The windows are contained in an arch with fluted keystones, painted black. Within the round arches there are decorative floral motifs carved in a dark grey coloured stone. Above the south east window there is a historic street sign for Alma Place. Most of the granite has been painted white apart from the plinth and steps. Above the door and windows there is a moulded cornice below the parapet wall. Attached to the pilaster at the north west end of the frontage there is a blue plaque giving the names of the Mining Exchange and Wheal Peevor purser's office. There are modern brackets for hanging baskets attached to all the main pilasters.

Fig 34 Frontage of Wheal Peevor purser's office on Alma place.

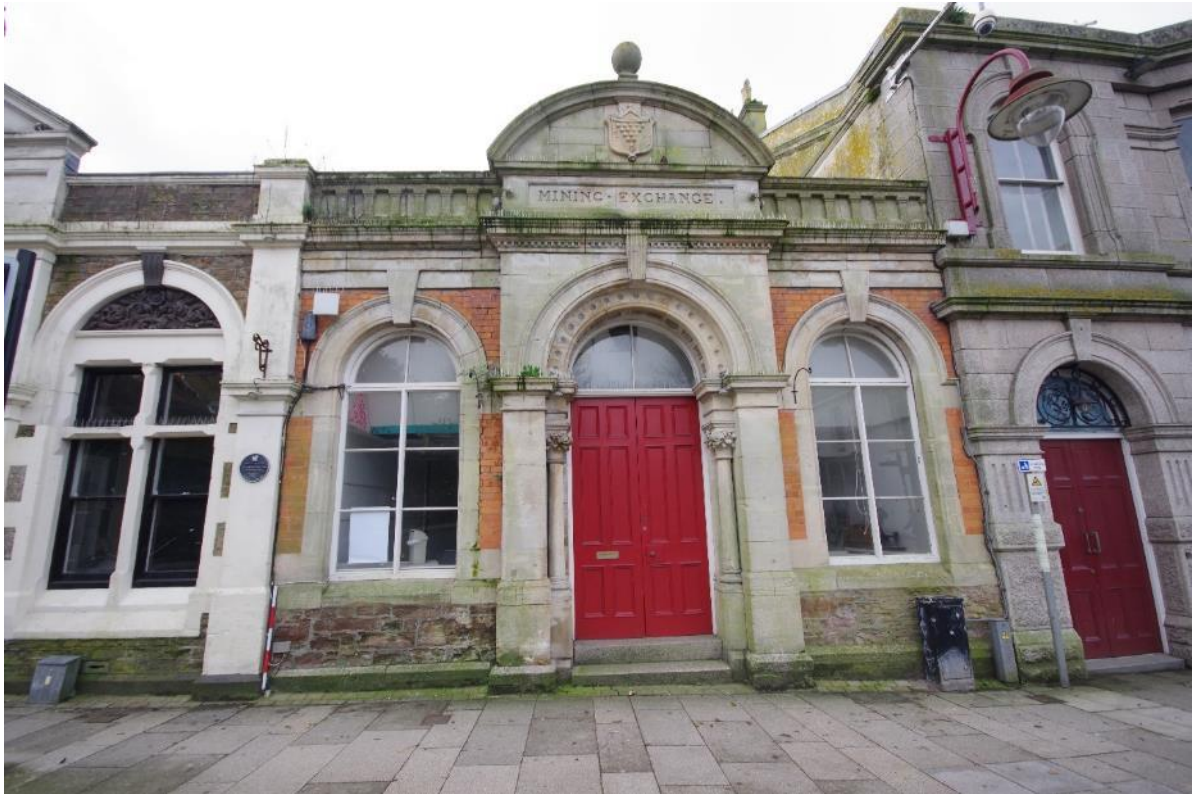
a carved blind balustrade either side of the central bay where there is a recessed panel inscribed 'MINING EXCHANGE.'. Above this there is a segmental pediment with a ball finial on top. Within the pediment is the crest of the Duchy of Cornwall (15 bezants) and the inscription 'ONE AND ALL'.

Fig 35 Frontage of the Mining Exchange on Alma Place.

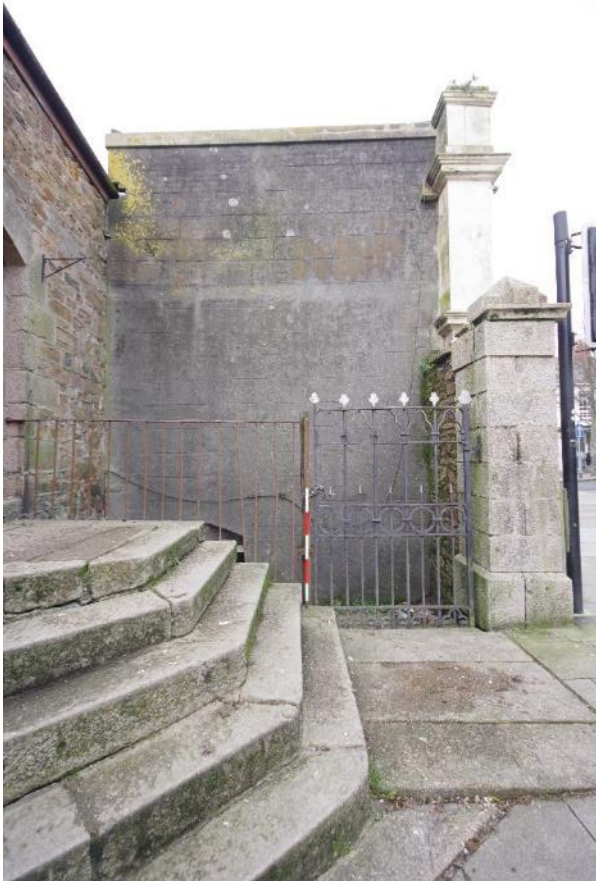
The south east, side elevation of Wheal Peevor purser's office was constructed in c1883. The wall is covered with an original cement stucco render. Against the lower part of the wall there is a flight of contemporary granite steps leading down to a segmental arched door opening with brick arch and jambs at the south west end of the wall, which when first built gave access into the market courtyard. It now gives access to a concrete block-built passageway between extensions which leads to the courtyard.

In front of the steps leading down to the courtyard, there are granite steps leading up to the first floor of the market house. To protect from the drop between the two sets of steps, there are 19th century iron railings and a modern iron gate. The gate is fitted to a granite pier at the end of a short section of walling which projects south east from the frontage of Wheel Peevor purser's office.

Fig 37 South east elevation of Wheal Peevor purser's office.

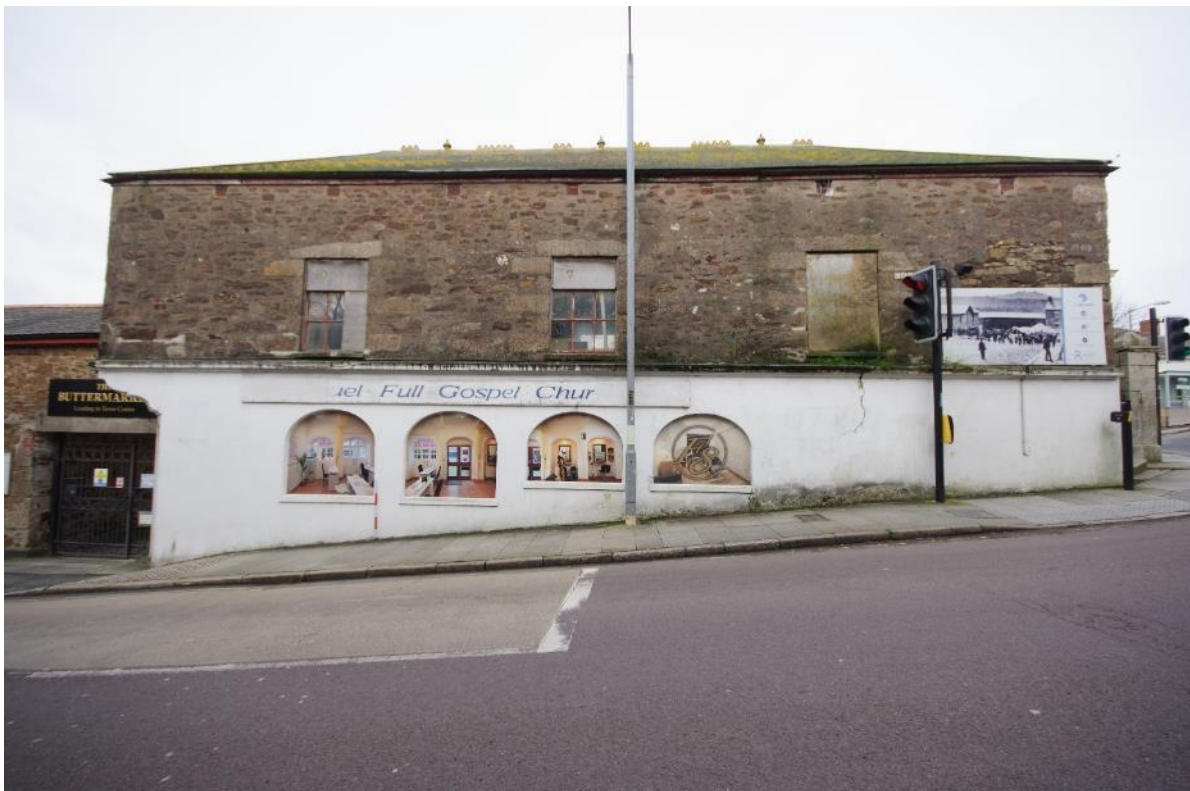
The first floor of the south east elevation is exposed randomly coursed slatestone rubble with very heavy, later cement repointing and dressed granite quoins at either end of the wall. There are two phases of walling here: the lower part up to a level with the tops of the window lintels is the original phase 1 wall, and above this is the walling added in 1884 (phase 6) when the building was heightened. There are three original (phase 1) rectangular window openings in the lower part of the first floor wall. These have granite lintels and jambs with slate sills. All three windows were either partially or completely boarded over but all contained nine-pane Crittall windows with the top three panes being opening casements. These windows are replacements and date either to when the building was heightened in the 1880s or to c1900 when the printing works was added. In the heightened section at the top of the wall there are perforated bricks used as ventilators. There would have been seven sets of bricks but those above the north east window have been removed. The hipped, slate covered roof retains its 1884 ceramic ridge tiles, some of which are crested and there are also three domed ridge ventilators of the same date.

Fig 38 South east elevation of the market house.

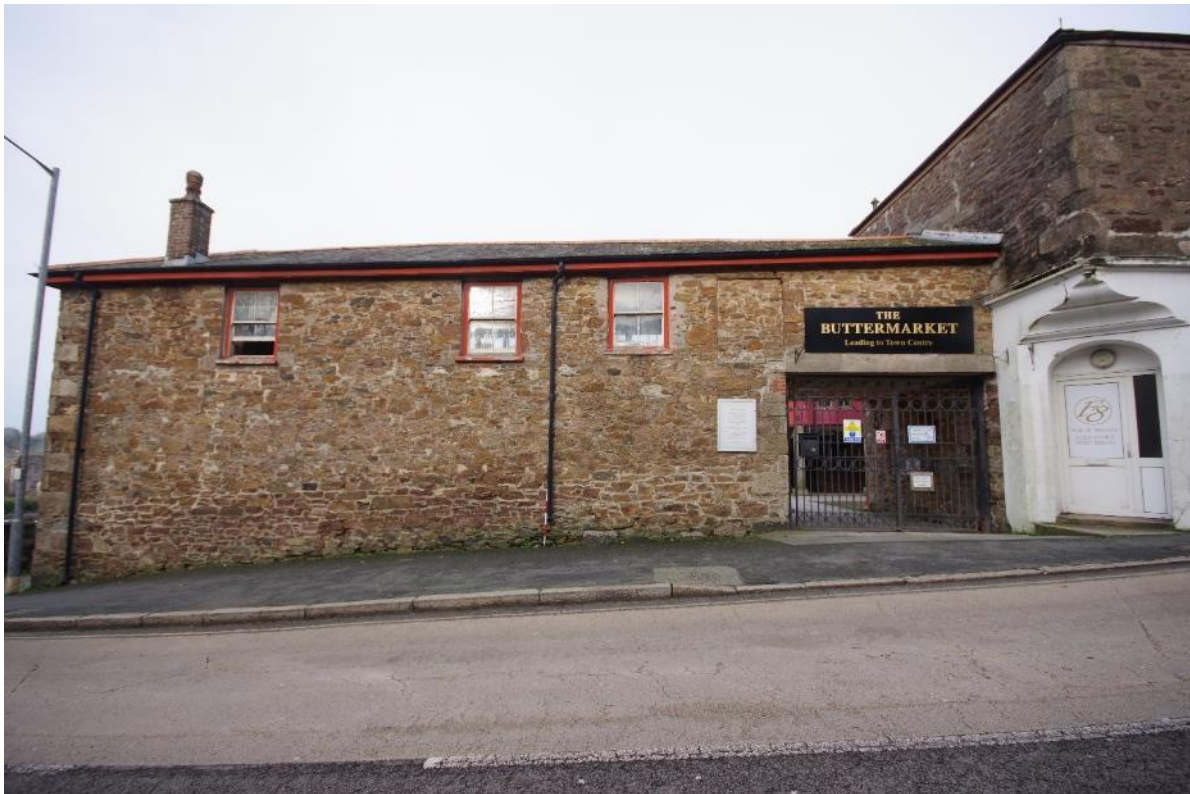
The slate roof covering with ceramic ridge tiles is a 1997 replacement. The brick chimney stack towards the south west end of the roof appears original.

Fig 40 South east elevation of the south east range.

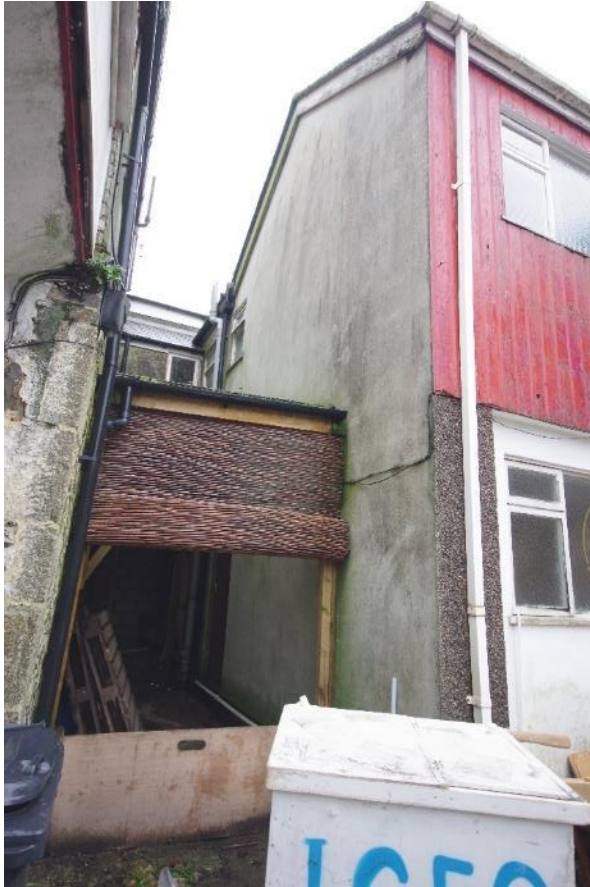
The extensions were added to the rear of Wheal Peavor purser's office in the 1960s and 1970s. The north west side elevations of the extensions is cement rendered concrete blockwork. The 1960s extension has a flat roof and 1970s extension is gabled. At ground floor level there is a modern timber door giving access into both extensions. The walling to the north east of the door is not rendered and is exposed concrete blockwork. At the north east end of the wall there is a passage giving access to the c1883 granite steps up to Alma Place in the east corner of the site. At first floor there are two windows, both have two large panes and a top opening casement. There are modern downpipes and stench pipes between the two window openings.

Fig 44 North west elevation of extensions to Wheal Peevor purser's office.

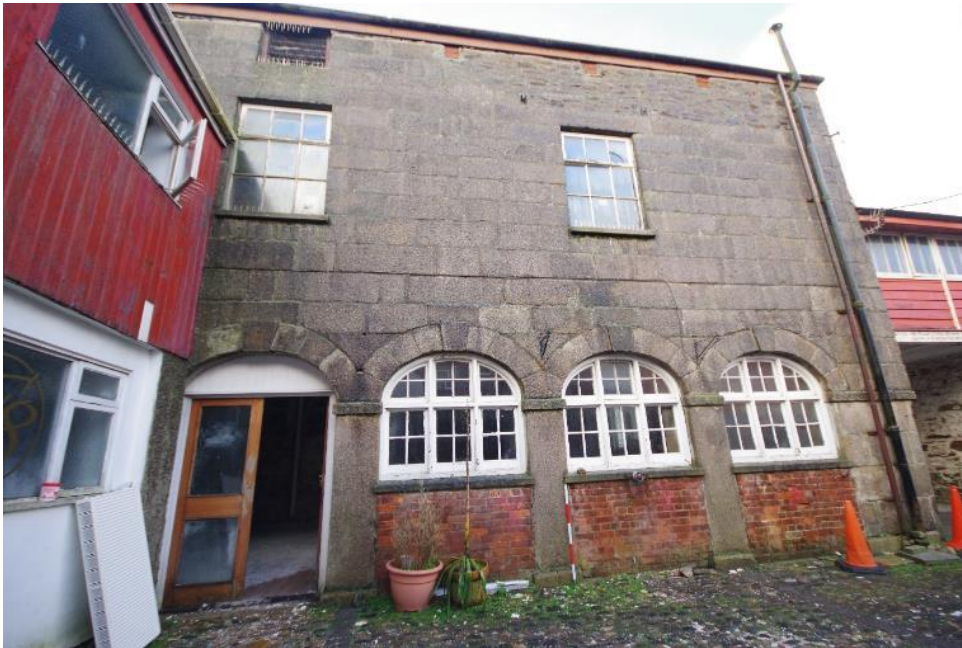
(including the top half of the window opening) were removed and the remaining lower half of the window opening filled with timber louvres. At the base of the heightened wall to the south west of the former gable, there are two sawn off timbers with sockets. The purpose of these timber is unclear, but they may be the remains of a canopy or the ends of the original tie-beams of the roof. At the top of the heightened section of wall there are several pairs of perforated bricks used as ventilators.

Fig 45 North west elevation of the market house.

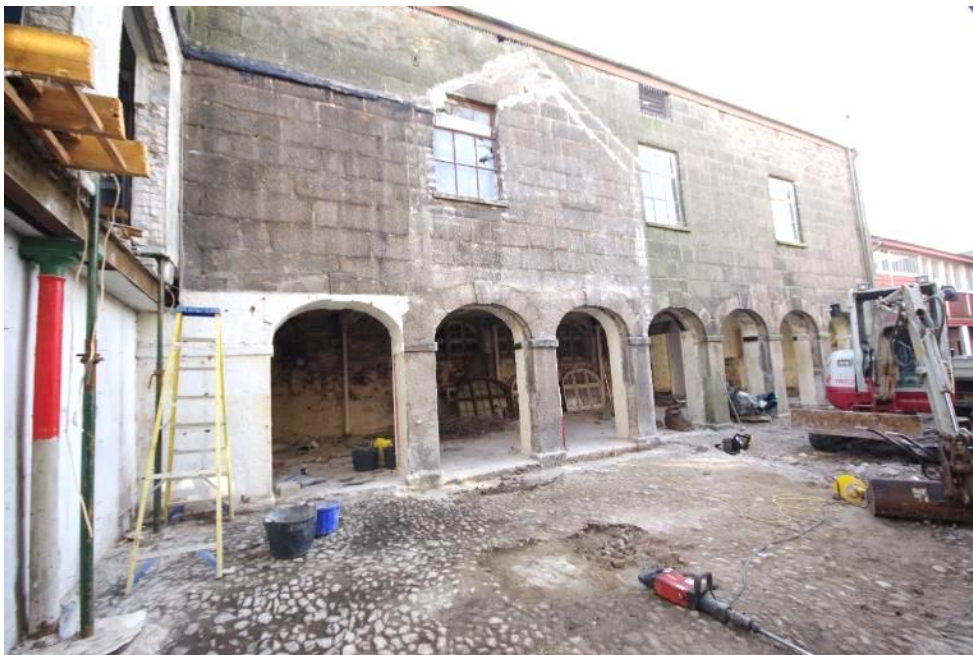
During the renovation, the 1960s and 1970s extensions on the rear of the Wheal Peevor purser's office were demolished, temporarily revealing the market house frontage in full. This revealed that all seven arches of the arcade remain intact, along with the third window at first floor, which retained a Crittall window contemporary with the other two windows. It also revealed that the heightened section on the north east side is a mirror image of the south west, with two sawn off timbers at the base and three pairs of perforated brick ventilators at the top.

Fig 46 North west elevation of the market house fully exposed during the watching brief.

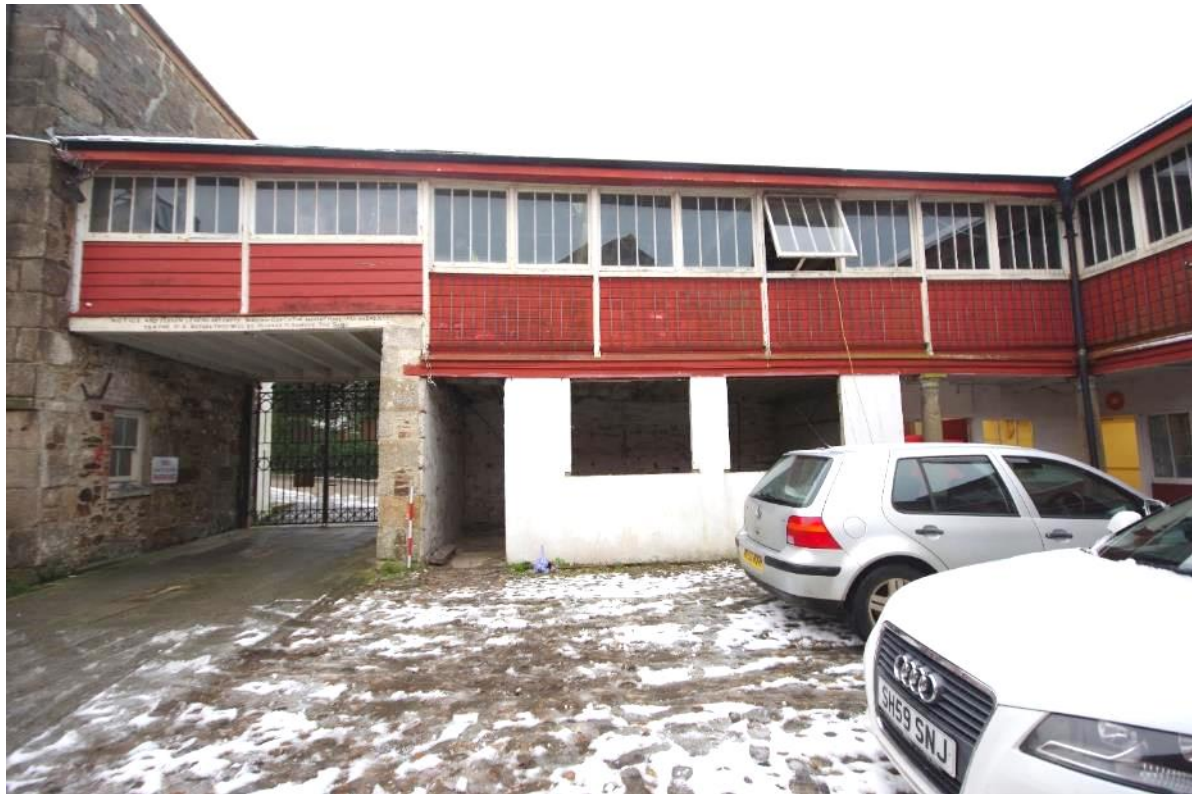
The first floor of the north west elevation is characterised by a long row of windows which span the entire length of the elevation. This is part of the original design to light a passage which extended along the fronts of the stalls on the first floor. The windows vary in size, but all of them have narrow vertical panes. There are four pairs of modern replacement windows (probably replaced in 1997) above the inserted room and units 4 and 5. Each of these windows has four panes. The pairs of windows are divided by original vertical posts which are chamfered with runout stops. The area below the windows here has replacement modern timber cladding with modern railings in front, presumably both added as part of the works in 1997. One of the windows (the fourth from the south west end) is a top opening casement. Above the cart opening from Station Hill, the windows appear original, are shorter and wider than those to the south west. There is a chamfered post dividing the two parts, similar to the rest of the elevation. The south west half contains a single wide eight-pane window, and the north east half contains a fixed five-pane window and a two-pane casement window.

Fig 47 North west elevation of the south east range.

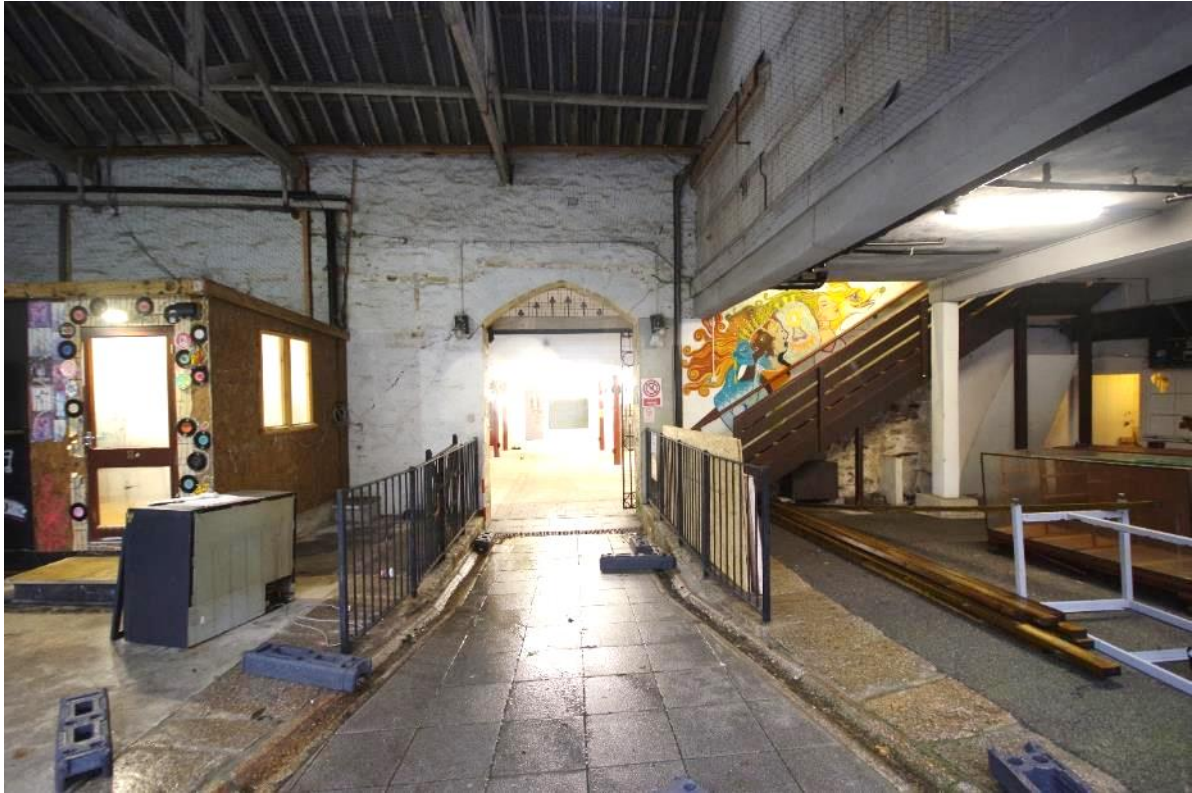
During the watching brief the modern shop unit (G23) was completely removed, revealing the south east elevation of the booth (G22). The elevation was constructed from vertical timber planks with a timber dentil course at the top. The wall contained the remains of a fixed six-pane window, however, the bottom four panes of glass, and glazing bars, were missing.

Fig 51 South east elevation under covered market area.
