Redruth Buttermarket Historic Building Record and Watching Brief

Historic Building Record and Watching Brief

Client	Redruth Revival Community Interest Company
Report Number	2025R037
Date	July 2025
Status	Final
Report author(s)	Jo Sturgess and Connor Motley
Checked by	Jo Sturgess
Approved by	Andy Jones
Project number	147224
Data location	\\CAU\Archive\Sites\R\Redruth Buttermarket HBR and WB
Historic England / ADS OASIS online reference	cornwall2-535700 ADS number: 20036509
Planning references	PA21/09197

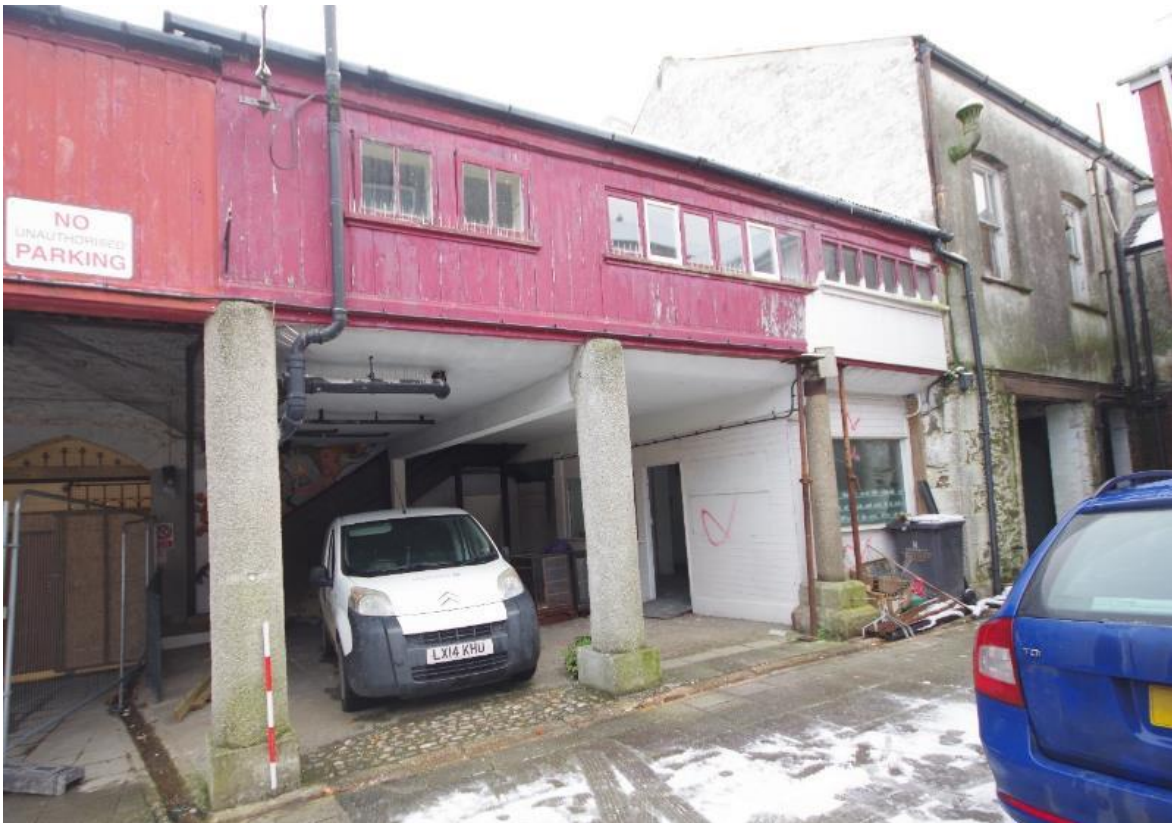
At first floor level is the Mining Exchange, inserted and heightened in 1880. The elevation here has a 19th century cement stucco render with incised lines and contains two 1880 segmental arched window openings. The openings contain 1880 sash windows with horns and margin panes, although the lower sash of the south west window has been replaced and now has a single pane. There is a 20th century ventilation pipe at the south west end of the elevation. There are various downpipes and stench pipes at the north east end of the elevation, some of which are modern UPVC, and others are historic cast iron. The timber soffit is original. The gutters along the elevation are all modern replacements.

Fig 53 South east elevation of the Mining Exchange extension (left) and Mining Exchange (right).

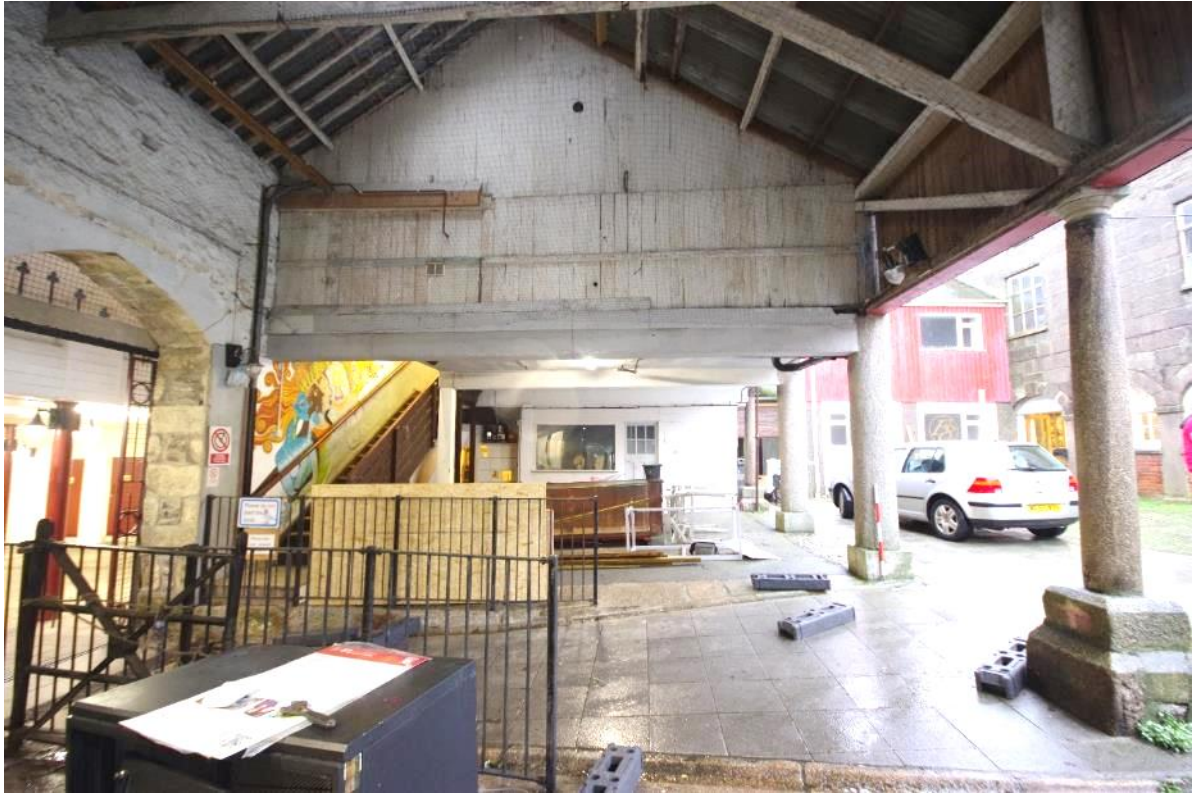
Forward of this gable, under the roof of the covered market is the end wall of the Mining Exchange's 1922 extension which is at first floor level and supported on iron beams which have been encased in concrete in the late 20th century. The 1922 timber stud wall of the extension is clad with vertical timber planks and horizontal battens. There is a hole in the upper part of the wall for a removed pipe or ventilator, and a small modern plastic ventilator near the base of the wall. The ground floor of the elevation is set back from the extension wall.

In the north corner of the courtyard there is a small toll collector's booth with a timber plank frontage which has decorative applied mouldings. The south west elevation of this booth is clad with vertically set planks and has historic timber plank door with pediment over on the north west side of the elevation and a 12-pane fixed window which has been painted over to the south east. The top of this frontage has a plain cornice with dentil moulding. The rest of the ground floor elevation is formed by an inserted late 20th or early 21st century shop unit with horizontal plank wall containing two large window openings. The north west opening has a single large pane of glass in it and a timber shelf below. The south east window is boarded over. In the centre there is a reclaimed c1930s timber door with three tall vertical panels in the lower half and six lights in the upper half; the lower three are frosted.

Fig 55 South west elevation of the Mining Exchange extension and area below.

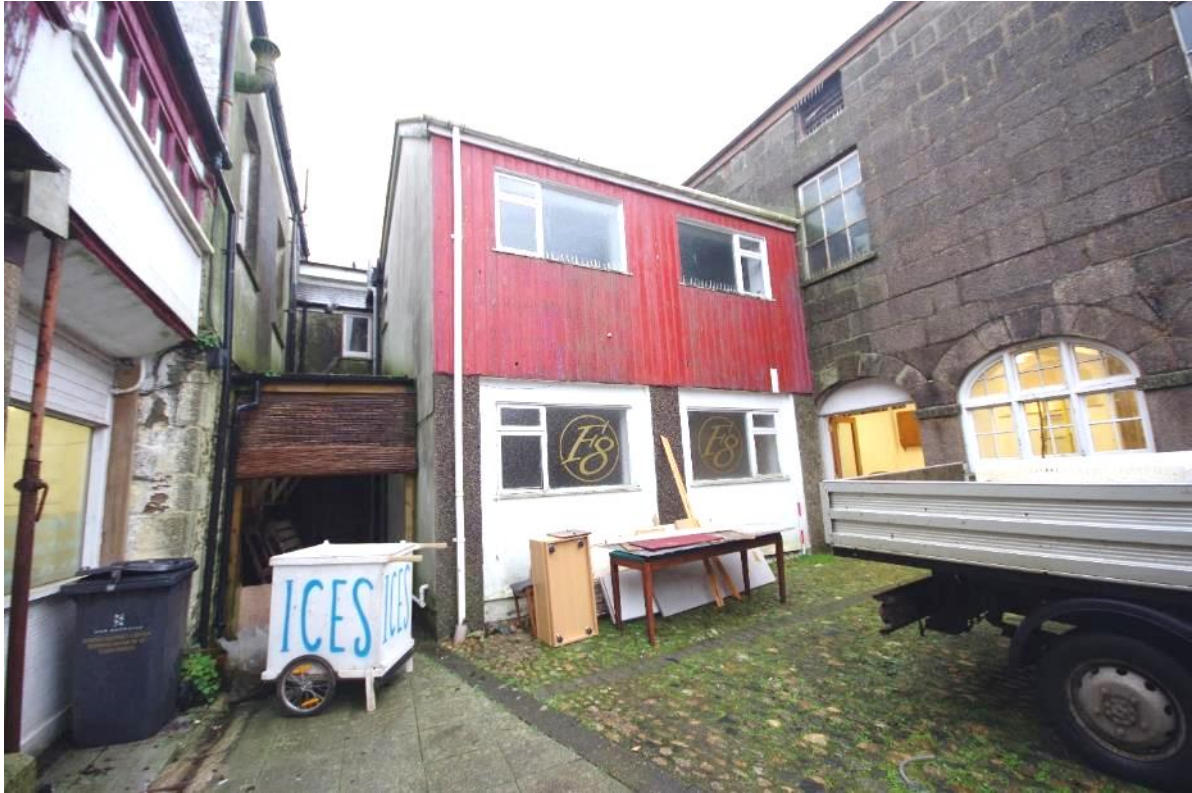
The original (c1883) rear wall of the Wheal Peevor purser's office is mostly obscured by an extension added in the 1960s and another added in the 1970s. However, the elevation of a small early 20th century WC extension which protruded from the rest of the rear wall of the purser's office still remains visible. This is to the north west and set back from the elevation of the 1970s extension. It has an incised ashlar cement render, the same as that on the south east side elevation of the purser's office and contains a two light casement window. It has a lean-to slate covered roof, and modern UPVC gutter and downpipe.

The rest of the rear of Wheal Peevor purser's office is obscured by the later extensions. The south west elevation of the 1970s extension is constructed from rendered concrete blockwork. At ground floor level it has two recessed sections of rendered wall containing two windows with side casements and has protruding pebble dashed quoins and central pier. The first floor is clad with vertical timber planks painted red and contains windows of the same design as those at ground floor level. There is a modern UPVC downpipe fixed to the north west quoin.

Fig 56 South west elevation of extensions to Wheal Peevor purser's office.

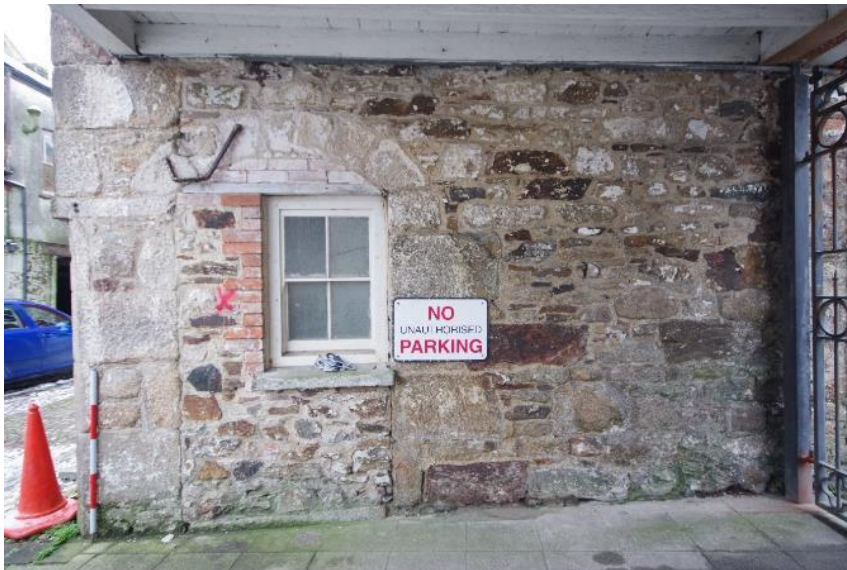
At the same time that this door opening was blocked, a new door opening was inserted at the south east end of this elevation at ground floor level. This door opening was placed here so that the printing works could be accessed from Station Hill rather than from the market courtyard. The door opening has since been altered in the mid or late 20th century so that it now cuts at an angle across the corner of the building. The opening now contains a modern UPVC door and has a large, moulded cornice above it (possibly added when the building was converted as a gospel church).

During phase 2 the south east range was added against the south west elevation of the phase 1 market house at first floor level, leaving space for a cart opening at ground floor level. The elevation of the market house above the roof of the south east range is constructed from randomly coursed stone rubble. The top approximately 1m of the wall was added when the building was heightened in 1884 (phase 6). In c1900 a chimney stack was added at this end of the building to serve the printing works, but this was removed in the late 20th century.

Fig 57 South west elevation (ground floor) of the market house.

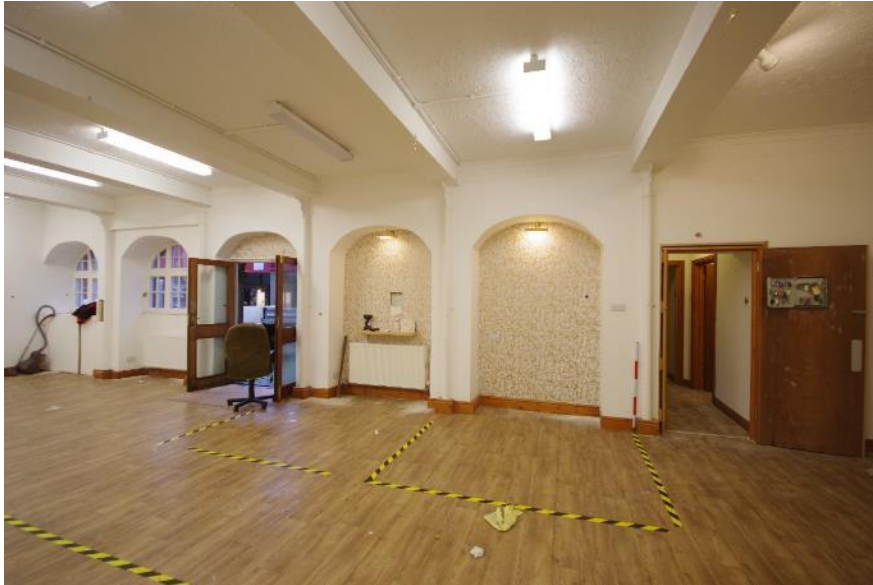
Fig 59 G1 north west (front) wall.

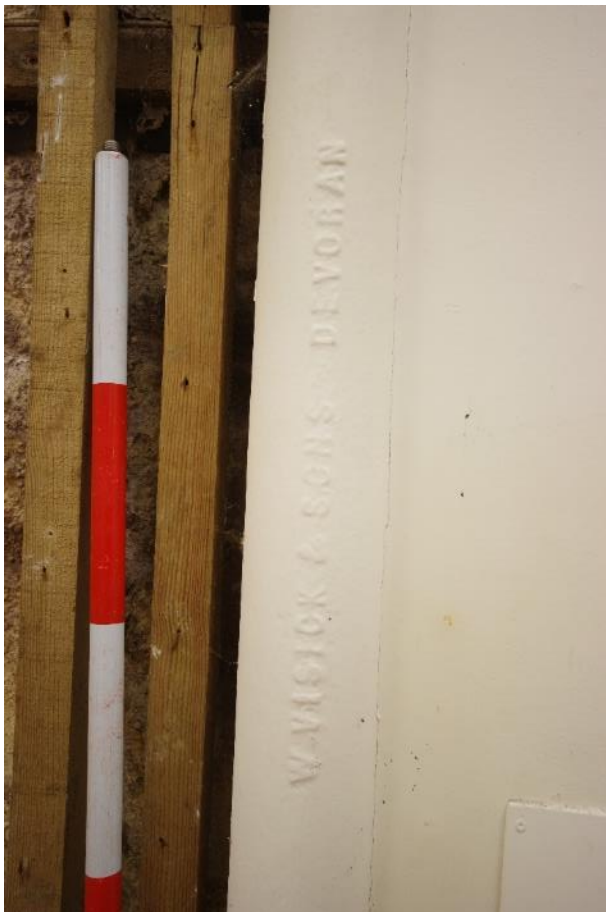
columns against the wall between each arched opening, supporting the floor joists above. They are embossed with 'W. Visick & Sons Devoran'. Since Visick and Sons moved their premises from Bissoe to a new foundry in Devoran in 1894 it is clear that the columns were inserted after this date, almost certainly in c1900 when the room was converted as a printing works to protect the floor above from vibrations caused by the machinery.

Fig 60 G1 detail of maker's name on column.

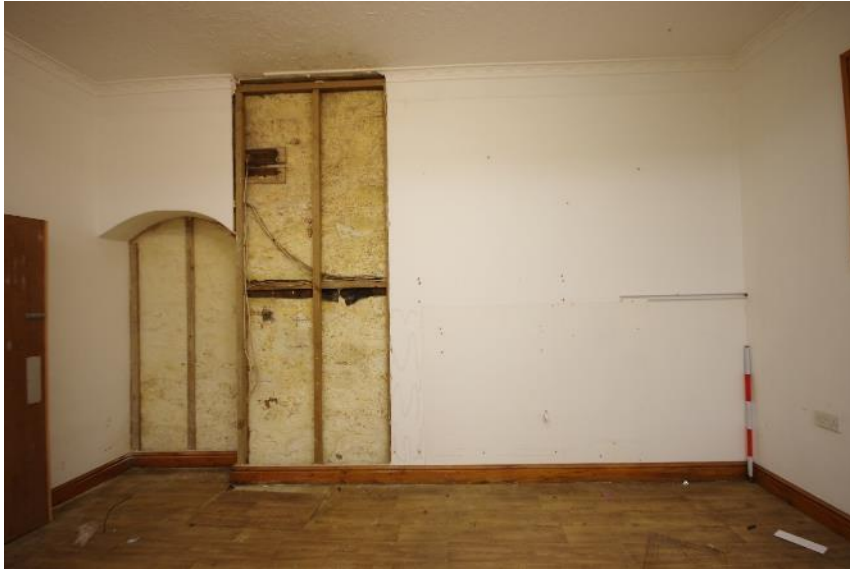
Fig 61 G1 north east wall.

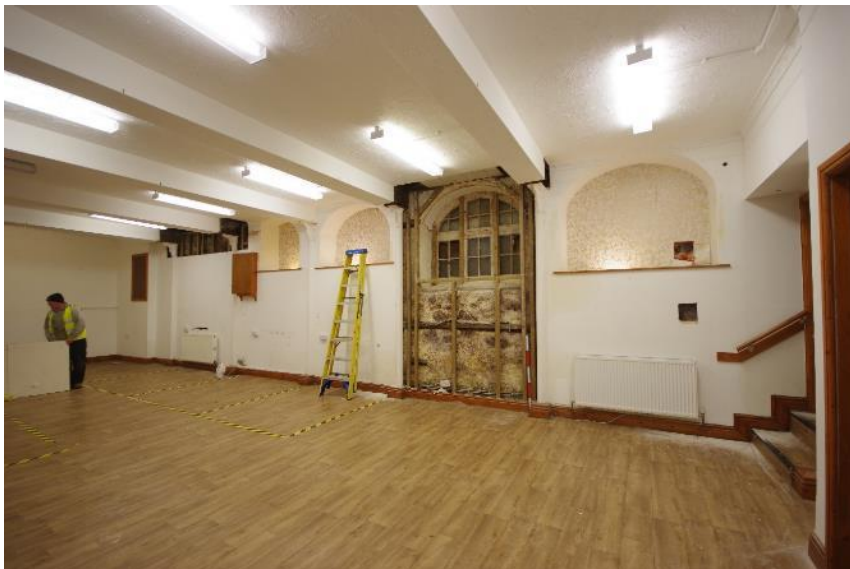
Fig 62 G1 south east wall.

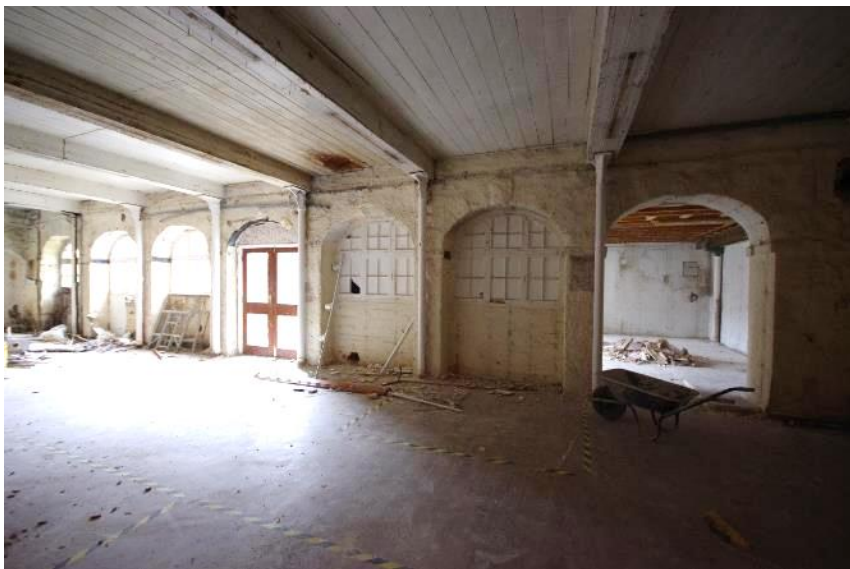
Fig 63 G1 north west wall during watching brief with modern fittings removed

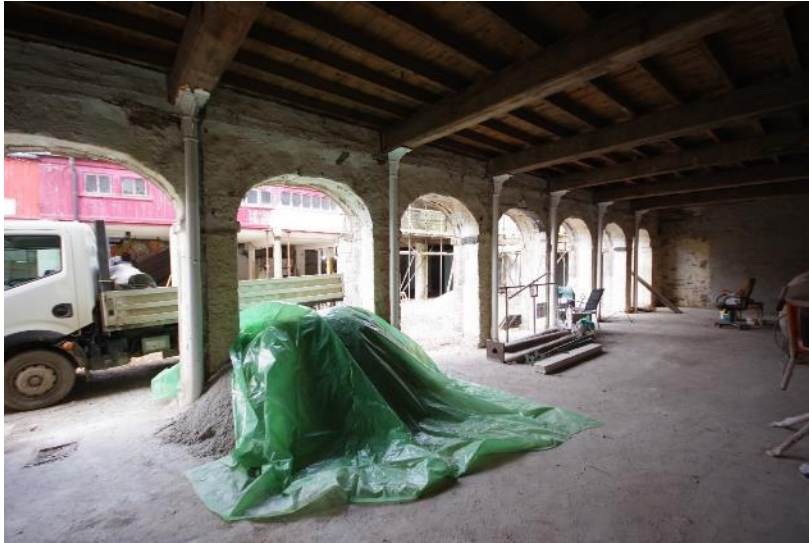
Fig 64 G1 north west wall during watching brief with c1900 windows removed from arcade.

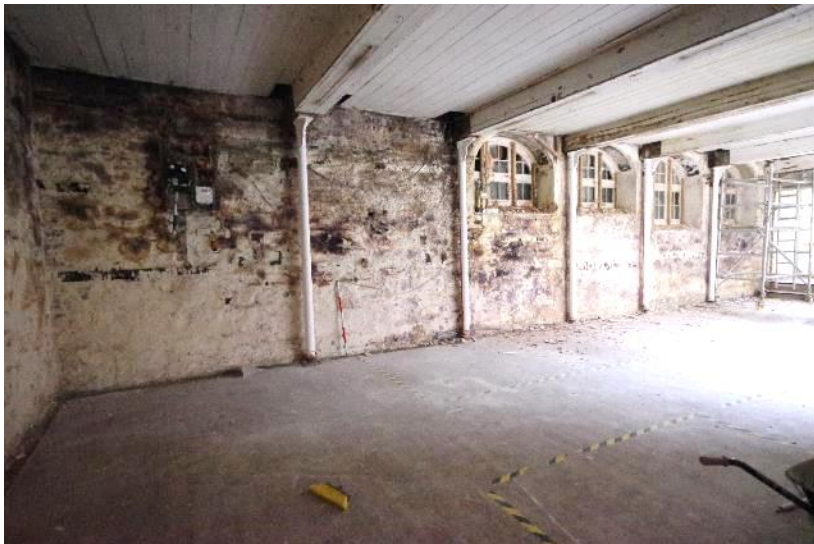
The ceiling was covered with modern boarding at the time of the survey, but remains of earlier white painted boarding could be seen behind it. When the boarding was removed the floorboards and joists of the first floor were exposed. They had been painted white, indicating that a hung ceiling had never existed originally.

Fig 65 G1 south east wall during watching brief with modern fitting removed.

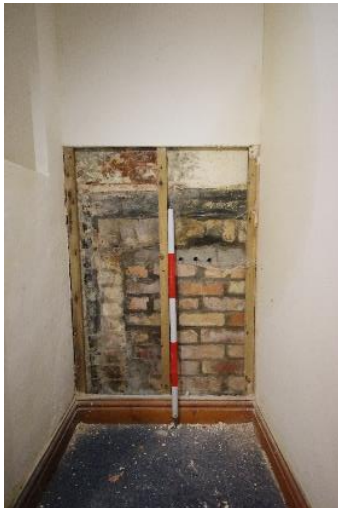
Fig 67 G2 south west wall showing blocked fireplace.

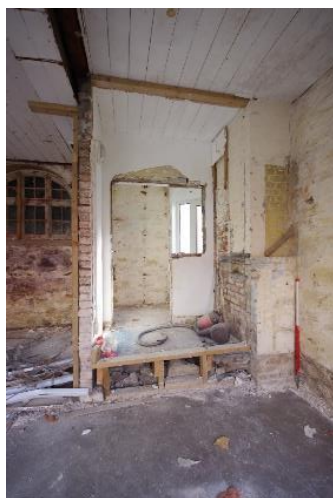
Fig 68 G2, G3 and G4 during watching brief, showing raised floor and chimney breast. Looking south east.

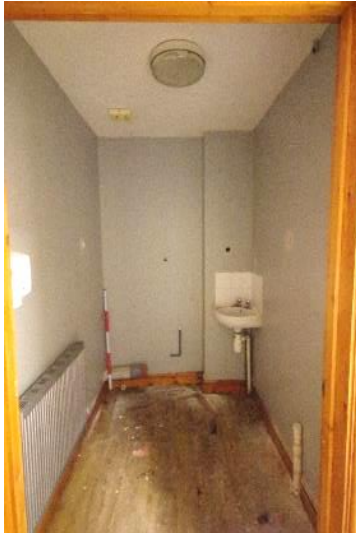
The floor had a modern wood-effect vinyl covering on top of a concrete screed and there was a modern suspended ceiling. Further removal of the screed floor around the blocked arcade opening revealed the original granite flagstone floor surface of the market house still *in situ*. A square drain opening had been inserted through the floor just in front of the blocked arcade opening.

Fig 70 G5 looking north west.

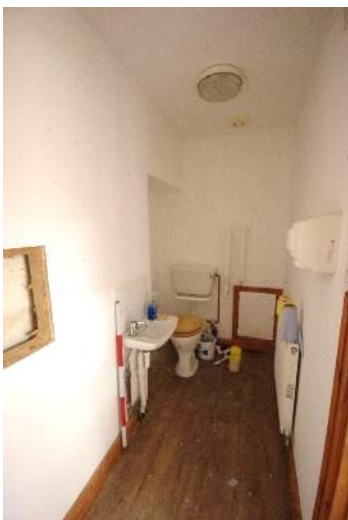
The floor had a modern wood-effect vinyl covering on top of a concrete screed and there was a modern suspended ceiling. Further removal of the screed floor around the two blocked door openings revealed the original granite flagstone floor surface of the market house still *in situ*.

Fig 71 G6 looking north west.

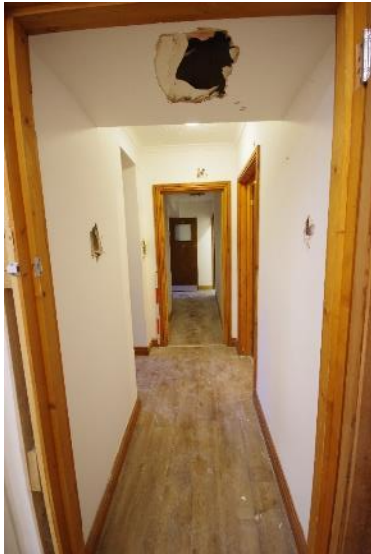
The floor has a modern vinyl wood-effect covering. The ceiling is constructed from plasterboard. Following demolition of the building and removal of the concrete floor, the 19th century courtyard surface was revealed comprising stone setts.

Fig 72 G7 looking north west.

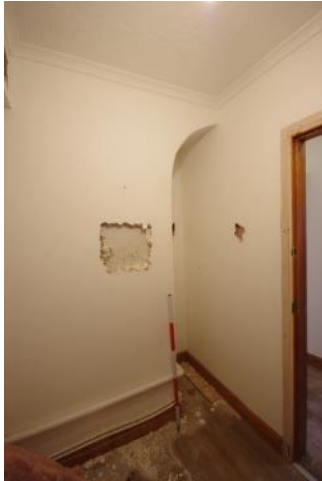
The floor has a modern vinyl covering over concrete. The ceiling is constructed from plasterboard. Following demolition of the building and removal of the concrete floor, the 19th century courtyard surface was revealed comprising stone setts.

Fig 73 G8 south east wall showing arch.

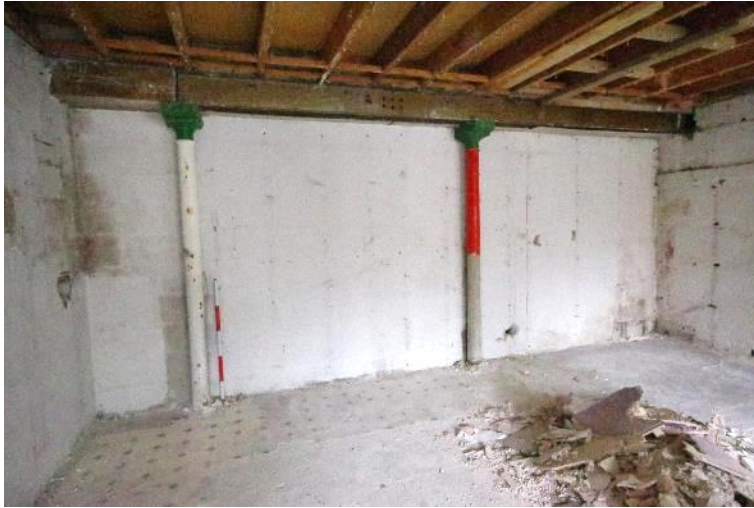
Fig 75 G8 and G9 north east walls during demolition with exposed original supporting columns for Wheal Peevor purser's office.

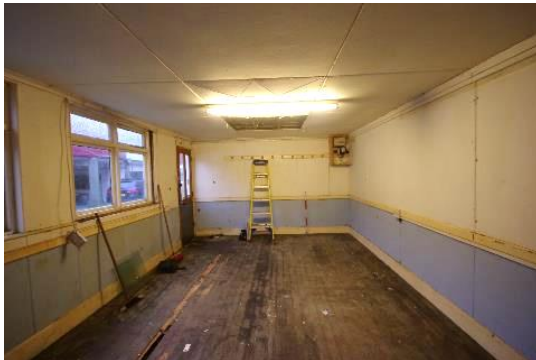
The north west (front) wall was added in the 1930s or 40s on the site of two former columns. It is constructed from concrete blockwork. There are two four-pane windows in this wall with top opening casements containing patterned rolled plate glass, although two panes have been replaced with clear glass in the north east window. To the north east of these there is a door opening with replacement mid-late 20th century half glazed door.

Fig 78 G12 looking north east.

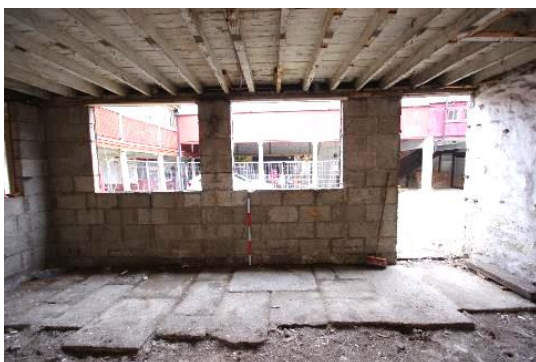
Fig 79 G12 during watching brief looking north west.

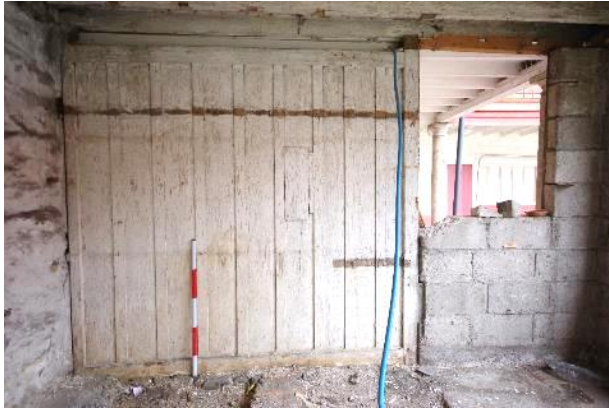
Fig 80 G12 south west wall during watching brief showing original plank and muntin wall.

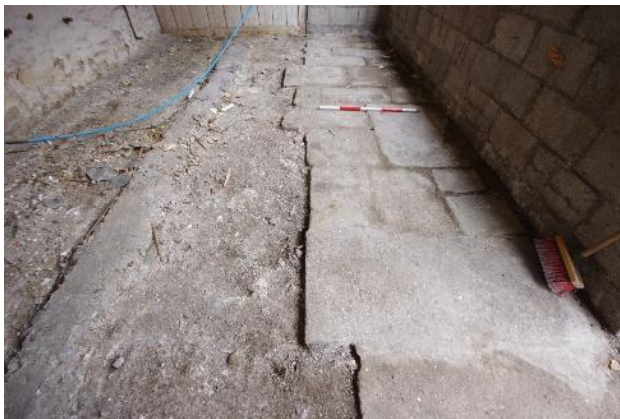
The room contained a suspended timber floor at the time of the survey. When this floor was removed it revealed the original granite flagstone surface in the area of the former colonnade along the north west side of the room. To the south east of this the original floor had been replaced with a concrete floor.

Fig 81 G12 floor during watching brief showing granite flagstones.

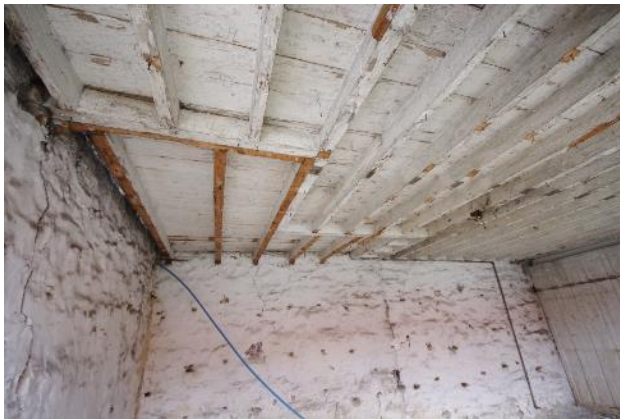
The ceiling was covered with fibreboard at the time of the survey. When this was removed it revealed the original whitewashed floor joists and boards above.

Fig 82 G12 ceiling during watching brief showing position of former staircase.

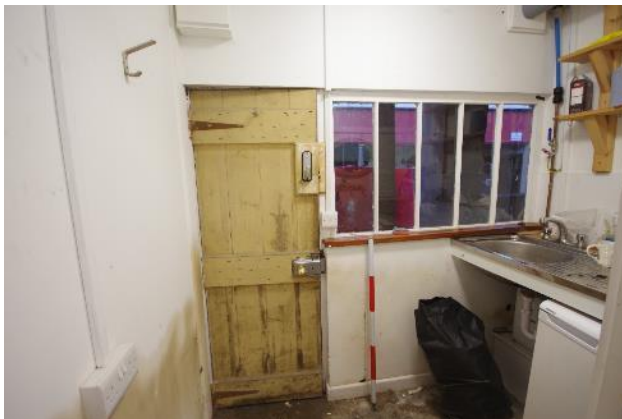
The walls are all covered with modern plasterboard. At the south west end of the north west (front) wall there is a 19th century ledged door with replacement strap hinges and a brass doorknob. Next to the door there is a five-pane workshop window. A modern kitchen sink unit has been inserted in the north corner of the room. The north east wall is an original partition wall (seen in G12 as a plank and muntin partition). Dividing the original room space is a modern partition wall running north east to south west. There is a modern door in the partition giving access to a modern toilet to the south east. The rear, south east wall is the original stone rubble wall of the south east range; but was not exposed as part of the works.

The floor has a modern concrete finish, and the ceiling is covered with modern plasterboard.

Fig 83 G13 north west wall.

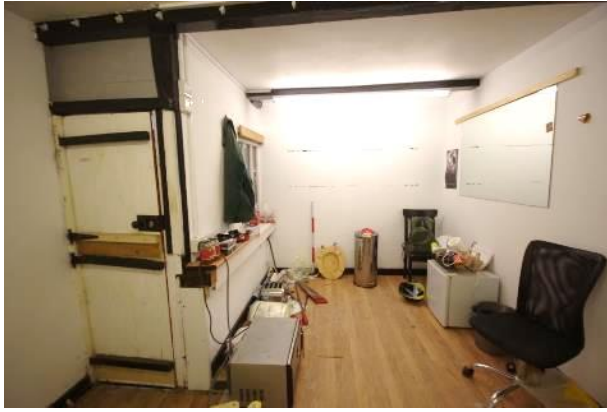
The floor has a modern vinyl covering over an inserted concrete floor and ceiling is covered with modern boarding, but two joists are visible in the south east range aligned north west to south east.

Fig 84 G14 looking north east.

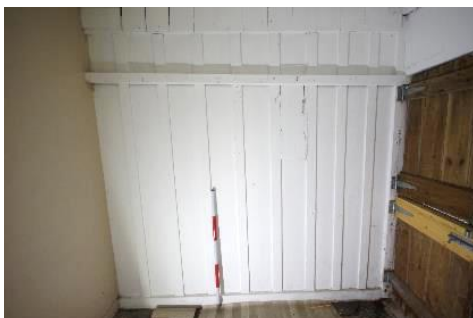
Fig 85 G15 north west wall.

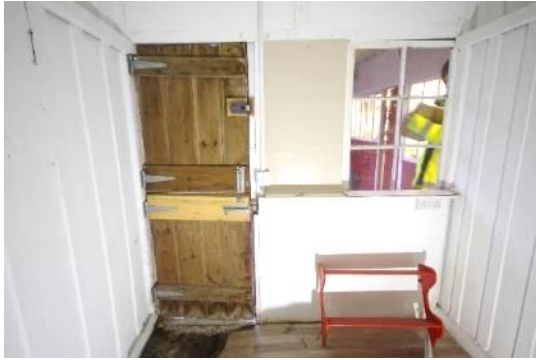
Fig 86 G15 north east wall.

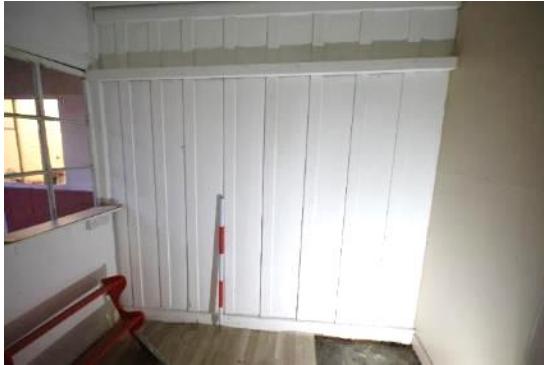
Fig 87 G15 south east wall.

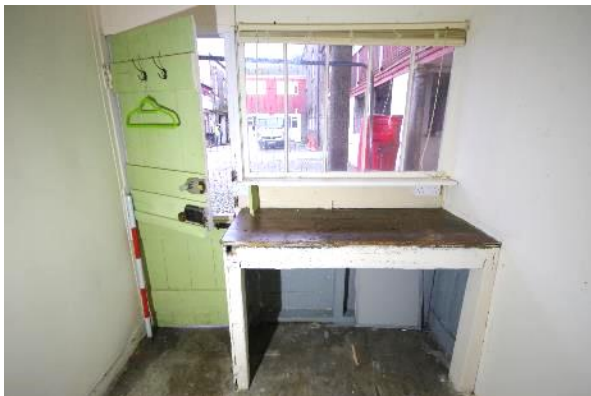
The floor has a concrete screed covering and the ceiling is covered with modern boarding.

Fig 88 G16 north east wall.

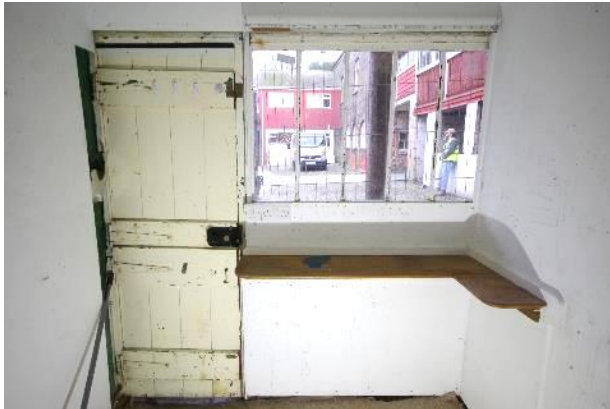
The floor is carpeted over a concrete screed. The ceiling was covered with modern boarding at the time of the survey, but during the works the boarding was removed revealing the 19th century boards and joists above which had been whitewashed indicating that originally, they would have been exposed.

Fig 89 G17 north east wall.

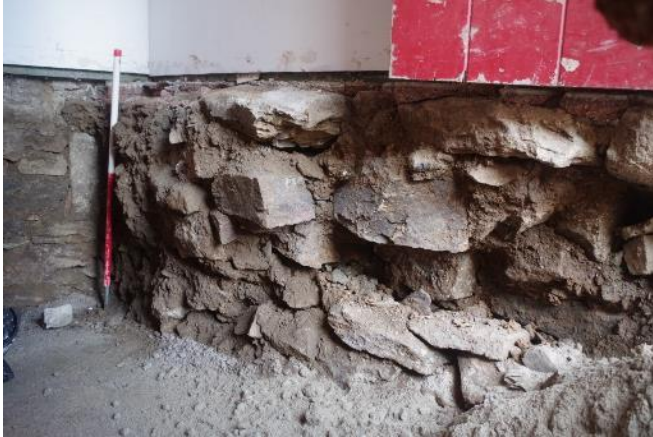
Fig 90 G17 during watching brief, south east facing section of trench showing (110).

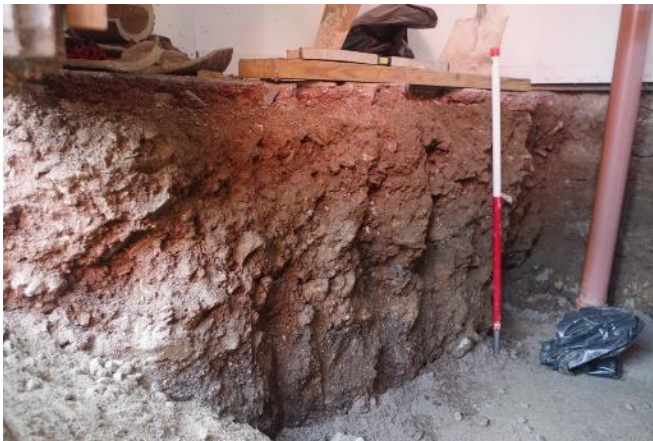
(121), was positioned on top of the later concrete surface (111), suggesting that the south east door jamb is a later replacement. Outside G17 in the colonnade, the 19th century granite flagstones (103) overlay the earth make-up layer (116), as elsewhere. To the north east of the flagstones there was a granite drainage channel (120), and beyond this was the modern slate sett surface (119), laid in c2000, which was bedded into a grey aggregate mix (118), 0.05m thick. This modern bedding layer overlay (117) a yellow aggregate 0.1m thick, which was also associated with the c2000 works. The lower aggregate layer (117) overlay the 19th century earth make-up layer (116).

Fig 91 G17 during watching brief, north west facing section of trench.

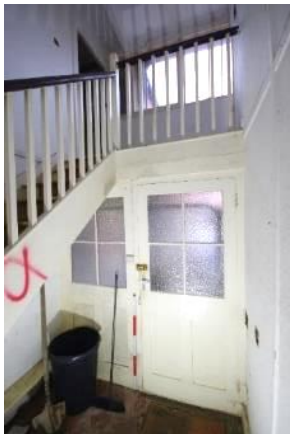
Fig 92 G18 north east wall.

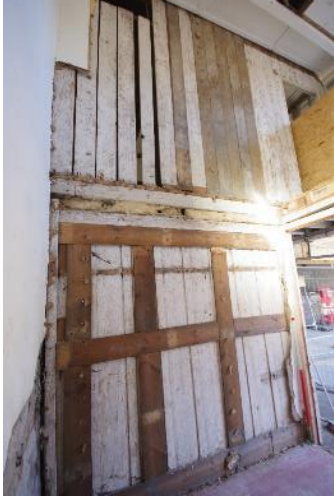
Fig 94 G18 during watching brief, north west wall with removed boarding.

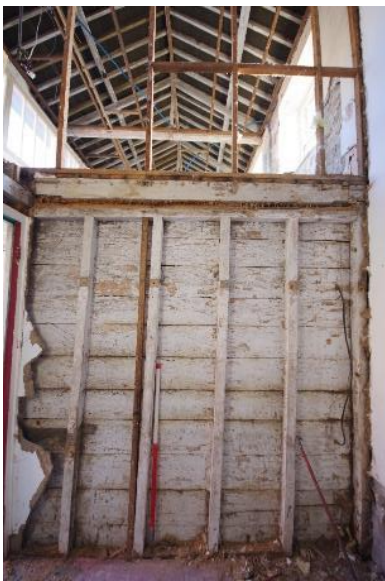
Fig 95 G18 during watching brief, south east wall with removed boarding.

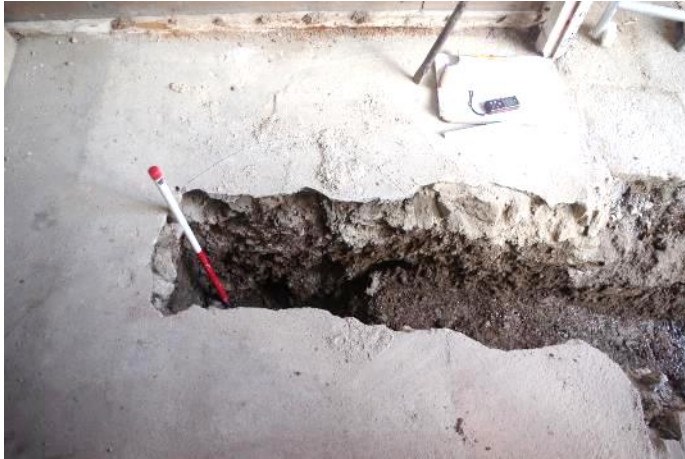
During the watching brief the floor inside G18 was excavated in order to install services. The trench was 3m wide and up to 0.75m deep. On the south west side of the trench a make-up layer (101) extended up to 0.45m from the lowest point in the trench. Halfway across the trench, this layer (101) sloped down to the north east. Overlying (101) there was a layer of mid reddish brown silty clay containing moderate stones (102), which lay directly beneath an original floor surface inside the room of stone setts (106). Layer (102) was also seen to lie directly beneath the granite flagstones of the colonnade outside the room. Overlying the original floor surface (106) was a concrete surface (107) of probable 1930s or 40s date, laid directly onto historic stone setts (106). Outside in the colonnade there was a narrow area of dark brown earth infill between the granite slabs and the setts (104) of the interior. Between the north east side of the granite flagstones (103) and the granite columns (105) there was modern concrete patching (104).

Fig 96 G18 during watching brief, south east facing section of trench in floor.

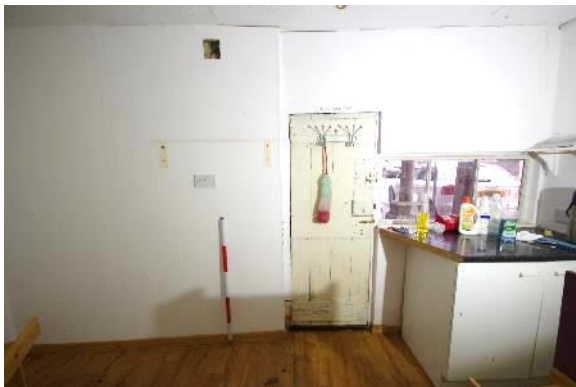
Fig 97 G19 north east wall.

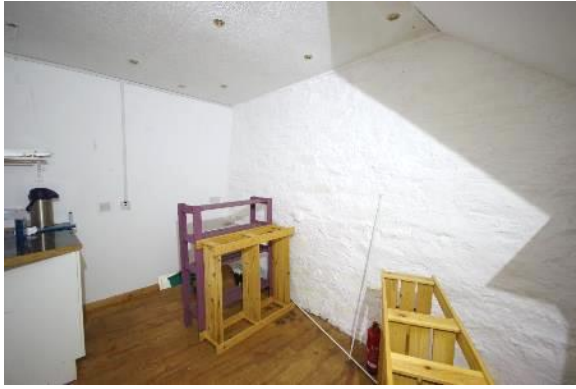
Fig 98 G19 looking south.

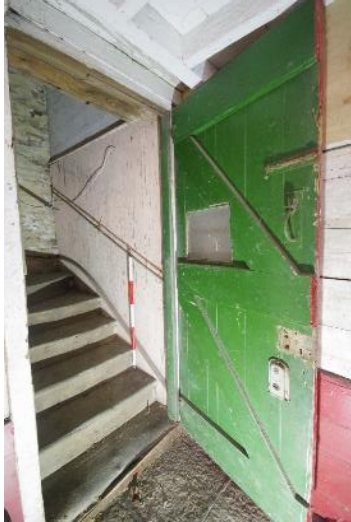
The original timber winder staircase has very worn treads and leads up from the door in the north east wall to the south west, turning at right angles against the south west wall and continuing up to the south east.

The ceiling is timber panelled.

Fig 99 G20 looking west.

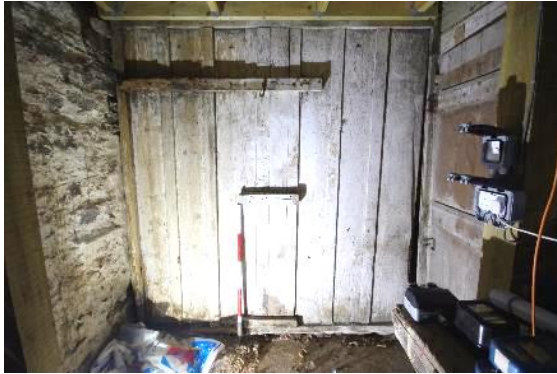
The ceiling is formed by the exposed floor joists and boards above which have been whitewashed. Against the centre of the north west wall there is a square configuration of joists to support a hearth for a fireplace on the floor above. There are three mid 19th century urinals manufactured by George Jennings of London (the inventor of public toilets) stored in this room.

Fig 100 G21 north east wall.

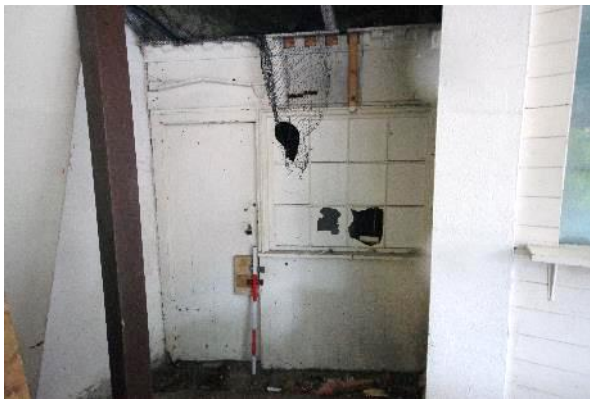
Fig 103 G22 frontage.

The ceiling is matchboard panelled and has a mid 20th century light fitting.

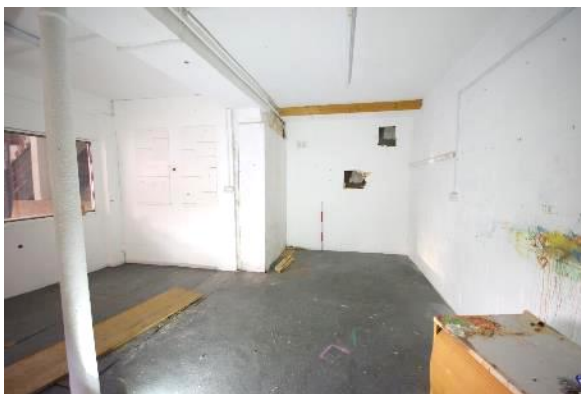
Fig 105 G23 Looking north west.

The ceiling is cement covered and painted white. There is a beam running north west to south east directly below the rear wall on the Mining Exchange which may be an RSJ inserted in the 1920s when the Mining Exchange extension was added. Supporting the central part of the beam there is a possibly reused c1880s cast iron column, the same as those supporting the rear wall of Wheal Peevor purser's office, and to the south east of this a section of cast iron rising main pipe has been reused as a support pillar.

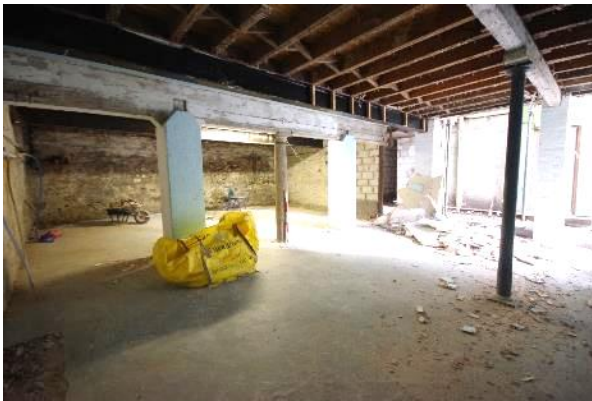
Fig 107 G24 looking east.

During the watching brief on the below floor works. The extent of the 19th century surface of granite setts was recorded before its removal (see Fig 194). During excavation of the floor a large rectangular granite block was recorded, set in the floor at the south west end of the room. A fragment of the capital from the reused granite column in the centre of the room was recovered from within the cobbled surface. The concrete surface was 0.1m deep and immediately overlay the surface of granite setts which was 0.1m deep. The setts were bedded into a layer of stony hardcore 0.2m deep which in turn was laid on a layer of mid brownish orange compact silty clay. Several trenches for new services were excavated across the room.

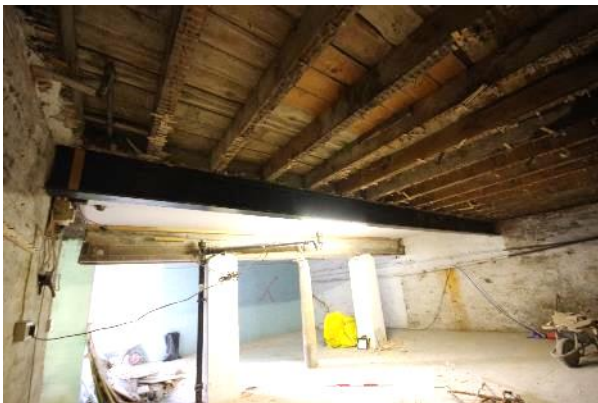
Fig 108 G24 looking west showing walls and ceiling.

This room along with the north eastern part of G23 was first created in c1877 when the north west range was built. On a plan dated 1892 (Fig 15) the room is labelled as the wholesale meat market. In 1880 the ceiling was raised when a new first floor structure was inserted for the Mining Exchange and the previous 1870s floor removed. At this time the 1870s granite columns which had supported the front (south east) wall were removed and replaced with a section of brick wall and brick pillars. Major alterations also occurred in the late 20th or early 21st century with the insertion of RSJs to support the ceiling.

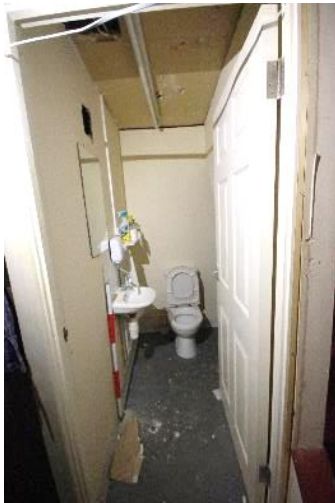
Fig 109 G25 looking north west.

The floor surface is modern concrete, and the ceiling is covered with fibreboard.

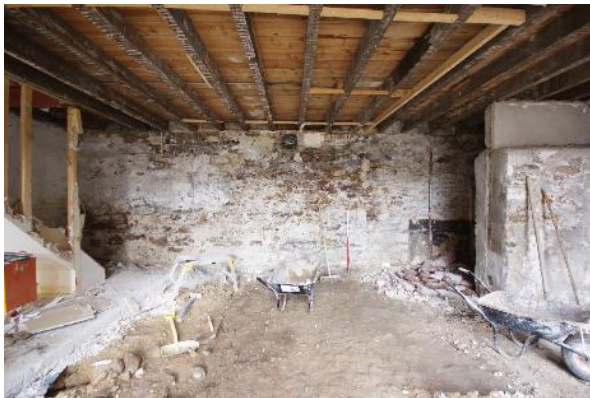
Fig 111 G26 North east wall following demolition of rooms.

The modern rooms (G25 and G26) were demolished as part of the works exposing the historic walls. The phase 1, north east wall was constructed from randomly coursed stone rubble bonded with earth mortar and was whitewashed. There were three large square sockets at the top of this wall, close together and near the centre, one open, one infilled with cement and the other filled with brick. These sockets may have been associated with the stairs up to Alma Place that were formerly located against this wall prior to the construction of Wheal Peevor purser's office in c1883.

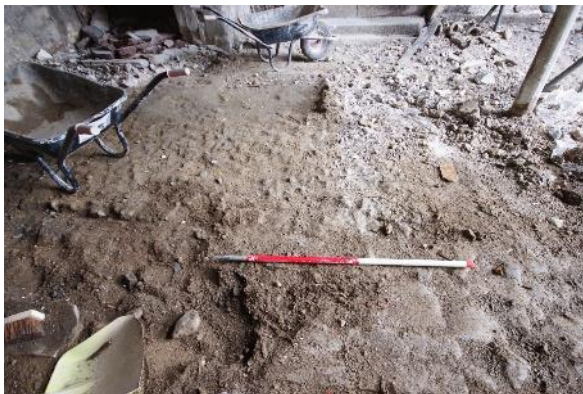
Fig 112 G26 Stone sett surface uncovered during watching brief, looking south east.

Following the removal of the concrete floor the historic granite and slatestone sett surface of the courtyard was seen to survive below G25 and G26, with a drainage gully in the setts running from north east to south west.

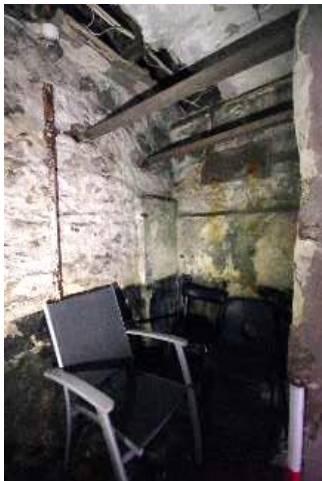
Fig 113 G27 looking east.

This small WC appears to have been added in c1883, at the same time as Wheal Peevor purser's office, possibly to replace two earlier WCs to the south east which were buried in c1883 when the granite steps leading from the courtyard up to Alma Place were inserted.

The room has a 19th century lath and plaster ceiling. Part of the ceiling is missing and the floor joists and boards of Wheal Peevor purser's office above are visible.

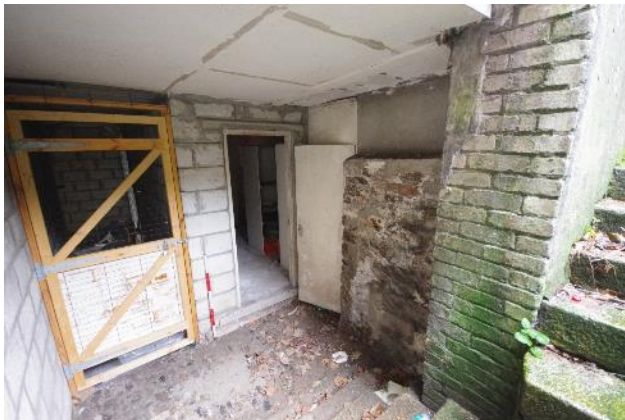
Fig 115 G27 G28 looking north.

At the bottom of the c1883 granite steps leading down to the courtyard from Alma Place is a small rectangular open area below Wheal Peevor purser's office. This space was part of the open area under Wheal Peevor purser's office before modern rooms were inserted below it, and an extension made to the rear of Wheal Peevor purser's office in the 1960s. The yard area has concrete block walls on the south west and north west sides associated with 1960s and later alterations. On the north west side there is a modern timber frame mesh door giving access to a passage created by the 1960s extension and the later rooms added under Wheal Peevor purser's office and a modern timber door giving access to G26. The passage has a 19th century surface of stone setts, and stored in it are two cast-iron columns marked 'W. Visick & Sons, Devoran' like those in the market house, and both have hinge attachments for gates (it is unclear where they have been removed from). The north east side of the area is formed by the wall of the WC (G27) added in c1883. The $\frac{3}{4}$ height wall is constructed from stone rubble and has remnants of whitewash on it. There is a reused chamfered stone in this wall, and it has been heightened with concrete in the late 20th century to take it up to the underside of Wheal Peevor purser's office. There is a modern timber door at the north west end of this wall. Forming the south east side of the area is the base of the c1883 granite steps leading up to Alma Place. The small yard area has a 19th century surface of stone setts which extends into the passage and was seen during the course of the works to survives below the modern rooms under Wheal Peevor purser's office and below the 1960s and 70s extensions.

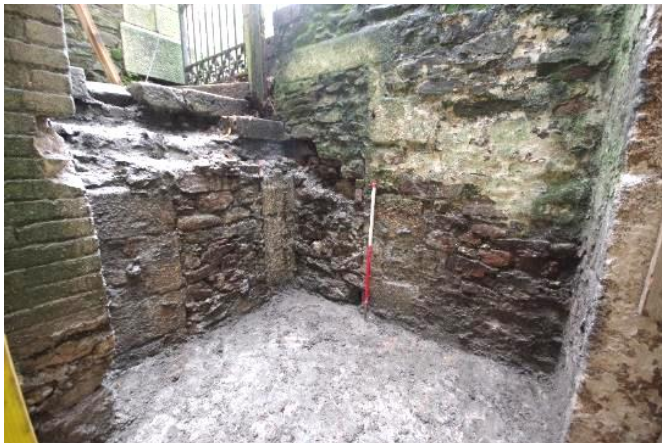
Fig 120 G29 (left) with blocked door opening. Concealed room (right) with blocked door opening. Looking east, when granite steps were removed during watching brief.

The south west (front) wall of the room butted up against the jamb of a blocked door opening of another room concealed below the steps up to the market house. This other room was not opened up as part of the works, but its north west (front) wall was constructed from randomly coursed stone rubble and its centrally set door opening had dressed granite jambs and a granite lintel and threshold. The function of this room is unknown but may have been a storeroom or earth closet dating to phase 1, and it certainly pre-dates G29.

The south west (front) wall of G29 contained the remaining lower half of the door opening to the room which had dressed granite jambs and stone rubble walls on either side of it. The interior of the room became visible when one of the granite slabs of the steps was lifted temporarily. Inside the room was seen to extend to the south east below large granite slabs on the corner of Alma Place. The walls all had lime plaster still adhering which was whitewashed except for the south west half of the south east wall which had stone rubble blocking in it. The floor surface was covered by rubble and was not visible. Outside the building to the south west a granite and slatestone sett surface was uncovered in the area that had been covered by the c1883 granite steps.

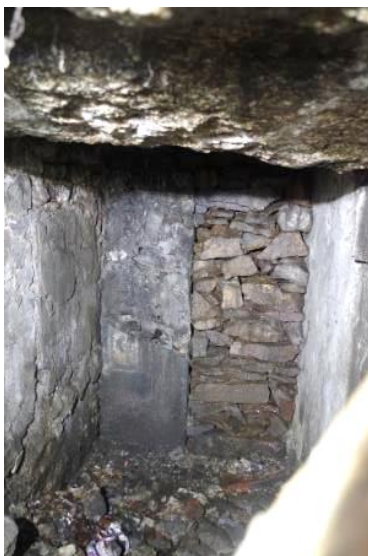
Fig 121 G29 interior looking south east, when exposed during watching brief.

This room was uncovered during the course of the watching brief when the c1883 granite steps giving access up to Alma Place were removed. The small room had probably been a WC/earth closet built as part of the 1870s remodelling work, which was replaced in c1883 by G27. The top half of the room had been truncated when the steps were inserted in c1883 and the interior then covered by granite slabs and the door opening in the south west wall blocked with stone rubble.

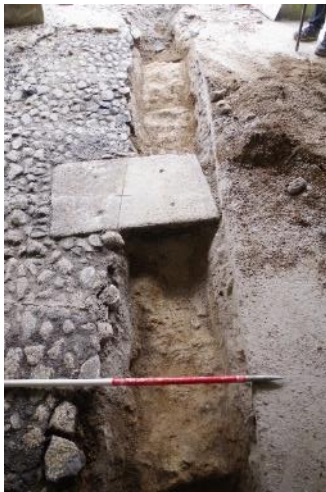
Fig 122 Stone sett surface and trench across the top of the granite lintels of the water tank, looking south east.

During the watching brief on service trenches in and around the courtyard, a water tank was uncovered below the 19th century stone sett surface under the covered market area. A service trench was excavated running north west to south east under the Mining Exchange extension. The trench cut through the modern concrete surface revealing the 19th century stone sett surface below comprising mainly irregular fist size granite setts approximately 0.1m deep. Within the granite sett surface there was a large, dressed, rectangular granite slab containing four drilled holes, each containing the remains of a timber peg. When the granite slab was lifted a circular aperture 0.5m wide carved through a single block of granite 0.4m thick was revealed. The aperture opened directly into the top of a below ground water tank. Below the stone sett surface elsewhere was a bedding layer of mid orangey brown silty clay 0.15m deep. This directly overlay a series of large granite lintels all aligned south west to north east forming the top of the water tank. The interior of the water tank was rectangular with rounded corners and was aligned north west to south east. It measured 3.5m long by 1.5m wide and 3m deep and was cement-lined. Around the tops of the walls there was a strip of soot adhering, which was almost certainly caused by the extinguishing of the fire in the meat market in 1982. There was also soot deposits on the underside of the granite lintels forming the top of the tank. Two holes in the north west wall of the tank allowed water inside. The hole near the north corner had a long lead pipe leading down into the base of the tank. The base of the tank was not visible since it still contained water.

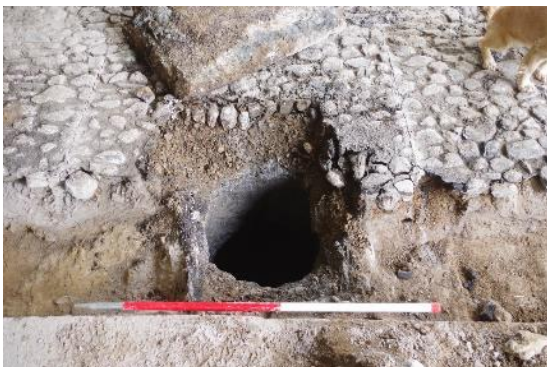
Fig 123 G30 Aperture in top of tank, looking north east.

The water tank was probably inserted as part of the remodelling work in the 1870s (phase 3). Originally a pump would have been located over the circular aperture so that water could be collected for washing down stalls etc.
