Redruth Buttermarket Historic Building Record and Watching Brief

Historic Building Record and Watching Brief

Client	Redruth Revival Community Interest Company
Report Number	2025R037
Date	July 2025
Status	Final
Report author(s)	Jo Sturgess and Connor Motley
Checked by	Jo Sturgess
Approved by	Andy Jones
Project number	147224
Data location	\\CAU\Archive\Sites\R\Redruth Buttermarket HBR and WB
Historic England / ADS OASIS online reference	cornwall2-535700 ADS number: 20036509
Planning references	PA21/09197

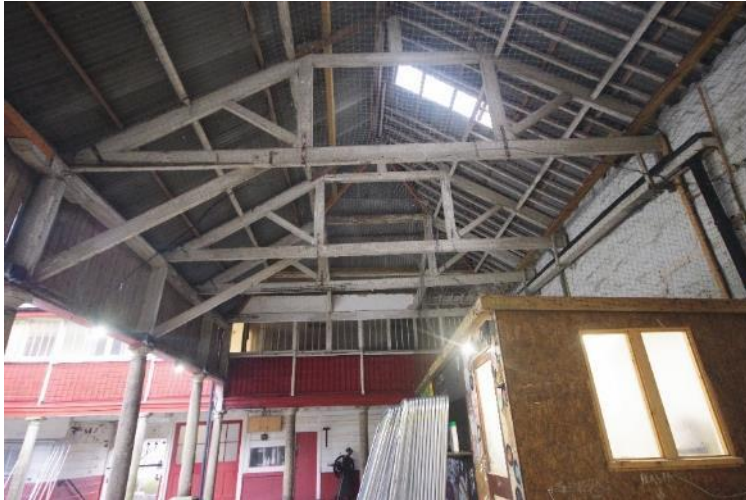
Fig 125 G31 Roof structure looking south west.

The floor is mainly covered with a concrete screed to the south west of the opening though to Market Way and with asphalt to the north east. During the watching brief the historic stone sett surface was seen to survive below the modern surfaces along with granite surface drainage gullies running along the outer sides of the columns and returning, sloping down to either side of both door openings though to the former meat market. A water tank (G30) was also uncovered under the Mining Exchange extension (see section 5.4.33) along with a brick lined drain under the modern staircase, which was constructed from handmade bricks, with a dressed granite opening at the top of the hole (Fig 195). It is thought that a downpipe from the roof fed into this drain in order to fill the tank (G30) with water. Inside the hole there was a metal pipe presumably connecting to the water tank (G30). The historic surfaces, the water tank and drain appear to date to the 1870s (phase 3).

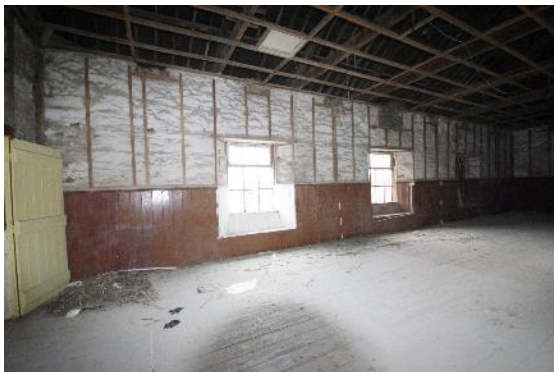
Fig 126 F1 north west wall.

There are three original window openings in the north west wall which have timber lintels, and all contain replacement c1884 nine-pane windows, with a fixed cast iron six-pane window in the lower two thirds and timber three-pane casement window at the top. All the windows have matchboard panelled window seats below.

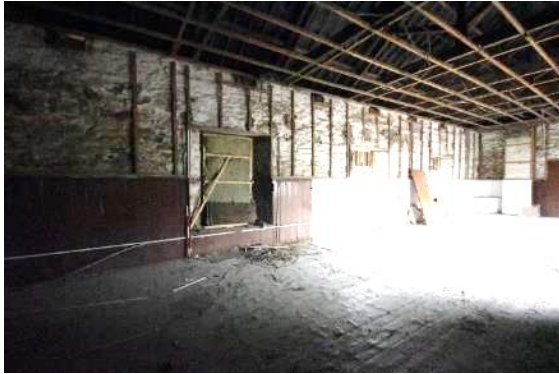
Fig 128 F1 south east wall.

There are three original window openings in the south east wall which have timber lintels, and all contain replacement c1884 nine-pane windows, with a fixed cast iron six-pane window in the lower two thirds and timber three-pane casement window at the top. All the windows have matchboard panelled window seats below. The south west window has an RSJ inserted below it. There seven are brick ventilators at the top of the wall in the heightened 1884 walling. At the south west end of the wall the corner of the room is boxed in with panelling where a door opening has been inserted on the ground floor below. There is a scar where the original phase 1 ceiling has been removed at the level of the window lintels. Above the windows are sawn off timbers, from the phase 1 roof structure.

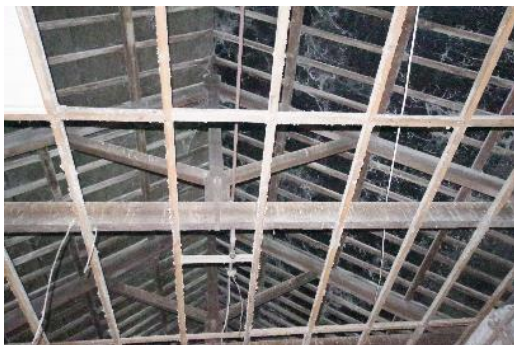
Fig 130 F1 market house roof structure.

A modern plasterboard suspended ceiling has been removed at a level with the top of the walls. There are pipes surviving above the former ceiling which would have supplied gas lighting in the room. The roof structure above dates to 1884 and comprises king post trusses with mortice and tenon joints with the king posts secured to the tie beam with iron straps and bolts. The 1884 purlins and common rafters survive intact.

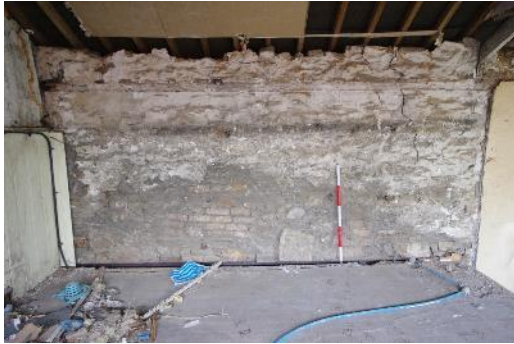
Fig 133 F2 south east wall.

The dado panelling had nearly all been removed from the south east wall as part of the works at the time of the survey. This exposed the rear stone rubble wall of the building which had been whitewashed both above and behind the panelling except for an arched area low in the wall. This area had been rebuilt in 1997 when the original brick arch of the cart opening below was removed and replaced with a concrete lintel. The original arch clearly matched the arch over the pedestrian gate in the south west range, since the rusticated keystone seen reused in the 1997 infill matched that in the arch of the south west range. The other infill material included the bricks from the arch and stone rubble bonded and pointed with cement mortar.

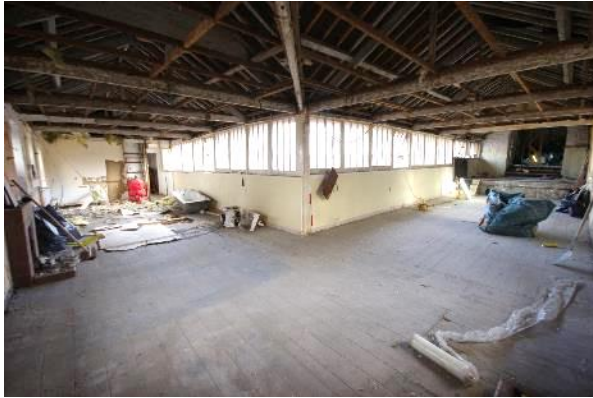
Fig 134 F3 north west and north east walls.

The north east wall in the south west range is the original phase 2 front wall overlooking the courtyard. Eight windows with four vertical panes each, occupy the whole length of the upper half of the wall. These windows are all late 20th century replacements added in 1997. They are all fixed windows except for the fourth window from the north west, which is a top opening casement. However, the original posts separating each pair of windows survive and are chamfered with runout stops. The walling below the windows is covered with modern plasterboard.

The north west wall in the south east range is the original phase 2 front wall overlooking the courtyard. Eight windows with four vertical panes each, occupy the whole length of the upper half of the wall. These windows are all late 20th century replacements added in 1997. They are all fixed windows except for the fourth window from the south west, which is a top opening casement. The walling below the windows is covered with modern plasterboard.

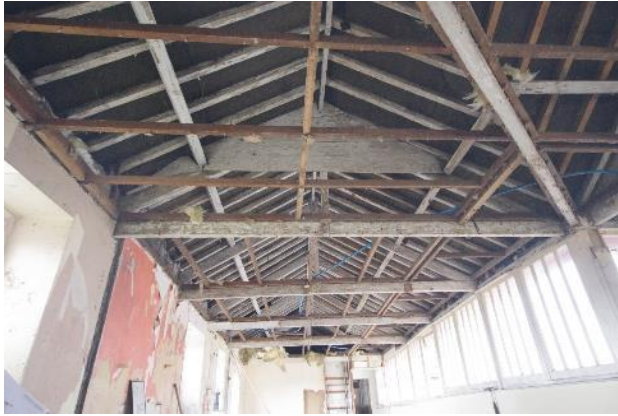
Fig 138 F3 roof structure looking north west.

The inserted 1930s or 40s ceiling had already been removed by the time of the survey, and the space was open to the roof structure. The original phase 2 roof structure survives mainly intact, and all the timbers have been whitewashed indicating that there was no ceiling originally. The trusses are simple tie beam trusses with mortice and tenon joints and have a king post strut which is secured to the tie beam with an iron strap. There is one purlin on each side and a central ridge beam. Most of the common rafters also survive, however, the roof covering was completely replaced in 1997.

A truss towards the south east end of the south west range (in line with the front wall of the south east range) has horizontal plank panelling fixed to it. This is the remains of an original partition wall. Attached to the purlins of the roof structure, on the courtyard side of the room, there are multiple pulley wheels. Generally, there is one pulley wheel on each side of every roof bay, except where they are missing. These pulley wheels were presumably used to raise and lower timber shutters on the fronts of market stalls position in the rear half of the room. They indicate that there was probably one stall in each bay.

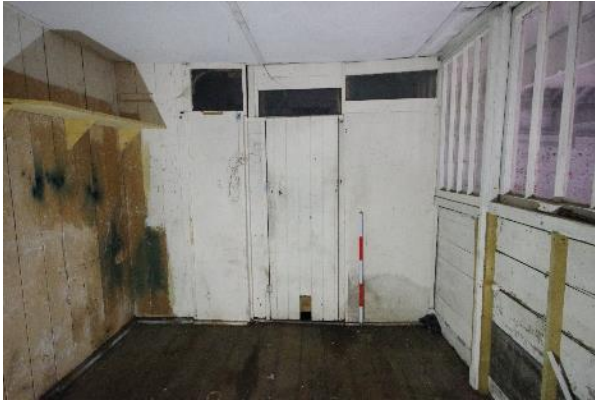
Fig 140 F5 north west wall.

The south west end of the north west wall is the original 19th century matchboard panelled wall. The rest of the stud wall is covered with replacement fibreboard. There are three 20th century borrowed lights at the top of the later section of walling, of varying sizes. To the north east of the centre of the wall a door opening through to F7 contains a vertical plank door.

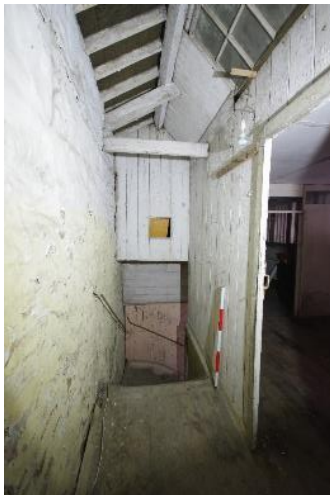
During the works the 20th century ceiling was removed revealing that the original phase 2 roof structure survives mainly intact, and all the timbers have been whitewashed indicating that there was no ceiling originally. The three trusses are simple tie beam trusses with mortice and tenon joints and have a king post strut which is secured to the tie beam with an iron strap. There is one purlin on each side and a central ridge beam. Most of the common rafters also survive, however, the roof covering was completely replaced in 1997. The truss which is situated across the middle of the room has vertical matchboard panelling attached on the south east side, which is also whitewashed, this is the remains of a former partition wall here. A 20th century water tank has been inserted in the roof space at the south east end.

Fig 142 F5 roof structure after removal of the ceiling, looking south east.

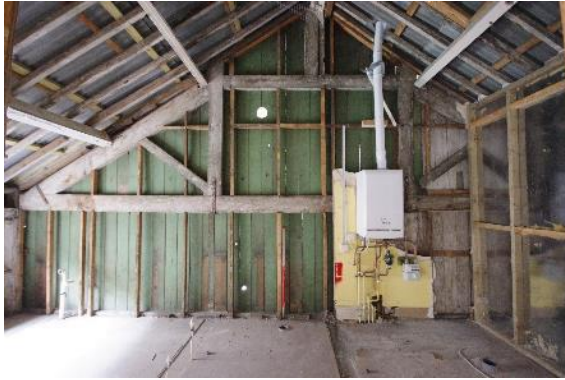
Fig 166 F11, F12 and F13 south west wall during the watching brief with truss exposed.

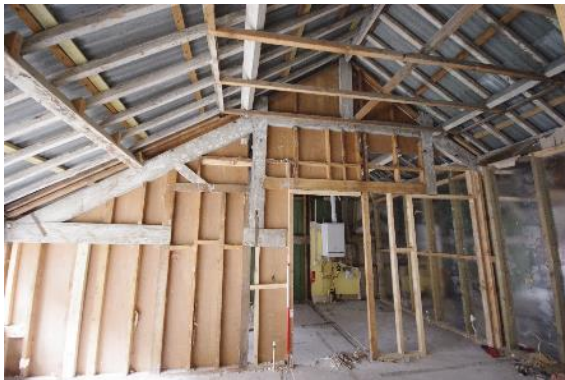
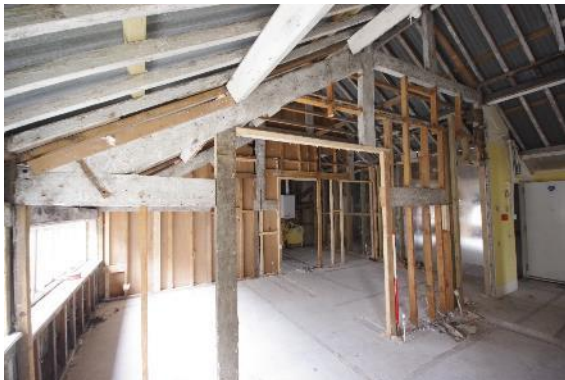
The central truss and the one to the north east had both been sawn through with parts removed in order to insert door openings in the rooms. A blocked 1922 door opening was revealed at the south east end of the centre truss, with the 1922 door frame still *in situ*. This door opening was located in the wall dividing F10 and F11. In the walling covering the truss which divided F9 and F10, a fragment of newspaper was found which was dated 27th July 1960.

Fig 167 F10 and F14 south west wall during the watching brief with truss exposed.

Fig 168 F9 and F15 south west wall during the watching brief with exposed truss.

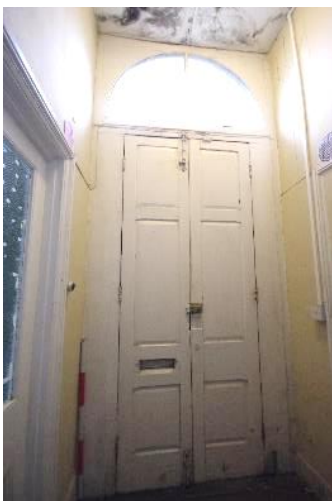
Fig 170 F16 north east wall.

although the upper two panels have been replaced with a single pane of patterned rolled plat glass in the early-mid 20th century. There is a Bakelite light switch next to the door on the north east side.

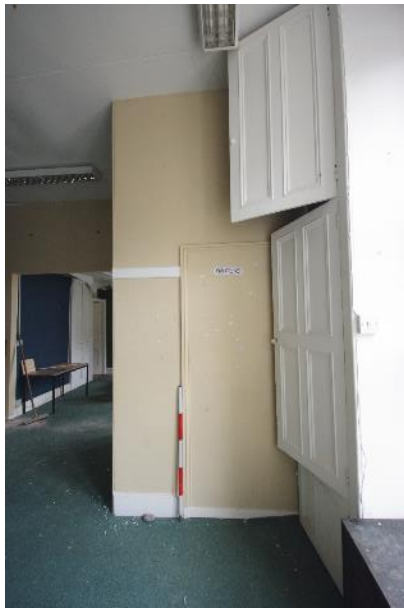
Fig 172 F17 south east side of lobby and safe cupboard to right.

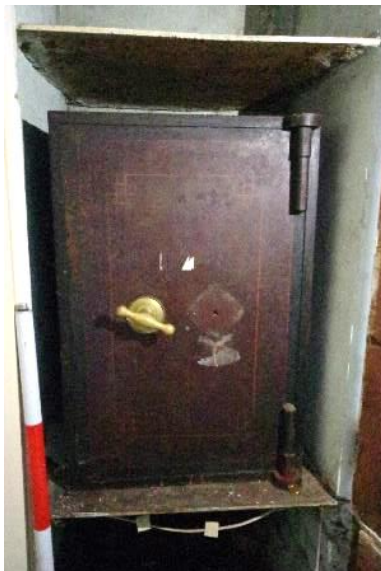
Fig 173 F17 safe by 'E Cotterill & Co manufacturer's Climax Works, Birmingham' in safe cupboard in north east wall.

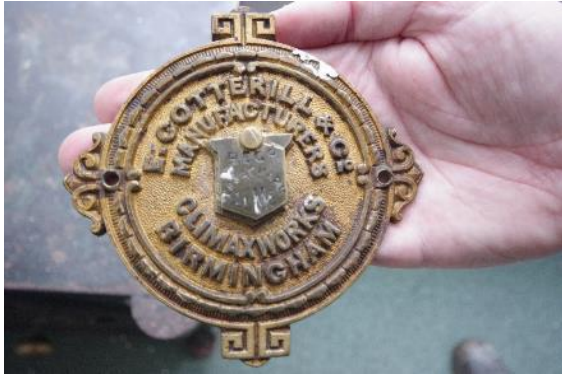
Fig 174 F17 plaque from safe in cupboard, 'E Cotterill & Co manufacturer's Climax Works, Birmingham'.

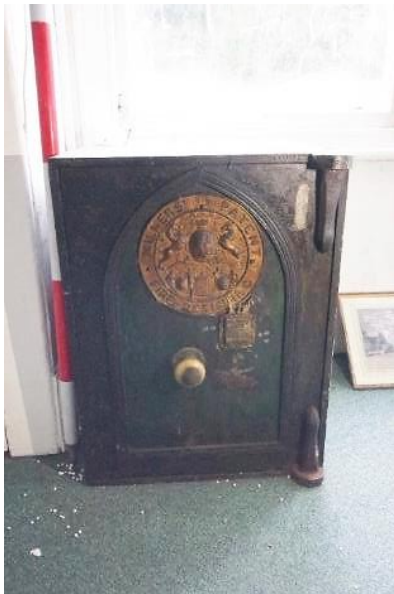
Fig 175 F17 safe 'Milner's patent fire resisting safe, powder proof solid lock Liverpool & London' from safe cupboard on north east wall.

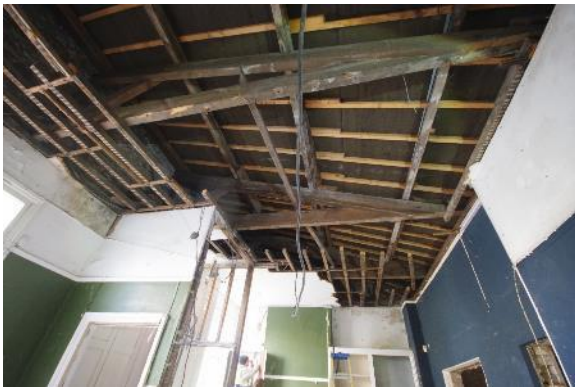
During the watching brief the ceiling was removed allowing the roof structure to be seen. The mono-pitch roof slopes from the north east down to the south west. The original trusses comprise a principal rafter and tie beam with a strut between the two at the north east end and adjoining brace. They are lap-jointed and nailed. There are three rows of original purlins. The principal rafter of the second truss from the south east is a modern replacement, along with part of the north east purlin, and there is also a modern replacement purlin in the centre of the roof. All of the common rafters are modern replacements added when the roof covering was renewed in the late 20th century.

Fig 178 F17 Roof following removal of ceiling showing trusses.

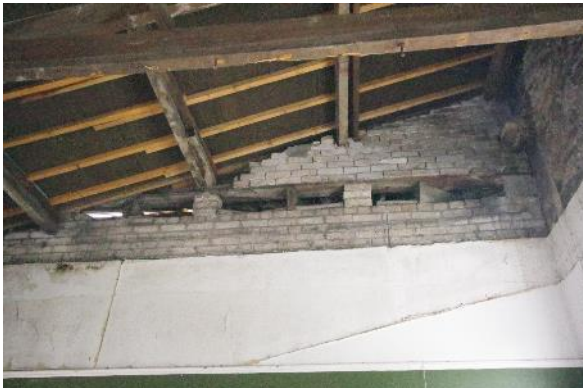
Fig 179 F17 Top of north west wall during watching brief showing cornice of mining exchange frontage upper right and void through to mining exchange roof space.

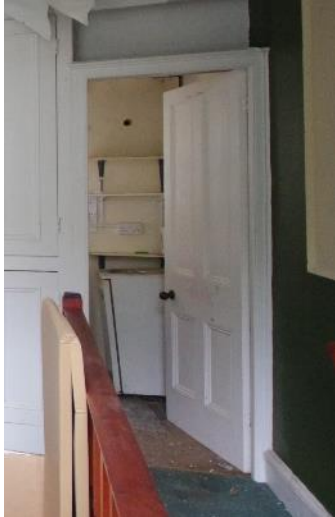
Fig 180 Looking south west through into F18.

The floor comprises original timber boards and the ceiling is covered with matchboard panelling. A small simple principal rafter with collar is visible in the lean-to roof space above.

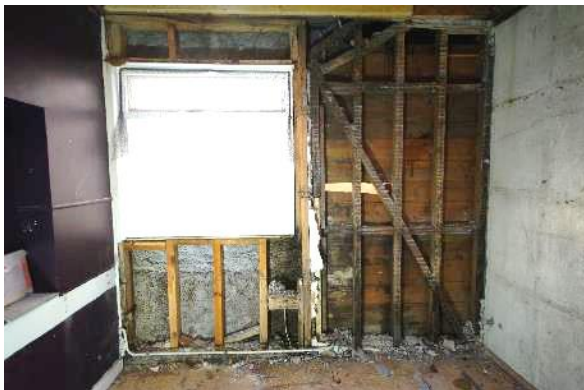
This extension was demolished, but during that process, the walls were stripped revealing the phase 1 granite wall of the Market House to the south east, the phase 5 rear rendered wall of Wheal Peevor purser's office and the phase 7 side wall of the WC extension to Wheal Peevor purser's office. It also revealed that the 19th century stone sett surface of the courtyard survived below the building.

Fig 182 F19 during watching brief, north west wall showing the two phases, the early 20th century extension wall on the right and 1960s wall on the left.

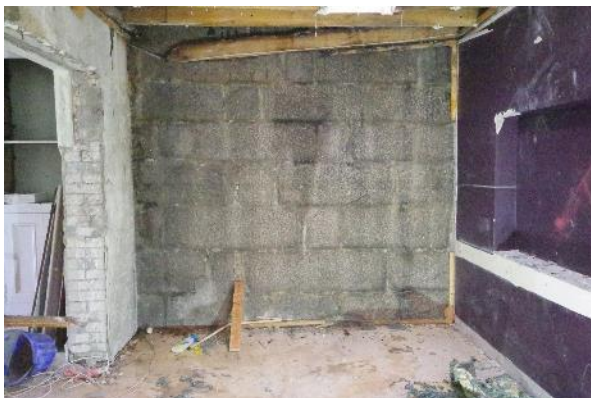
Fig 183 F19 during watching brief, south west wall with 20th century covering removed showing exterior ashlar granite wall of the market house.

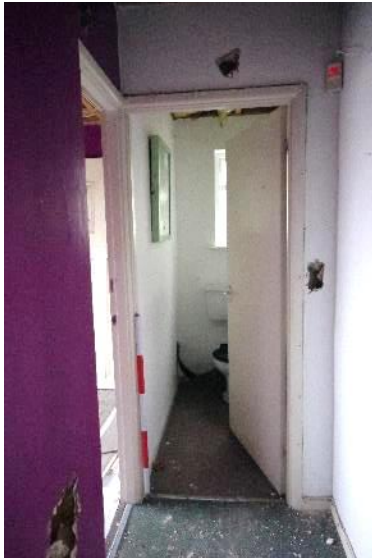
Fig 184 F20 looking through to F23.

The suspended ceiling has fibreboard covering. The 1970s roof structure above is gabled and is constructed from simple collar trusses, nailed together.

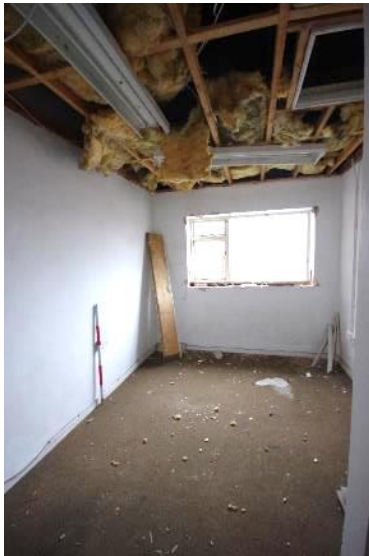
Fig 185 F21 south west wall.

This extension was demolished, but during that process, the walls were stripped revealing the phase 1 granite wall of the Market House to the south east. In this wall there was an original phase 1 window opening with a granite lintel, jambs and sill, containing a late 19th century fixed six-pane iron window, with timber, bottom opening casement over containing three panes. The demolition also revealed that the 19th century stone sett surface of the courtyard survived below the 1970s extension.

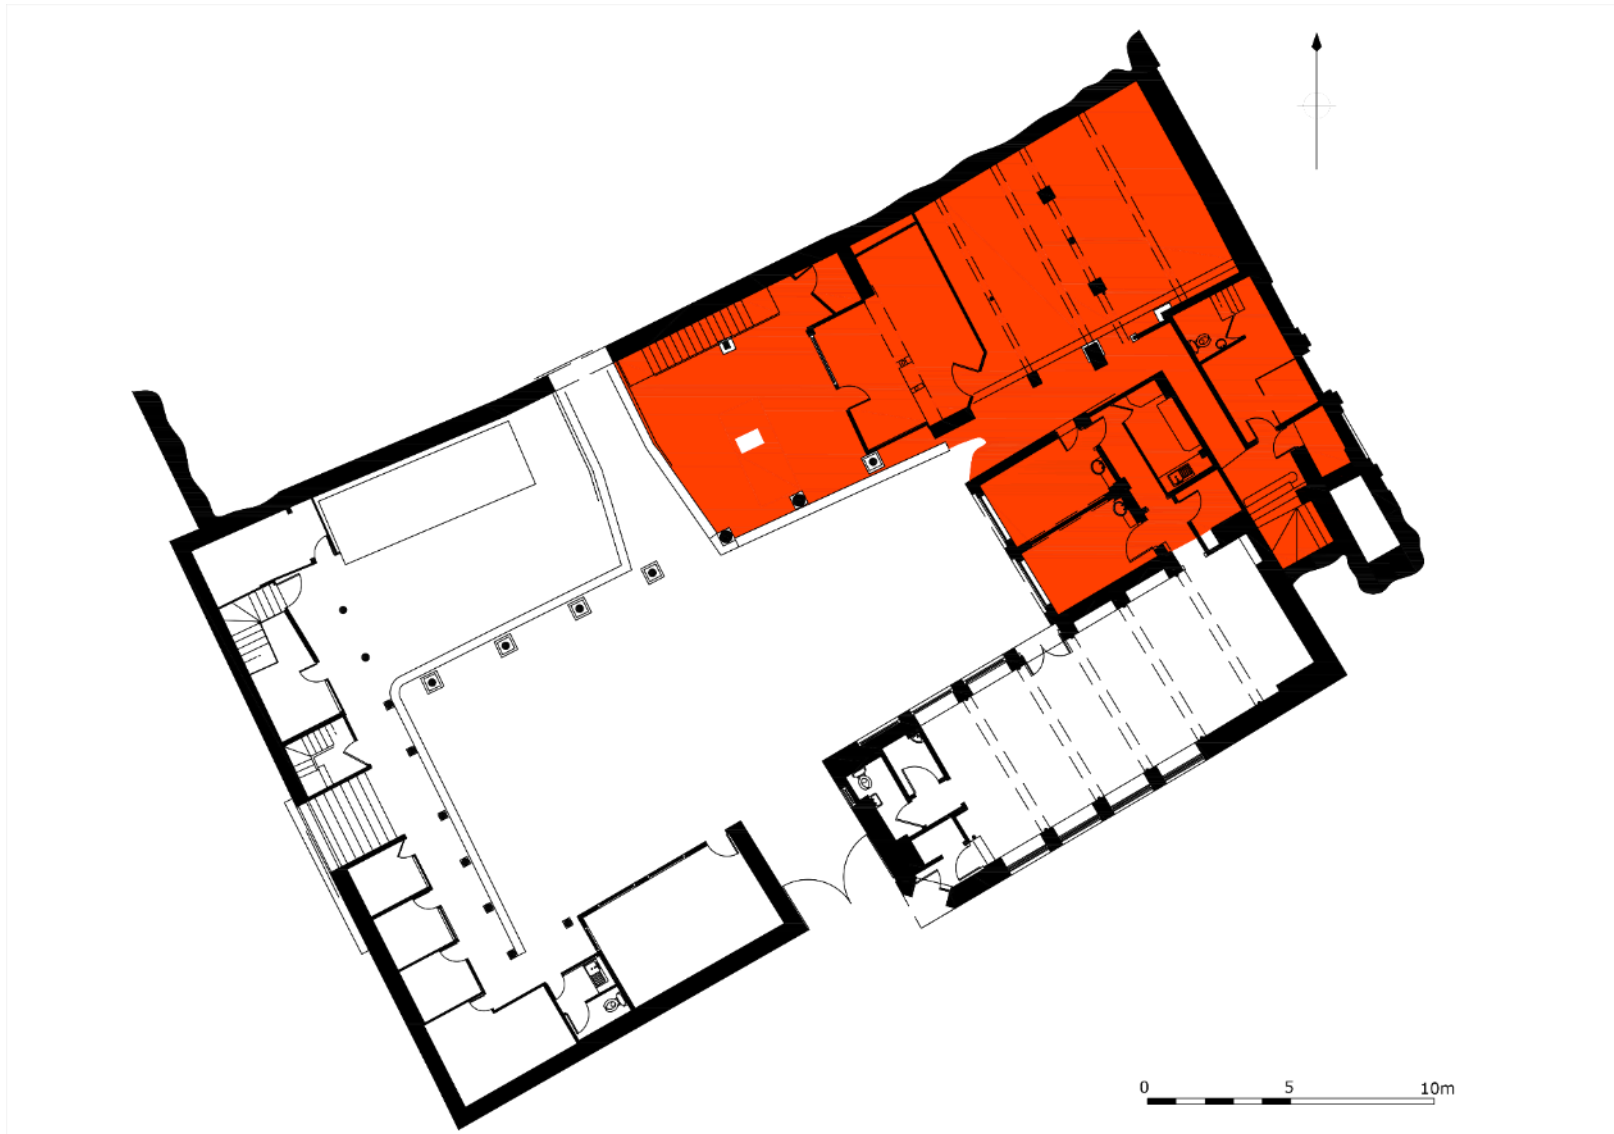
Fig 186 Extent of 19th century stone sett surface uncovered during watching brief.

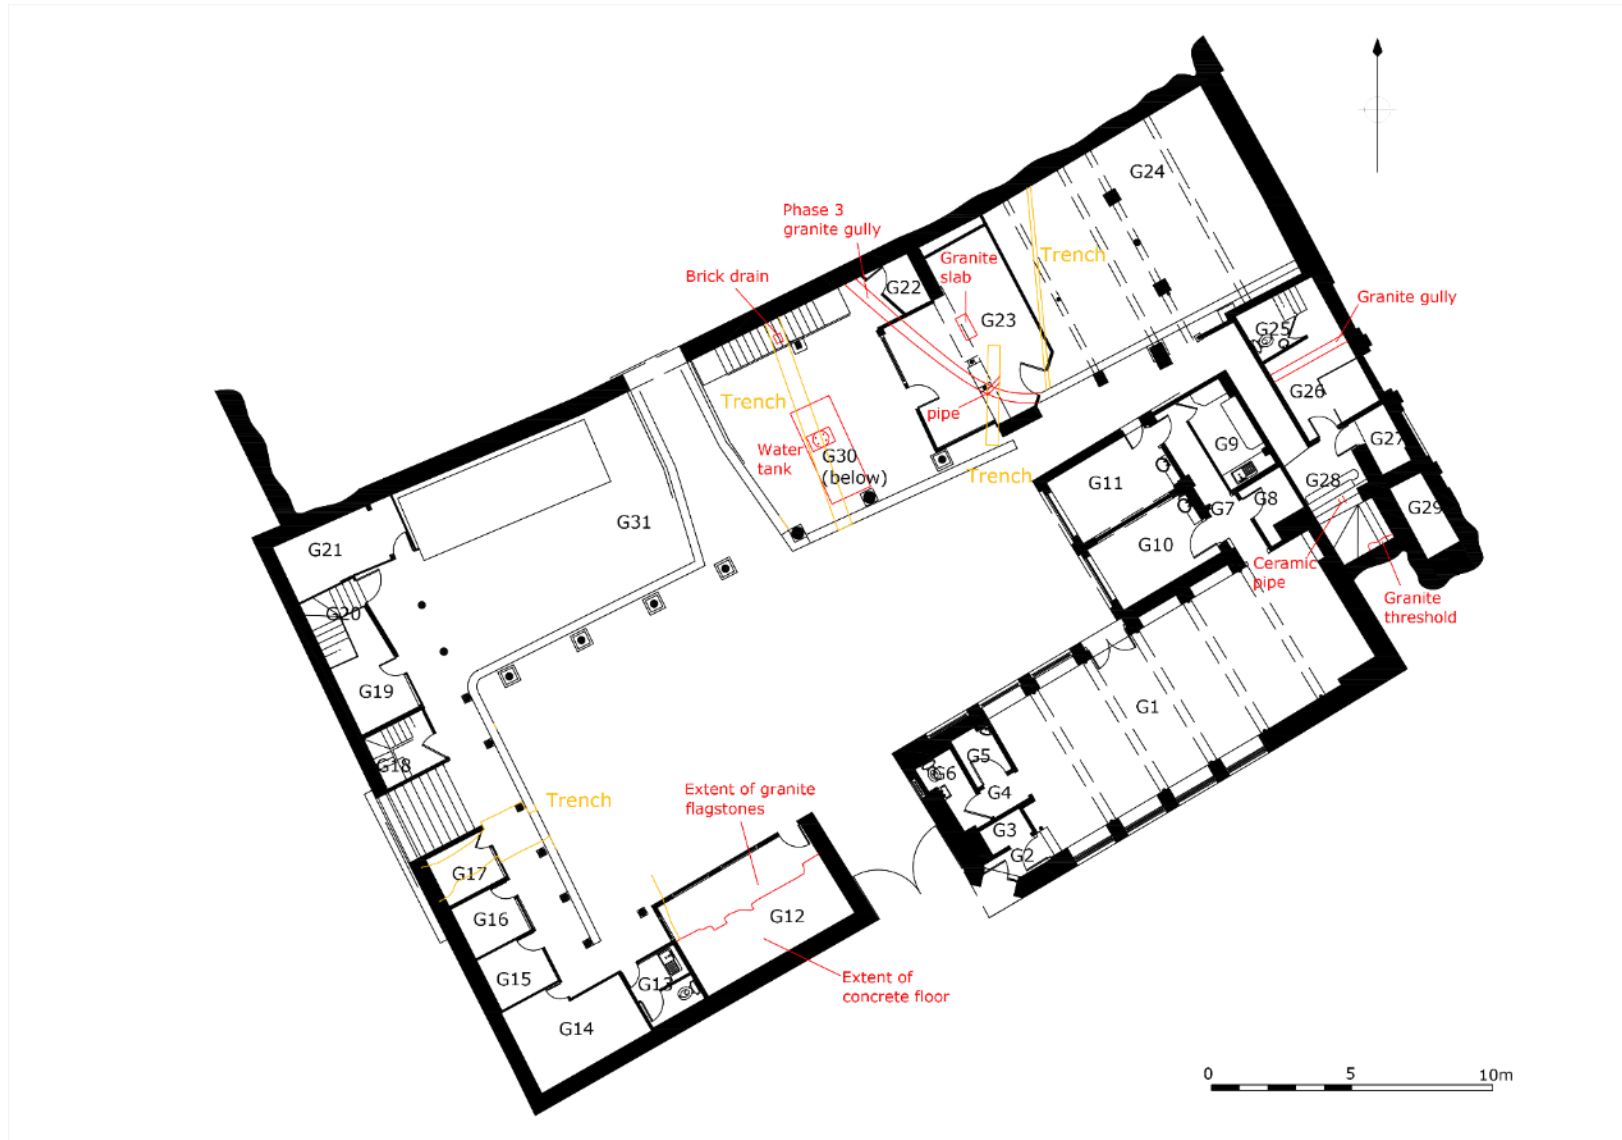
Fig 187 Location of trenches and features seen during the below-ground watching brief.

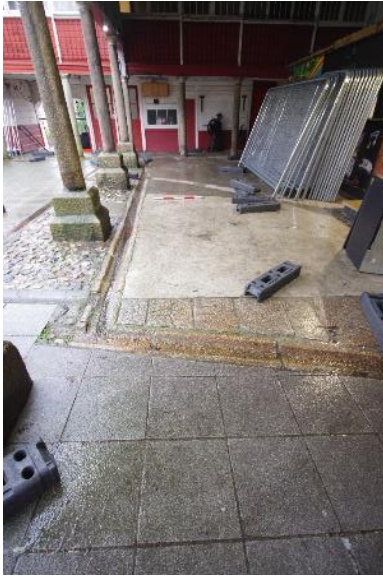
Fig 188 F17 Surface of covered market looking south west.

Joining the north west side of the courtyard, the covered market area, built during phase 3 (1870s) is also supported on granite columns of the same design as those in the south west and south east ranges, only these have been placed on two-tiered granite plinths. The plinths clearly date to phase 3 but the columns may be reused from removed phase 1 or 2 buildings. One of these columns with a phase 3 plinth survives below the Mining Exchange extension and another below the Mining Exchange, along with two other plinths with their columns removed and replaced with brick pillars.

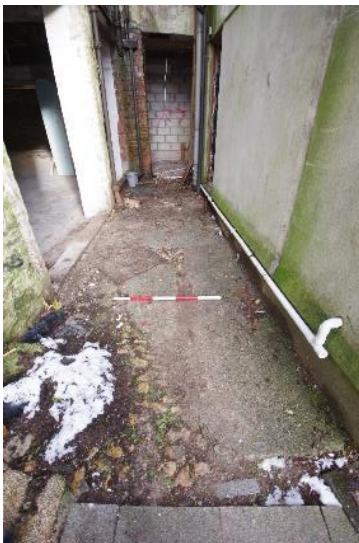
Fig 190 19th century stone sett surface between the Mining Exchange and Wheal Peevor purser's office looking north east.

In the passage between Wheal Peevor purser's office and the Mining Exchange, the 19th century stone sett surface survived with later patch repairs in concrete and inserted manhole covers. Where the passage extended below Wheal Peevor purser's office giving access to the granite steps up to Alma Place, the original granite stone sett surface of the courtyard survived.

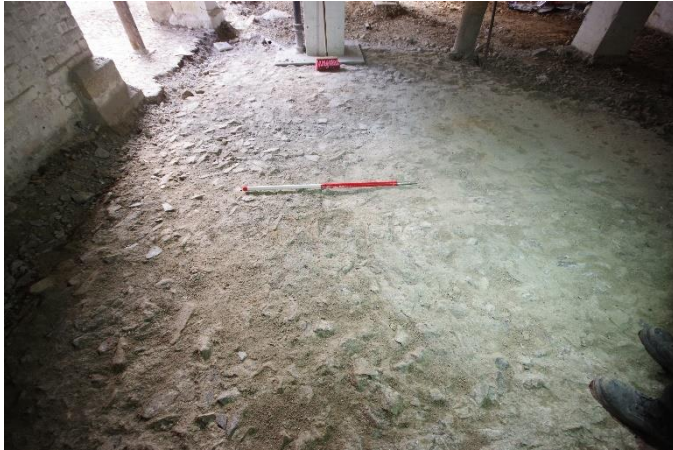
Fig 194 19th century stone sett surface below Mining Exchange.

During the watching brief on the below floor works. The extent of the 19th century surface of granite setts was recorded before its removal (see Fig 194). During excavation of the floor a large rectangular granite block was recorded, set in the floor at the south west end of the room. A fragment of the capital from the reused granite column in the centre of the room was recovered from within the cobbled surface. The concrete surface was 0.1m deep and immediately overlay the surface of granite setts which was 0.1m deep. The setts were bedded into a layer of stony hardcore 0.2m deep which in turn was laid on a layer of mid brownish orange compact silty clay. Several trenches for new services were excavated across the room.
