ATS Building, Liskeard, Cornwall
Historic building record

Report No: 2025R031

Historic building record

Client	Cormac Solutions Ltd
Report Number	2025R031
Date	January 2026
Status	Final
Report author	Antony Angove
Checked by	Jo Sturgess
Project number	147358
Data location	\\CAU\Archive\Sites\L\Liskeard, ATS Building 147358
OASIS online reference	cornwall2-539755
ADS reference number	20040292
Planning reference	PA24/06555

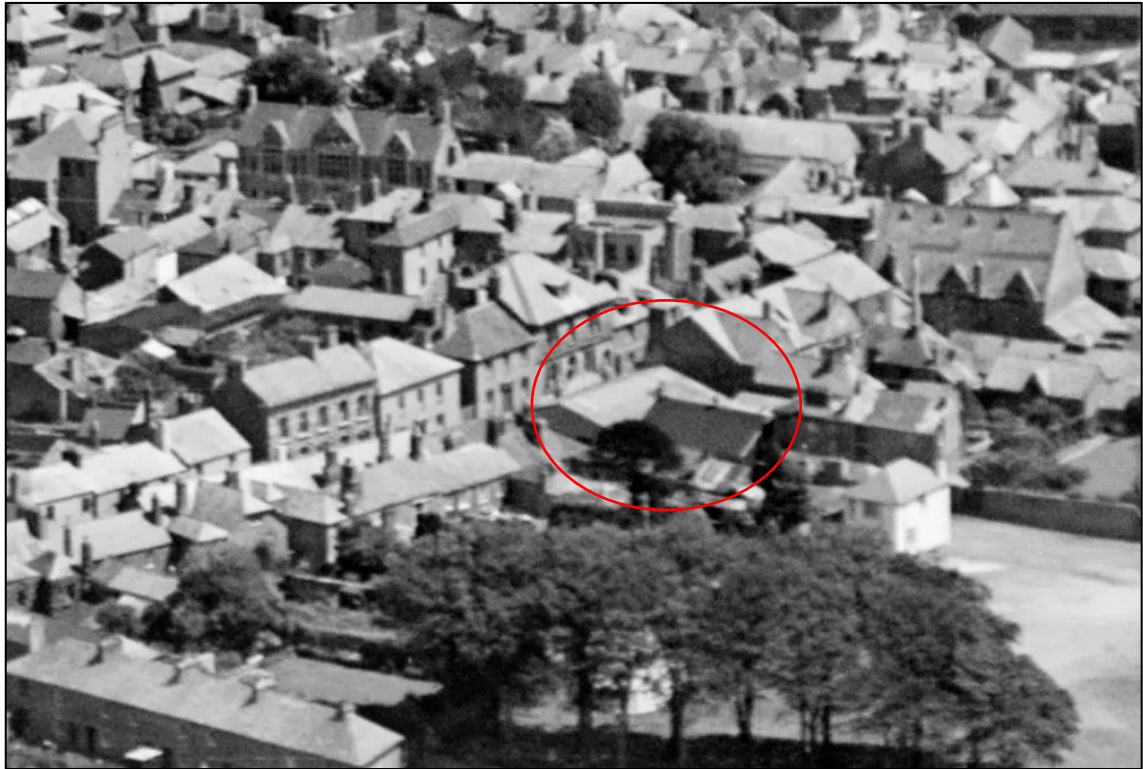
Fig 8 Aerial photograph, taken July 1930 © Historic England.

An oblique aerial photograph taken in July 1930 (Fig 8) shows the garage, with its west gable end and roof ridge running eastwards to meet the earlier surviving gable wall adjoining Rosedean House.

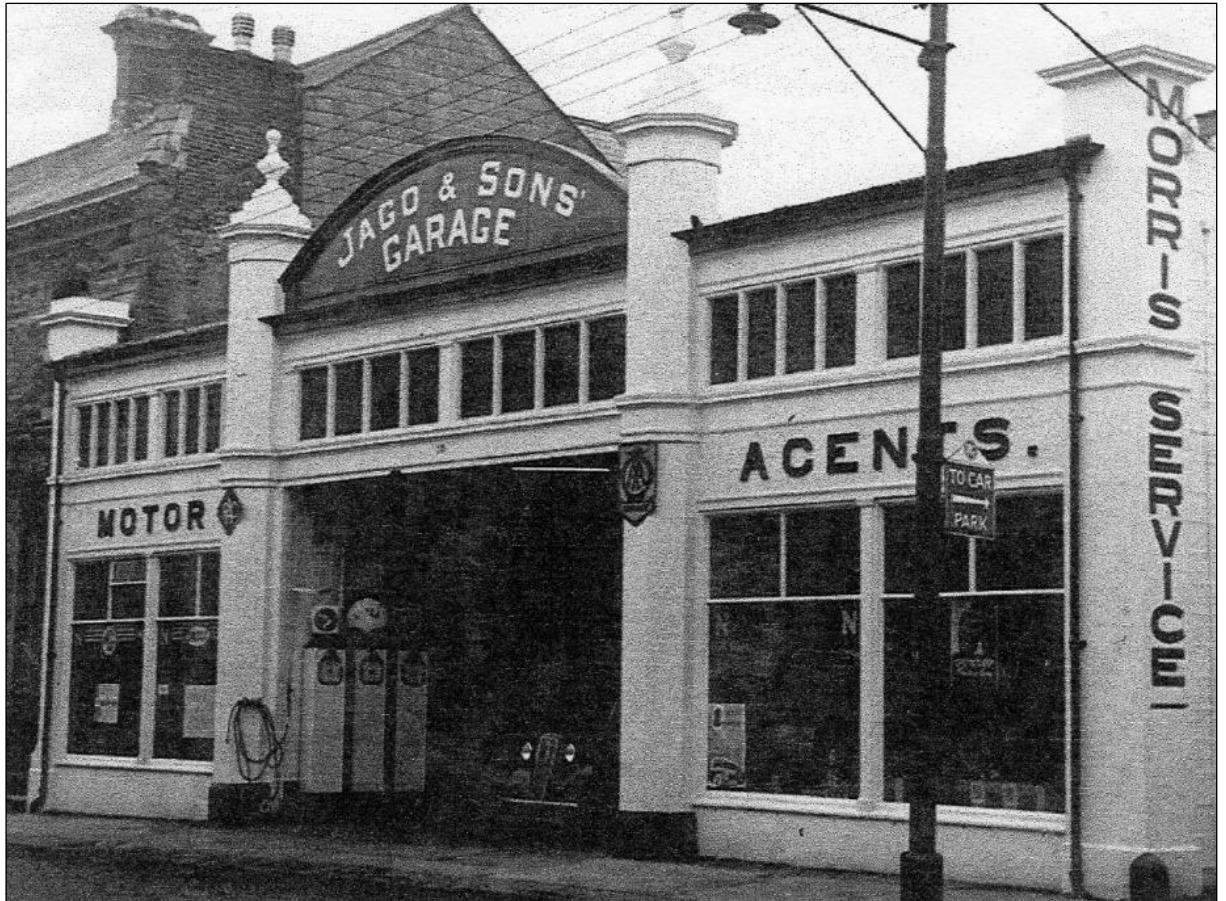
Fig 10 The former Jago's Garage, Dean Street, probably in the 1940-50s.
Photograph courtesy Liskeard Old Cornwall Society.

Another photograph dating from the late 1940s to early 1950s also shows the building with a sign for 'Jago and Sons Garage' over the main entrance (Fig 10). By this time, the brick piers and finials on the frontage of the building had been painted white, whereas previously they are shown in Figure 9 as unpainted brickwork.

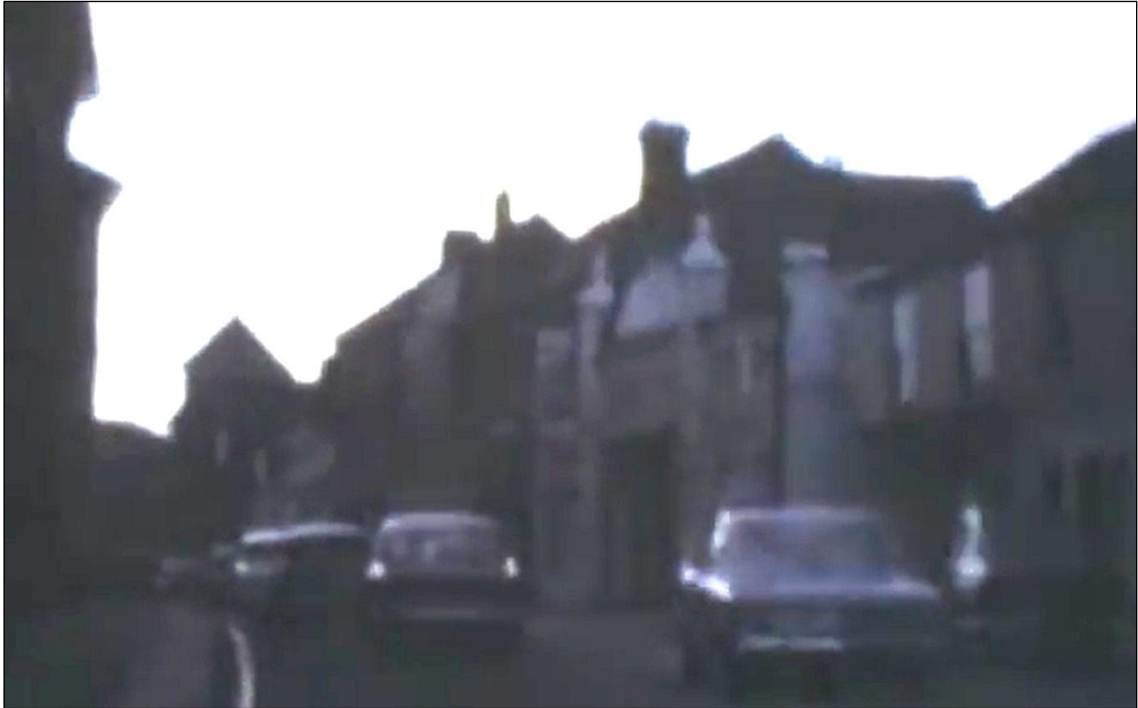
Fig 12 Dean Street, looking east towards the garage, c1971. Screenshot of video courtesy of Geoff Clayden.

The building appears in a video taken in 1971 (Fig 12), which shows the Jago's signage on the pediment at the front of the building and the original façade still intact.

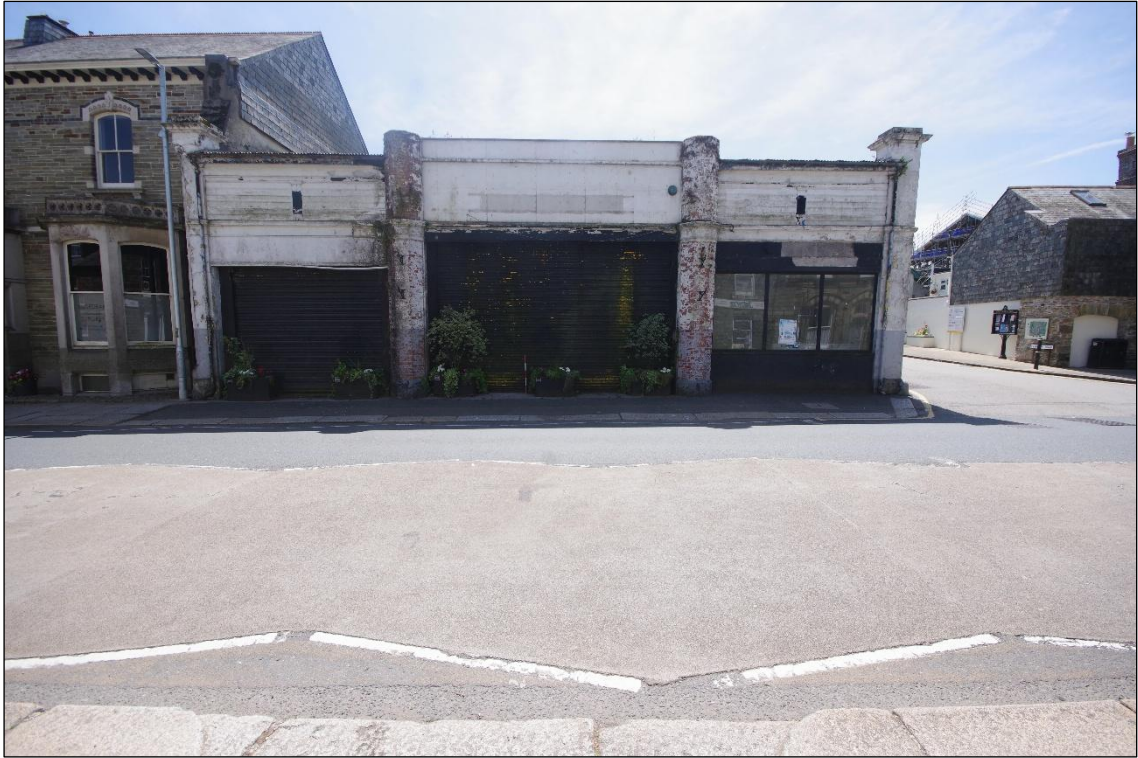
Fig 16 External north elevation of the garage.

The north (front) elevation retains some of its 1920s fabric and design, although much was removed and significantly altered in the late 20th and early 21st century. The original frontage is shown intact in a mid-20th century photograph (Fig 10). The elevation has three bays with the central bay containing an original vehicle entrance which now contains a modern roller-pulley garage door. There is a smaller, inserted modern garage door opening with pulley door located in the eastern bay. In the western bay, a modern replacement three-pane window lights the former customer service area.

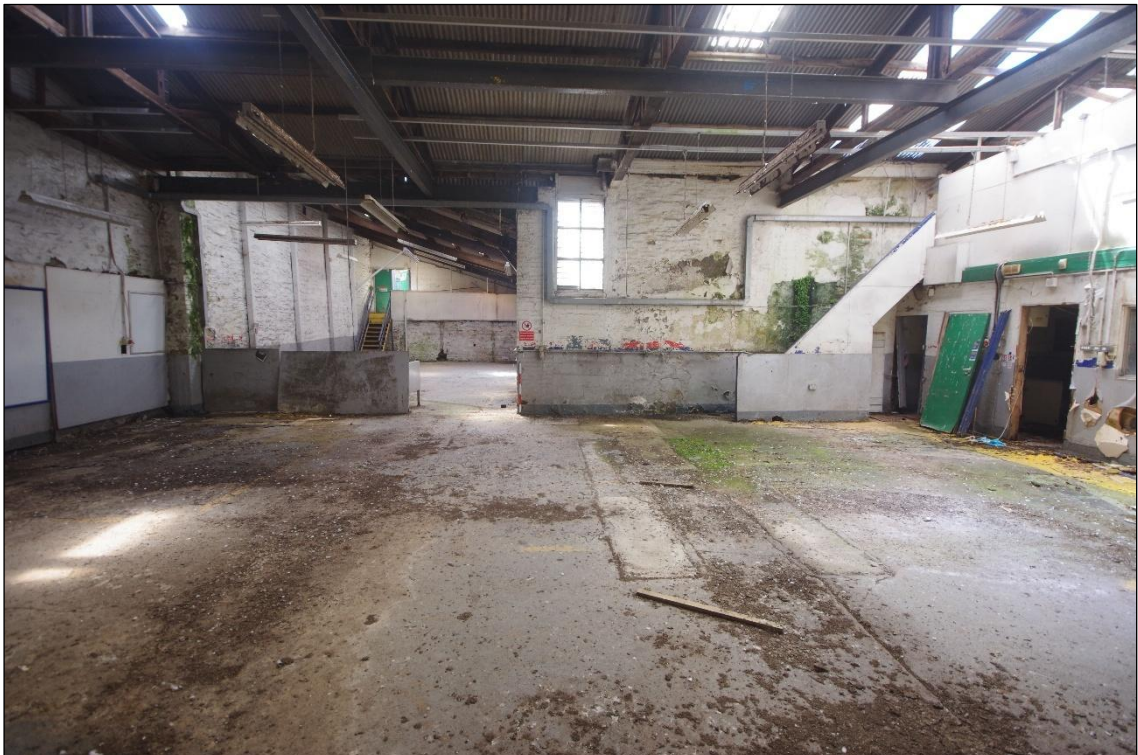
Fig 23 Interior south wall of the northern part of Room 1 (Garage).

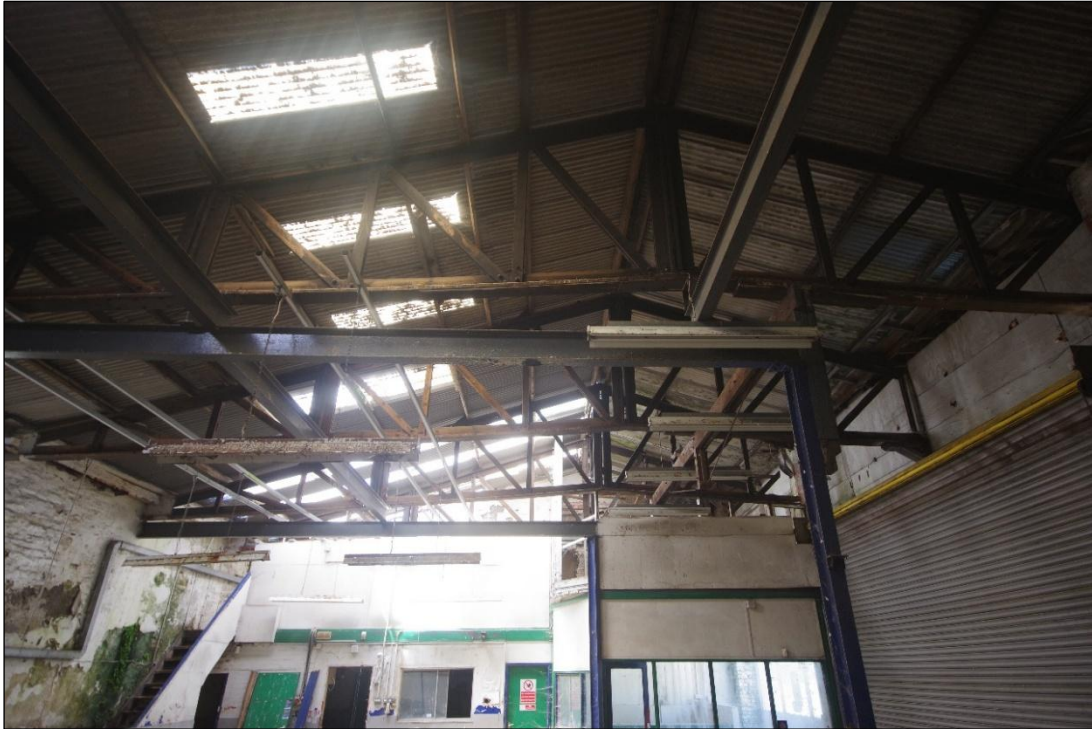
Fig 30 Roof structure at north end of room 1 (garage) looking west.

The original 1920s (phase 2) pitched garage roof structure survives in the northern half of the building. It is aligned east-west with a wider slope to the south and comprises 1920s steel roof trusses with rivetted joints. Several additional steel girders have been inserted, probably during the building's use by ATS Euromaster during phase 5, coinciding with the installation of strip lighting suspended from the roof structure. The roof covering is corrugated cement with corrugated skylights along the southern pitch (probably a replacement of a similar 1920s roof covering).

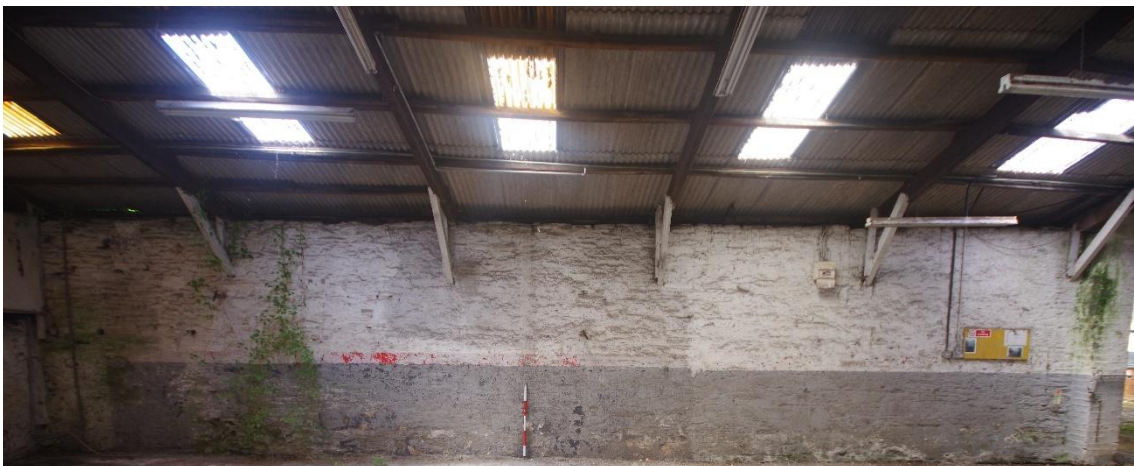
Fig 31 Roof structure in the south extension of room 1 (garage) looking west.

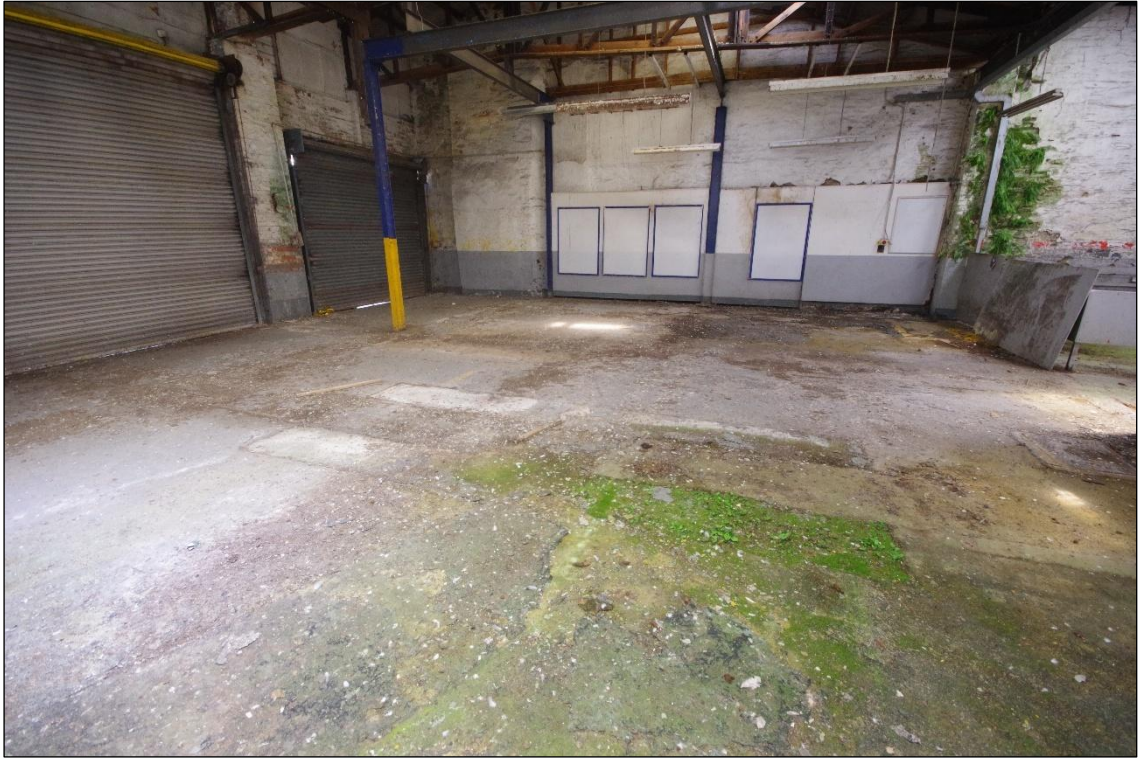
Fig 33 Floor surface at north end of room 1 (garage).

The floor surface is concrete in both the original phase 2 northern end of the room and in the phase 5 southern extension. It displays extensive wear marks and scarring consistent with the movement and operation of equipment during the building's use as a garage.

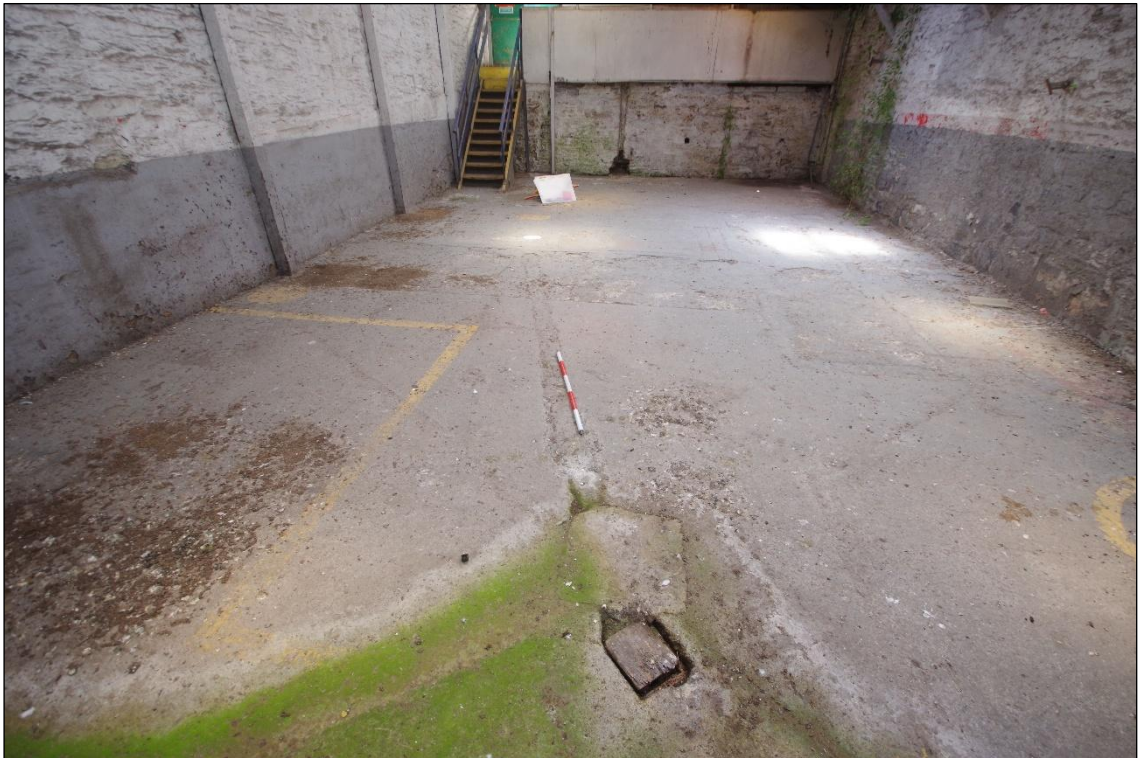
Fig 34 Floor surface in the south extension of room 1 (garage).
