# Twelveheads Bridge, Bissoe, Cornwall

## Archaeological watching brief

<b>Client</b>	<b>Highways, Cornwall Council</b>
<b>Report Number</b>	<b>2009R059</b>
<b>Date</b>	<b>August 2009</b>
<b>Status</b>	<b>Final</b>
<b>Report author(s)</b>	<b>Nigel Thomas</b>
<b>Checked by</b>	<b>Peter Rose</b>
<b>Approved by</b>

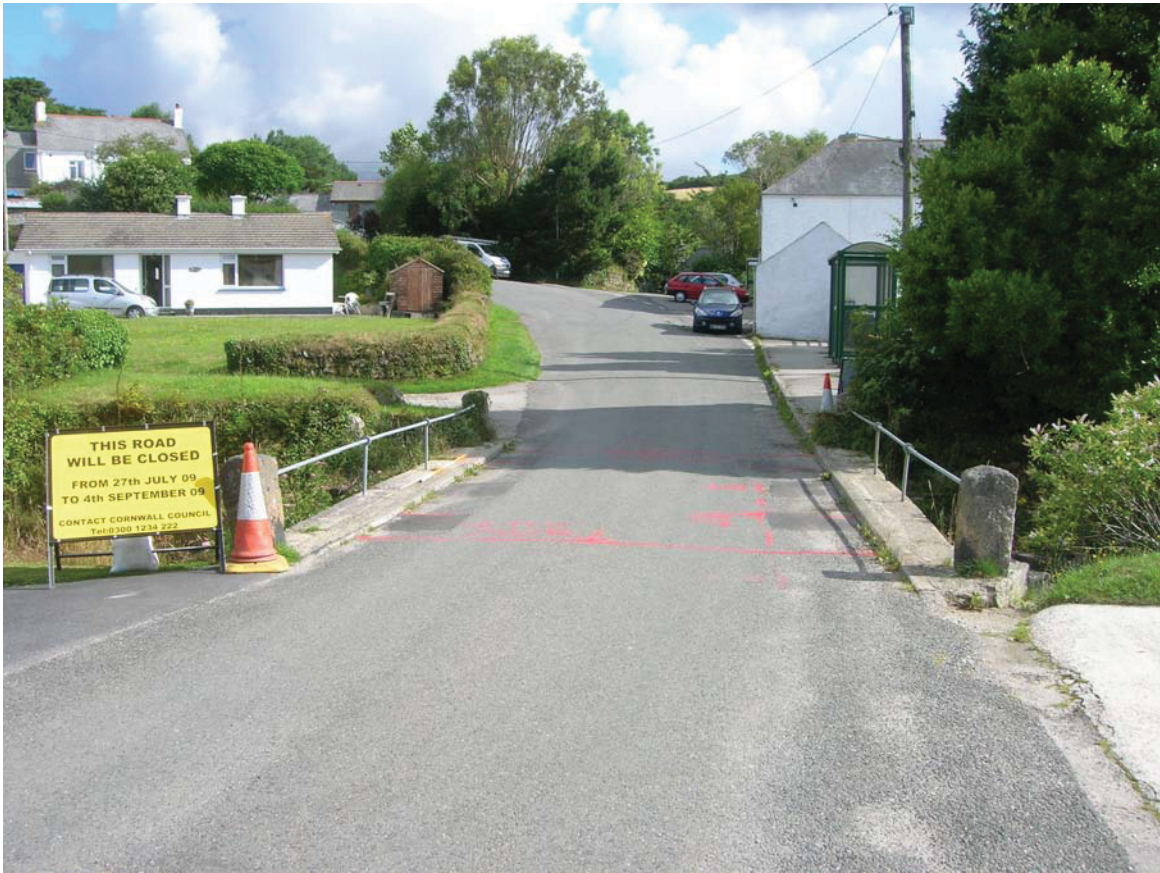
Fig 6 View of the bridge looking north

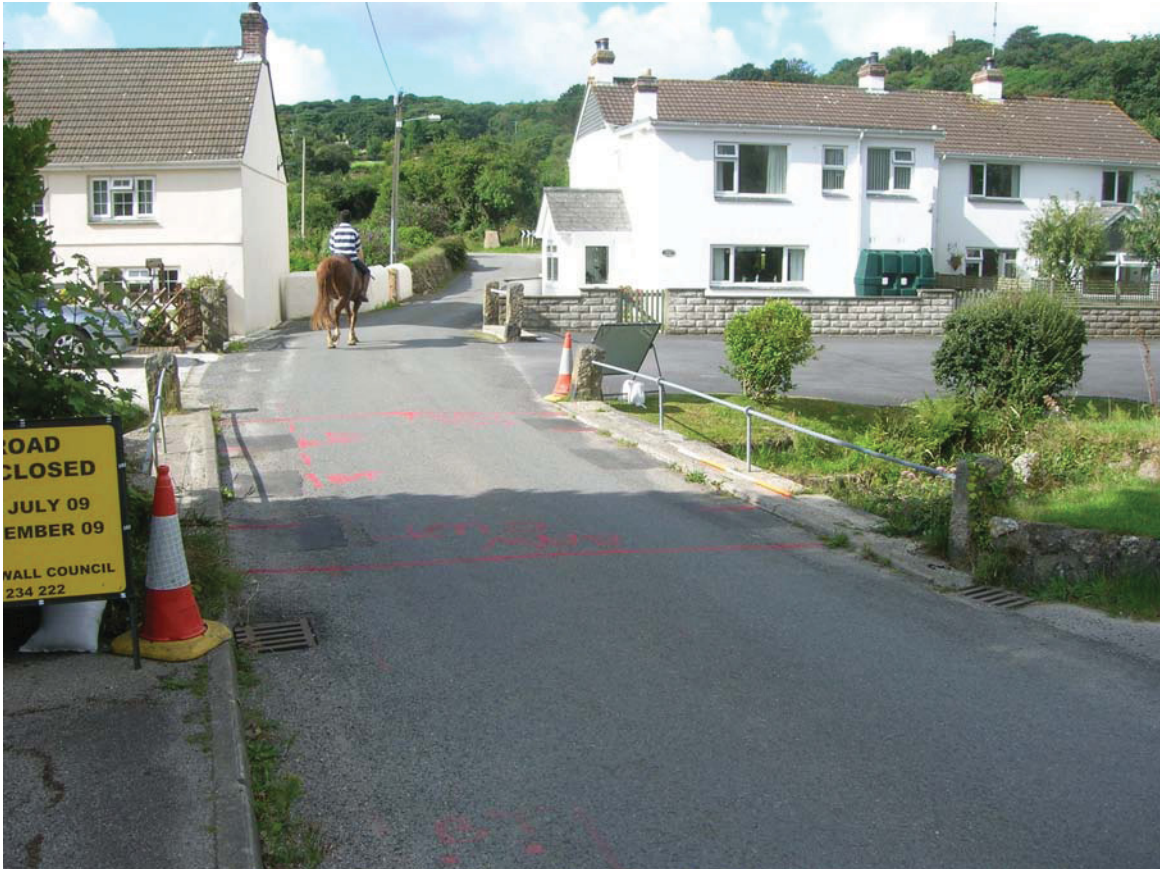
Fig 7 View of the bridge looking south

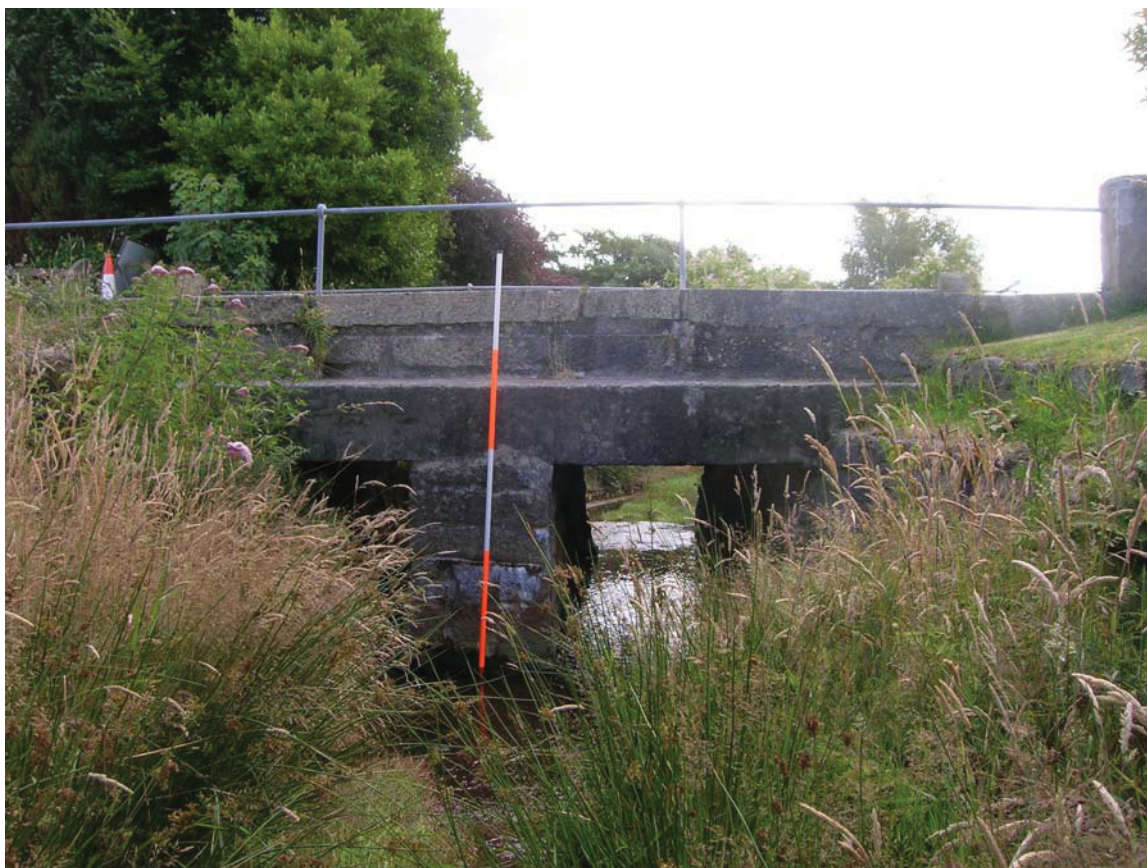
*Fig 8 Upstream elevation*

The upstream bridge facing was found to have a complete line of dressed granite kerbstones set at a lower level than the present ones. All of the facing on this side, as on the downstream side, had been bonded with cement-based mortar and so had been rebuilt at the time of the 1980s renovation. It is not known whether the apparently older set of kerbstones are original to the bridge or not, or whether some material had been reused from elsewhere.

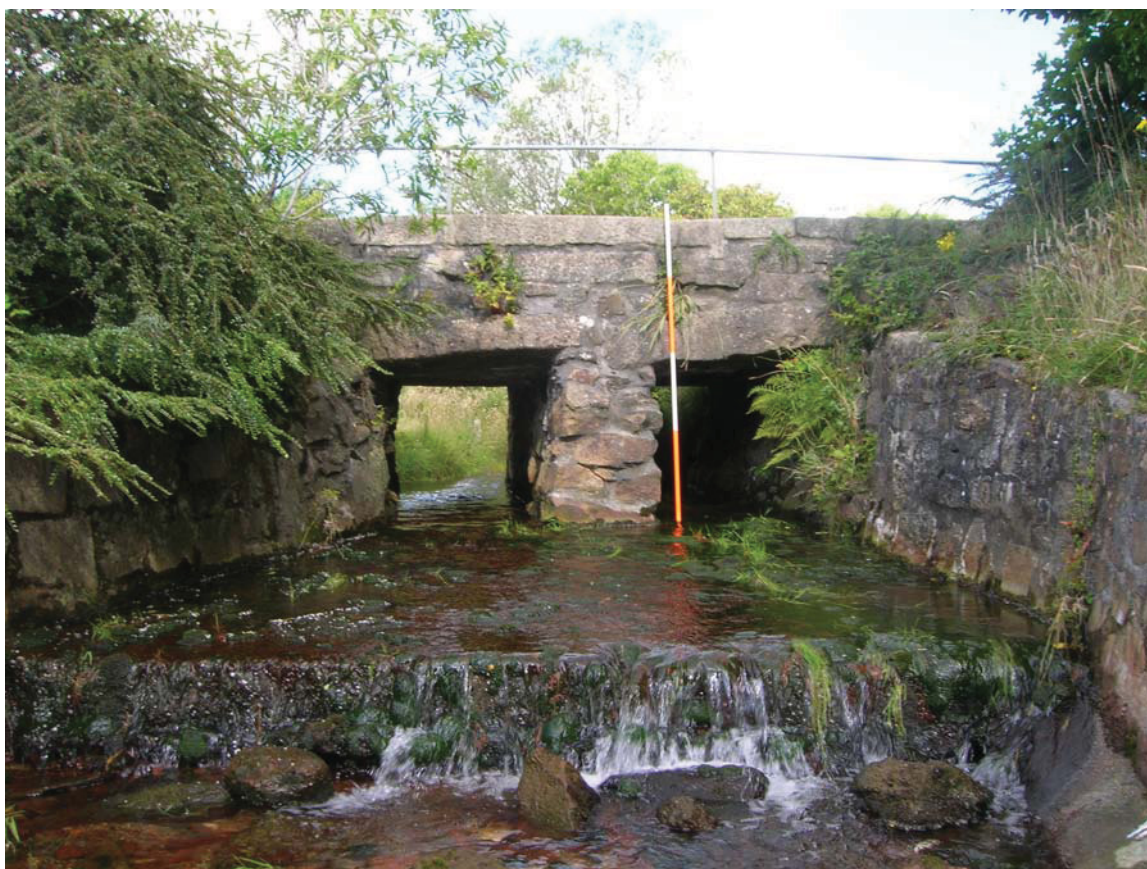
*Fig 9 Downstream elevation*

The bridge has no parapets but instead has roughly squared granite pillars at the ends, now linked by modern galvanised railings. Beneath the railings are neatly squared granite kerbs. Both the railings and kerbs appear to have been rebuilt during the 1980s works. On the downstream side kerbstones near the northern side had been replaced with shorter granite pieces. The dressing on these stones does not match the originals.

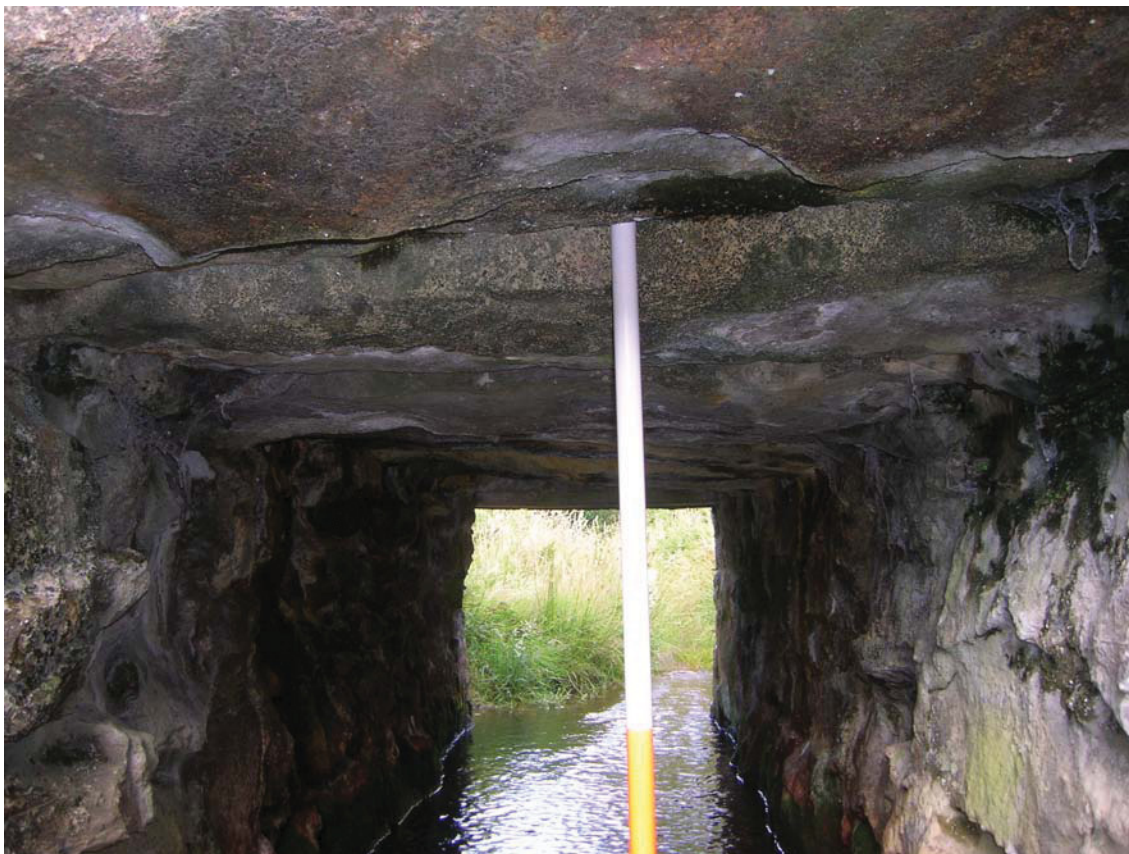
All except one of the granite lintels appear to have been undisturbed from the time the bridge was built. The exception was one on the southern span, which overlapped the south abutment and appeared to be too narrow to make a good fit with the other lintels. Other stone (a mixture of granite and slate) was packed in to fill any holes. Above this was a thick layer of roughly compacted orange-brown to grey coarse hardcore. This material was mine waste. There was no trace of any other earlier surfacing such as cobbles.

*Fig 10 Southern span*

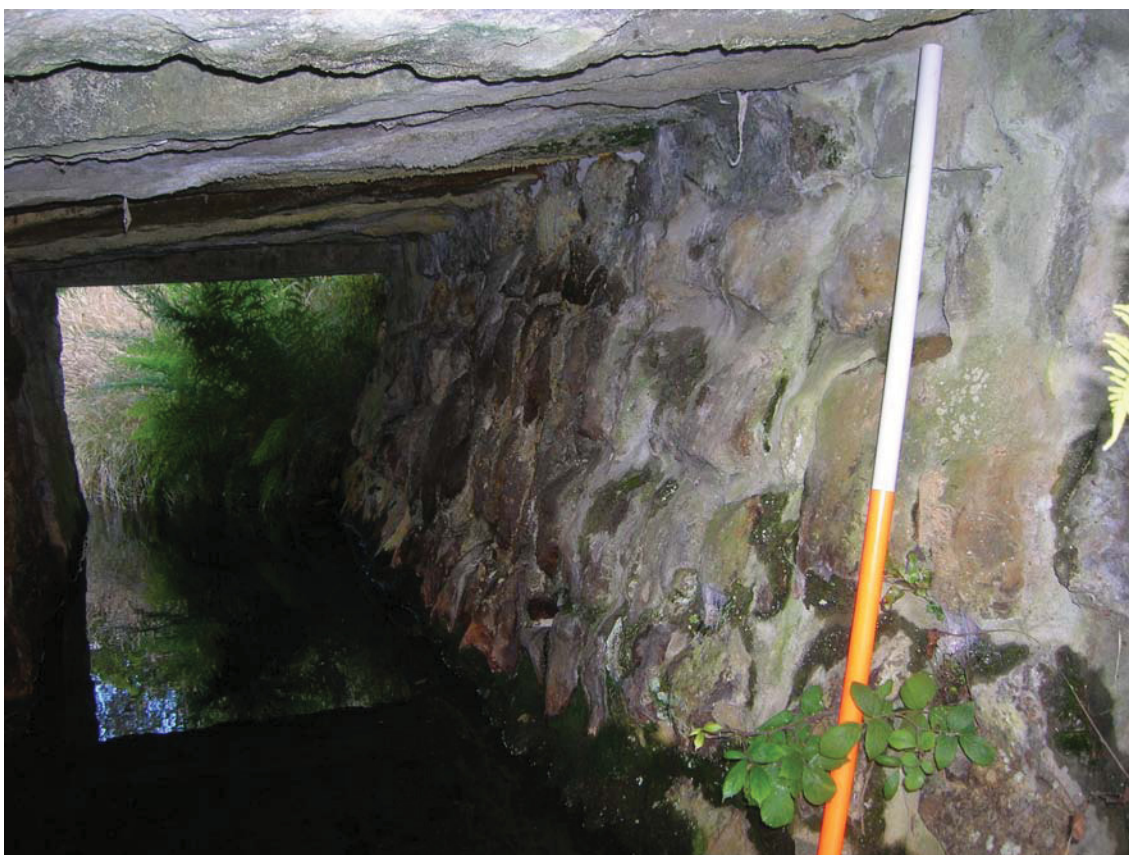
The northern bridge abutment is built of upright granite stones set in a battered wall face. All of this, like the rest of the masonry, has been re-pointed with cement-based mortar.

As the majority of the lintels have not been disturbed, it seems that the battered wall face which forms the northern abutment is probably an original feature and not a replacement or rebuild.

*Fig 11 Northern span, showing the battered abutment face*

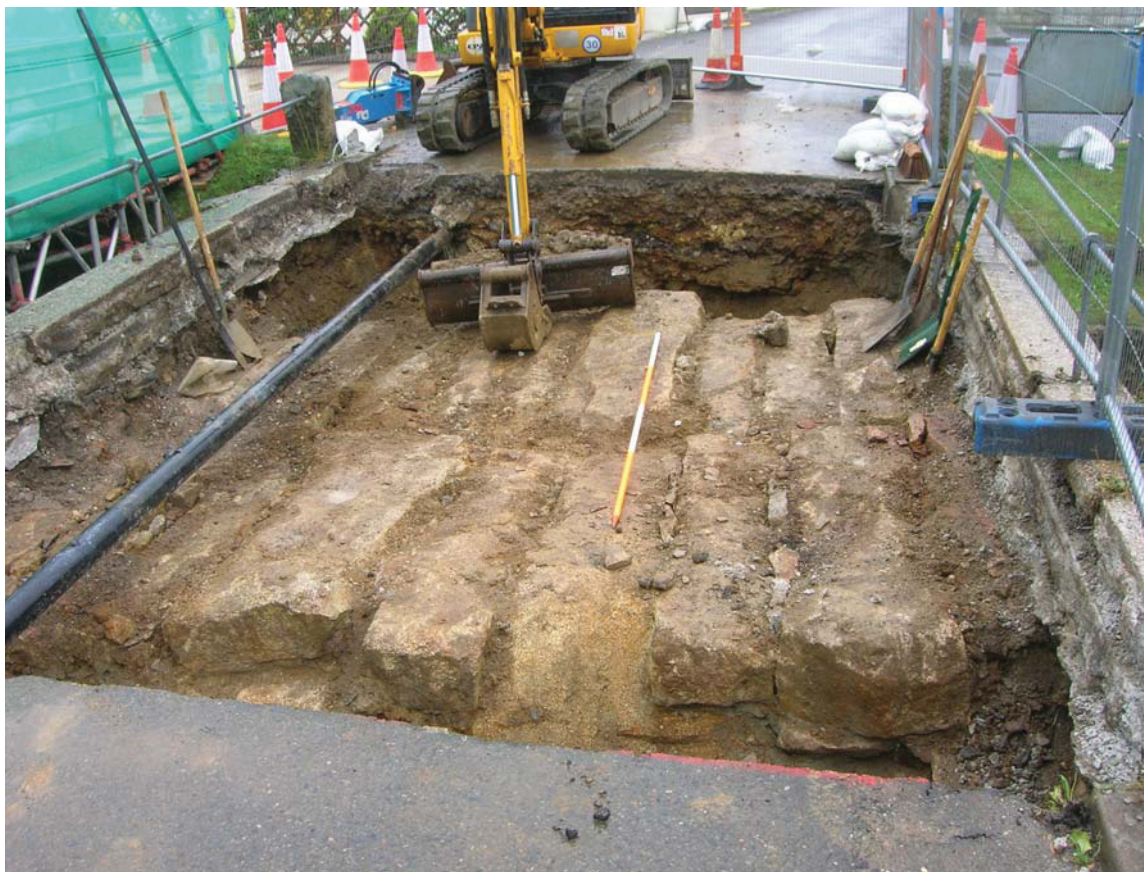
An archaeological watching brief was undertaken when the blacktop surfacing and underlying depth of hardcore had been taken off and the bridge deck exposed by the contractors. A measured survey of the bridge deck was undertaken and the granite lintels recorded.

Fig 12 Overall view of bridge (from north) with roadway fill removed

The strengthening programme entailed removal of the existing surface and fill, and installation of an *in situ* reinforced concrete slab, and then reinstatement of the road level and surfacing. The new slab extends over the existing granite lintels and over the abutments, and will have the effect of spreading any traffic load weight over the whole structure. There will be no visual loss of historic components as the granite beams will remain visible from underneath. As the bridge facings are already modern, the historic material left in the bridge can only be seen from beneath, and comprise its abutments, pier and the granite lintels.

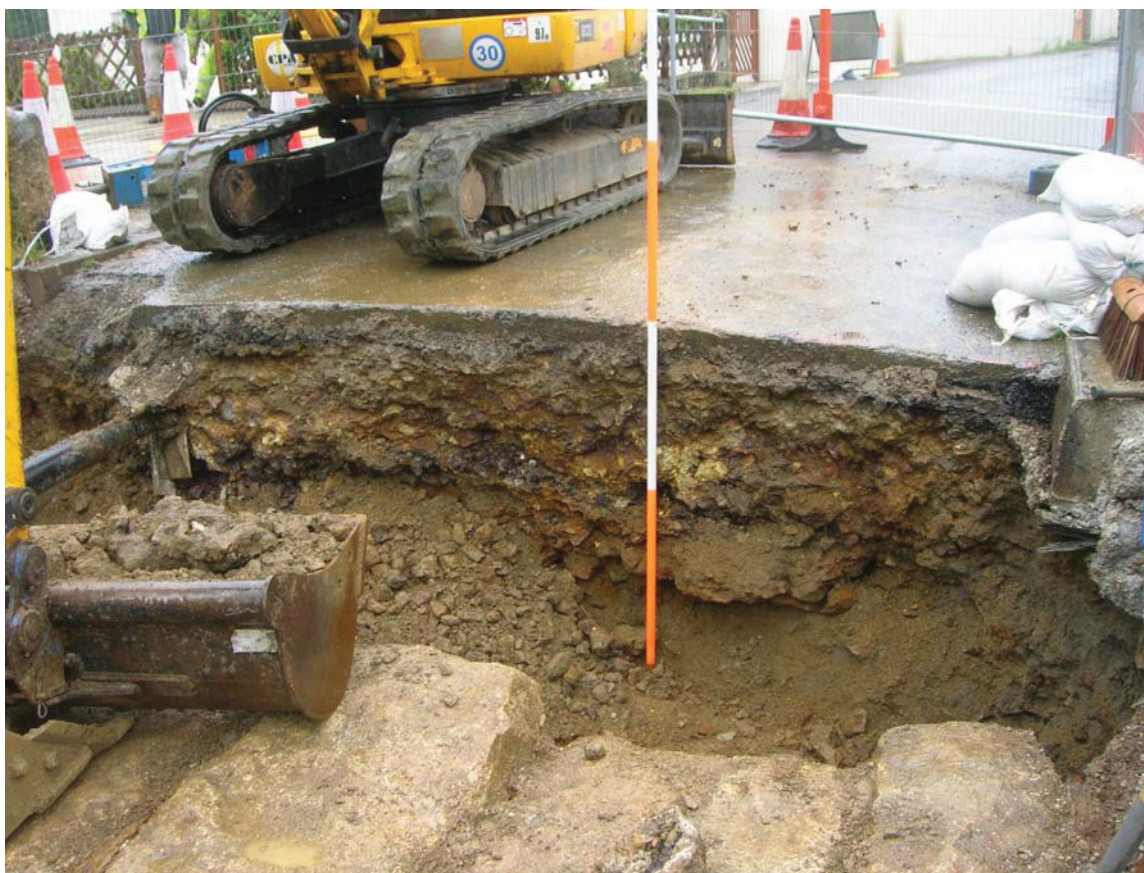
Fig 13 Roadway built up with mine waste

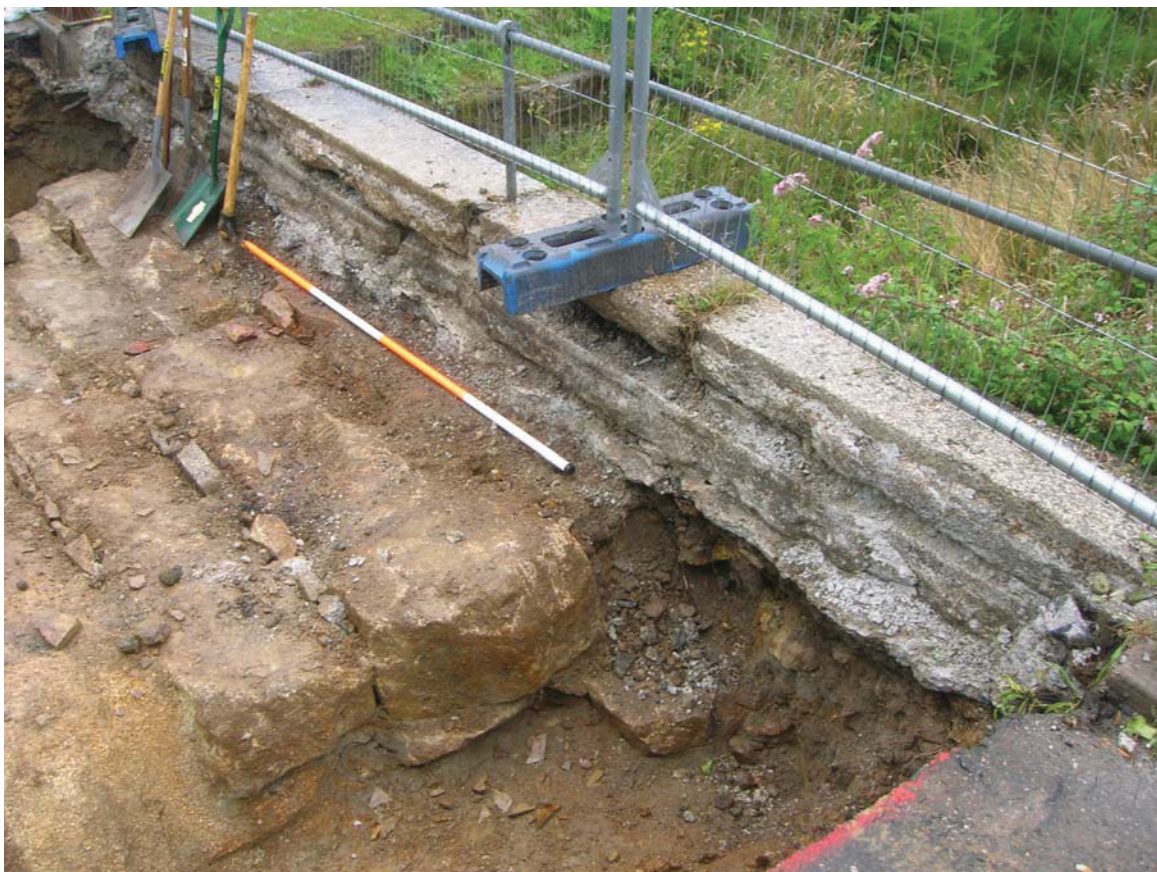
Fig 14 Rebuilt upstream side of the bridge showing 2 levels of kerbstones

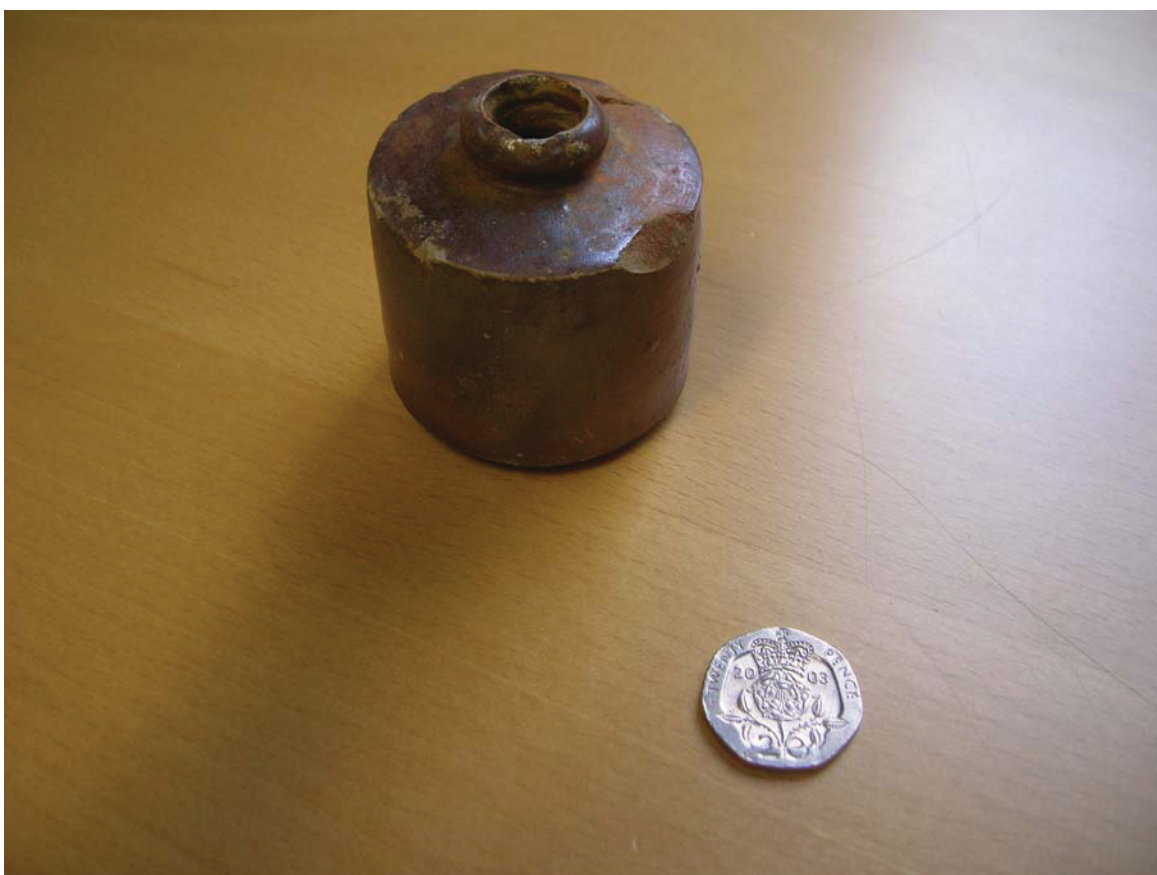
A small brown-glazed stoneware ink bottle was recovered from the fill material by the contractors. This was found on top of the lintels, suggesting it was deposited on the bridge deck during construction. The bottle is a common type which would have been in common use in the mid to late 19<sup>th</sup> century (date range c1840-1880).

Fig 15 Stoneware ink bottle (mid-late 19<sup>th</sup> century)
