West Portholland 'Fish sheds', Veryan, Cornwall

Archaeological building recording and watching brief

Client	Mrs FE Williams
Report Number	2009R024
Date	March 2009
Status	Draft
Report author(s)	Jo Sturgess
Checked by	Nigel Thomas
Approved by	Peter Rose

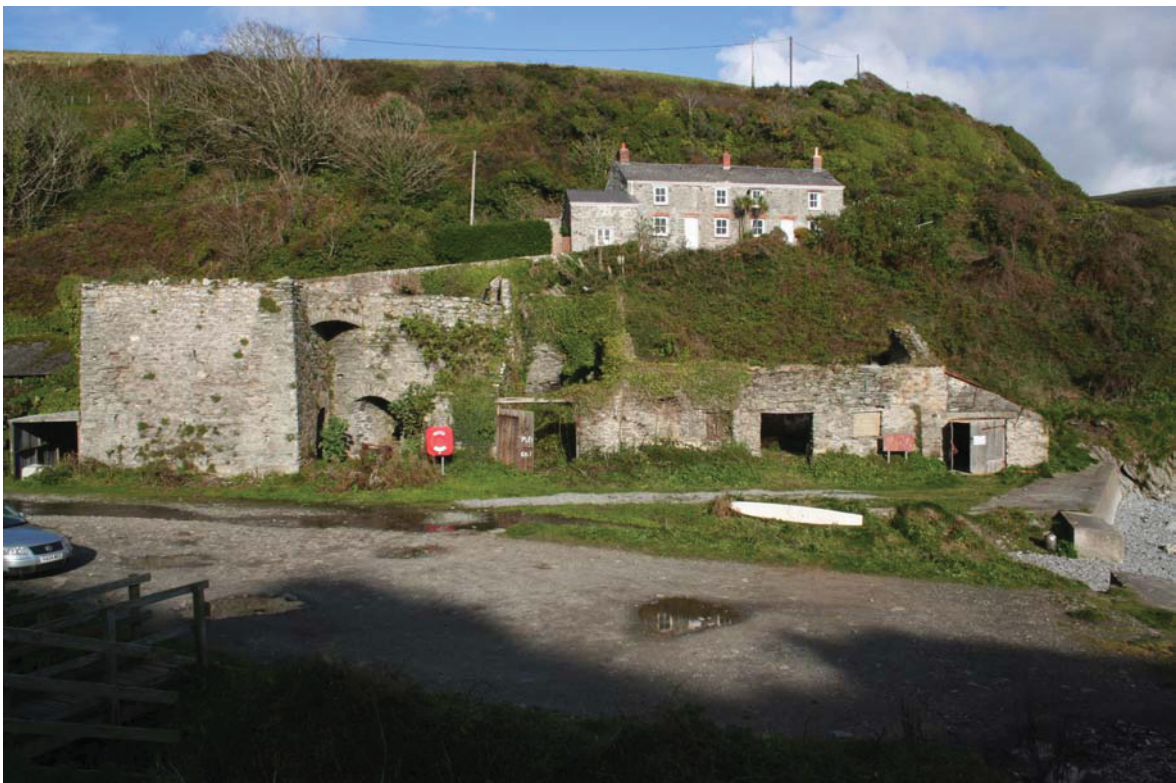
Cover illustration

View of the 'Fish sheds' looking north, taken in November 2008 before the re-development of the buildings.

(See Figs 11 and cover)

This lime kiln clearly abuts and post-dates lime kiln 5 but appears to have been built before 1840 (see Tithe map Fig 4). Stylistically it is similar to lime kiln 5; square in plan, constructed from uncoursed killas rubble, bonded by lime mortar and similar draw arches. The kiln has been inserted into the western half of the former fish cellar and incorporates the back (northern) wall of this building. It also incorporates an earlier low section of walling at its south-east corner. It has two eyes, one on the east elevation opening into Building 2 and the other on the south elevation. A description of the east elevation is given in section 4.2.4 west wall of Building 2. The eye on the south elevation is set centrally at the back of its draw arch unlike that on the east elevation where the eye is set back towards the south. The location of the pot is not shown on any of the historic maps.

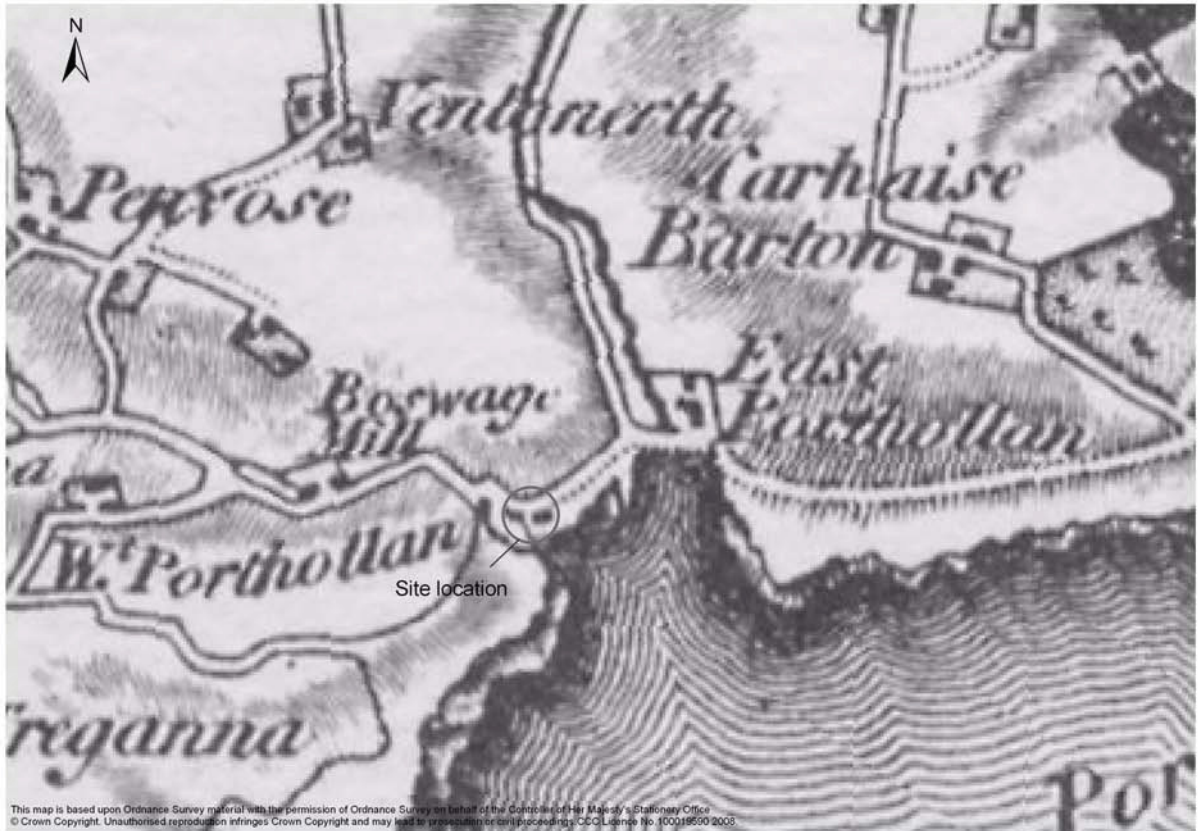
Fig 3 c1809 OS Surveyors' Drawings (not to scale but originally surveyed at 2" to the mile)

The first available map to show West Portholland is the OS Surveyors Drawings of 1809 (Fig 3). Although this is a small scale map it does show that there were buildings here at this date. The Tithe map of 1840 (Fig 4) shows the house (Building 1) the fish cellar already converted for use associated with limeburning (Building 2) and both lime kilns (Buildings 5 and 6). It also shows a building immediately to the east of the lime kilns that no longer exists. The accompanying Apportionment lists the owner of Building 1 as John Trevanion and the occupier as Stephen Dastow; the building is described as a 'house'. Although the lime kilns are shown on the map they are not listed on the Apportionment.
