St Mary's Church, Sheviock, Cornwall

Archaeological Watching Brief

Client	Sheviock Parochial Council
Report Number	2010R090
Date	March 2010
Status	Draft/2nd draft/ Final
Report author(s)	S R Taylor
Checked by	A Jones
Approved by	P Rose

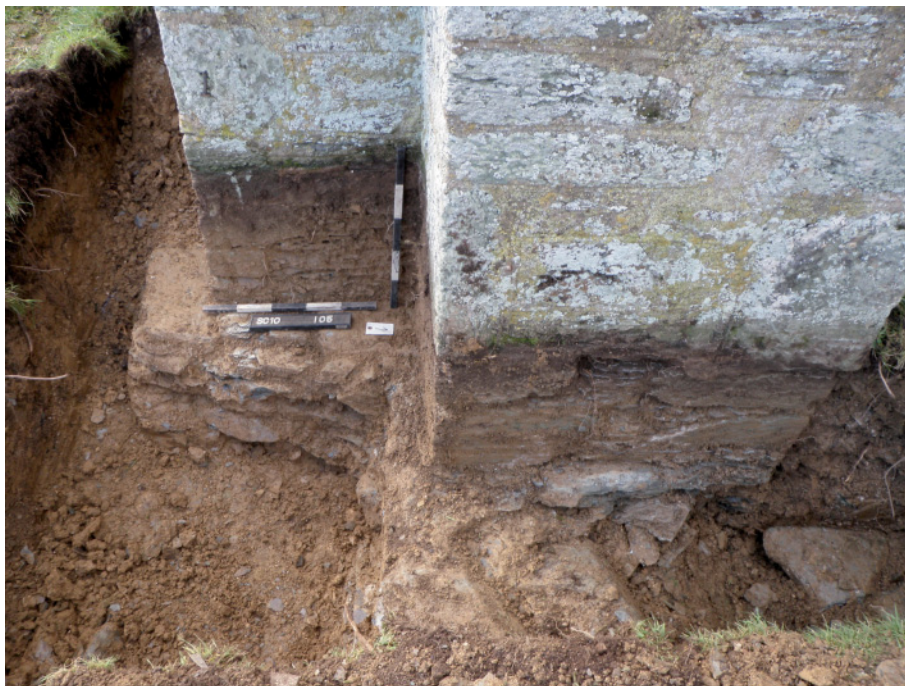
Foundations 105 and 115 (Fig 3)

It became quickly apparent that the trench could not be excavated against the wall of the church because the building had been constructed upon a substantial foundation of slate rubble. This material projected out from the base of the building, 0.1m from the walls and up to 0.3m around the buttresses of the south transept. The foundations were not fully excavated but were at least 0.3m deep. Similar foundation levels have been observed at the base of other Cornish churches, for instance Mullion (Thorpe 2003) and St Winnow (Mossop 2004). The foundations of the transept, 105, could be seen to be added to the foundations of the nave, 115, at the junction connecting the two in the area between the transept and the porch. It could thus be demonstrated that the transept post-dated the nave, even if only by a short span of time.

Fig 3 South east buttress of transept showing foundation layer 105

The foundation layers of the south transept and the nave showed that, although the two sections may have been broadly contemporary, the transept was built onto the nave. Perhaps contemporary with this early fourteenth century construction is the slate drain that runs along the southern side of the nave beneath the later porch.

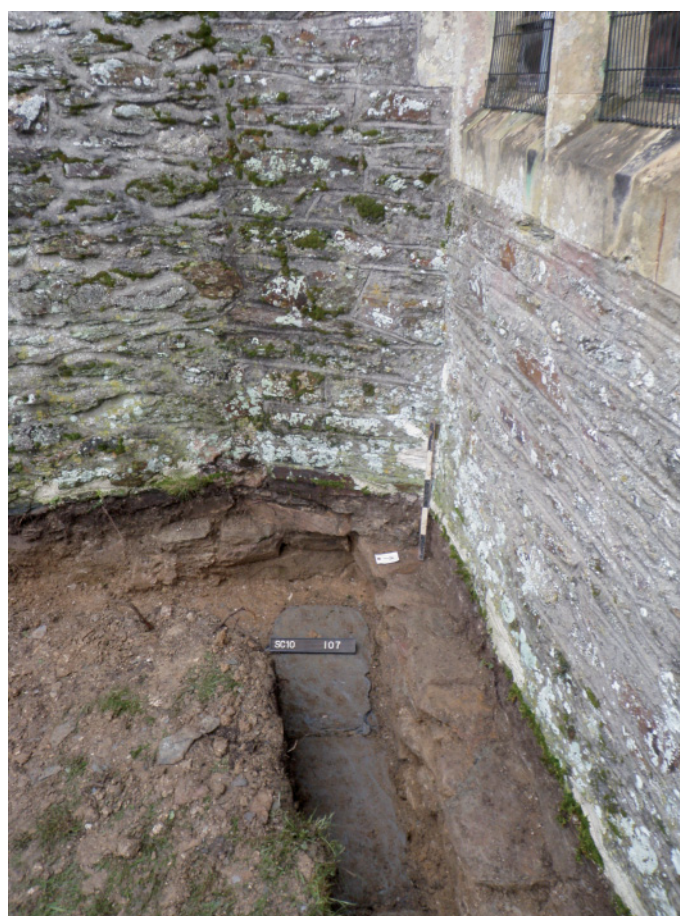
Culvert 107 (Figs 4 and 5)

A stone-lined culvert, 107, was recorded in the corner between the eastern end of the nave and the south transept. It was constructed of slate rubble on a slate base with slate capping. It was 0.35m wide and 0.24m deep in total. It led away from the corner towards the south-east,

with a total length of 2.1m visible in the trench. The inside of the culvert contained a dark silty fill rich in mortar fragments and the shells of land snails.

The interface between the transept and the nave had been filled by coursed stone rubble, 111. It was unclear whether this concealed an earlier downpipe that had fed the culvert or whether the walling had been added after the decommissioning of the drain following the installation of cast iron guttering in 1902.

Fig 4 Culvert 107 in front of wall section 111

Another slate drain or culvert, 107, running from the intersection of the transept and the nave, may date to the middle nineteenth century period of extensive repairs inspired by G E Street. This corner has been blocked up by later masonry in what may be an attempt to divert rainwater away from this area. The subsequent installation of guttering in 1902, as part of a major programme of works including the restoration of the spire, may have been a further attempt to prevent damp in this part of the church. The guttering is inscribed with the date and the initials of the rector, Gerald Pole Carew (Cusworth 2009, 404).

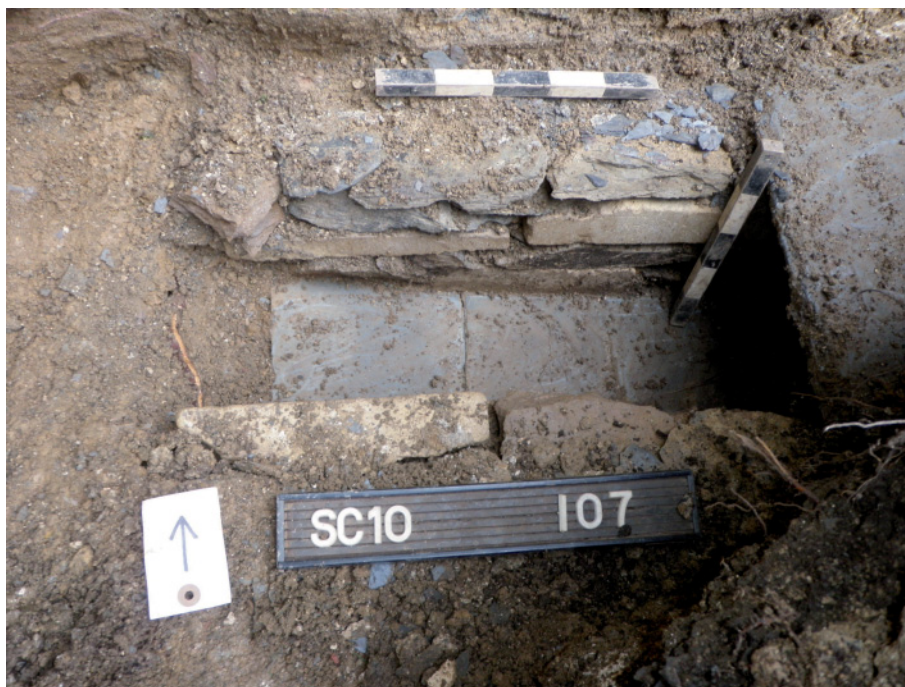
Fig 5 Culvert 107

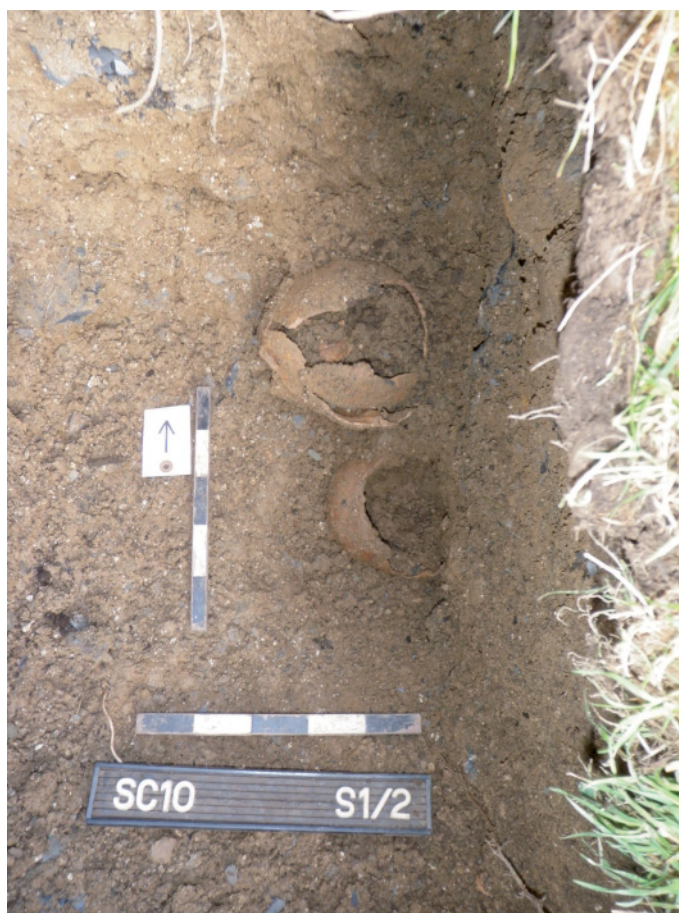
Human remains (Fig 6)

In the course of the excavation of the trench a large number of human bones were revealed. At the eastern edge of the south transept, to the north of the corner buttress, two craniums, S1 and S2, were uncovered at a depth of 0.5m. The craniums were missing their jawbones and no related remains were found. Although the remains must have been located within a cut feature, for instance a pit, no such cut was observed. Alternatively, they may have been within a layer of dumped redeposited material acting as a make-up layer. This seems unlikely given the presence of an *in situ* burial directly beneath them (see below). Several iron nails, possibly coffin nails, were recovered from the disturbed deposit, (102), that may have filled this putative pit, [103]. Other finds from this deposit included part of an iron window frame fitting of nineteenth century date, an iron rafter spike, a fragment of roofing slate, and a piece of red brick

An attempt was made to rebury the bones in the same area at a greater depth but part of an articulated skeleton, S3, was revealed at 0.7m. Only a small number of vertebrae, some rib bones, and part of a shoulder were uncovered: however, this was enough to verify that the skeleton was articulated and *in situ*. The body was aligned with the head (not uncovered) to the west, feet (not uncovered) to the east in the Christian manner. If the body was that of an average-sized adult the head would have been just in front of the south transept wall.

Fig 6 Skeletons 1 and 2

Since the attempt at reburial had encountered an articulated skeleton a decision was made to re-cover the skeleton and to keep all disarticulated bone in bags to be reburied by an appropriate authority at a later date. Other concentrations of bone were noted in the angle formed by the buttresses at the south-eastern corner of the south transept, where the majority of the remains were long-bones. This might suggest a single depositional event. Other parts of the trench contained seemingly random concentrations of bone, most at a depth of 0.3m to 0.6m, the base of the trench. All were contained within layer (110), beneath disturbed layer (102). This layer also contained ridge tile fragments of early post-medieval date, one of which was decorated with an incised wavy line (see Thorpe below).

A large amount of human bone was recovered from relatively shallow depths. Two craniums were recovered from a single location and a concentration of long-bones was recorded in the area to the south-east of the south-eastern corner of the south transept. The disarticulation of the remains, the shallow depth at which they were buried, and the robustness of the types of bones in question strongly suggests that these remains had originated elsewhere and had been reburied following disturbance, most likely during the excavation of fresh graves.
