# Steval Point Battery, The Garrison St Mary's, Isles of Scilly

## Archaeological Watching Brief

Report No

2010R103

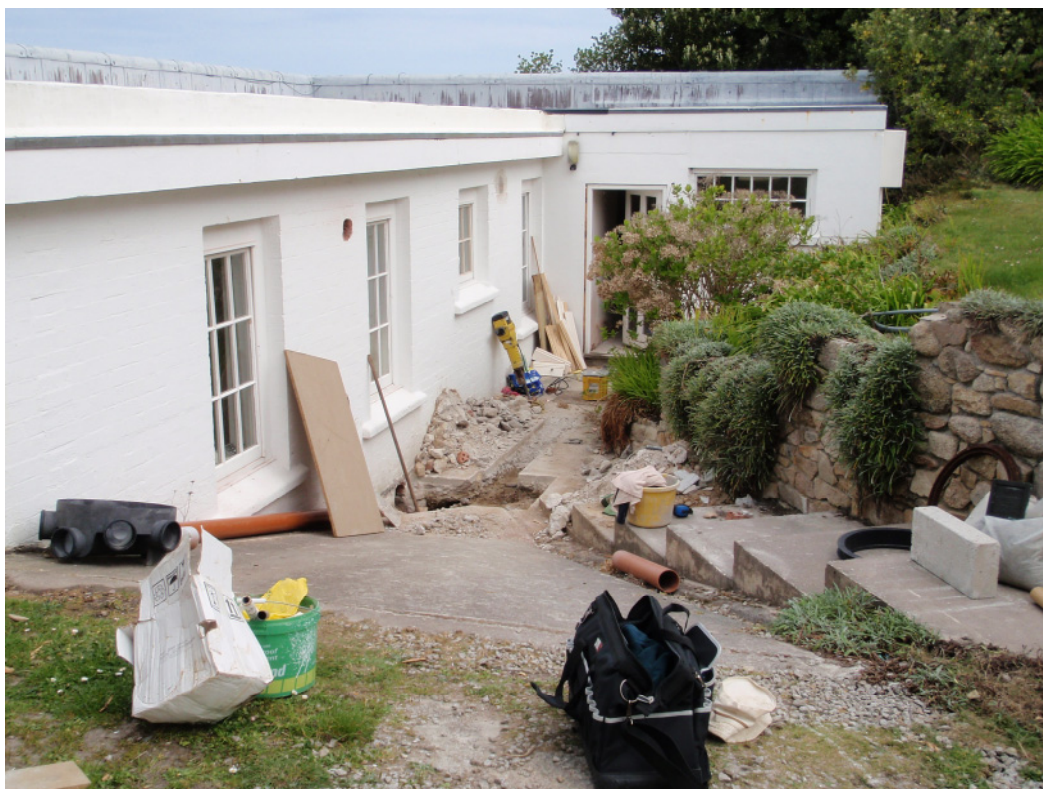
Fig no	Description
Front cover	The rear of the building showing the drain excavation
Fig 1	Location map
Fig 2	Site plan
Fig 3	Detail from the 1907 OS map
Fig 4	Section drawing of drain edge
Fig 5	The excavated drain trench
Fig 6	The iron object

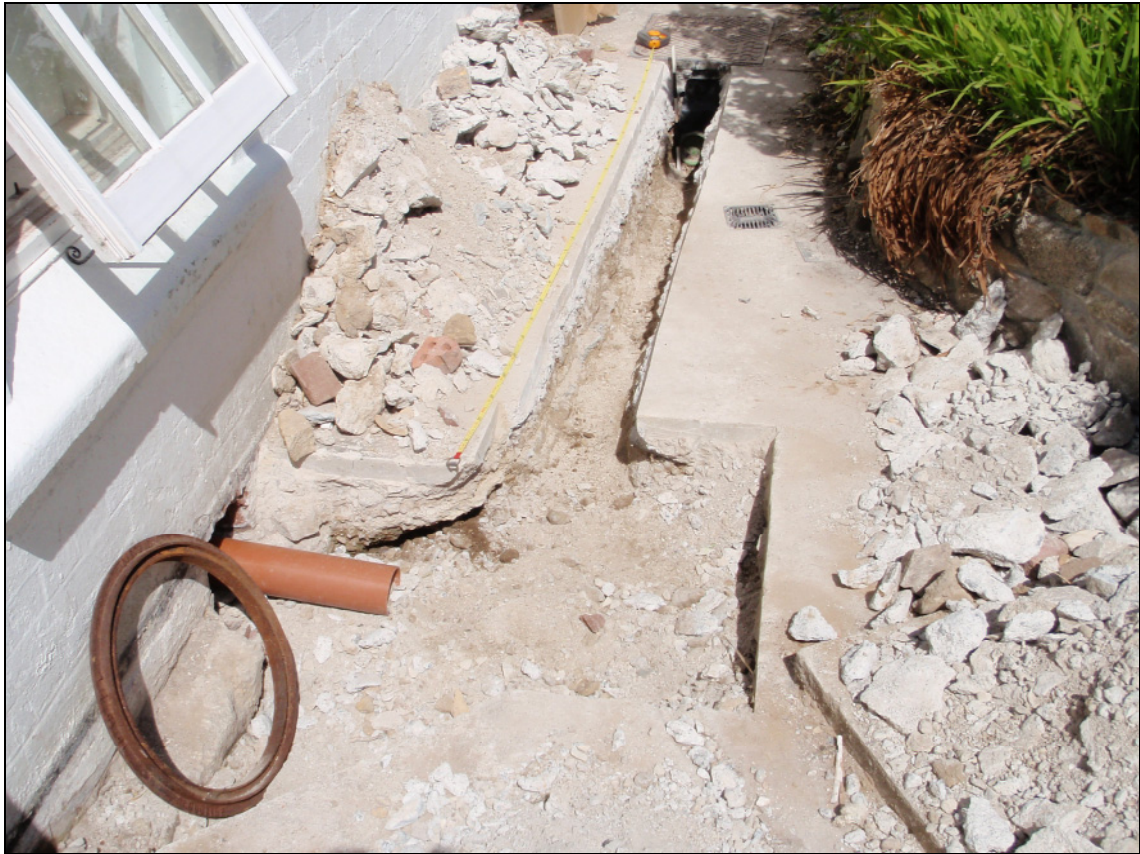
The excavated edge of the drainage channel revealed three layers of concrete: the present pale grey concrete yard/drive surface 50mm thick (1); an underlying pour of rougher pale grey concrete 50-70mm thick (2); and another layer of brown concrete 50-300mm thick (3), which was deeper towards the western end of the trench where the underlying layers had been cut away. Below this was a 1 inch thick layer of grey concrete (4) forming a sloping surface. This layer was interpreted as either an earlier path or, more likely, bedding for an old drain, and, like the underlying layer, appeared to have been cut away halfway along the section. Below this was a layer light brown concrete make-up (5) and a then a layer of compact dark brown sandy clay (6), which was not fully exposed by the excavation.

*Fig 5 The excavated drain trench (photo: HE Projects)*

The excavation for drainage works did not disturb any significant archaeological deposits, although the bottom layer (6) evidently contains demolition material and it should be noted that any further groundworks have potential to reveal more of this deposit.

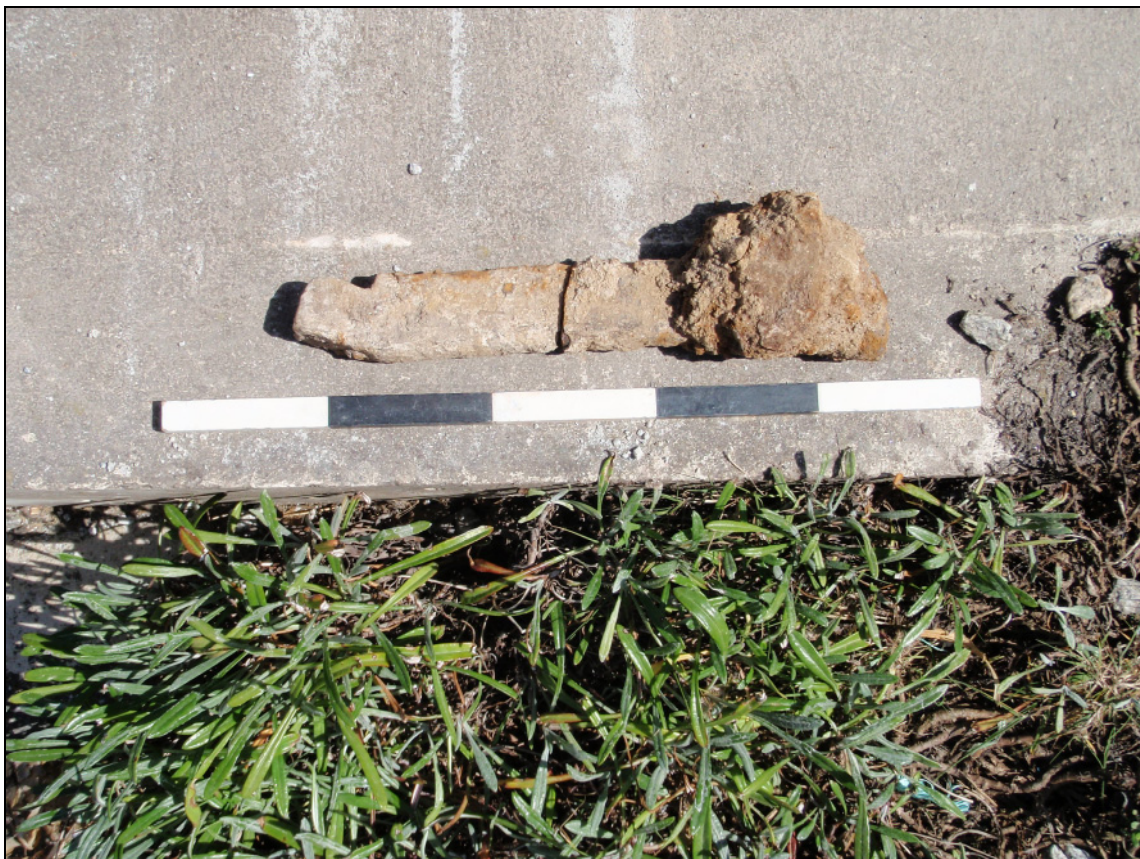
Layer (6), also interpreted as a make-up or levelling layer, contained fragments of brick and saltglazed drainpipe. It also contained a length of broken wrought bar 14 inches long by 2 inches wide by up to 1 inch thick. The bar had a distinct flange at one end and, the other end was covered in concretion.

*Fig 6 The iron object (photo: HE Projects)*

A study of the 1898 War Department Pattern Book, an illustrated document with specifications for military fixtures and fittings did not reveal any matches for the iron bar, which has been placed in one of the underground rooms for safe keeping.
