# **Little Brook, Shutta Road, East Looe, Cornwall**

## **Historic Building Record**

Little Brook, Shutta Road, East Looe,  
Cornwall, historic building record

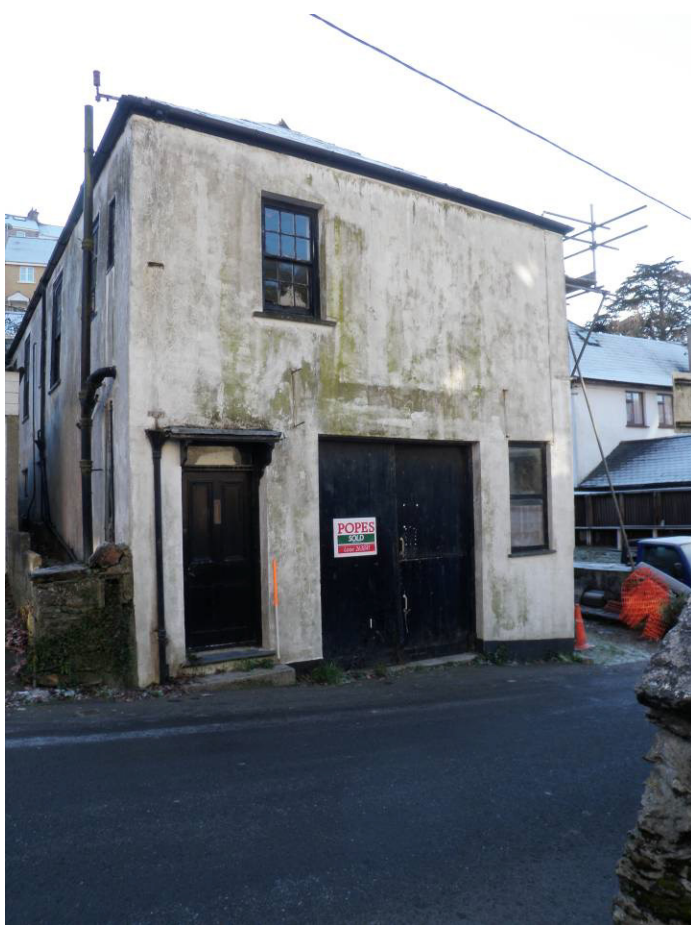
Fig 6: Exterior north elevation

### **North wall (fronting Shutta Road, Figs 6, 11, 18)**

This wall is constructed from slate rubble bonded with lime mortar and has brick jambs either side of the wide centrally set ground floor door opening. The exterior face is rendered and painted white. All the openings are original. The timber doors and 12-pane sash window are also original. The window to the west is a modern replacement. On the first floor there is a chimney breast with a blocked fireplace. A chimney stack from a first floor fireplace has been removed and slated over.

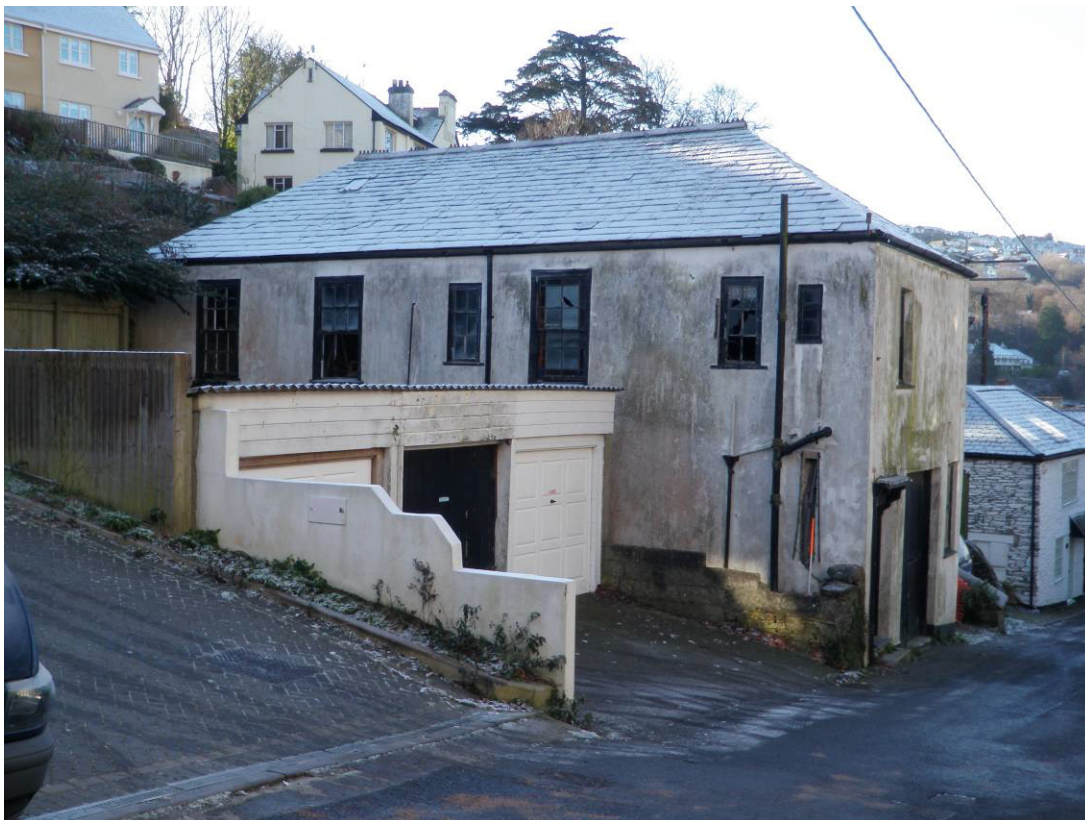
*Fig 7: Exterior east elevation*

### **East wall (Figs 7, 8, 12, 15)**

The east wall is constructed from slate rubble bonded with lime mortar on the ground floor, with rendered and painted laths attached studwork on the first floor. The internal face of laths and plaster had been removed by the time of the site visit. This wall is terraced into the slope from the level of the ground floor window sills. All the window openings appear to be original. The windows on the first floor are also original and include two 12-pane sash windows, a 24-pane sash window with stained glass at the top of the stairs, and three smaller original windows. The two windows on the ground floor are modern replacements.

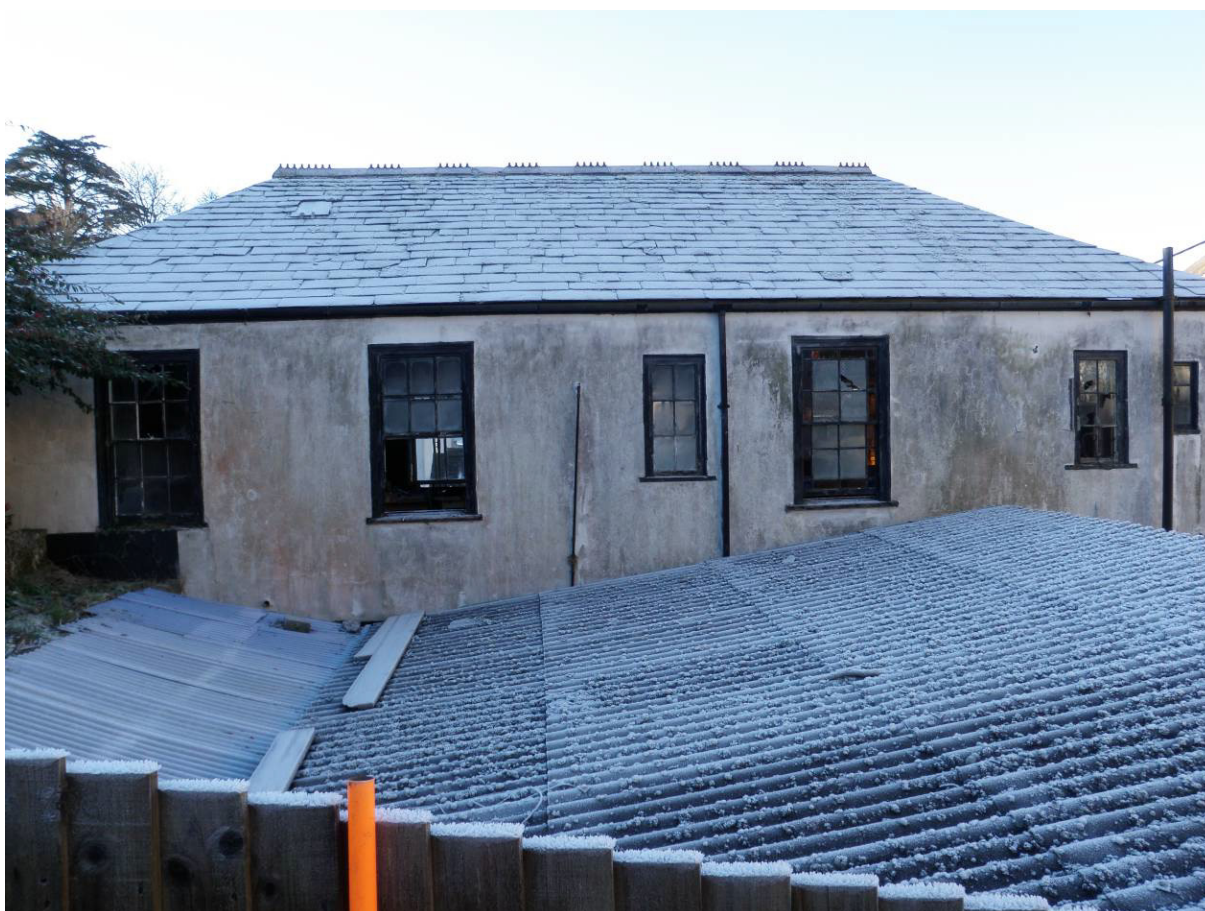
*Fig 8: Exterior east elevation (first floor level)*

The roof structure comprises bolted timber king post trusses and has an original (but re-laid) nailed slate covering. The ridge tiles are original crested tiles.

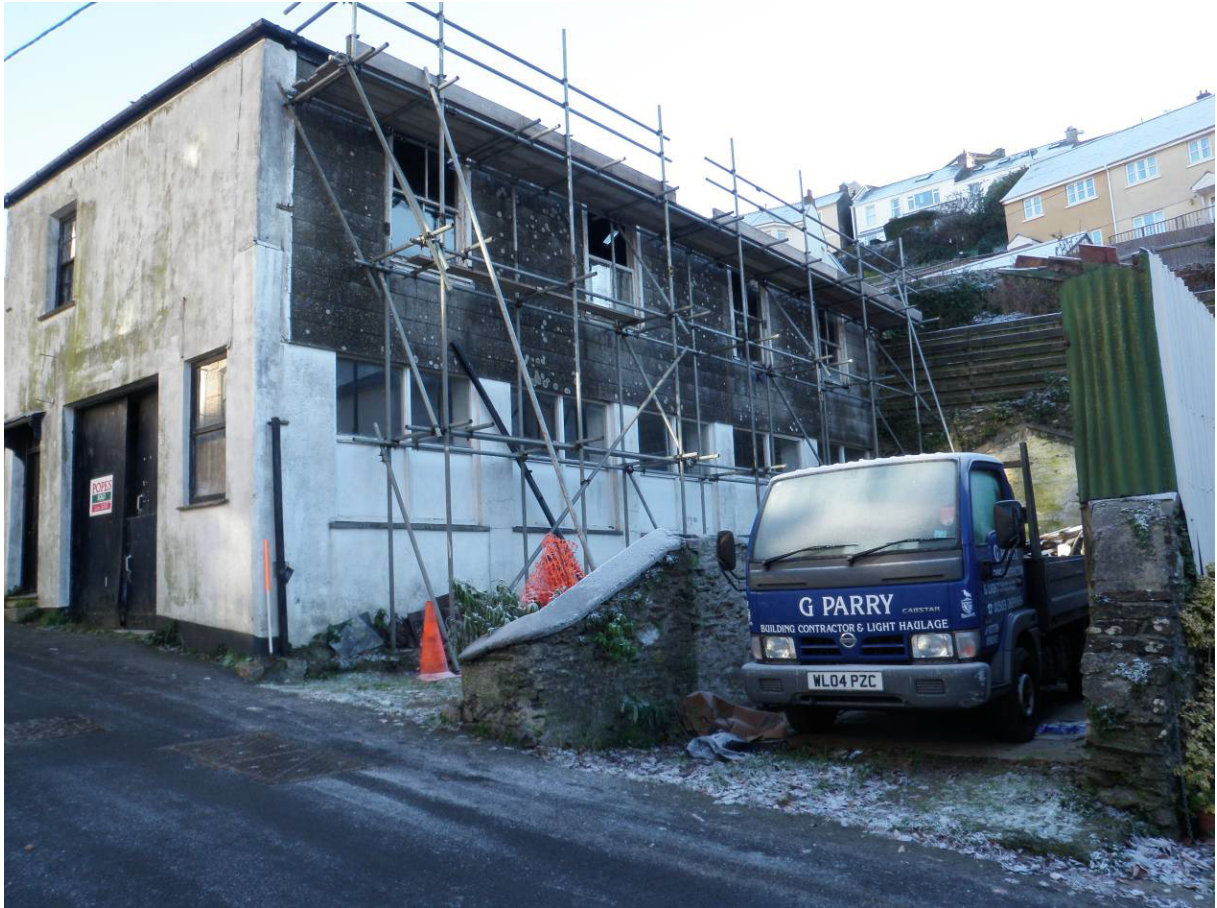
*Fig 9: Exterior west elevation*

### **West wall (Figs 9, 14, 17)**

The west wall is constructed from slate rubble bonded with lime mortar on the ground floor with brick pillars between the wide window openings. The first floor wall is timber studwork whose original external rendered laths have been removed and replaced with asbestos tiles. The internal face of laths and plaster had been removed by the time of the site visit. All the openings are original and the first floor has four 4-pane sash windows. The ground floor windows are all modern replacements although the slate sills are original. On the first floor at the centre of the elevation two later inserted fireplaces have been removed.

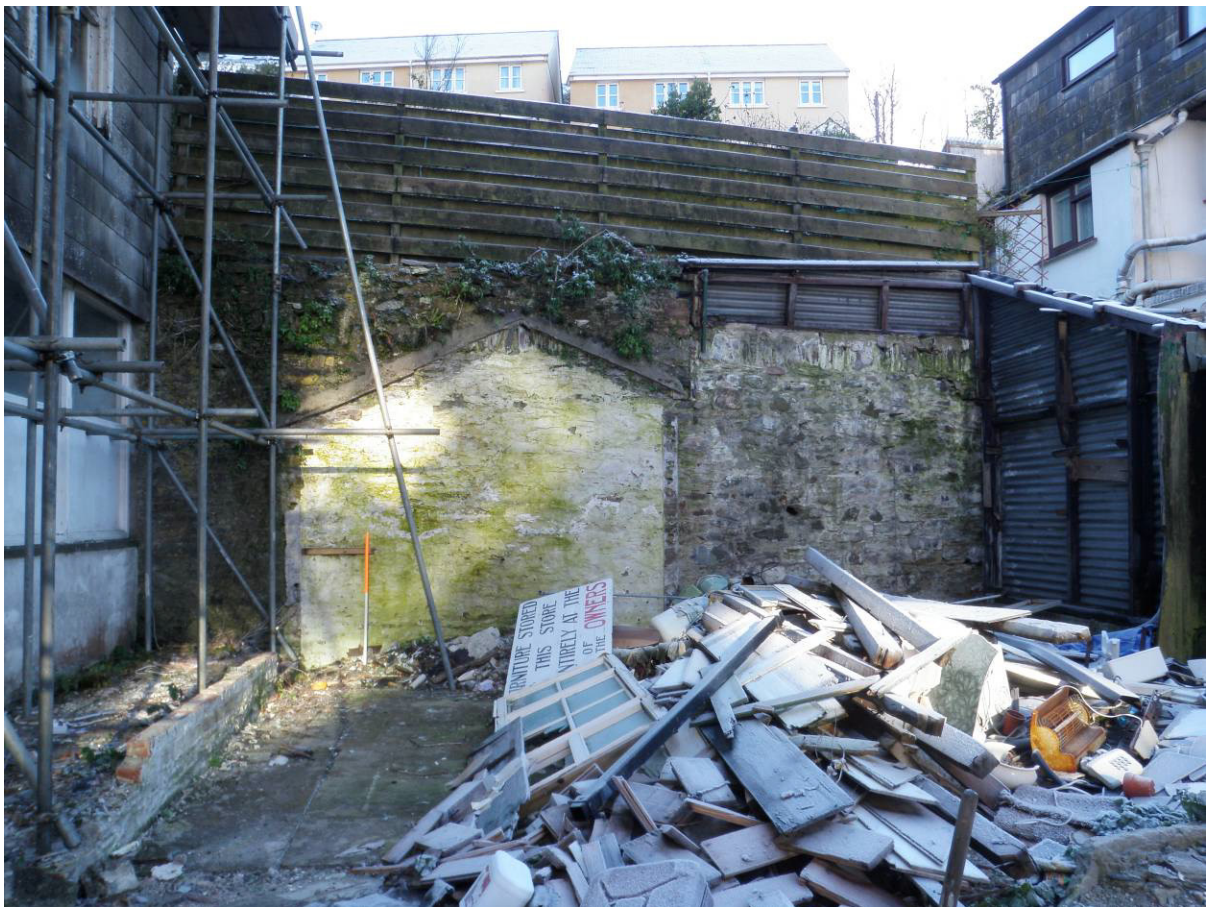
*Fig 10: Rear boundary elevation*

### **Exterior yard (Fig 10)**

The yard is located on the western side of the building. At the time of the survey all the former small buildings here (shown on modern OS mapping) had been demolished. The rear boundary retaining wall comprised slate rubble bonded with lime mortar with vertically set coping stones. In the north-west corner of the yard are the remains of retaining walls associated with a small building constructed from slate rubble bonded with lime mortar.

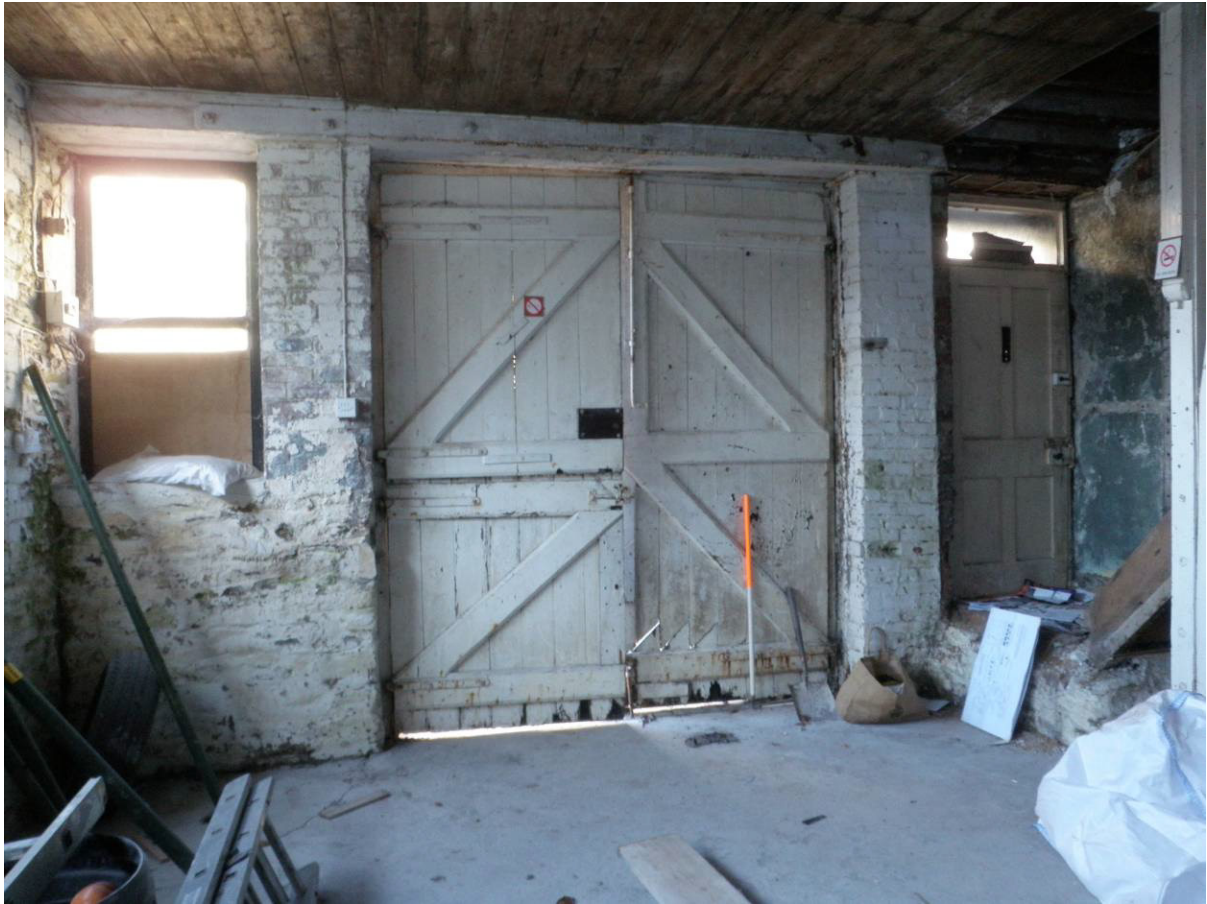
*Fig 11: Ground floor interior of north wall*

### **Interior Ground floor (Figs 11, 12, 13, 14)**

The floor itself is modern concrete and the ceiling is modern timber boarding. In the north-east corner there is a stone-built plinth supporting the base of the original staircase. The stairs were originally separated from the rest of the ground floor by a timber planked partition wall (now removed). There is evidence for another removed

partition wall aligned east-west which formerly divided the ground floor into two rooms of similar proportions. This was constructed from timber tongue and groove boarding. The original use of the ground floor is unclear although its function was clearly either commercial or industrial.

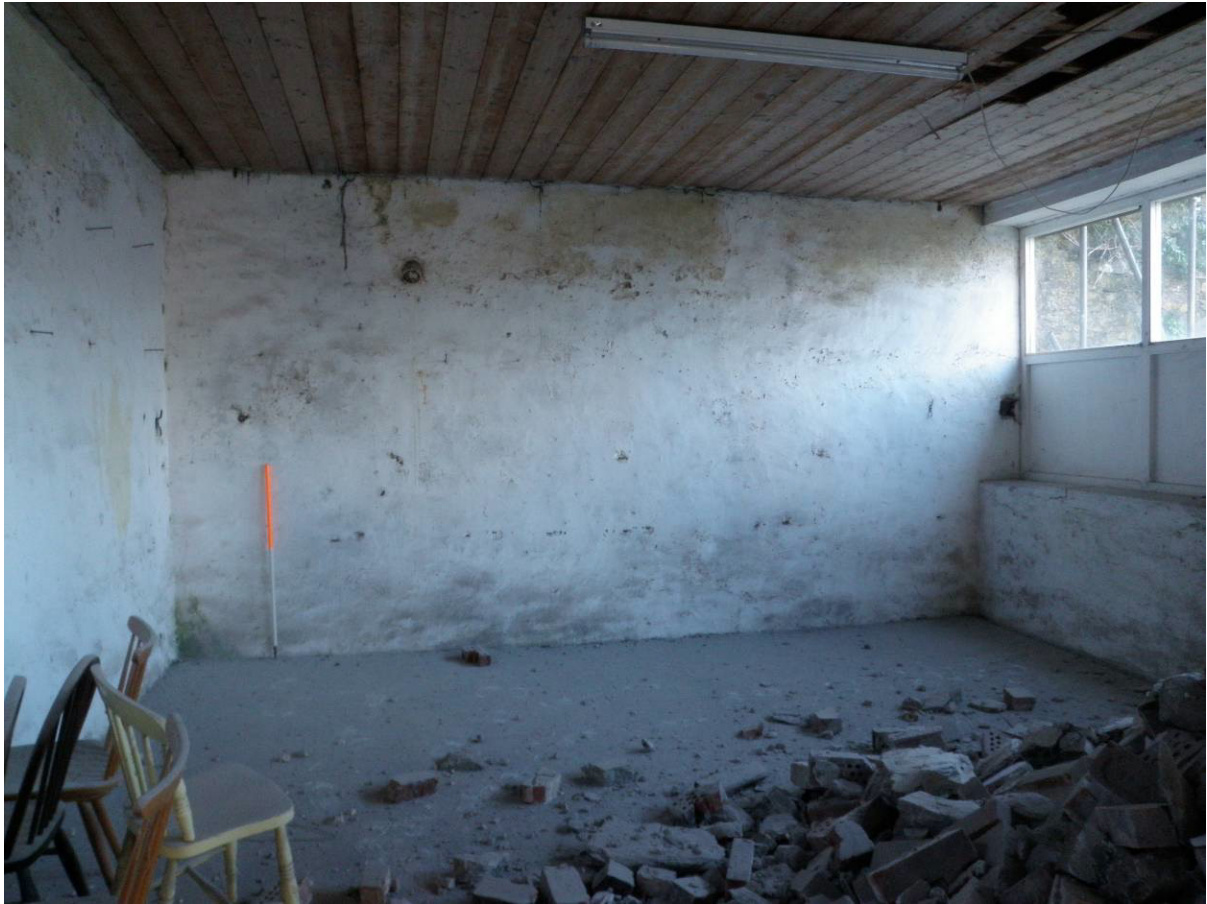
*Fig 13: Ground floor interior of south wall*

### **South wall (Figs 13, 16)**

As the ground rises steeply to the south, the south wall of the building is a retaining wall on the ground floor up to first floor level. This part of the wall is an earlier boundary wall which has been built up at first floor level. The external first floor elevation was not accessible at the time of the survey. The whole wall is constructed from slate rubble bonded with lime mortar. Viewed from the interior, on the ground floor a flue pipe has been inserted and on the first floor there is a chimney breast and two fireplaces (one blocked). The former brick chimney stack above has been removed and slated over.

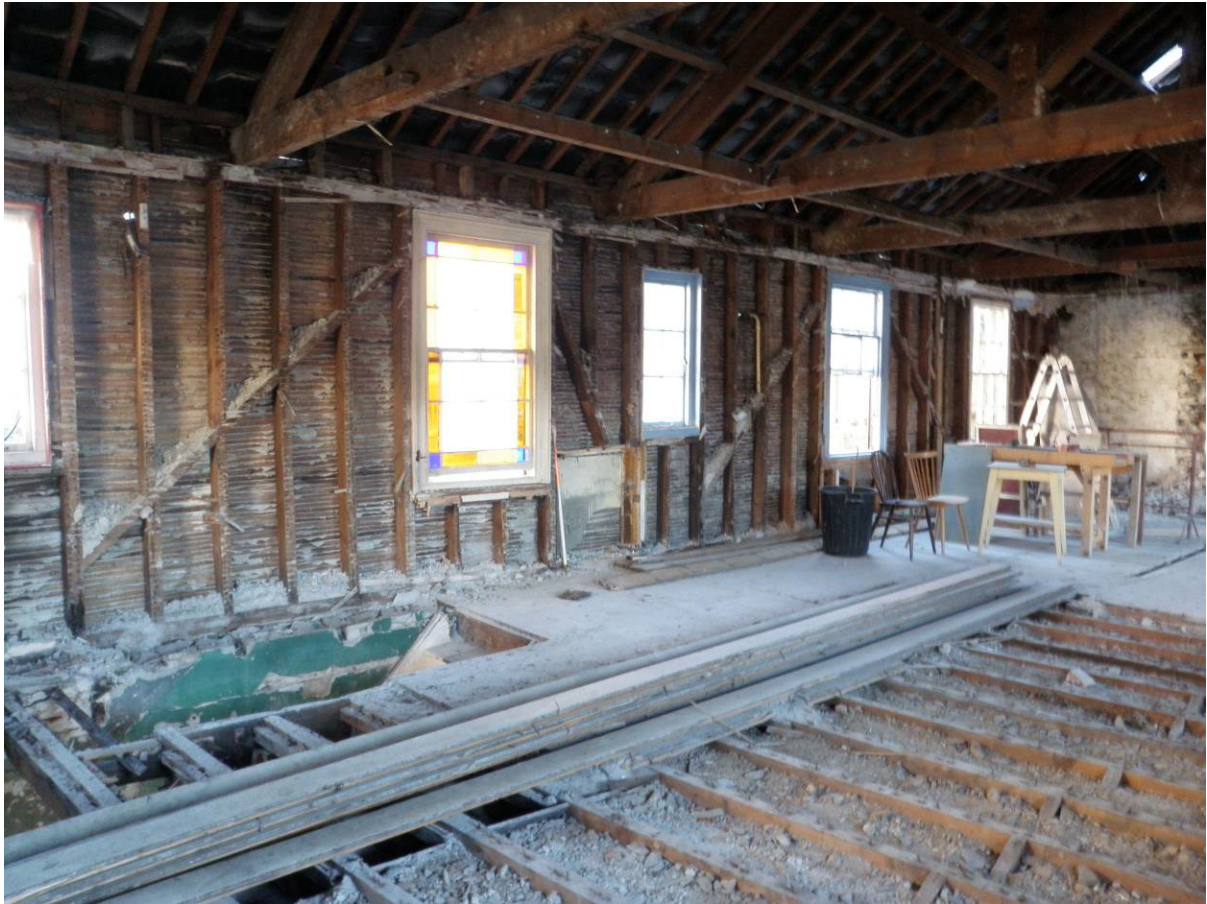
*Fig 15: First floor interior of east wall*

### **Interior First floor (Figs 15, 16, 17, 18, 21)**

At the time of the survey all partition walls and the ceiling on the first floor had been removed along with many of the original floorboards. It seems likely that many of partition walls and the ceiling were an original part of the domestic accommodation on this floor. The two former fireplaces in the southern wall indicate that there were two separate rooms at this end of the building. Fig 21 shows the layout of the first floor prior to demolition.

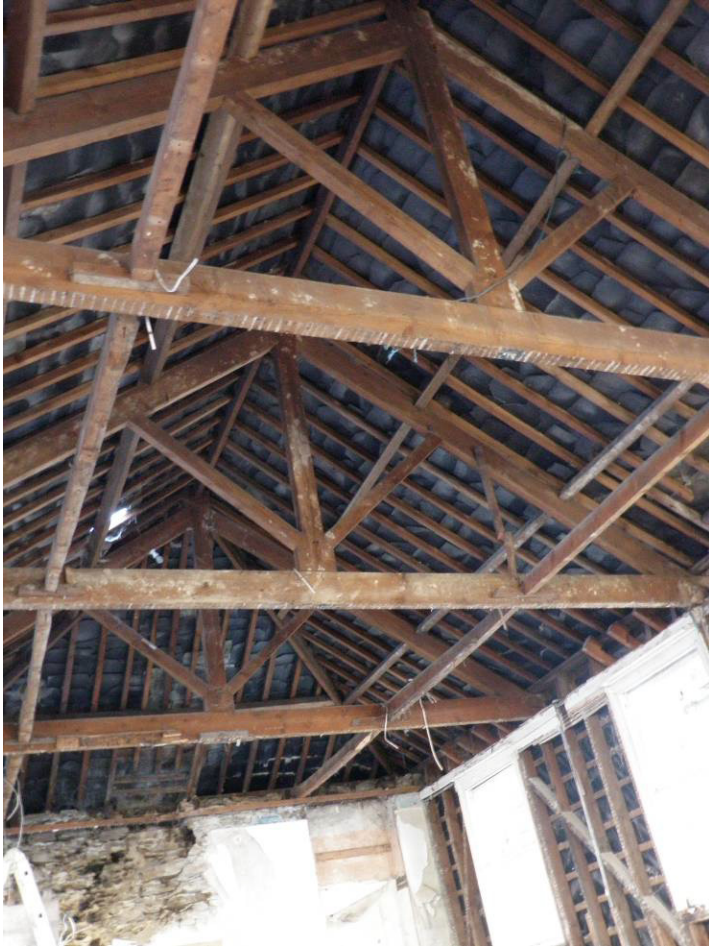
*Fig 19: Roof structure looking south*

### **Roof (Figs 8, 19)**
