# **Tregew Farm outbuildings, Feock, Cornwall**

## **Historic building record**

<b>Client</b>	<b>Mr and Mrs W Buckley</b>
<b>Report Number</b>	<b>2011R006</b>
<b>Date</b>	<b>December 2010</b>
<b>Status</b>	<b>Final</b>
<b>Report author(s)</b>	<b>Nigel Thomas</b>
<b>Checked by</b>	<b>Peter Rose</b>
<b>Approved by</b>

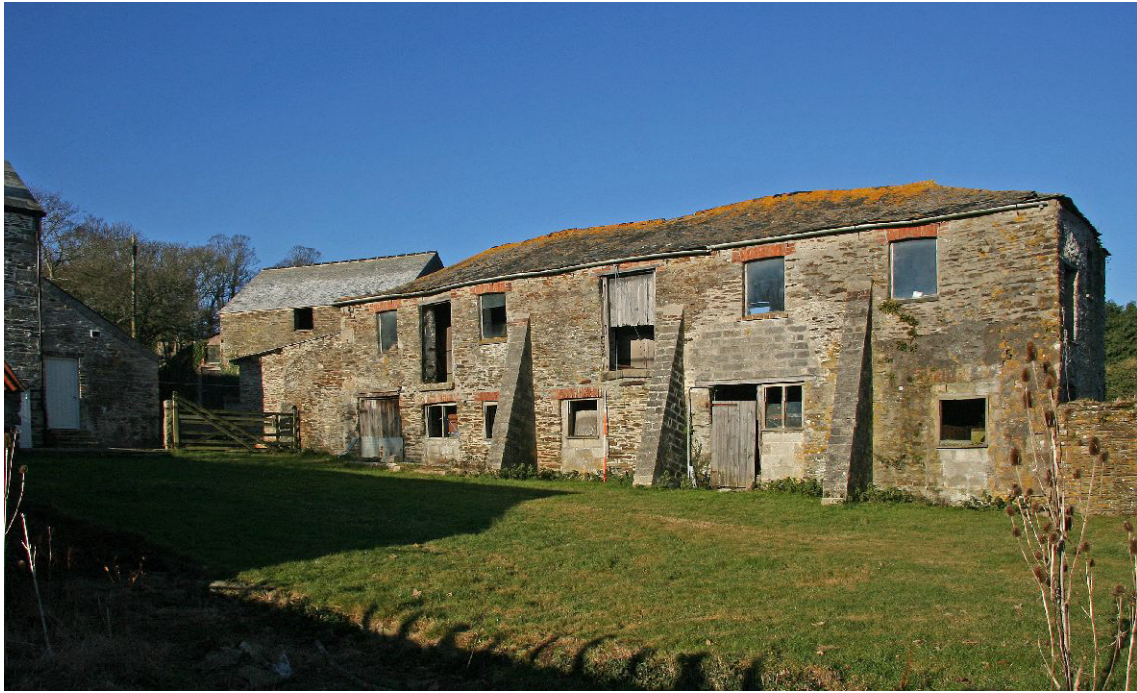
*Fig 7 Main barn range, viewed from the SE*

All openings are original, and most retain their shallow red brick arches, although in a few places arches have been replaced with lintels. There are no joints between the two parts of the range; the evidence of the brick arches and general character of the masonry indicates all the construction is of one phase.

The RH end appears to have been a cowhouse on the ground floor with a threshing barn above. The LH end nearer the farmhouse appears to have originally been a stable with a loft above. This part seems to have been absorbed into the main barn when a new stable was built behind.

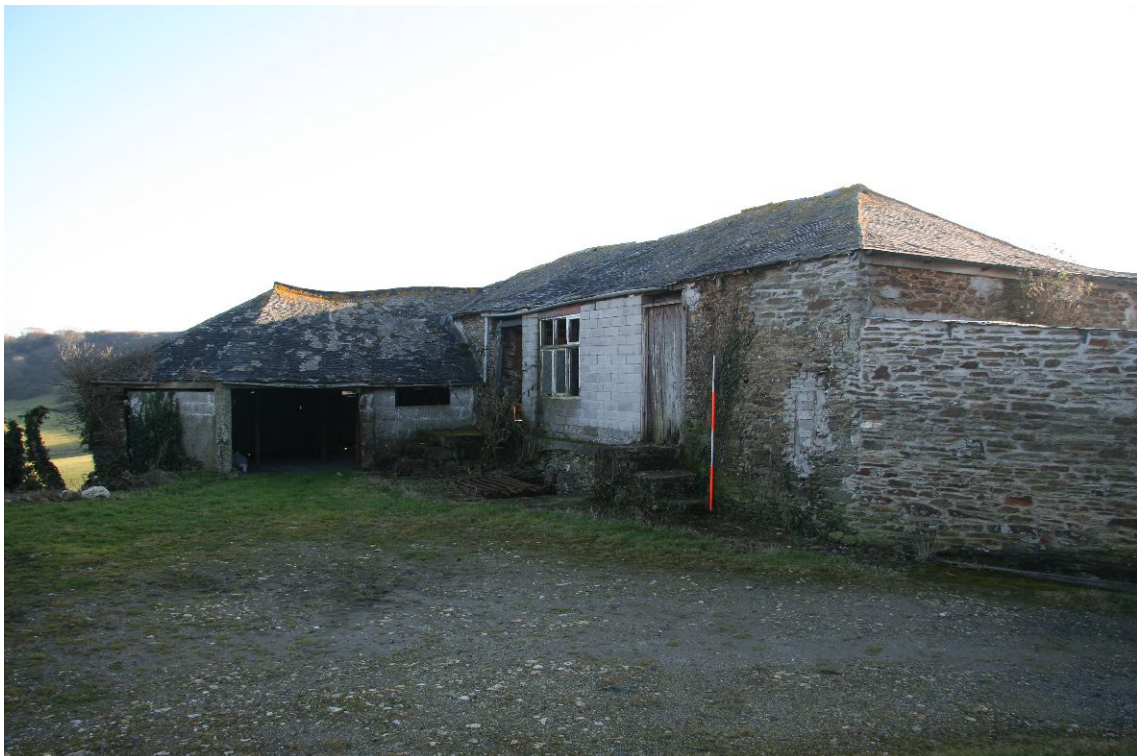
*Fig 8 The rear of the barn range viewed from the NW, with the attached horse-engine house*

Between the loft doorways the original slate walling has been replaced with concrete block-work incorporating a window. This infilling is likely to have been added after two modern silos were installed inside the building. Below the modern part of the wall is a concrete lined chute and small opening, perhaps for storing roots inside the ground floor area of the range or was associated with the silos within.

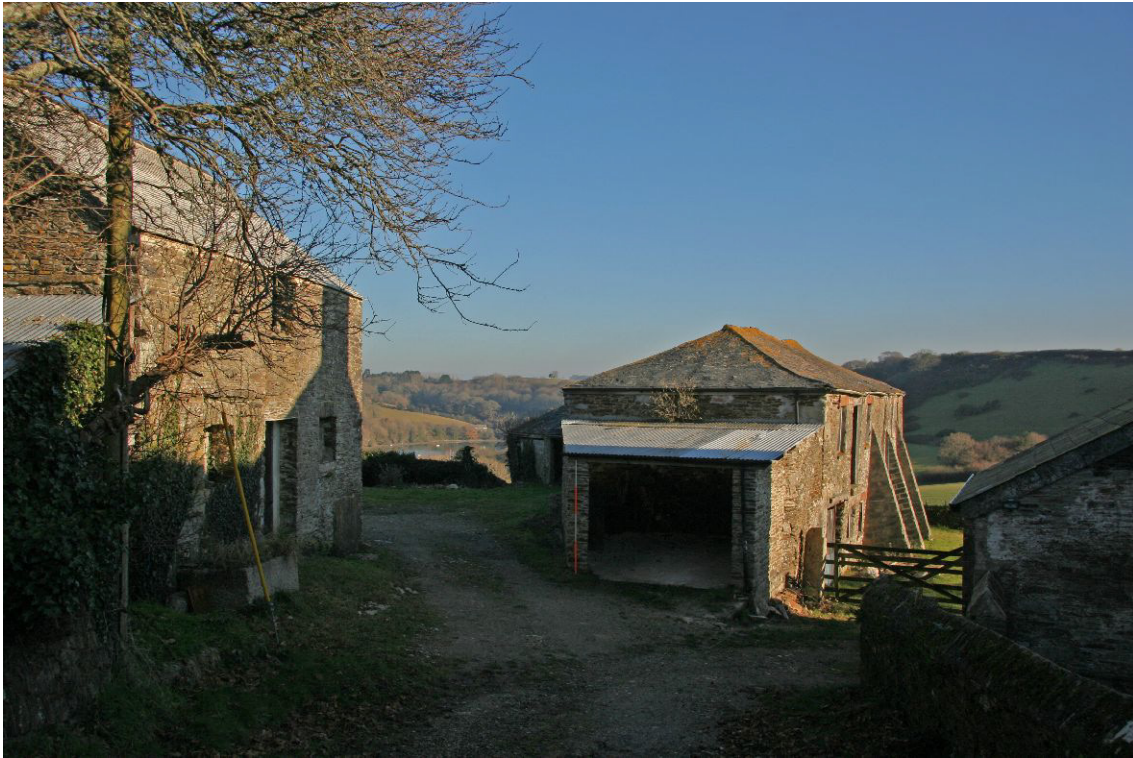
*Fig 9 View from the farm lane towards the barn range*

No features were observed in the visible part of the barn range, although this wall was partly covered with logs at the time of the visit. A central blocked opening (just below floor level) is visible from the interior of the barn range.

The former mowhay visible on the Tithe map was on the higher ground to the left of the barn

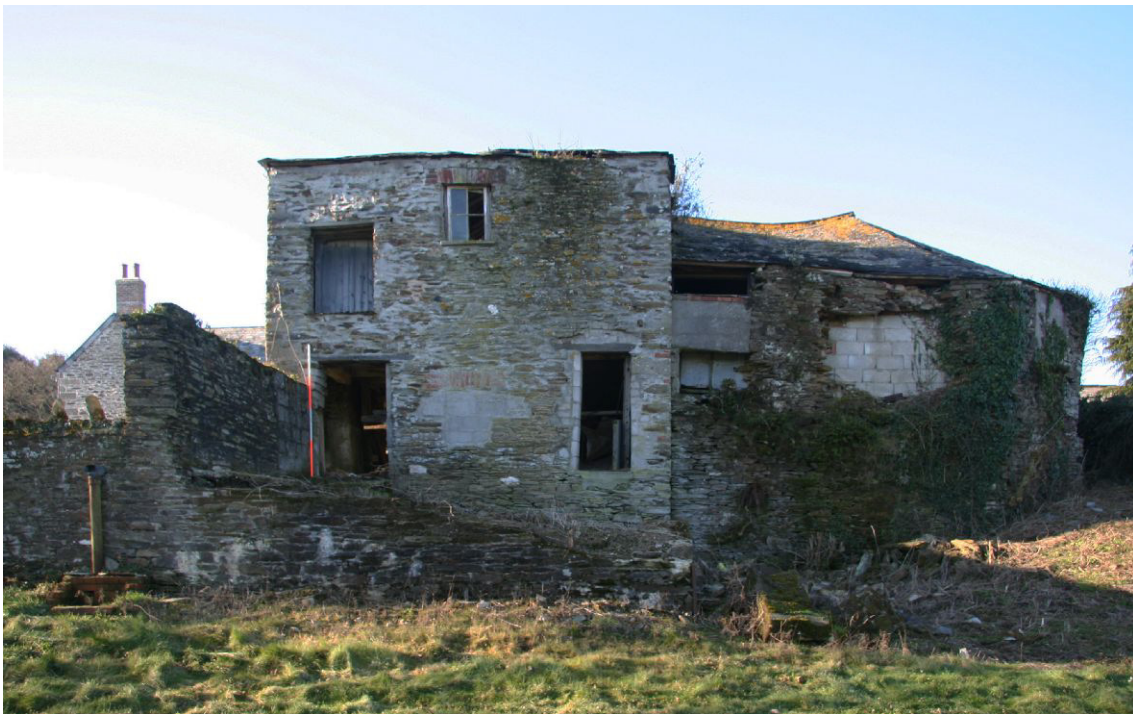
*Fig 10 The E end of the barn, with the attached horse-engine house*

Both doorways on the ground floor are later insertions, the RH door connecting to a rear feeding passage in the cowhouse.

The walling in front is all that remains of a roofed structure with an apsidal pierced N end, a likely pound house (cider house) for the old orchard in the foreground

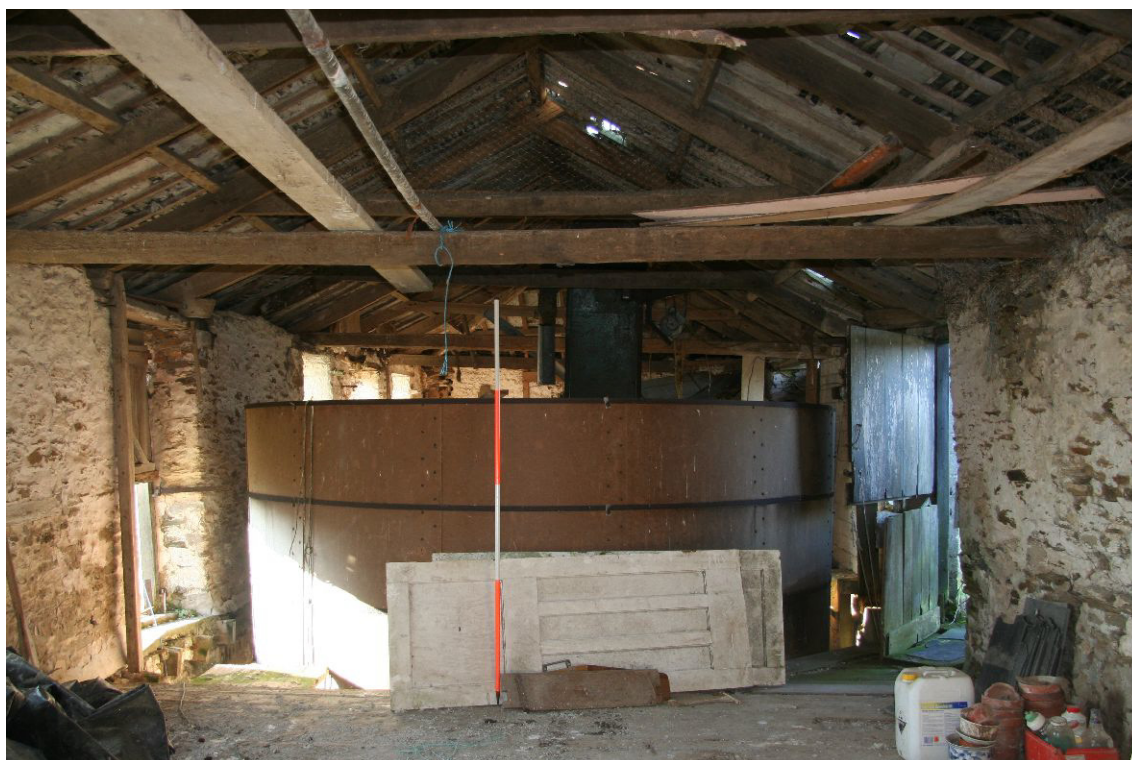
*Fig 12 The upper floor of the barn range, looking W*

Insertion of two modern silos has cut through the flooring, including part of the threshing floor between the two doorways.

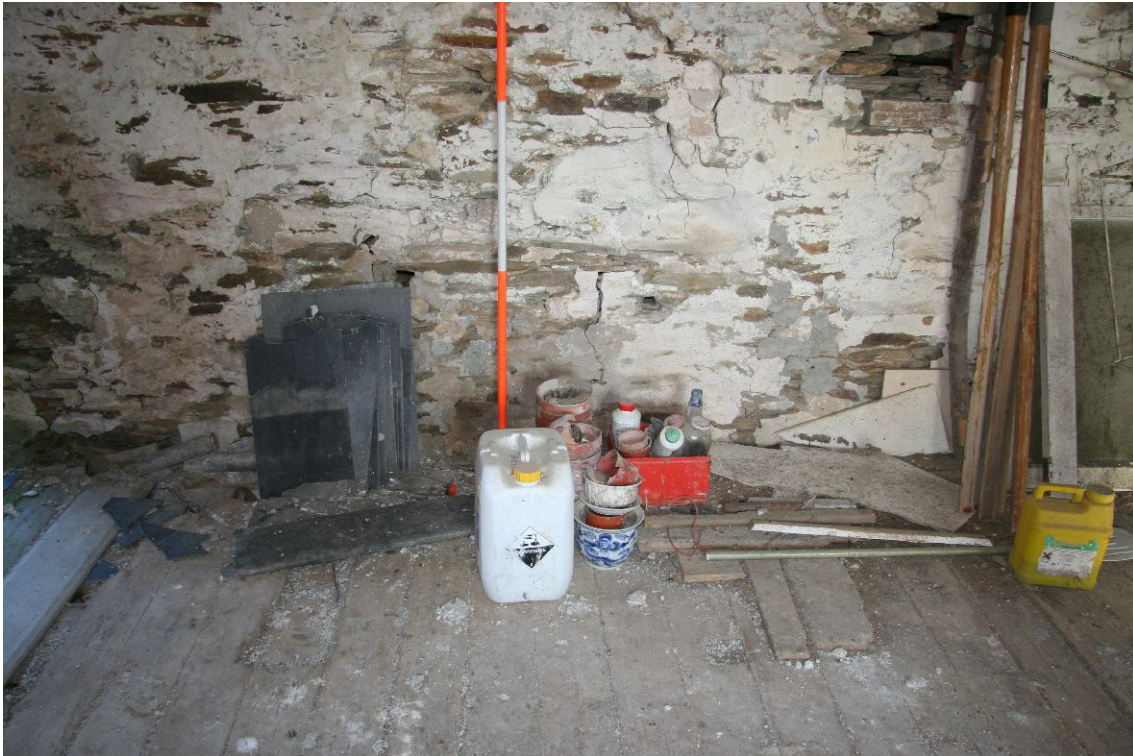
*Fig 13 A shallow recess in the rear wall and two indents in the floor provide evidence of location for a threshing machine or winnower*

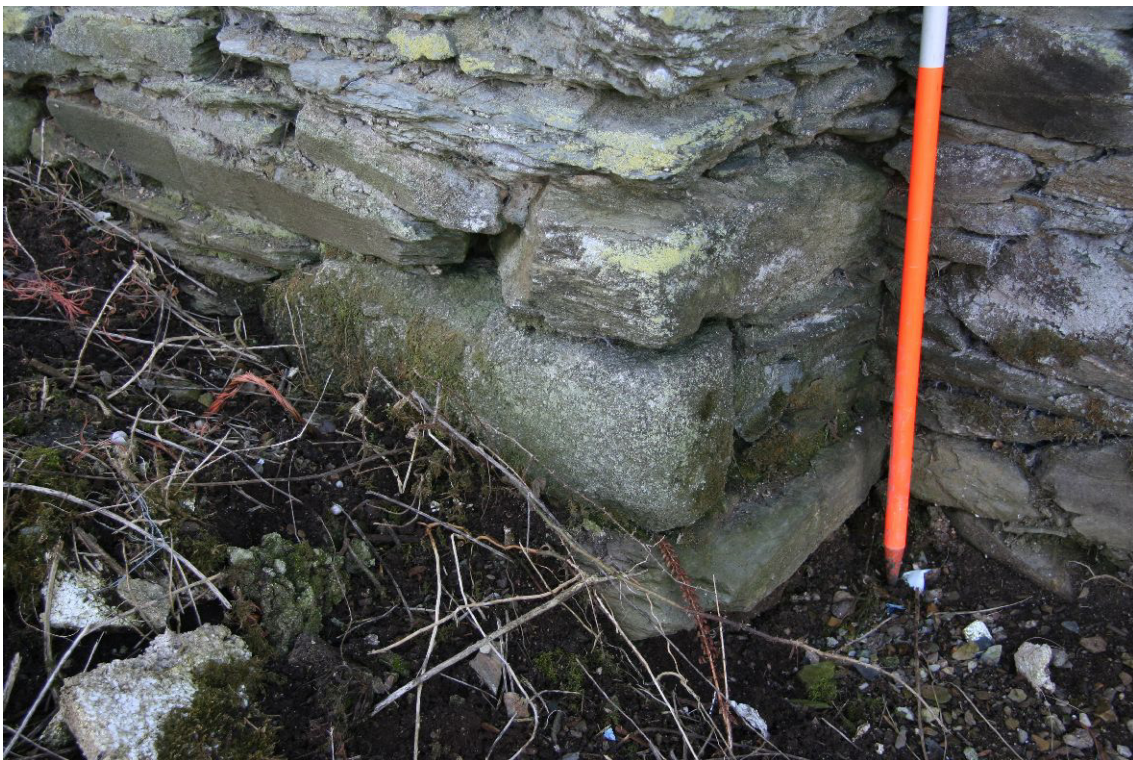
*Fig 14 17<sup>th</sup> century granite kneeler stone, reused as a quoin in the NE corner*

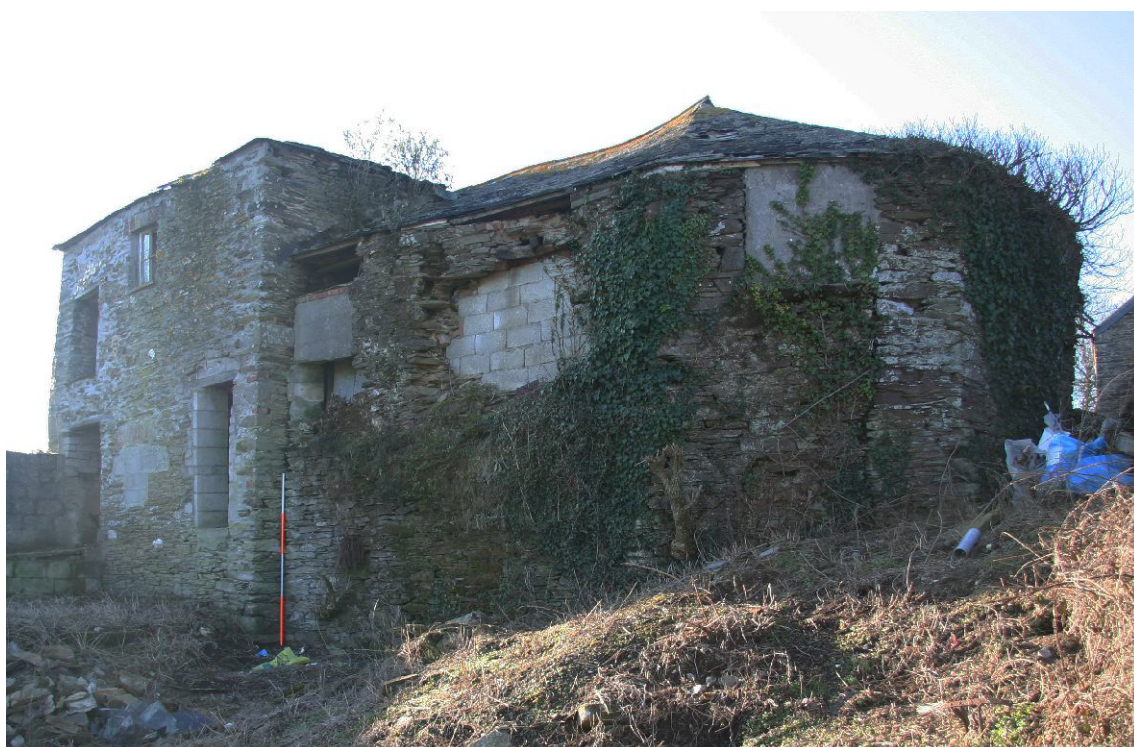
*Fig 16 Horse-engine house, viewed from the NE*

This is the polygonal end of the apse plan. This part is constructed from slate rubble masonry bonded with lime mortar. The slope of the land drops away sharply here (there has been modern dumping below the building) and there is visible movement and cracking in places.

Note the collapsed stone masonry and sagging roofline

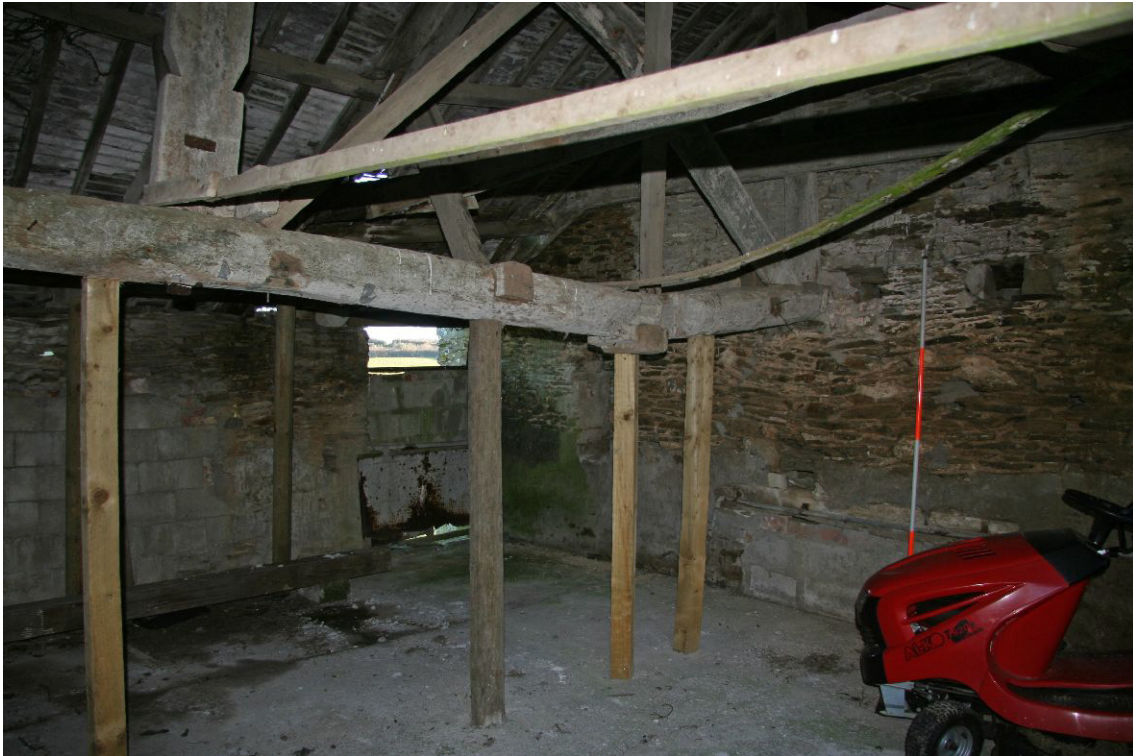
*Fig 17 Interior of the horse-engine house, looking SE*

Inside the building the space is dominated by a substantial timber beam running the length of the house. This supports the roof timbers and also once carried the gearing of the horse-engine. The timber has cracked and sagged (now supported by temporary props) and has partly pulled the barn wall facing out of alignment. The position of the top main bearing of the horse-engine is still visible on the beam. Any corresponding bearing location in the floor has been masked by later screed.

The principal beam, now cracked and propped up, would have supported gearing and axles driving machinery in the barn

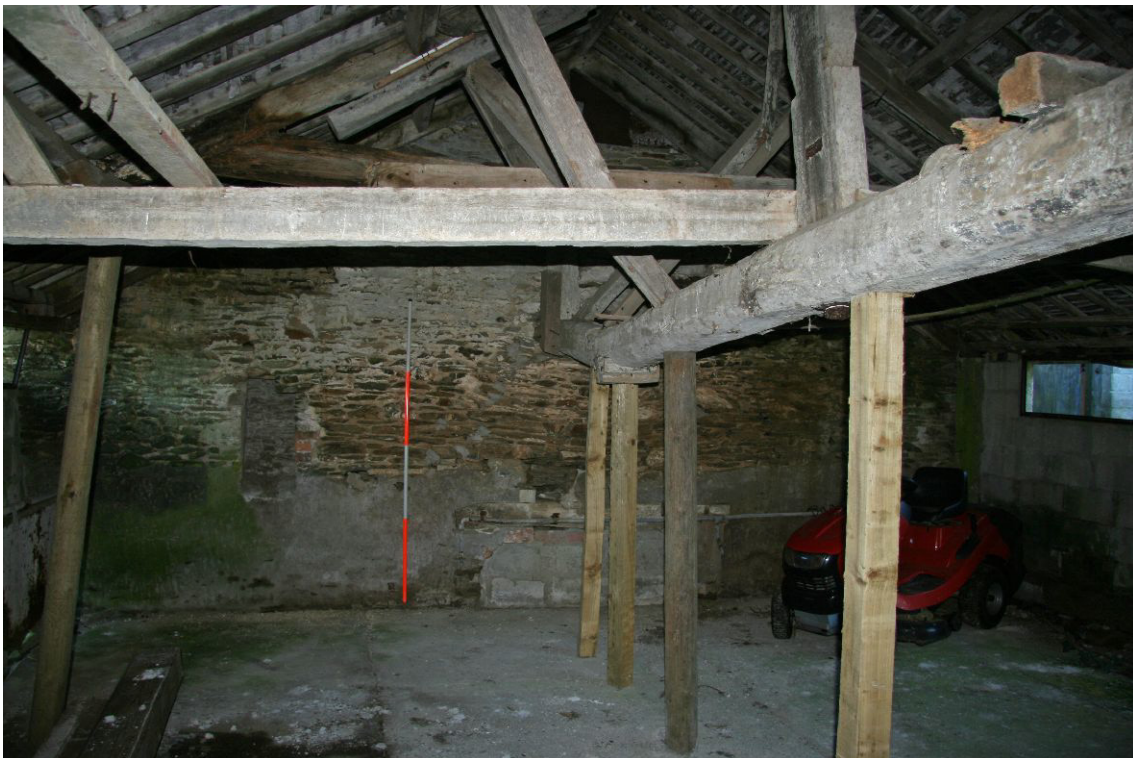
*Fig 18 Interior of the horse-engine house, looking S*

The blocked opening low in the wall to the R of the scale may pre-date construction of the horse-engine house. The slot inserted into the wall L of the scale may be a belt drive from an oil engine.

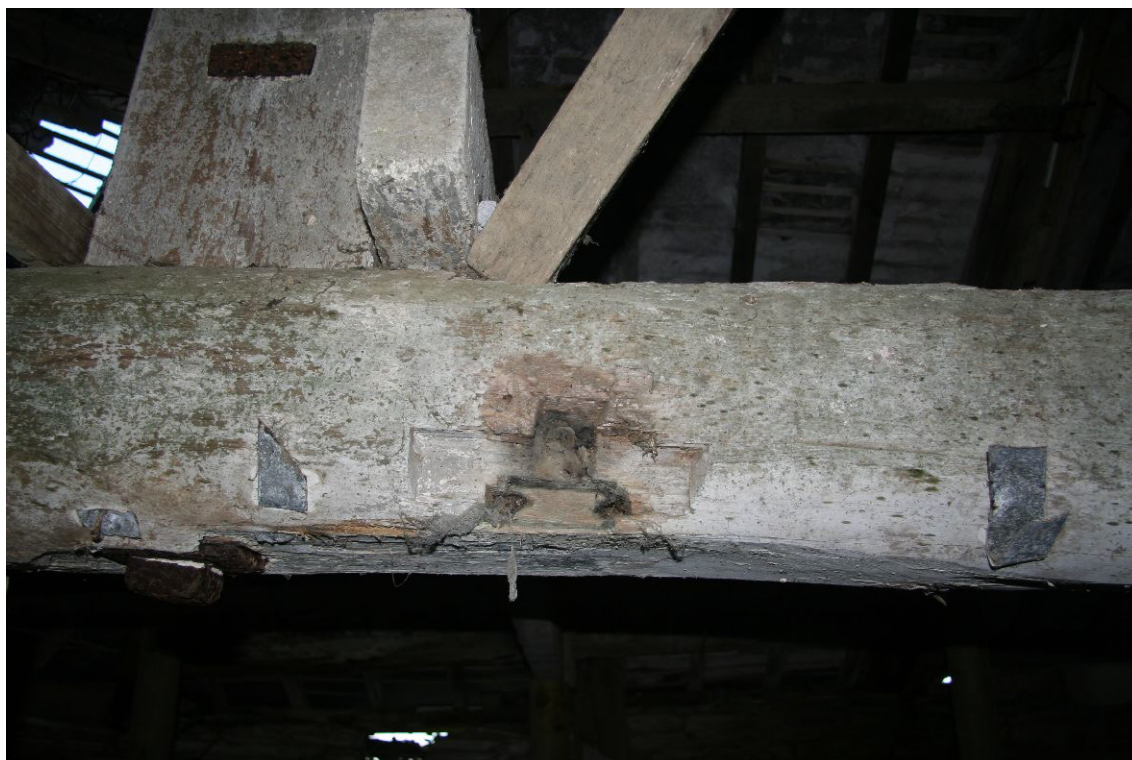
*Fig 19 The location of the principal bearing which supported the horse-engine gearing*

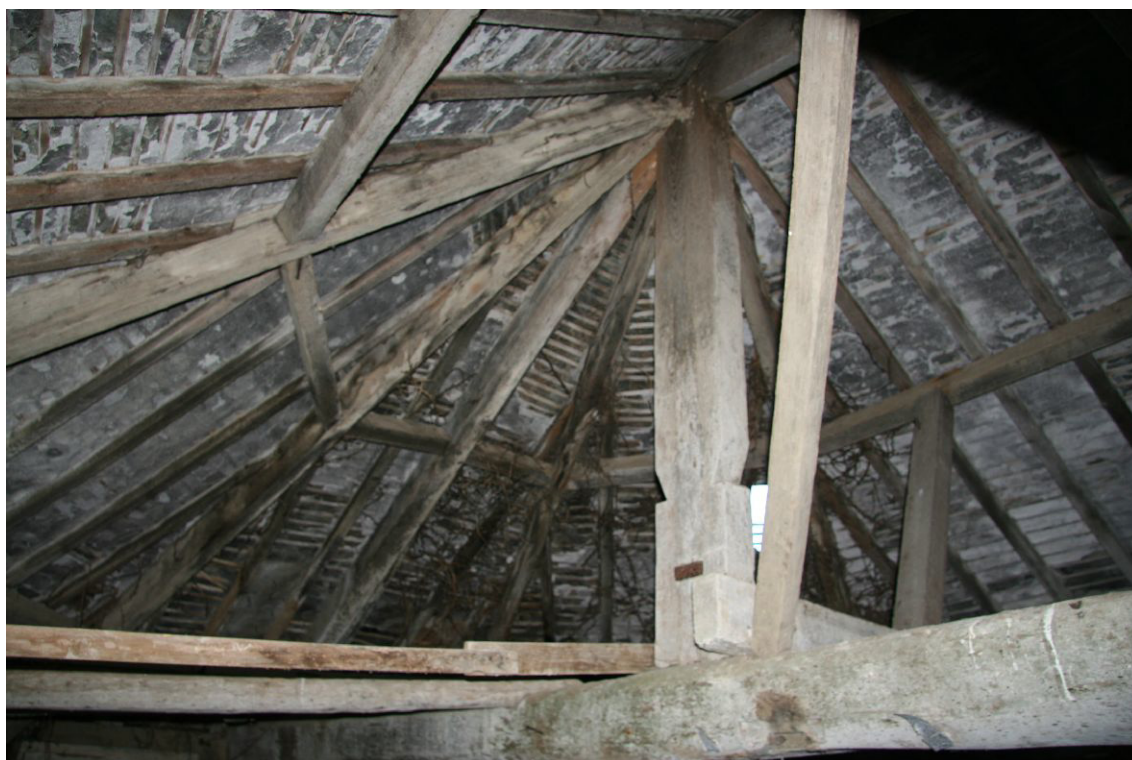
The roof covering is of scantle slate laid on laths. Ridge tiles, like those on the barn, appear to be modern replacements. At some time the slates have been at least partly cement washed in order to prevent slippage, but the cement wash is now very eroded and fragmentary. Movement and partial collapse in the eastern side wall has caused an interesting sag in the ridge line. There has also been movement and cracking in the north part of the wall.

*Fig 20 Detail of the scantle slate roofing and timberwork of the horse-engine house*

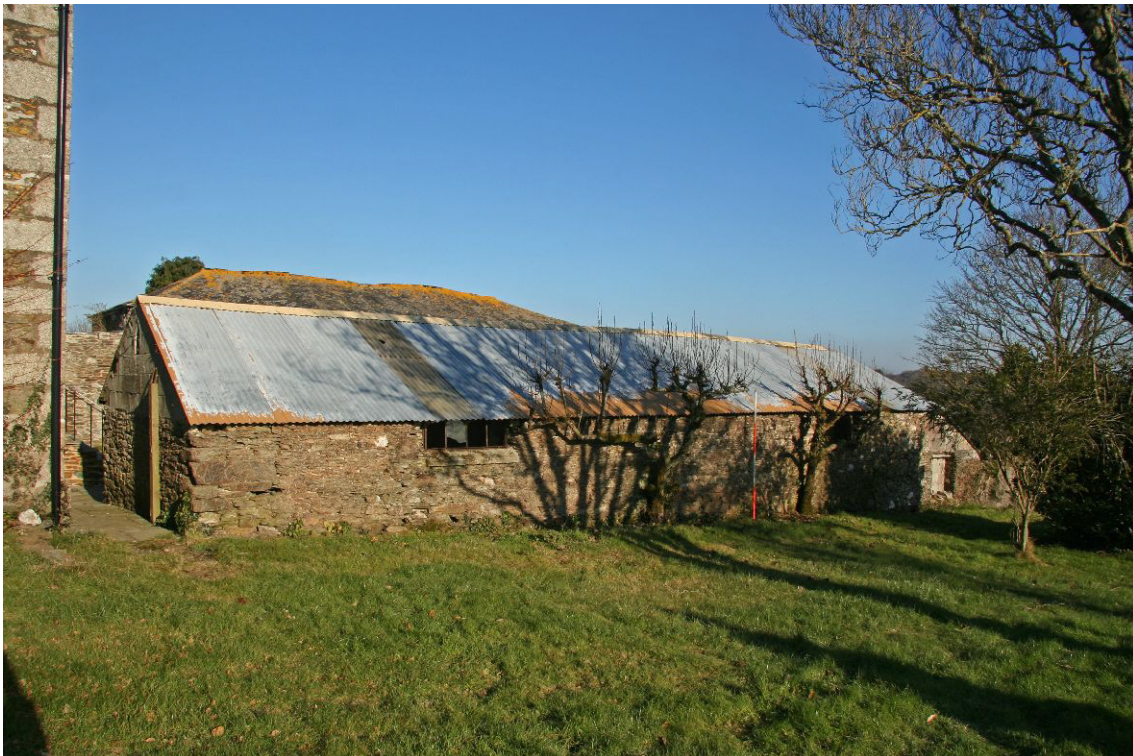
*Fig 22 Rear view of the calf-house from the SW*

The lack of stone masonry gables at both ends and the remains of a diagonal timber at the NW corner indicate that this building's roof was originally hipped at both ends, like the barn behind.

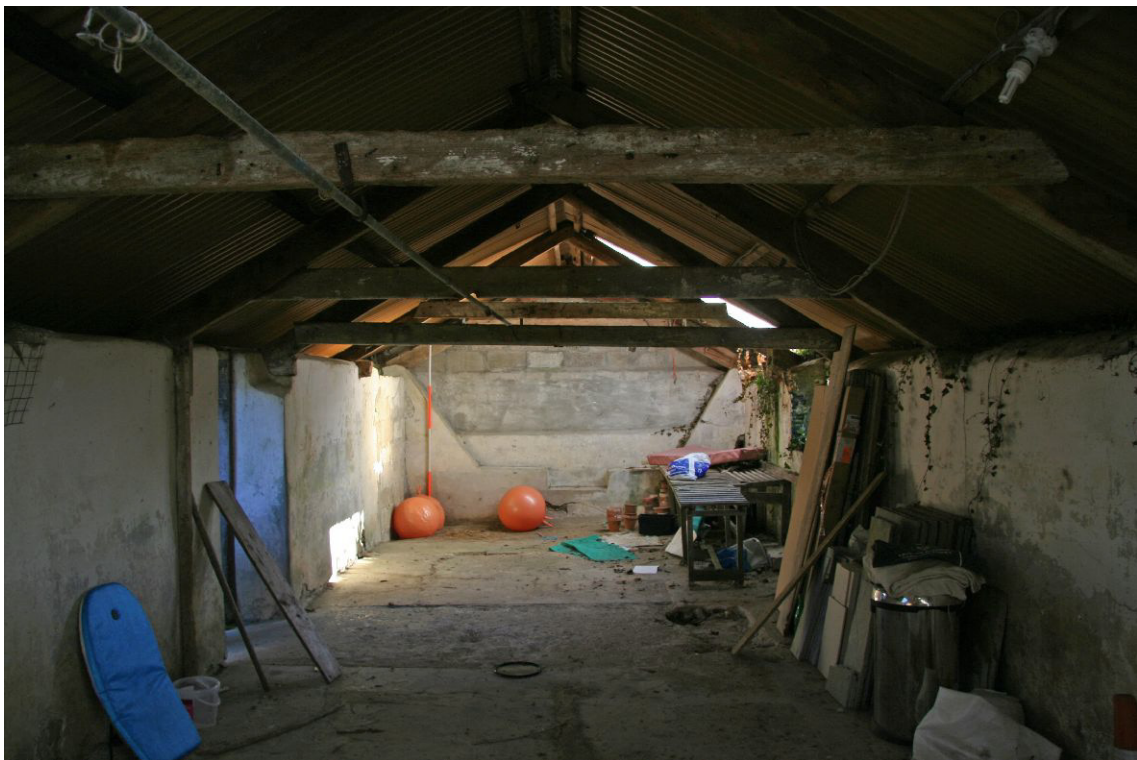
*Fig 24 Interior view of the calf-house, looking E*

The modern concrete floor is some 120mm higher than the original floor level, as evidenced by granite thresholds in the doorways. Insertion of the raised floor level necessitated alterations to the roof; the original tie-beams on the trusses were cut away and shortened to make collars at higher level.

The diagonal recessed feature to the R of the scale is probably for a hay rack.

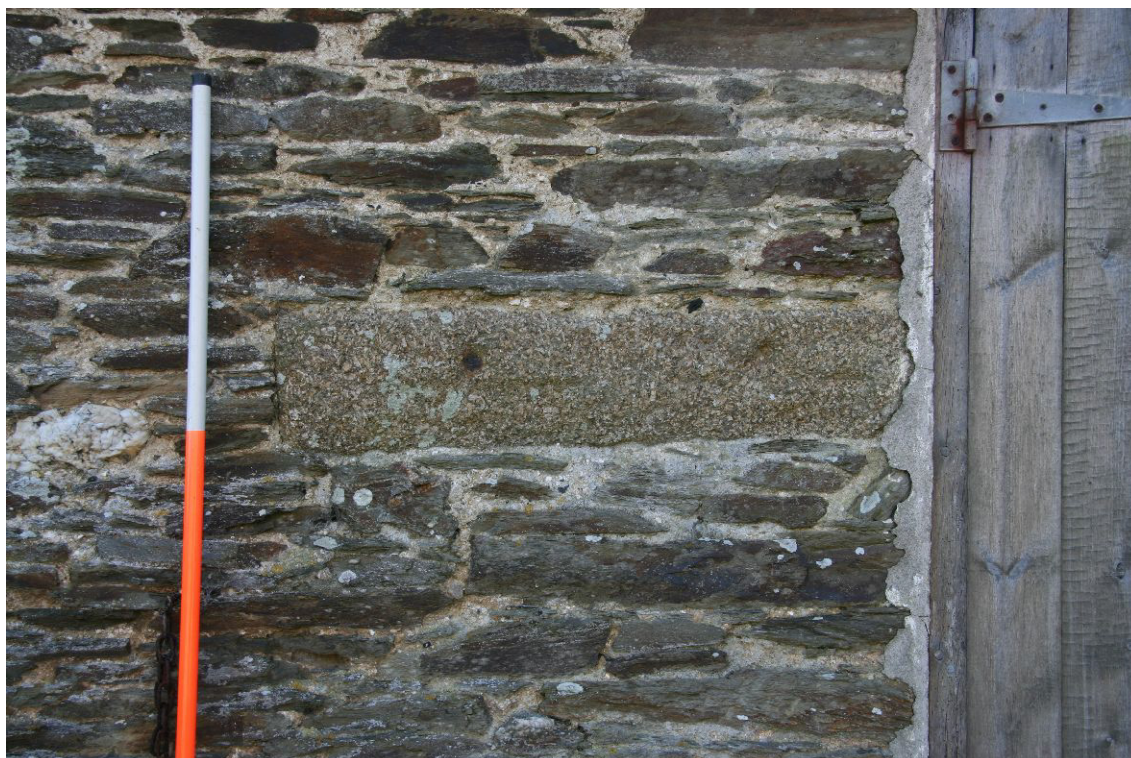
*Fig 25 A sill or lintel of a 17<sup>th</sup> century 2-light window reused in the wall of the calf-house*

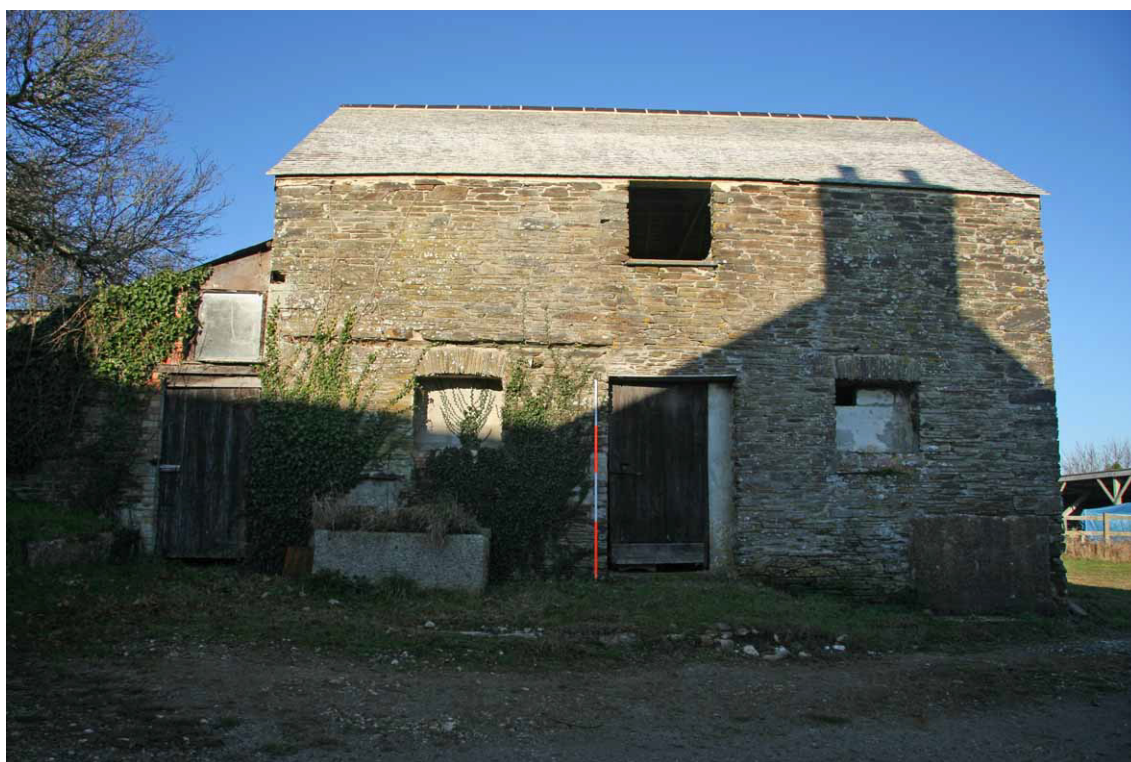
*Fig 26 NW Stable, front SE elevation*

This presents a window|door|window front on the ground floor, apparently the design of a stable with a wide central doorway and a generous window/ventilator opening on each side. The central doorway has lost its slate arch; this has been replaced by a steel lintel with stone masonry above.

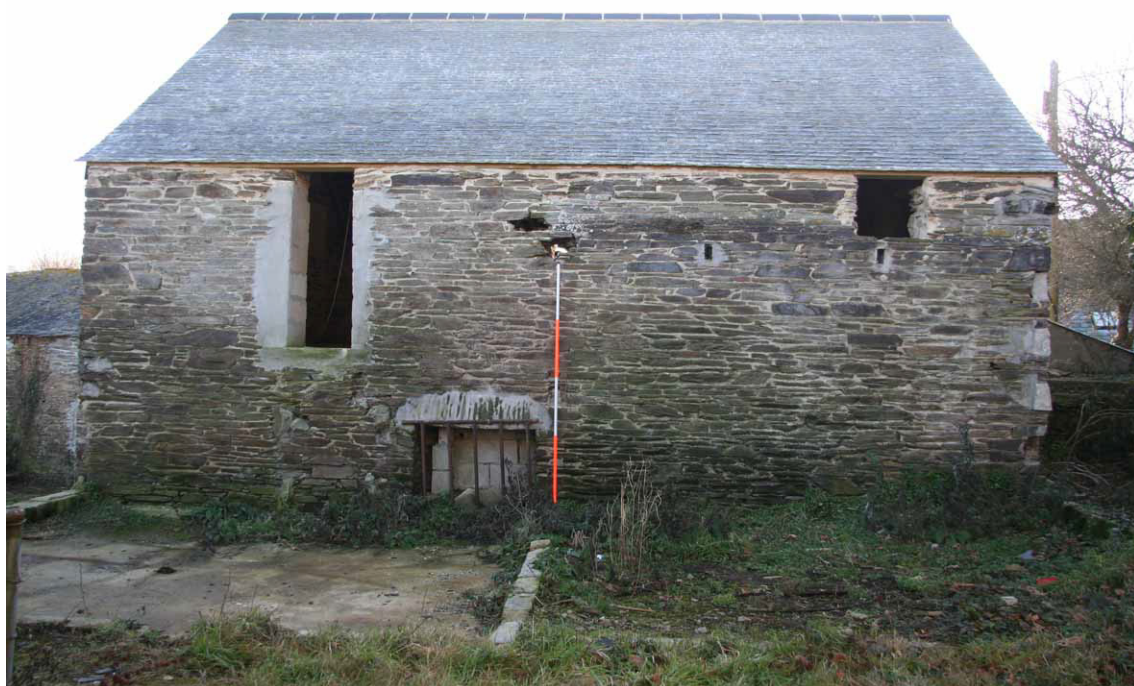
*Fig 28 NW Stable rear elevation, showing secondary openings on upper floor*
