Tintagel Castle, Cornwall

Archaeological watching brief during replacement of interpretation boards

Historic Environment Projects

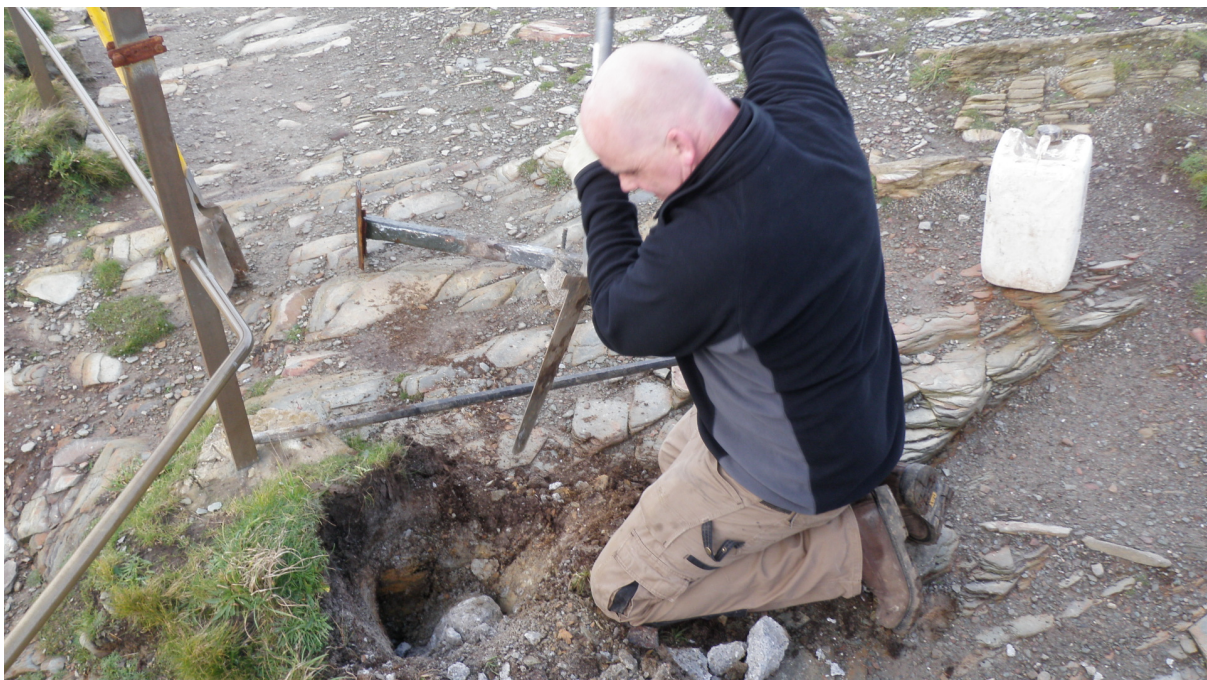
The existing lectern stand had been set into a concrete-filled posthole to the south of the tunnel fence adjacent to the path. The concrete was broken out and the posthole cleaned out to a depth of 0.40m below ground level. The posthole was 0.35m in diameter and cut through slate bedrock. No archaeological deposits were exposed.

Fig 2: Posthole 2 - breaking out concrete from the existing posthole adjacent to The Tunnel.
