Launceston Priory, Launceston, Cornwall

Clearance and archaeological recording in advance of consolidation

Client	Launceston Town Council
Report Number	2011R047
Date	June 2011
Status	Final
Report author(s)	James Gossip BA MIFA with John Allan BA MPhil FSA and contributions from Dr Roger Taylor and Nigel Thomas BA MIFA
Checked by	Nigel Thomas
Approved by	Peter Rose

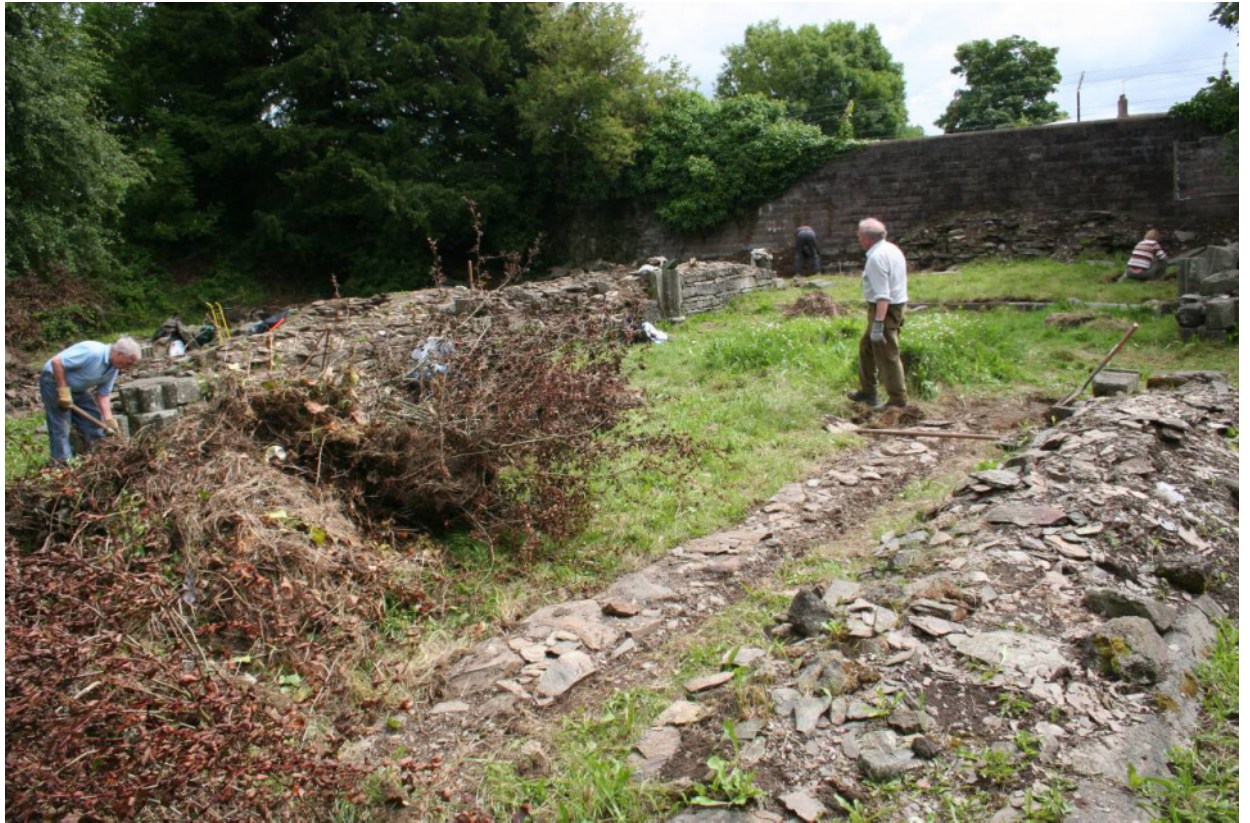
Fig 4: Clearance work underway, June 2008

HE carried out works in advance of main consolidation stage. This was undertaken by one HE archaeologist assisted by local volunteers, including members of the Friends of Launceston Priory and members of the Cornwall Archaeological Society (Figs 4 and 5).

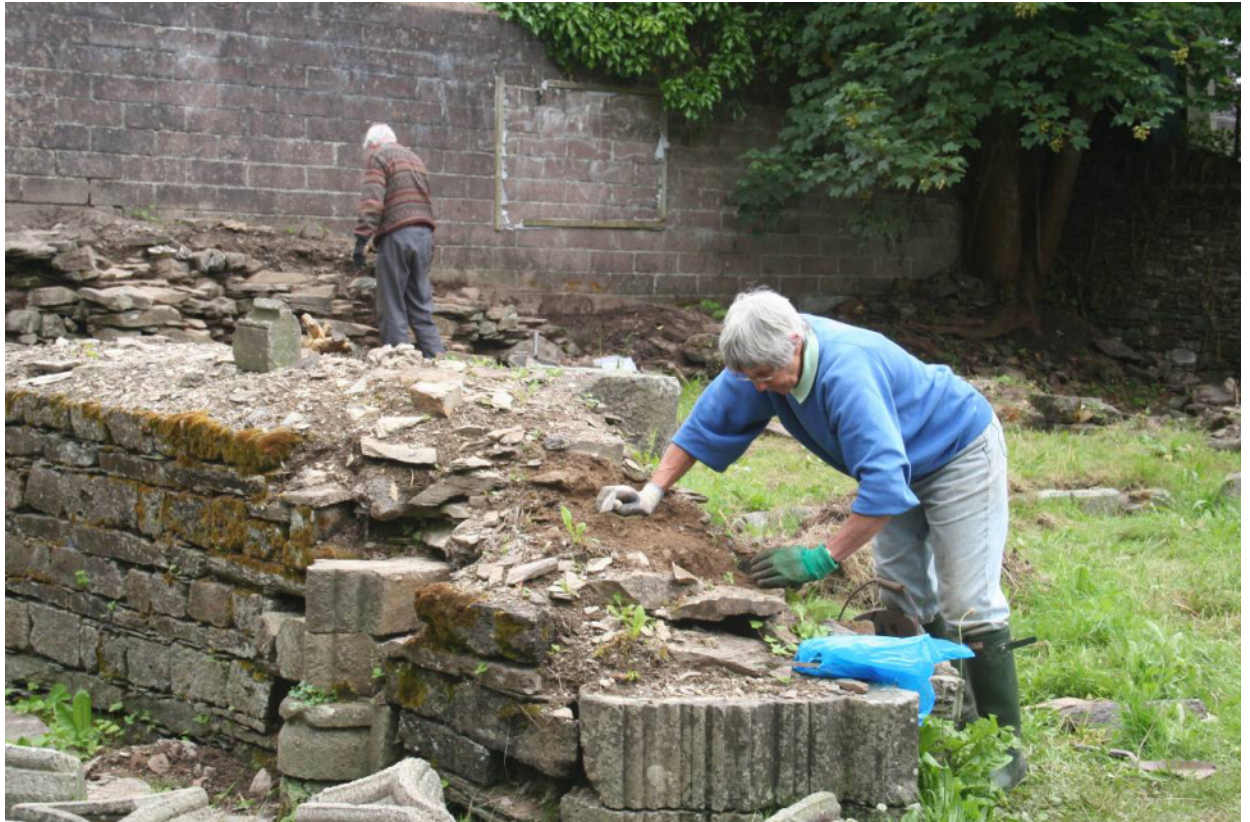
Fig 5: Clearance work underway, June 2008

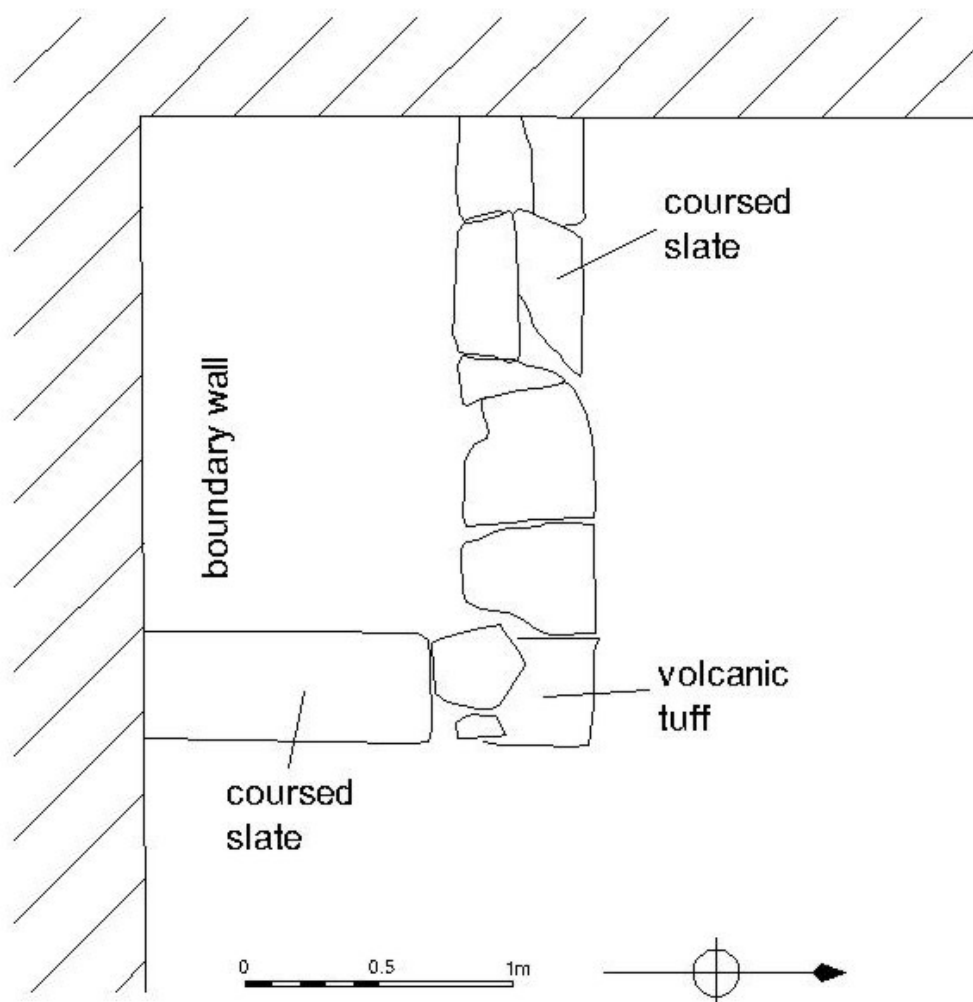
Fig 6: Cloister foundations revealed in the south-west corner of the priory site

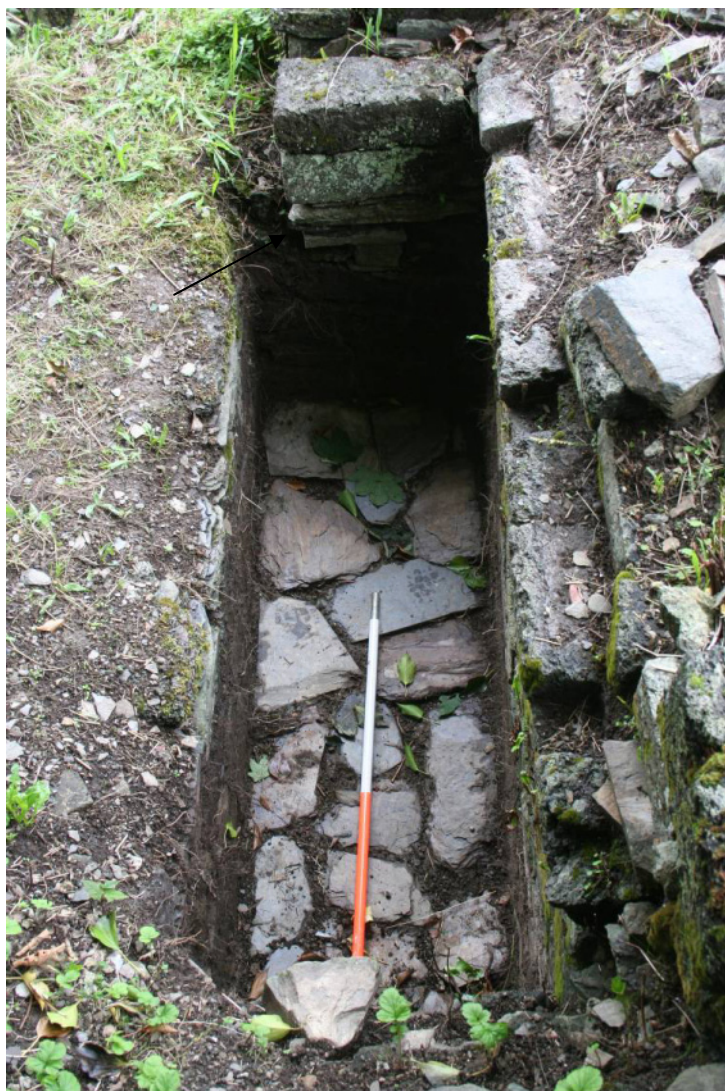
Loose masonry and accumulated rubbish was removed from the tomb of Roger de Horton to a depth of 1.2m (Figs 7 and 8). The tomb sides were constructed of coursed volcanic tuff blocks with a base of flat slate slabs. A projecting course on the north side was pierced with notches, perhaps to support a grave cover or canopy. Two fragments of a large grave cover were found in the Presbytery and these have been placed over the backfilled tomb.

Fig 7: Tomb of Roger de Horton excavated to its base

As part of the finished works the exposed tombs of Roger de Horton and Stephen Tredydan have been backfilled with gravel to c 50mm of the surrounding ground surface. Fragments of a stone grave cover found near the tomb of Roger de Horton were placed over the backfilled tomb.

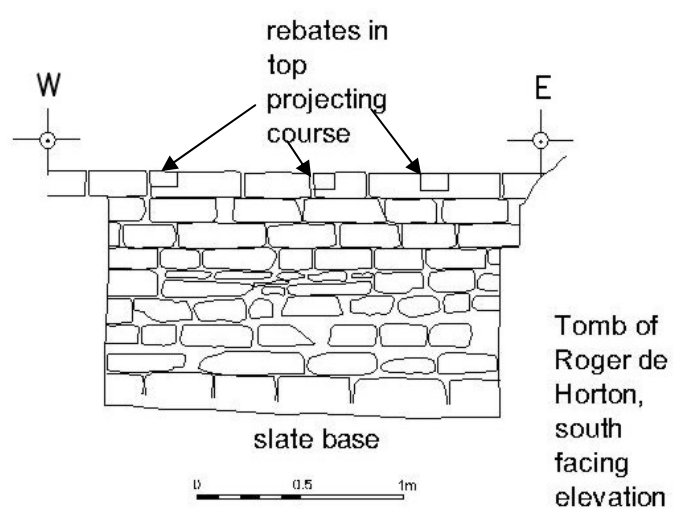
Fig 8: Tomb of Roger de Horton, south facing elevation

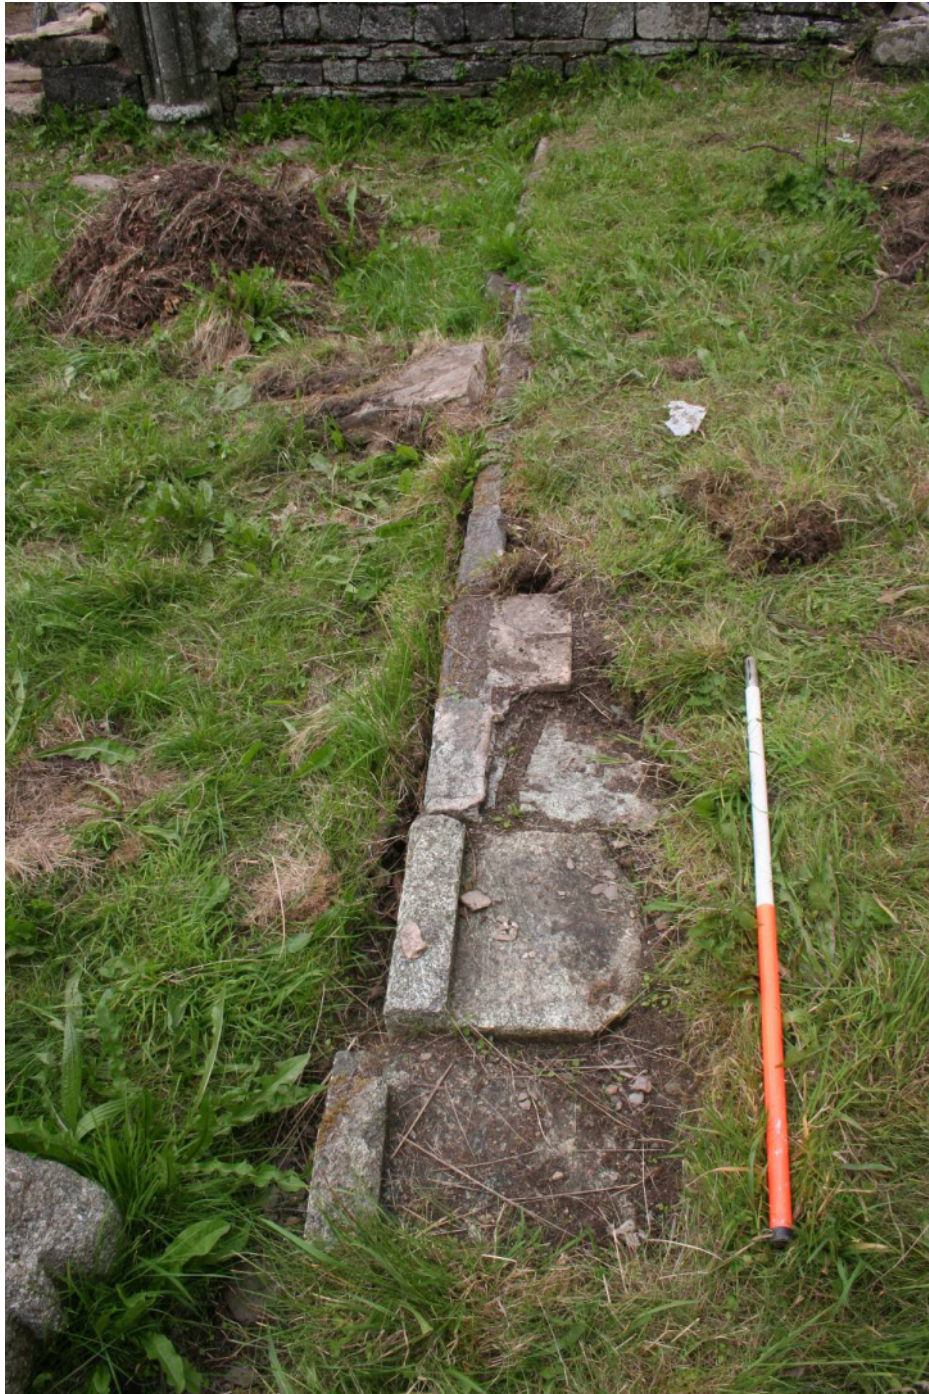
Removal of turf from above the altar steps revealed several surviving *in situ* blocks, cut with a rebate in order to fit ceramic tiles (Fig 9). Where these were missing slate blocks had been used to replace them.

Fig 9: Presbytery steps (11) showing the rebated riser blocks to accommodate tiles

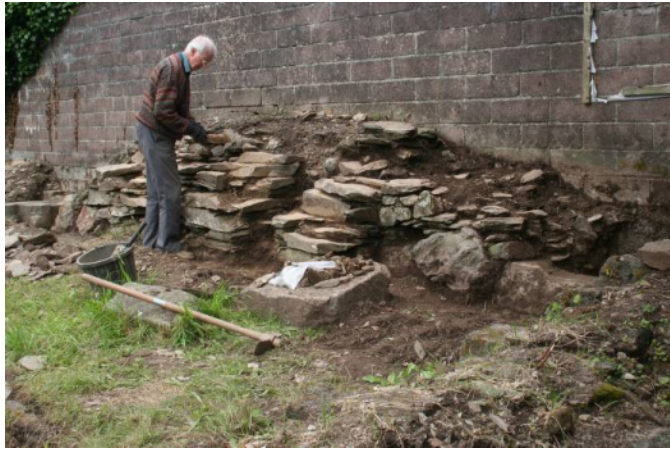
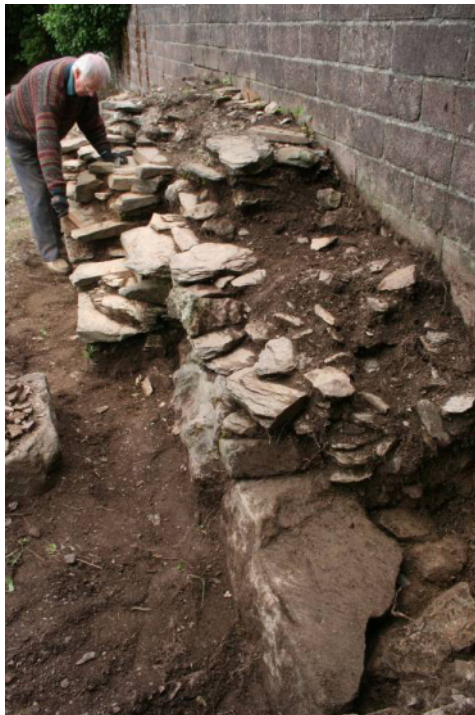
Figs 10 and 11: the foundations of the high altar (12) being cleared of rubble

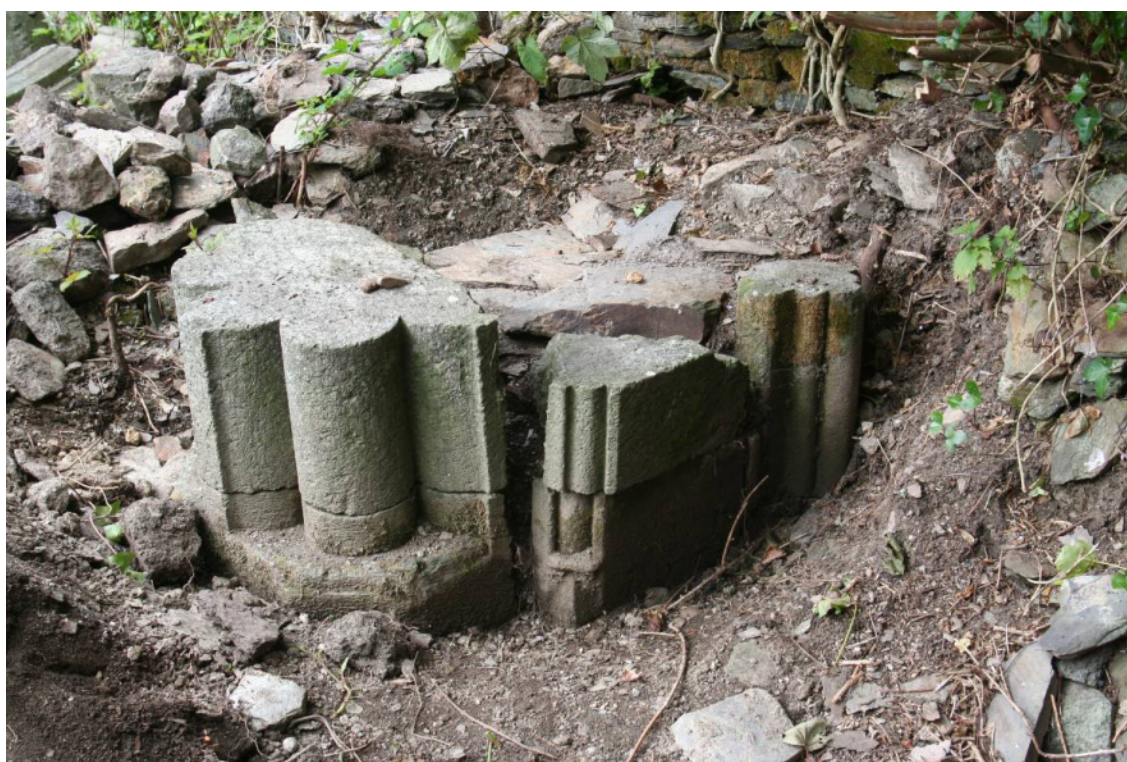
Clearance of vegetation revealed a large shaft base which had become obscured since 2001 (Fig 13). A trefoil shaft base was also uncovered on the north side of the wall to the west of tomb 16. The wall was found leaning severely on its northern side and had also been disturbed by roots of a sycamore tree.

Fig 13: Shaft base 13 cleared of loose masonry and vegetation

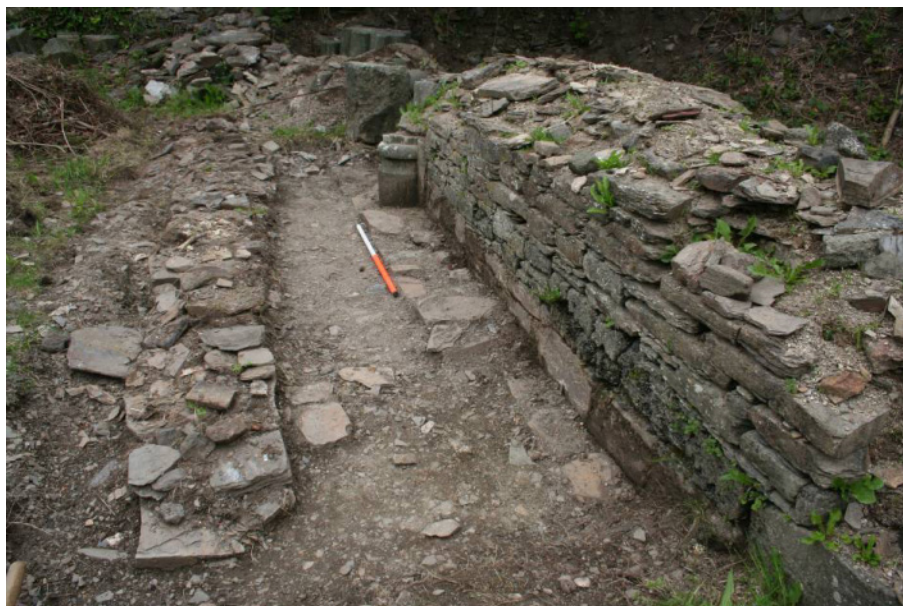
Removal of turf along the southern side of the wall revealed slate rubble footings offset by 0.35m from the face of the wall (Fig 14) and choir stall foundations (8).

Fig 14 North wall of choir (14) with offset foundations and foundations of choir stalls (8) revealed

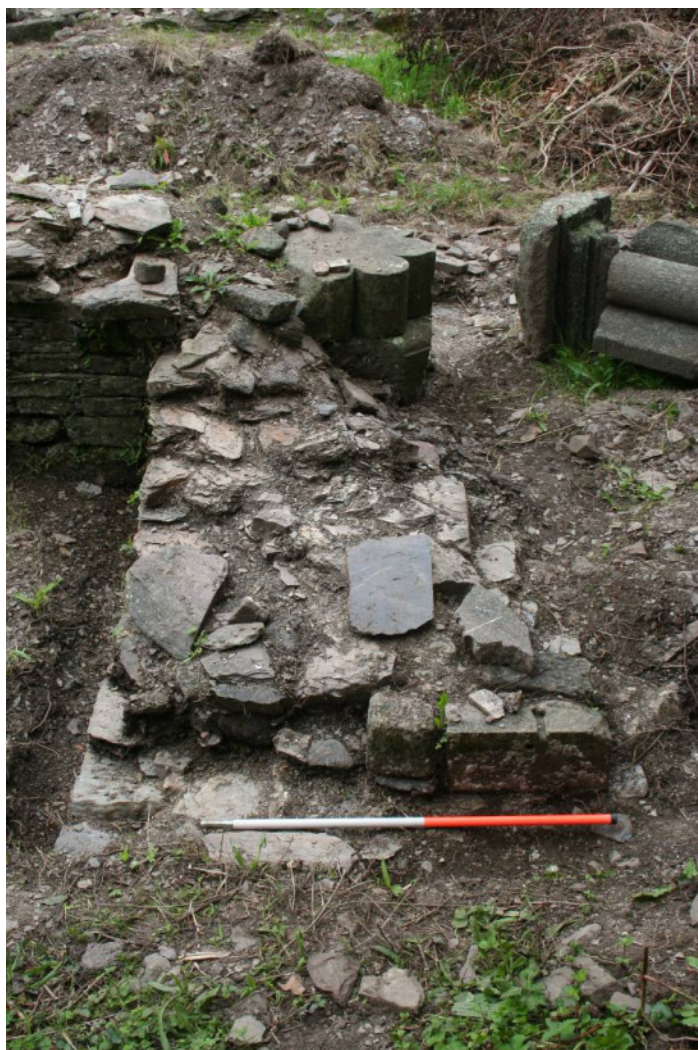
Clearance of a large quantity of loose fragmented masonry and clearance of turf at the base of the wall showed that the wall face had been robbed of stone on its eastern side. De-turfing also revealed sub-surface stonework indicating a possible continuation of the wall towards the north, possibly to meet wall 20 (Fig 15). Close inspection of the join shows that wall 15 abuts wall 14 and its masonry is not tied-in.

Fig 15: Wall 15 with robbed west face revealed and possible continuation to the north

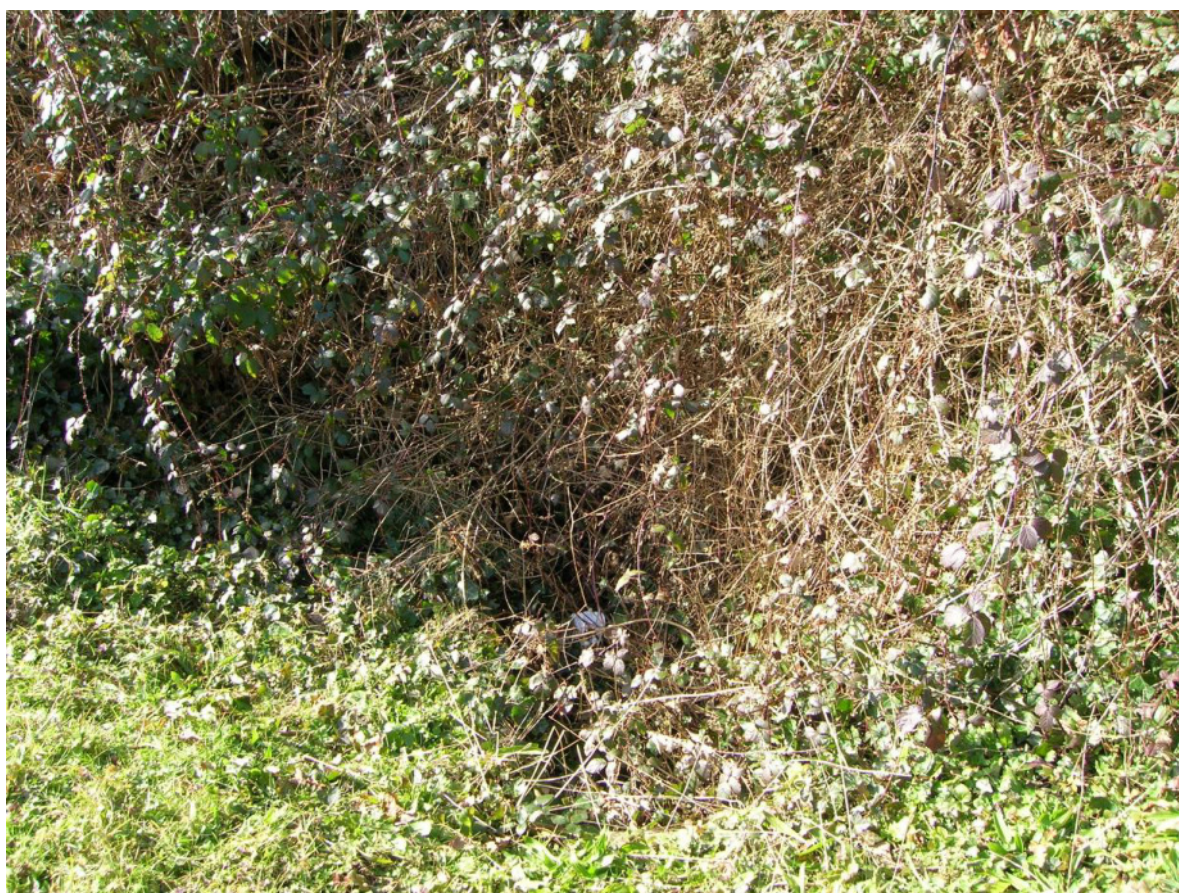
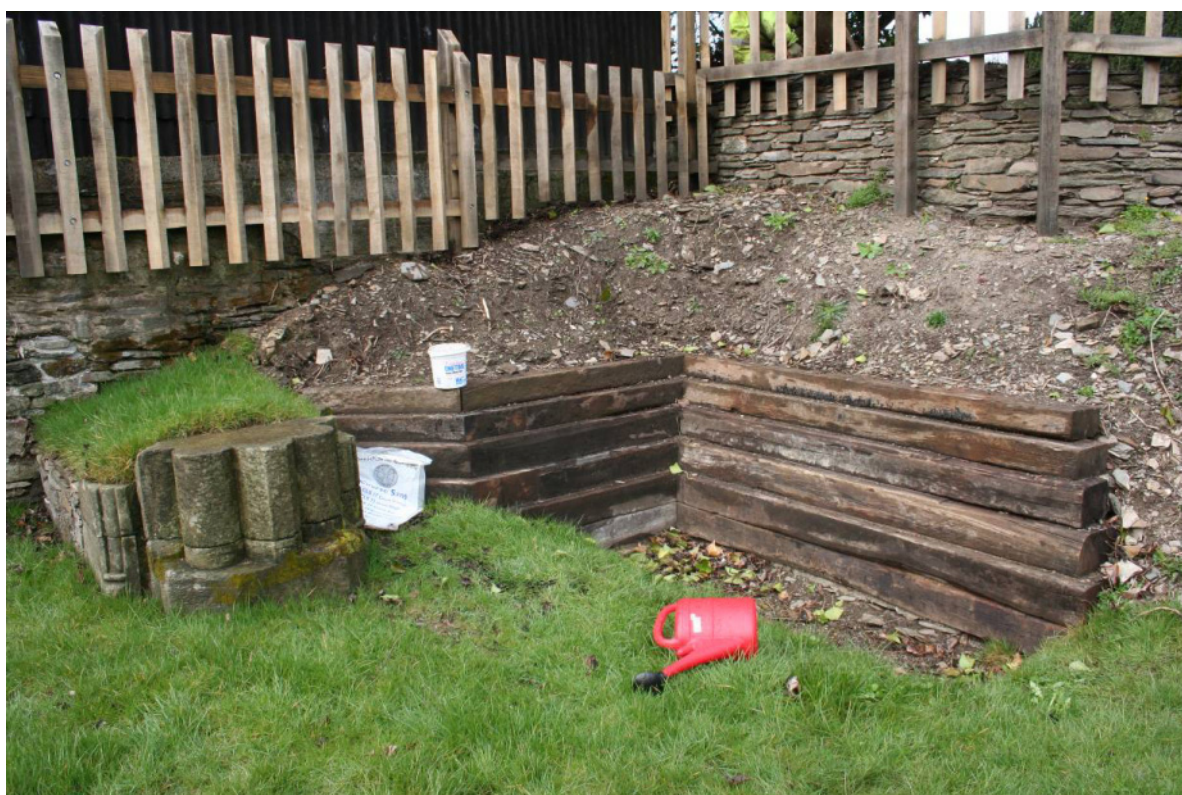
Overhanging dense vegetation, loose masonry and accumulated rubbish was removed from the tomb of Stephen Tredydan (Fig 16) to a depth of 1m, at which point a layer of sand and clay was reached. This contained numerous fragmented human long bones which had been deposited there following a 'clean-up' operation in 1976 (Arthur Wills *pers comm*). This material was not excavated but a sondage was cut to establish the depth of the grave. A single large slate slab formed the base at a depth of 1.4m, viewed at the base of the sondage cut through the sandy backfill. The east, west and north elevations were slate rubble coursed whilst the south elevation comprised dressed volcanic tuff blocks.

Fig 16: Before and After – Tomb of Stephen Tredydan (16)

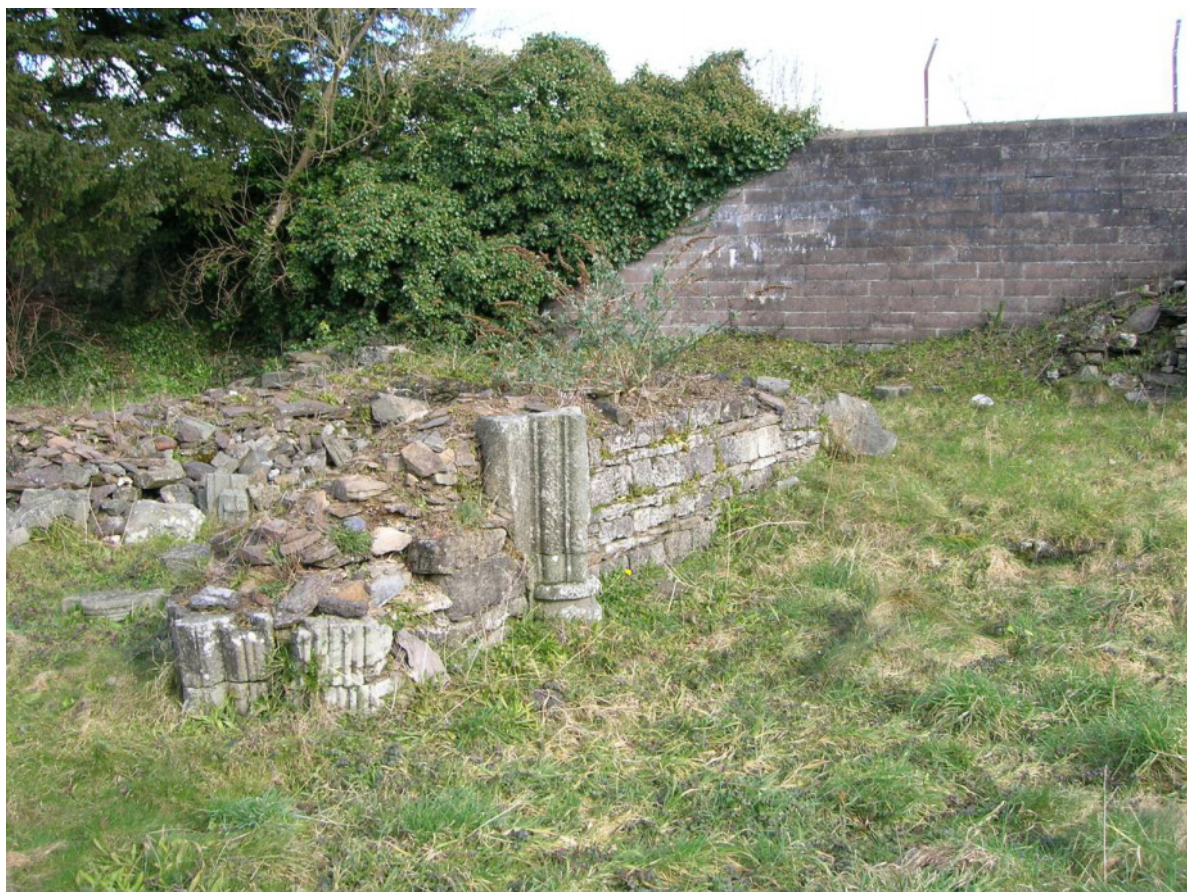
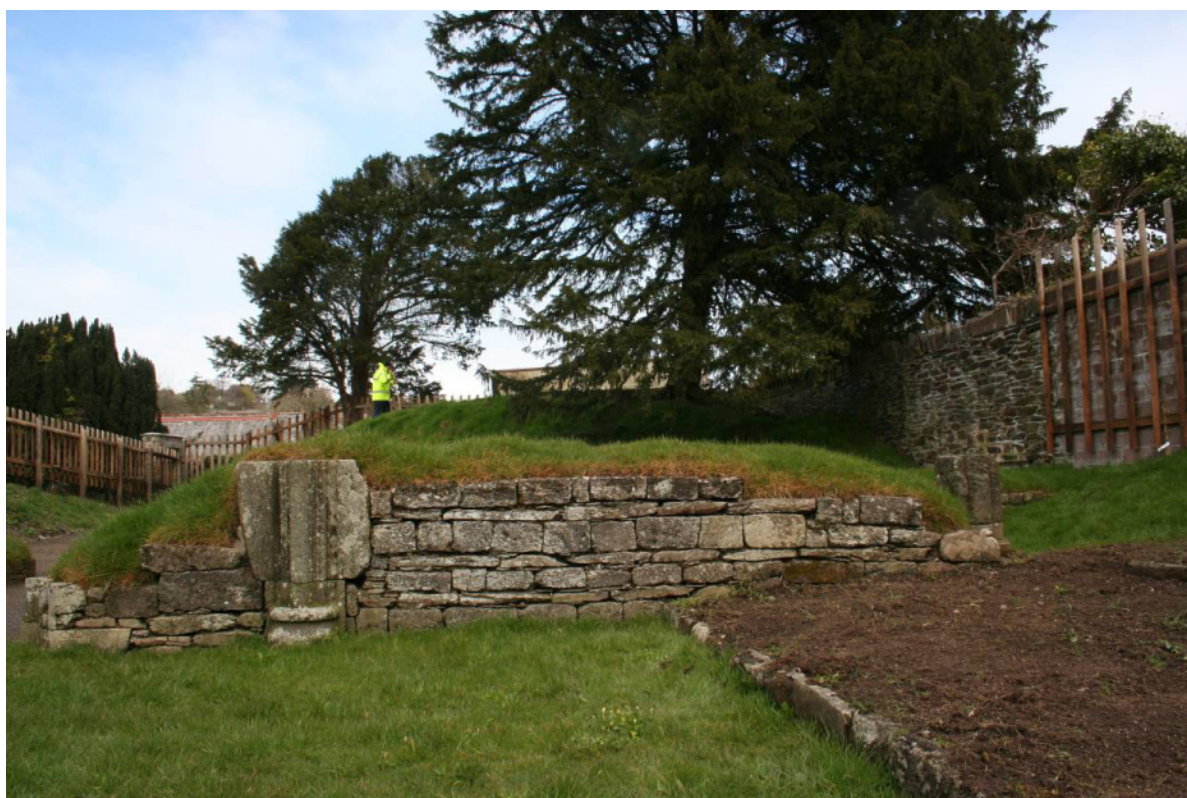
Fig 17: Before and after: Wall 17, north wall of presbytery

Removal of loose masonry and soil enabled effective consolidation and turfing of the wall (Fig 17).

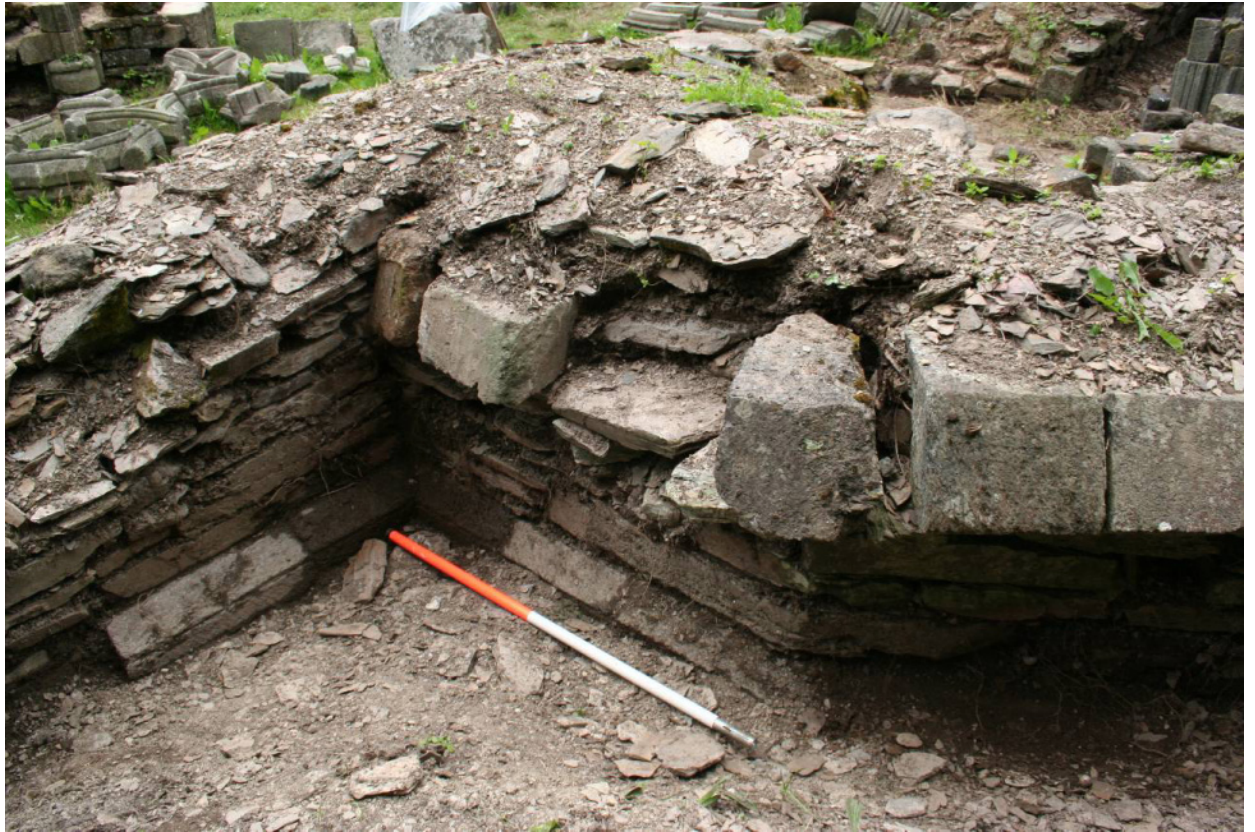
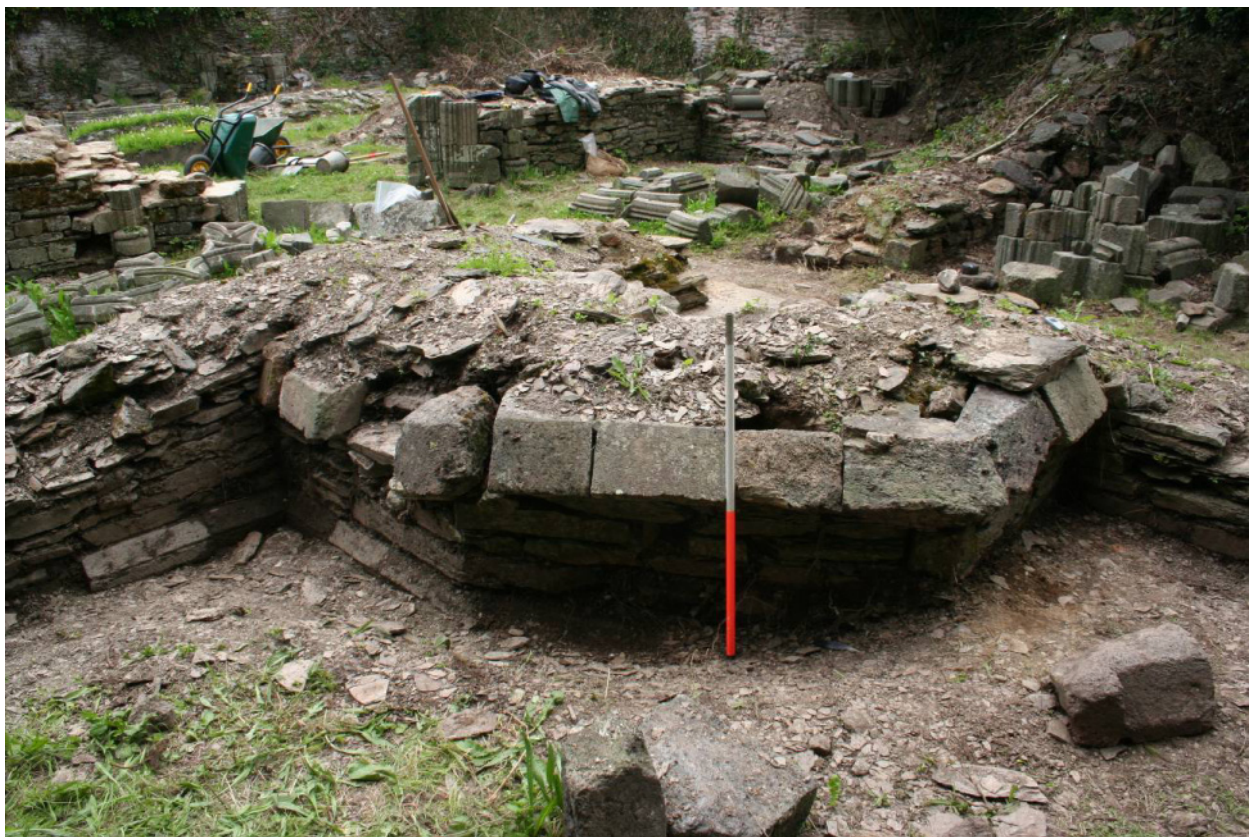
Fig 18: Wall 22 exterior wall of porch stairwell, chamfered plinth revealed by clearance

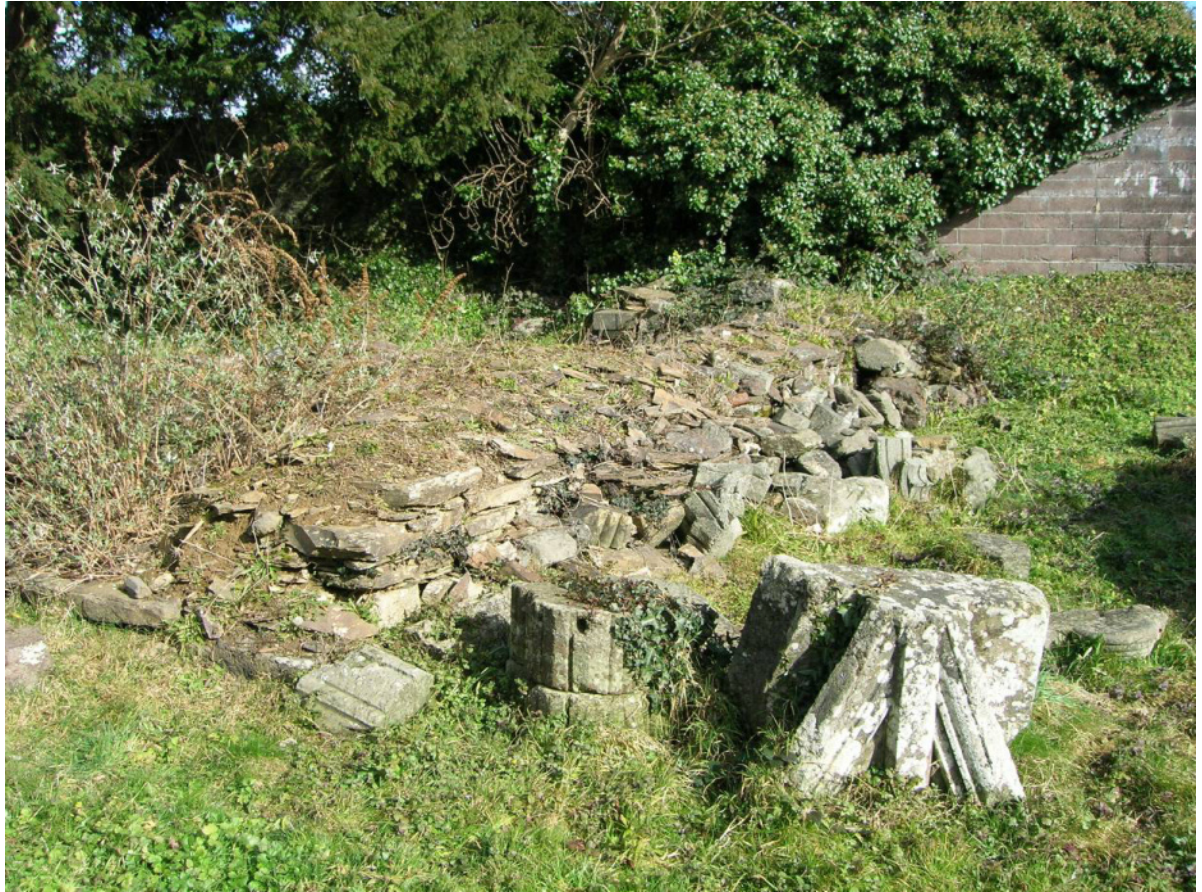
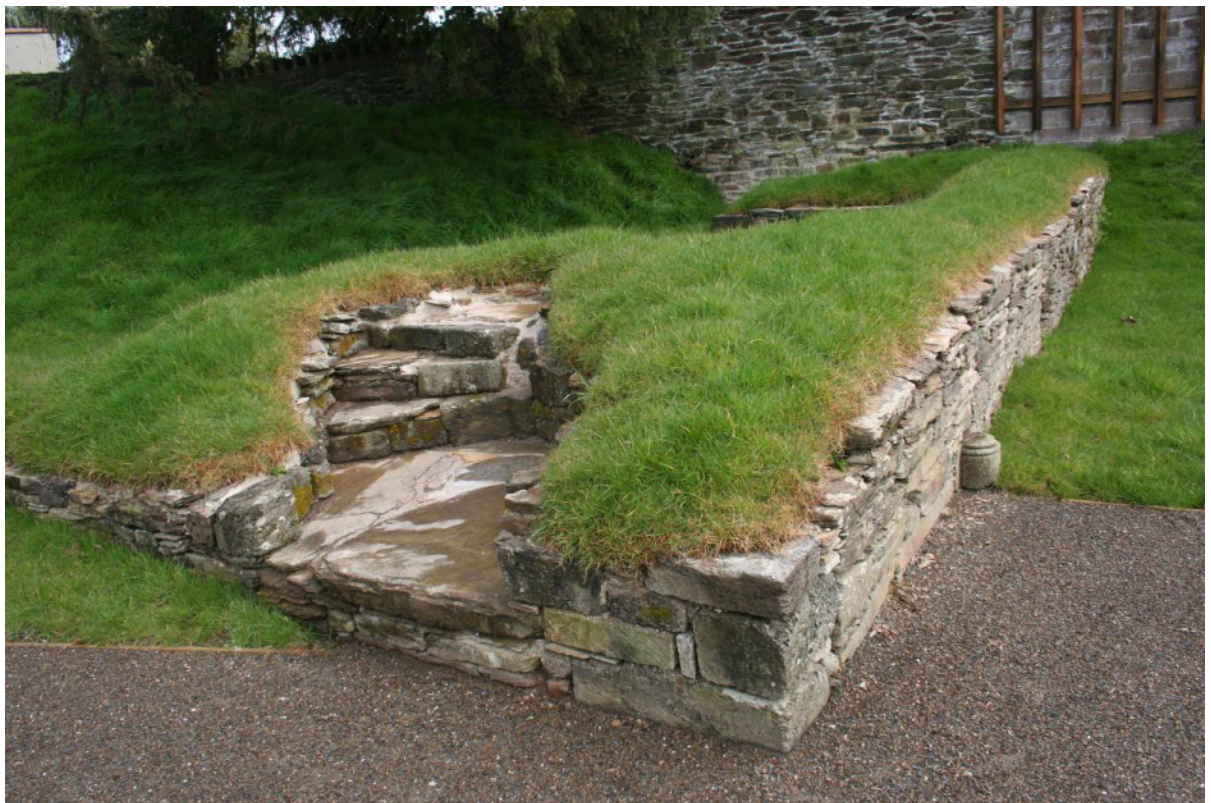
Fig 19: Before and After – Wall 21 (north wall of north aisle) and porch steps 23

Clearance of loose masonry and soil enabled consolidation of the porch steps. Slabs forming the base step were raised to remove a large buddleia root and re-laid (Fig 19).

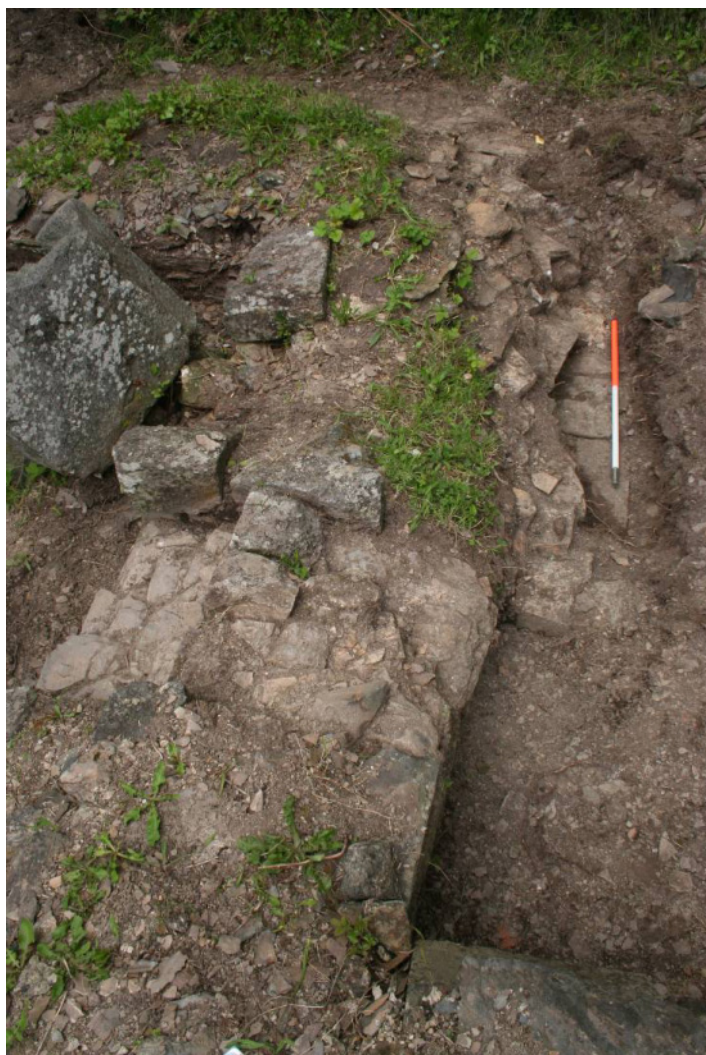
Clearance of loose stone and soil of the wall top revealed that stone facing had been robbed from the eastern elevation and the north side of wall 30. Clearance of turf and excavation of soil at the base of the eastern side of the wall uncovered large dressed stone blocks 0.35m below ground, suggesting foundations or the remains of a possible earlier phase wall (Fig 20).

Fig 20: Wall 23 (east side of porch) showing robbed wall face and offset foundations

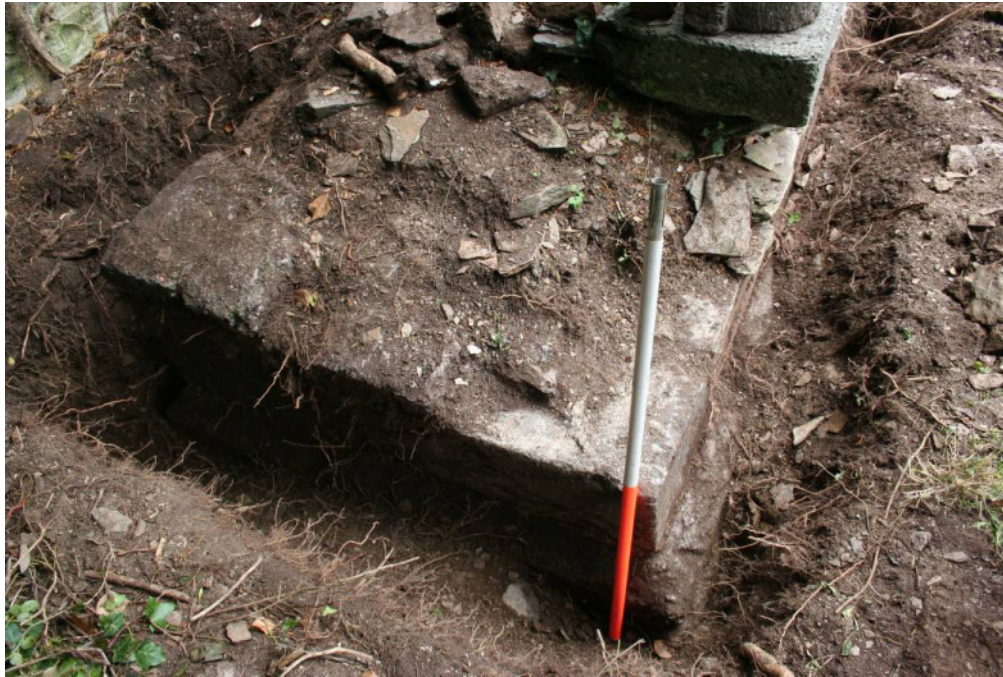
Loose soil and vegetation was cleared from the eastern side of the wall in order to clarify its return (Fig 21). Excavation revealed dressed blocks facing the eastern elevation and northern end of the wall below ground level, built upon a chamfered plinth base 0.35m below surface.

Fig 21: Wall 24, edges of buttress revealed by clearance

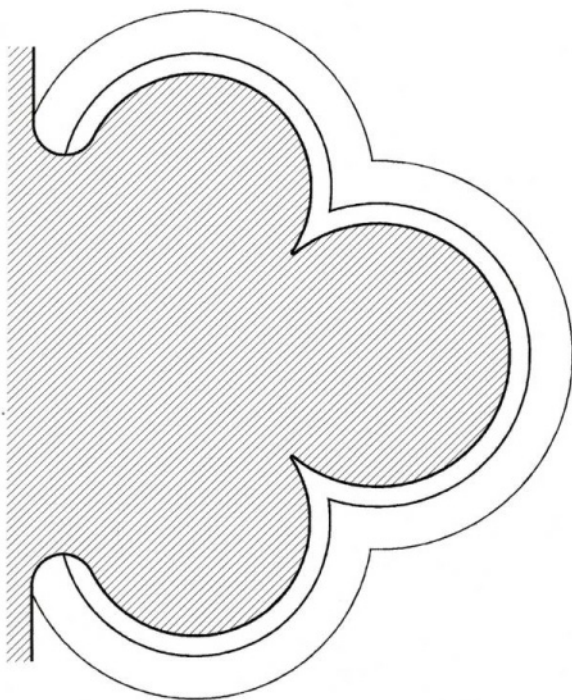
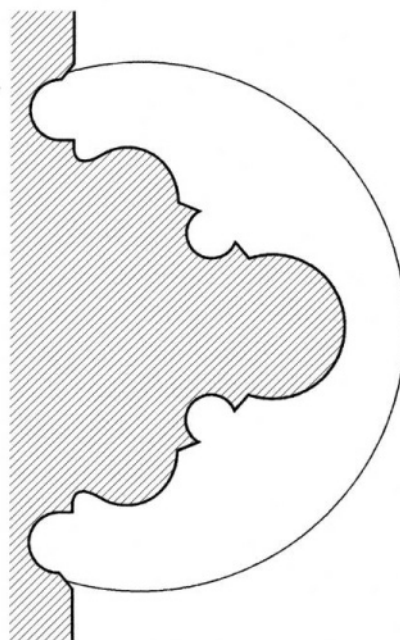
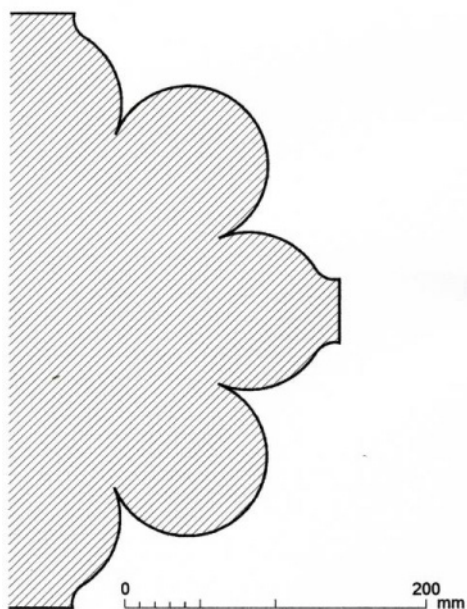
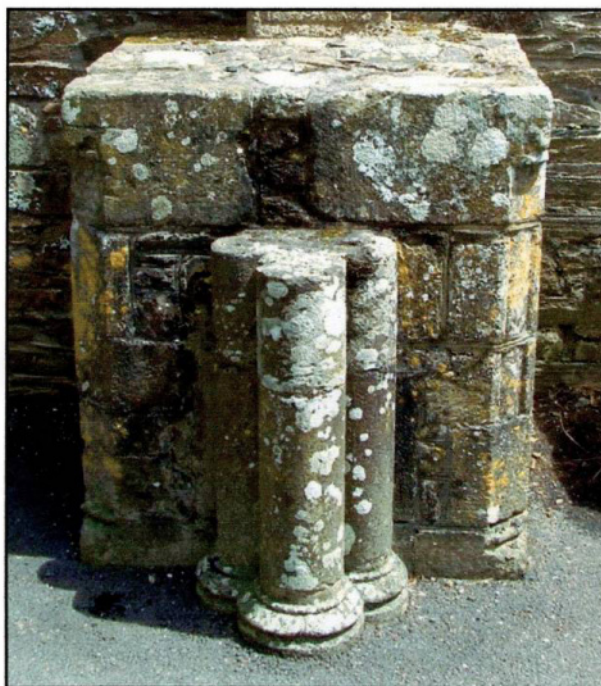
In tackling this collection, the profiles of the moulded masonry surviving *in situ* in the monument were first drawn (Figs 26–27); corresponding pieces were identified among the loose fragments. The most significant of the other architectural fragments examined were as follows:

Fig 26: Launceston Priory: profiles of engaged shafts and respond; view of shaft 1 rebuilt beside St Thomas' church.

The impressive features of the choir and presbytery must have been their vaults and windows. Although the engaged shafts surviving in the walls seem rather small (Fig 26, shaft 2), the loose fragments show that there was a vault with an elaborately moulded ridge rib, and it probably had a cross-rib as well. In view of the diagonal setting of the base of the north-east corner shaft and the use of bundles of three mouldings in the attached shafts in the north and south walls, it appears that the vault incorporated diagonal ribs. Since no bosses or elements of the *tas-de-charge* appear to survive among the other fragments, insufficient evidence survives to allow a more detailed reconstruction of its form.

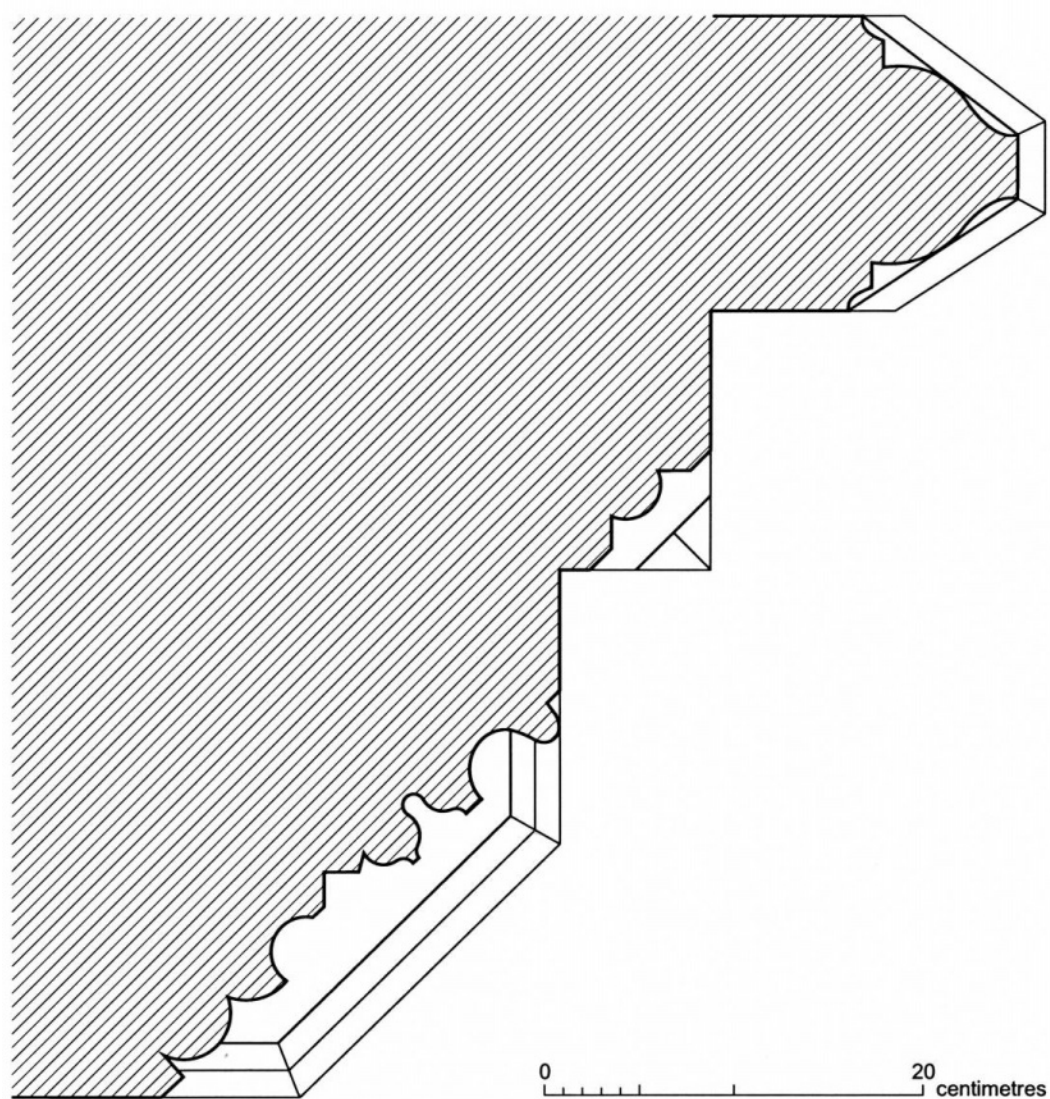
Fig 27 Launceston Priory: mouldings of the north doorway of the choir
