Launceston Priory, Launceston, Cornwall

Clearance and archaeological recording in advance of consolidation

Client	Launceston Town Council
Report Number	2011R047
Date	June 2011
Status	Final
Report author(s)	James Gossip BA MIFA with John Allan BA MPhil FSA and contributions from Dr Roger Taylor and Nigel Thomas BA MIFA
Checked by	Nigel Thomas
Approved by	Peter Rose

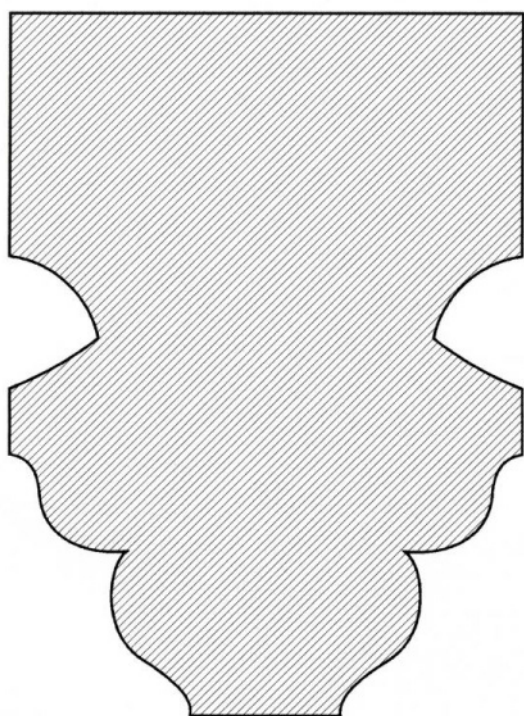
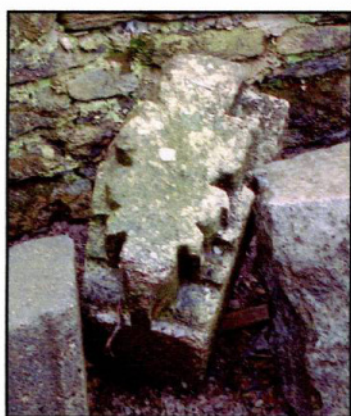
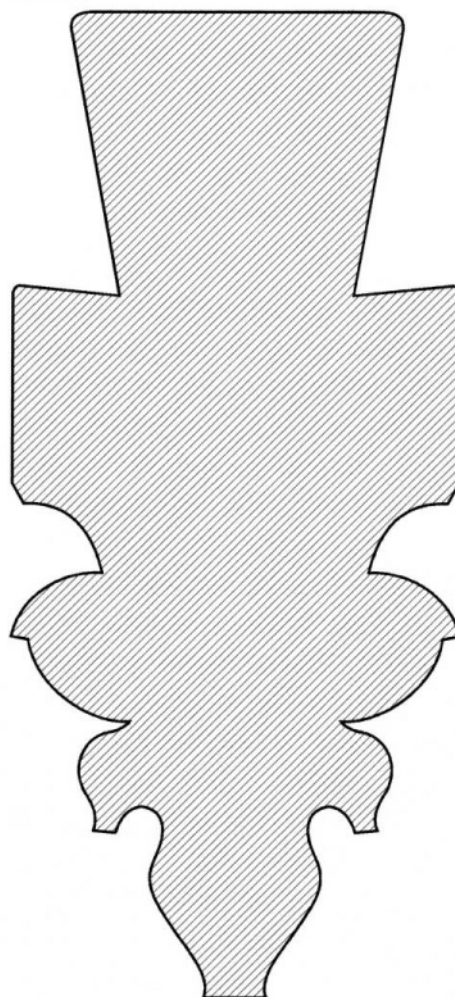
Two different profiles of vault rib were noted, one simpler and probably earlier than the other (Fig 28, Ribs 1 and 2). All the examples of type 2 are ridge ribs, whose straight faces and key-shaped upper projection are readily distinguishable from curving tiercerons. One important fragment (Fig 28, lower) incorporates the profile of a rib of this type in an arch voussoir. This provides possible evidence for a transverse vault rib; the relationship could arise at its junction with the outer mouldings of the clerestorey windows. It may alternatively mark the junction of the ridge rib with the outer voussoirs of the east or west window, although a boss might be expected at that junction.

Fig 28: Launceston Priory: vault rib mouldings

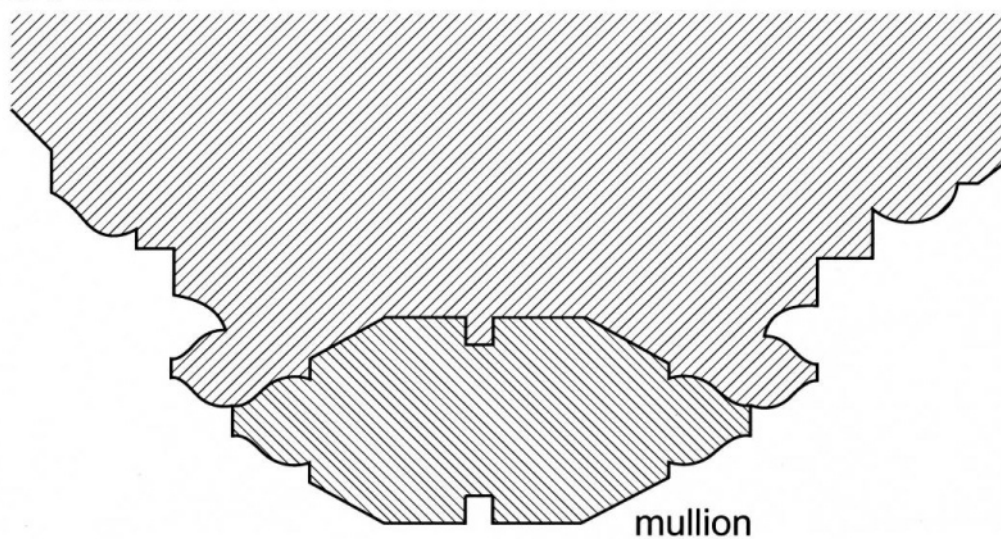
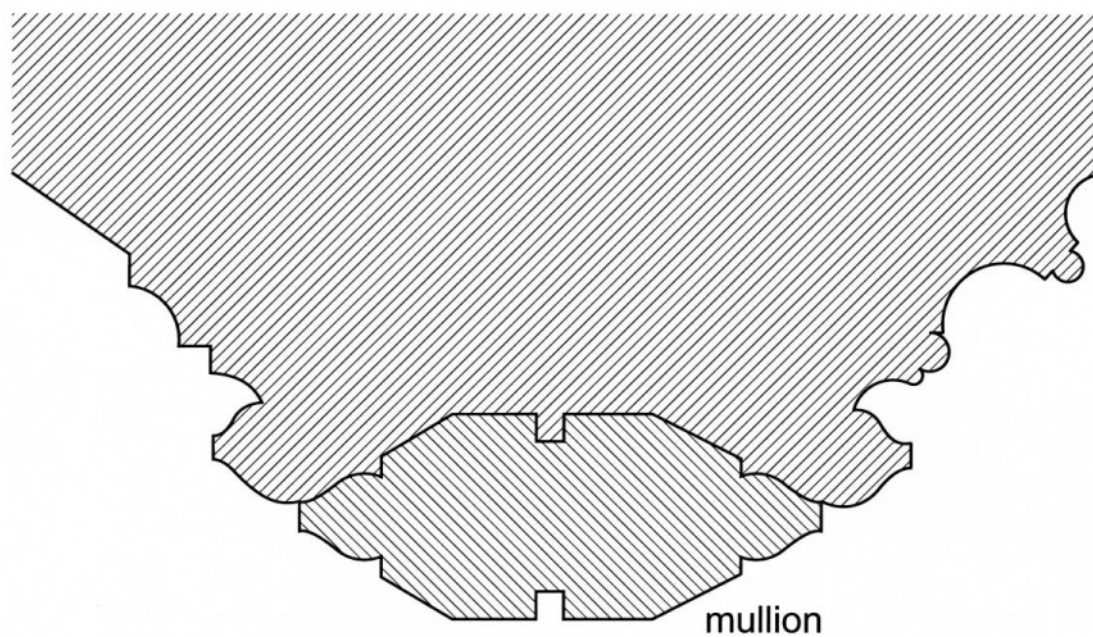
Fig 29: Launceston Priory: window mullion profiles superimposed over two jamb mouldings

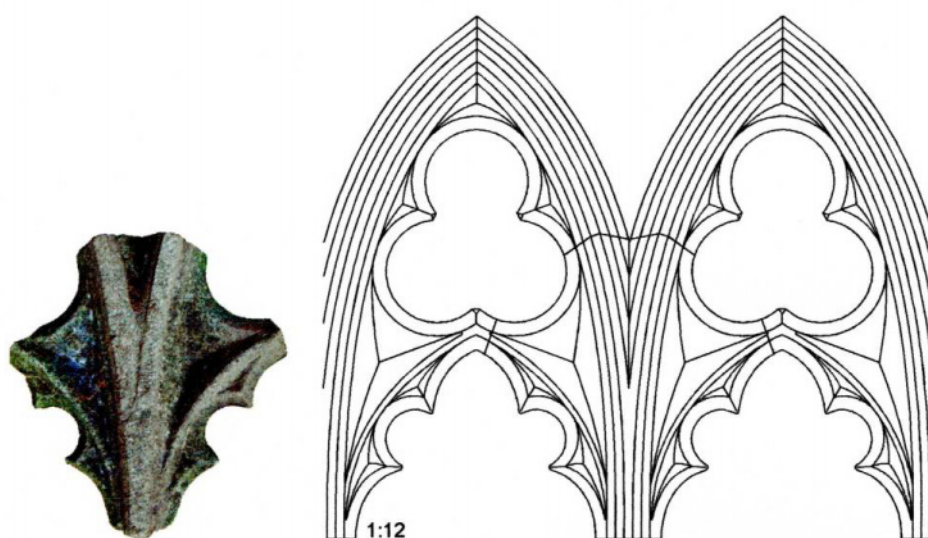
Fig 30: Launceston Priory: tracery fragment with proposed reconstruction

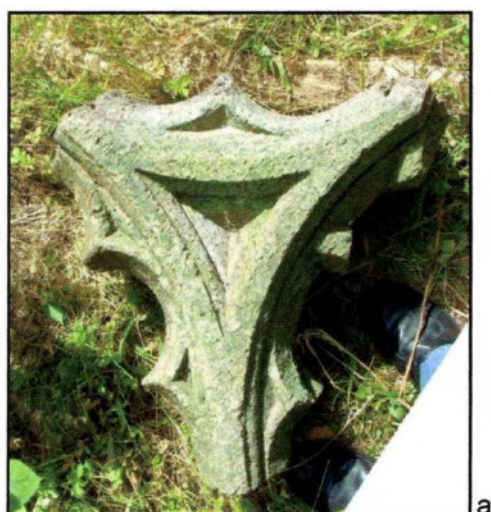
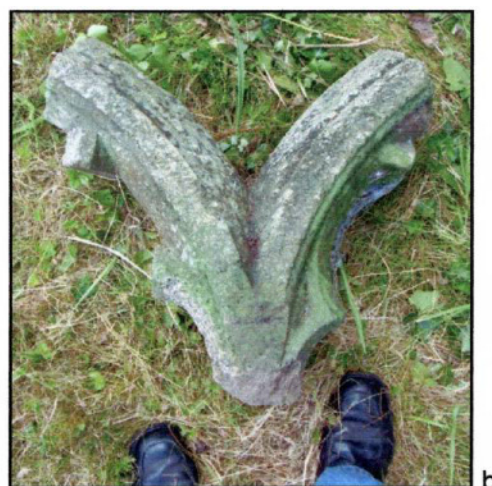
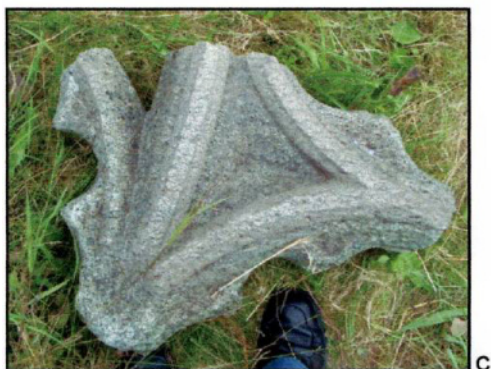
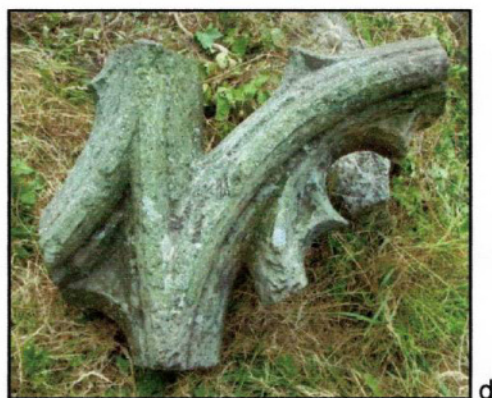
Fig 31: Launceston Priory: fragments of Decorated window tracery

The most exciting feature of the architectural fragments is the series of portions of tracery from complex windows in the Decorated style. These can only be interpreted accurately if detailed measured drawings of each piece are prepared – a task outside the scope of the present project. A single example of precise drawing leading to this kind of reconstruction is shown here: the junction of the heads of two cinquefoil lights, with a pair of upper foils which can each be restored as parts of trefoils (Fig 30). Various other components of window lights and circular motifs with internal foils are shown in Fig. 31. There is also a portion of a circle with what may be one side of an internal *mouchette* (curving dagger-shaped motif) which is clearly from a complex pattern; Richard Parker's provisional sketches of the restored design are shown in Fig 32, left side. Another fragment shows part of a wheel motif with two abutting internal foils, a possible restoration of which is also shown (Fig. 32, right side).

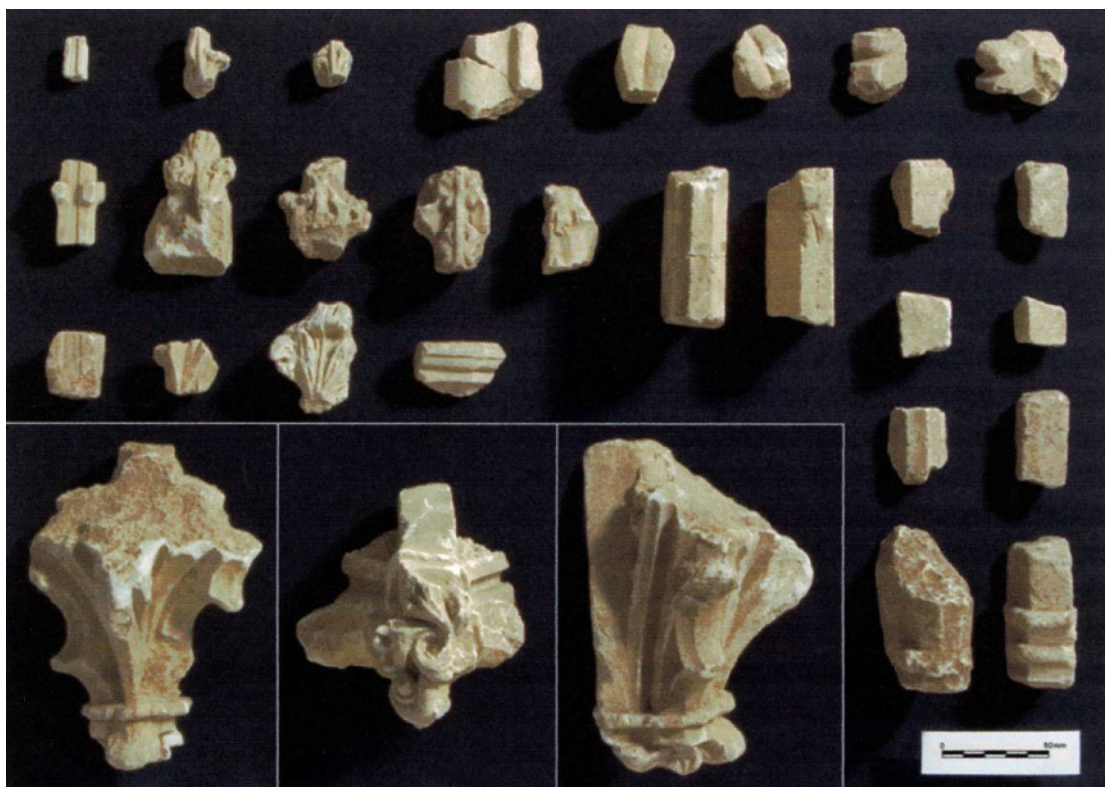
Fig 33: Launceston Priory: Beer stone fragments salvaged from the area of the high altar by Arthur Wills in 1976

In his account of his excavation of the presbytery, Peter recorded that 'numerous fragments of beautifully carved Bere [Beer] stone have been discovered around the site of the [high] altar (Peter 1893a). In the course of cleaning in 1976 a series of richly carved white limestone fragments was recovered by Mr Arthur Wills; these are certainly of Beer stone, confirming Peter's identification of the source. They are exquisitely carved. Portions of finials, shafts and foliage ornaments from miniature canopies are represented; the most telling piece is the terminal from a pendant of a small canopy with an internal ribbed vault and with lively foliage carving on the underside (Fig 33).
