Lanlivery churchyard wall, Cornwall

Archaeological watching brief

Report No 2011R047	Report Name Lanlivery churchyard wall, Cornwall.	Report Author Anna Lawson-Jones
Event Type Archaeological watching brief		
Client Organisation Cornwall Council	Client Contact Andy Cook	
Monuments (MonUID) MCO26722		
Fieldwork dates (From) 21 st March 2011	(To) 31 st March 2011	(Created By) Anna Lawson-Jones
		(Create Date) April 2011
Location (postal address; or general location and parish) Lanlivery church yard walling, Lanlivery, Cornwall.		
(Town – for urban sites) n/a	(Postcode) PL30 5BT	
(Easting) X co-ord SX 08021	(Northing) Y co-ord 59025

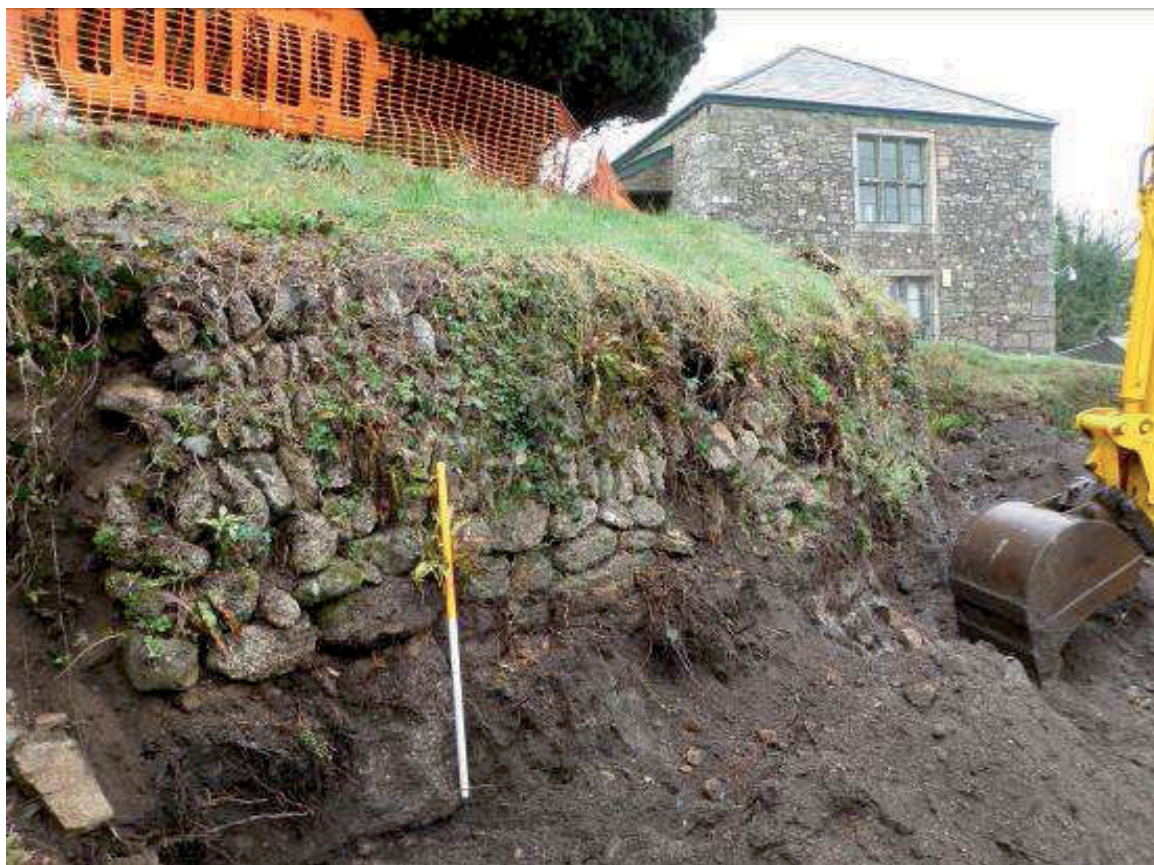
Figure 6 Looking north-east along the churchyard wall prior to dismantling, showing newly revealed basal wall foundations.

The above-ground 18m long walling to be repaired had an approximate 2m height along its length. Thomas (2010) recorded the likely presence of the original lann walling approximately 1m to the north, within the churchyard matrix itself. At the time of fieldwork, the potential top of earlier walling could still be seen as an uneven/stony break of slope – see Figure 6.

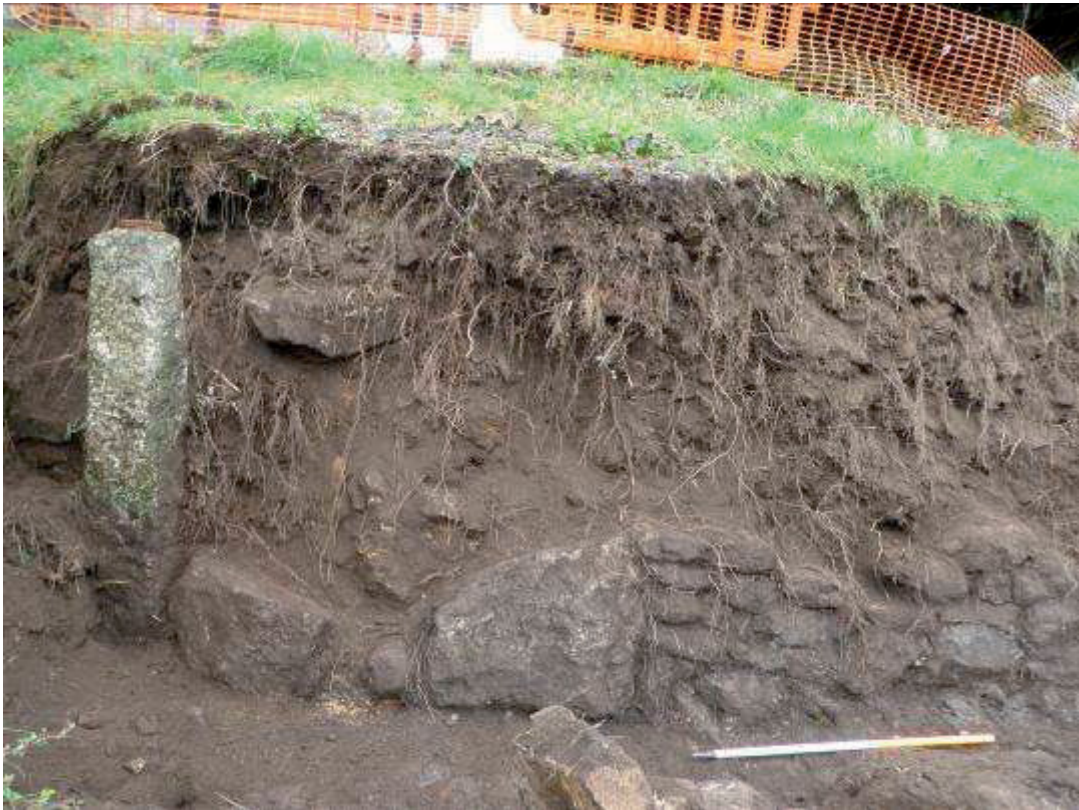
Figure 7 Looking north at the western end of the wall, showing the c19th century granite gate post (subsequently removed) and differing wall construction techniques.

shed for the wall builders) it was found to be c1.8m in height. It was almost certainly linked to the animal enclosure or pen shown on the 1880 (Figure 3) and 1907 OS maps. It was lifted complete and stored for later reuse as a garden decoration. Photograph Figures 7 and 9 show the gate post *in situ*. Access behind the shed showed that an approximate 2m length of the extreme western end of the wall (at its junction with the modern walling separating the former vicarage garden from Lanlivery Cottage garden) was mortared, stable and did not require reconstruction. However, to the east of this point – extending from approximately 2m west of the gatepost eastwards the walling did need to have its upper dry stone courses removed. Below this a series of larger, granite blocks (up to 0.6m long) were recorded, supporting occasional horizontally lain, smaller blocks of up to 0.3m length and 0.55m high. To the immediate east of the gatepost two large (up to 0.8m long) granite blocks were seen (without overlying stones) – Figure 7, which were immediately abutted by smaller, neater, horizontally placed stones to the east – 0.75m high. Although visually these two basal sections of walling look strikingly different it is unlikely that they date to markedly different periods of construction. The pronounced difference at this point appears to be the result of the wall being destabilised during insertion of the gate post, and the result of other collapse and repair. It is probable that the whole length of walling in this area is of 19th century origin, with the earliest surviving section being the larger, basal granite blocks.

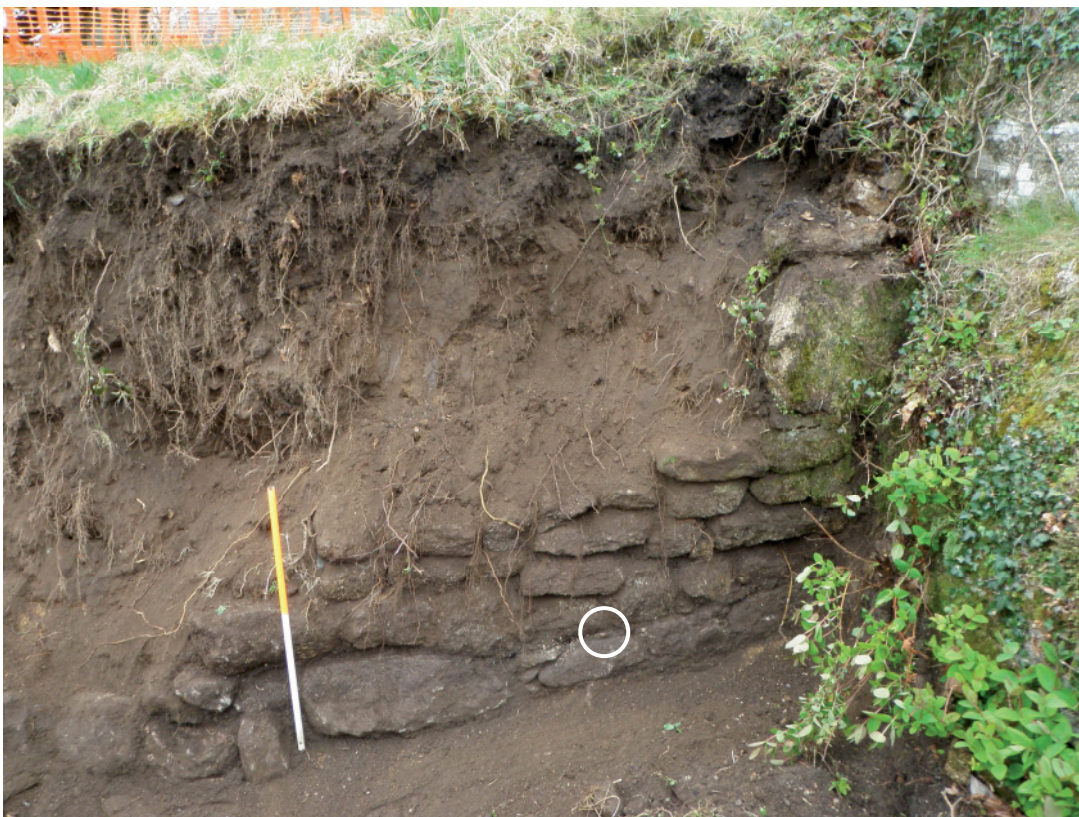
Figure 8 Looking north at the extreme eastern end of the wall - where it joins the Listed church steps. The white circle marks the find spot (between the stone coursing) for two sherds of c19th century pottery (which dates this part of the wall).

The eastern c3m long stretch of walling abuts the Listed churchyard steps – see Figure 8. Here a similar pattern of larger slab-like granite blocks formed the lowest layer, with horizontally laid smaller stones positioned above. These, smaller stones were notably neat and had a near vertical face, unlike the slight northward battering noted in the rest of the wall. It is likely that this short section – located between the church steps and the completely collapsed portion (shown in Figures 8 and 9), was laid with particular care because of its proximity to the steps. Again 19th century in date, this short stretch of wall had the most substantial retained height – up to 1.3m high (at the actual junction with the steps wall). Located between the basal slabs and the overlying smaller stones, two adjoining pieces of *in-situ* 19th century terracotta pottery were found (see Figure 10) - the only material dating evidence found for the wall.

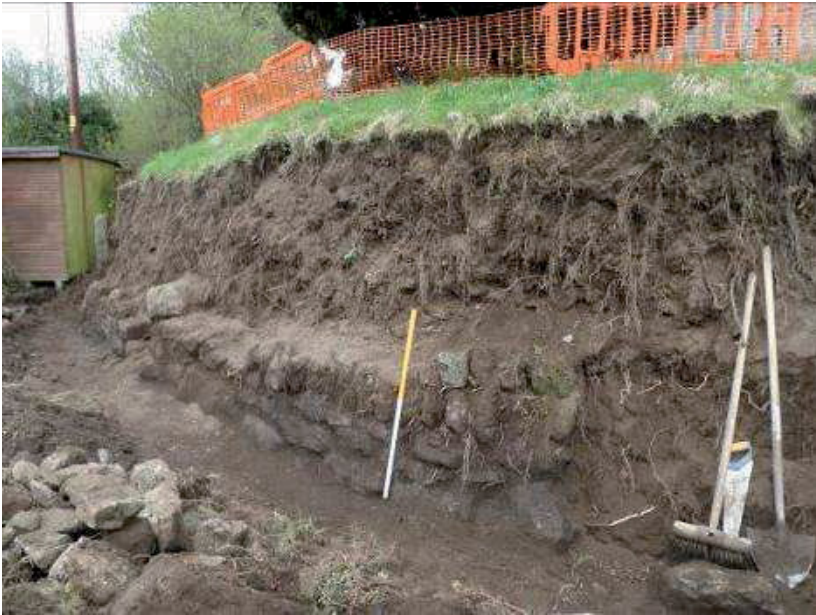
Figure 9 Looking south-west along the exposed basal walling, showing the gap caused by recent collapse and subsequent repair work.

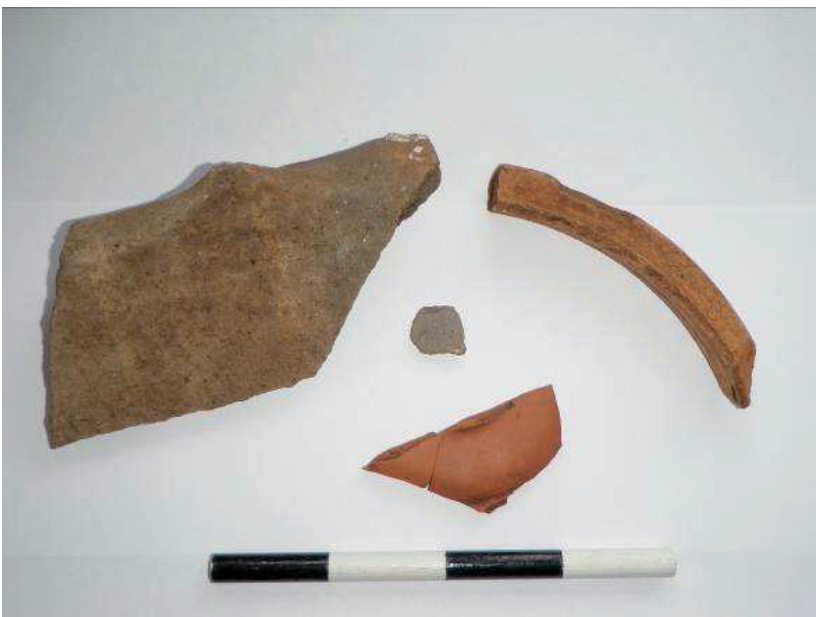
Figure 10 Retained finds; large piece of partially painted medieval ridge tile; small piece of medieval pottery; rim sherd of post-medieval storage jar; and adjoining red terracotta sherds of c19th century date- confirming late date of eastern end of walling. 0.2m scale.

- Earlier finds were selectively kept; including two late terracotta ware pieces useful in the dating of the wall (see Figure 10).

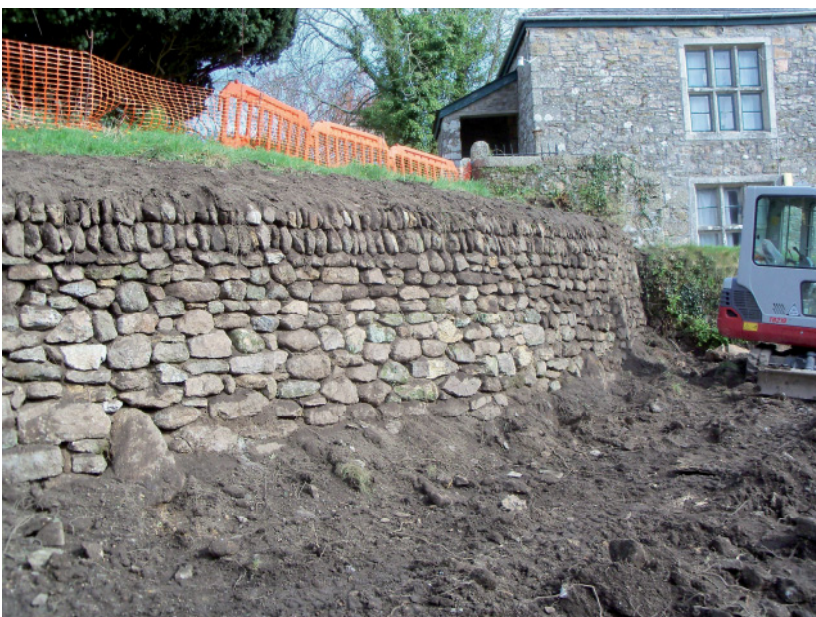
Figure 11 Looking north along the completed new walling.
