REPORT

INTERKONSULT Limited

A Ground Radar Survey of the West Face of Welton-le-Wold Gravel Quarry, Lincolnshire

July 2003

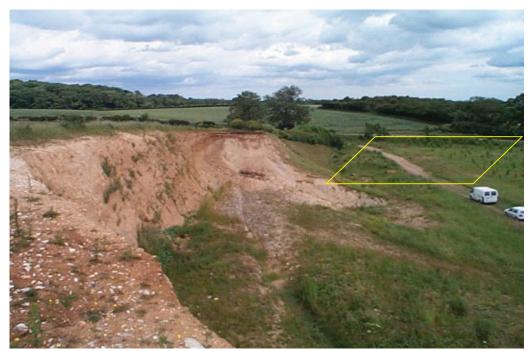
Figure 1 – GPR Mapping area

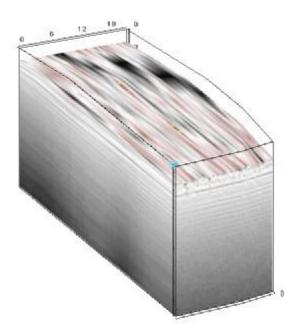
Figure 3 – Block Model Composite of Profiles

The three-dimensional composite of the profiles also confirms a more permitive area to the Northwest of the survey grid. A horizontal section through the block at 2.5m depth is overlain on the topographic Plan WLW001 and Figure 4. The dark anomaly which coincides with the marked bench line extends towards the north-western part of the grid where the gravel beds are already known to be intact. When the GPR overlay image is compared to an aerial photograph both in its natural and filtered formats (Figure 6), the same "shadow" depicted on the GPR image is visible on the photograph and probably coincides with either differential vegetation growth or a slight difference in surface levels. Such an effect would be consistent with different ground materials or states of compaction associated with a back-filled quarry bench.

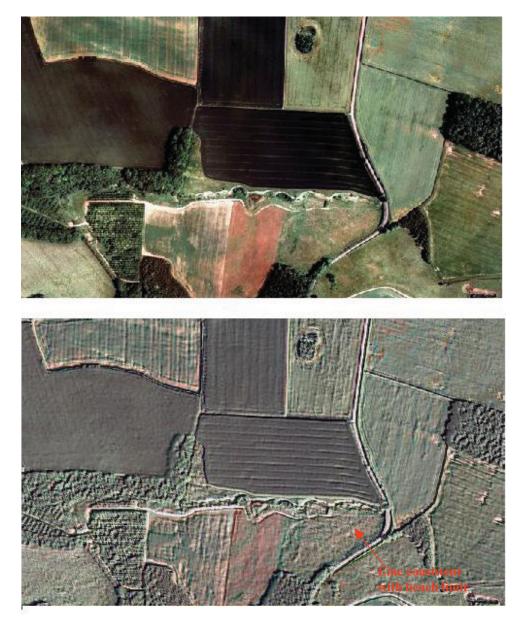
Aerial photograph enhanced with emboss filter

Figure 6 - Aerial photograph showing possible limit of bench

However, a marked change in permitivity was detected in most of the profiles occurring beyond a depth of approximately 2.5m. When plotted on the topographic grid, an area of ground with different characteristics is evident and coincides with the edge of the 1970s bench position although it is not intact for the entire length. This feature also seems to be evident on enhanced aerial images of the area.
