Overall site plan of the wreck remains as recorded across six seasons of survey, 2004-2010.

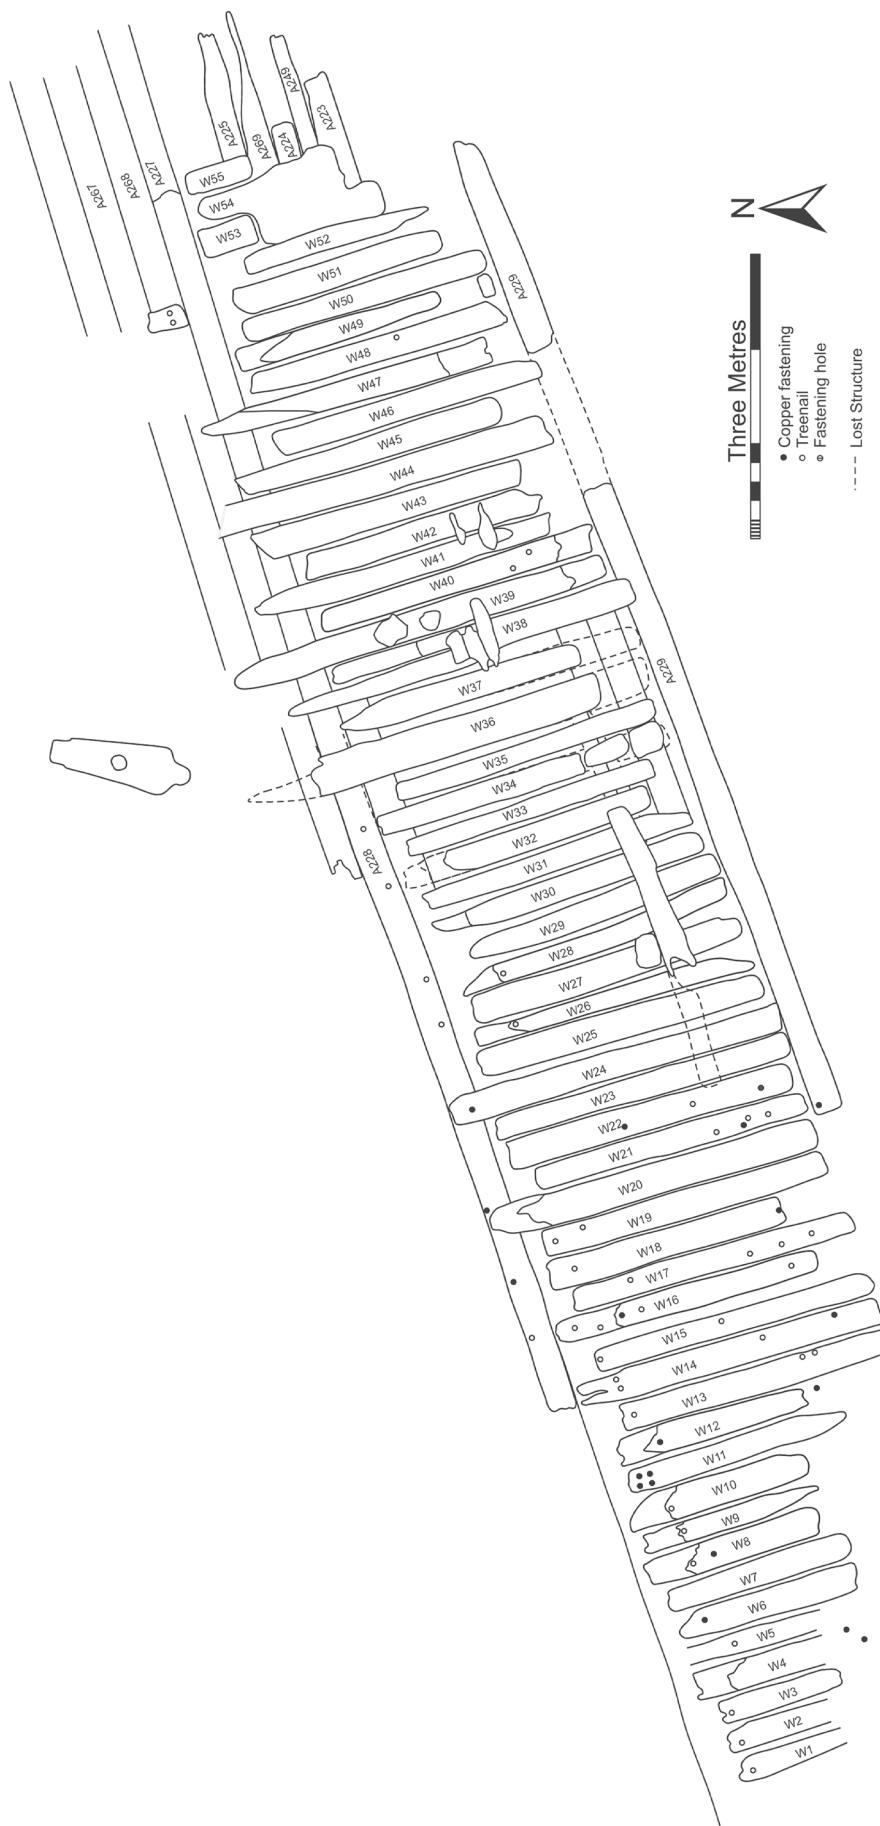
*Detail of the western
section of wooden
hull remains.*

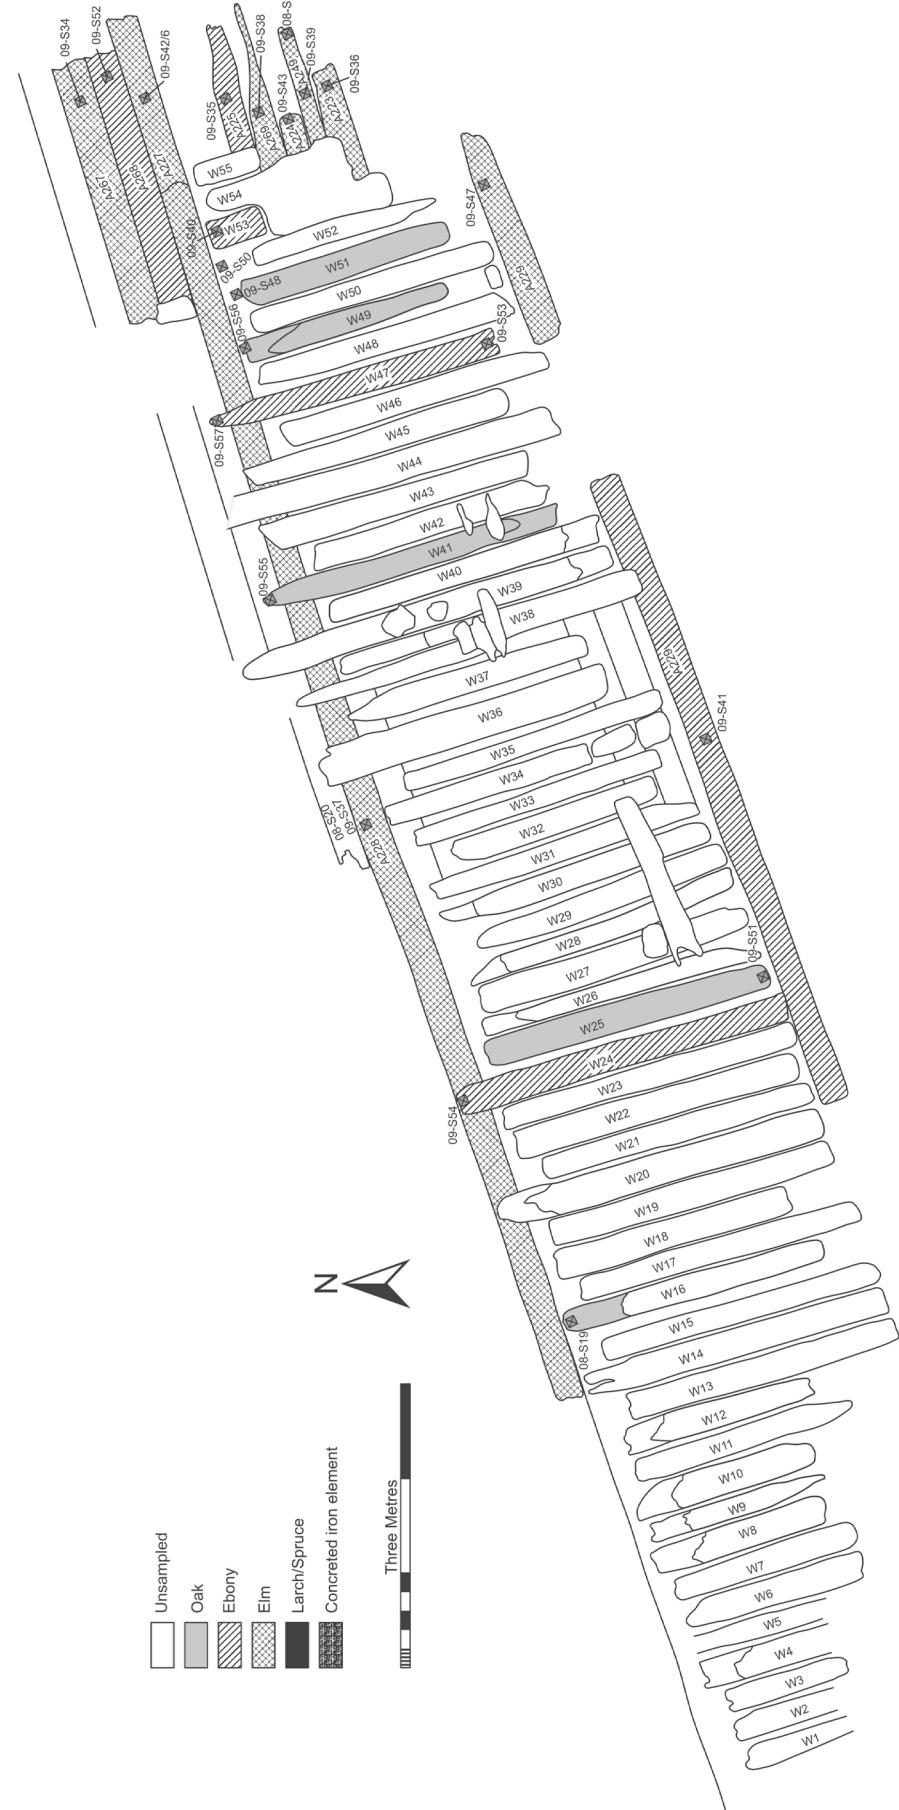
Results of timber sampling for wood identification on the western section of the wreck.

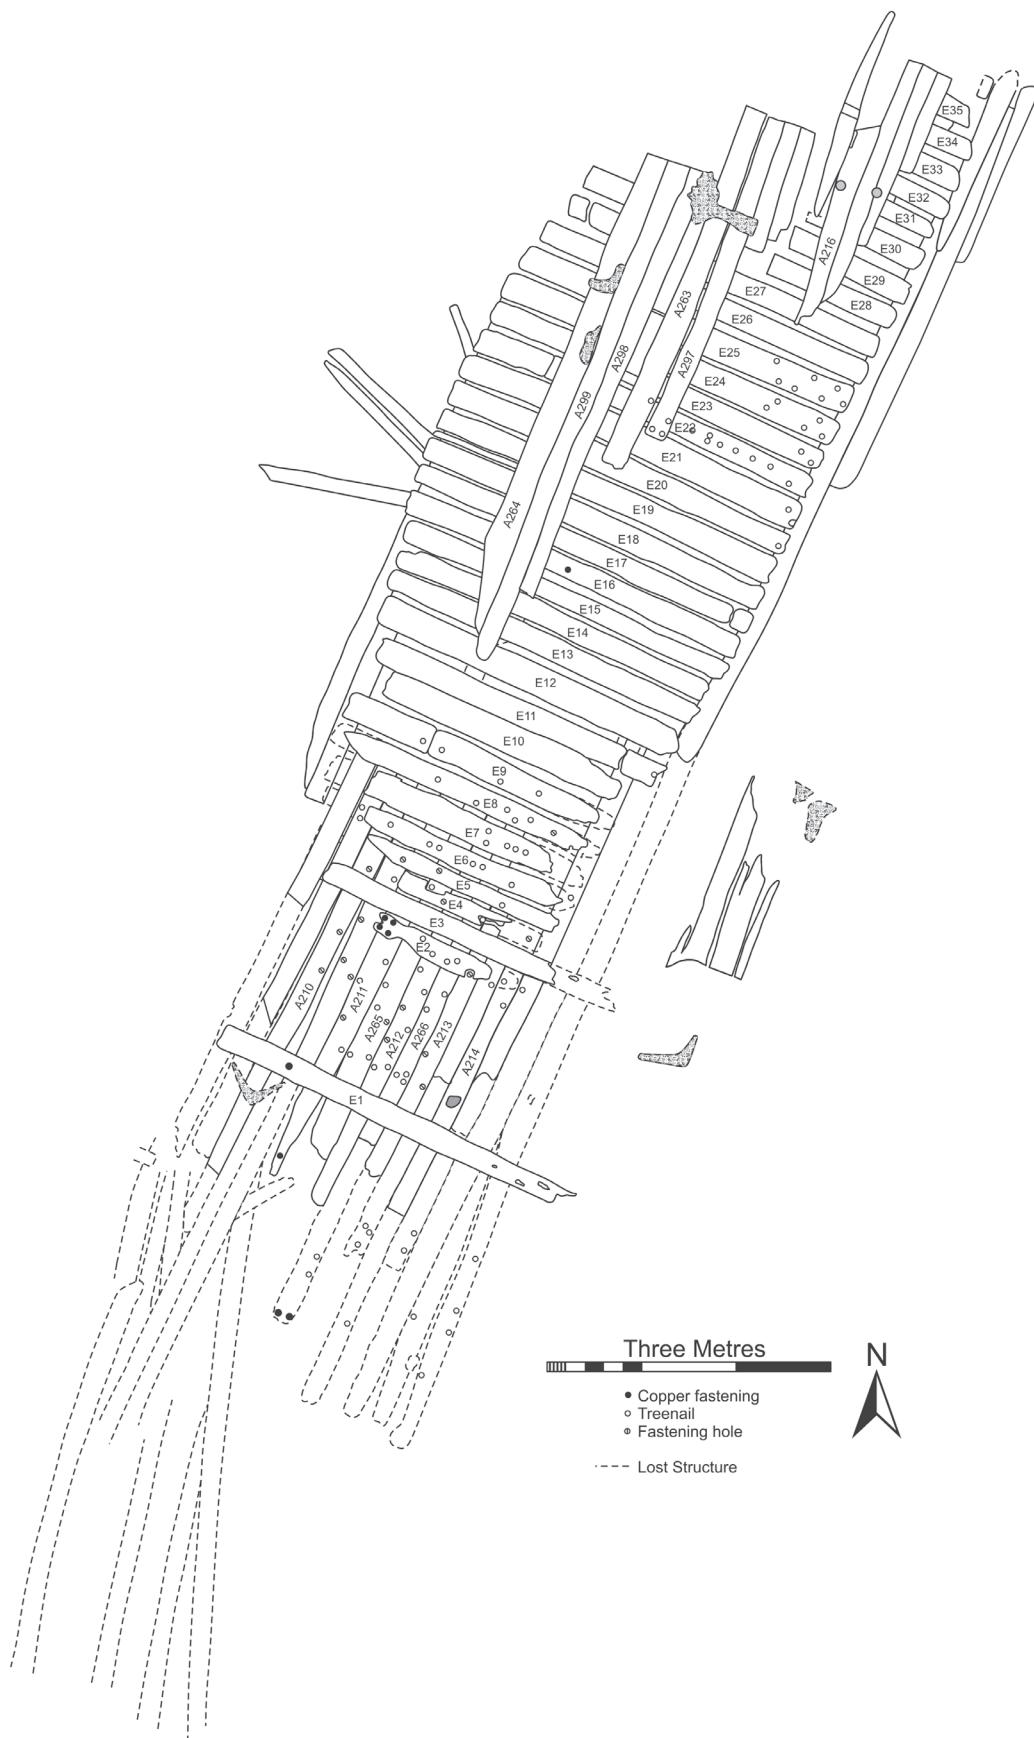
Detail of the eastern section of wooden hull remains.

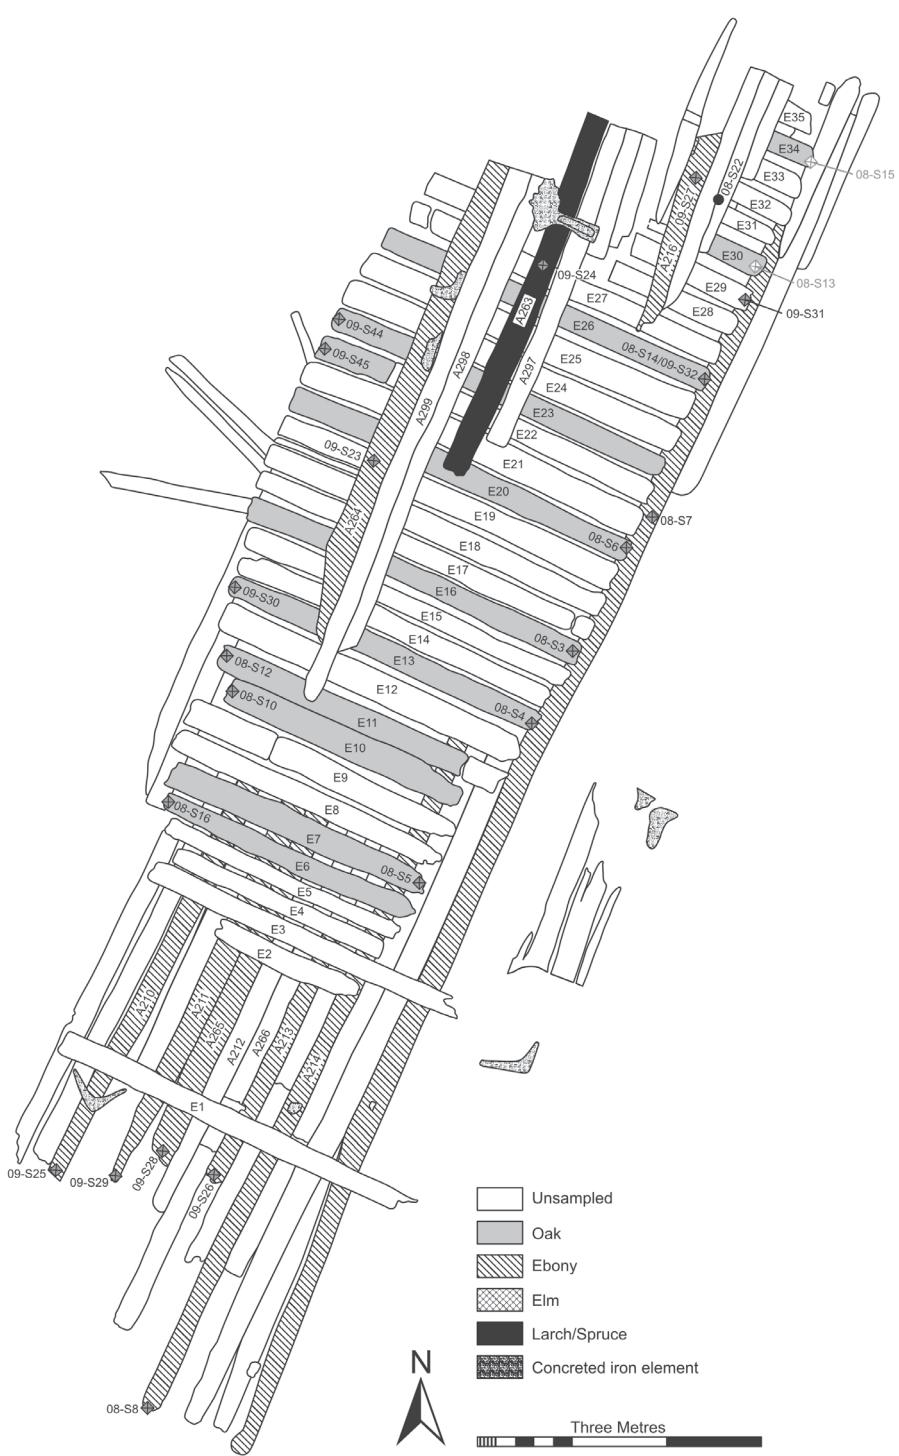
Results of timber sampling for wood identification on the eastern section of the wreck.
