Carn Mor Dun, Culbokie

Archaeological Measured Survey

National Grid Reference	NH 6033 5859
Author	Mary Peteranna
Site Code	CUL12
Report No.	2012-08/CUL12
Client	Forestry Commission Scotland
Date	28-03-2012
OASIS No.	rosscrom1-122186

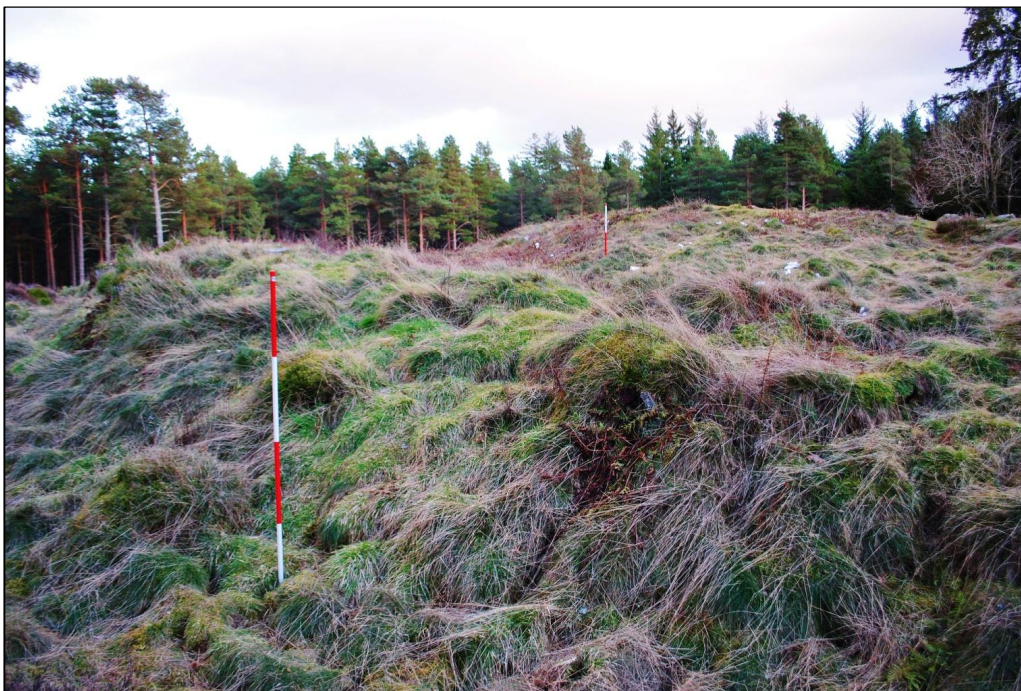
Illus. 1 Looking across the second rampart with the first (inner rampart) visible in background

- 4.2 The dun comprised three concentric ramparts with an entrance in the southwest. The northwest quadrant of the site was best preserved, where the wall height of the second (central) rampart stood up to approximately 1.8m high. There were no visible wall faces. The first rampart (innermost) was spread up to 8.3m wide and its internal diameter measured 16.2m across. The second and third ramparts, where preserved, spread up to 5m across. The entire site measured 56.5m in diameter, NW-SE, to the base of the third (outermost) rampart. The second and third ramparts were only visible as breaks of slope in the SE quadrant of the site. It is possible that the walling for the second and third ramparts was not continuous on all sides.
