# Lochluichart Wind Farm, Ross-shire Archaeological Watching Brief

## Final Report

National Grid Reference	<b>NH 32717 66928 (centred)</b>
HC Planning Reference	<b>RC-05-1052</b>
Site Code	<b>LWF11</b>
RoCAS Report	<b>2012-12/LWF11</b>
Author	<b>Lynn Fraser</b>
Client	<b>Natural Power</b>
Date	<b>09-08-2012</b>
OASIS No.	<b>rosscrom1-132028</b>

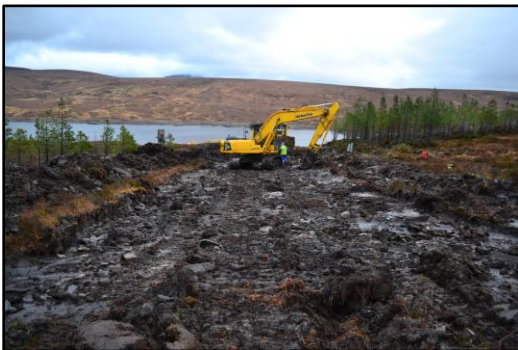
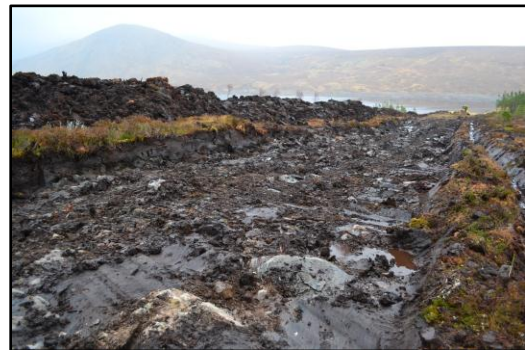
Peat, to a depth of 0.5m in places, was removed exposing a layer of large sub-angular boulders sitting in and on mid-grey/brown sand, which was heavily gleyed in areas (Plates 1 and 2). Podsolisation was evident in places where boulders were pulled out of the ground. Trees were contained within the peat removed and their roots visible amongst the boulders; many of the trees were charred suggesting a fire from either natural causes or muir burn.

**Plates 1 and 2:** Stripping the access road.

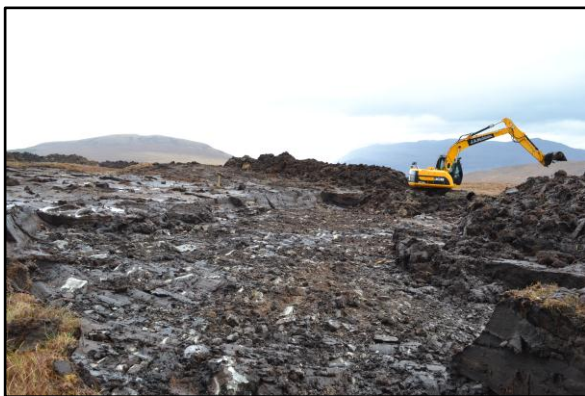
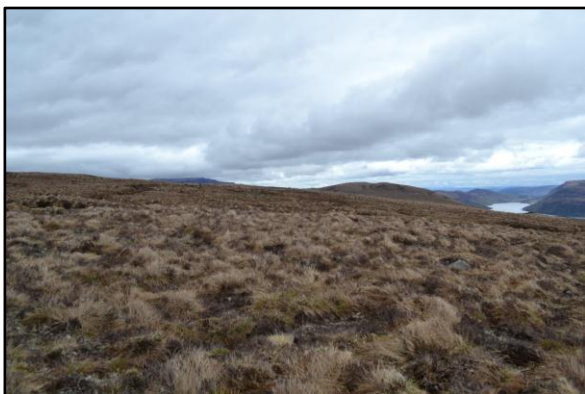
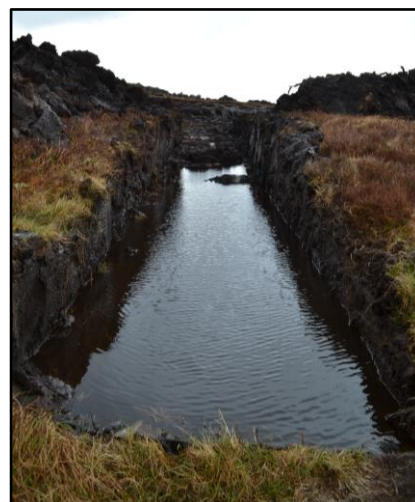
The majority of the footprint for Turbine 29 and its crane pad were watched on 25 April 2012 (Figure 3; Plate 4). This was required due to its proximity to a stalkers' path. The weather was very wet, windy and cold, which again made the working conditions challenging. A slot trench dug from the nearby stalkers' path towards the turbine and crane pad area almost immediately filled with water (Plate 5).

Peat, up to a depth of 0.75m in places, was removed exposing a layer of large sub-angular boulders sitting in and on mid-grey/brown sand. Tree roots were contained within the peat. The area was devoid of archaeology.

As a result of the watching brief on Turbine 29's footprint, a rapid walkover survey was conducted on 8 May 2012 in the areas of Turbines 24, 31 and 37; the location of Turbine 26 was also surveyed due to its proximity to the stalkers' path (Plate 6). The purpose of the rapid walkover survey was to see whether there was any surface archaeology visible and assess the likelihood of archaeology being present beneath the peat. There was no surface archaeology visible apart from drainage ditches, which had been cut by Lochluichart Estate in the last ten

**Plates 4 – 6:** Clockwise from top left: Plate 4, turbine 29 being stripped; Plate 5, water-filled trench at turbine 29; Plate 6, area for turbine 26.

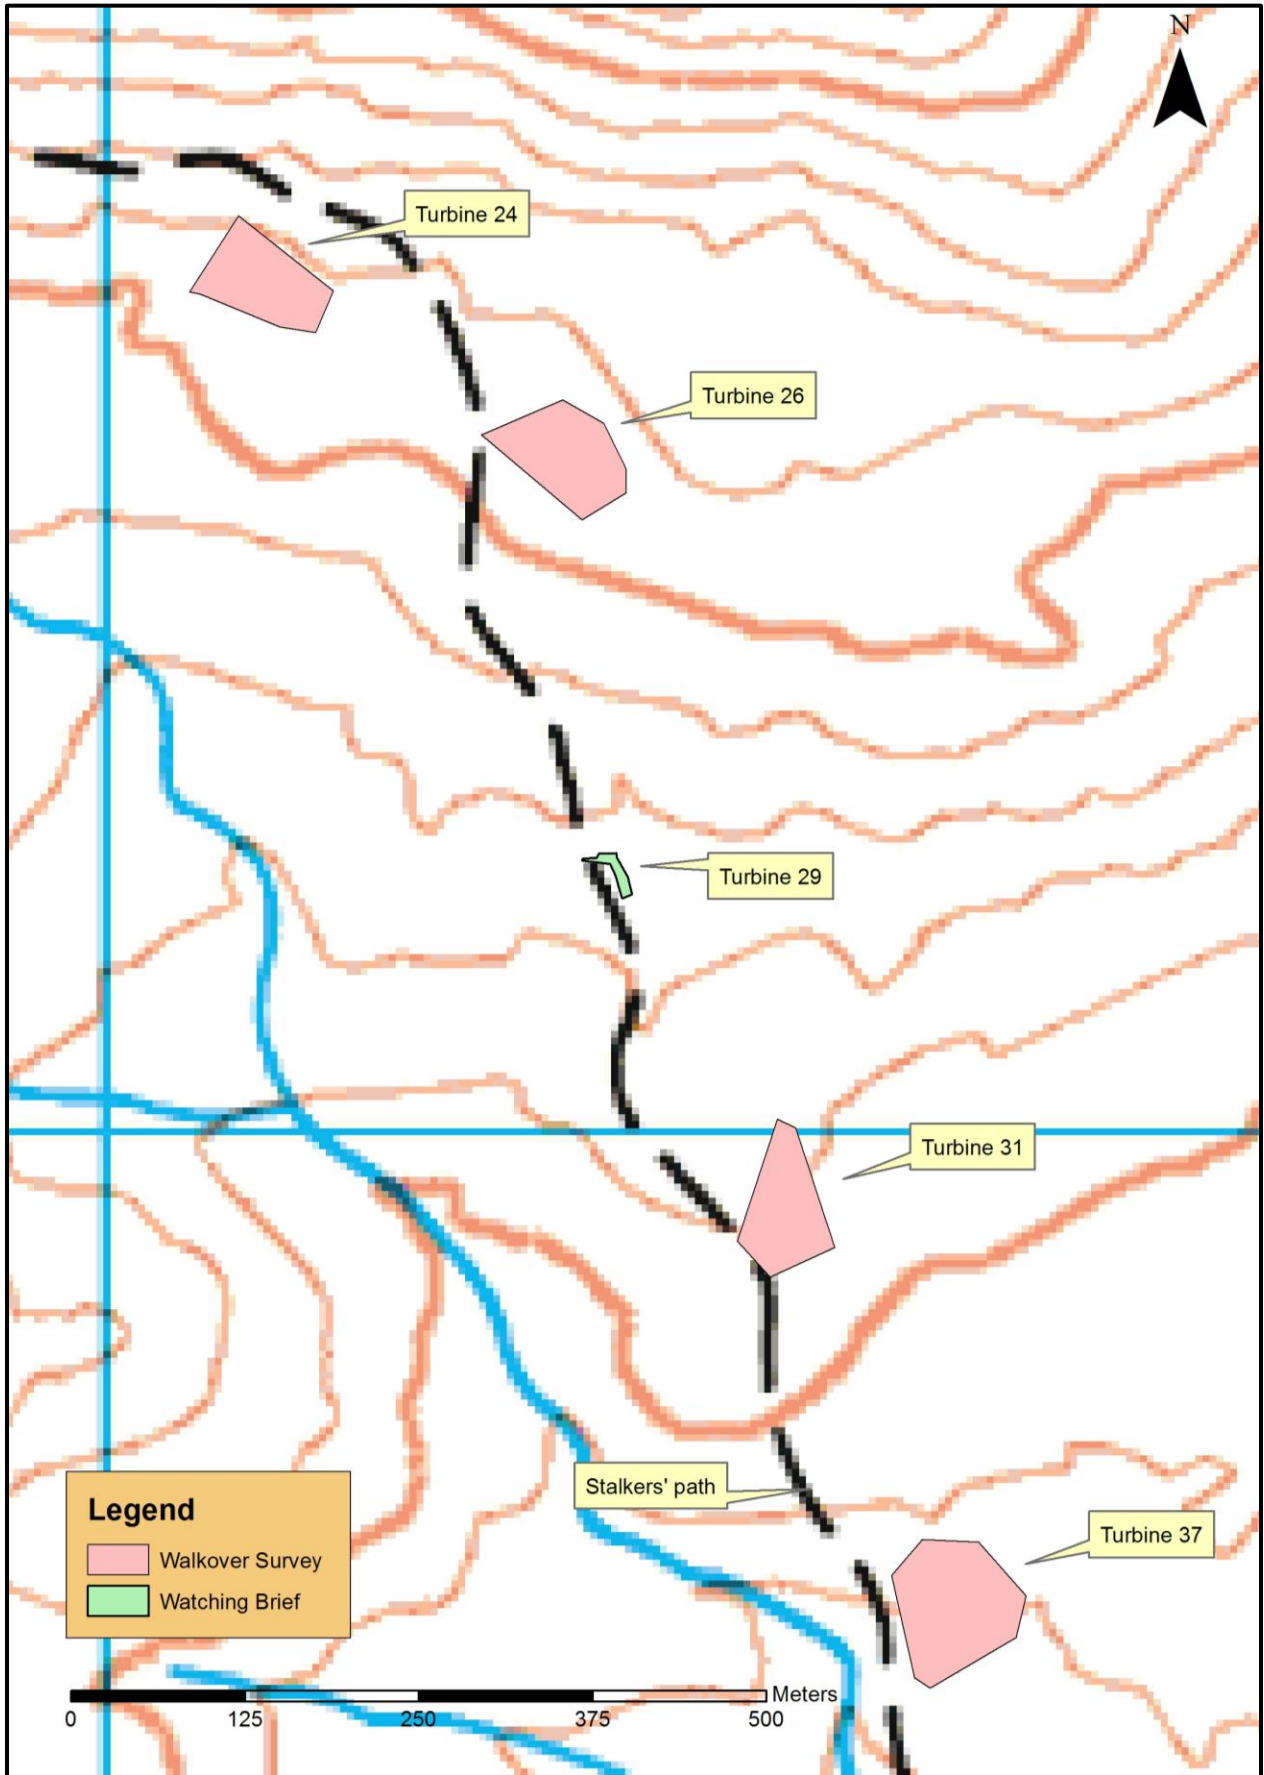
Figure 3: Location map of the watching brief for Turbine 29 and survey of Turbines 24, 26, 31 and 37.
