# Scatwell Lodge Hydro Scheme Scatwell Estate, Strathconon

## Archaeological Desk-based Assessment and Walkover Survey

**NH 39925618 to NH 38465494**  
**SCA12**  
**Mary Peteranna**  
**2012-14/SCA12**  
**GreenCat Renewables**  
**17-08-12**  
**rosscrom1- 132419**

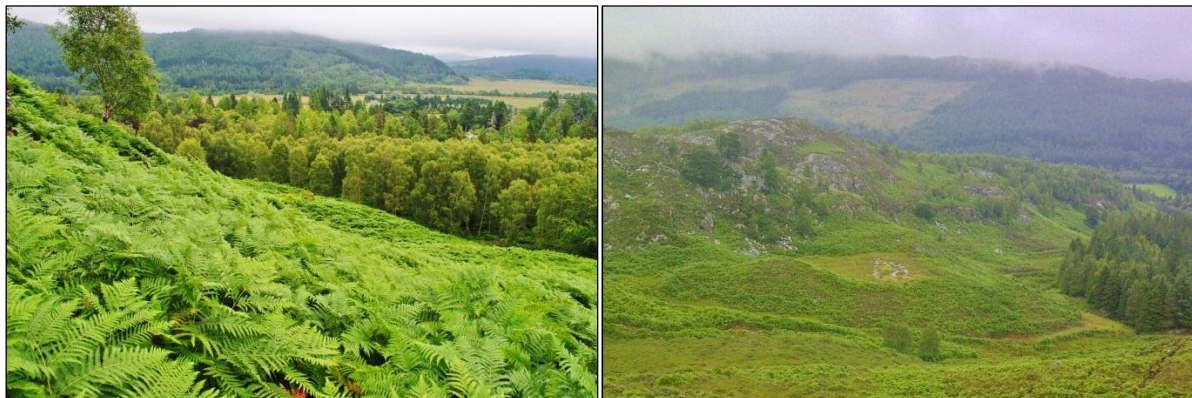
5.2.1 The development areas for the new hydro scheme at Scatwell were walked over and surveyed on the 6<sup>th</sup> of August 2012. The weather for the survey day was mostly cloudy with dry and windy conditions and the ground was dry underfoot, due to the recent spell of dry weather. Stands of very high bracken resulted in significant difficulty in identifying archaeological features at the northeast end of the routes south of the road. However, because this area was located on a steeply sloping scree-covered hillside, the potential for archaeological sites is very unlikely (Plate 1).

Plate 1 Dense bracken at NE end of pipe route

Plate 2 View NNE across the NE end of pipe route

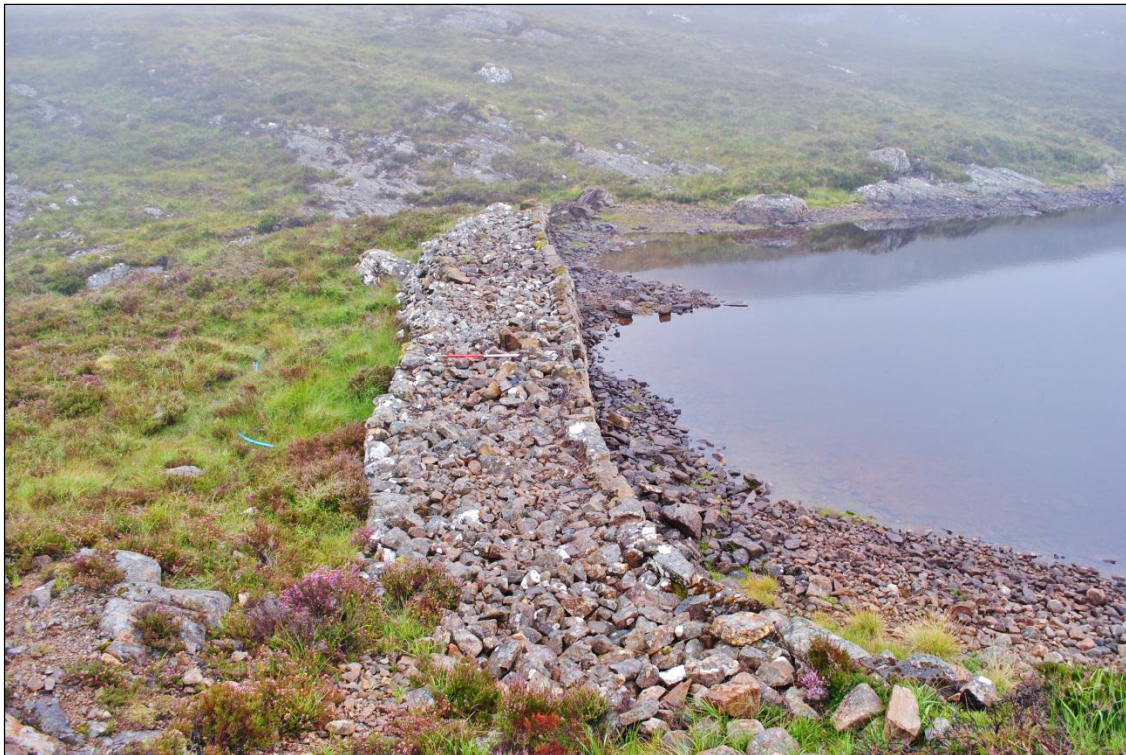
- 6.2.1.1 The dam, located at the east end of Loch a' Mhuilinn (NH 3848 5492), comprises double-faced drystone walling with a rubble core of small-medium stones (Plate 3). The stone had been sourced locally. The dam structure measures 24m long overall and 2.25m across at the widest point. It stands 0.65-0.80m high on the west side and 1.0-1.2m high on the east side.
- 6.2.1.2 The west wall face is well-built and stands nearly vertical above the stony loch shoreline. It comprises large flat slabs with mortar, much of which has worn away (Plate 4). The east wall face is significantly battered, falling away to the sloping, heather-covered ground surface (Plate 5). The dam structure curves slightly around the loch sides at the north and south ends and a metal gate appears to block the south end, although this may have been used as an outlet for water overflow.

Plate 3 – Loch a' Mhuilinn dam, facing SSE

- 7.2 As per the information provided by the client<sup>12</sup>, Loch a' Mhuilinn dam will be refurbished. This will involve incorporation of an intake structure into the existing structure and rebuilding the eastern face of the dam in order to minimise leakage. During the survey, the dam was photographed in detail prior to the proposed refurbishment in order to provide a photographic record of this c.19<sup>th</sup> century site.

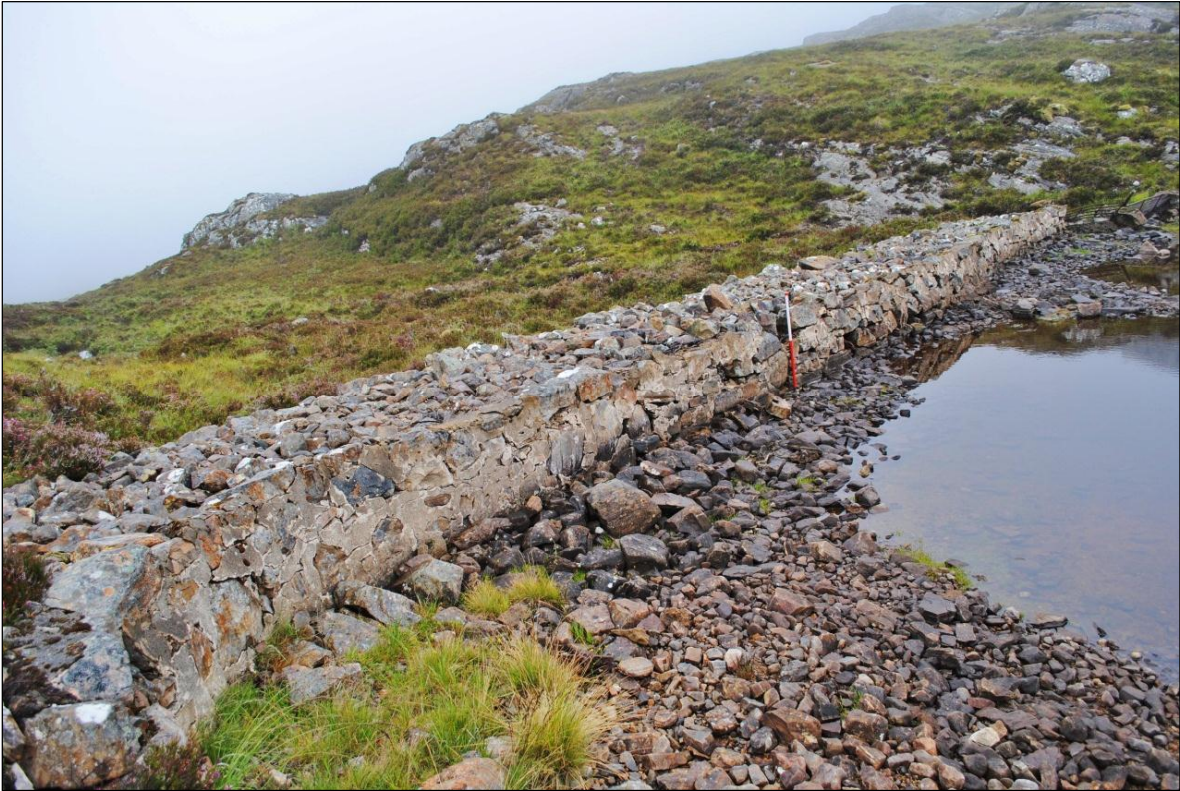
**Plate4** Loch a Mhuilinn dam westface ,facingSE

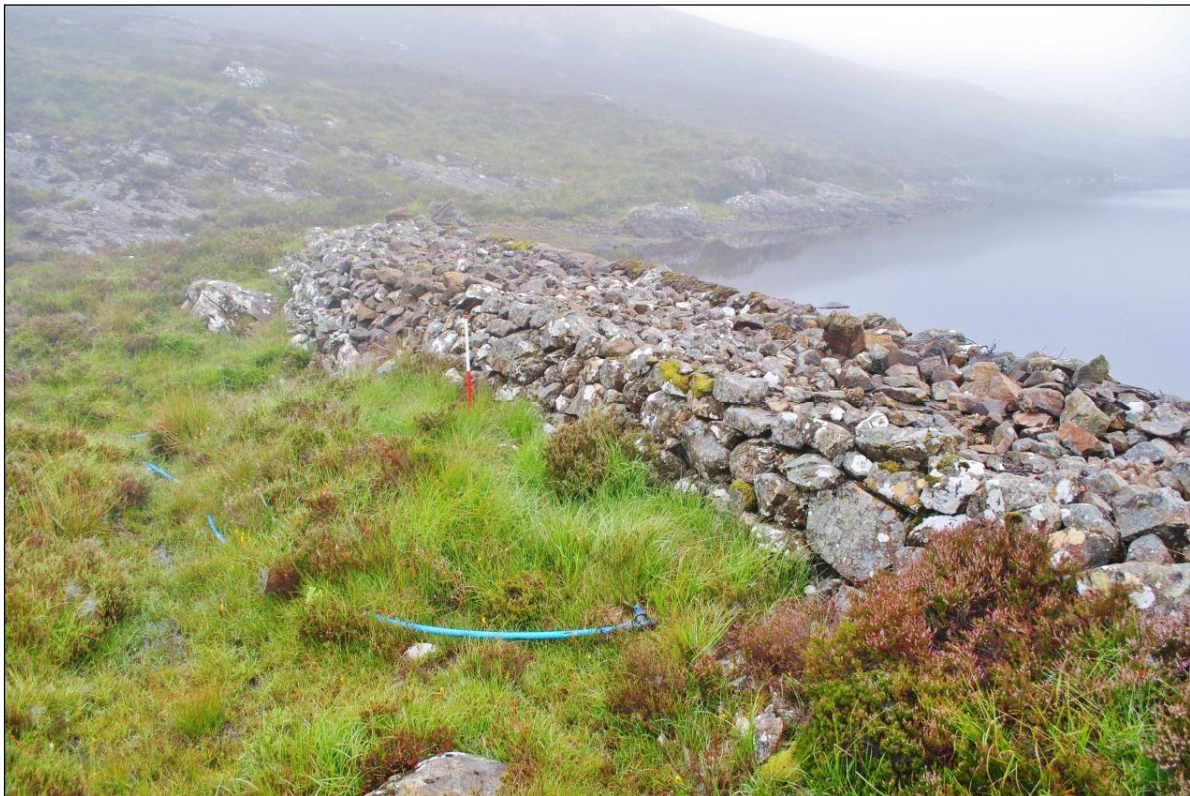
**Plate5** Loch a Mhuilinn dam eastface ,facingSE

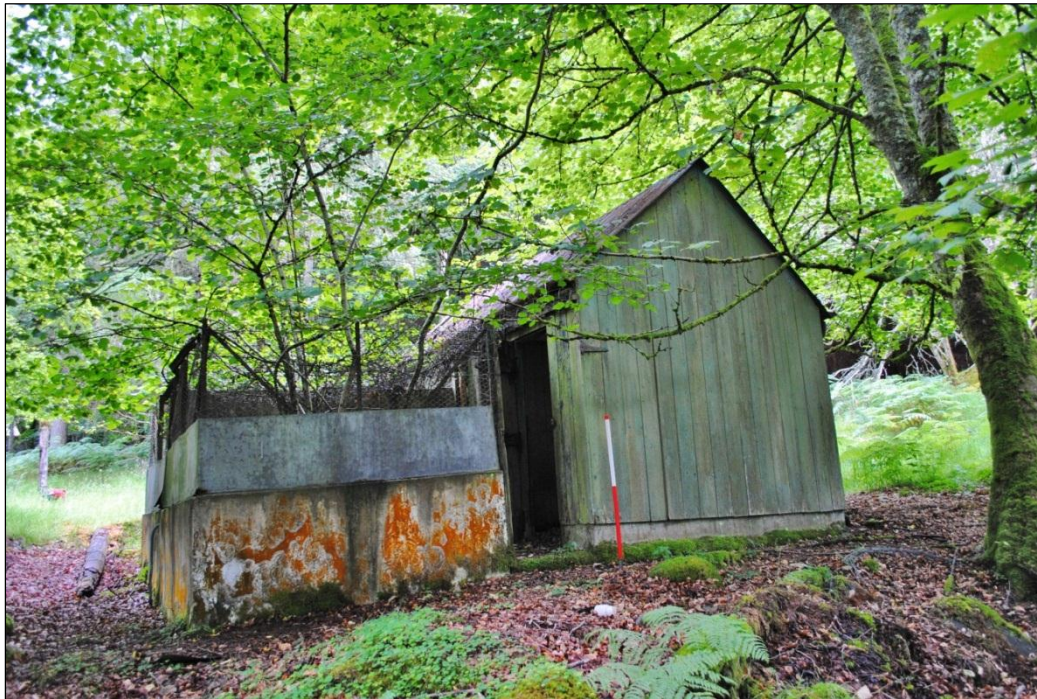
6.2.2.2 The kennel building comprised pale green wood cladding with a corrugated iron roof and an attached concrete and metal mesh fence to the east side. The building measures 4.0m NE-SW by 2.7m and stands 2.0m high to the base of the roof (Plates 6 and 7).

Plate 6 Disused kennels near the northeast end of the survey route, facing WNW

- 7.3 The disused kennels, located near the northeast of the pipeline route, is proposed to be demolished to allow for construction of the powerhouse in a location designed to cause minimal impact to the landscape. The kennels building was recorded and photographed during the survey in order to provide a record for the site prior to its demolition.

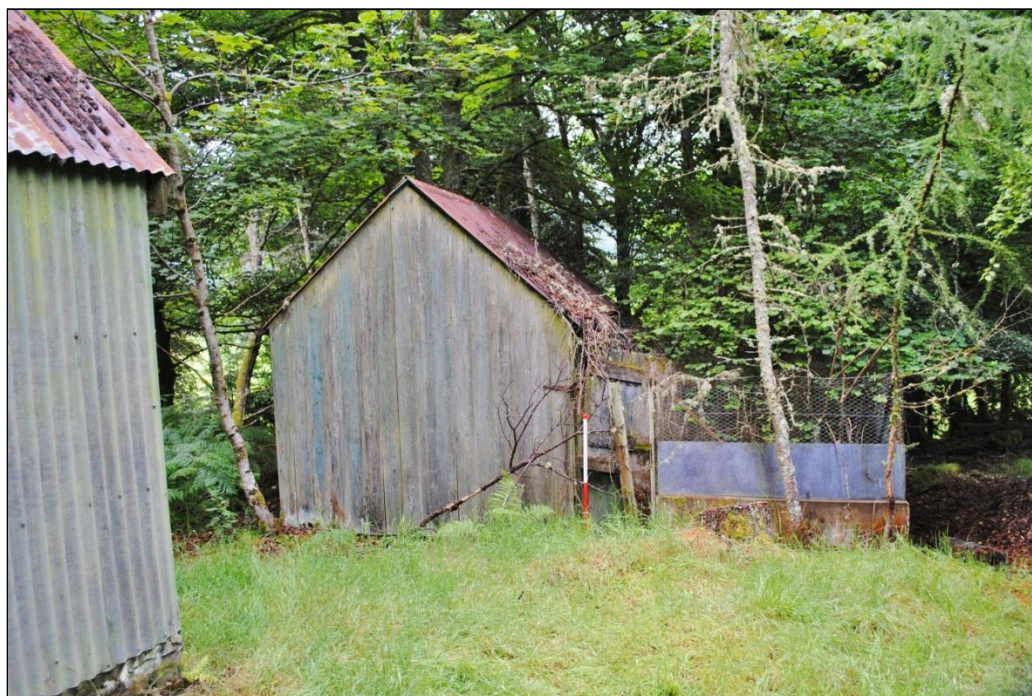
Plate 7 Disused kennels near the northeast end of the survey route, facing NE
