Inverness Flood Relief Channel Phase 4

Data Structure Report

RoCAS Report

2012-15/IFC11-12

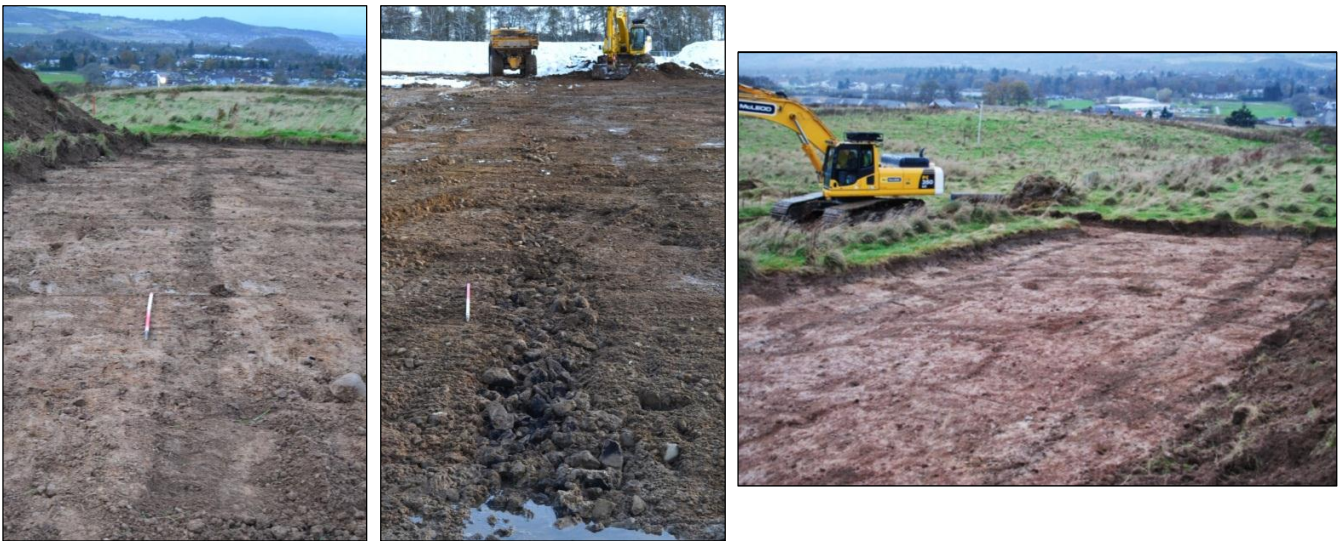
A total of fifty-four field drains were recorded during the watching brief, and comprised two main types: soil/stone-filled trenches containing 10cm diameter ceramic pipes and stone-filled trenches. The majority of the field drain trenches measured approximately 0.30m wide and contained ceramic pipes. Most of the field drain trenches were oriented on a NW-SE axis (Figure 5). The stone-filled field drains measured between 0.6-1.1m wide, most of which were 0.9-1.0m wide. In only one case was it recorded that one field drain cut another: Feature 31, a 1.1m-wide stone-filled field drain was cut by Feature 32, a 0.3m wide ceramic pipe field drain. This suggests that the trenches containing orange ceramic pipes post-dated the field drains containing stone fill only.

Plates 1-3 Feature 32 field drain facing NW (left), Feature 36 field drain facing SE (centre), Features 48-49 field drains facing WNW (right)

In many cases, the distinction between gravelly natural subsoil and the gravelly fill of the field drain trenches was difficult to see, and the change was often most visible when a linear change appeared on the surface of the subsoil (Plates 1-3). Several field drain features were half-sectioned (Figure 6) to characterise the trenches, which survived between 0.15-0.45m deep below the surface of the subsoil. Due to the quantity of field drains uncovered, after an adequate characterisation of the field drains of the same type and fill was completed, the contextual details were no longer recorded.

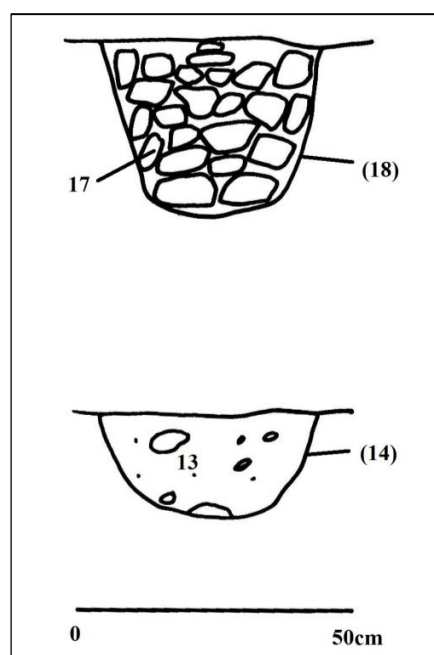
Figure 6 NW-facing section of Feature 9 field drain (top) and NW-facing section of Feature 7 field drain (bottom)

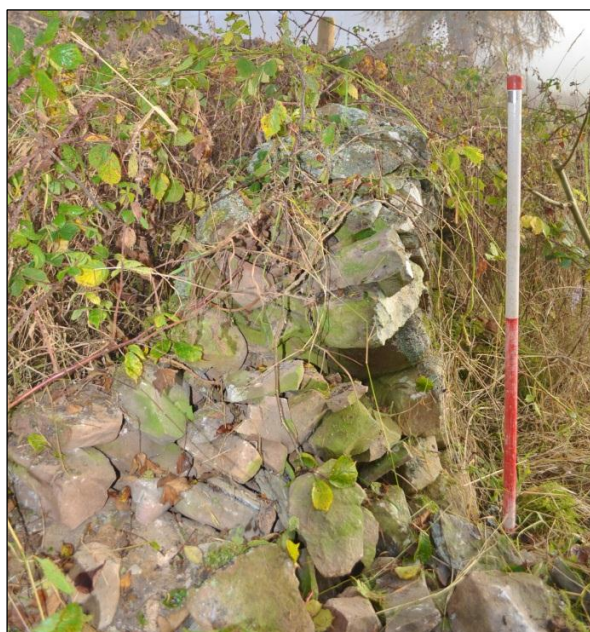
A drystone boundary dyke (Feature 4) was partially demolished during construction works, prior to the start of the watching brief. The stone wall, double-faced with rubble core, ran alongside the northeast edge of the main area of the site compound (Figure 7) and comprised medium subangular stones (Plate 4).

Plate 4 Feature 4, drystone dyke NW-facing section; facing SE

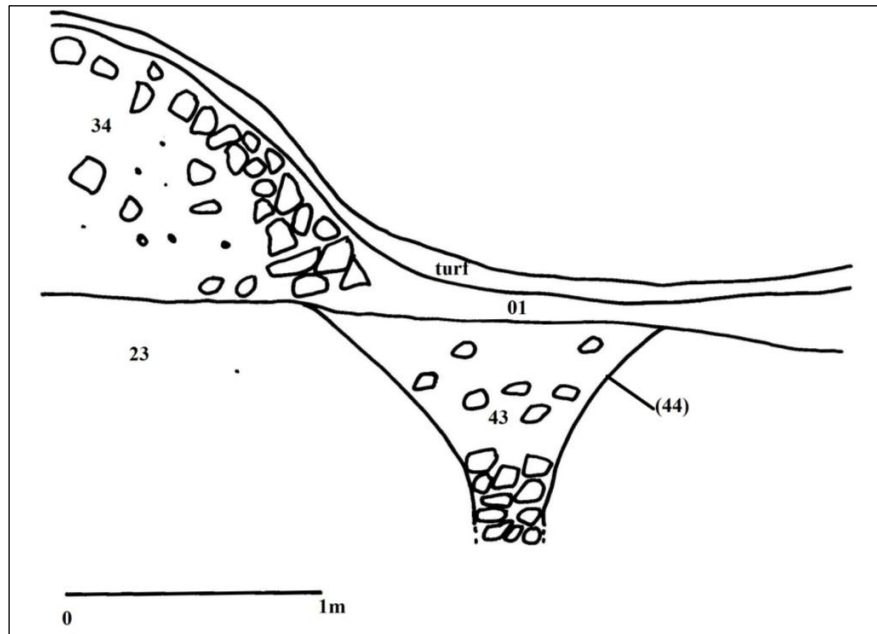
An earth/stone bank (Feature 17) and ditch (Feature 22) crossed through the centre of the flood relief channel main area prior to the start of works. The bank was demolished and the ditch was cleared out during the excavation works to be used for drainage. The bank measured approximately 1.1m high and 1.2m wide and the ditch measures 0.3m wide at its base. It was recorded in section (Figure 7).

Figure 7 NE-facing section through earth/stone bank, Feature 17, and ditch, Feature 22

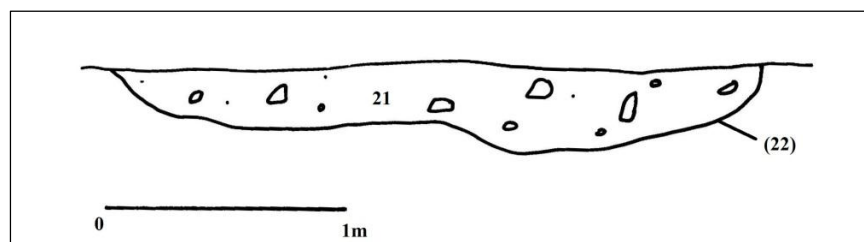
An amorphous pit/ditch feature was uncovered in the east corner of the main area below the location for the site compound (Figure 7). The feature appeared as an amorphous dark patch in the subsoil, with scattered patches of charcoal fragments. It was cleaned back and recorded. A slot trench 0.3m wide was excavated through the feature (Figure 8), which measured approximately 12m long and varied between 1-2.5m in width (Figure 9). The depth of the pit/ditch varied between 0.15-0.45m and fill comprised mixed stony soil and subsoil patches, with the scattered charcoal fragments throughout the soil patches. It was interpreted as the remains of a pit resulting from removed burnt vegetation. It was probably cleared during agricultural improvements.

Figure 8 SE-facing section through Feature 11, amorphous pit/ditch

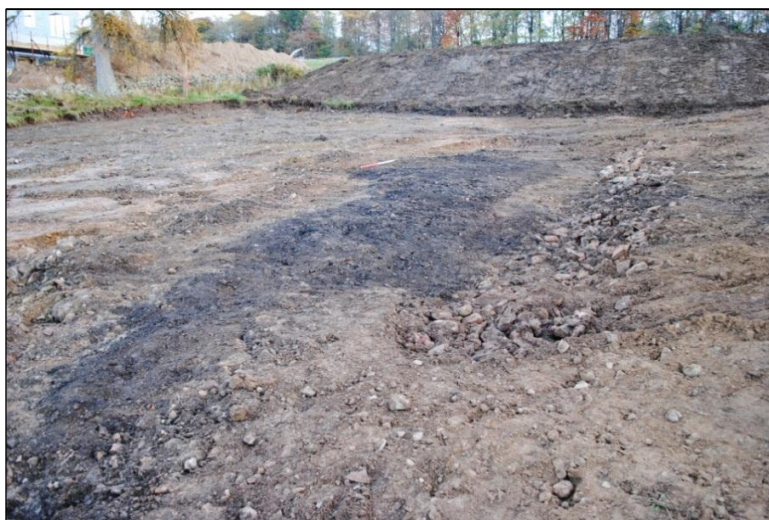
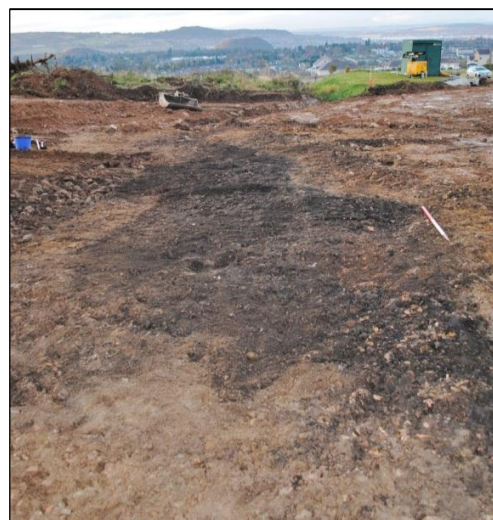
Plates 5-6 Amorphous pit/ditch, facing E (left) and facing NW (right)

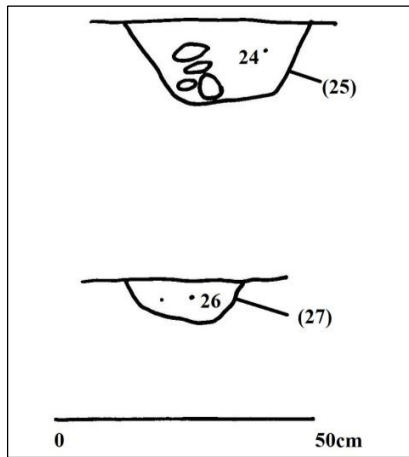
Figure 10 Feature 12, N-facing section (top)
Feature 13, SW-facing section (bottom)

6.2.5.1 Feature 12 was a subrectangular pit measuring 0.9m long by 0.36m wide. It was half-sectioned to a depth of 0.15m (Figure 10) and contained two fragments of glazed pottery, 1 small fragment of burnt bone and an unknown iron object (SF01-04). The use of the pit is unknown and the small finds in the pit may be residual from redeposited topsoil fill.

The pit was located within a grouping of linear ploughmarks (Feature 13) measuring approximately 0.30m wide each (Plate 7). One ploughmark was half-sectioned to a depth of 0.07m (Figure 10). A stone field drain (Feature 14) cut through and post-dated the ploughmarks (Figure 12).

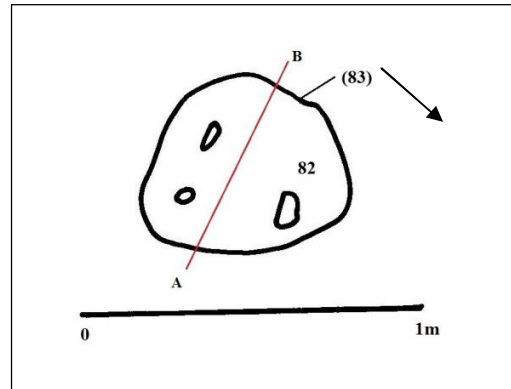
Figure 11 Plan of pit, Feature 41

6.2.5.2 Feature **41** (Figure **11**) was a subcircular pit uncovered in the northwest corner of the main area. It contained stony soil fill and measured 0.60m in diameter. It was half-sectioned to a depth of less than 10cm. Its significance and use are unknown.

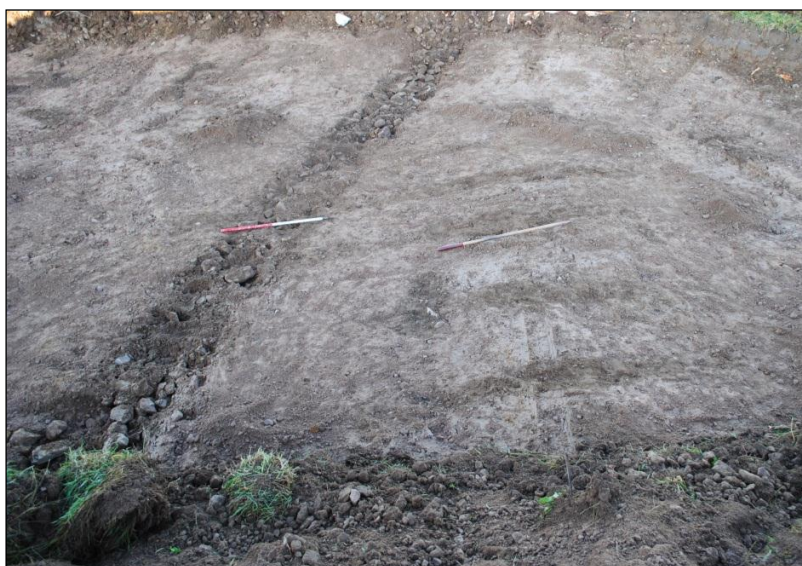
Plate 7 Ploughmarks, Feature 13, and subrectangular pit, Feature 12 (centre), field drain (Feature 14) to left; facing N
