Kilmory Burial Ground, Isle of Rum Archaeological Survey

Report and Written Scheme of Investigation

National Grid Reference	NG 36100 03600 (centred)
Site Code	KIL12
RoCAS Report	2012-17/KIL12
Author	Lynn Fraser and Steven Birch
Client	Scottish Natural Heritage
Date	25-09-2012
OASIS No.	rosscrom1-134370

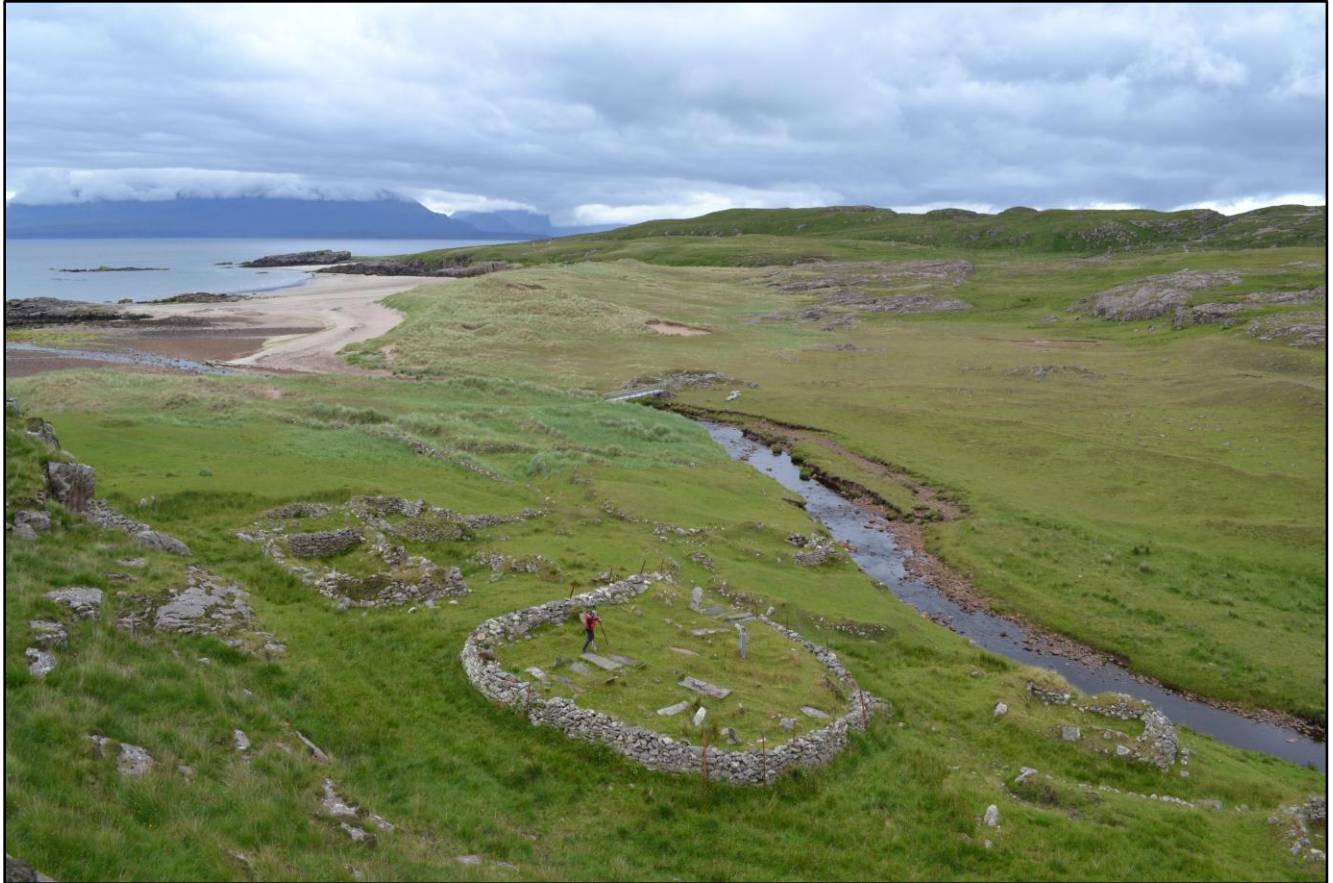
Plate 1: The burial ground with structures to the north and east.

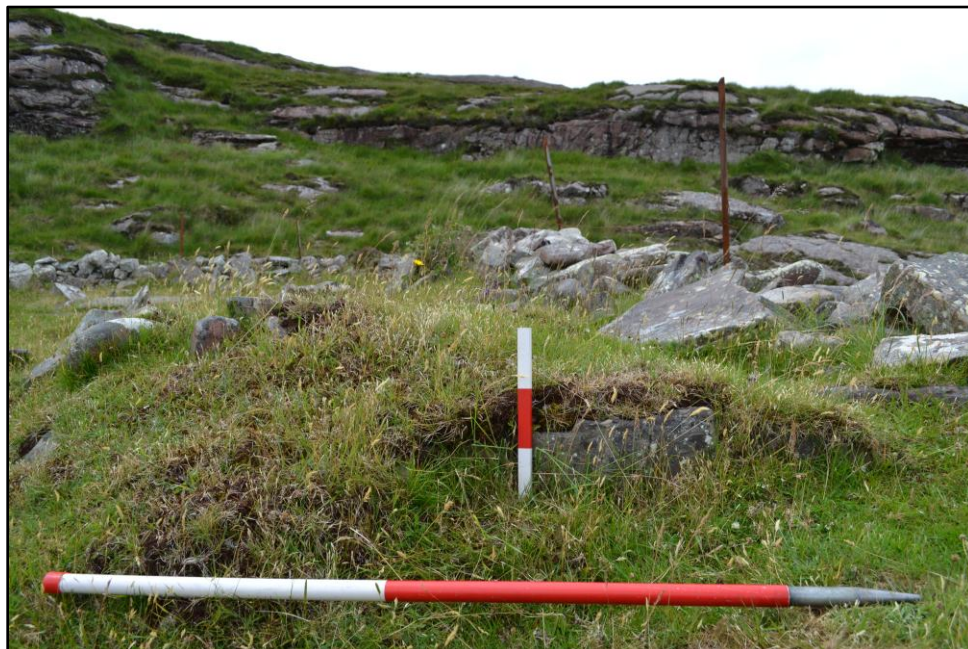
A small cairn-like mound of stones, with a face of moss-covered stones on its east side, was located in the north-east corner of the burial ground (Plate 4).

Plate 4: The small cairn in the north-east corner of the burial ground

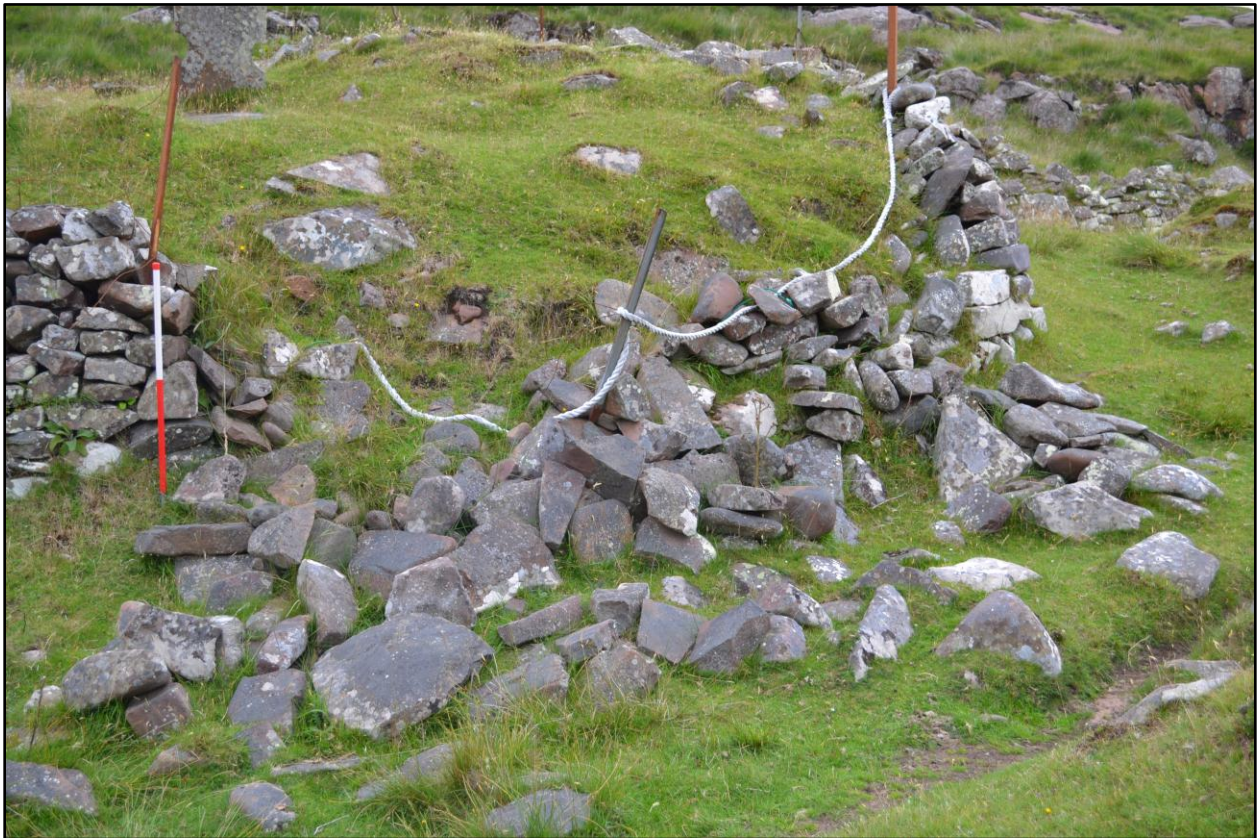
The earliest and most significant damage to the wall is in the north-east corner. There is substantial tumble from the top and centre of the wall; some of the lower stones appear to be in place, although obscured by the tumble (Plate 5). Many of the fallen stones are loose on the ground surface, but some are now embedded in the ground at the base of the tumble, which is well spread. There is some evidence of erosion where the stones have pulled out of the bank. Burnt bone was noted in the erosion area at the northern end of the north-east corner.

Plate 5: The north-east corner of the wall has the most significant damage. The Cowan headstone can also be seen top left, with the small 'cairn' to its right.

- 6.2 Any proposed repair work on the burial ground wall should be carried out by an experienced drystone dyker.
- 6.3 The damage in the north-east corner of the wall should be repaired using the loose stones on the ground in this area. Any embedded stones should be left *in situ*. Further stones can be sourced from the river bank where one of the settlement structures has eroded away. If the repair work here involves cutting into the burial ground bank, an archaeologist should be present to conduct a watching brief.

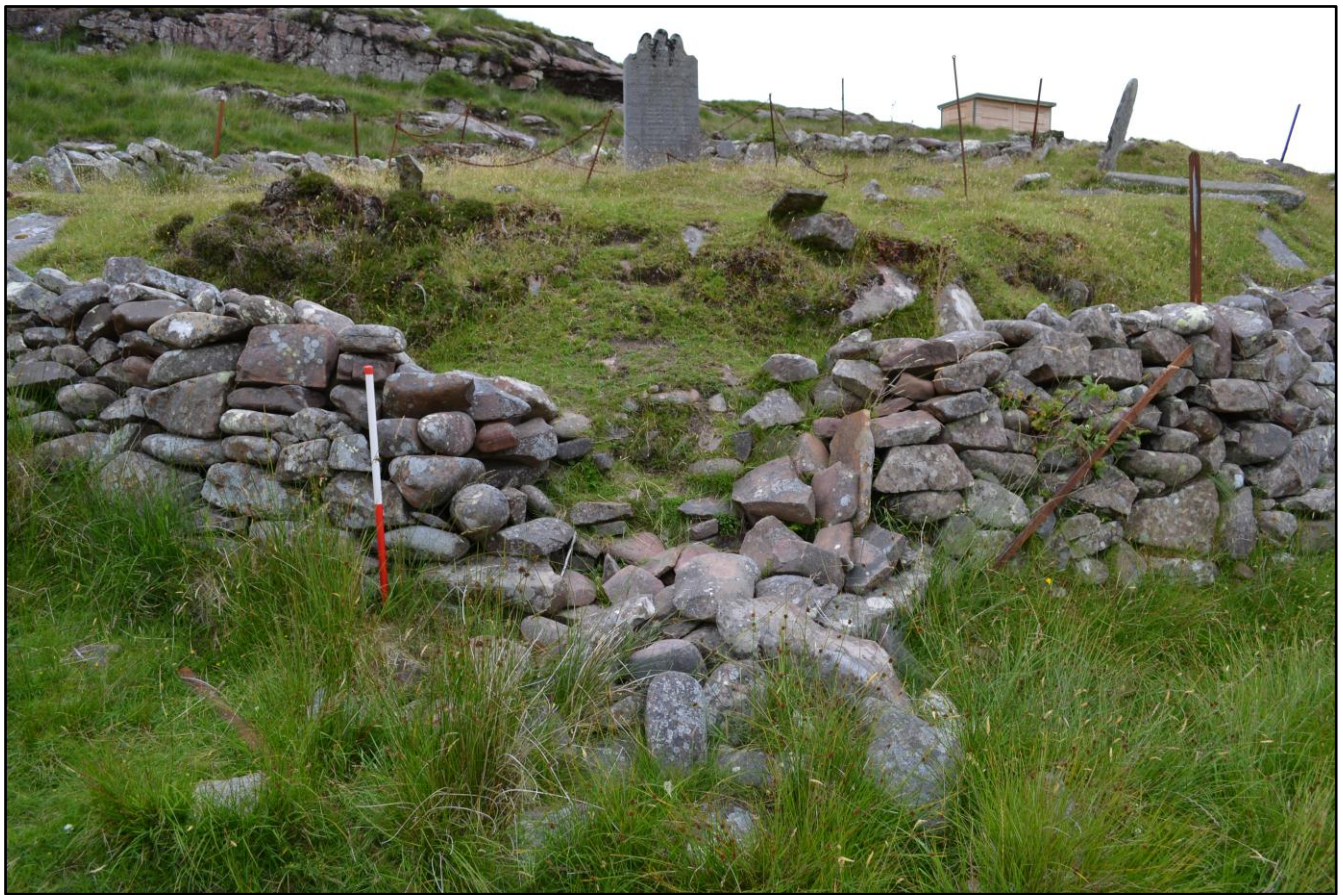
The damage to the wall in the south-east corner is less substantial (Plate 6). Here stone courses are still set into the bank of the burial ground. There has been tumble from the centre and outer courses, whilst the lower courses appear intact. The fallen stones are generally sitting on the ground surface at the base of the wall. Stones are visible in the bank of the burial ground, possibly from an earlier wall; there has been erosion to the bank here with the formation of small 'steps' where people have gained entry to the burial ground (Plate 7).

Plate 6: Less damage has taken place at the south-east corner of the wall. The Matheson headstone can be seen centre top and the Cowan headstone top right.

- 6.4 The south-east corner is recommended as the location for a set of steps to allow public entry to the burial ground. It appears to be the entry point of choice as evidenced by the erosion 'steps' in the bank and these could be enhanced with the insertion of stone steps into the bank. Prior to the construction of the steps, and repairs to the wall, a small evaluation excavation to record what is under the erosion steps should be carried out by an archaeologist. The purpose of the evaluation trench will be to strip off the turf in this area, clear away the tumble at the base of the wall and clean back a little of the surface in order to evaluate whether there is an original wall in the bank behind the present wall before setting stone steps into the bank; large, flat stones can be sourced from the river bank for this purpose.

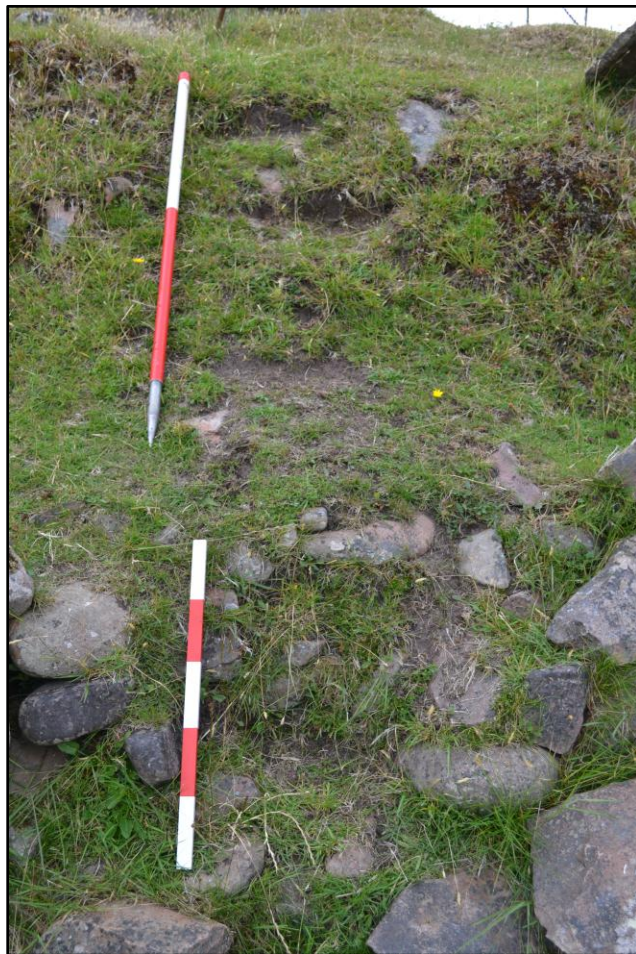
Plate 7: Erosion 'steps' in the south-east corner of the burial ground above what may be the stones of an earlier wall set into the burial ground's bank (upper scale 1m, lower 0.5m).

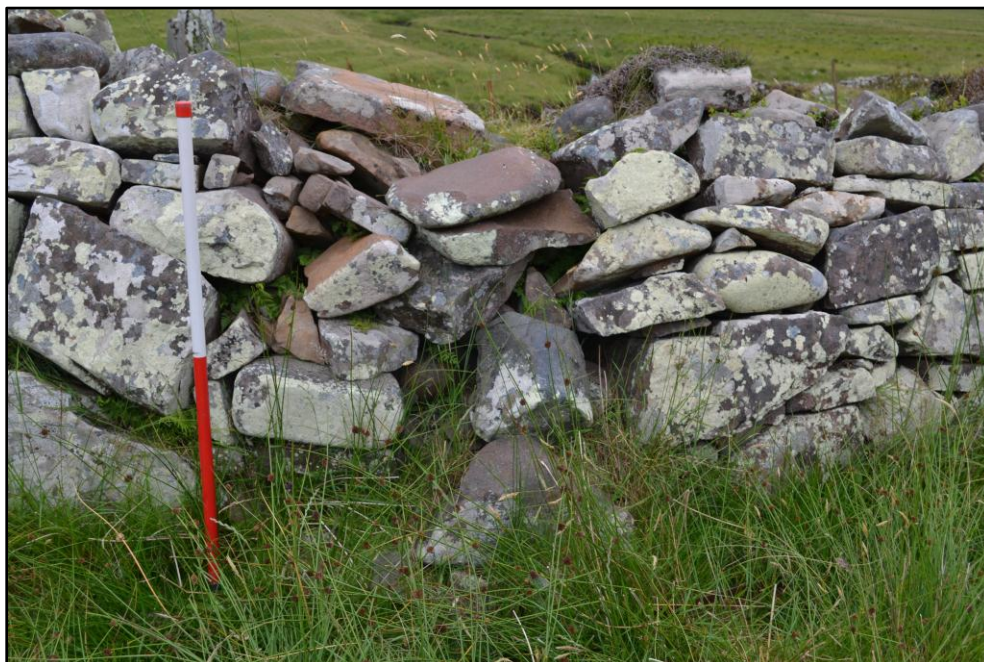
The north-west corner, although well-constructed, is starting to show signs of damage (Plate 8).

Plate 8: The north-west corner of the wall is starting to collapse.

- 6.5 The north-west corner of the wall should be repaired to prevent any further deterioration in its condition.
- 6.6 There are gaps around the whole wall where stones have fallen out; these should be attended to.

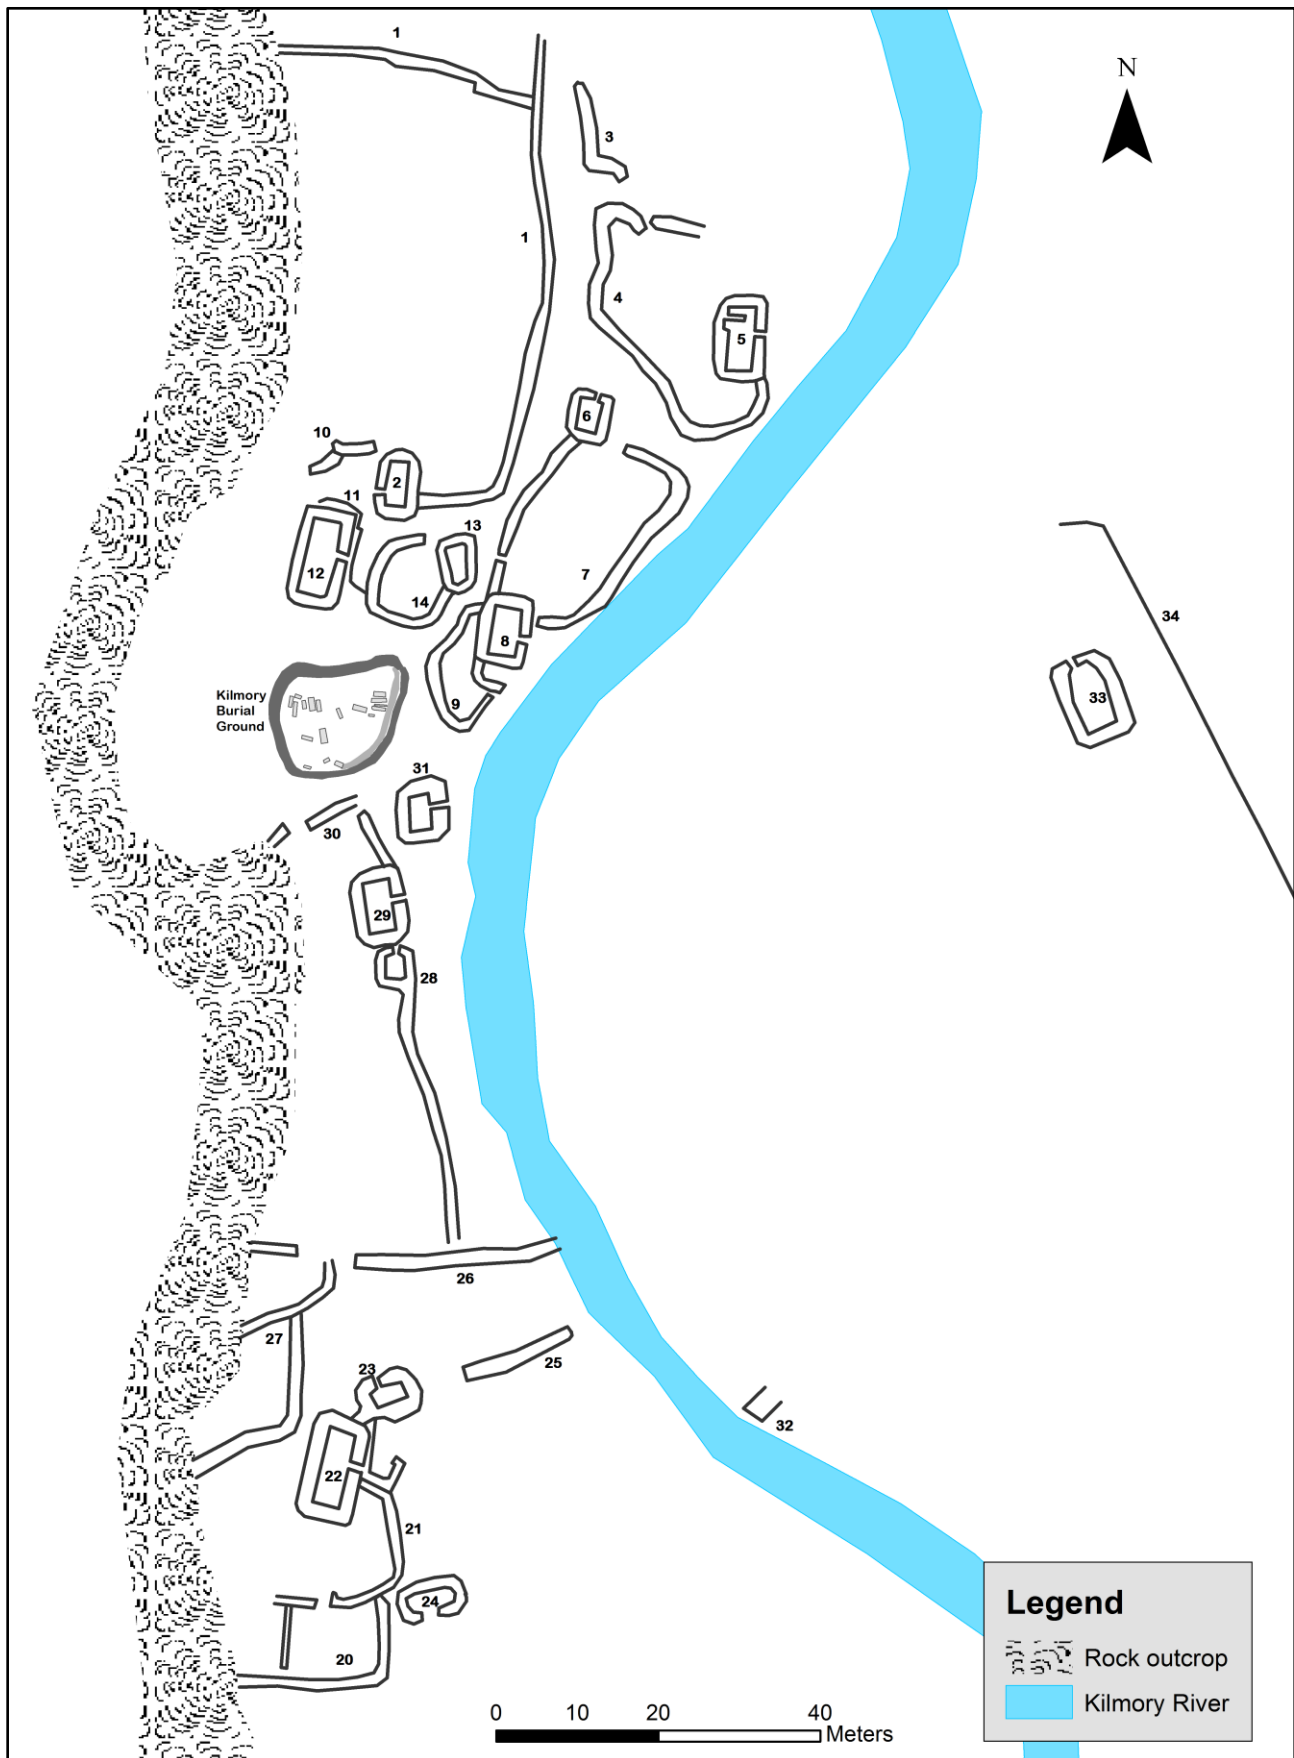
Figure 6: A plan showing the layout of Kilmory settlement strung out between the rocky outcrop to the west and the river to the east.

Although not the main focus of the archaeological survey, a rapid recording exercise was carried out to provide an up-to-date measured plan of the Kilmory settlement (Figure 6), with brief notes being made on a small number of the structures as time allowed. The structure numbers referred to in the following paragraphs relate to the numbers shown on Figure 6, 7 and 8 and in the gazetteer, where further information can be found (Appendix 2).

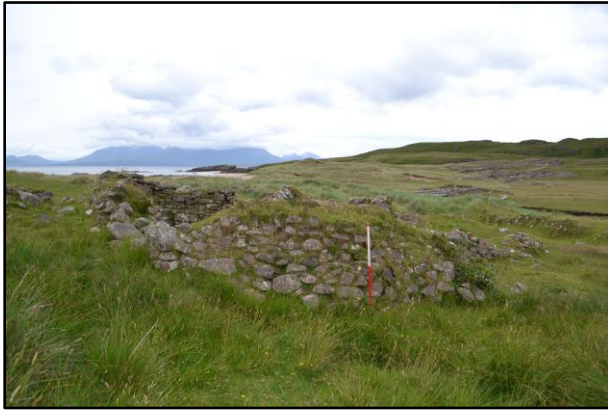
Plate 9: Structure 2

Structure 2 (Figures 6 & 7; Plate 9) is a ruinous, grass-covered stone building approximately 6m x 3m with rounded corners both externally and internally suggesting an early construction date. The walls stand up to a height of 1.25m.

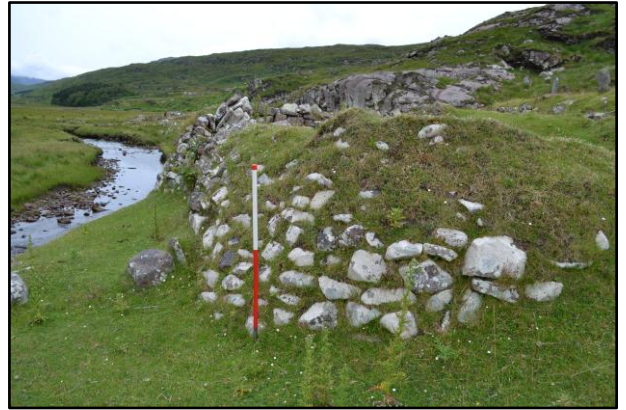
Plate 10: Structure 8

Structure 8 (Figures 6 & 7; Plate 10) is a degraded house situated on the edge of the river bank, which is being eroded by the river. The south-east corner of the structure is eroding into the river and the house is in significant danger of collapsing at this point. Within the structure at the south-east corner is a small, slightly raised, one-quarter circle platform and a small 'aperture' in the wall; the purpose of these features was not apparent.

- 6.7 The iron fence posts and wire should be removed; the posts set in the top of the wall have contributed to the deterioration of the wall.
- 6.8 Structure 8 (Figure 7) is currently eroding into the adjacent stream. Consideration should be given to a small-scale excavation to recover as much detail from this structure as possible before it is lost.

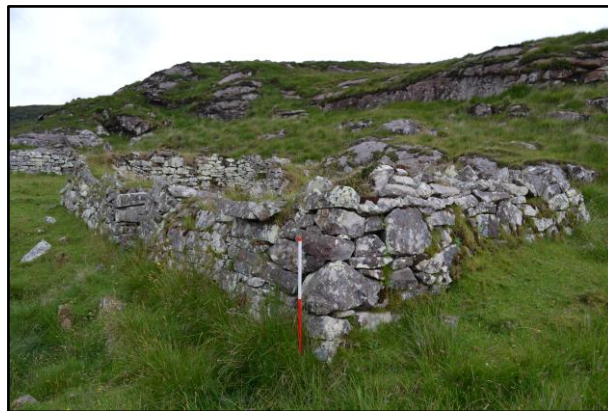
Plate 11: Structure 12

Structure 12 (Figures 6 & 7; Plate 11) is a substantial ruinous stone building and is the structure that has erroneously been identified as St. Mary's Church in the past. The walls stand to 1.5m at the south gable and 1.25m at the north gable. The structure sits on a platform with some facing stones visible; it is possible that the present structure stands on the site of an earlier building.

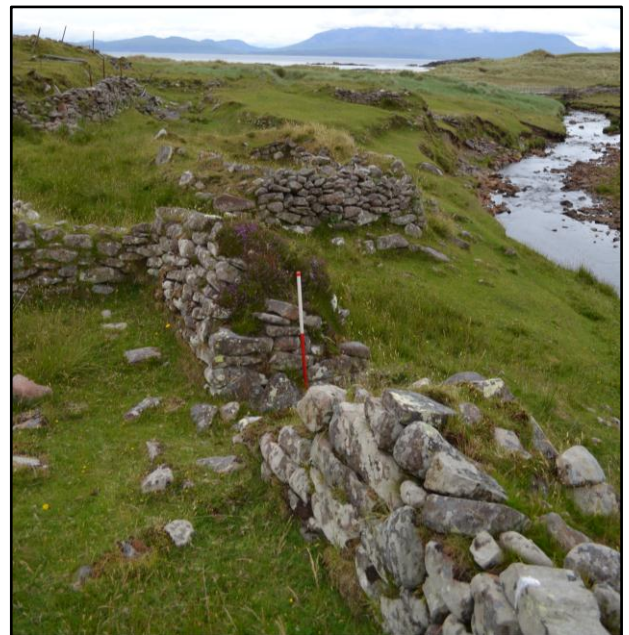
Plate 12: Structures 29 & 31

Structure 29 (Figures 6, 7 & 8; Plate 12) is a partially turf-covered building with rounded internal and external corners. The walls stand to a height of up to 1.5m externally and up to 1m internally.

Structure 31 (Figures 6 & 7; Plate 12) is a partially turf-covered building with rounded external and internal corners. The walls survive up to 1m high. It would appear to be standing on a possible earlier structure's footing.

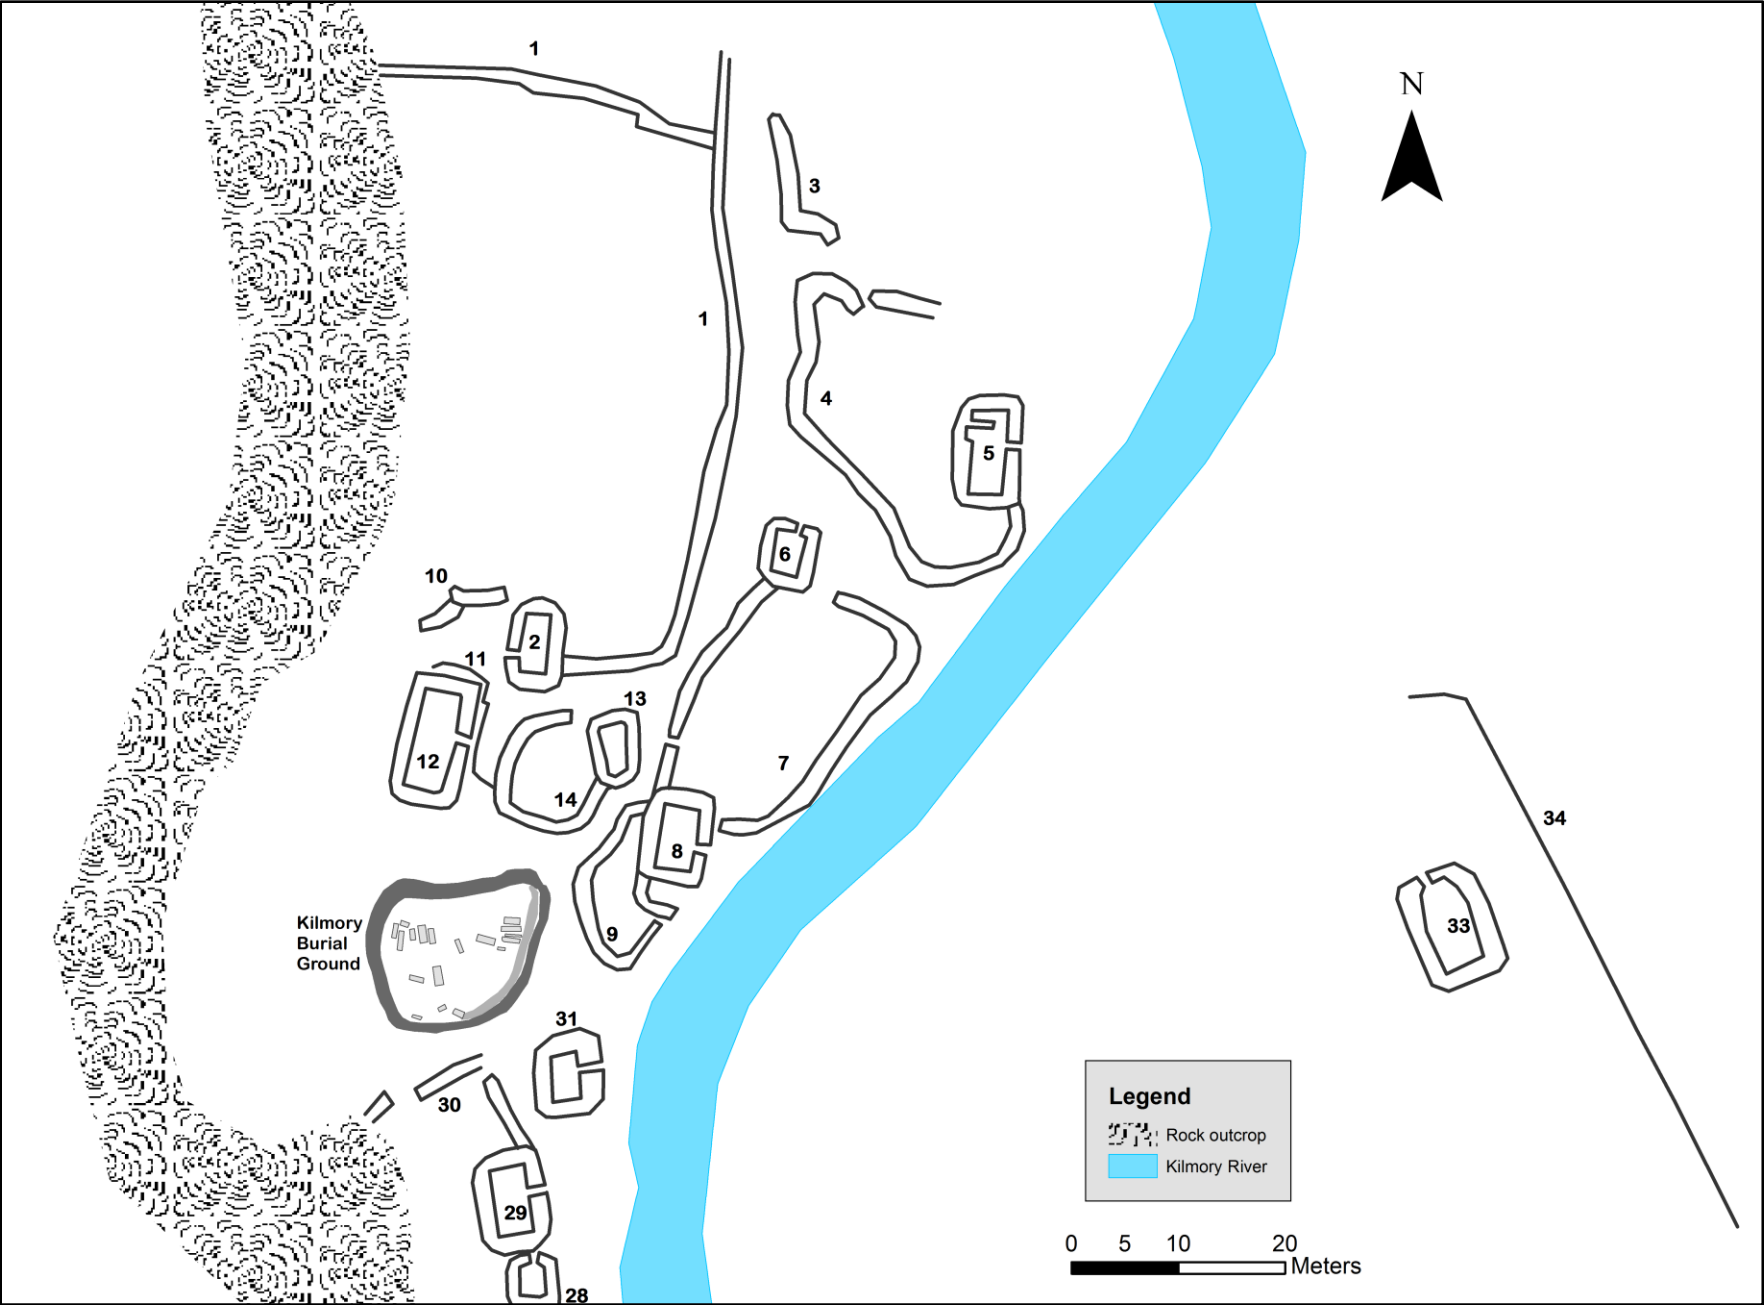
Figure 7: Plan of the north area of the Kilmory settlement

Structure 28 (Figures 6, 7 & 8) is a small, turf-covered building with walls standing up to 0.5m high.
