WATER MAIN RENEWAL
DRUMBUIE AND PLOCKTON, WESTER ROSS

ARCHAEOLOGICAL WATCHING BRIEF

National Grid Reference	NG 77617 31127 (Drumbuie, centred) NG 80619 33706 (Plockton, centred)
Authors	Mary Peteranna, John Wombell
Site Code	PLOC12
Report No.	2012-23/PLOC12
Client	Scottish Water Solutions
Date	10-12-2012
OASIS No.	rosscrom1-139670

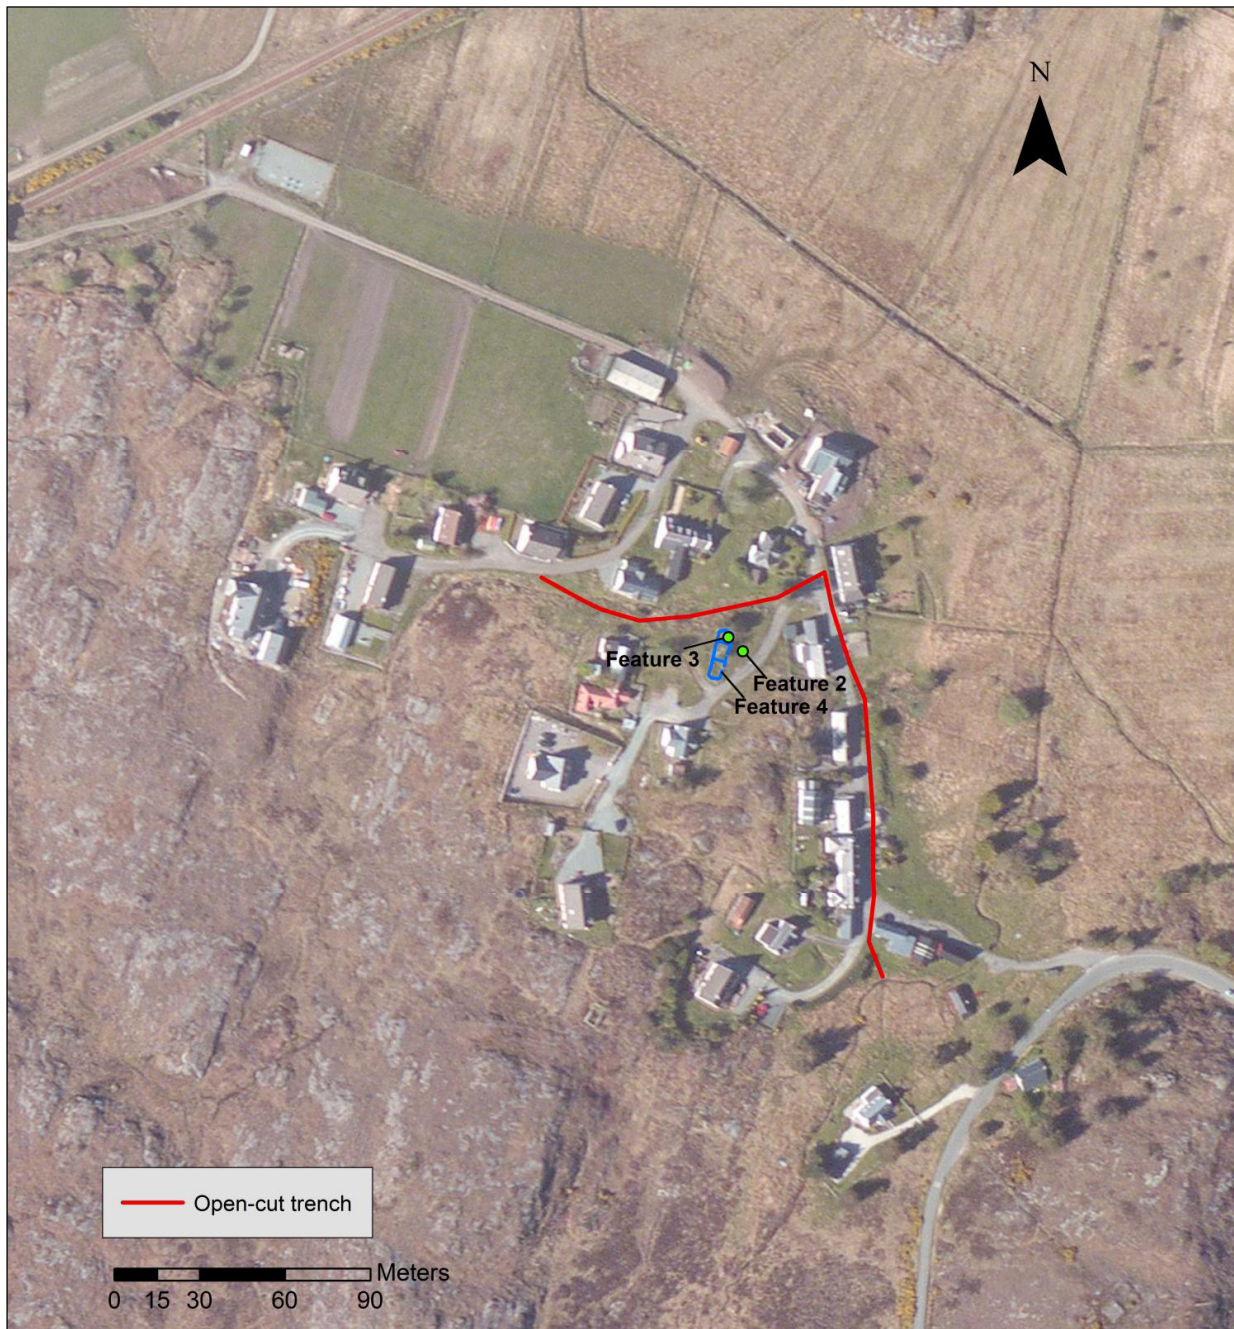
Figure 2 – Drumbuie water main renewal route

Three surface features were recorded during the watching brief (Figure 2) to the south side of the trench near Feature 4, a ruinous farmstead (centred on NG 77580 3110). The water main trench (Feature 1) ran approximately 1m away from the outshot of the building site. The old AC water main, communal sewer and telcom cables lie 1.5m north of the outshot – the new water main trench was dug to follow the existing AC water main.

Feature 4 is a drystone building with two compartments measuring 11m NE-SW by 3.5m internally. The walls of the farmstead, generally ruinous and robbed-out, are double-faced and measure up to 0.65m wide with a 1m-wide spread. The NE corner of the main building is heavily buttressed with drystone work. There are two entrances 0.75m wide located in the centre of each compartment in the east wall. The building has square internal and external corners and is slightly cut into the gently west to east sloping surface. There is a 'V'-shaped cut-off ditch approximately 1.5m from the upper west side of the building.

An outshot measuring 3.5m NE-SE by 2m internally abuts the north gable end of the main building. There is an entrance located at the northeast end of the east wall. Rubble from the structure obscures what appeared to be a raised platform to the left of the doorway. There is a more definite later stone platform of unknown use measuring 1m E-W by 0.75m in the SE corner (Feature 3). It may overlie a second earlier platform. There are two mature Rowan trees and a small Holly shrub growing inside the ruins of the main building and a mature Rowan growing inside the outshot and a mature Holly shrub growing just outside the north gable of the outshot.

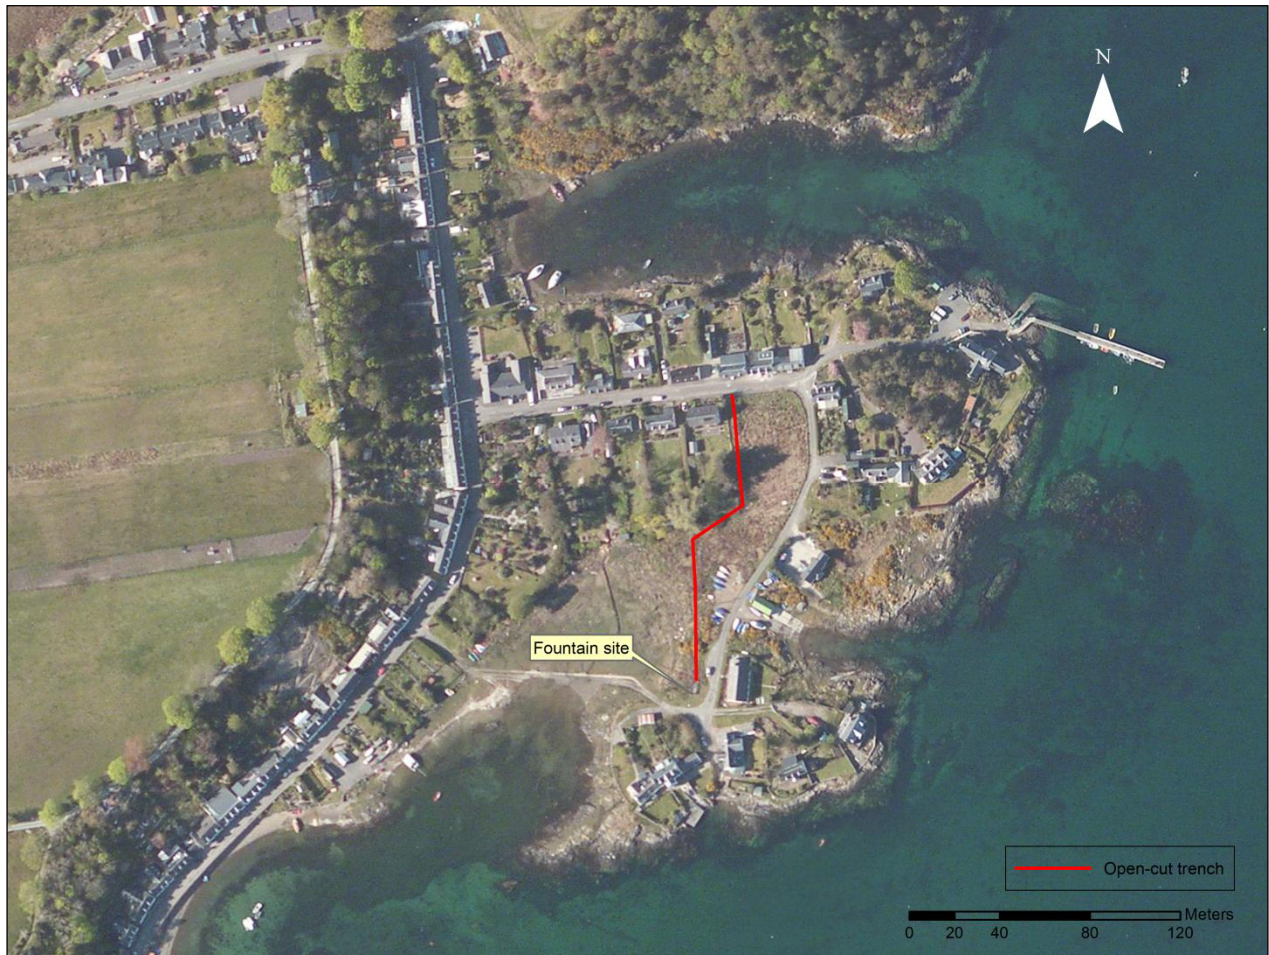
Figure 3 – Plockton water main renewal open-cut trench section

The trench for the Plockton water main renewal would mostly run through previously disturbed ground along the original pipeline route. After consultation with National Trust for Scotland, and after seeing visible evidence of a very thin topsoil layer, it was agreed that only the central section of the open-cut trench in Plockton was excavated under archaeological supervision. The north section of the route ran through private ground, outwith the remit of National Trust for Scotland, and the south section ran over the previously excavated water main route, which had blasted through rock. The route was also inspected for visible surface features.

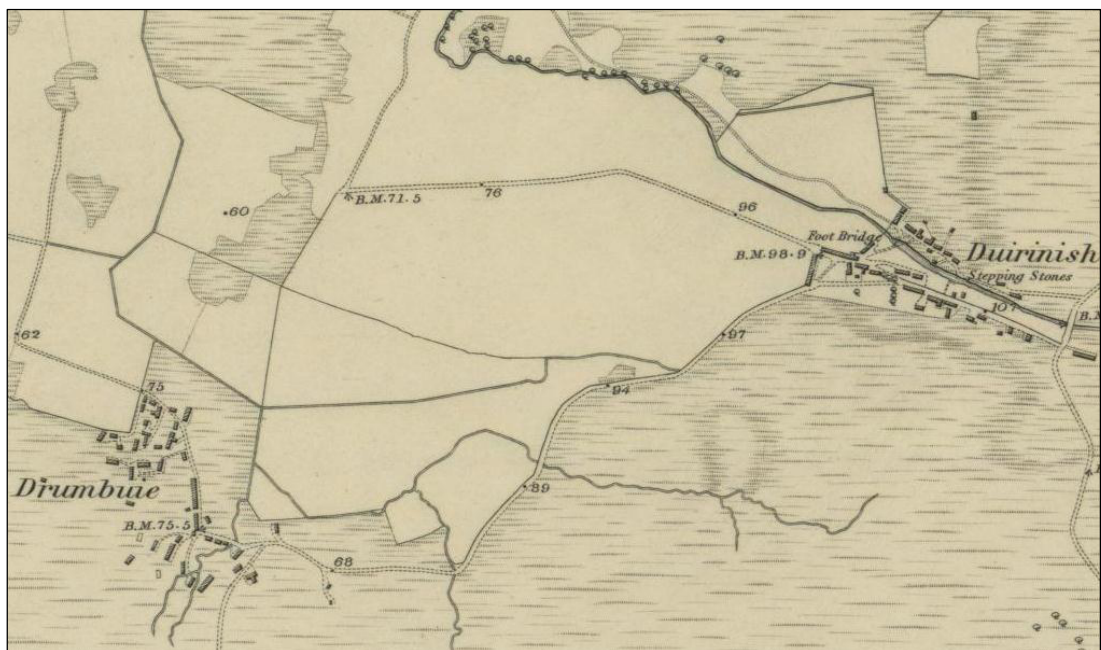
Figure 4 – 1st Edition OS map (1880) of Drumbuie to SW and Duirinish E

Forty-four roofed buildings and two unroofed buildings are visible on the 1st Edition OS map of Drumbuie, situated SW of the village of Duirinish (Figure 4).

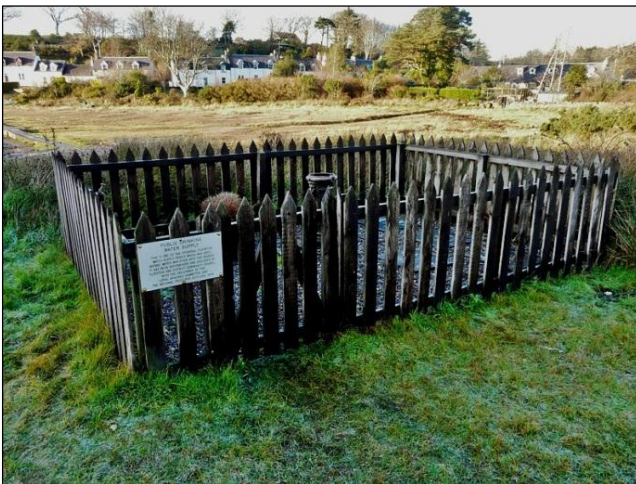
Plate 3 - Enclosed fountain located at the S end of the route in Plockton, facing SE

The south end of the route terminated at an enclosed site marking a disused fountain. There were no visible archaeological remains noted in association with this site and there are no details of the site on the Highland HER.

One rubble field drain was identified in the open-cut trench in Plockton, which immediately filled with water. The ‘fountain’ site, HHER No. MHG9217, had been enclosed and a sign marked the location. Although there were no details about the site on the HER, the sign read as follows:

The description of it as a ‘fountain’ suggests a piped water supply that ran continuously. The old cast iron fountain body remains in the enclosure with a modern tap inside it that pokes out of the spout. It is reasonable to assume that all of the original pipe work was removed when the water main was installed.

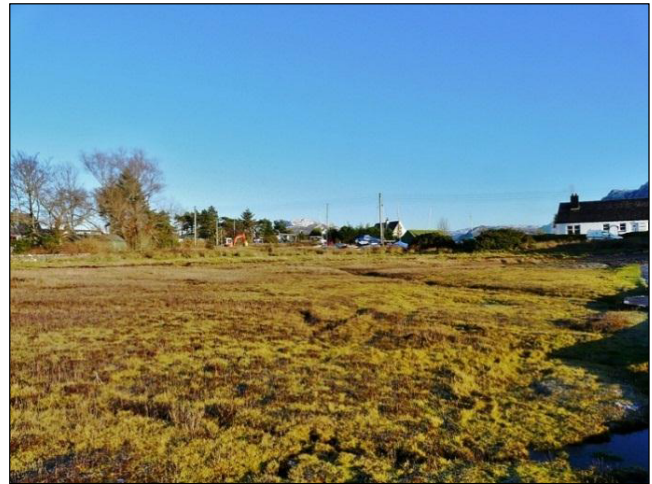
Plate 4 - S section of the Plockton route, facing ENE

In Plockton, the central section of the open-cut trench, approximately 25m in length, was excavated under archaeological supervision. The topsoil depth varied between 150mm and 800mm over rock. One archaeological feature, a rubble field drain was noted.

There were no archaeological other features of interest nor any archaeological horizons identified during the watching brief in Plockton. Only two small fragments of decorated pottery were noted in the topsoil.

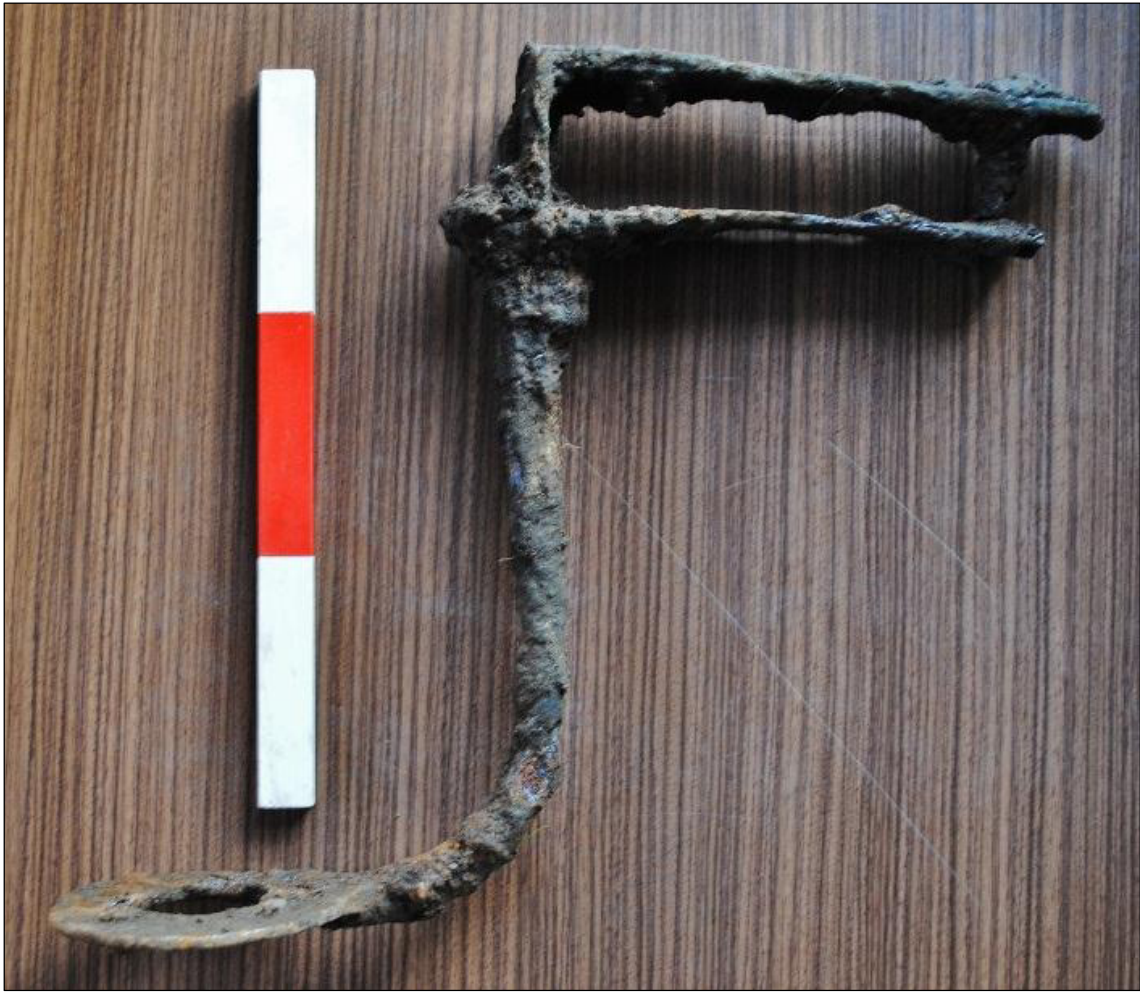
Plate 5 - SF01, horse cart step from Drumbuie

The probable horse cart step (SF01) recovered from the topsoil at Drumbuie was found in good condition and is considered to be of archaeological interest, as it would be associated with the middle to late 19th century settlement in the village. However, it was not found within an archaeological horizon and therefore little more can be said about it. It will be submitted to the Scottish Treasure Trove.
