## **Killiehuntly Woodland Creation Scheme**

### **Archaeological Desk-based Assessment and Walkover Survey**

**NN 80016 96078**  
**KIL13**  
**Mary Peteranna**  
**2013-02/KIL13**  
**Scottish Woodlands**  
**18-1-13**  
**rosscrom1-141982**

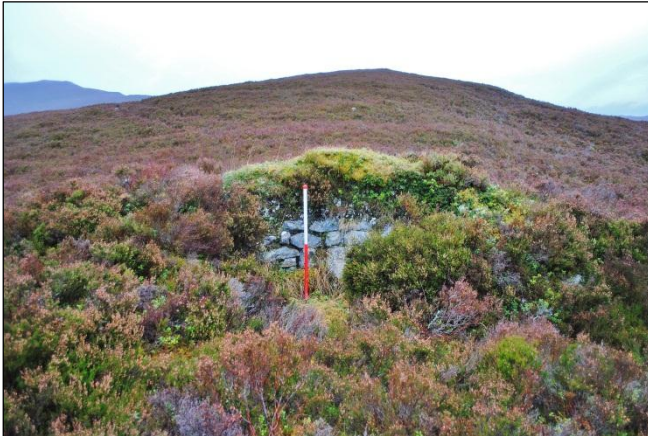
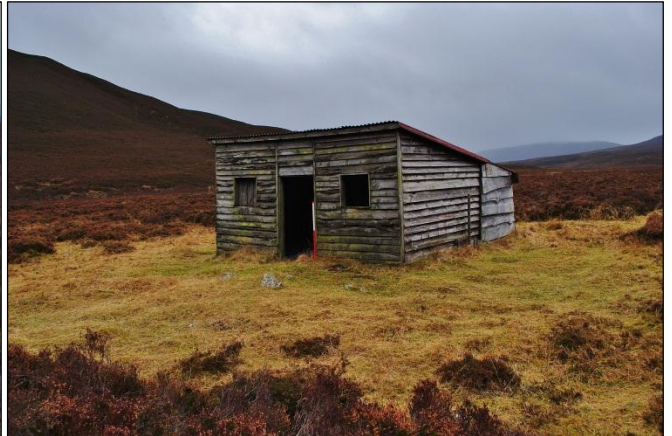
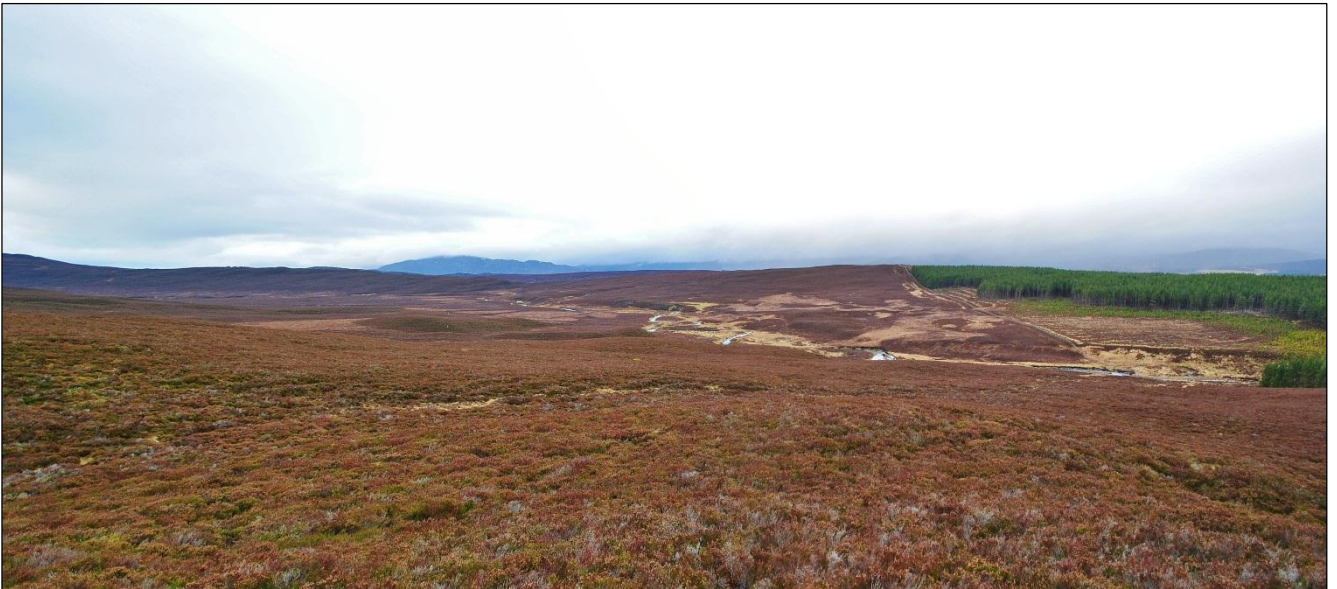
**Cover** - Top left: *Shooting butt (Site 4d, facing SW)*; top right: *stalker's hut (Site 7i, facing S)*  
bottom: *W-facing view across Gleann Chomhraig*

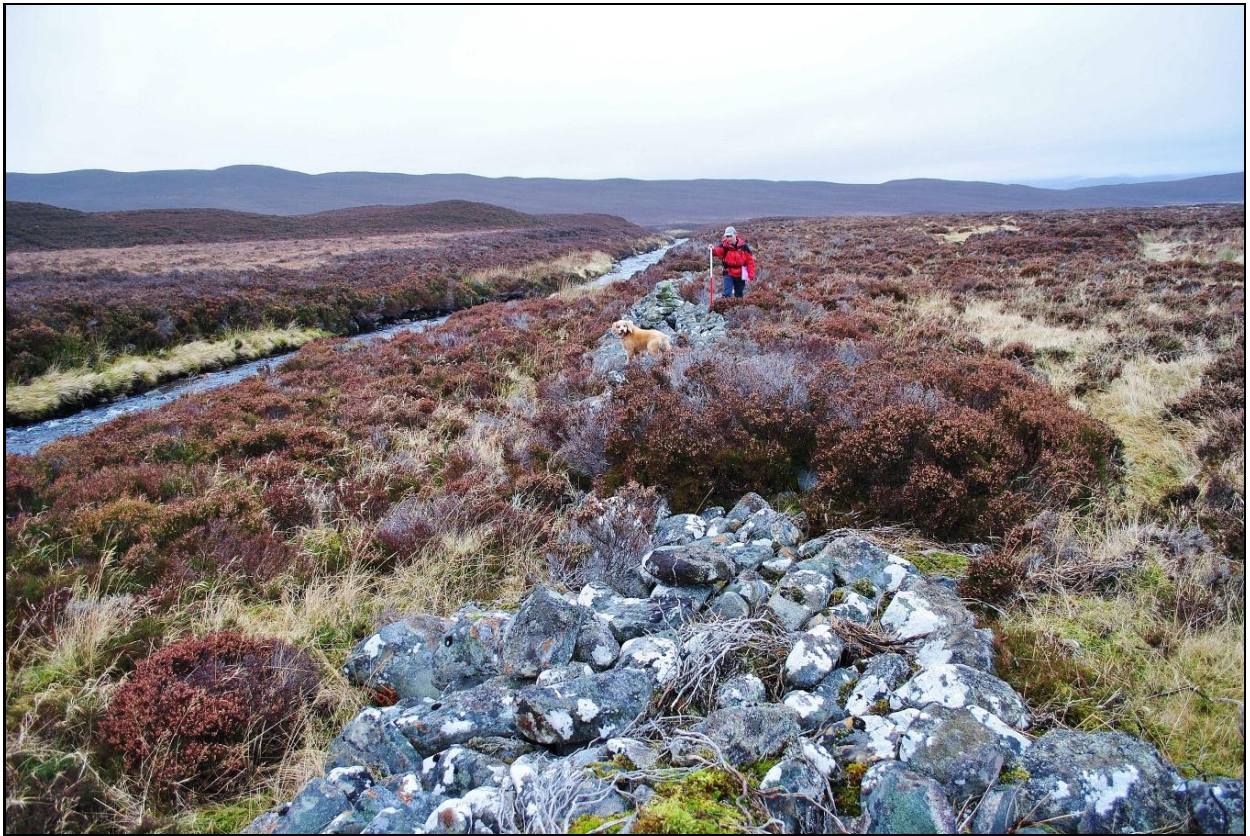
**Plate 1 Site 6 Ruinous stone-built dyke enclosing Gleann Chomhraig settlement, facing NNW**

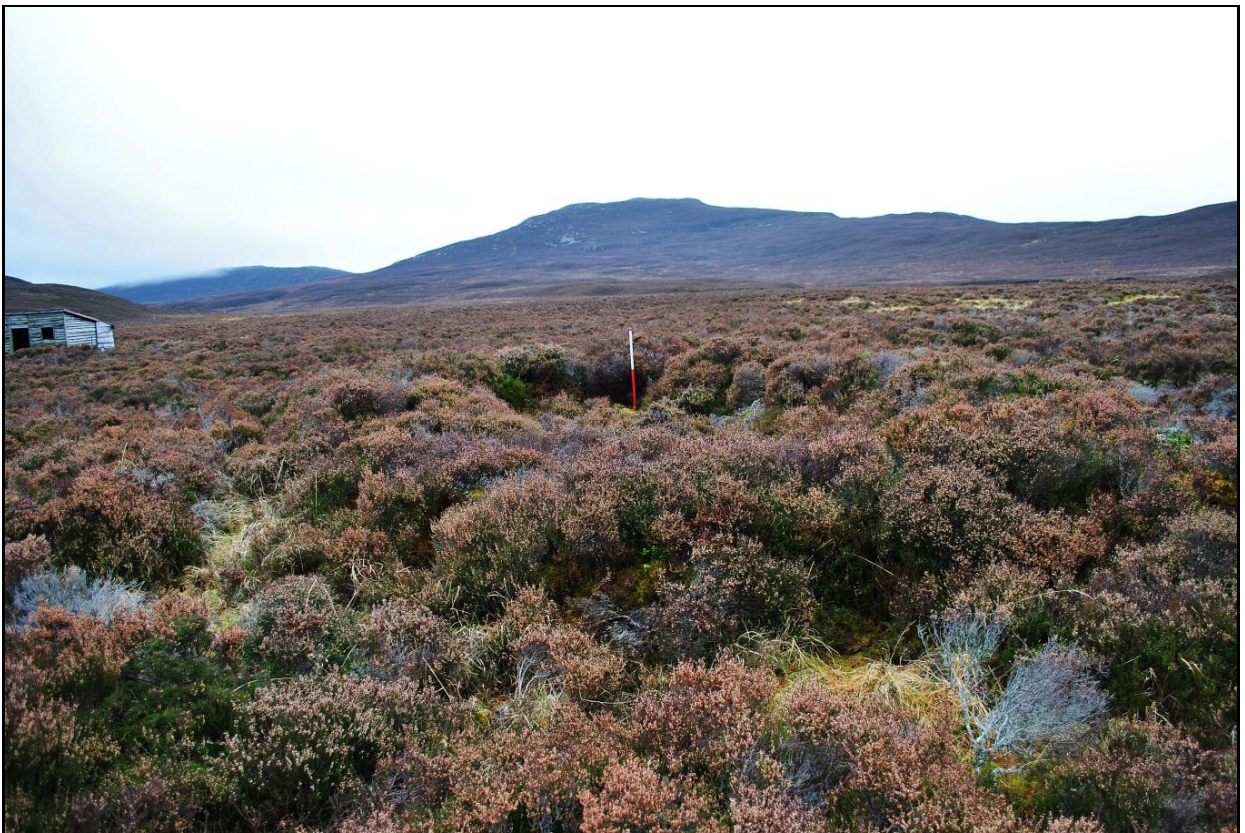
**Plate 2 Site 7a Heather-covered remains of a stone/turf-built subrectangular structure in Gleann Chomhraig, facing SW**

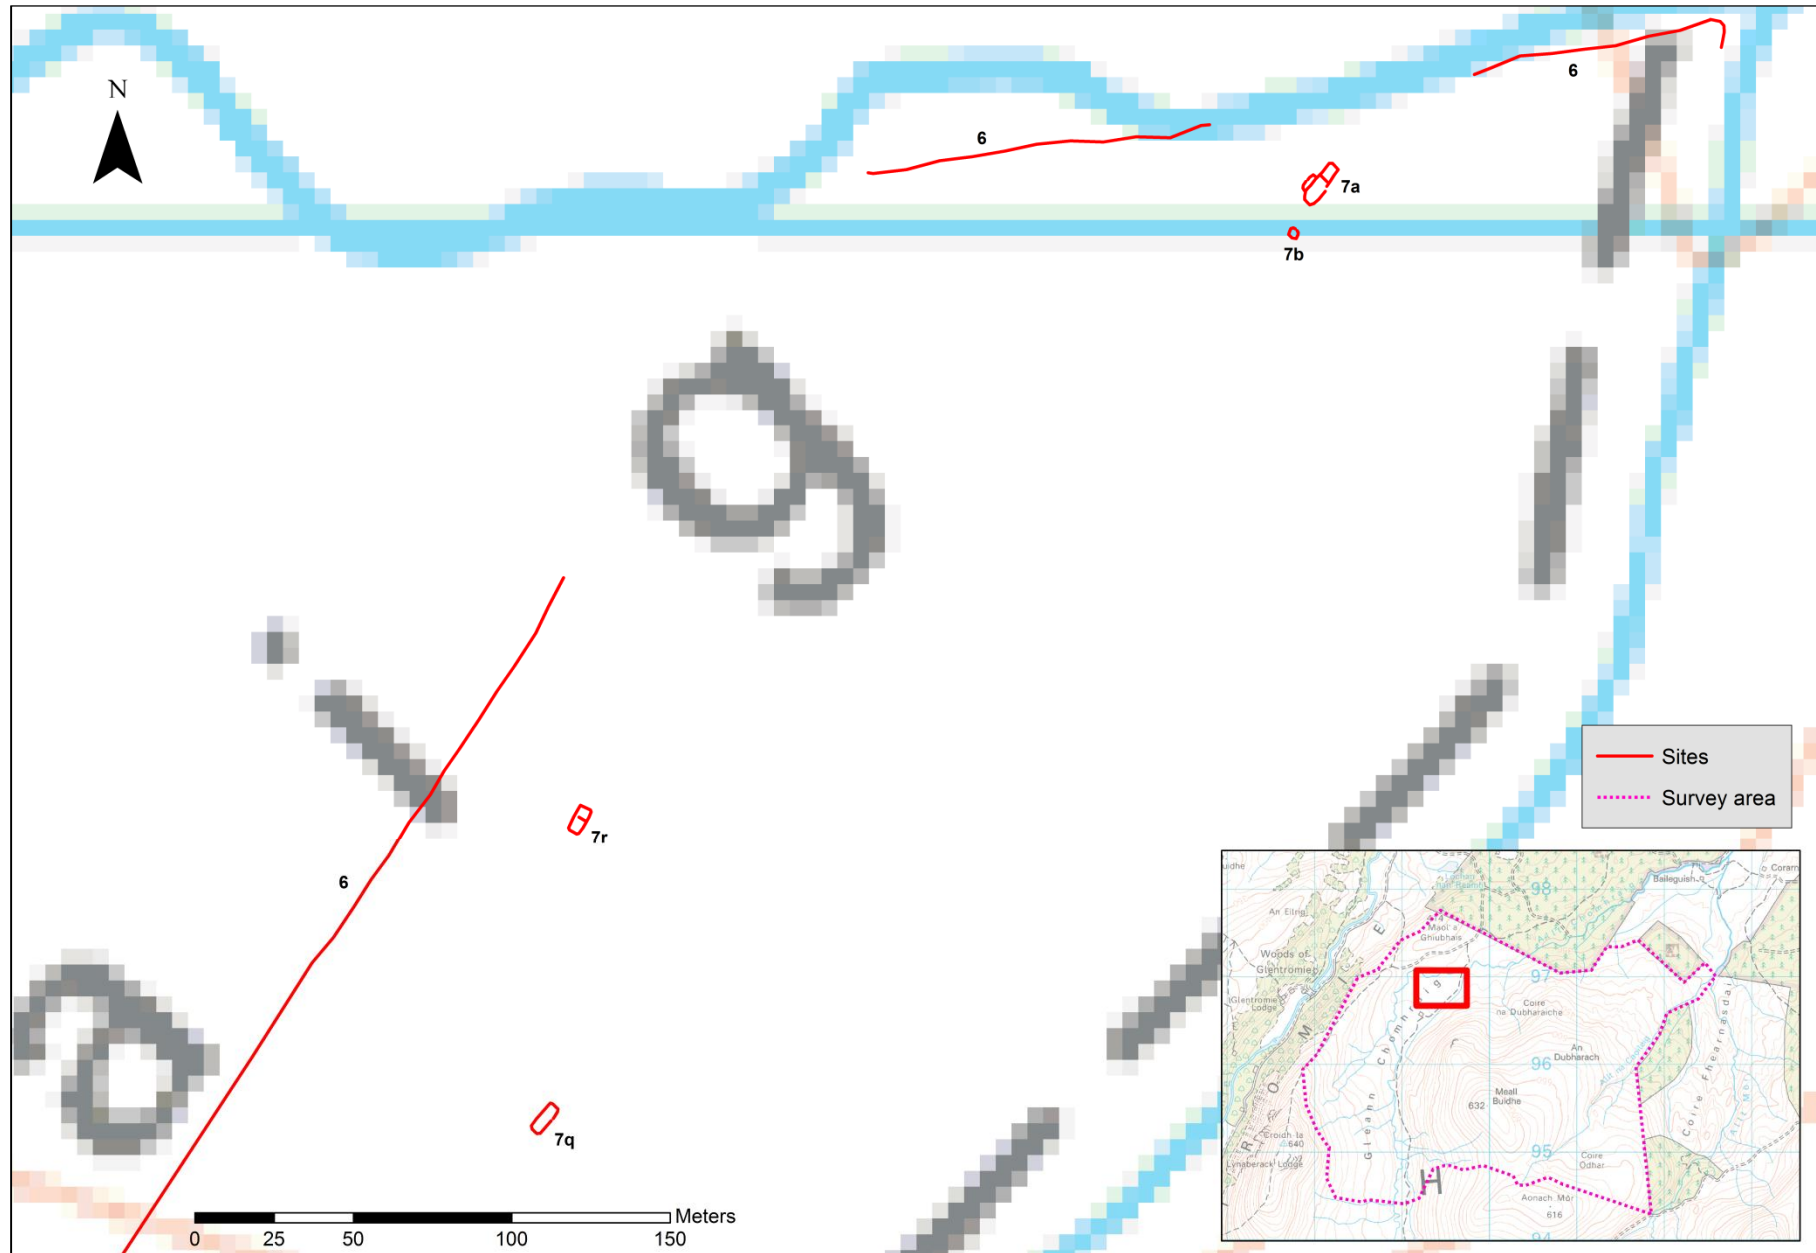
**Figure 6** Archaeological sites in the NE half of Gleann Chomhraig settlement

5.2.1.2 Although many of these sites had been recorded during the 1994 Ordnance Survey, the present survey identified two sites (7a and 7b, Figure 6) that were not shown on the current OS mapping. The present survey also identified five sites (7c-7g, Figure 5) built into the boundary dyke whereas the current OS map depicts only one.
