ROSS & CROMARTY ARCHAEOLOGICAL SERVICES

New House Site at Land 140m NW of Ardvassar Youth Hostel Archaeological Watching Brief

ARD13 Controlled Strip: New House Site near Ardvasar Youth Hostel

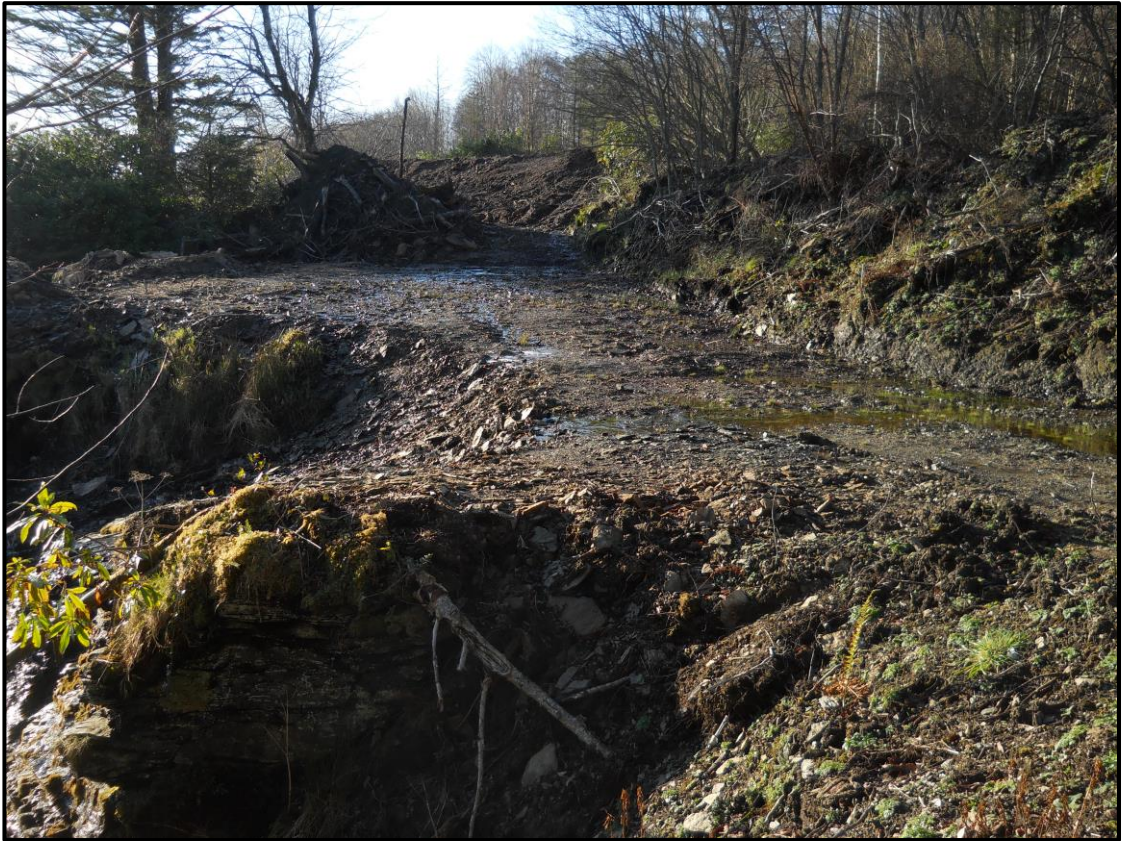
Plate 1: Looking over the narrow levelled platform of Plot 1 to the access cut leading up into Plot 2

One year ago, tree surgeons came onto the site to undertake vegetation clearance, particularly to clear infestations of rhododendron, but also small trees and shrubs. During this work an access route was cut through the site into the lower development plots. Level platforms had already been cut, with inter-connecting tracks. The house plots, all of which are located immediately above the shoreline bedrock, have been revetted into the slope with minimal removal of overlying sediments; this being minimal at the seaward edge of the sites, but cutting between 0.3m to 0.9m in depth at the back, west side of the sites (Plate 1).

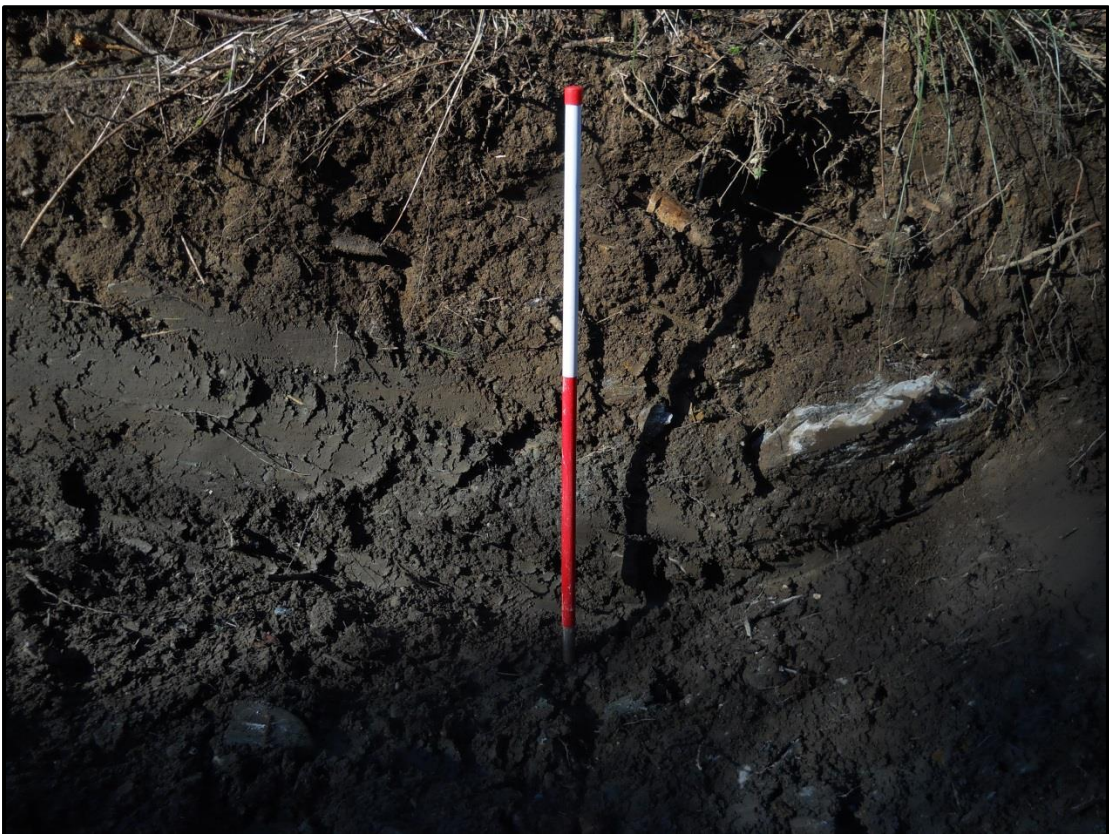
Plate 2: SE-facing section through cut of access track showing upper brown soil with numerous tree roots and underlying grey clay

Where exposed, these sediments include shallow topsoil (mainly forest soils), some of which are peaty in nature, which overlies wet and sterile grey clay deposits (Plate 2). Some of the deposits contain numerous tree roots and old, decayed tree remains. The grey clay, in turn, directly overlies schist fragments and bedrock.

During the watching brief, only a short section of the access track was cut from the present made-up car parking area and down into a previously cut access route. The exposed sediments in section in the track cut included redeposited material with small to large stone clasts, old tree remains and modern rubbish including polythene bags and rubber conveyor belting. Further to the northeast, sediments included a fine brown forest soil horizon overlying grey clay deposits. The grey clay also contains tree roots and a few large stone clasts, and is wet and poorly drained.
