Glen Convinth Woodland Creation

Archaeological Desk-based Assessment and Walkover Survey

National Grid Reference	NH 49581 34493 (Centred)
Site Code	GCV13
Author	Lynn Fraser
Report Number	2013-20/GCV13
Client	CKD Galbraith
Date	20-05-2013
OASIS No.	rosscrom1-151155

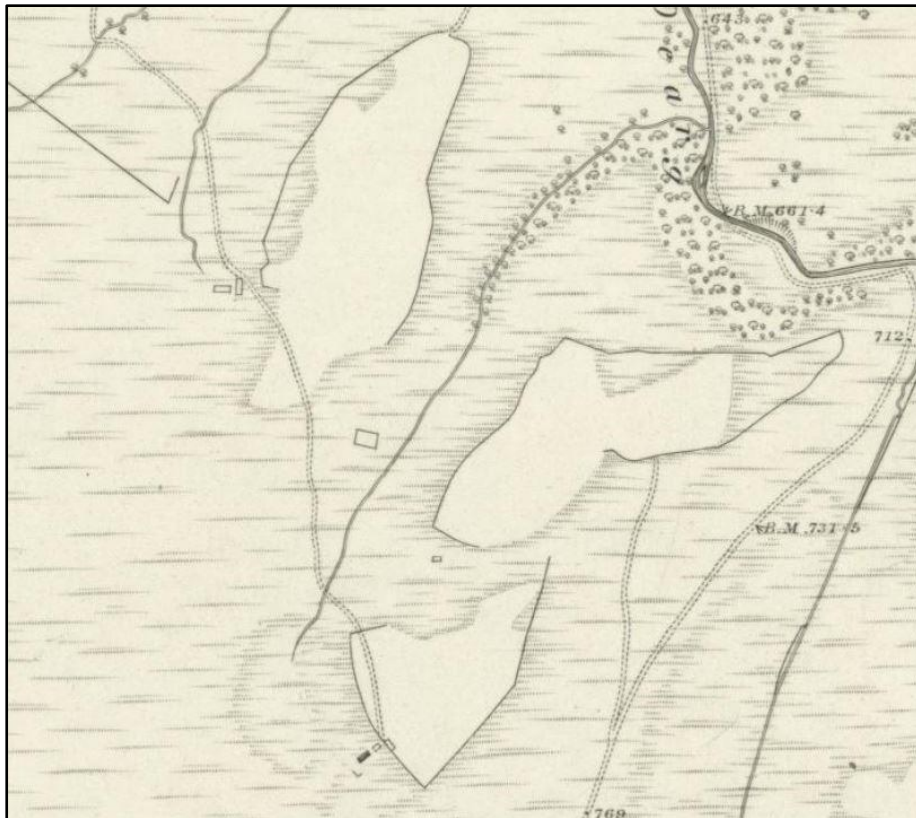
Figure 2: Excerpt from the OS 1st Edition 6-inch map showing the farmsteads and associated boundaries (© NLS)

The 1st edition Ordnance Survey mapping depicts a group of two unroofed and one roofed building with two open-ended enclosures, a single unroofed building to the north-northeast and a rectangular sheepfold to the north of this grouping. A track runs from the group of three buildings towards the north-northwest where there are two unroofed buildings depicted alongside the track. Another open-ended enclosure commences to the east of these buildings and a boundary dyke starts to the northwest of them (Figure 2).

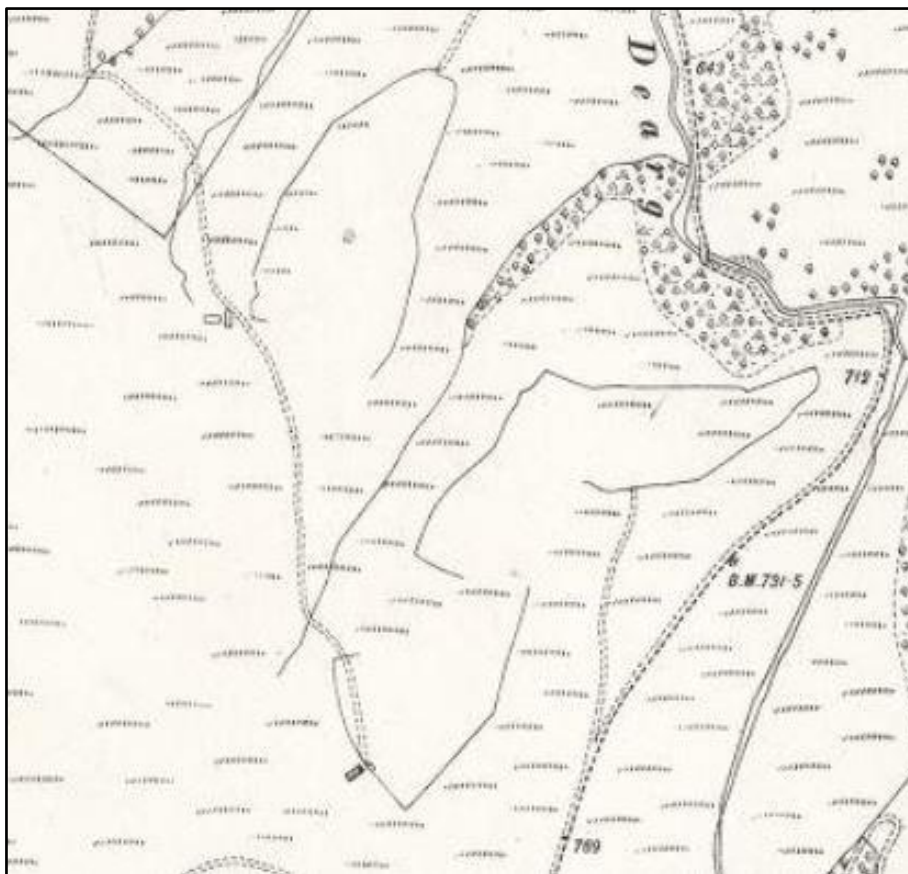
Figure 3: Excerpt from the OS 2nd Edition 6-inch map showing the changes to the farmsteads and other structures (© NLS)

The 2nd edition mapping shows minor changes. The group of three buildings is now depicted as one roofed and one unroofed structures. The unroofed building to the north-northeast and the sheepfold are no longer depicted (Figure 3).

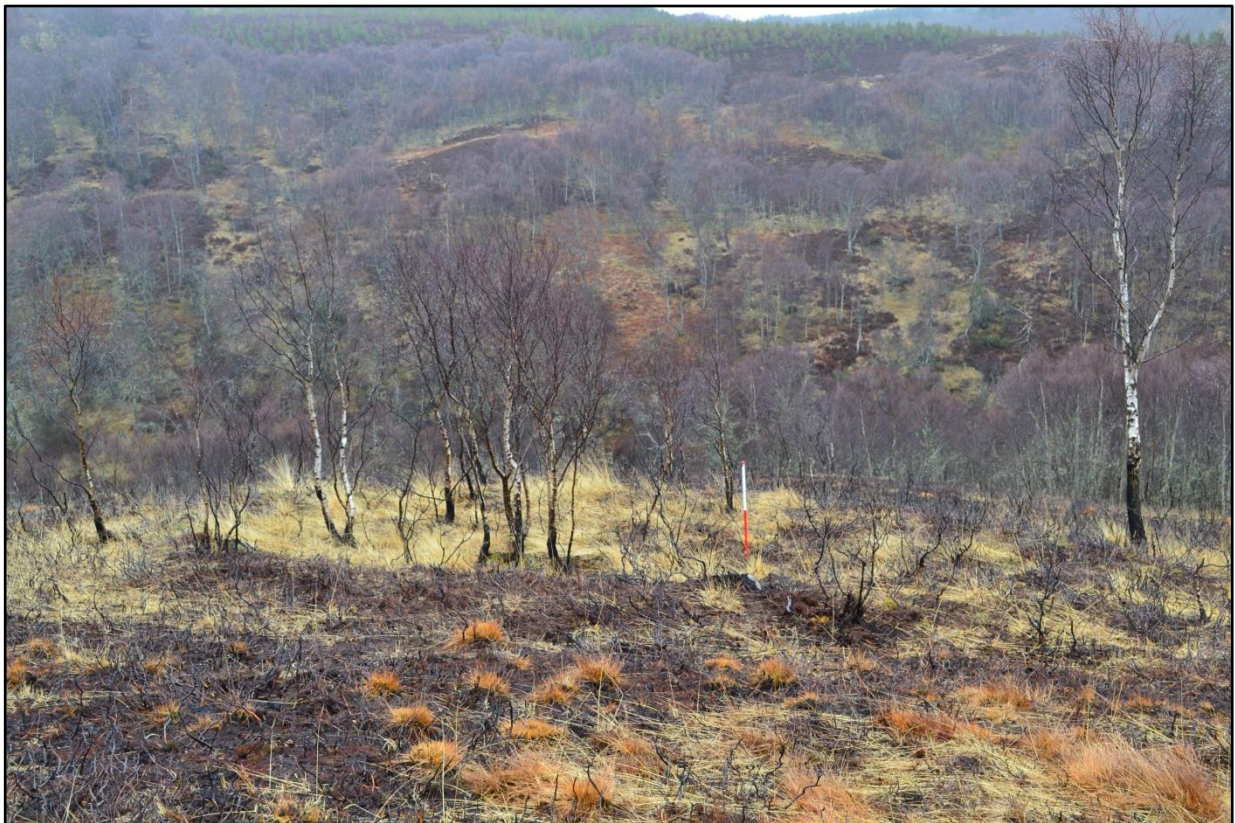
Plate 1: Site 9, the hut circle

A previously recorded hut circle and possible associated field system identified by Jill Harden to the south-east of the White House in the northern-most part of the survey area (Sites 9, 10, 33-35, 59-63; Figure 5) were rapidly recorded. The hut circle sits on a platform on a steep east-facing terrace and measures approximately 4m in diameter internally (Plate 1). It currently has young birch trees growing on it. To the west of the hut circle, on more level ground, are various turf and stone dykes and stone clearance heaps. Whilst the more upstanding of these will undoubtedly date to the post-medieval period, there are some lengths of wall and clearance piles that are well set into the peat and are most likely prehistoric in date and associated with the nearby hut circle.

- 7.2 Sites should be marked out with highly visible fencing or flags prior to planting of the new woodland.
- 7.3 The young birch trees growing on and around the hut circle (Site **9**) should be removed by hand if possible. Future self-sets should be monitored and removed from the buffer zone.

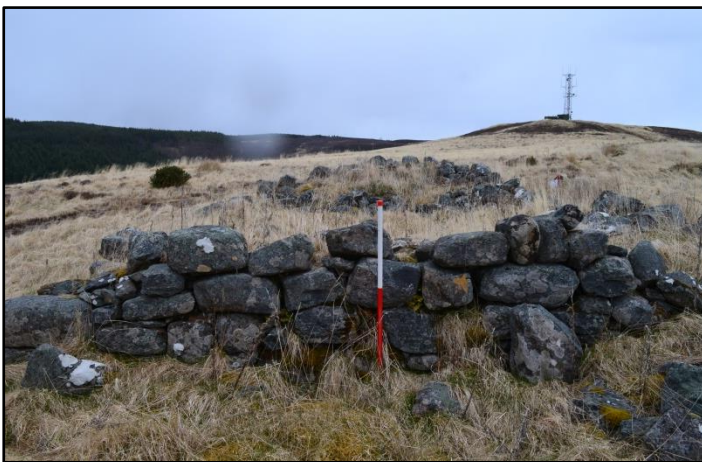
Plate 2: Site 3a, house

Glen Convinth farmstead (Site 3-5) is situated in the vicinity of the current transmitter mast (Figure 7) and this presented as a degraded stone-built longhouse aligned southwest-northeast. It measures approximately 17m by 4m and is divided into three parts. The south-westerly compartment has a twinning pen situated in one corner suggesting a later use of the structure. At the south-western end of the structure is a small platform, which may be the footings of part of the original south-western building shown on the 1st edition OS map (Figure 2) before being amalgamated with the smaller building to the north-east as depicted on the 2nd edition OS map (Figure 3). The footings of a second building are to the immediate north-east of the longhouse. These are grass- and turf-covered and much degraded. The north-western end appears to have been truncated by the construction of the road to the transmitter mast. A short distance to the west of the transmitter mast is a grass- and turf-covered corn-drying kiln, although the kiln bowl is visible at the north-west end. The area to the north-east of the farmstead is enclosed by a series of stone and turf boundary dykes.

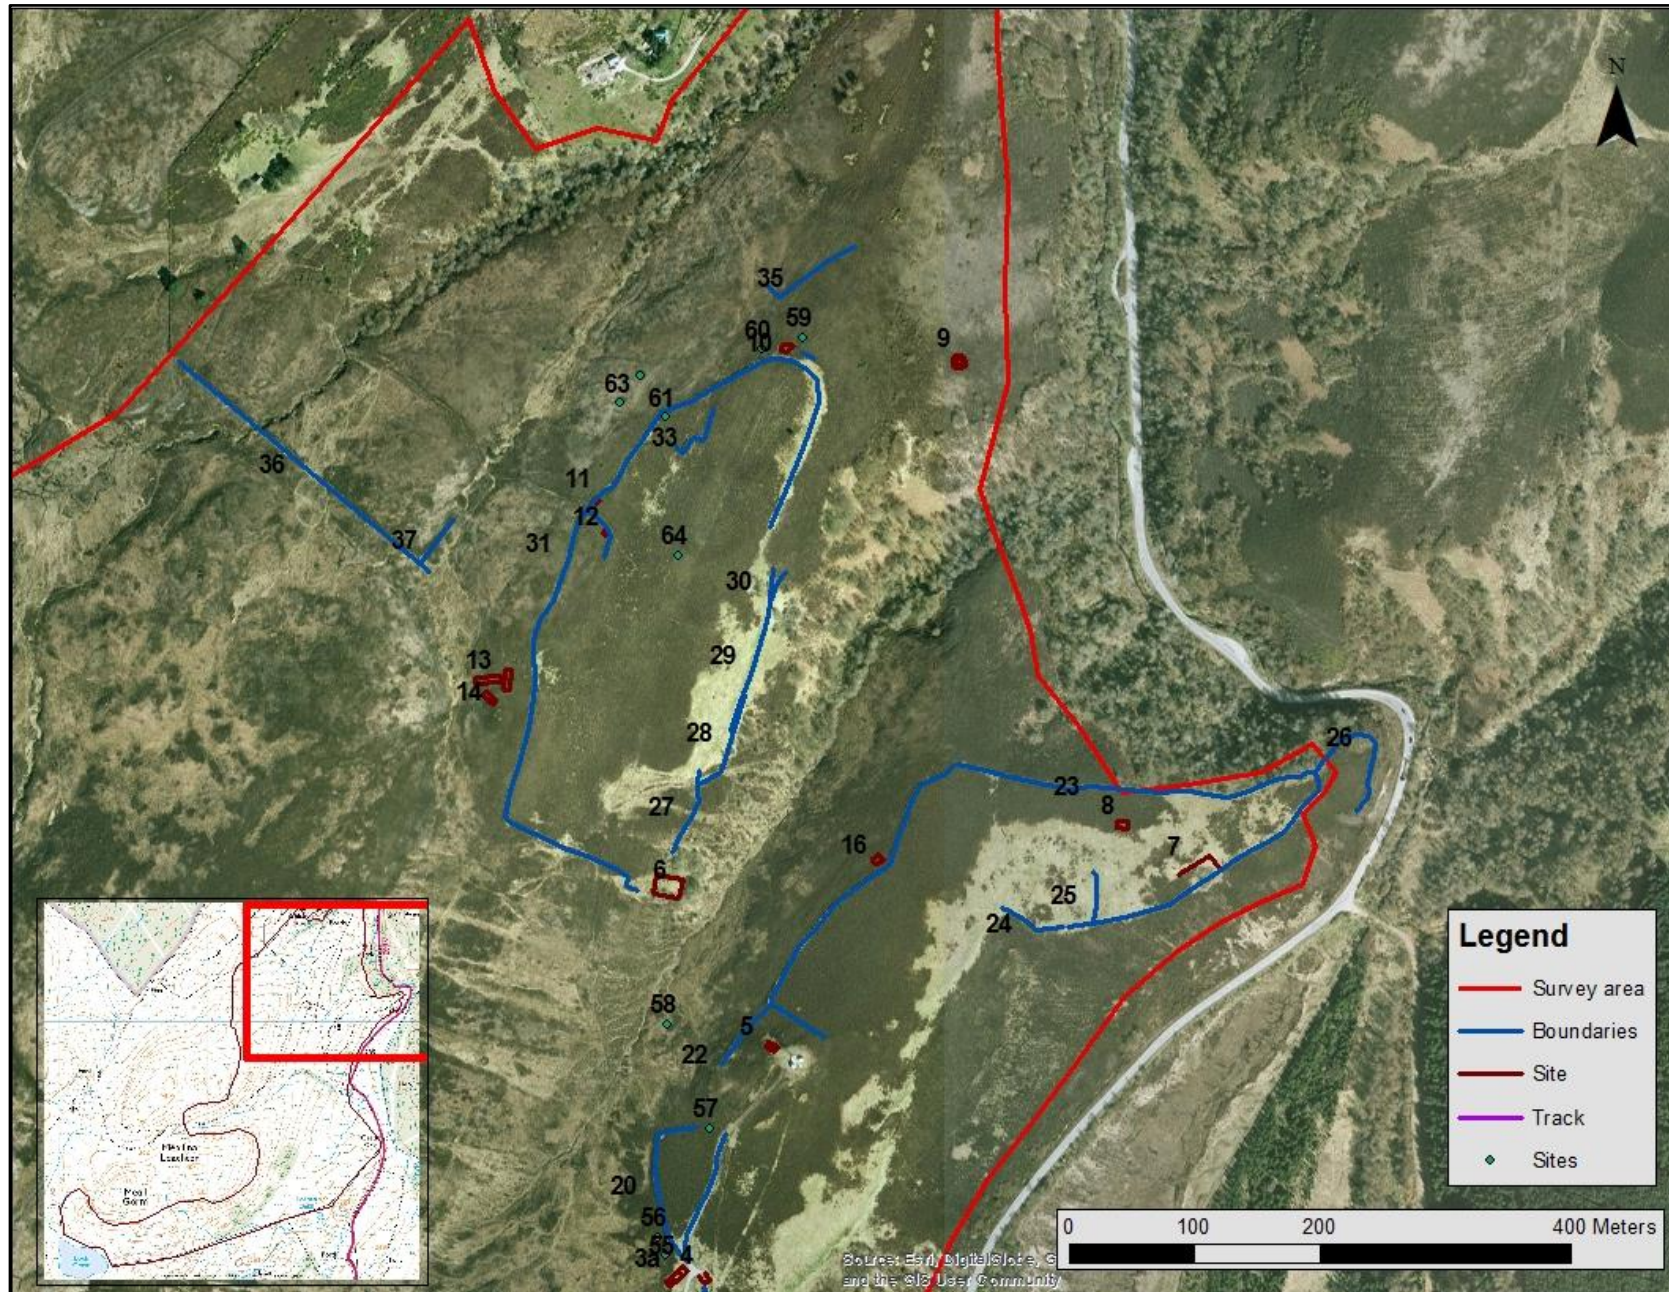
Figure 5: Distribution of the archaeological sites recorded in the northern end of the survey area

A small stone-built feature (Site 64) was recorded on a ridge (Figure 5). The stones are set into the ground in a slight arc. There is no obvious interpretation for the setting, but it could possibly be a prehistoric feature.

The second farmstead, White House, (Sites **13-15**) is located in the north-western part of the survey area (Figure **5**). It comprises two longhouses and a corn-drying kiln (Plates **4** and **5**), although on both the 1st and 2nd edition OS maps the farmstead is shown as only two unroofed buildings suggesting these structures are quite early in date and had gone out of use prior to 1872. The structures are in a much degraded state with very low stone footings visible; the kiln bowl, however, is reasonably well-preserved. The area to the north-east of the farmstead is enclosed by a series of turf and stone dykes.
