***AUCHNAGALLIN LEASE AREA, GRANTOWN-ON-SPEY***

**ARCHAEOLOGICAL DESK-BASED ASSESSMENT  
AND WALKOVER SURVEY**

**2013-21/ANG13**

**Forestry Commission Scotland**

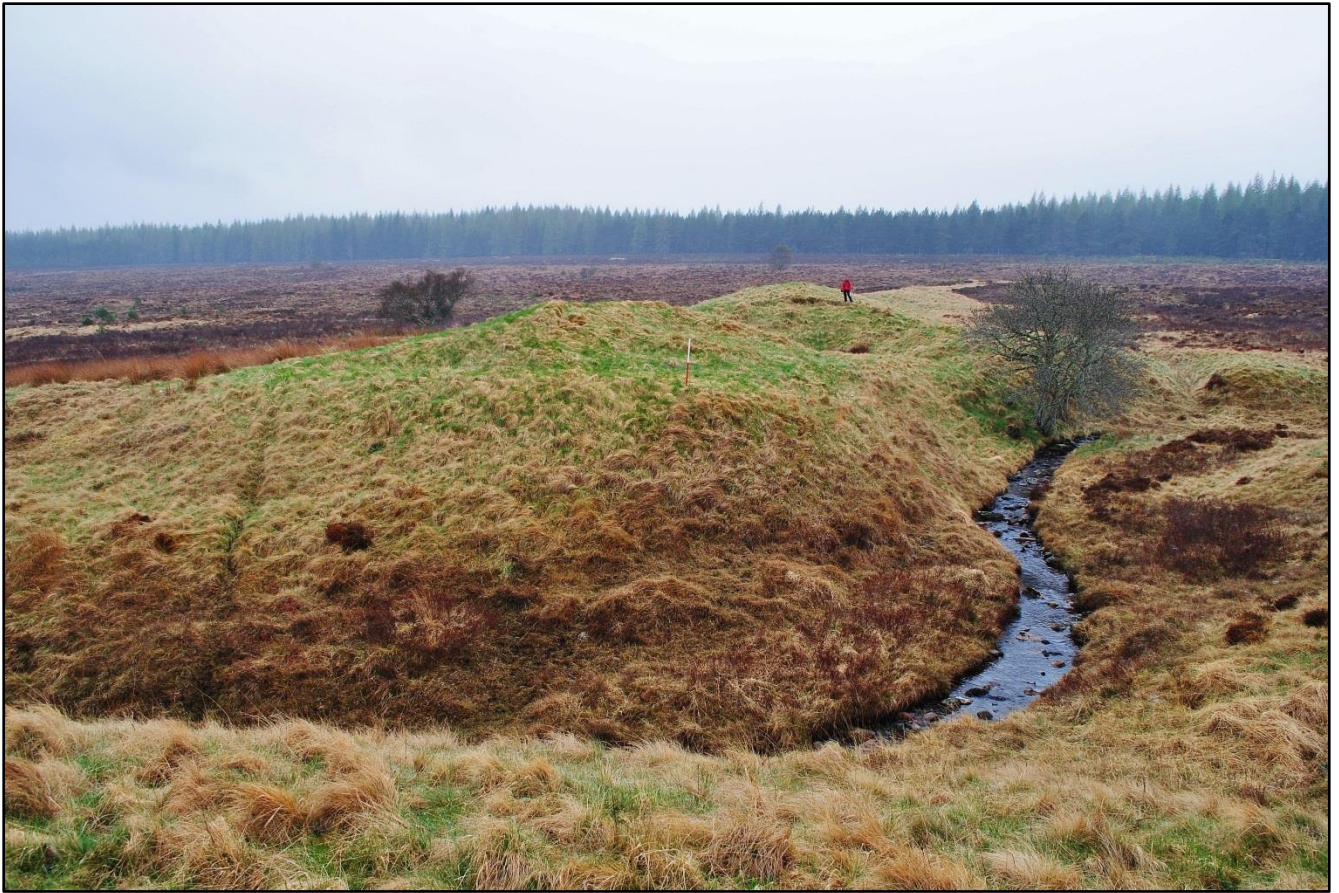
**Plate 1:** Site 1, the quarry or gravel pit.

Sites 1-3, a quarry (Plate 1), limekiln (Plate 2), track, dam (Plate 3) and walls, form a small industrial complex (Figure 5). The area where the track crosses the stream has been interpreted as a dam as the stream has been modified on both the upstream and downstream sides. The modification is most evident on the downstream side where there is a large mound of stone, which has a circular appearance that may have been the base of a structure. Additionally, the stream channel here has been filled with stones for several metres.

| Site No. | Site Type | Site Name | Description | Alignment | Condition | Period | Ht OD (m) | Easting | Northing | Photo No. |
|---|---|---|--|---|---|---|---|---|---|---|
| 1 | Quarry | Auchnagallin | A sinuous, grass-covered mound aligned E-W is the site of disused quarry pit; it comprises several large pits, the largest at the W end, w/ fragments of low turf/banks on the edges; a faintly visible track (on 2nd Ed OS map) leads from the site to the road. A small, circular pit is located on the top of the quarried mound. It may be a smaller quarry pit. | WNW-ESE | Very degraded | Post Medieval | 265 | 304829 | 833433 | 1-3 |

- 7.1 The following buffer zones should be retained around archaeological sites recorded during the walkover survey (Figure 6):
  - A 5-metre buffer zone all the sites recorded with the exception of site 2, the limekiln outwith the survey area, and site 3b, the track. Preservation of the entire area of the possible field system (Figure 4) has not been recommended due to the uncertain interpretation and poor survival of the remains found.

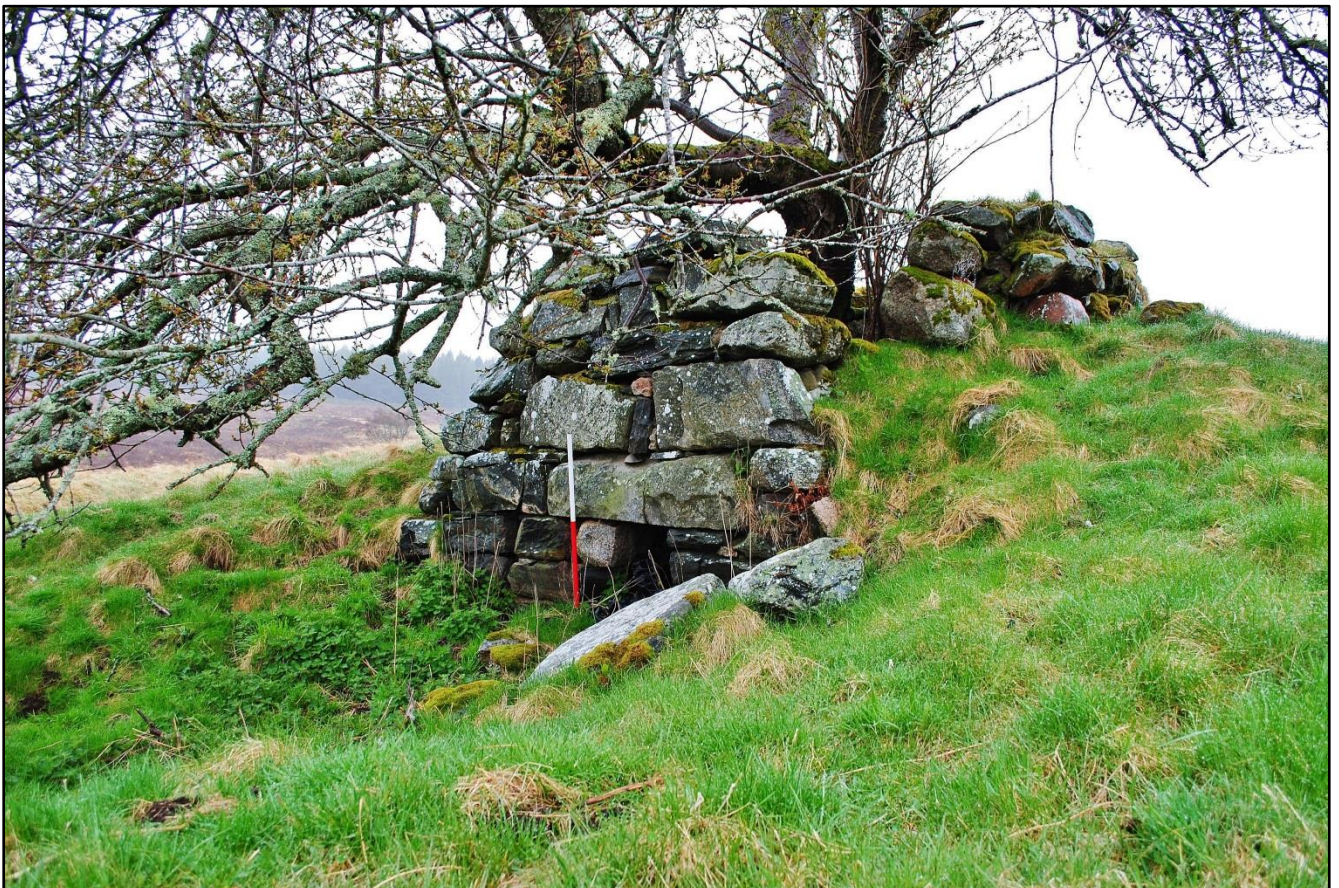
**Plate 2:** Site 2, the limekiln.

| Site No. | Site Type | Site Name | Description | Alignment | Condition | Period | Ht OD (m) | Easting | Northing | Photo No. |
|---|---|---|--|---|---|---|---|---|---|---|
| 2 | Limekiln | Auchnagallin | A ruinous, D-shaped limekiln comprises 1m-wide boulder/stone walls with a flue on the SE side. It stands 1m high on the E, N and W sides where it is enclosed by a U-shaped bank spread 1.5m wide. It measures 2m high and 3m across on the SE side. | - | Ruinous | Post Medieval | 265 | 304951 | 833403 | 4-8 |

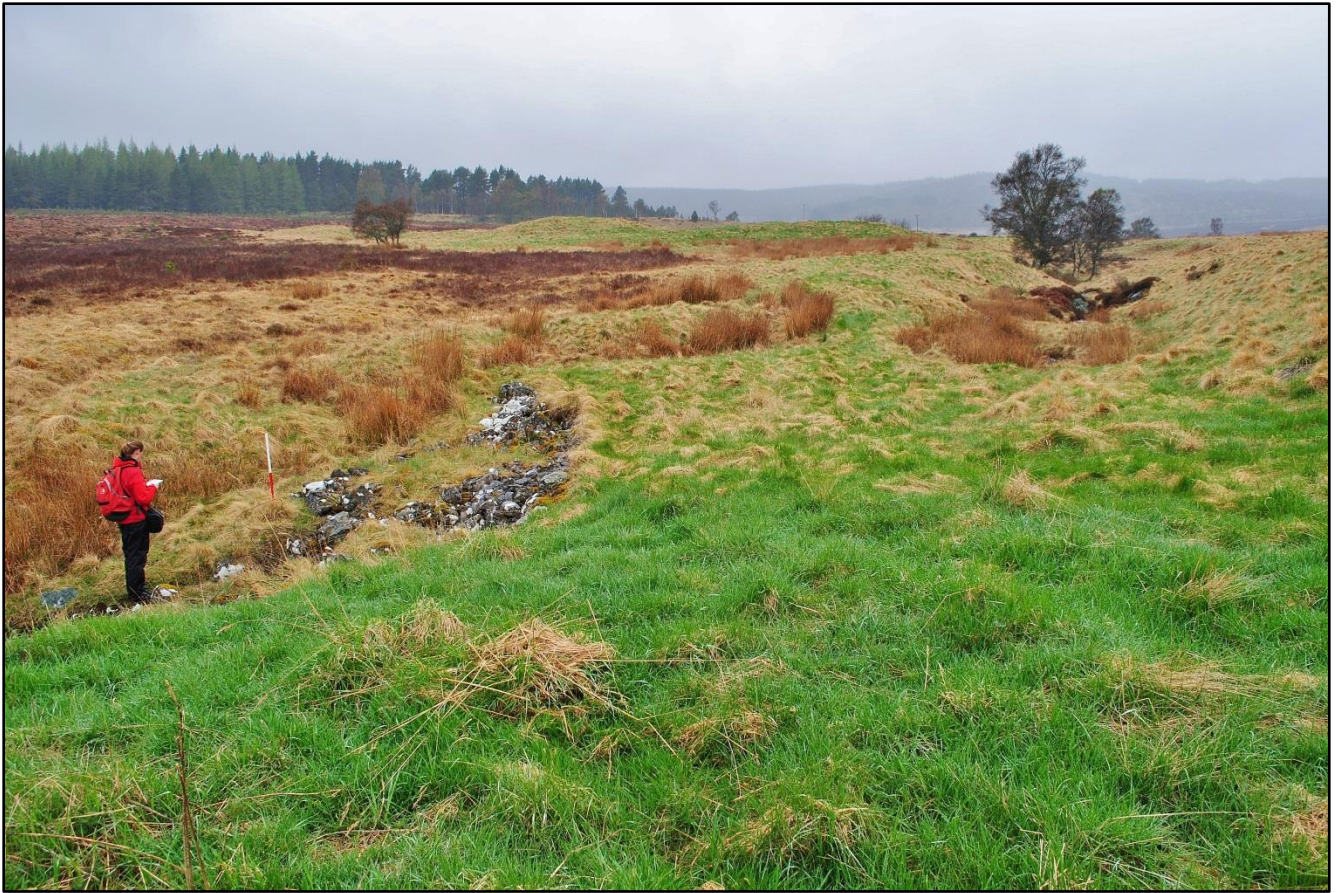
**Plate 3:** Sites 3a and 3b, the dam and track with site 1, the quarry, in the background.

| Site No. | Site Type | Site Name | Description | Alignment | Condition | Period | Ht OD (m) | Easting | Northing | Photo No. |
|---|---|---|--|---|---|---|---|---|---|---|
| 3a | Wall or dam | Auchnagallin | Along the S edge of a grass-covered platform crossing a burn is a rubble-built wall face 0.6m high and 0.4m wide forming the edge of a dam or revetment for the platform. It measures 15m long WNW-ESE w/ a stone spread up to 5m wide at the base. | WNW-ESE | Ruinous | Post Medieval | 265 | 304911 | 833381 | 9-12 |
| 3b | Track | Auchnagallin | The line of a disused, grass-covered track leads from the road, across the burn to the disused quarry, Site 1. The burn crossing comprises a grass-covered platform 10m wide, w/ a possible dam or revetment wall (Site 3a) along the S edge. | NW-SE | Degraded | Post Medieval | 265 | 304889 | 833402 | - |
