# Cameron Square, Fort William – Ground Investigation Archaeological Watching Brief Final Report

**CAM13**

**2013-24/CAM13**

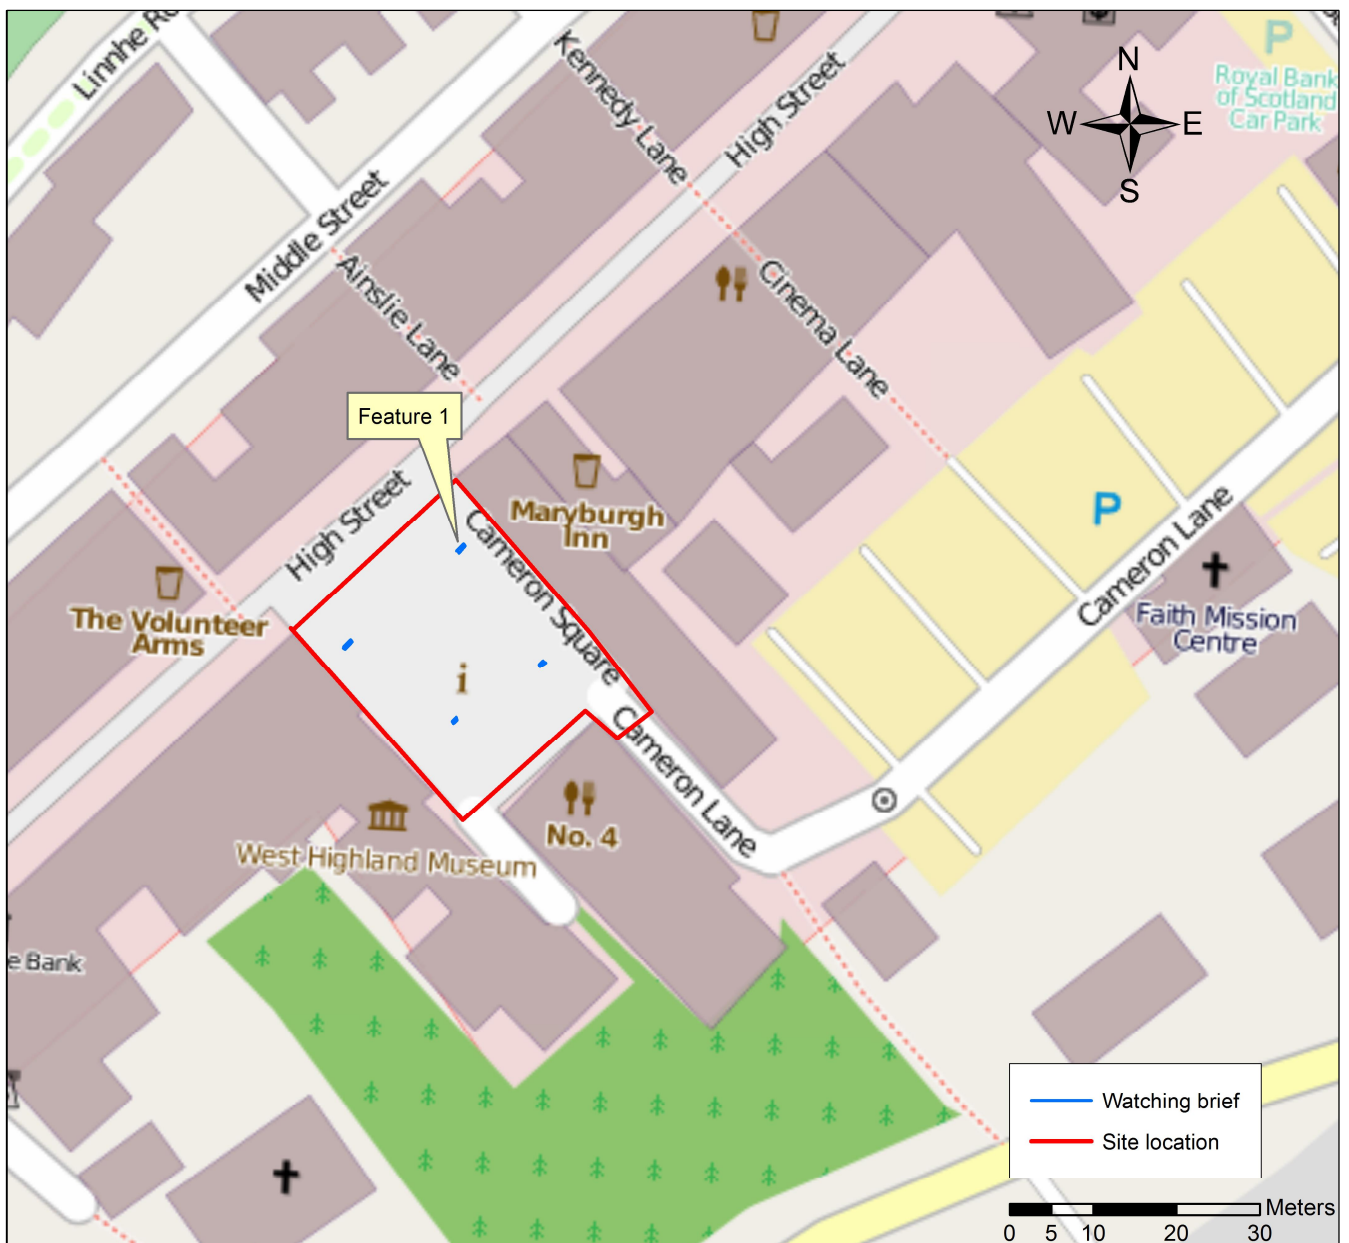
Figure 4 Location map<sup>17</sup> showing the four trenches monitored during the watching brief

The archaeologist had not been previously notified of the methodology to hand dig trenches in the locations of previously identified utilities. Test trenches 13/01 and 13/02 and Window samples 13/01 and 13/02 were monitored during the fieldwork (Figure 4), after which it was determined, due to the methodology, that monitoring of the three final trenches would provide little information as they were being dug in previously disturbed locations.

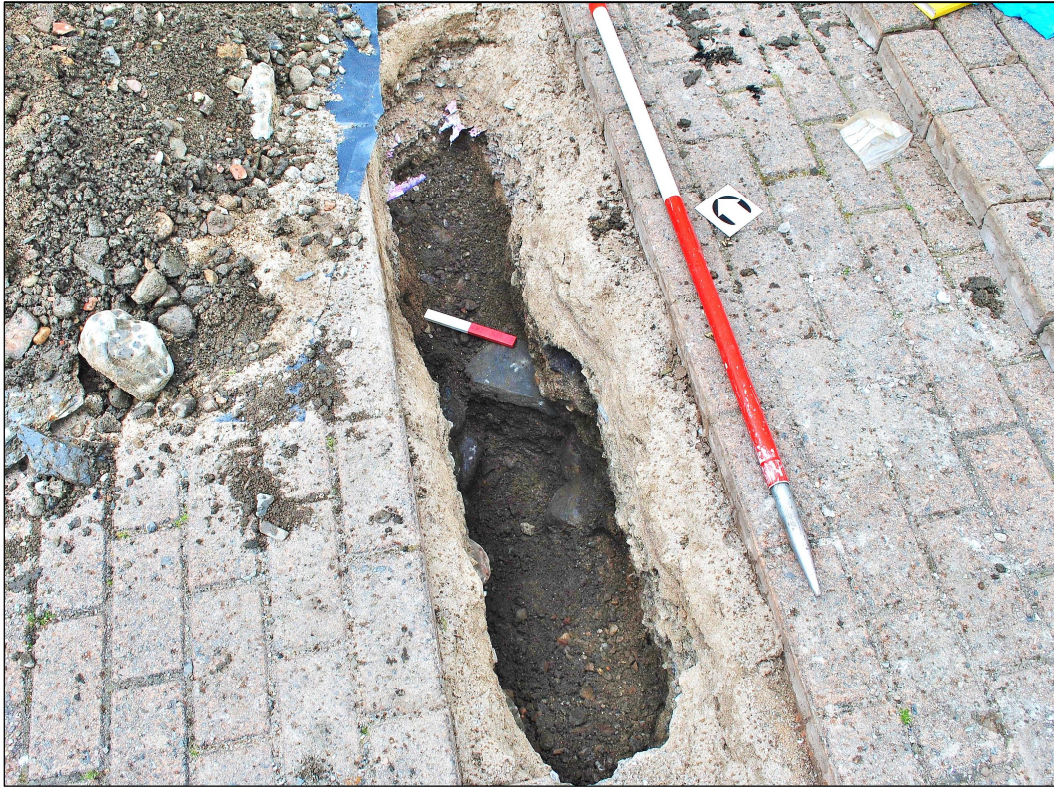
**TT13/02**, located in the north corner of the square, measured approximately 1.2m long by 0.3m wide. Utilities services were located at both ends of the trench. At the centre of the trench, at approximately 0.56m below the surface, a thin schist capping stone covered a slight drain (Feature 1). Only a small portion of the drain, which comprised a channel 0.14m wide and 0.17m deep with small cobbles lining the sides, was uncovered (Plate 1 and Plate 2). There appeared to be no structural base to the drain, which was filled with gravelly soil contained glazed pottery sherds, slate fragments and animal bone apparently Post Medieval in date.

**Plate 1**      **Feature 1, a cobble-lined drain at the base of TT13/02**

The cobble-lined drain, Feature 1, is of archaeological interest and indicates the potential for archaeological remains, particularly dating to the origins of the Post Medieval town, on the site. Furthermore, the historical mapping and historical records indicate there is significant potential for archaeological remains to survive below the present surface on the site, i.e. the footings of the 19<sup>th</sup> century Kennedy Monument, the footings of the old church/town house at the southeast end of the site and remnants of earlier structures in front of the West Highland Museum.

It is recommended that site clearance during development work be conducted under archaeological supervision.

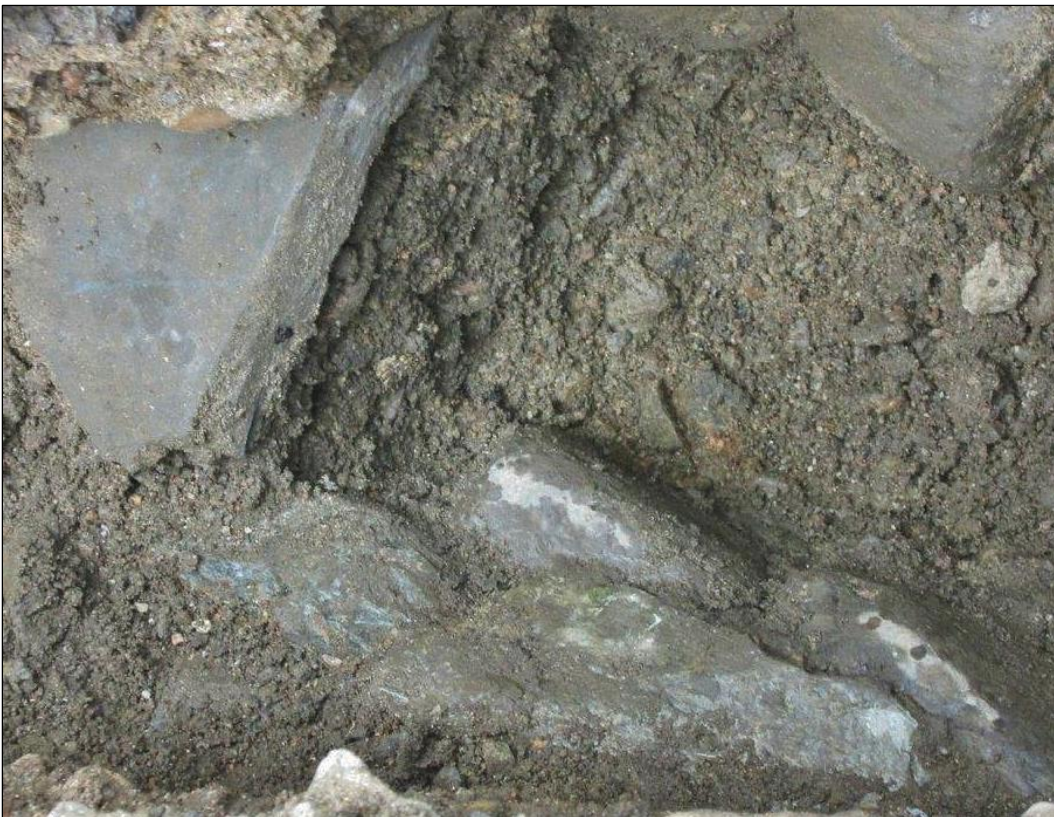
**Plate 2**      **Feature 1, a cobble-lined drain in TT13/02**

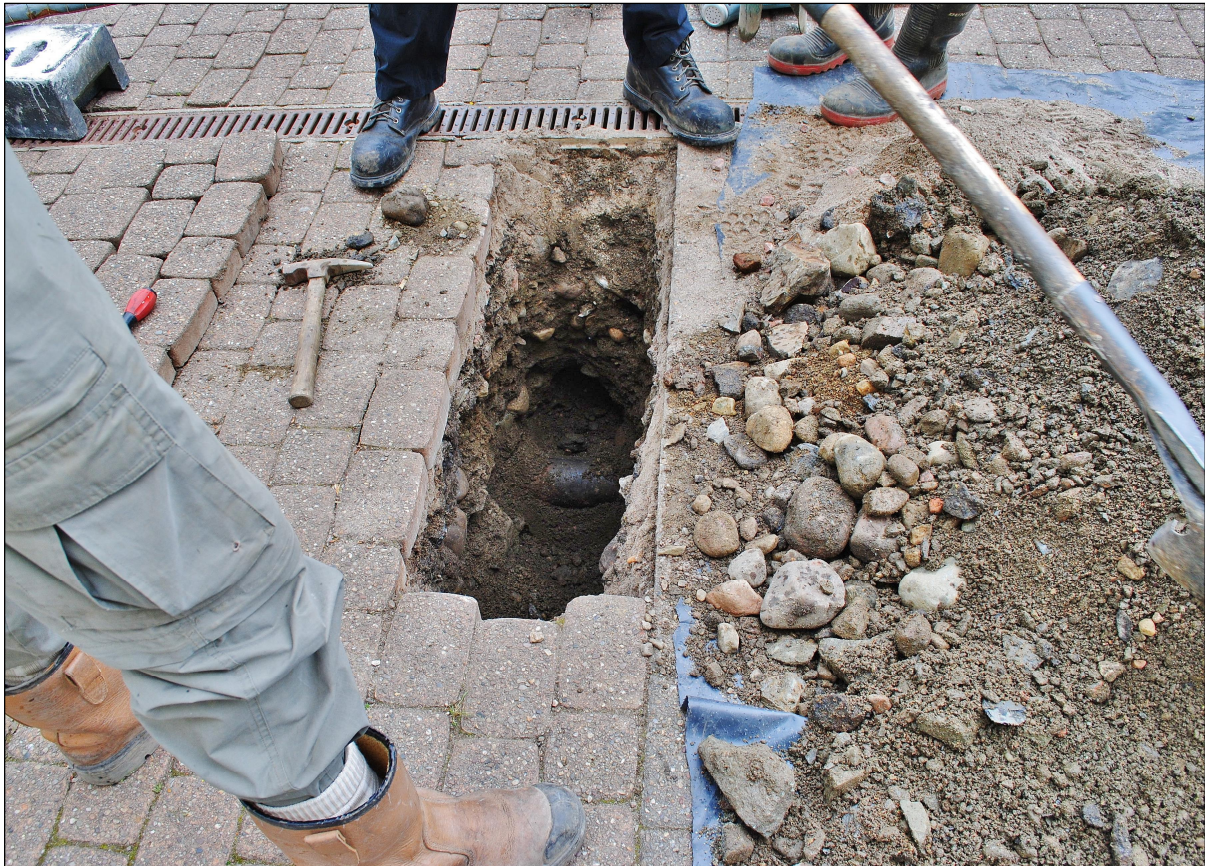
**TT13/01**, located in the west corner of the square, measured approximately 1.2m long by 0.3m wide. A utilities pipeline was located in its base within a gravelly sand fill (Plate 3). There were no pottery sherds or other finds noted in the trench fill.

Plate 3 TT13/01, utilities pipeline at the base of the trench
