Ross and Cromarty Archaeological Services

West Coast Archaeological Services

Tiree Capital Maintenance - Water Main Rehabilitation, Schemes 1, 2 & 4

ARCHAEOLOGICAL MONITORING

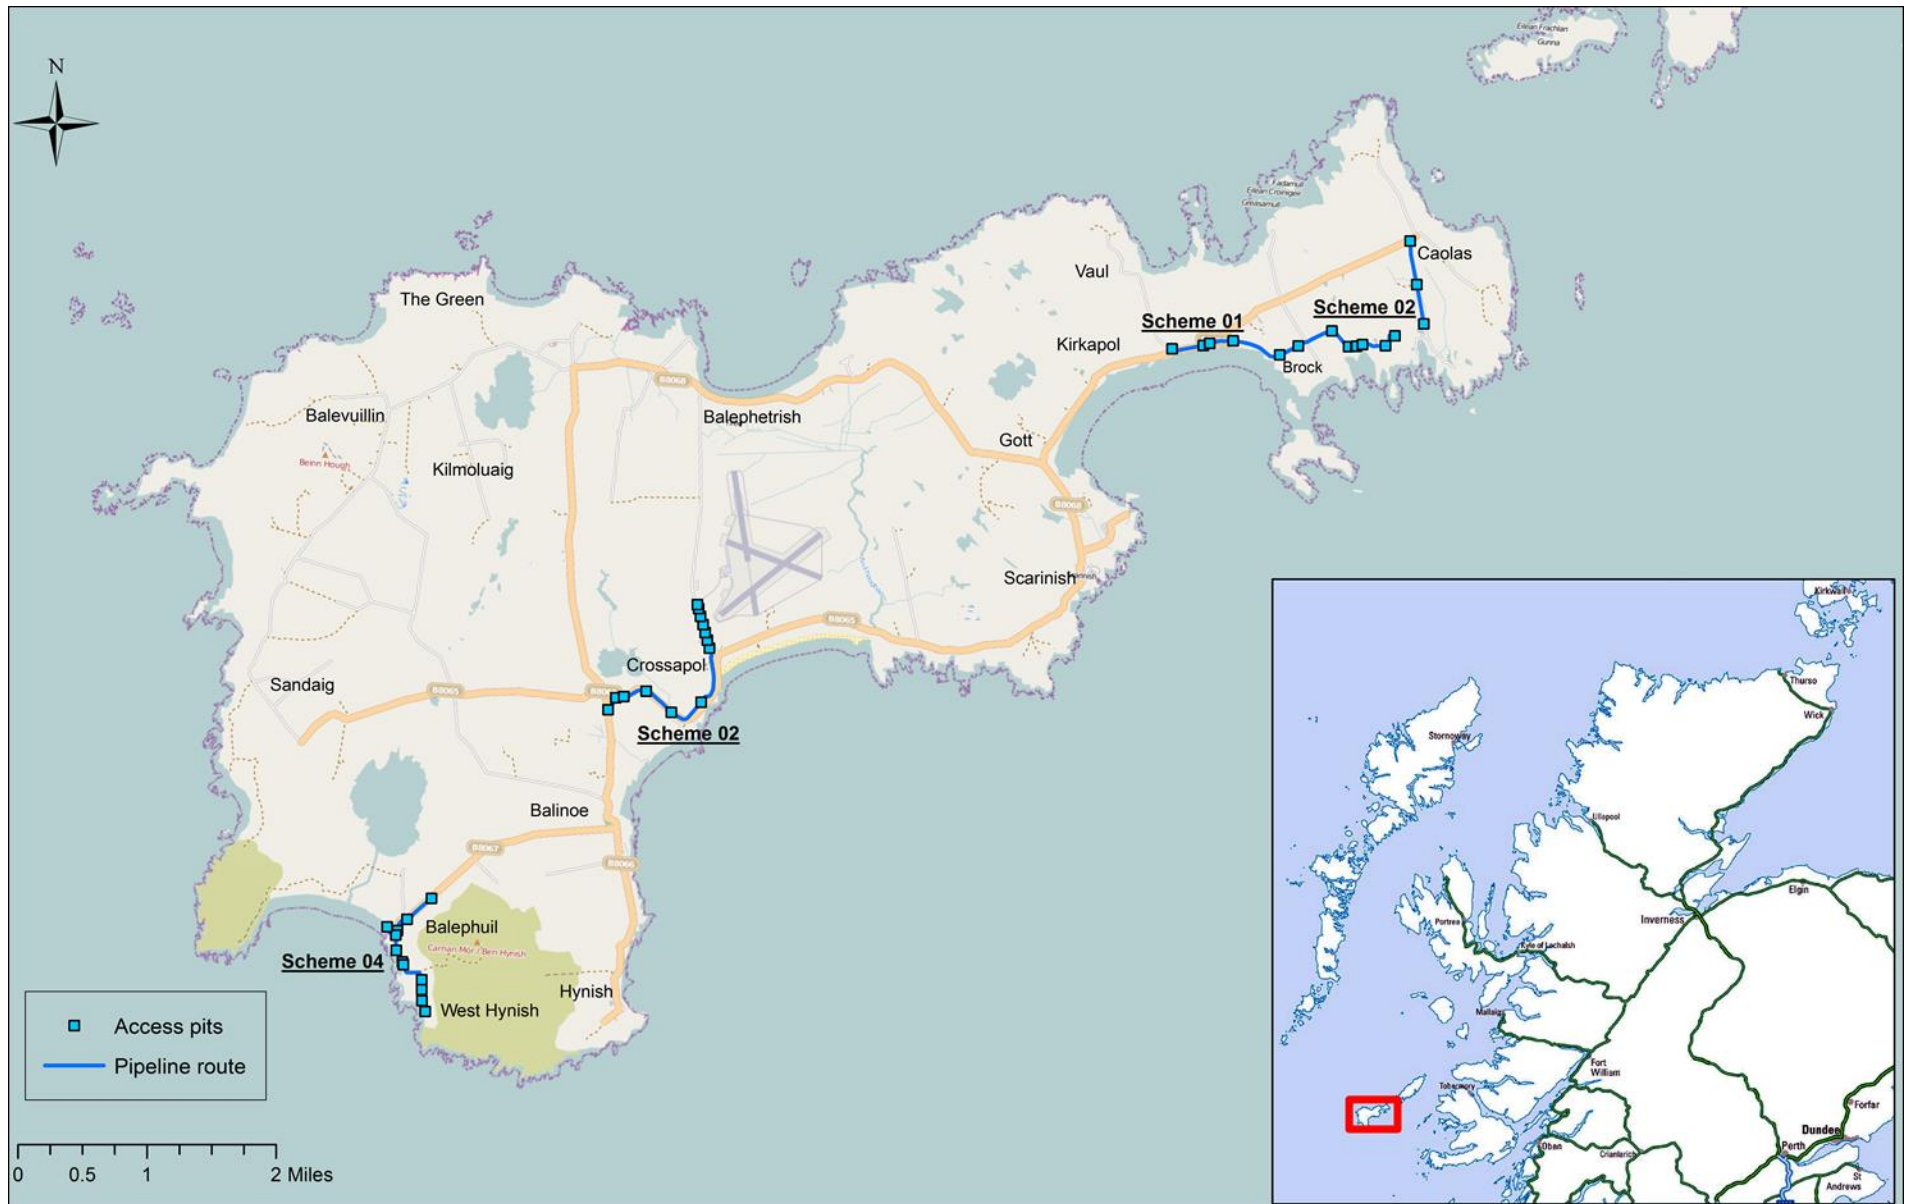
The Isle of Tiree is located off the west coast of Scotland, approximately 48 miles northeast of Oban and 17m west of the Isle of Mull. The neighbouring island of Coll is located northeast of Tiree. Three areas on the island situated around 10-20m OD underwent development work to rehabilitate the existing water main line (Figure 1).

Figure 1: Map³ of Tiree showing the location of the proposed pipeline works based on information supplied by Scottish Water

Open trenching was used throughout rather than the planned use of access pits shown in Figure 1. The stretches of pipeline depicted in Figure 2 were excavated under archaeological supervision using either a flat-edged bucket or a trenching machine and do not represent the full extent of the pipeline. The pipeline trench was generally about 0.25 – 0.30m wide and up to 1.2m deep.

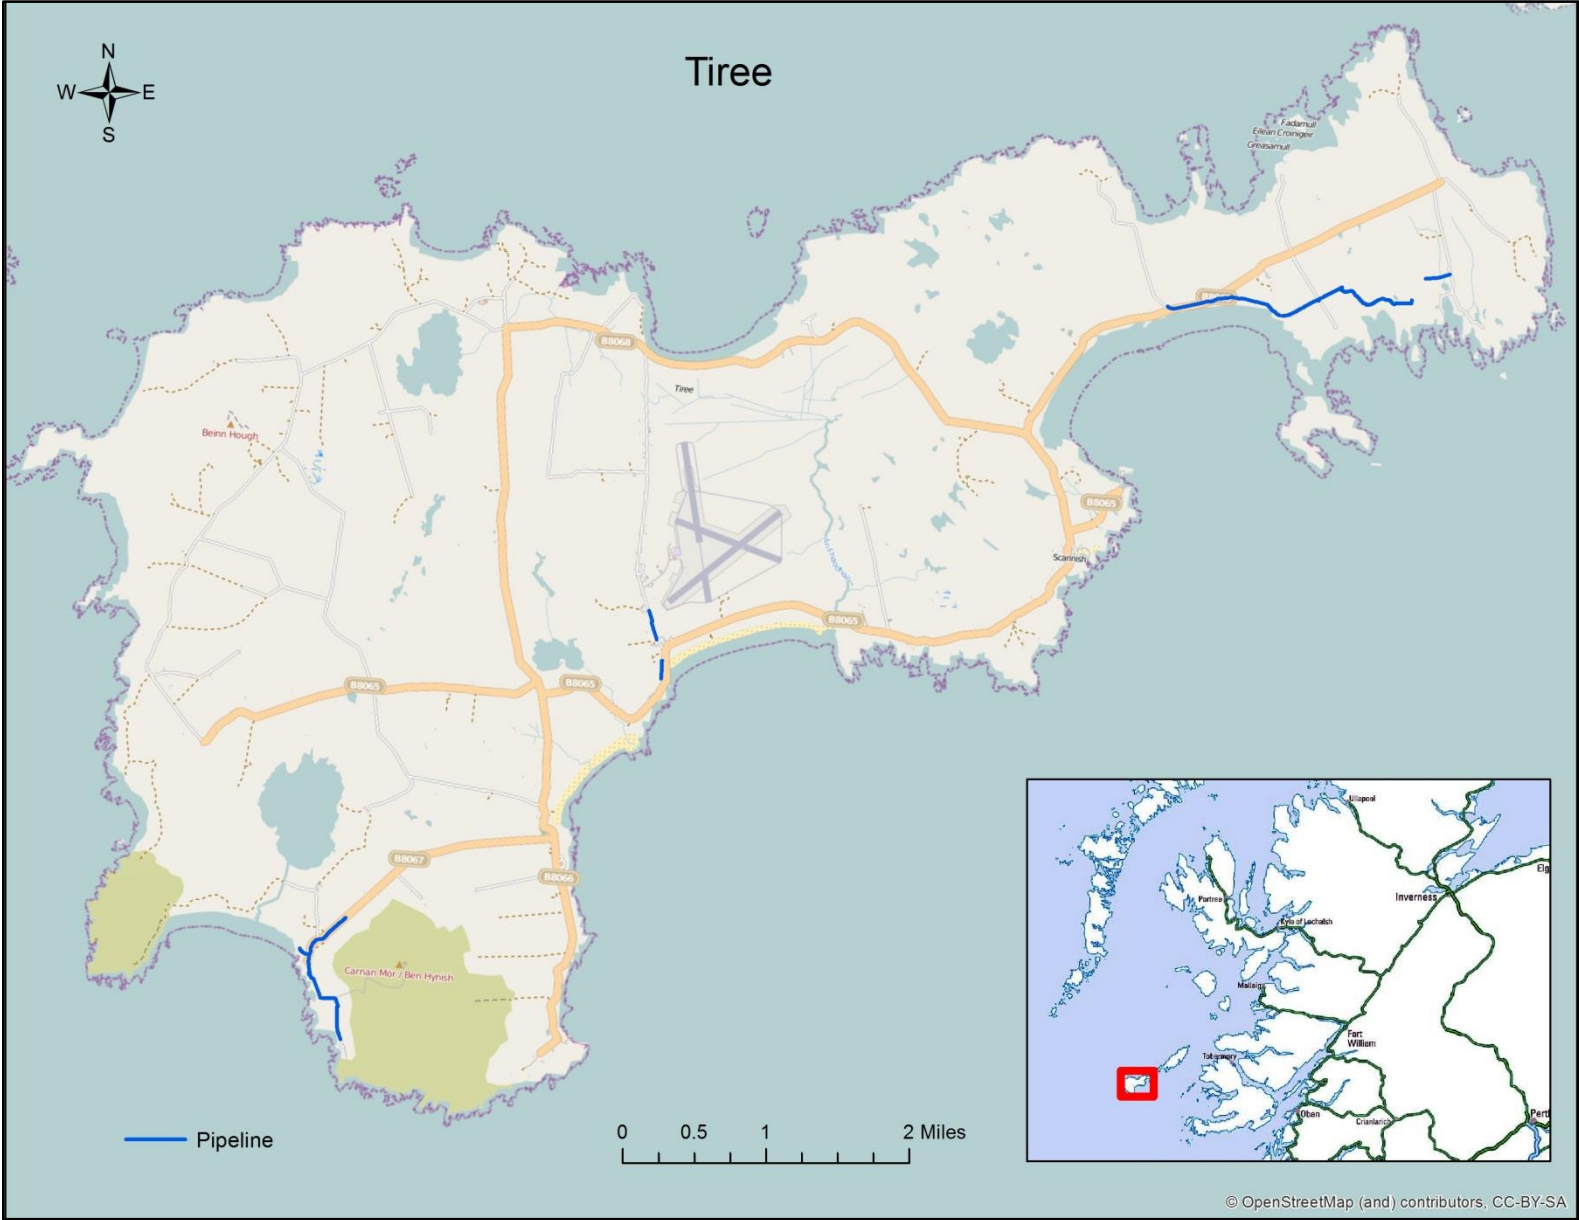
The archaeological monitoring of sections of the water main trench excavation was conducted through watching brief under close archaeological supervision of a mechanical excavator or trencher. It was not deemed necessary for the entire length of the new water mains trench to be subjected to a watching brief. Decisions as to the lengths to be watched were made based on the excavation method employed by the ground crew, ground conditions and the archaeology, and potential therefor, in the immediate vicinity (Figure 2).

Figure 2: Map⁶ showing the location of the pipeline monitored during the archaeological watching brief.

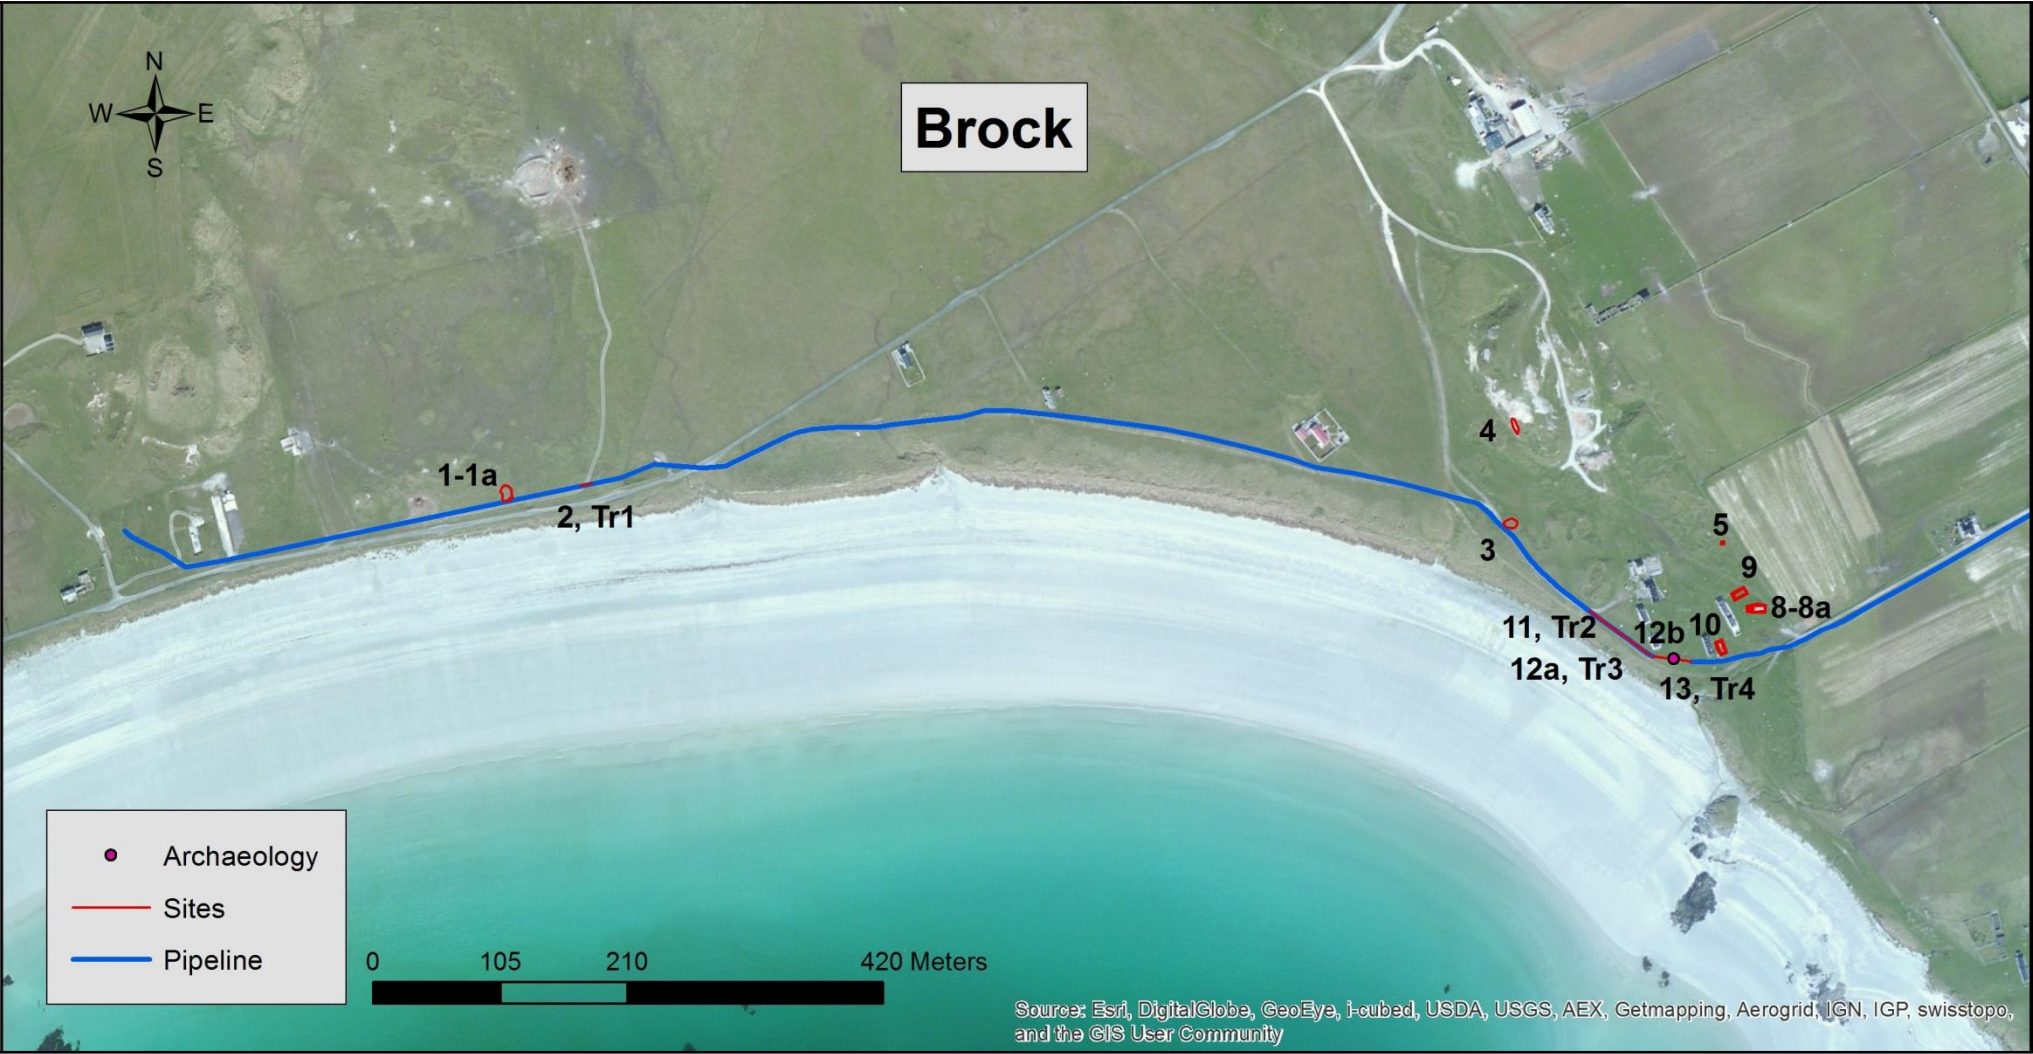
Figure 3: Plan showing the pipeline monitoring from Silversands (west) to the small settlement at Brock (east).

Approaching Brock, a layer of coal could be seen in the trench section (Trench 2), which became thicker closer to the settlement. Being made up of coal and ash deposits separated by sand deposits; this was interpreted as an earlier track surface or surfaces. The lenses of coal and ash continued towards the settlement. Adjacent to one of the houses in Brock, a cut was seen in the north-facing side of the pipe trench (Site 12a; Feature 1; Trench 3), which had layers containing lumps of quick-lime. This was interpreted as a quick-lime preparation pit (Figure 4; Plate 1). The final site of interest in this stretch of pipeline was another midden (Site 13; Trench 4). The midden extended for approximately 3-4m and was up to 0.9m in depth. The upper deposits contained coal, ash, pottery and glass. The midden became more organic in nature with depth and the deposits included large fish bone, animal bone, shellfish, charcoal, ceramics and glass. Three clay pipe stem fragments were recovered. The contents of the midden suggest that it is no older than 150 -250 years.

A series of degraded Post-Medieval structures in the vicinity of the pipeline were recorded at Brock (Sites 5, 8-10), which undoubtedly relate to the middens and trackway revealed by the trench excavation.

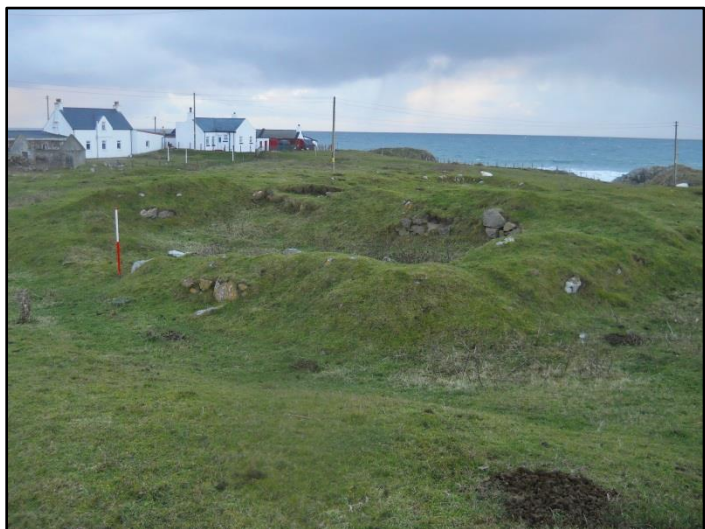
Plate 5: Site 43a at Balephuill

Trench 17 (Figure 9) ran perpendicular to Trench 14 through a nexus of post-medieval structures (Sites 43a (Plate 5) – 43d). The pipeline route was chosen in conjunction with the archaeologist present to minimise damage to the structures. The route taken ran through the enclosure (Site 43c) avoiding Site 43d and cut the enclosure wall at a ninety degree angle at a point where there was little visible stonework (Plate 6). The bank proved to have a single course of stones on its inner face, but was otherwise composed of a mound of silty sand over an old ground surface, which overlay clean wind-blown sand. The bank appeared to have been formed from cutting a ditch on its south-side. Within the enclosure, the stratigraphy included a 0.63m deep mid-brown, sandy silt layer representing a spade-dug cultivation soil. It is presumed that the enclosure was used for vegetable cultivation before falling out of use. Two fragments of an earthenware vessel were found (SF 16).
