ROSS & CROMARTY ARCHAEOLOGICAL SERVICES

Woodland Creation Scheme Balvraid, Tomatin

2013-31/BAL13

WOODLAND CREATION PROPOSAL – BALVRAID, TOMATIN ARCHAEOLOGICAL WALKOVER SURVEY

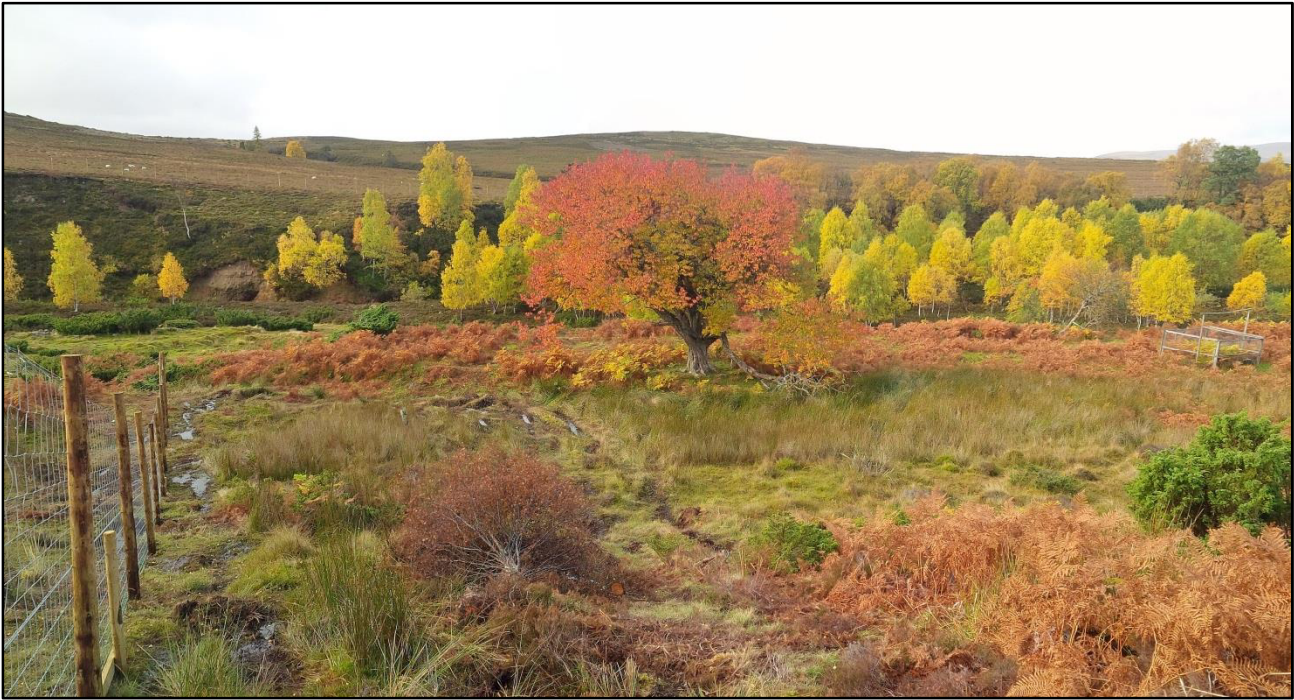
A standalone tree marks the north corner of a built platform on a lower river terrace on the northeast side of the burn (Figure 2, Plate 1). There is visible stone walling on the southwest side (Plate 2) with a turf/stone bank visible on the northwest side of the platform. The south edge of the site is formed by the steep natural terrace and there is a slight edge visible forming the northeast side of the platform.

Plate 1: Site 1 – the standalone tree marking the north corner of the enclosure, looking SE

- 6.1 As per the site plan provided by SAC Consulting, Sites 2-4 will be located in an area of natural regeneration and will not be impacted by any new planting. However, Site 1 is located near or within an area of new planting and should be safeguarded from destruction.
- 6.2 The following buffer zones should be retained around archaeological sites recorded during the walkover survey:
- A 5-metre buffer zone around Sites 1-4.

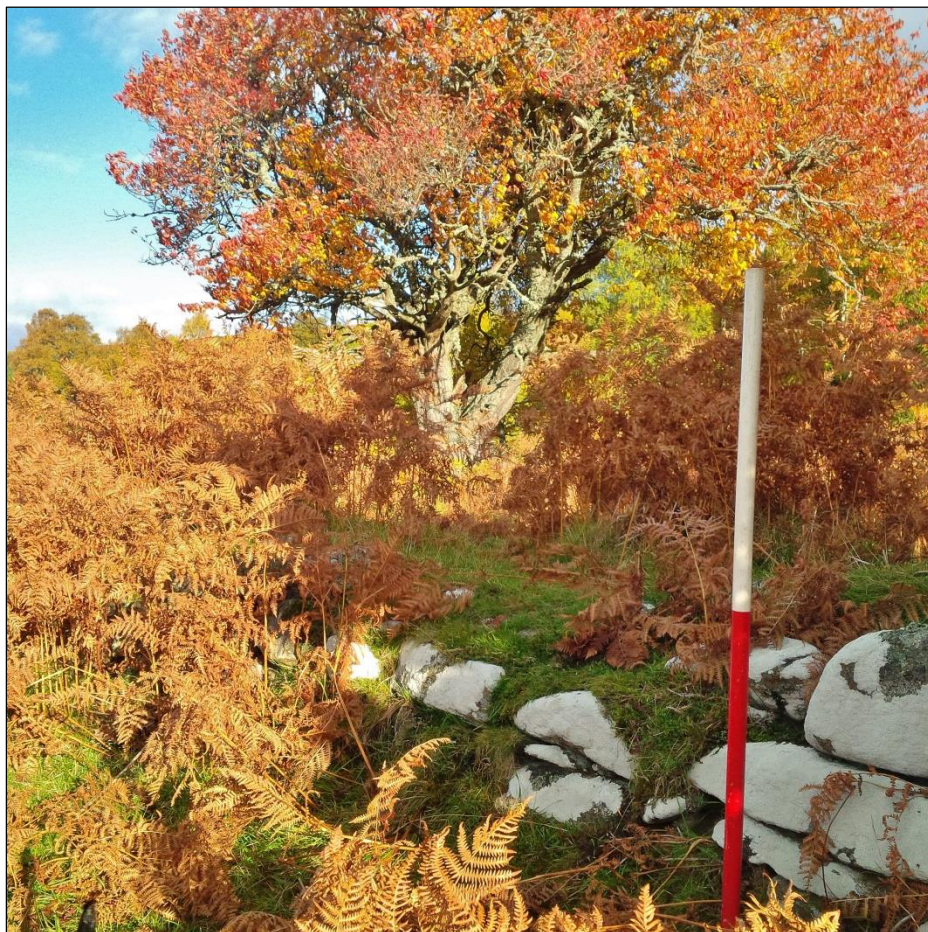
Plate 2: Site 1 – drystone walling on the southwest side of the enclosure, looking NE

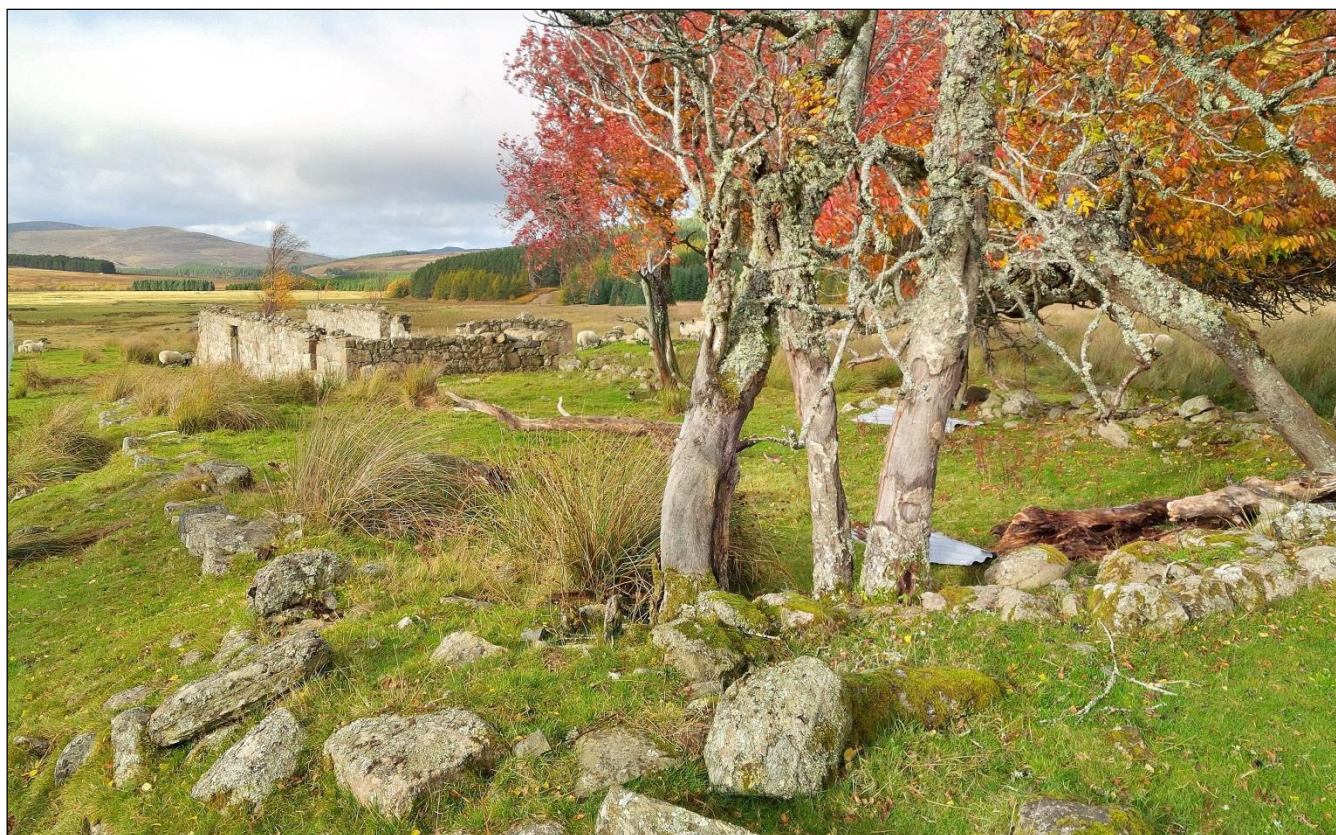
The ruins of the abandoned farmstead (Plate 3) on the northwest side of the survey area were rapidly surveyed and are shown in Figure 2. The layout of the site, depicted as still in use on Bartholomew's 1934 map of Inverness-shire, appeared to be much the same as shown on the 1900 2nd Edition OS map.

Plate 3: Site 5 – ruined farmstead of *Croft*, looking NW

The woodland creation area lies beyond these sites and they will not be impacted by the works.
