ROSS & CROMARTY ARCHAEOLOGICAL SERVICES

Tiree Water Mains Rehabilitation - Extension

ARCHAEOLOGICAL MONITORING

2013-33/TIR13

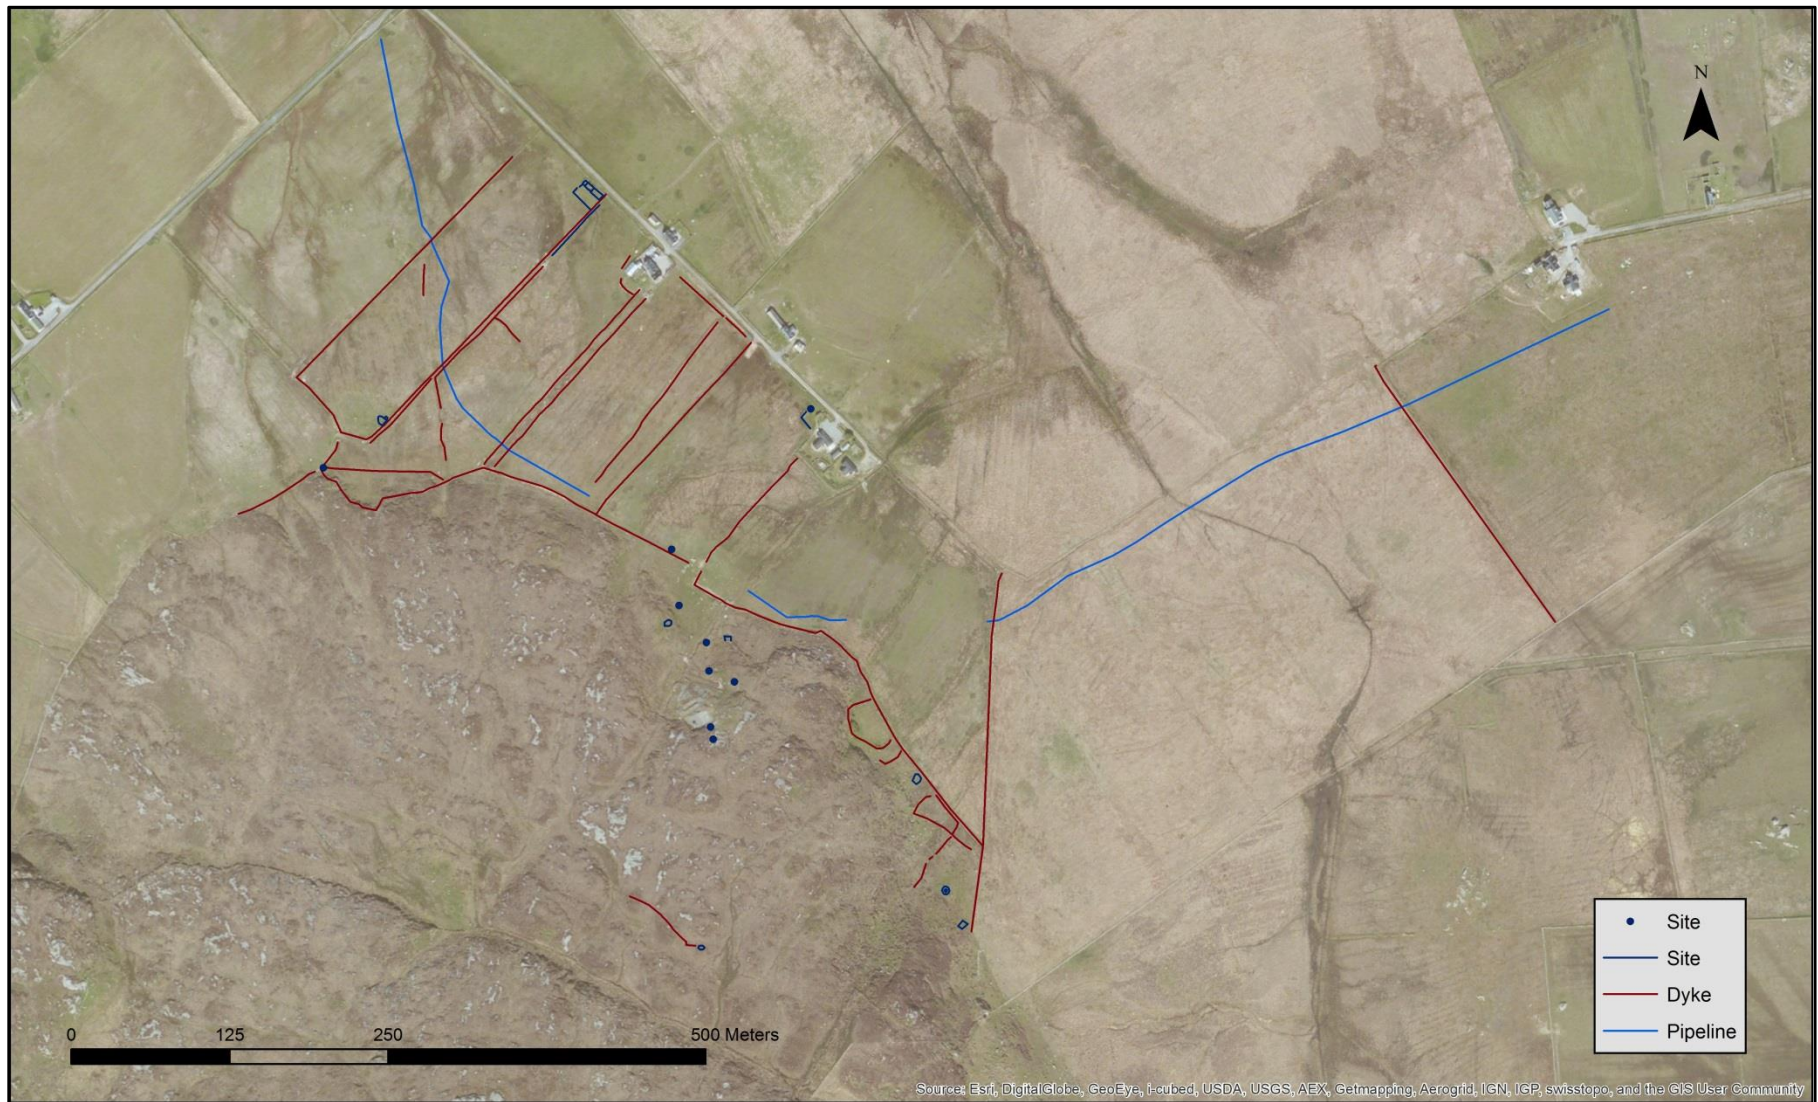
Figure 2: Plan⁸ showing the location of the pipeline monitored during the archaeological watching brief together with the sites recorded.

Open trenching was used throughout. The stretches of pipeline depicted in Figure 2 were excavated under archaeological supervision using a flat-edged bucket and do not represent the full extent of the pipeline. The pipeline trench was generally about 0.25 – 0.30m wide and up to 1.2m deep.

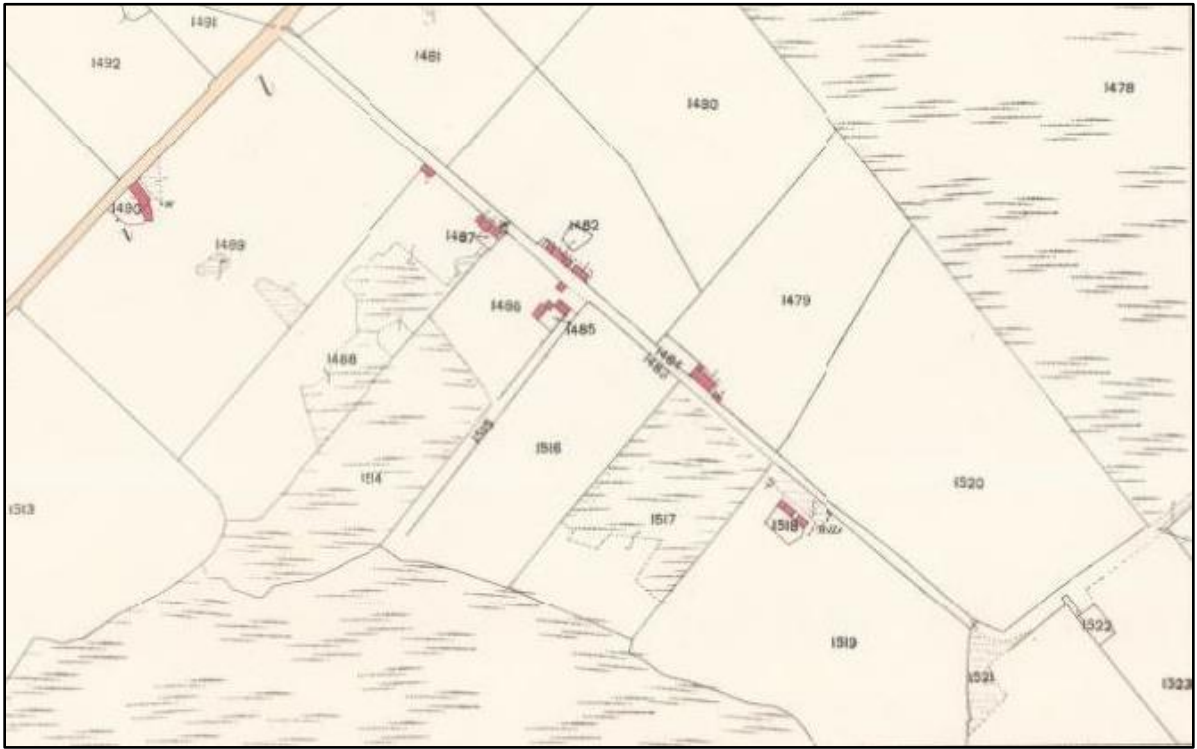
This map covers the western end of the water mains extension and shows several roofed buildings situated at the edges of fields through which the pipeline runs. Most notably those associated with field numbers 1490, 1488, 1487, 1485 and 1518 (Figure 3). Field boundaries are also depicted.

Figure 3: Excerpt from the 1st edition OS mapping showing the buildings and field boundaries in the vicinity of the western end of the water main extension. © NLS

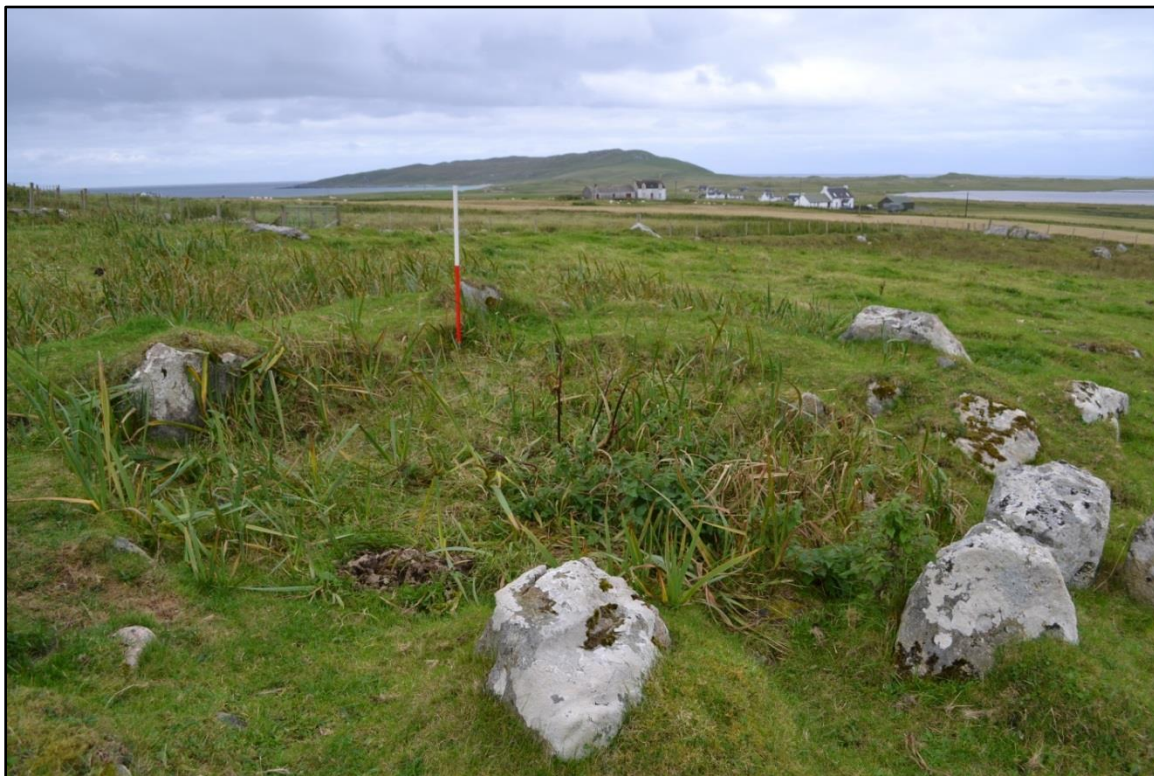
Plate 1: Site 3, a possible structure.

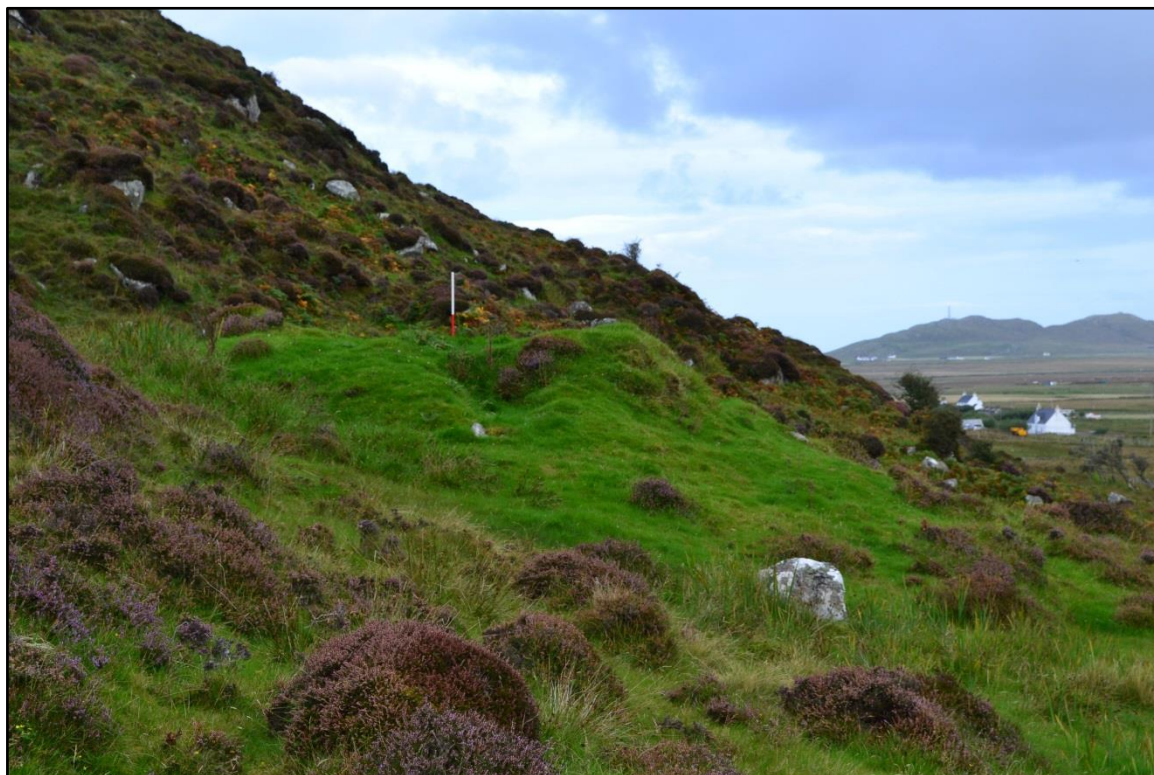
Plate 2: Site 44, a possible structure

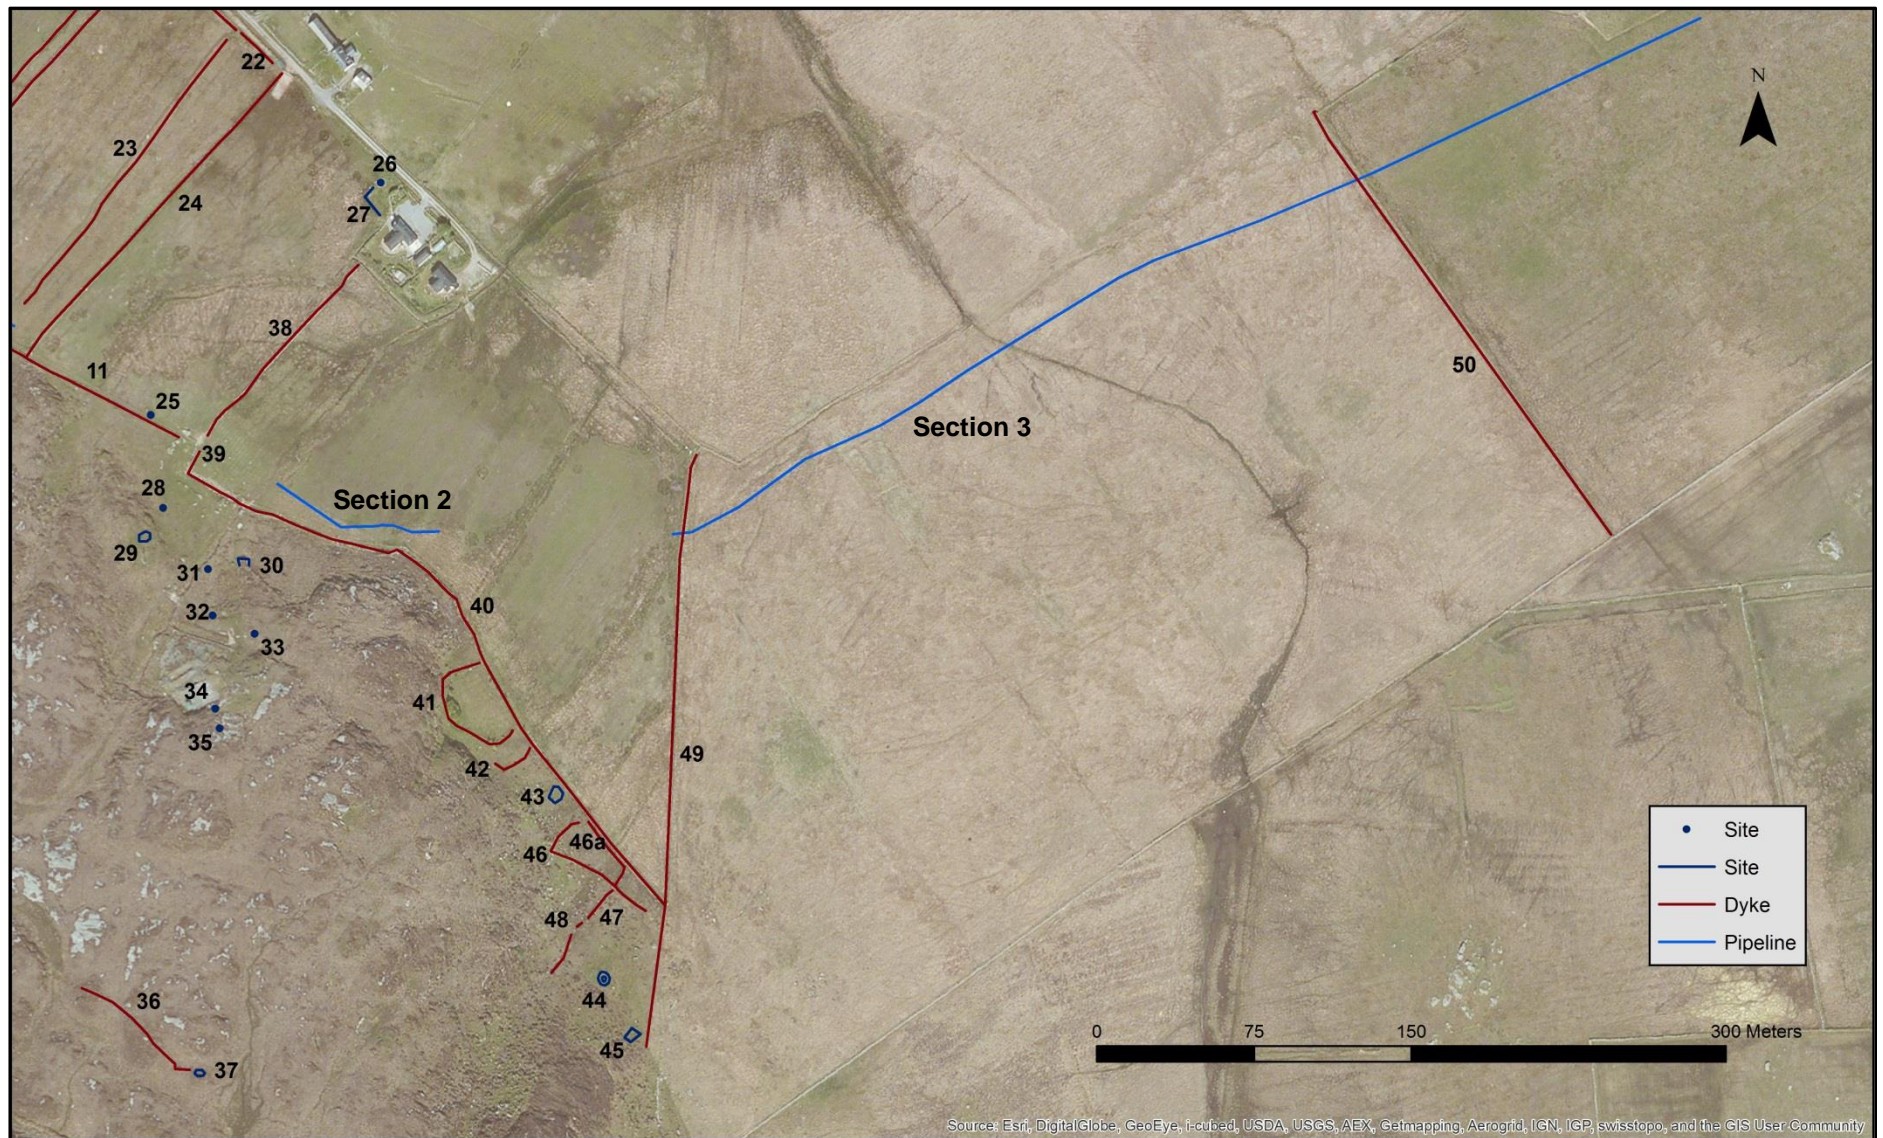
Section 2 of the pipeline trench monitored at the base of Carnan Mor (Figure 5) also displayed a thin topsoil overlying clay. The ground through which Section 3 (Figure 5) was cut changed to peat. The large amount of water within the trench here made it difficult to observe its base. There was nothing of archaeological interest observed in either trench.

Figure 5: Plan¹¹ of Sections 2 and 3 of the pipeline route monitored from Carnan Mor towards Balemartine and the archaeological sites recorded.

In the vicinity of Sections 2 and 3, several boundaries and sites were also rapidly recorded, many of which do not appear on the historical mapping. Sites **39 – 41, 46, 49** and **50**, all dykes, appear on the 1st and 2nd edition OS maps. Sites **30 – 32** (cairns and a stone platform) do not appear on the mapping, but have been previously recorded¹²; local knowledge has since suggested that these particular sites have been erected within the last twenty years. Site **33** is a further cairn that looks to have been constructed fairly recently, possibly at the time of the water tank installation. Sites **34** and **35** are the upper bases for the sky winch used during the water tank installation. Sites **36, 37, 42, 43, 44** (Plate 2), **45** and **46a-48** do not appear on the historical mapping and nor have they been previously recorded. They form a complex of structures and dykes suggesting agricultural activity. Structures **37** and **43-45** are fairly small and appear to be possible shielings. All are in a much degraded state, which, together with their absence from the historical mapping, would suggest that they pre-date the Ordnance Survey 1st edition map surveyed in 1878.
