ROSS & CROMARTY ARCHAEOLOGICAL SERVICES

Site Adjacent to Paddockhaugh and Dykeside Farm, Birnie, to the South West of Elgin: Watching Brief

| RoCAS Report | 2013-37/BIR13 |

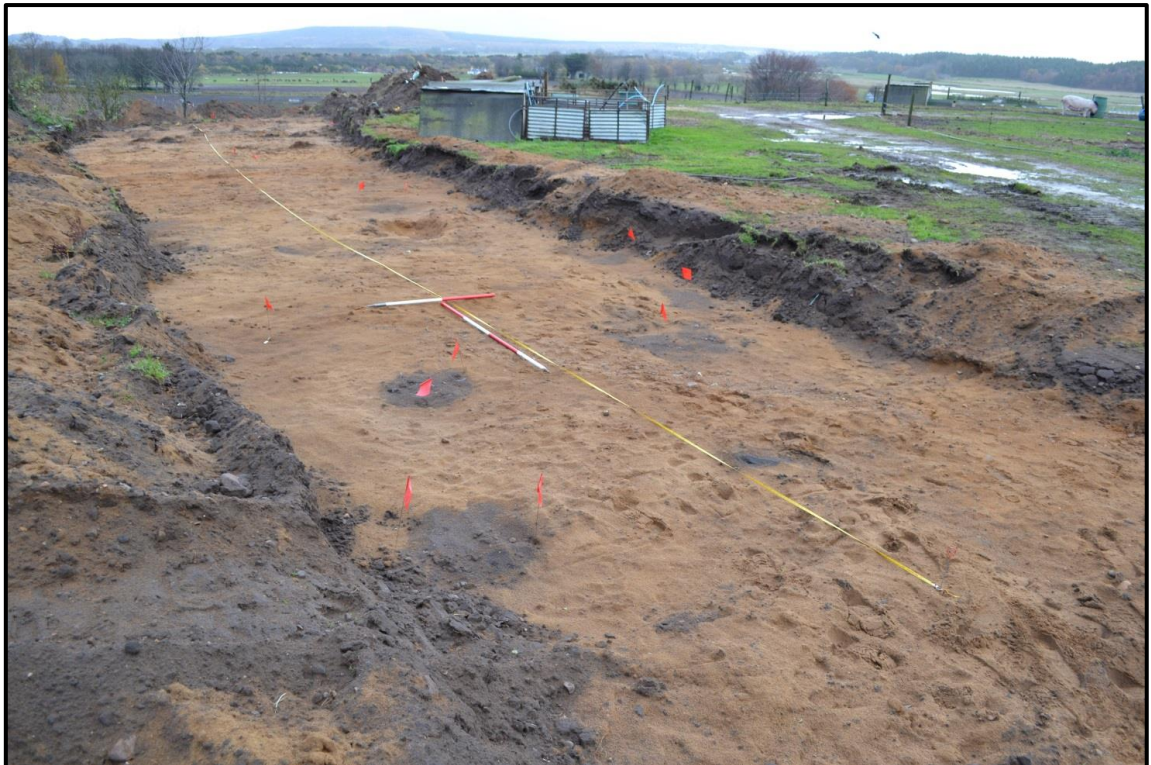
A length of the southern end of the track, located to the north of the lagoon, was first stripped of topsoil (amounting to 0.3m) to ascertain the extent and nature of any archaeological features so that the developer could make an informed decision as to whether to continue with the development. It was anticipated, based on the location of the previous excavations' trenches (Figure 2), that the access track would run through an old NMS trench with the possibility of some previously unexcavated features. This proved to be the case with a thin scatter of small features exposed along the track to the break of slope (Plate 2); some of which had previously been excavated. Following consultation with Dr Hunter, NMS these features were not excavated; they were, however, planned at a scale of 1:20. They will be covered with a membrane prior to construction of the road. Based upon this trial clearance the developer was satisfied that the length of proposed track running from the southern end of the exposed ploughsoil to the northern end of the existing hardstanding could be dealt with by removing only 0.15m of the topsoil and laying membrane over the remainder prior to depositing aggregate, so as to protect the underlying archaeology. The remainder of the watching brief did not reveal any archaeological features or finds.

Plate 2: A scatter of features on the terrace to the north of the pot ale lagoon

As anticipated, a scatter of features was revealed on the terrace in the vicinity of previous excavations by NMS. Some of these features had been excavated as part of those excavations. The remainder of the features revealed were not excavated as the results would not add greatly to the corpus of information from the site.

The archaeological features uncovered at the southern end of the access road should be covered with a protective membrane prior to construction of the road.
