ROSS & CROMARTY ARCHAEOLOGICAL SERVICES

## Newfield North, Alness Trial Trenching Evaluation

National Grid Reference	<b>NH 6692 7032 (centred)</b>
Planning reference	<b>13/03436/PREAPP</b>
Site Code	<b>NNA14</b>
RoCAS Report	<b>2014-01/NNA14</b>
Client	<b>Pat Munro (Alness) Ltd</b>
Author	<b>Mary Peteranna</b>
Date	<b>23-1-2014</b>
OASIS Report No.	<b>rosscrom1-169850</b>

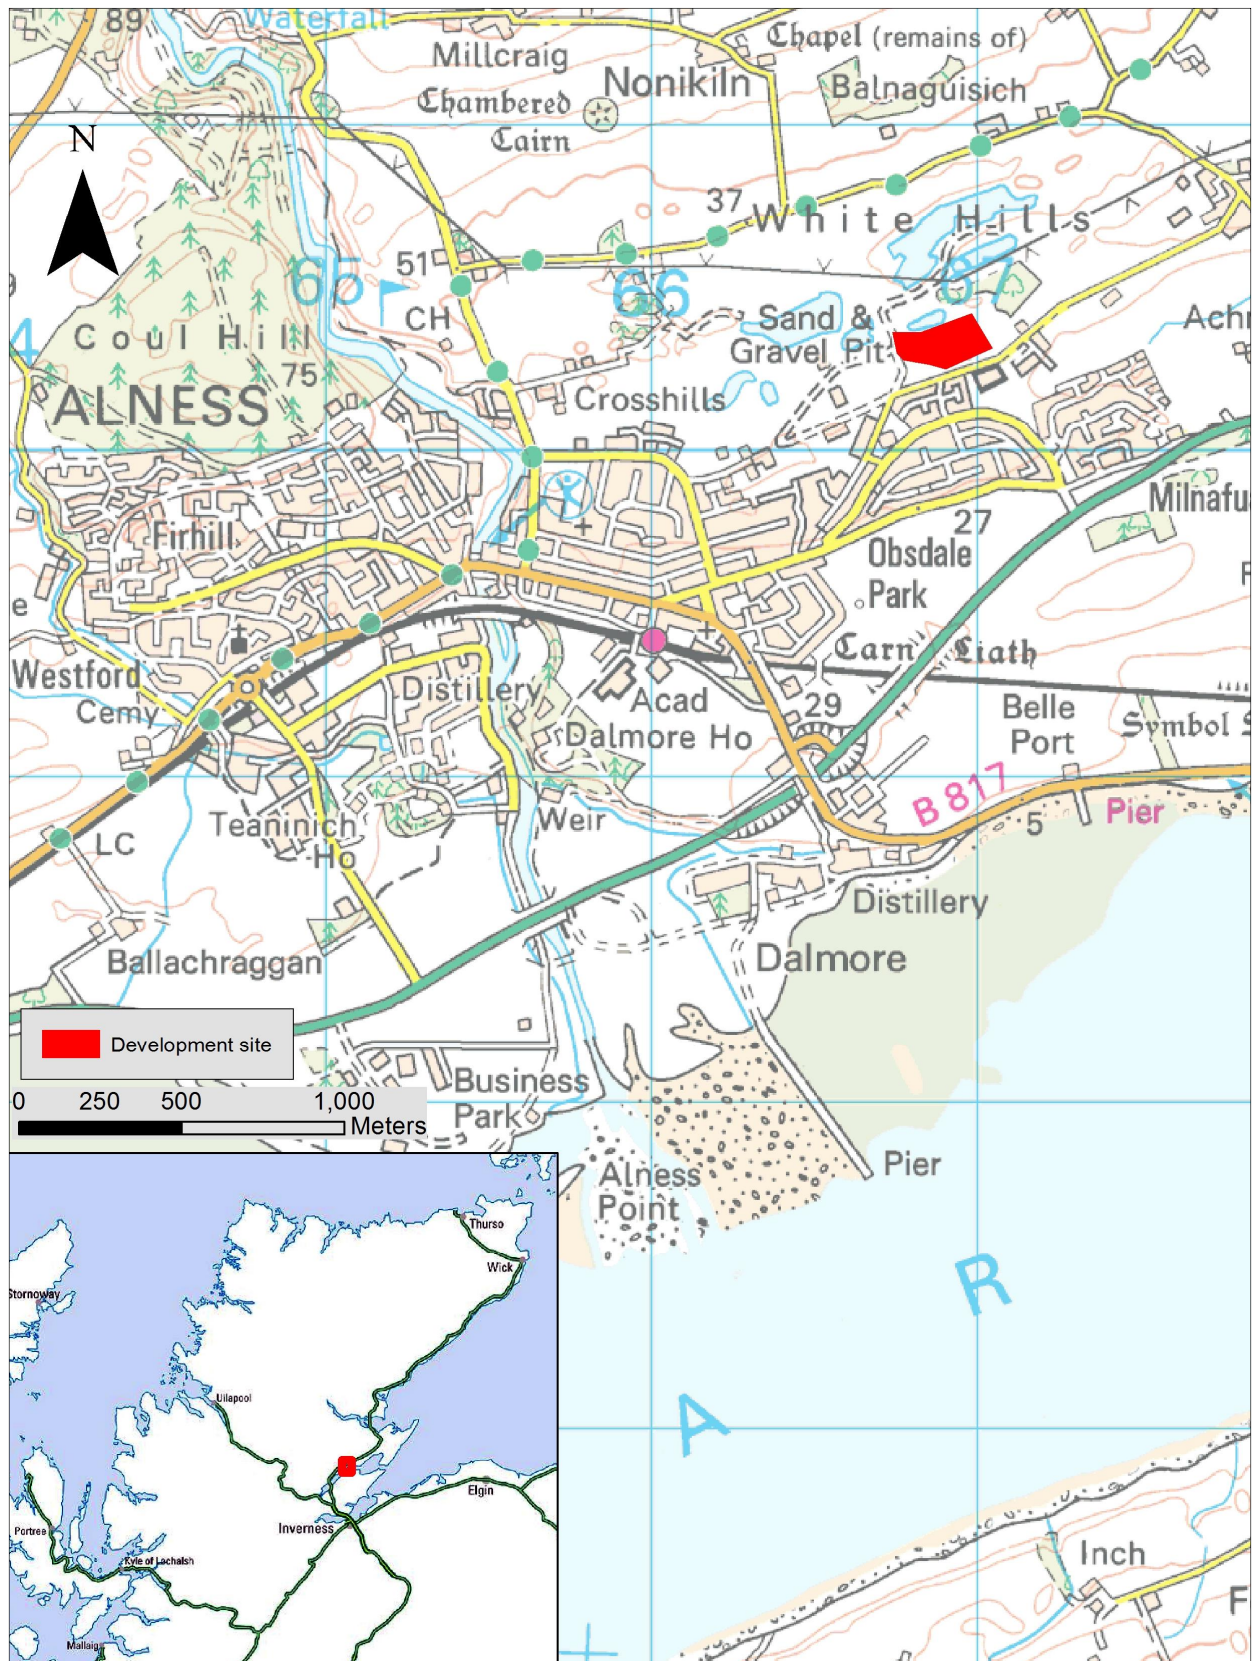
Figure 1 Site location

- 2.1 The development site is centred at approximately Ordnance Survey National Grid Reference NH 6692 7032, in the northeast corner of Alness at Newfield (Figure 1). The proposed development site (Figure 2), 4km northwest of Invergordon, is located on the north of side of current housing schemes and southeast of sand/gravel quarries. The area to the north is named *White Hills* on Ordnance Survey mapping.

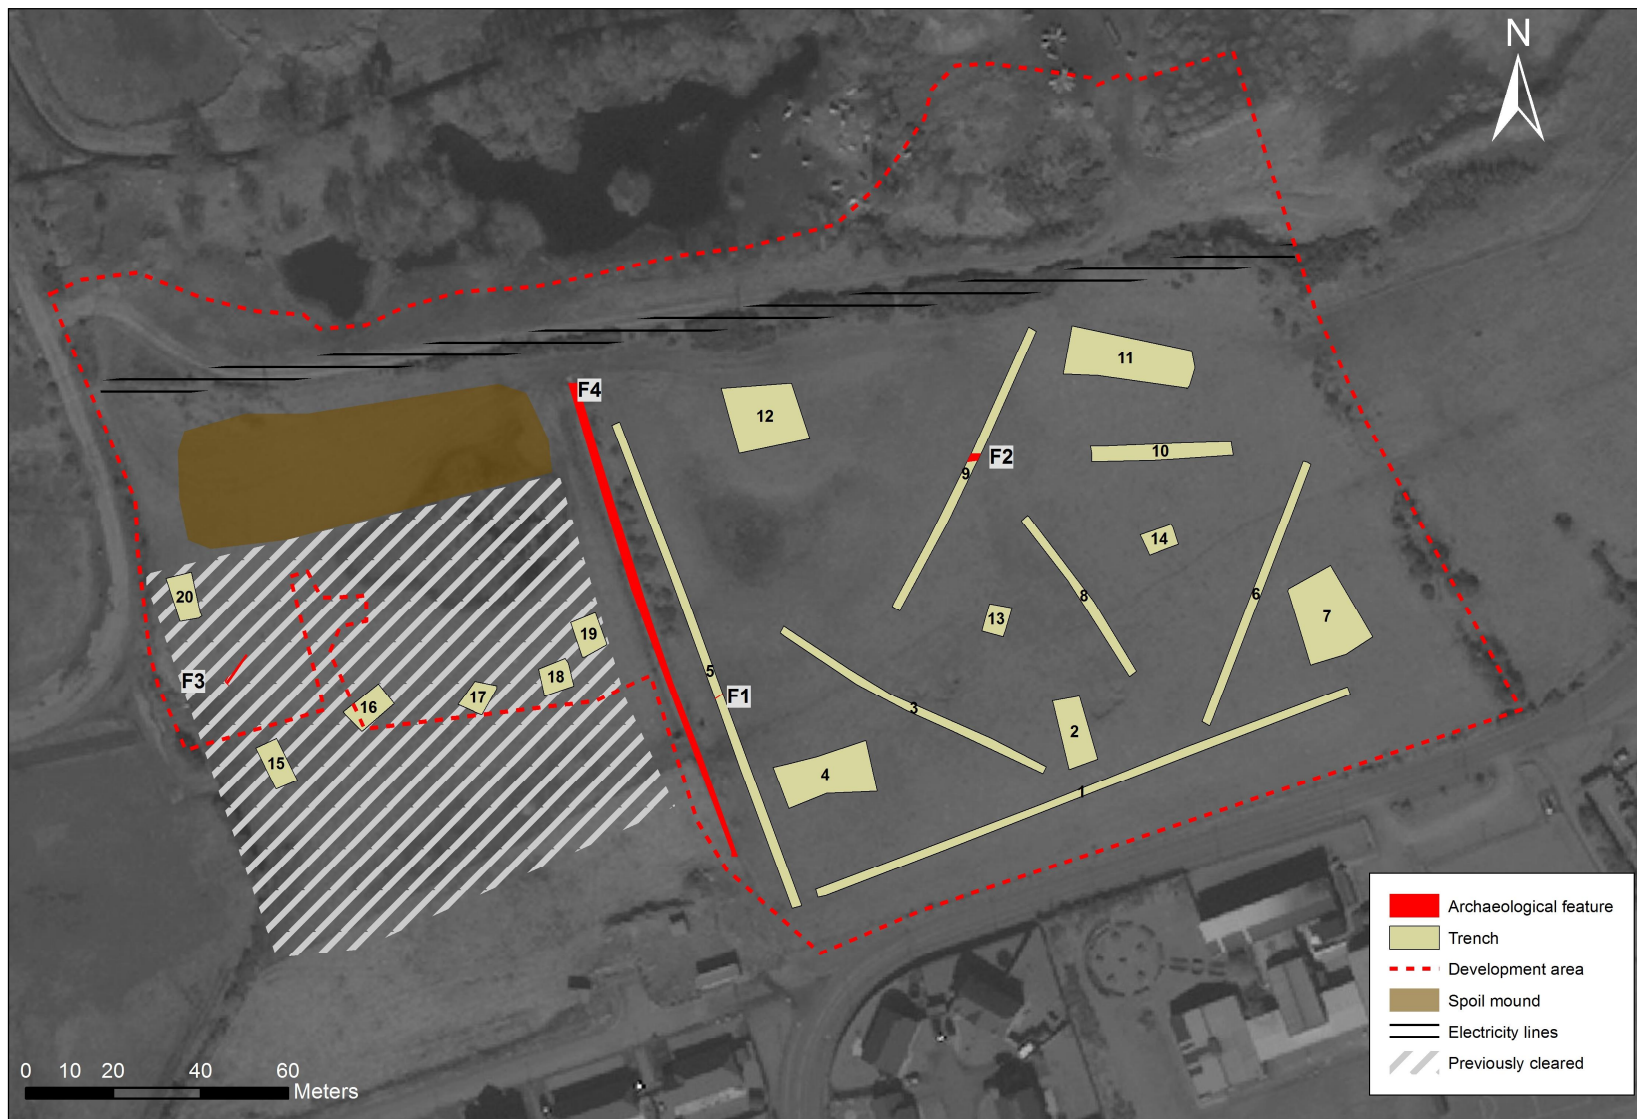
Figure 3 Location of trenches and archaeological features<sup>9</sup>

**5.2.1** Four features (F1-F4) were identified on the site (Figure 3). Two field drains (F1 and F2) were recorded in Trench 5 and Trench 9 during the evaluation. All other trenches were sterile of archaeology. A third feature (F3) recorded had been previously uncovered during groundworks near the western edge of the development area. The fourth feature (F4) was the remains of a boundary running NW-SE across the centre of the site.

- 4.3.2** Twenty trenches (Table 1) totalling 2,581m<sup>2</sup>, 6.3% of the total site area (40,700m<sup>2</sup>), were excavated across the proposed development area (Figures 2 and 3).

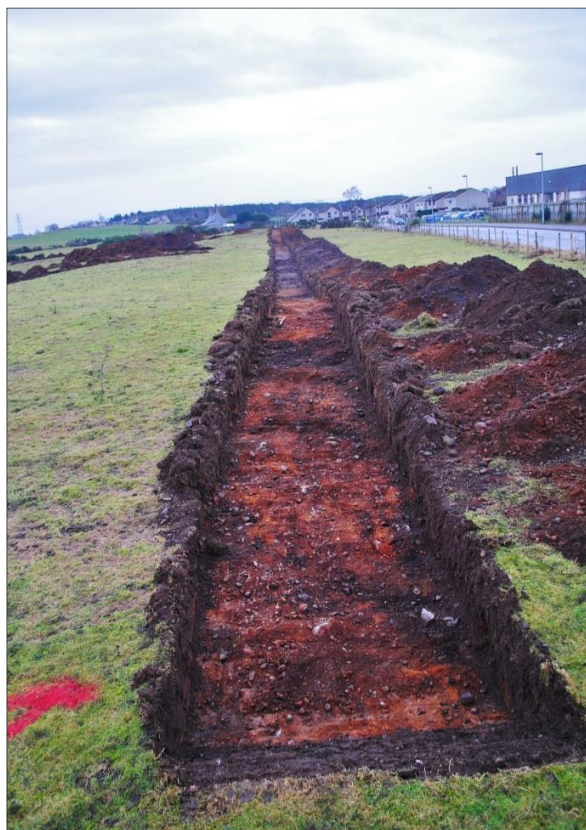
Plate 1 Trench 1, facing ENE

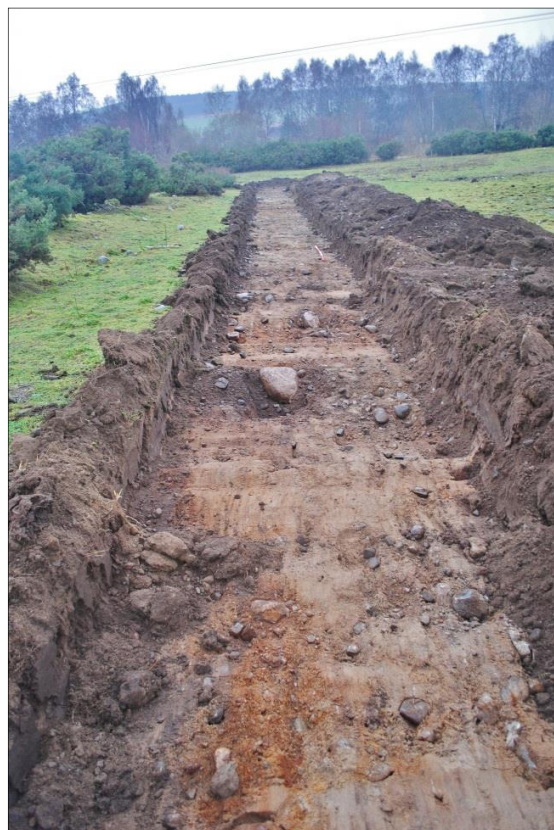
Plate 2 Trench 5, facing NNW

Feature 1 (F1) was a small, hand-cut field drain measuring approximately 30cm in width and containing small stones. Aligned ENE-WSW, it was located in a low-lying part of the site and providing drainage to the wet clay subsoil. The feature was not excavated as it became quickly waterlogged. A continuation of the feature was noted in the northwest end of Trench 3.

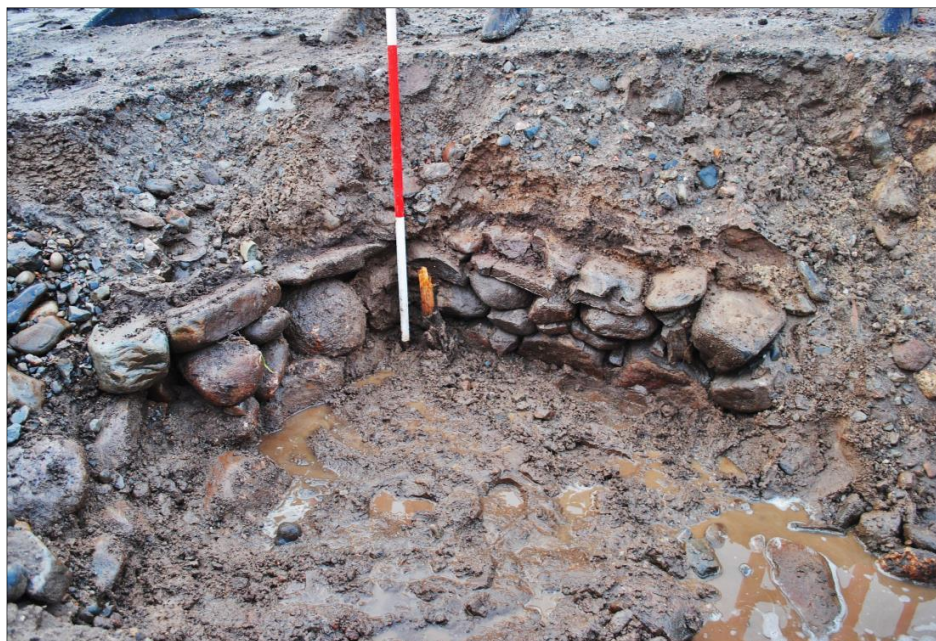
A portion of built walling (F3) was noted in an already-open pit over a silted-up drain on the west side of the site. The pit had been re-opened during recent groundworks and had reportedly been discovered by site workers at least once before in previous years. The remains of the feature comprised northwest and southwest faces of a cobble-lined revetment pit standing up to 0.5m high (Plate 3). Although the southeast face of the structure had previously been removed the structure would have opened to northeast, in alignment with the field drain. One long-time site worker also recalled that the structure was first uncovered when a combine harvester slumped into the pit. He reported that the structure was covered over thereafter with railway sleepers. Excavation and recording showed evidence of a timber structure associated with it. A small exploratory trench was excavated on the northeast side of the structure, revealing the continuation of a drain associated with the structure (Plate 5). The walling has been interpreted as a manhole or culvert for the drainage ditch.

**Plate 3** Feature 3: remains of a cobble-lined culvert / manhole over a drainage ditch; facing W

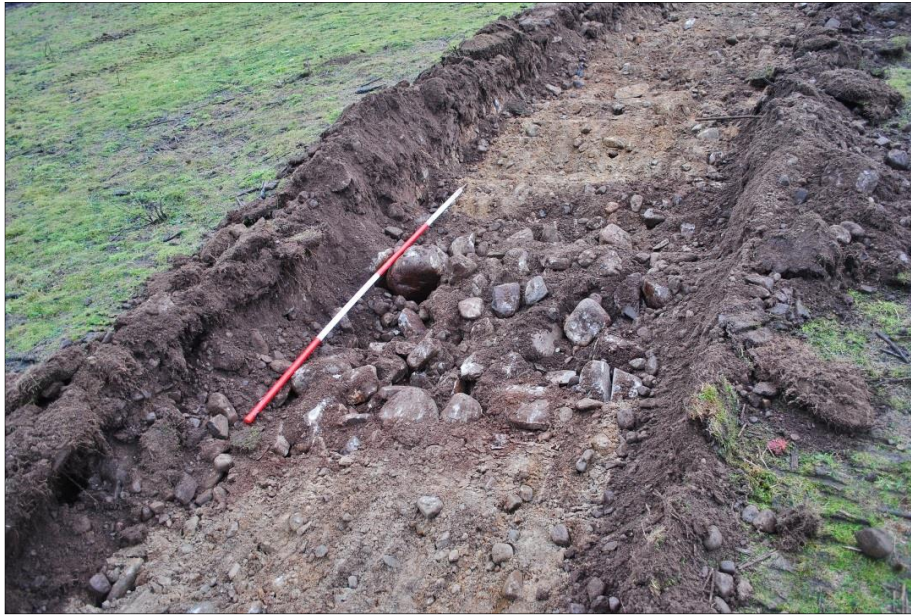
Feature 2 (F2) was uncovered in Trench 9, with a continuation of it visible in the west end of Trench 10. A surprisingly large, hand-cut ditch (Plate 4), the field drain measured 1.8m wide and contained a gravelly stone fill. The feature corresponded with the drainage system uncovered below Feature 3 (F3), located on the west side of the development site. Site workers reported that recent groundworks in the west area had uncovered the remains of the same drainage trench. Given the conclusive nature of this feature, it was not excavated.

**Plate 4**      **Feature 2 field drain, facing SW**

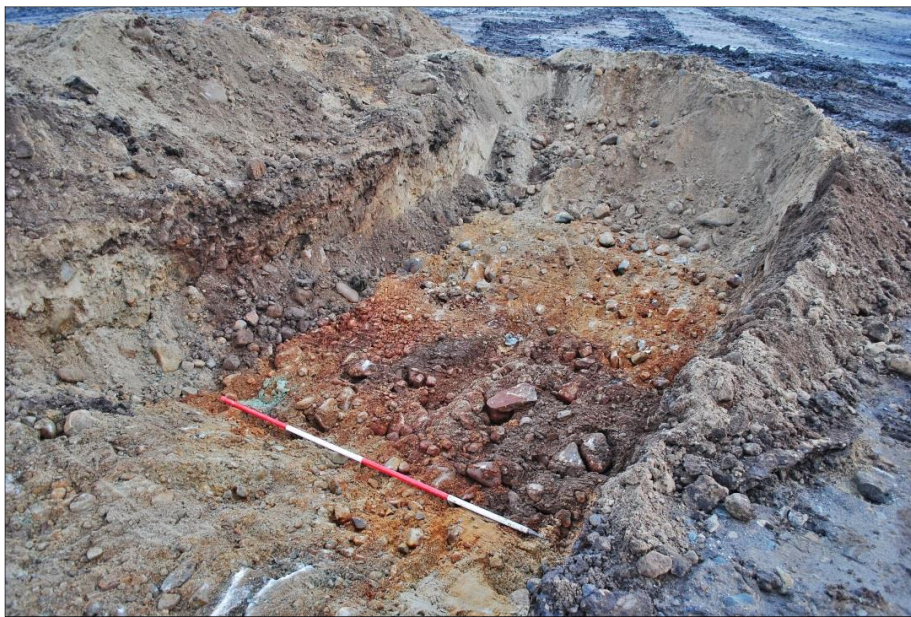
**Plate 5**      **Feature 3 field drain uncovered on the northeast side of the culvert/manhole; facing SE**
