**PROPOSED FELLING COUPES WITHIN A82 PROJECT
ZONE, INVERNESS ROSS & SKYE FOREST DISTRICT**

**ARCHAEOLOGICAL DESK-BASED ASSESSMENT AND
WALKOVER SURVEY**

Creag Nan Eun forest block – South Loch Ness

Client	Forestry Commission Scotland
National Grid Reference	NH 46175 20126(Centred)
Site Code	CNE14
Report Number	2014-09/CNE14
Author	Lynn Fraser
Date	14-03-2014
Approved by	Mary Peteranna
Date	14-03-2014
OASIS No.	rosscrom1-174705

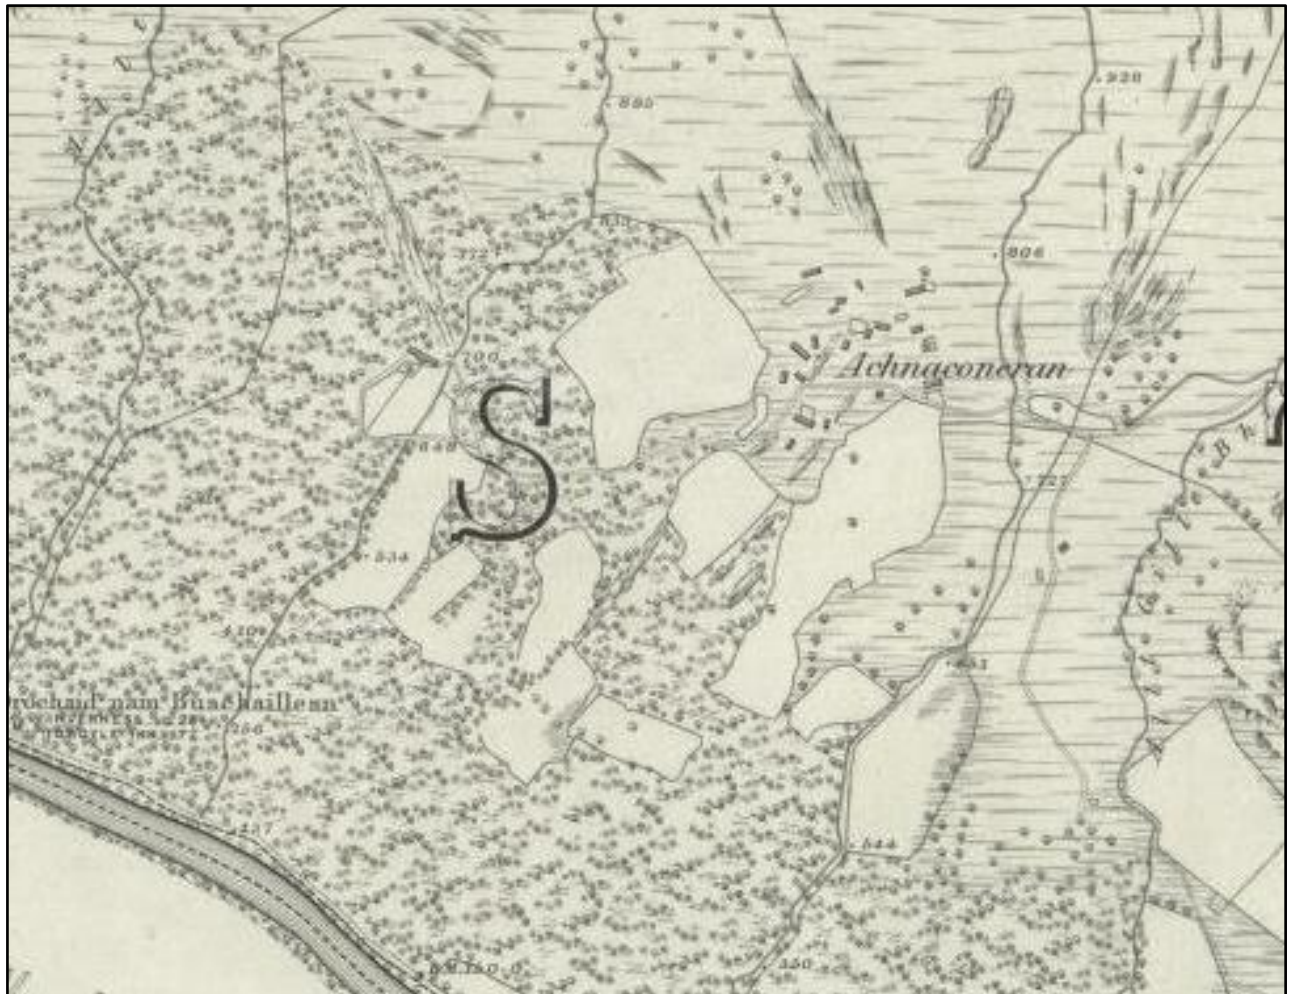
Figure 2: Excerpt from the OS 1st edition map, Sheet LIII ©NLS

At the western extremity of the survey area, to the west of Invermoriston, bordered by the *Allt na Criche* burn, is a boundary dyke that runs parallel with the burn before turning to the northeast and then north (Figure 2). This dyke continues outwith the survey area. To the east of the dyke, and on the western side of an unnamed burn, is a long T-shaped building with an irregularly shaped enclosure. A track runs from this farmstead outwith the survey area to the settlement of *Achnaconeran* to the east. A boundary dyke runs in a NNE-SSW direction from the lower edge of the survey area running past *Achnaconeran*. An unroofed building is depicted to the west of the track leading south from *Achnaconeran* to the south of two enclosed fields.

To the northeast on *Invermoriston House* there are boundary dykes depicted together with a sluice and mill lead on the eastern side of the *Allt Coinneag*.

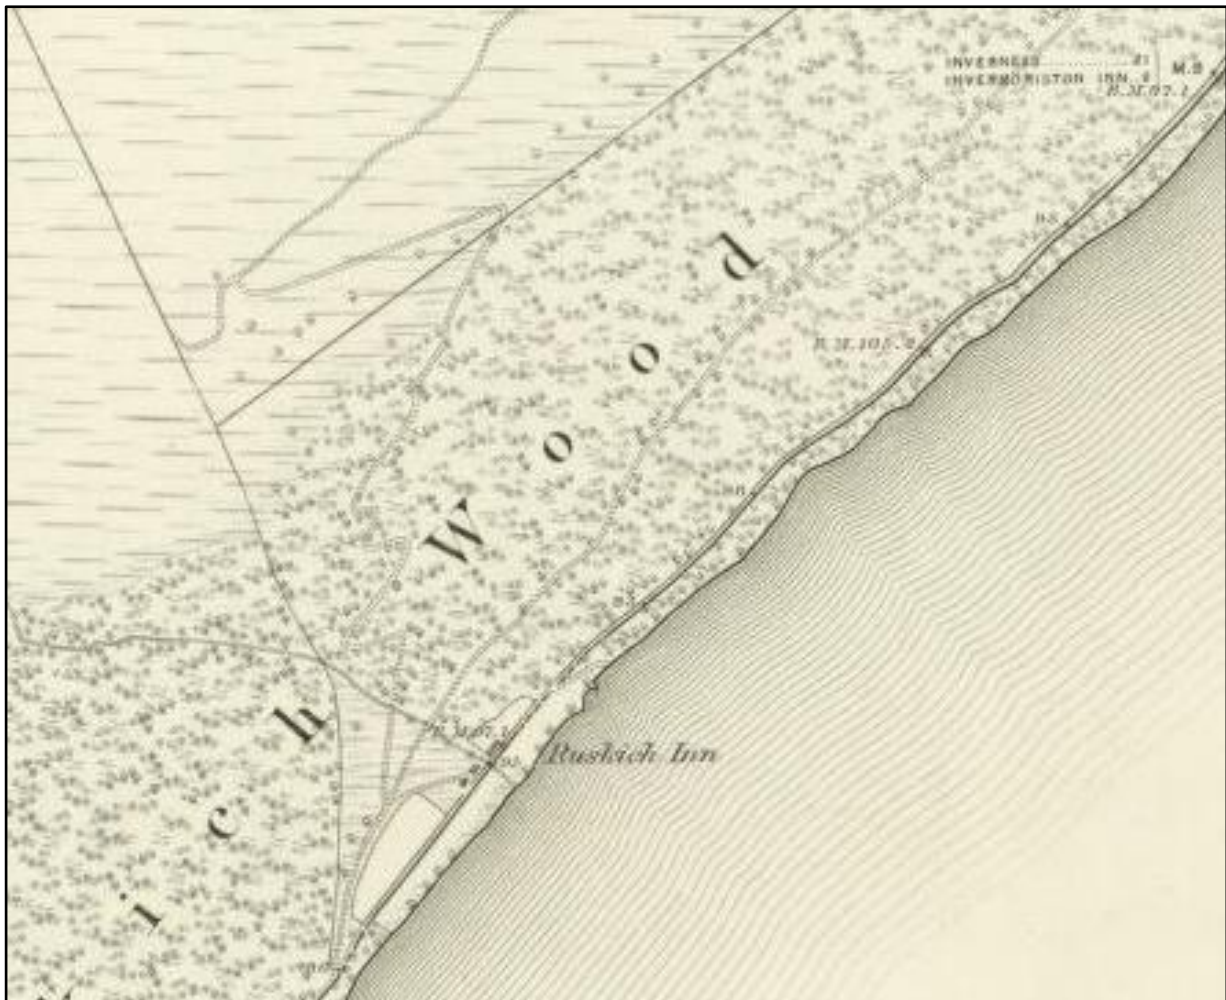
Figure 4: Excerpt from the OS 1st edition map, Sheet XLI ©NLS

This map depicts a group of three roofed buildings located on the northwest edge of the main road, which are labelled *Ruskich Inn* (Figure 4). There are two enclosures that are associated with the buildings. A boundary dyke or fence begins at the road edge to the southwest of the buildings and climbs up slope in a northerly direction to the edge of the survey area. It is joined by a perpendicular dyke or fence at the top edge of the survey area, which then runs along the survey area extremity in a north-easterly direction to the end of the survey area. Here it is abutted by an enclosure, which lies outwith the survey area. There are a number of tracks, which converge at the *Ruskich Inn* indicating it had an important role to play in the travel and communication of the inhabitants of the area.

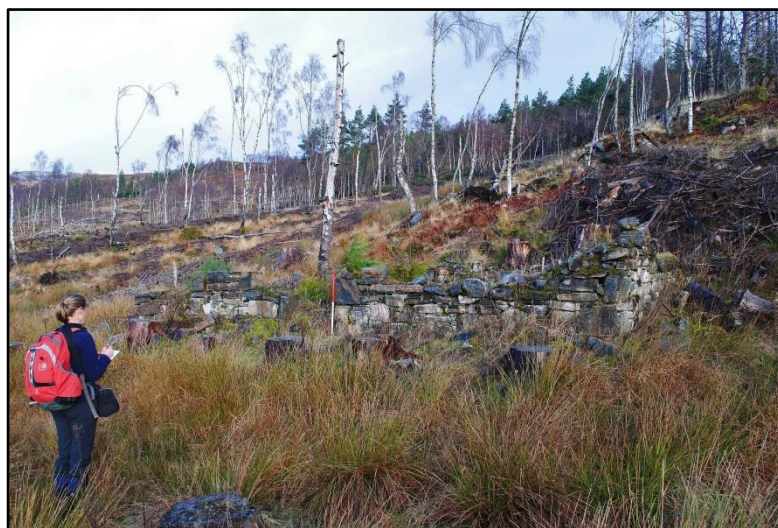
Plate 1: Site 1a-c

Located at the western extremity of the survey area, on the bank of a burn, two houses were recorded (site 1). Site 1a-c (Plate 1) was a rectangular stone-built house, which measured approximately 9m x 4m externally. The walls stood up to 1.25m high at the east gable and an entrance was situated in the middle of the south wall. On its west end were much degraded footings, about 6m in length, of what was an earlier building. This interpretation is supported by the historical mapping. The 1st edition OS map of 1871 (Figure 2) shows a long building with a small porch on the south side. This building has reduced in size by the time of the 1901 2nd edition OS map.

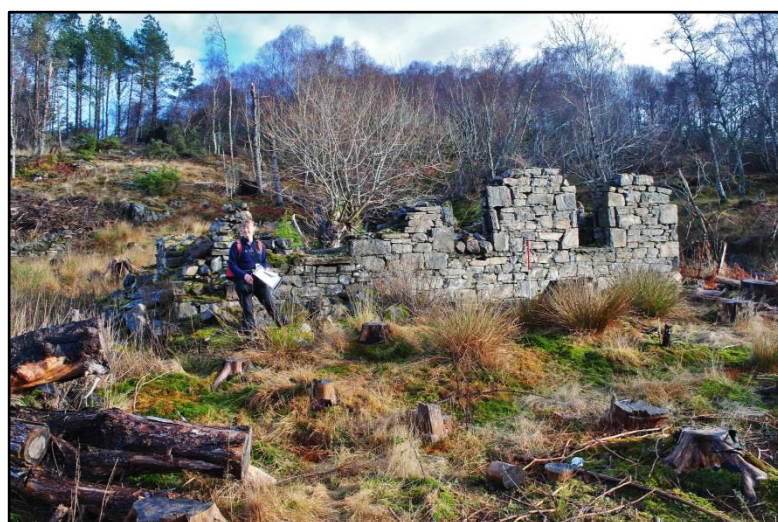
Plate 2: Site 1d-f

Site 1d (Plate 2) was a T-shaped house with walls standing up to 2.25m high. Although no entrances were visible, three splayed window recesses were noted on the south wall. To the south of the house was a shallow platform upon which the building sat (Site 1e). The leg of the T could not be assessed completely due to a large amount of windfall on it, but it appeared to abut the main body of the house suggesting it was a later addition. A stone and turf bank (Site 1f) enclosed the house on the north side. Both houses had square corners and showed evidence of mortar. This house is depicted on the 2nd edition OS map, but not on the 1871 map, suggesting that it was built sometime between 1872 and 1901. The small square building depicted on the 2nd edition OS map was not located.

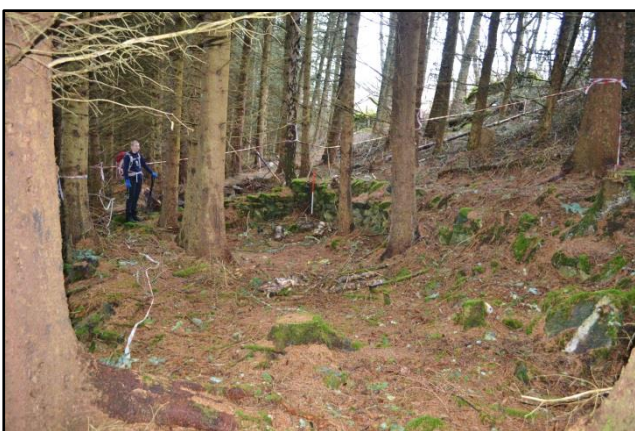
Plate 3: Site 8 showing the northeast wall revetted into the slope

footings consisted of large boulders standing to 0.4m high and spread over 1m. Site 8 (Plate 3) was the remains of a substantial rectangular building that had its north-eastern wall revetted into the bank. It measured about 8.5m x 3.5m internally with the walls standing up to 0.9m high and 0.6m wide. An entrance was visible in the southwest wall. This building corresponds with an unroofed building depicted on the 1st and 2nd edition OS maps.

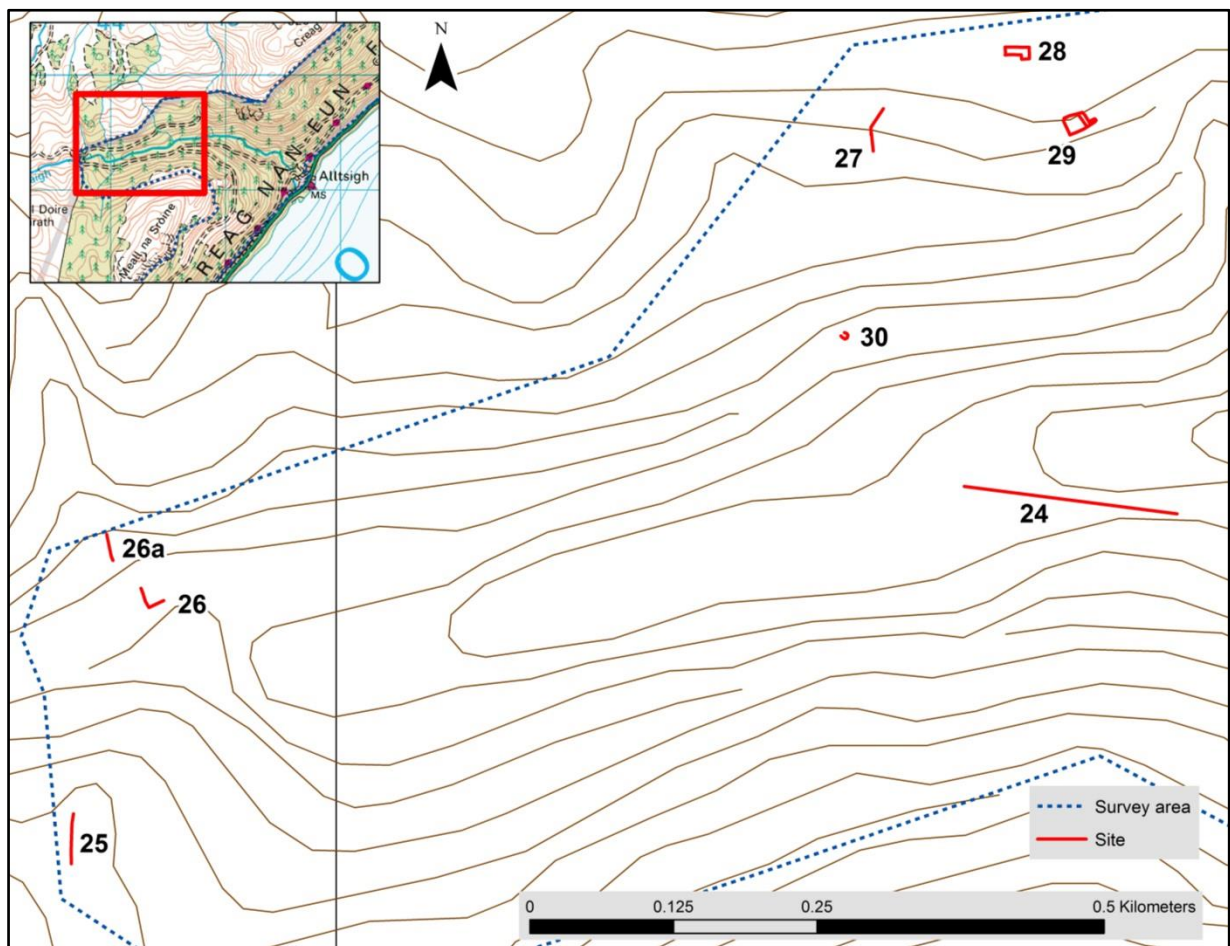
Figure 13: Location of sites 24-30. Contains Ordnance Survey data. Crown copyright and database rights 2014.

The second scattered group of sites was located at the north-western edge of the survey area in the vicinity of the Allt Saigh (Figure 13) and comprised a relict track (site 24), three dykes (sites 25-27), a building (site 28), a sheepfold (site 29) and a structure (site 30). The three dykes would have been part of the land use associated with the buildings and sheepfold. Site 28 was a stone-built, L-shaped structure. Four compartments were recorded, with three entrances in the north wall and one in the south wall. The sheepfold was located to the south of the building. Its double-faced walls stood up to 0.8m high and 1.2m wide, with an entrance in the southeast corner. The building, sheepfold and track are depicted on both the 1st and 2nd edition OS maps. The final structure in this area was sub-circular, open-ended and rubble-built.

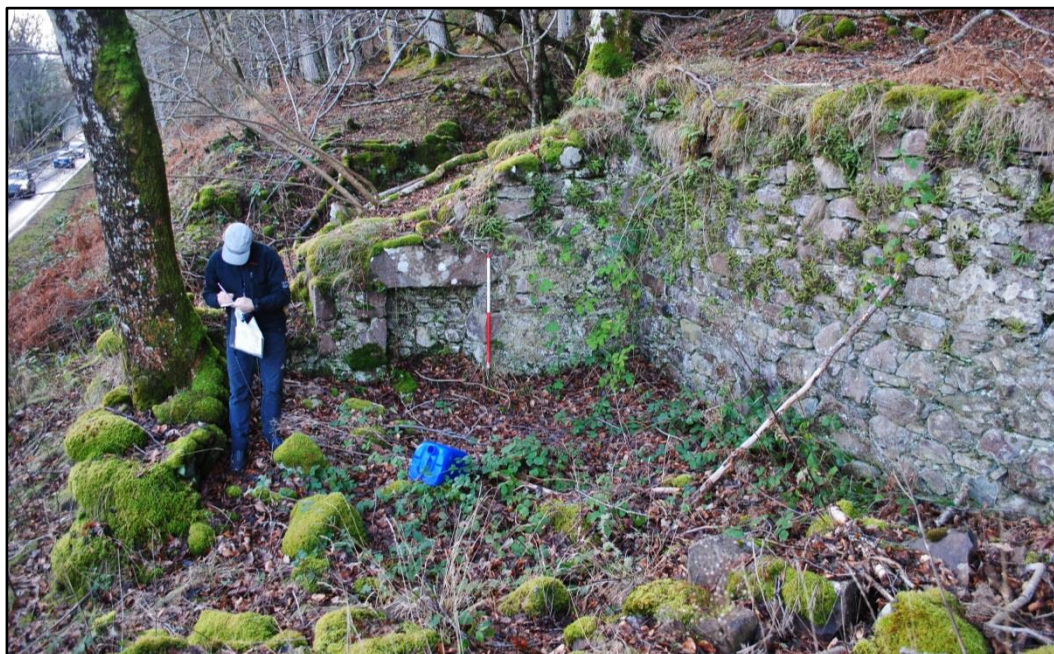
The remains of the former Ruskich Inn and associated buildings are clearly visible on the northwest side of the A82 (Figure 14). The largest of the three buildings (site 31) was well-built using stone and mortar. It measured approximately 21m in length and was divided into two compartments, the south-westerly of which had a fireplace in the gable end (Plate 6) and an entrance in the south-east wall. The walls stood to a height of up to 2.1m on the northwest side and were 0.6m thick. A short stretch of dyke (site 32) was recorded at the northwest corner of the building and would have been part of the enclosure wall depicted on the historical mapping. A set of flag-stone steps ran down the slope from the entrance to the enclosure at the northwest corner of site 31 to the roadside. Site 31 lies to the northeast of a burn, which has been revetted on either side, between the buildings, by walls (sites 33 and 34) standing up to 0.7m high and 0.8m wide, presumably to prevent flooding.

Plate 6: Site 31 showing the fireplace in the southwest gable.

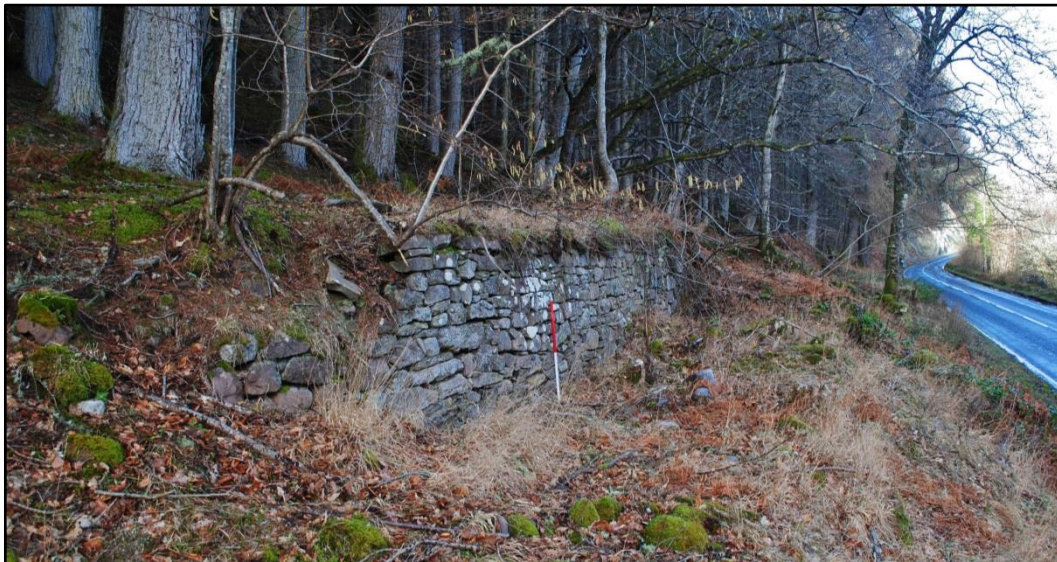
The central building (site 35) (Plate 7), to the southwest of the burn, was stone-built with the northwest wall, which stood up to 1.75m high, revetted into the slope. It measured approximately 9.5m by 3m. The most south-westerly building (site 40) (Plate 8) was the smallest of the three, measuring about 7.5m by 4m. Its walls stood up to 1.5m high and were up to 0.7m thick with an entrance in the southeast wall. The building is revetted into the slope on the southwest and northeast.

Plate 7: Site 35 showing the NW wall revetted into the slope.

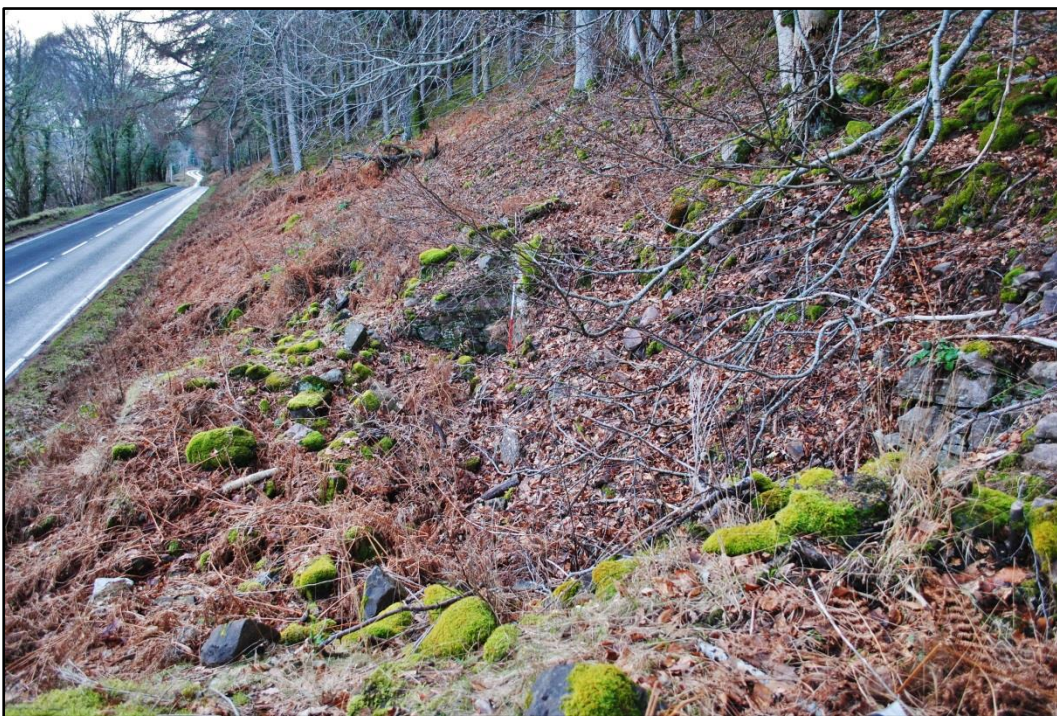
Plate 8: Site 40, the smallest of the buildings to the southwest of the group.

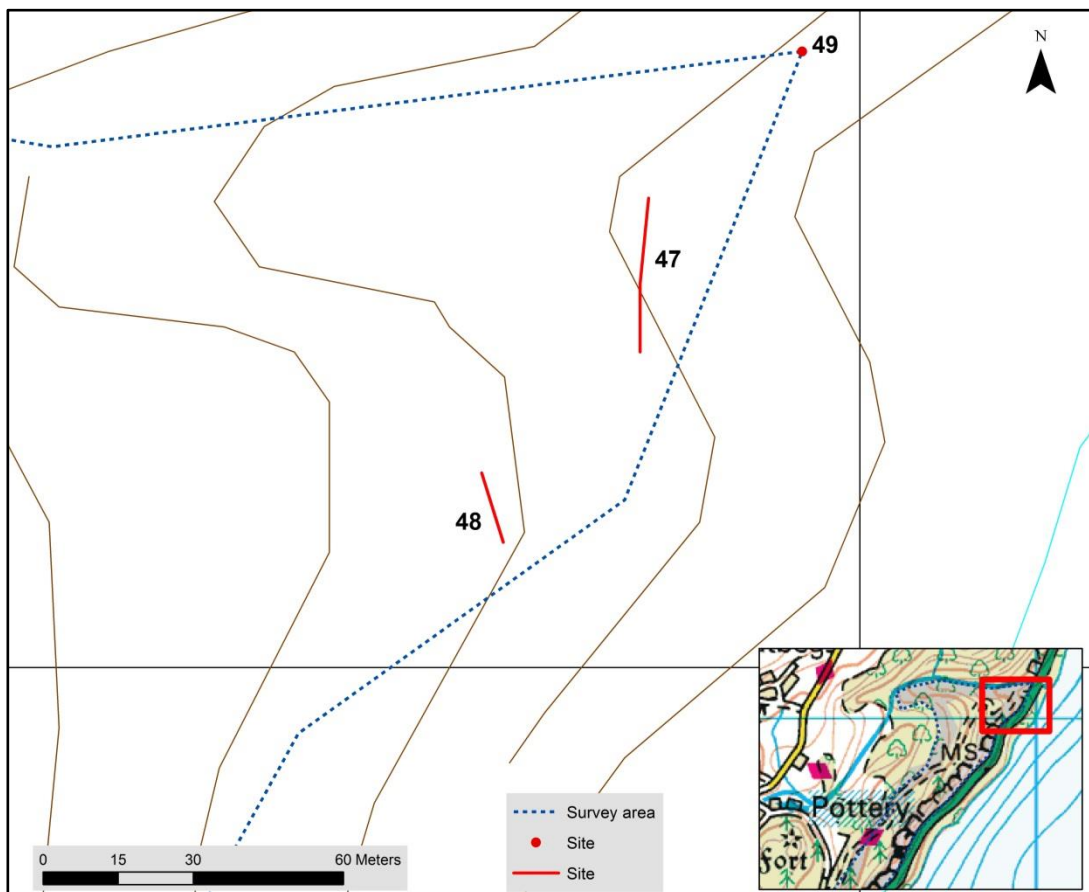
16: Location of sites 47-49. Contains Ordnance Survey data. Crown copyright and database rights 2014.

A moss-covered possible boulder/stone dyke fragment (site 47) was located on a flattish spur on the south side of the forest track. A definitive interpretation was not possible due to the large amount of stone and boulders present in the vicinity. A track is shown on the 1st edition OS map in this area and the stone could possibly be from a previous revetment wall that has been disturbed by the construction of the forest track. Site 48 was a rubble wall that may have been part of an enclosure, although the historical mapping does not show any structures in this area. Site 49, a stone-built bridge measuring

about 3m wide with a span of about 2.5-3m, although just outwith the survey area was noted as it appears to be unrecorded.
