# West Coast Archaeological Services

## New House and Agricultural Building 9 Croft, Poolewe

### Archaeological Controlled Strip Watching Brief

#### Final Report

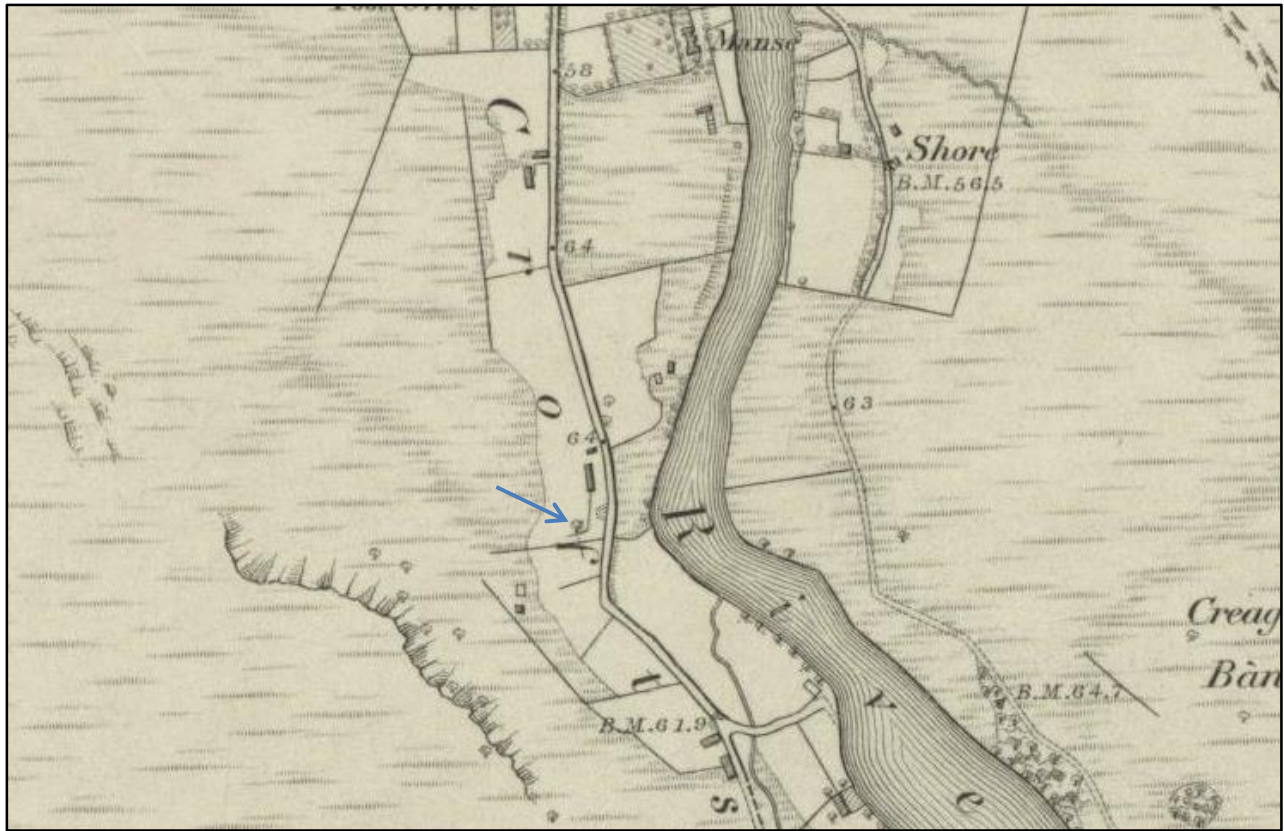
Figure 2: Excerpt from the 1875 1<sup>st</sup> Edition OS (arrow shows the location of the ruinous building)

The development site is located within a strip of cultivated land between a road, now the A832, and moorland on the west side of the River Ewe. A boundary dyke was shown running south from the buildings into the centre of the development site with two east-west aligned dykes crossing the site. Two roofed buildings are depicted beyond the northeast side of the development site and one small roofed and one small unroofed building are shown within unimproved ground beyond the southwest boundary of the new house site (Figure 2).

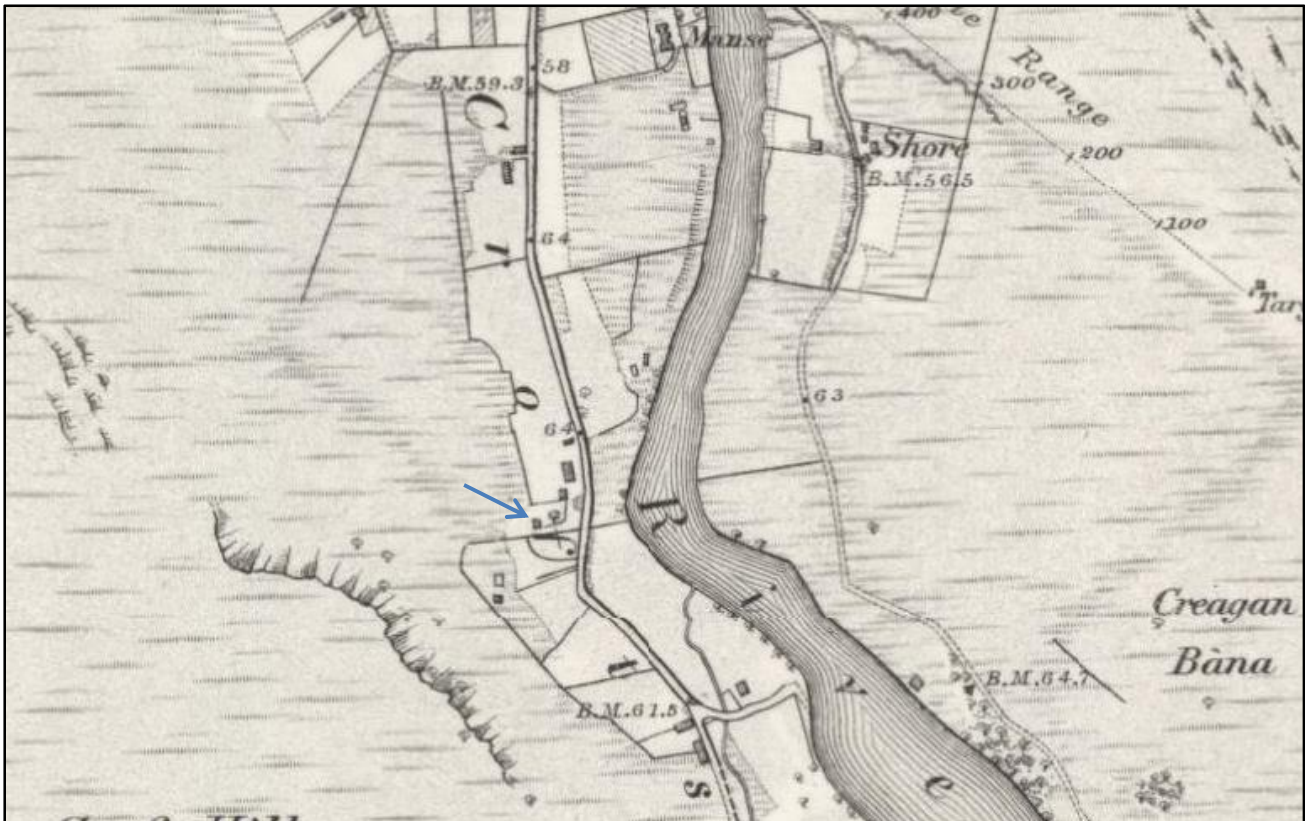
Figure 3: Excerpt from the 1902 2<sup>nd</sup> Edition OS (arrow shows the location of the ruinous building)

The area of the improved ground and the buildings beyond the development site to northeast and southwest are depicted the same on the Second Edition mapping as they are on the First Edition mapping. One new small roofed building is shown slightly offset to the south side of the northeastern group of buildings and a second new small roofed building shown at the end of the attached boundary dyke within the proposed house site and in the location of the present-day ruin. By this time, the boundary dykes enclosing the area are also shown as being linked to the N-S aligned dyke, indicating that the earlier dyke may be ruinous (Figure 3).

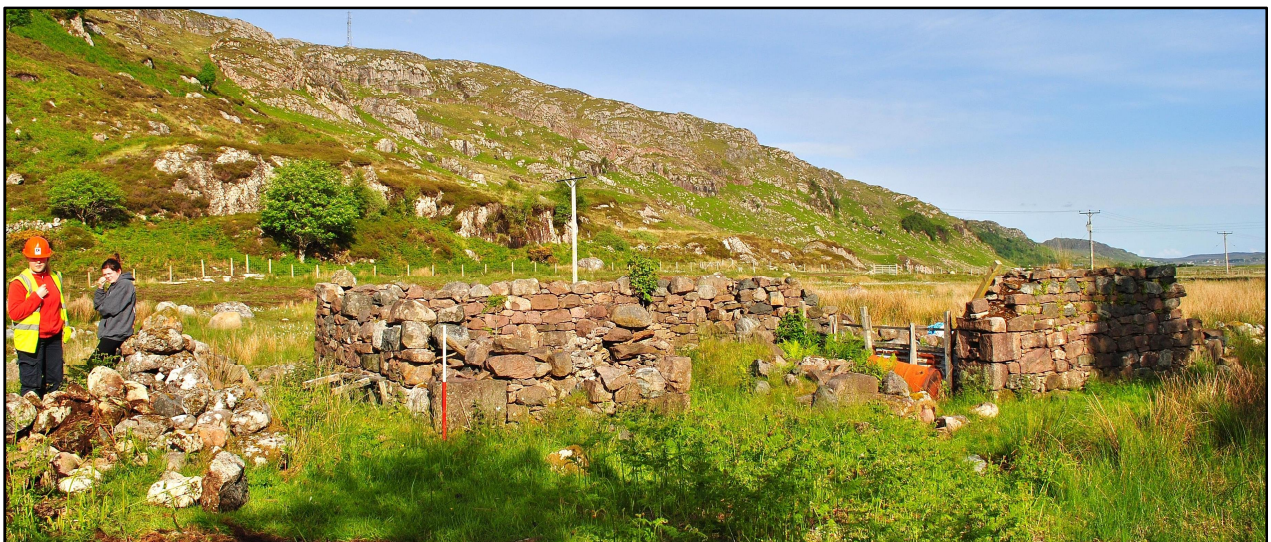
**Plate 1:** Ruinous stone building (Feature 2) prior to demolition

Prior to its demolition, the existing ruin on the site (Feature 2) was recorded in detail (Figure 5). It comprised a double-faced stone building (Plate 1) measuring 10.5m NNW-SSE by 4m overall. While the western wall was mostly standing to roof height at 1.6m, a large part of the remaining walls had fallen down. A 1.75m-wide entrance was located in the north gable end and another entrance face with door post slot was visible at the south end of the eastern wall. Two cruck-slots were noted within the interior of the south half of the structure (Plate 2), indicative of a cruck-frame construction of at least the southern part of the structure. There had been modification to the building over time, with a noticeable join within the centre of the western wall (Plate 3). The remains of an internal partition were recorded inside the building, although this may have been the north gable end of the original building on the site. A later partition was made in the building using a corrugated iron sheet.

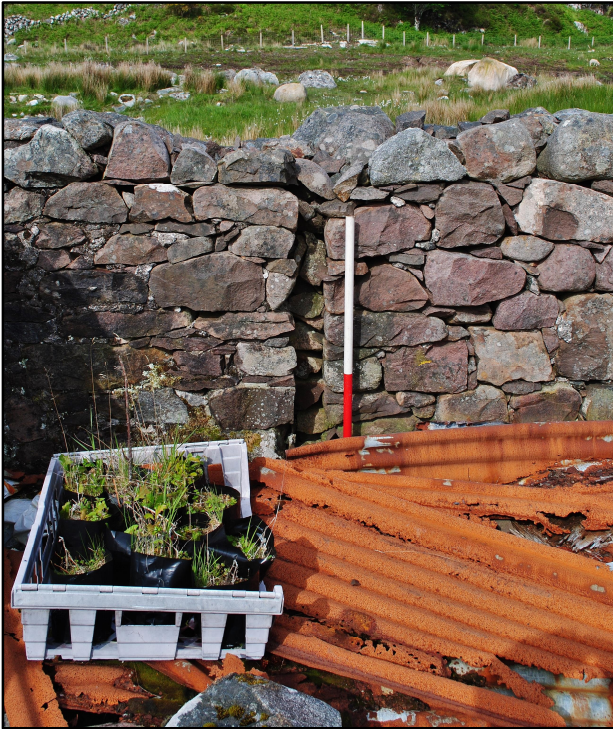
**Plate 2:** Cruck-slot, south side of western wall

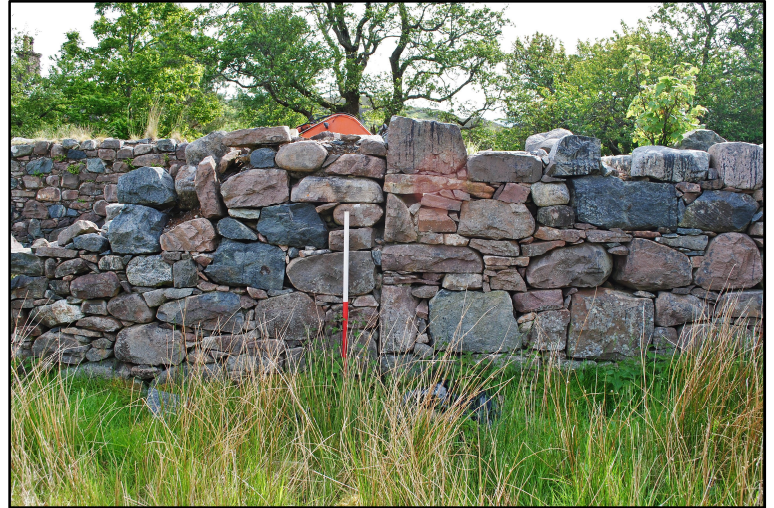
**Plate 3:** Visible join between north and south walls, west side of the building ruin

The dykes served to enclose areas of improved ground and demarcate the extent of crofts during the post-medieval period. The location and extent of these walls changed somewhat between the years of 1875 and 1902 (as shown in Figures 2-3). The ruinous stone building on the site is associated with the dykes and appears to have been built between 1875 and 1902 (Section 5.1.1). However, this structure appeared as a small square building on the 2<sup>nd</sup> Edition map (Figure 3) and must have been modified later with walling attached to the north side, as displayed by its rectangular appearance and the evidence for a wall join.

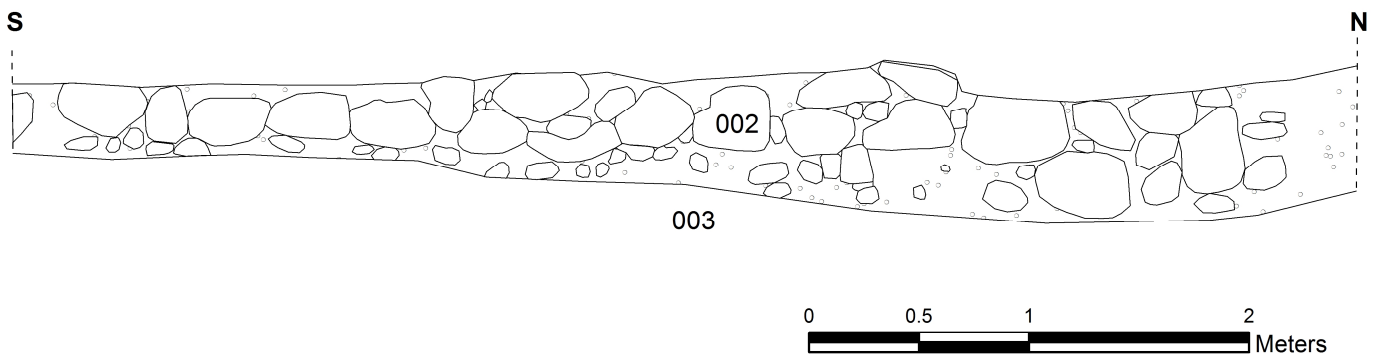
A platform edge, Feature 3, for the building site was excavated in the section of the shed footprint (Figure 5, Plate 4) and comprised 1-3 courses of large boulders and small cobbles (Figure 7). Given the differential nature of the ground conditions, soft peaty ground within boulders and outcrops, it seems likely that this structural alignment was built to support a level, hard base for the buildings on the site.

**Figure 7:** Section drawing of half of the east face of the platform edge, Feature 3

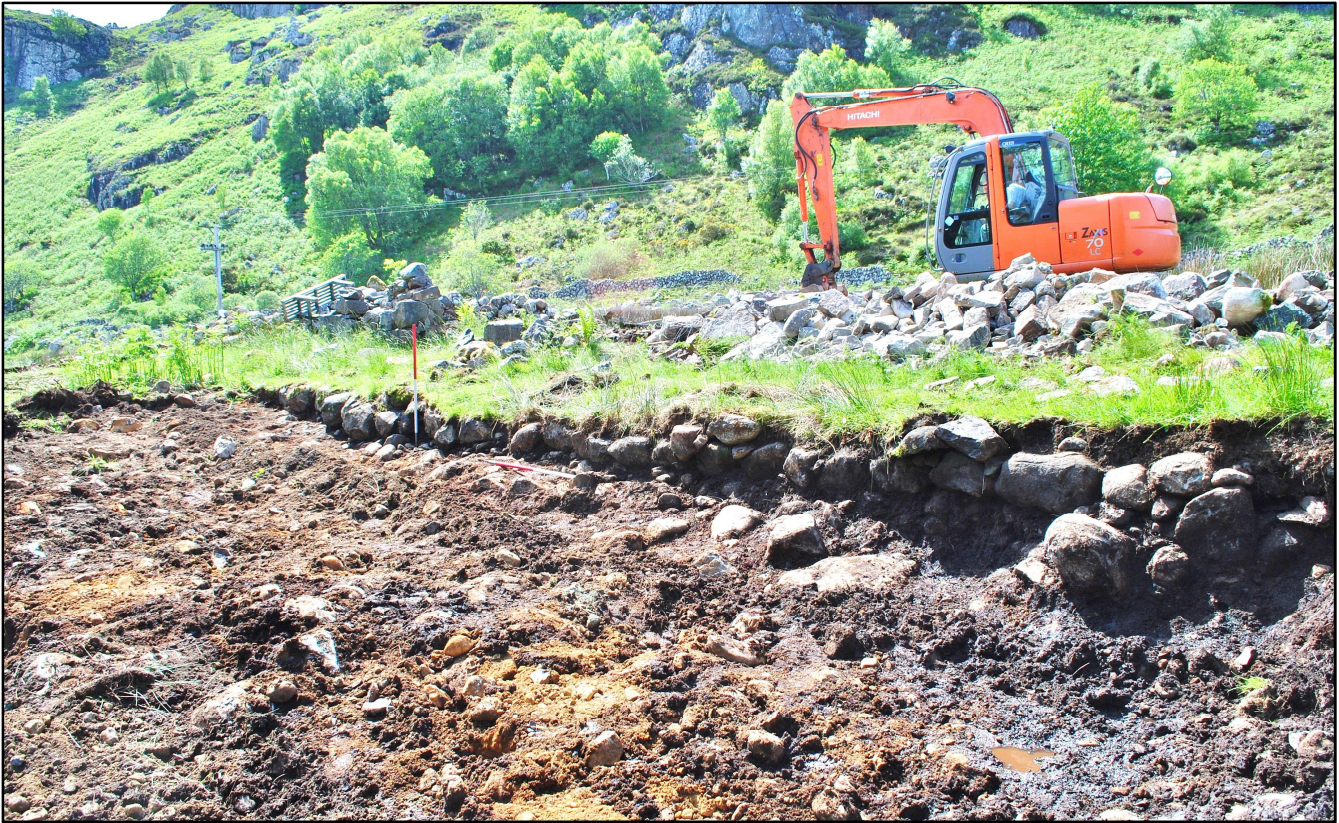
**Plate 4:** Looking southwest over the platform edge (Feature 3) during demolition of the ruin

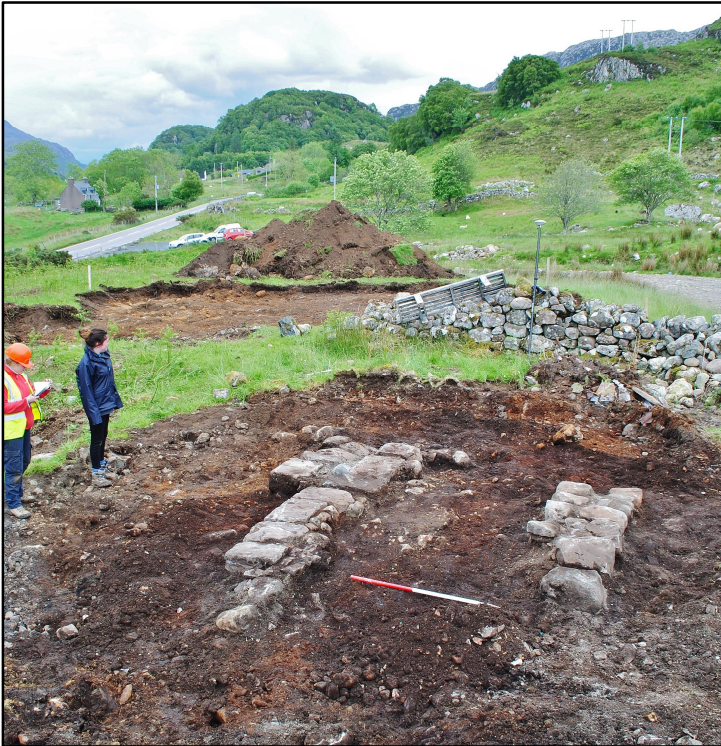
**Plate 5:**

After demolition of the building the remains of a 3m-long section of a wall (Feature 5) comprising dressed sandstone slabs was revealed below the base of the ruin (Plate 5). It was located at the centre of the two house-byre walls (Figure 5). Due to the nature of the demolition work, the relationship between the later building and this feature and any ground surfaces was not able to be ascertained.

Looking over the site of the ruinous building, post-demolition, with the fragment of the earlier wall (Feature 5) in the centre of the photo; the base of the west wall of the ruin are visible in centre right and the people in centre left are standing in the location of the ruin east wall.

The earlier building (Feature 5) was an altogether interesting result for the site clearance. Given the scope of the planning condition, it was purely fortuitous that the archaeologist was on-site for this event. Although the relationships between the later house-byre and this wall were destroyed during demolition of the ruin, the identification of the wall is prime evidence for construction of two separate buildings within the same site. Unfortunately, it is unclear as to which period the earlier building dates.

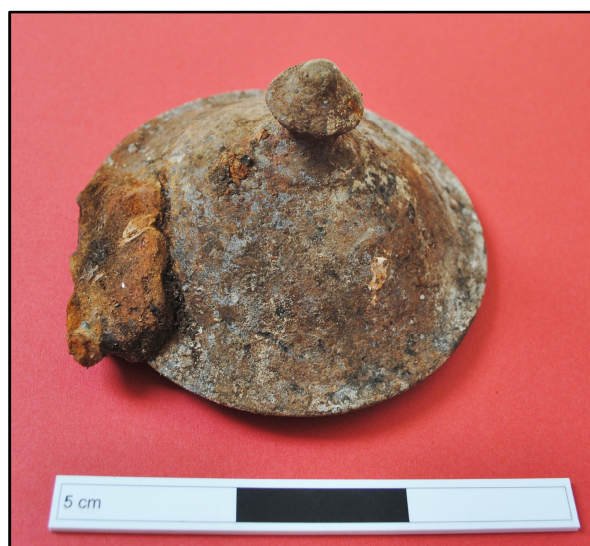
**Plate 6:** SF2-a, cast iron lid from the demolition layer

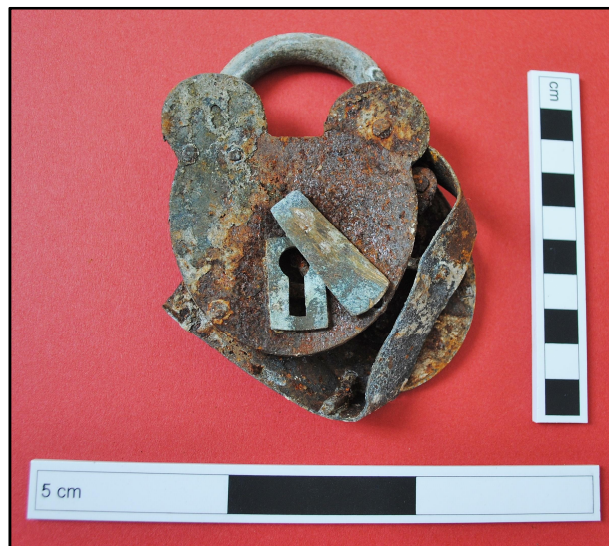
**Plate 7:** SF2-c, iron padlock from the demolition layer
