Castle Leod Strathpeffer, Easter Ross

Archaeological Test Pitting Evaluation

Results of the Archaeological Test Pitting Evaluation

National Grid Reference	NH 4860 5933
NMRS No.	NH45NE 9
Protected Status	Listed Building (A) 7826: Castle Leod
Highland HER No.	MHG6283
RoCAS Report	2014-35/CLD14
OASIS No.	rosscrom1-196922
Date	28 November 2014
Author	Mary Peteranna

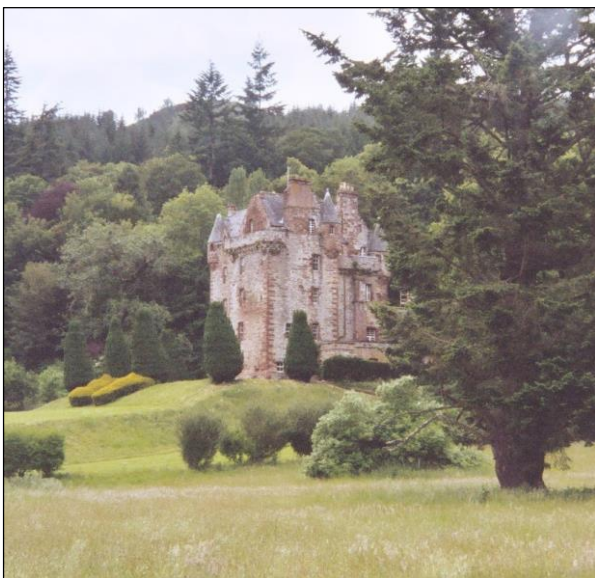
Plate 1:

View NW over Castle Leod in 2012, showing the steep slope of the eastern side of the mound

The upper platform of the castle mound, which had been partly laid with gravel, measures approximately 31m across on a NE-SW axis. The lower platform of the mound steps down about 1.5m at a distance of 8m from the southeast side of the castle tower. It measures approximately 49m NW-SE by 40m, with the steeper side of the mound being on the east-northeast side of it (cover plate and Plate 1). There is a clear edge to this side of the mound, whilst the west-southwest drop is more gradual.

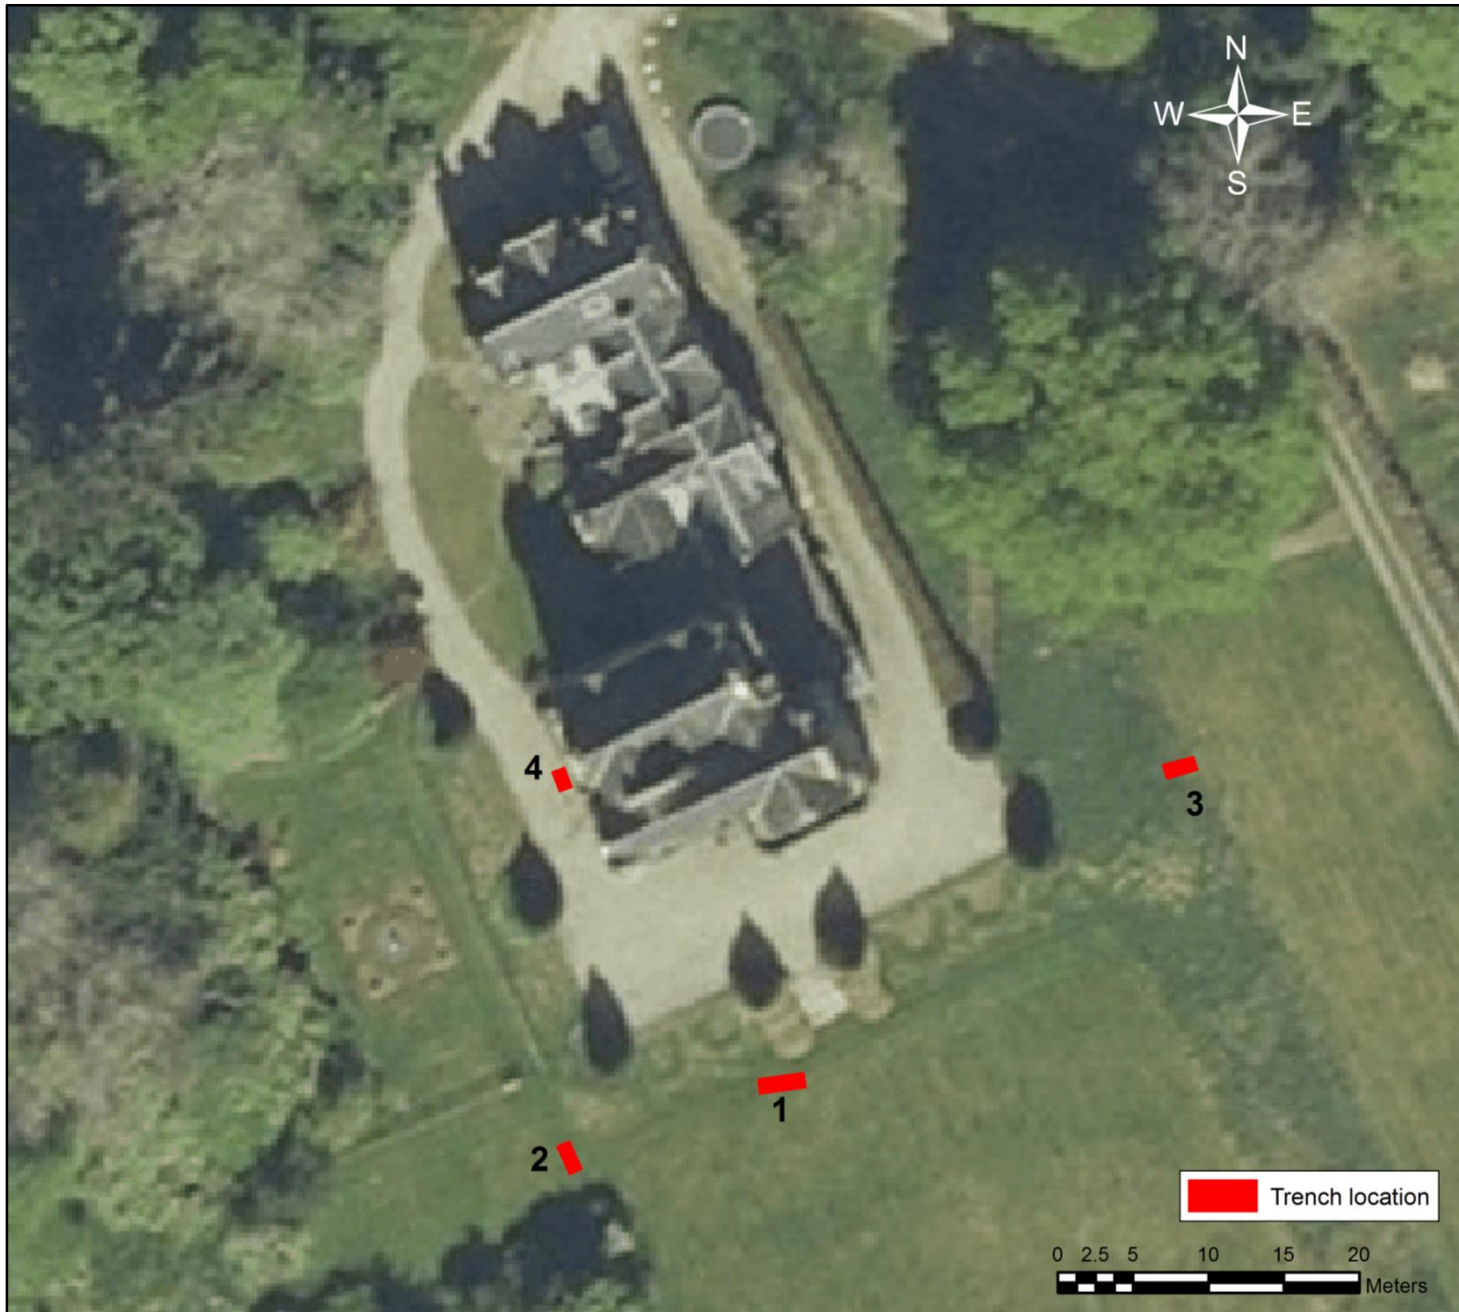
Figure 2

Trench locations ©
Getmapping plc 2014

Four test trenches (Table 1; Figure 2) were excavated. Trench 1 evaluated the northwest side of the middle terrace on the southwest side of the castle. Trench 2 evaluated the area west of the middle terrace. Trench 3 evaluated the archaeological material at the base of the mound on the east-southeast side of the castle site, particularly looking for evidence for a ditch feature around the mound. Trench 4 was excavated adjacent to the southwest side of the castle, to assess the depth of the castle foundations.

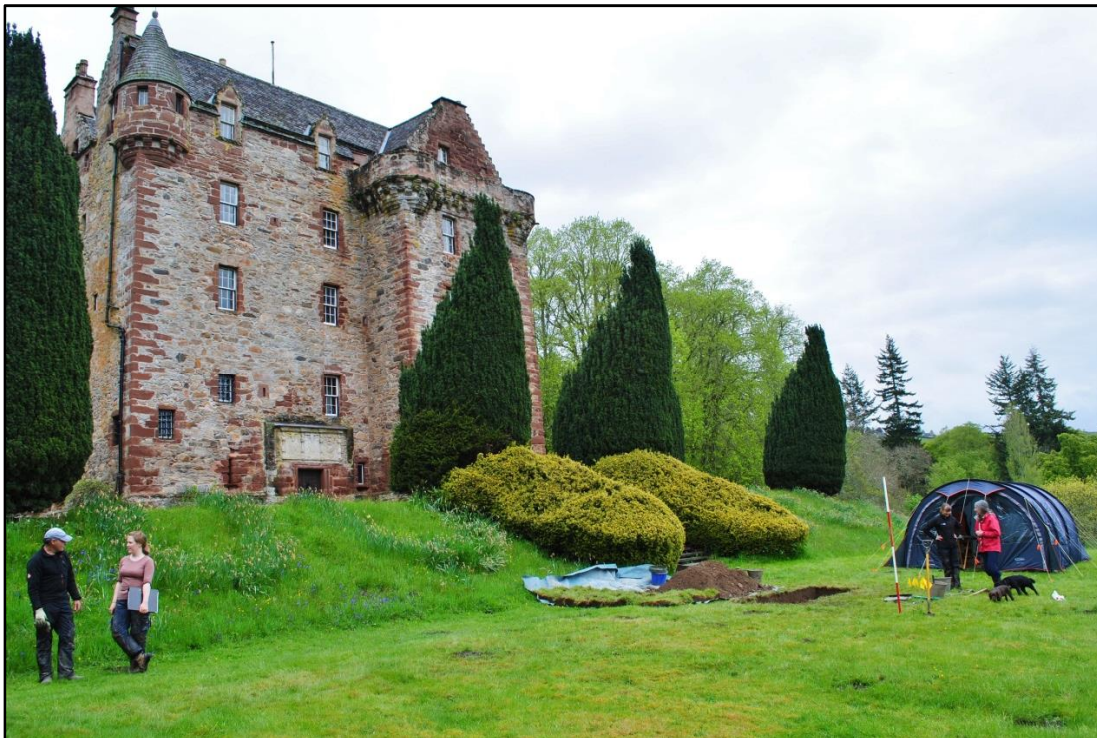
Plate 2

Trial trench evaluation in progress, showing the location of Trench 1 at the first break of slope of the castle mound, the intermediate terrace

Trench 1 was located at the base of the upper break of slope of the castle mound, approximately 17m south of the front of the castle (Figure 2; Plate 2). It was excavated to a depth of 30cm below the turf, where the natural subsoil was encountered (Plate 3). A sub-trench excavated in the east corner of the trench ensured that the subsoil layer had been encountered.

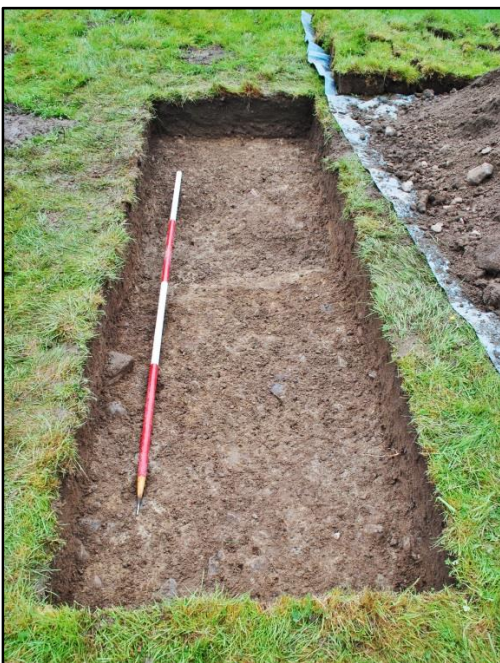
Plate 3

While no archaeological layers were identified, the nature of the ground suggested that the mound had been landscaped in the past, which may have removed archaeological material. The topsoil contained a mixture of glass fragments, clay pipe stems (Plate 4) and post-medieval pottery sherds.

Trench 1, post-excitation, showing the top of the natural subsoil

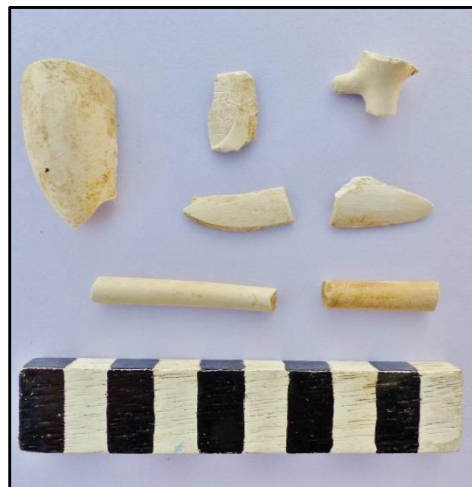
Plate 4

Clay pipe fragments (SF 9) from the topsoil in Trench 1; inset: stamped clay pipe bowl

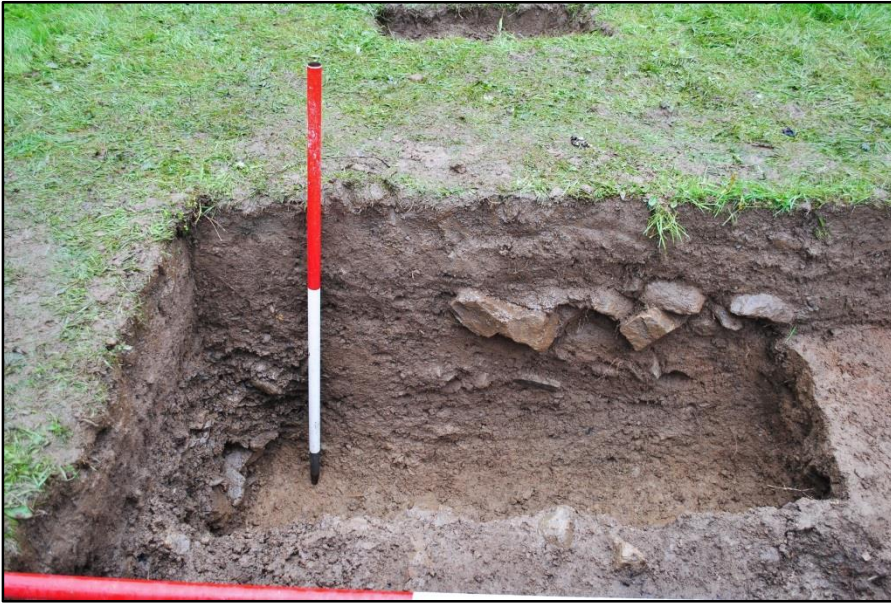
Plate 5

E-facing trench section, showing the possible wall base (2.08) in centre right; and the edge of the gravel/stone-filled ditch (2.10) to left

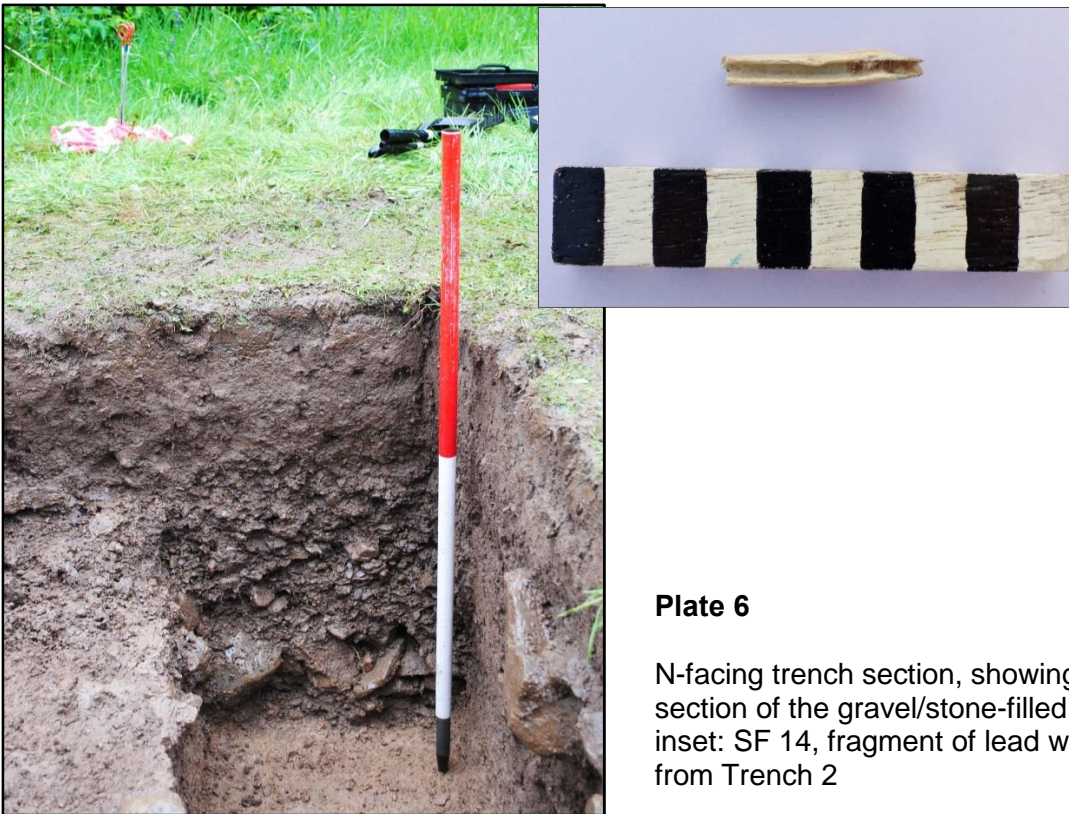
Plate 6

A sub-trench to evaluate this layer revealed a probable ditch (Context 2.10) extending beyond the south trench edge. From partial excavation, the U-shaped cut contained gravel-stone fill with larger stones at its base (Plate 6). The ditch, which survived below the topsoil, had been cut through the charcoal-flecked lower archaeological horizon (Context 2.06), from which a clay daub lump and mammal teeth were recovered. At the base of the trench, 0.70m below the turf was a further archaeological horizon containing rare charcoal flecks. This layer was not fully excavated to the natural subsoil due to time constraints but it provided further evidence for the survival of extensive archaeological deposits beyond the cultivated front terrace of the castle.

N-facing trench section, showing the partial section of the gravel/stone-filled ditch (2.10); inset: SF 14, fragment of lead window casing from Trench 2

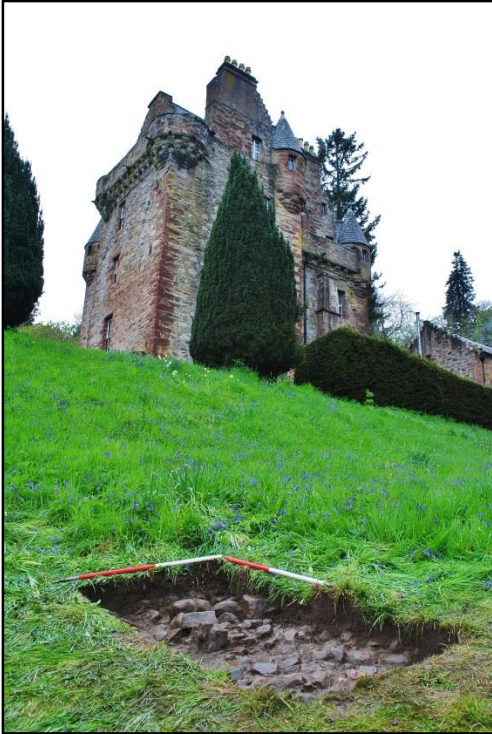
Plate 7 (left)

Location of Trench 3,
facing NW

Trench 3 was excavated at the base of the castle mound, approximately 10m from the southeast corner of the castle terrace (Plate 7). It was hoped that the trench would reveal evidence for a ditch at the base of the motte.

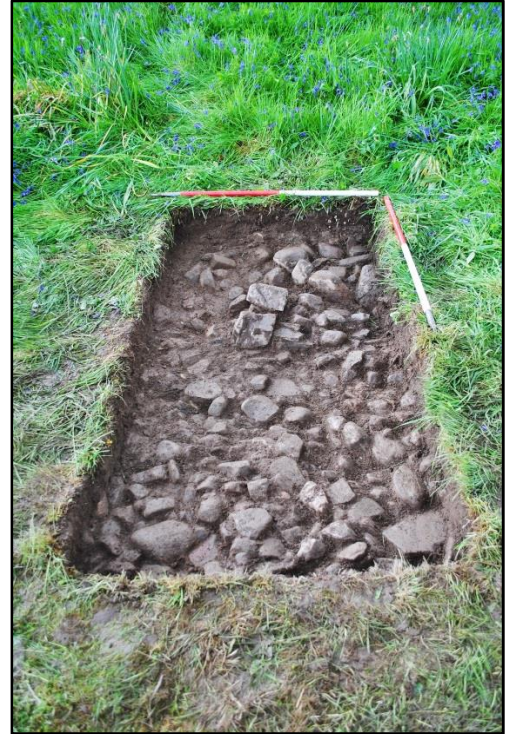
Plate 8 (right)

While the trench did not revealed extensive archaeological layers, the layer between the topsoil and natural subsoil comprised a compact spread of stone (Plate 8), which contained a significant amount of window glass fragments, roofing slate fragments and a possible stone whetstone. The stone spread was an inconclusive archaeological layer and may suggest further potential for archaeological material at the base of the castle site.

Stone layer (Context
3.02) in Trench 3,
facing W

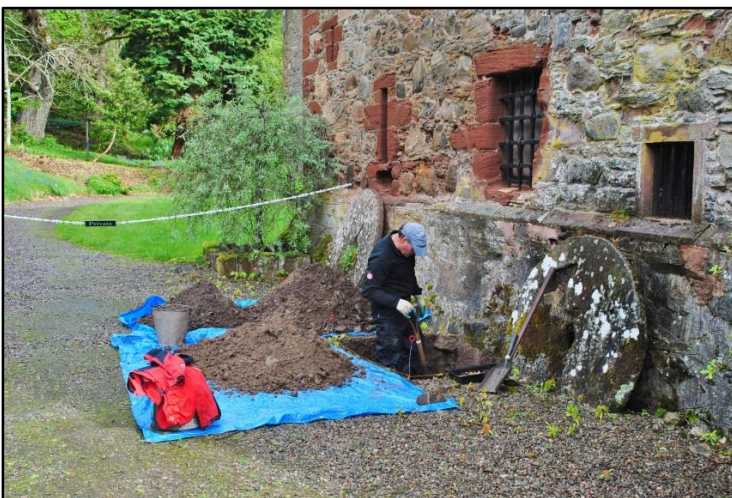
Plate 9

Location of Trench 4, facing NNW

Due to the sterile nature of the deposits in Trench 1, there was time during the evaluation to excavate a small trench adjacent to the southwest side of the castle (Plate 9). The trench revealed the base of the castle foundations (Plate 10 and Figure 4) and a drain passing through it, and contained some revealing artefacts relating to the castle occupation.

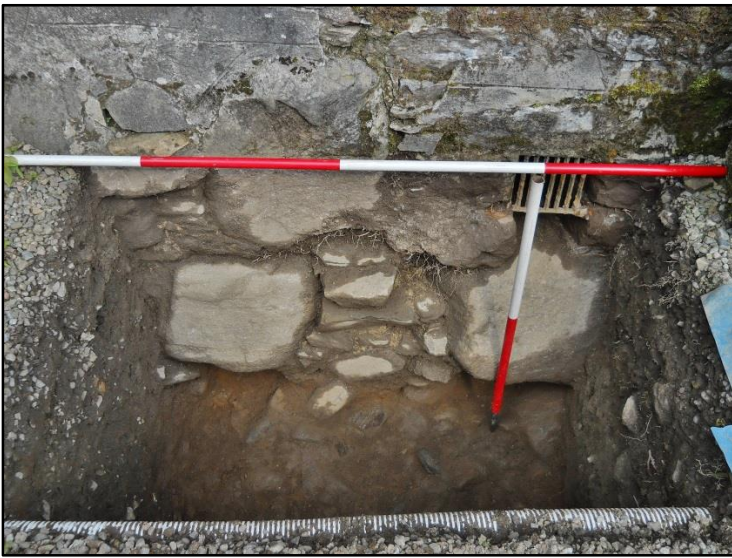
Plate 10

Foundations of Castle Leod (Context 4.11) overlying a cobbled layer (Context 4.09)

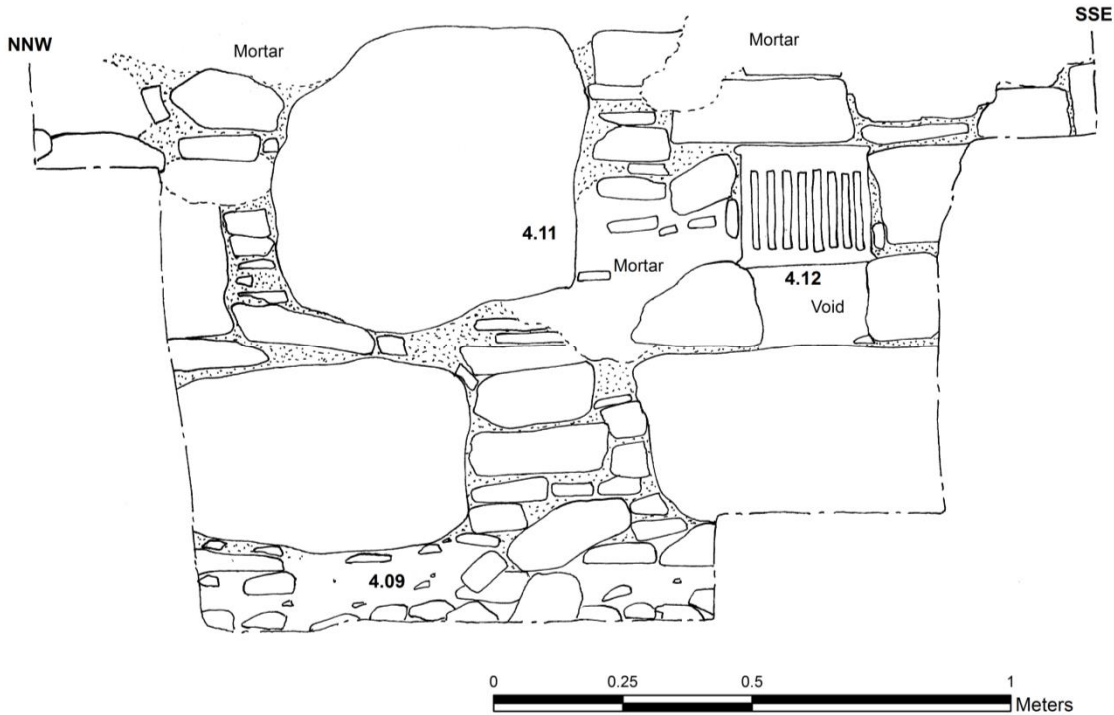
Figure 4

SW wall of Castle Leod showing the foundations (Context 4.11) overlying a cobbled layer (Context 4.09)

4.11	Structure	4	Mixed large boulders (including granite) and irregular stones and thin packing slabs, forms a battered and stepped-out face built over a layer of small angular stones (4.09); there are some large horizontal pinning stones and patches of lime mortar	4.09	-	-	-	-	-	-	Foundation courses of SW castle wall - 0.85m deep

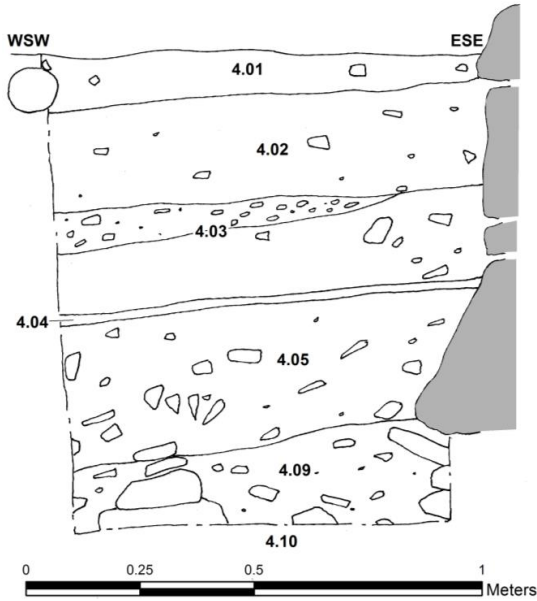
The layers excavated in Trench 4 contained a sequence of layers (Figure 5 and Figure 6) relating to two-three periods of construction or re-building of the castle and contained material such as window glass (Plate 11), roof slate fragments, mortar, as well as small black bead (Plate 12). The glass, originally part of window panes in the castle, was sent away for examination by specialist Robin Murdoch (Appendix 5). Using an x-ray fluorescence spectrometer, courtesy of Historic Scotland, Murdoch looked at the glass composition and origin. He determined that the glass must have been imported, probably from continental Europe, in the early 16th century. In later archaeological layers, different window glass signatures provided evidence of changes to the castle during the 17th to mid-18th centuries.

Figure 5 (left)
NNW-facing
section of
Trench 4

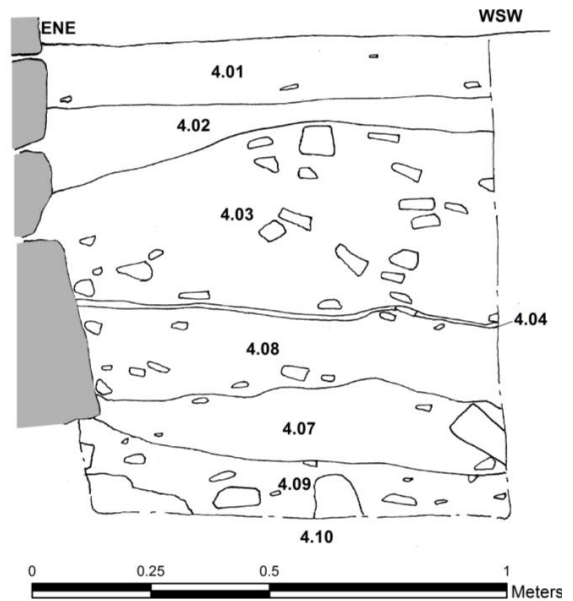
Figure 6 (right)
SSE-facing
section of
Trench 4

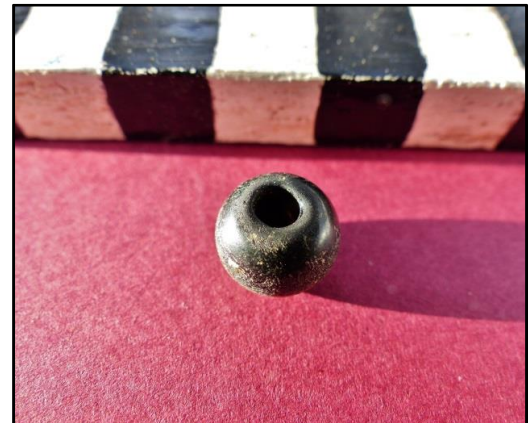
Plate 12 (right)
Small black bead
(SF 39) from
Trench 4

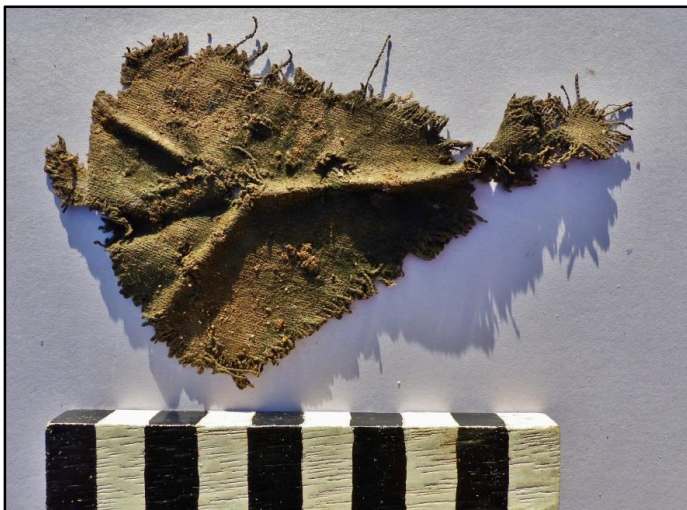
The drain (Context 4.12), which was lined with cobbles contained mixed ceramic sherds and animal bone, as well as an intriguing fragment of linen textile (Plate 13).

Plate 13
Fragment of textile (SF 38) from the drain
fill
