Archaeological Recording at St Peter's Church, Charles Street, Coventry

Report 0803

January 2008

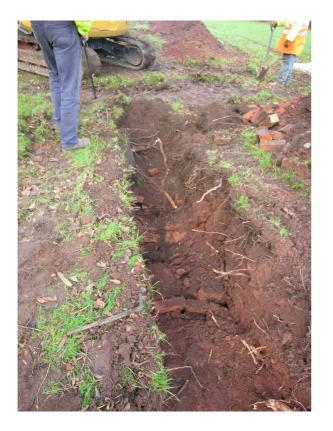
Fig. 5: Trench 1A looking south

5.4 Two of the brick tombs were uncovered in Trench 1A (Figs. 5-7). One of these consisted of the outside of an intact brick barrel vault (102), aligned east-west, whose full extent was not uncovered but which appeared to be at least 0.80m wide. The top of the vault was located 0.58m below the existing ground surface at 87.08m AOD. To the north of this was a similar brick barrel-vaulted tomb aligned east-west parallel The brick side walls of this tomb were uncovered showing that it with 102. measured *c*.1.35m wide. The south wall, which probably also formed the north wall of the barrel-vaulted tomb 102, was of double thickness mortared brick (103) and its top course was located 0.58m below the existing ground surface at 87.04m AOD. The northern wall (104) was of similar construction, the width of its top exposed course consisting of bricks laid lengthwise and being located 0.70m below the existing ground surface at 87.07m AOD. The springing of a barrel vault for the tomb was observed on both walls but the vault itself had been destroyed by a cut (106) that probably removed an associated monument that had once rested on the ground surface. This destruction was probably part of the graveyard clearance that resulted in the tombstones being placed against the graveyard wall. destruction of the barrel vault, the tomb itself had been filled with the fragmented brick remains of the vault itself and with broken fragments of gravestones (105).

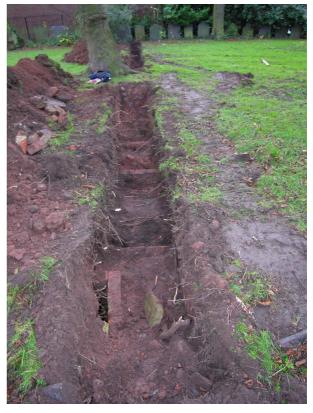
Fig. 8: Trench 1B looking south

- 5.6 A further three tombs were recorded in Trench 1B (Figs. 8 and 9). To the south was a single width brick wall (109) aligned west-east that continued the line of the south wall of the church. Wall 109 was located 0.70m below the existing ground surface and the springing of a barrel vault was observed on its north side. Another single brick width wall (111) was recorded 0.98m to the north of wall 109 and running parallel to it. Wall 111 was recorded 0.76m below the existing ground surface and probably formed the north wall of a tomb vault whose south wall was Immediately north of wall 111 was another single width brick wall (112) running parallel with and built against it. A gap of c.2cm between the two walls, which were definitely separate features, had been filled with mortar, but it is not known which was the earlier. Wall 112 was recorded 0.64m below the existing ground surface and probably formed the south wall of a tomb vault aligned eastwest. To the north the remains of the northern half of the mortared brick barrel vault (114) were recorded. All of the vaulting to the south of 114, together with the barrel vault of tomb 109/111, had been destroyed by a vertically sided cut (116) that probably removed above ground memorials during the clearance of the graveyard. Both tombs were backfilled with the fragmented remains of the vaults and with broken gravestones (110, 113).

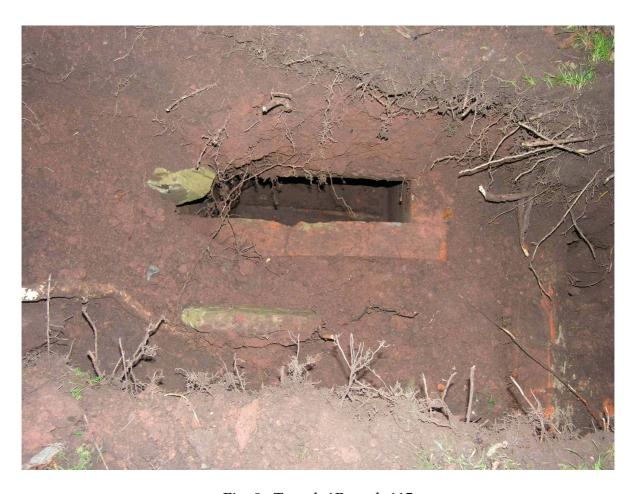
Fig. 9: Trench 1B vault 115

- 5.7 To the north of vault 114 was the corner of another brick built tomb. This was built of a single width brick wall (115) aligned roughly east-west and turning south-north. It was slightly out of line with the two tombs to the south. The top of the wall, recorded at 0.58m below the existing ground surface, appeared to have been capped with flat sandstone slabs 0.06m thick (119) rather than a brick barrel vault. What appeared to be the base of the tomb lay at 1.03m below the top of the wall and the tomb itself appeared to be empty, though this was uncertain as it was recorded only through a small break in the roof caused by the current machining (Fig. 9). All of the deposits and features described above were overlain by very dark grey sandy loam topsoil (118).

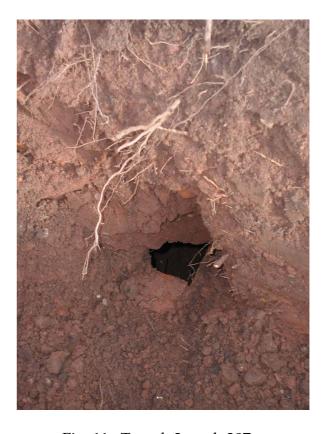
Fig. 11: Trench 2 vault 207

- 5.15 The edge of a brick vault (207, Fig. 11) was recorded in the north edge of the trench. This only appeared as part of the trench edge collapsed and little could be seen. It appeared to have been overlain by deposit 205. The recorded fragment was the south-west corner of a possibly rectangular tomb with walls a single brick thick. It did not have a barrel vault and may have been capped with sandstone slabs as with tomb 115/119 in Trench1, but this is uncertain. The upper brick course was located 0.95m below the existing ground surface and what may have been the base of the tomb was located a further 1.05m below this level. Part of the tomb appeared to contain brick rubble (208) suggesting that it had partially collapsed. What may have been a skull can be seen on a photograph taken through the small opening that was uncovered.

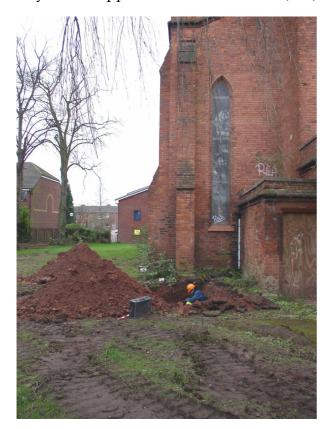
Fig. 12: Trench 3 looking west

5.17 A trench was cut for the foundation of a new fire escape to the south-east of the nave, immediately adjacent to the chamber on the south side of the chancel (Fig. 12). The trench was roughly rectangular in plan, aligned WSW to ESE and measured approximately 3m long by 2m wide and up to 1m deep (86.30m AOD). Geological natural reddish brown clay (308) was encountered at around 0.85m below the existing ground surface (86.45m AOD).

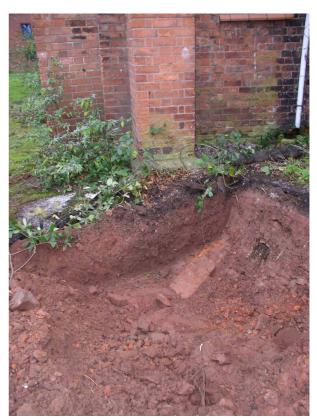
Fig. 13: Trench 3 drains 305 and 307

5.18 The geological natural was overlain by a layer of mixed reddish brown sand/sandy loam (303) 0.27m thick that was probably a make-up layer. This was in turn overlain in places by a layer of dark reddish brown sandy loam (302), up to 0.25m thick, that may have been the remains of an early ground surface but would probably have dated from the lifetime of the church. Layer 302 was cut by the trench (306) for a drain running north-west to south-east and aligned with a drain downpipe against the side of the church. The drain consisted of a cement trough, c.1m below the existing ground surface, capped by bricks laid lengthways across its width and overlain by dark reddish brown sandy loam that backfilled the trench (307, Fig. 13).

5.19 The backfilled drain trench was overlain by a layer of reddish brown sand and sandstone fragments 0.14m thick (301) that acted as make-up for the existing tarmac path (300) but may have been originally the make-up for an earlier pathway. Layer 301 had been cut by the trench (304) for another drain that replaced drain 306/307 and ran parallel and immediately to the north-east of it. The base of the new ceramic

drain pipe lay 0.85m below the existing ground surface and was overlain by mixed reddish brown sandy loam and clay (305) that backfilled the trench. The backfilled drain trench was overlain by the existing tarmac path (300).

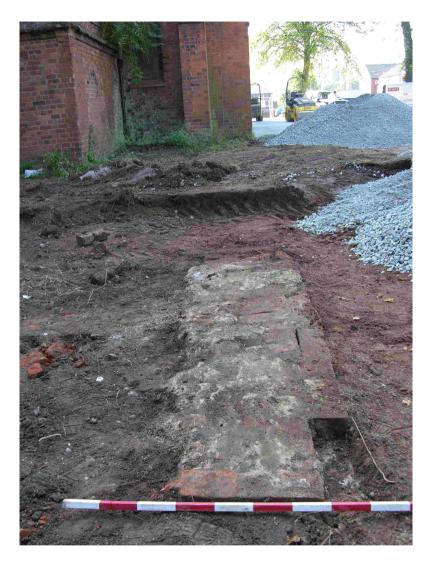
Fig. 14: Top of wall 402 and vault roof 412

5.21 To the east of the church a cut (417) for a large brick-built vault was recorded, with a dark grey brown sandy clay fill (418) to the east of the eastern wall (405) of the vault. The north wall of the vault (402) was visible when the topsoil was removed, along with *c*.0.36m of the remains of the barrel vaulted ceiling (412) (Figs. 14, 16). Part of the west wall (403) was also visible when the topsoil was stripped, but the tops of the south (404) and east (405) walls remained below stripped level. The vault measured 2.05m north-south and 2.30m east- west (internally) and was 2.24m deep from the surviving top of the west wall to the stone floor (406) below and slightly deeper to the east. The walls of the tomb bore traces of whitewash; the whitewash survived particularly well on the east wall. The central slab of the stone floor (Fig. 15) was inscribed with a shield bearing the letters IS (probably standing for JS) and the date 1851. This, and the fact that there appeared to be a void at the base of the stone indicated that there was a grave of 1851 beneath this 'floor' level. This would suggest that the vault was originally constructed to a depth of *c*.3m or more, a similar depth to those at St Martin's-in-the-Bull Ring, in Birmingham (Buteaux and Cherrington 2006, 39).

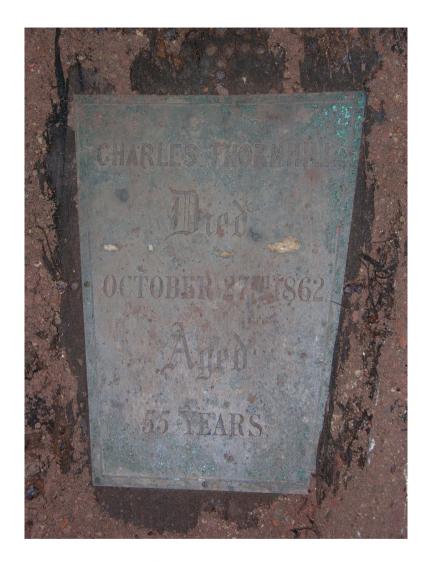
Fig. 18: Coffin plate of Charles Thornhill

5.22 On the south side of the vault was a lead coffin burial (410, Fig. 17). The coffin had been badly damaged by rubble falling in from above and was not sealed. The lead coffin bore some traces of decorative incised work along its side, although only a very small area was visible. A trapezoidal copper alloy *depositum* plate (Fig. 18) lay on the remains of a sheet of fabric on top of the lead coffin and read:

CHARLES THORNHILL Died October 27th 1862 Aged 55 YEARS

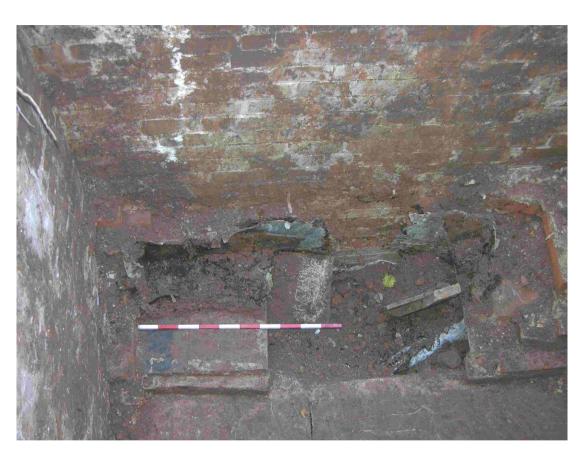
Fig. 19: Upper wooden coffin 409

5.23 Charles Thornhill's grave had been sealed by a series of stone slabs forming a shelf (411) which rested on bricks protruding out from the face of wall 404 and on a brick dwarf wall (416) running east-west across the floor of the vault. Stone shelf 411 supported the remains of another coffin. This coffin (409, Fig. 19) was a composite construction and it appears that this had also been covered with fabric, a practice common in the 18th and 19th centuries (Litton 1991, 99-102). The outer oak 'case' hid

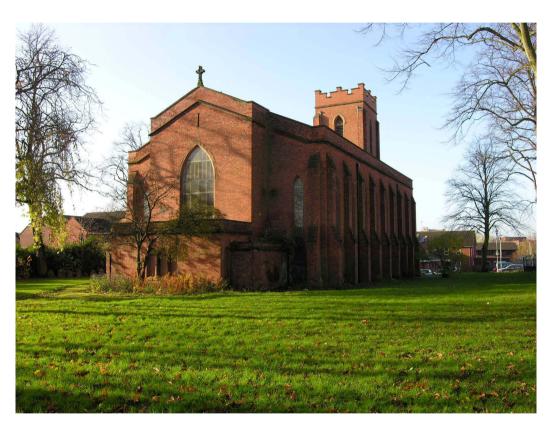
Fig. 24: View of church looking south-west

6.3 The church is brick built in Flemish bond with brick and red sandstone dressing (Figs. 24). The windows have flat-faced hood-moulds with square terminals, some of which have been dressed off. The east window has four lights in a rustic Perpendicular style (Fig. 25) and was subject to vandalism in August 2007, with part of St Peter being broken. The nave is buttressed with a parapet and large lancet windows. The west end of the church has a three-stage porch with tower above Fig. 26). The tower has angle buttresses with set-offs and a parapet with crow-stepped battlements (Fig. 27). The doorways on the west end have double-chamfered Tudor arches (Fig. 28). A large three-light window is set over the door and there are tall lancets to the belfry. The vestry, at the east end of the church, is low with a blocked triple lancet window (Fig. 29). To either side of the vestry are small ante rooms, the southern one has an external doorway (Figs 30 and 31). There is a single small window with a pointed arch on the western end of the north side of the building (Fig. 32). The windows all have sloping tiled sills (Fig. 33). The string course below the parapet is made up of decorative brick, projecting forward from the wall (Fig. 34). Two different shapes of brick have been used on the walls, one with a concave moulding and the other with a convex moulding; one brick type runs in a stretch along the wall and then changes to another for no apparent reason. The same brickwork is used around the top of the vestry and the two ante rooms.

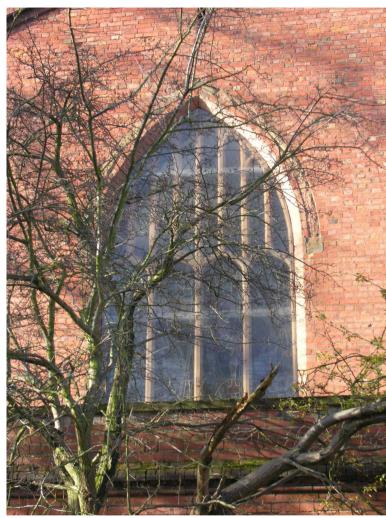
Fig. 25: East window

- 6.5 The stained glass in the east window is a 1955-6 replacement copy of the arts and crafts window that originally sat there (Pevsner and Wedgwood 1961, 264). The window shows an apple tree in the background and Saints Thomas, Peter, Paul and Francis in the lancets below (Fig. 47).
- 6.6 In summer 2007, after the main phase of building recording had taken place, the interior of the church was gutted. The wooden fixtures and fittings, including the memorial panel, font, vestry screening and pews were removed and broken up. The rotten wooden floor was lifted to reveal stone slabs in places and dwarf brick walls that supported the floor. No graves were noted below floor level.

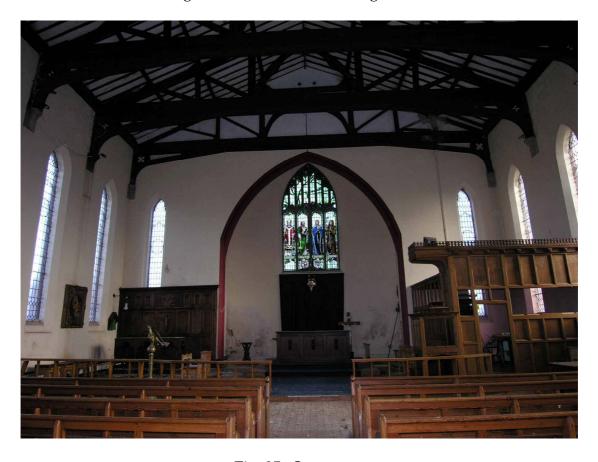
Fig. 35: Sanctuary

6.4 The floor of the church was largely wooden, heavily attacked by woodworm, broken in places. The sanctuary is defined by a moulded stone arch, the mouldings dying into plain responds (Fig. 35). The chancel is defined by very plain timber rails with a memorial date of 1944 (Fig. 36). The substantial roof has eight bays made up of nine closely-spaced trusses of tie-beam and queen-post design (Fig. 37). Short arched braces below the tie beam are decorated with pierced quatrefoils and
