Archaeological Recording at
Claybrooke Mill, Frolesworth Lane,
Claybrooke Magna, Leicestershire

Report 0712

Archaeological observation of groundworks for alterations to a late 19th-century stable was undertaken at Claybrooke Mill, Frolesworth Lane, Claybrooke Magna. No significant archaeological deposits or artefacts were recorded, although the work lies within the known site of medieval Claybrooke Mill. A photographic record was made of the stables building, some of whose elements appeared to be remnants of an earlier building. Any early archaeological remains in the area of the new building may have been removed during previous ground reduction.

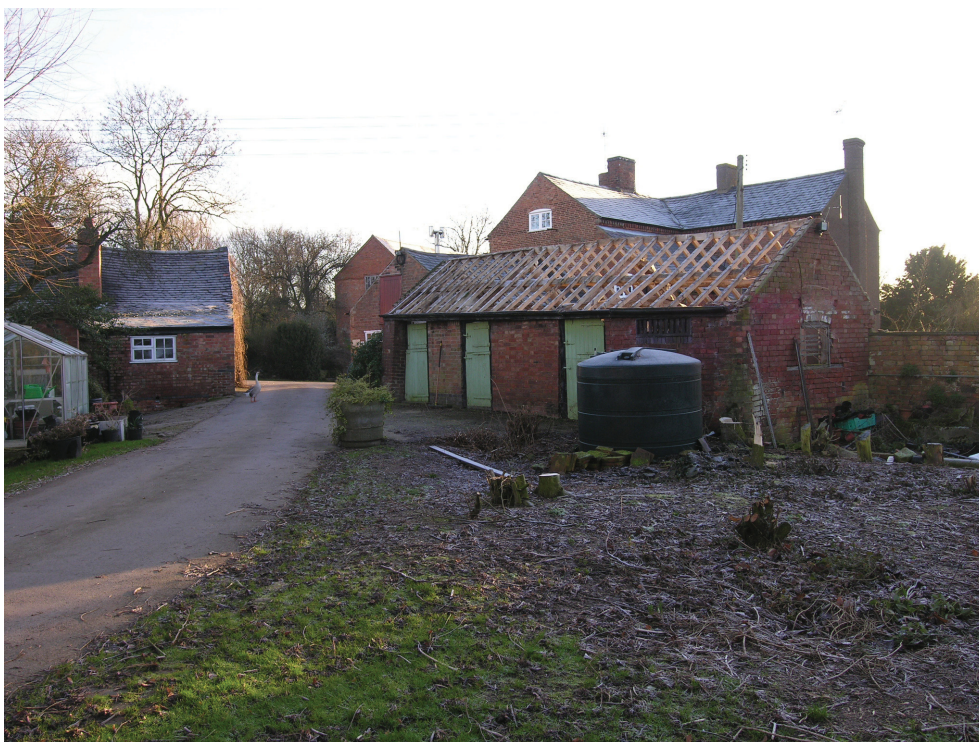
Cover: View of stables and house looking north

4.3 A remnant of wall foundation (11) was present in the south trench closest to the surviving end of the stable building. This wall had been standing as a garden wall in January 2007(see Cover). A small segment of this wall survived above ground surface as a continuation of the existing rear wall of the stables. Adjacent to the wall and west side of the stables was an area of brick floor (10).

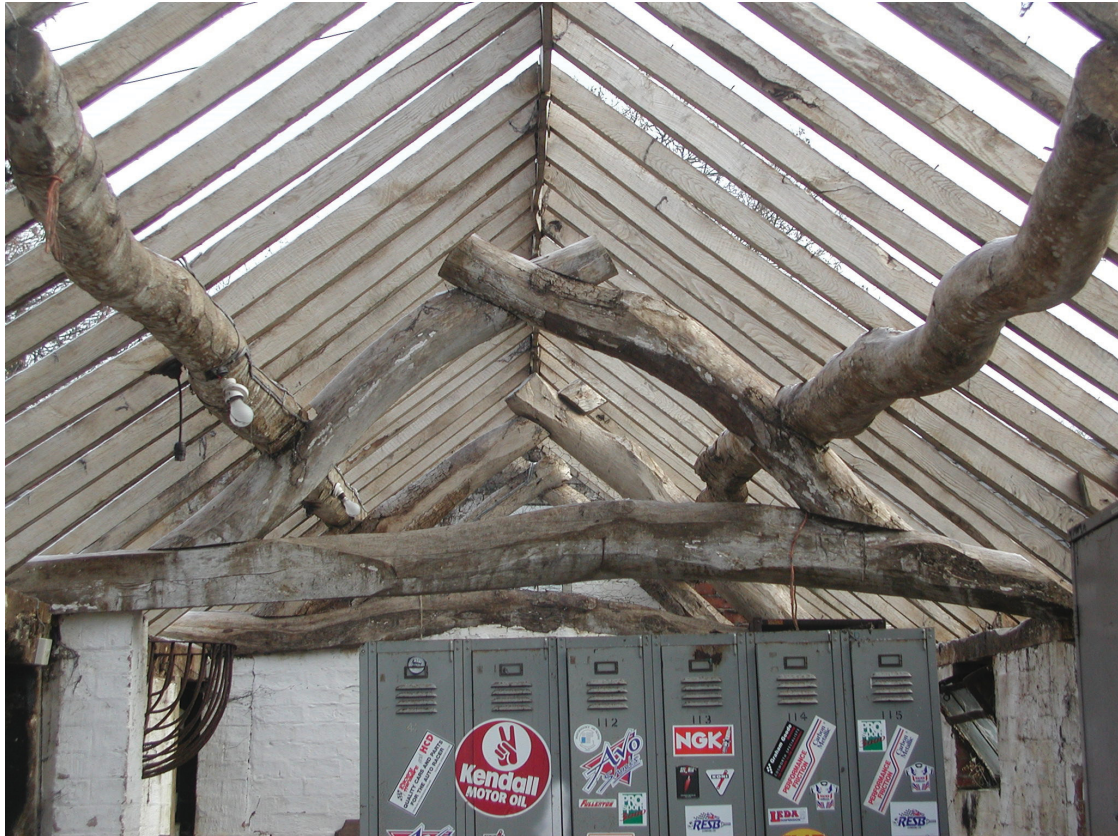
Fig. 13: Roof timbers

5.8 The roof timbers of the stables were visible from the south-east end and the common rafters appear to be modern, regular sized and machine cut. The principal rafters and trenched purlins were rough, irregular timbers, which were not squared or worked (Fig. 13). It is quite possible that the principal rafters and purlins were re-used from the earlier structure that stood in this area.

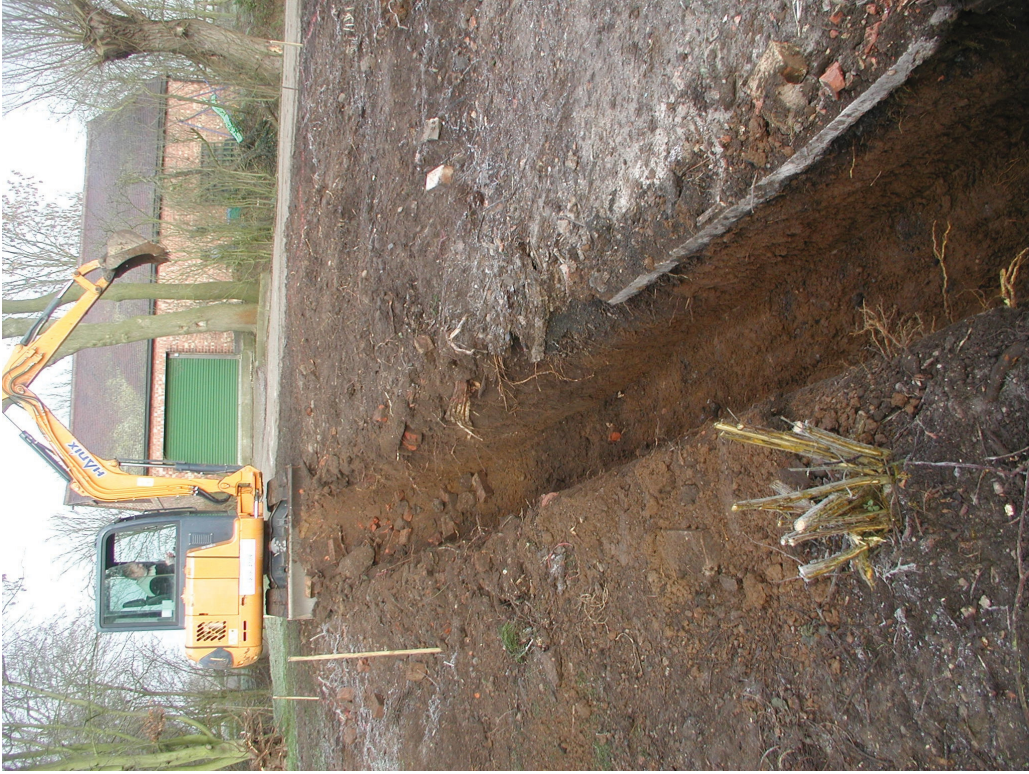
Fig. 5: Western foundation trench from the south

4.4 In the western foundation trench (Fig. 4, Section A) the natural was cut by a brick wall foundation (5), which extended north-west to south-east. This was composed of machine-made brick bonded by a grey mortar. The wall foundation was 0.42m wide and at least 0.6m deep. It seems likely that this wall belonged to the east-west building erected between 1889-91 and 1903 as a building is shown in this location in 1903 (Ordnance Survey 1903). To the north of the wall was a brick floor surface (6) This was roughly laid, unbonded, on top of the natural and extended for at least 4m along the trench. At the northern end of the trench a further area of brick floor (7) was revealed. This was at a similar level to floor 6 and composed of similar brick. These floors must have belonged to the north-south range shown on the 1903 map (Fig. 3).

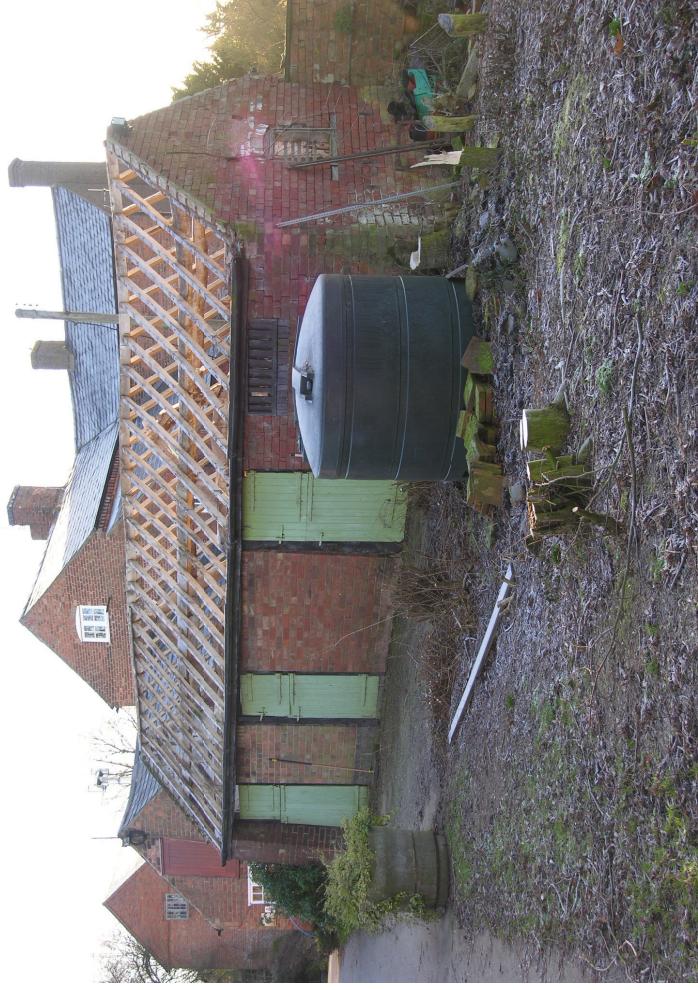
Fig. 6: Front elevation of stables from north-west

5.3 General views were taken of the front or north-west elevation looking east and south-east (Fig. 6). The existing stable block was 9.3m long and the front elevation had three stable doors. These were timber plank split doors with iron hinges (Fig. 7). The brickwork immediately north-east of the north-eastern door projected forward of the line of the front wall and appeared to be constructed of older darker brick than the front wall itself.

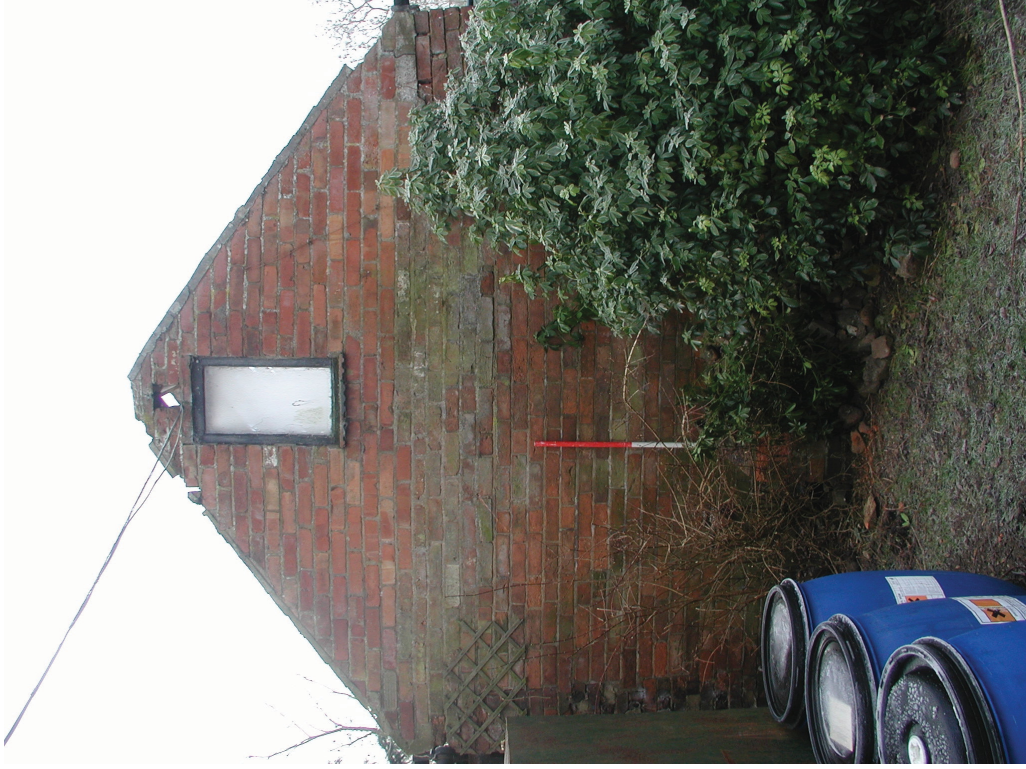
Fig. 8: Side elevation (north-east)

5.4 The north-east gable was partially obscured by a large bush or tree (Fig. 8). A single narrow window, probably a later addition, was located high in the gable. The south-east corner of the building was constructed from older, darker bricks than the main part of the wall (Fig. 9), in a similar manner to the north corner, and it may be that these are the remnants of the building illustrated on the 1839 map. A small three-sided brick structure was butted on to the wall. This was built of 19th-/20th-century bricks and was 0.4m high, 1.2m wide and 0.6m deep. This probably formed a fuel or goods store.

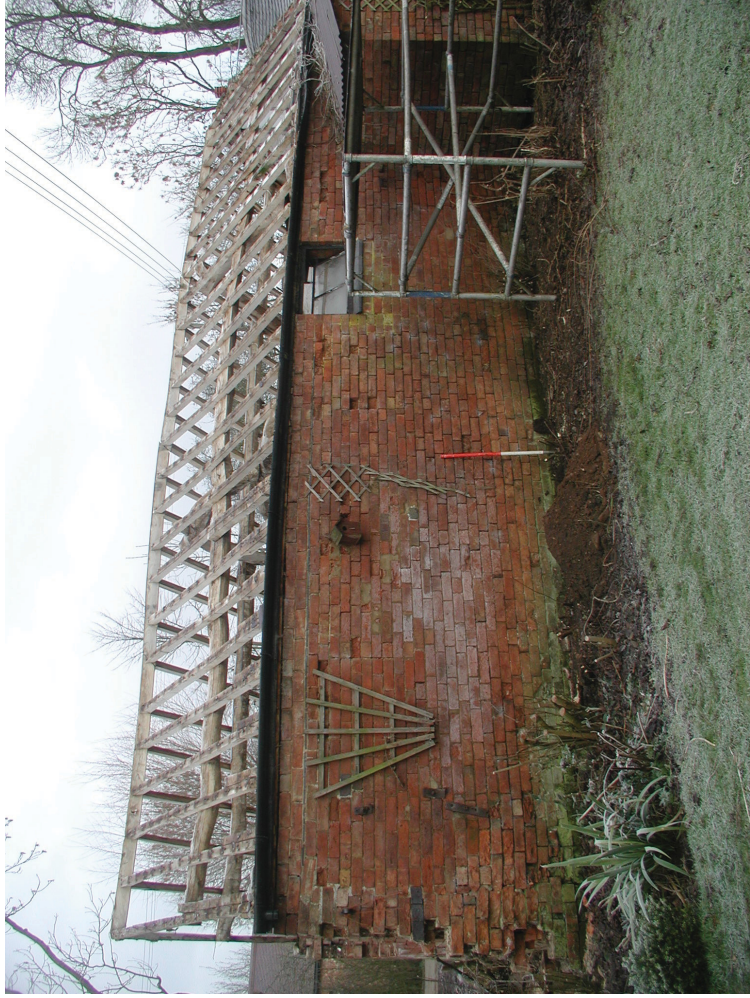
Fig. 10: Rear (south-east) elevation of stables

5.5 General views were recorded of the south-east elevation looking north and north-east (Fig. 10). A single casement window was present in the middle of the wall which may be a later, higher, insertion into an original opening. There was evidence of two 0.7m wide blocked windows further to the west (Fig. 11). The south-east elevation also had a 1.8m x 1.3m offshot chamber with a pitched corrugated iron roof.

5.6 A buttress was also present at the south-east end. This was constructed of machine-made bricks, but many bricks were showed evidence of spalling, decay and damage. The buttress appeared to have been subject to repair or rebuilding.

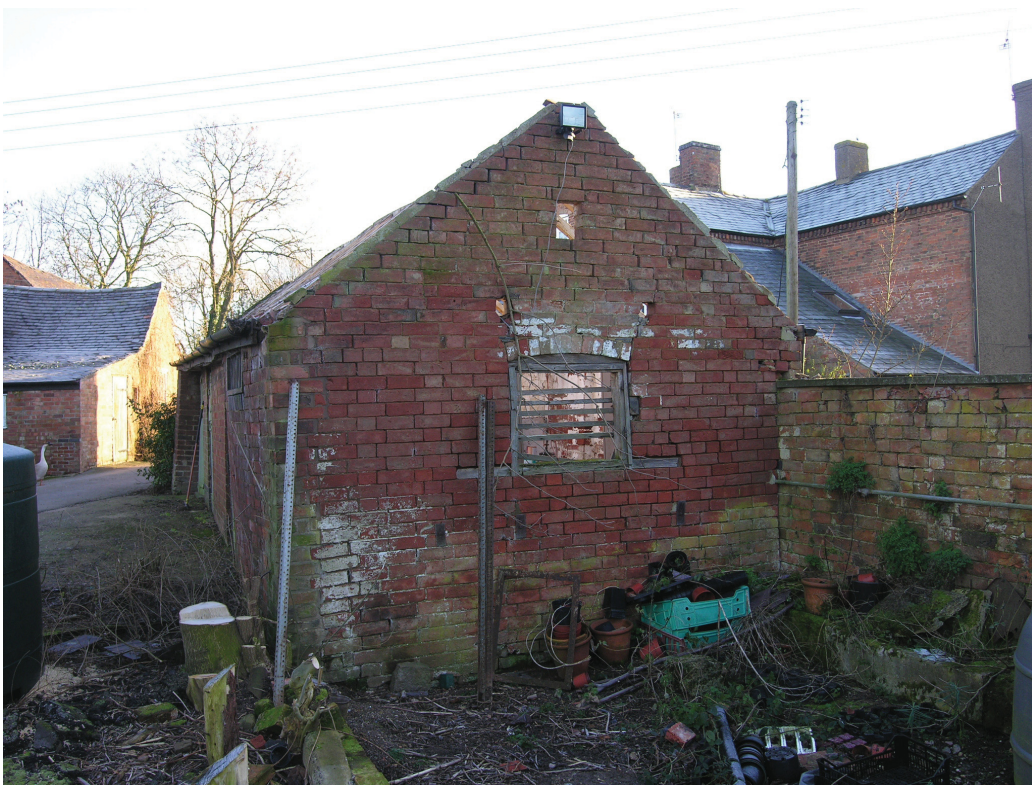
Fig. 12: Side elevation (south-west) from west

5.7 The south-west gable had previously had a roughly square window with a segmental brick arch (Fig. 12). However, the upper part of this wall had recently partially collapsed leaving only the lower third of the wall, some 1.3m- 1.8m high. The wall showed evidence of having previously being rebuilt as it was comprised of modern brick and butted up to the rear and front walls. This wall may have been constructed after the building to its south went out of use, effectively shortening the building and leaving the remains of the rear wall standing as a garden wall.
