Archaeological Observation at Burbage Hall, Burbage, Leicestershire

Report 0519

June 2005

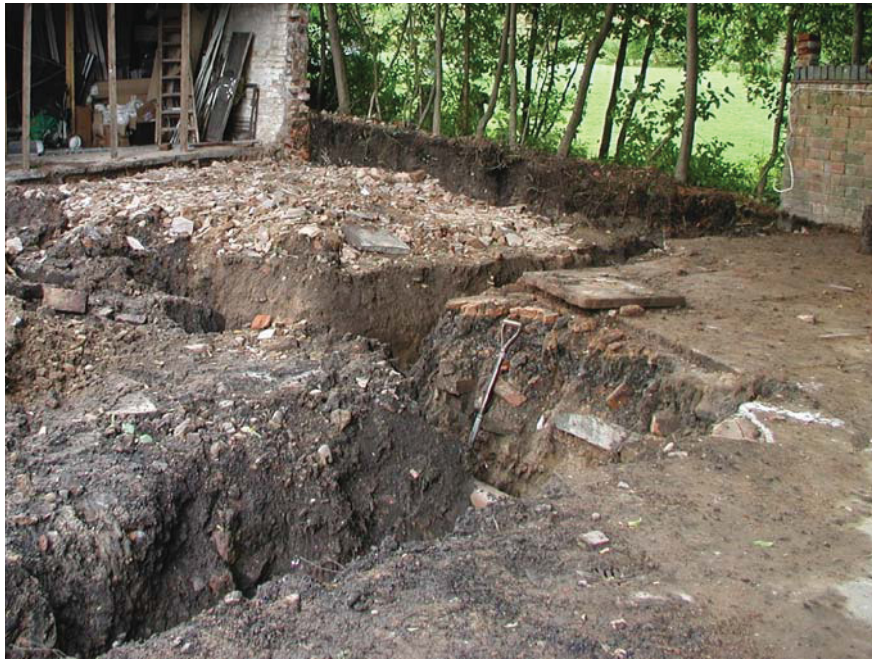
Fig. 5: Overall view of site looking west

4.2 The trenches were excavated to a depth of c.1m cutting into natural yellow brown clay and sand (105) at a depth of 0.30-0.40m below present ground level (Fig. 5). The natural clay was cut by a ceramic horse-shoe land drain (107), only visible in the northern section of the north-west trench. A brick-built drain (111) was visible cutting natural in the south-western trench (Fig. 6). The natural clay was overlain by a 0.30m deep layer of old topsoil (104) and this layer had been cut by the insertion of a series of brick walls (109, 110, 113, 114, 116, 117, 121, 122, 123, 124, 125) which had been demolished to below present ground level before the former garage had been built. The ground was also disturbed by two ceramic drains (119 and 126) and a metal pipe (118).

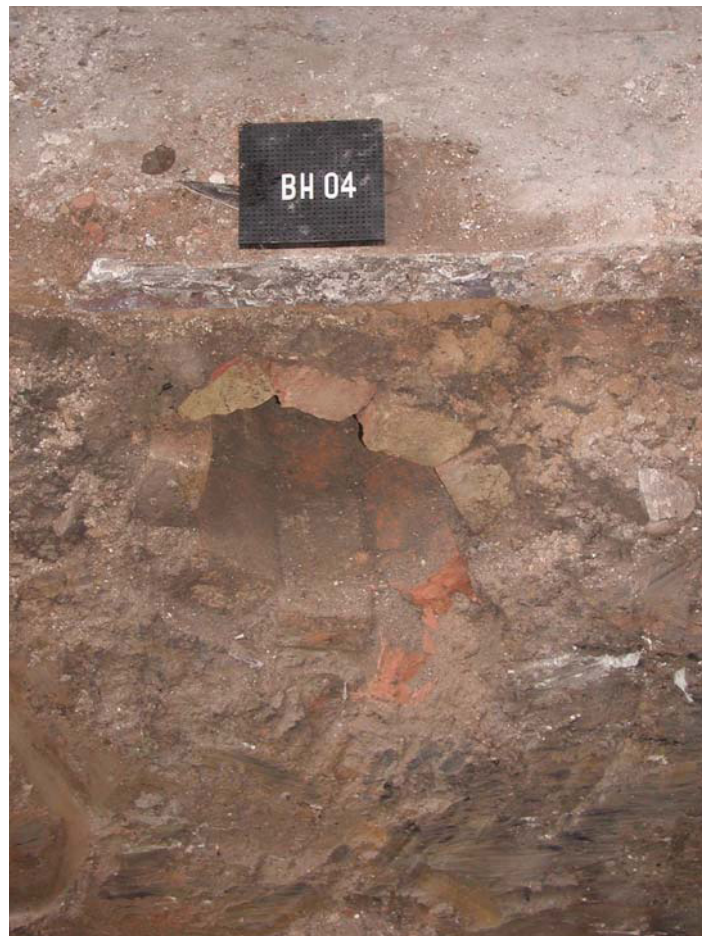
Fig. 6: Brick drain (111)

5.1 No evidence for medieval or early post-medieval activity was recorded during the groundworks for the new buildings. A large brick-built drain (111), ovoid in section, was recorded running below the still-standing outbuilding. A brick wall (113) was also recorded to its north-west. While it is possible that the wall was an internal wall within the outbuilding and was subsequently demolished and floored over, it seems more likely that the wall belongs to a structure which pre-dates the outbuilding. The bricks that made up the remains of the wall were hand-made but their size suggests 18th century rather than early post-medieval. A large number of brick walls were recorded below ground level in the area of the new garage and outbuilding. Most can be reasonably confidently related to walls shown on the historic maps but some may be earlier – possibly from structures that were partially demolished and adapted to the form shown on the maps.
