March 2021

THE FORMER THETFORD COTTAGE HOSPITAL SITE, EARL STREET, THETFORD, NORFOLK

**Informative Trenching as Part of a Programme of
Archaeological Mitigation Work**

Site Code: ENF 149244
Planning Reference: 3PL/2019/1344/F
NCC Consultation No: CNF 41815
Museum Accession No: NWHCM 2020.123
NGR: TL 8720 8317
OASIS ID: withamar1-418588

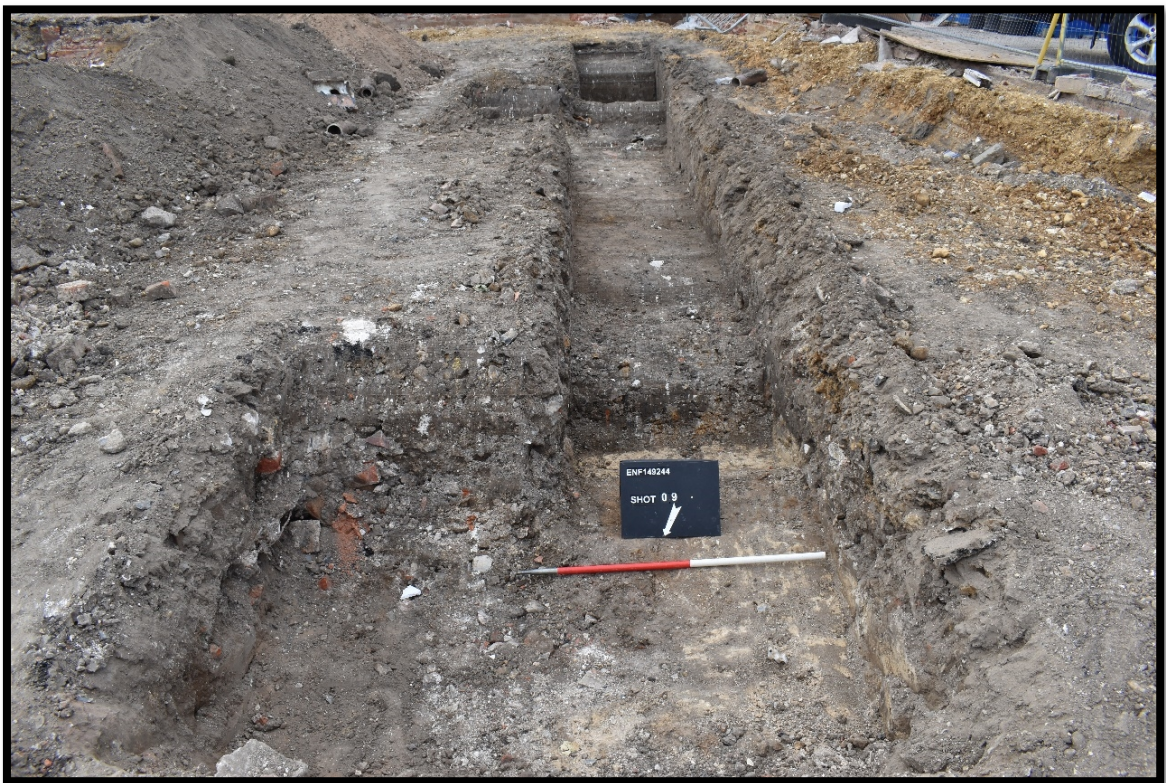
Plate 6: General view of the south part of Trench 1 facing southeast, scale 1 x 1m.

Trench 1 was located in the west part of the development area and aligned south southeast-to-north northwest (Fig. 2, Plates 6 & 7). The trench targeted the footprint area of new dwellings to be built on the Earl Street frontage. An obstruction in the form of a gas pipe meant that the trench was not placed along the central axis of the footprint as proposed in the Written Scheme of Investigation but angled across it. Two gaps in the line of the excavated trench are due to the presence of live electricity cables. The trench was machine excavated to a depth of 0.40m below the present ground surface where natural material (104) was encountered at 19.33m OD (Fig. 4, Section 1). The natural material (104) consisted

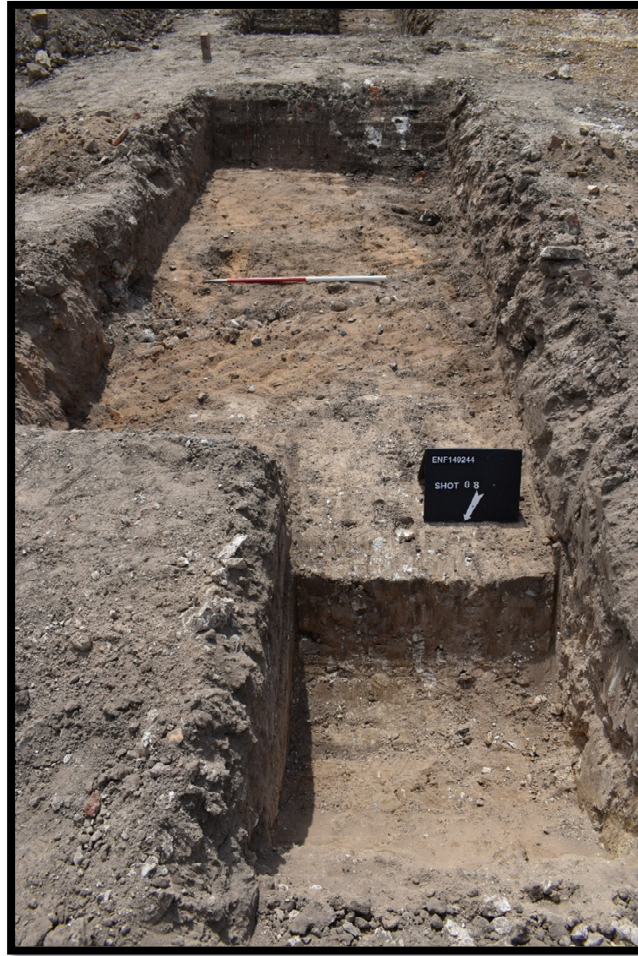
Plate 7: General view of the north part of Trench 1 facing southeast, scale 1 x 1m

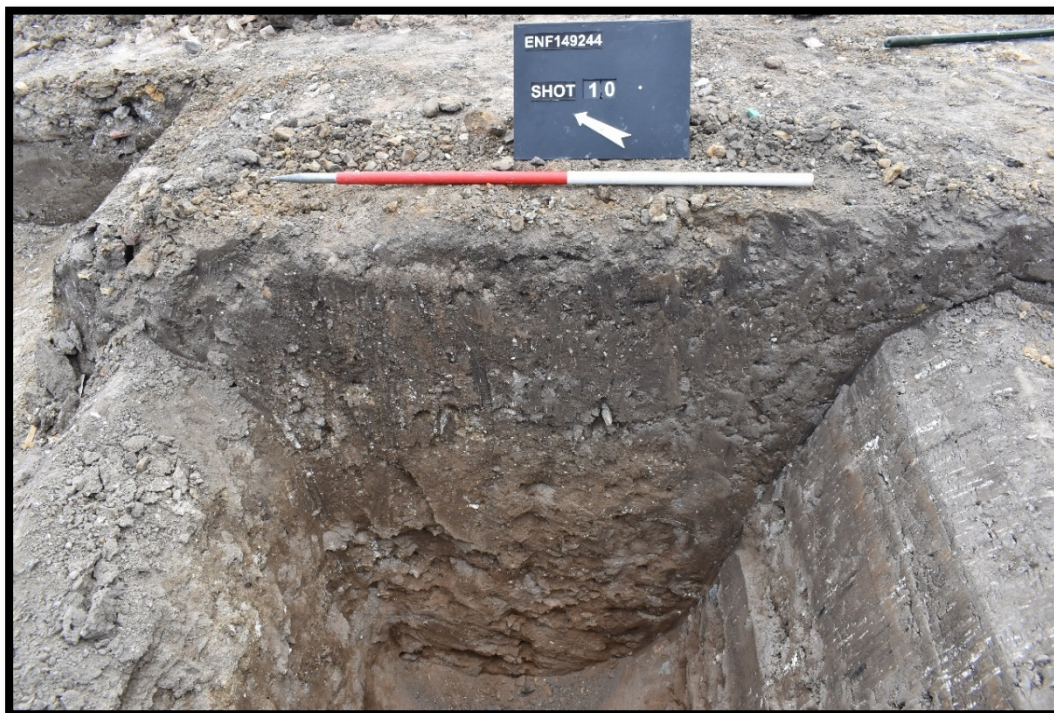
Plate 8: View of machine excavated sondage into probable Chalk Pit [103] facing east, scale 1 x 1m

Chalk Pit [103] was recorded in the south part of the trench (Fig. 3). It measured at least 6.95m north-to-south and continued beyond the east, west and south limits of excavation. A machine excavated sondage into the pit was located close to the south end of the trench. Natural white chalk was encountered at a depth of 1.80m (Fig. 4, Section 2 & Plate 8). The primary fill (100) consisted of light-to-mid brown sand and measured 0.60m in thickness. Above the primary fill (100) was a 0.68m depth of mid greenish brown silty sand (101). The uppermost fill of the pit consisted of dark grey silty sand (102) which measured 0.54m in maximum thickness.

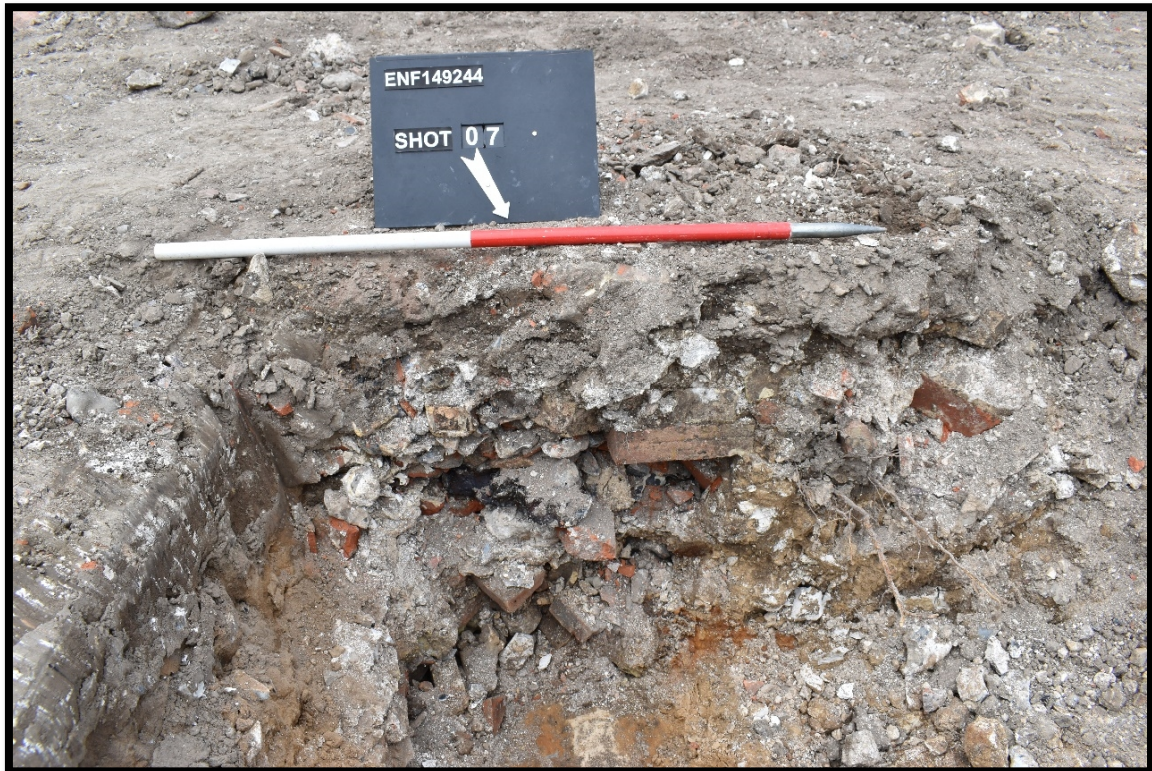
Plate 9: View of Wall Foundation [107] facing southwest, scale 1 x 1m

East northeast-to-west southwest orientated wall foundation [107] was located in the north part of the trench (Fig. 3). The cut measured 0.85m in width and had a depth of 0.65m (Fig. 4, Section 3 & Plate 9). The sides of the cut varied between steeply and vertically inclined whilst the base was flat. The fill of the cut consisted mostly of rubble including brick, tile and lumps of white mortar. Fragments of late 19th century or early 20th century bottle glass were also present. The rubble comprised around 80% of the deposit whilst the remaining 20% of the deposit consisted of dark grey silty sand.

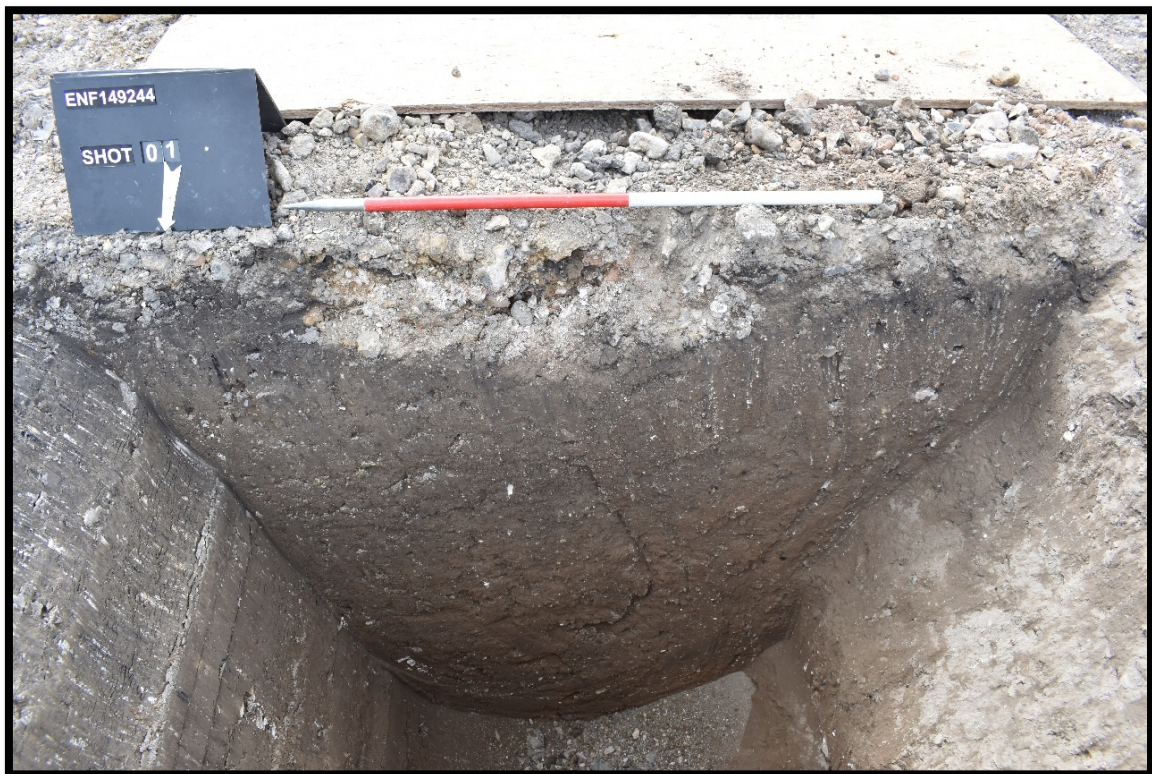
Plate 10: View of probable Chalk Pit [215] in Trench 2 (Sondage 1) facing south, scale 1 x 1m

In Sondage 1, the machine excavated sondage into probable Chalk Pit [215] measured 1.86m in depth. Natural white chalk was encountered at the base of the sondage (Fig. 6, Section 4 & Plate 10). The primary fill of the chalk pit consisted of reddish brown sand (206) which measured 0.23m in depth. Above the primary fill (206) was a secondary deposit of mid greyish brown silty sand (205) which measured 0.37m in maximum depth and recorded to a width of 1.17m. Sealing (205) was a 0.65m thick layer of mid brown silty sand (204) which measured 1.60m in width. This was sealed in turn by a tertiary fill comprised of mid greenish brown silty sand (203) which measured 0.50m in thickness and recorded to a width of 1.86m. The uppermost fill (202) consisted of dark grey silty sand. It measured 0.26m in maximum thickness and was recorded for distance of 2.10m east-to-west.

A south southeast-to-north northwest orientated wall foundation (201) was inserted into the uppermost fill of the chalk pit [215] in Sondage 1 (Fig. 6, Section 4, Plate 10). The wall foundation consisted of a very hard and compacted mixture of light yellow lime mortar and flint fragments. It measured 0.82m in width and had a thickness of 0.28m. Its sides were vertical whilst the base was flat. The wall foundation was covered by a thin layer of demolition material (200) resulting from the recent demolition of the hospital. It measured an average of around 70mm in thickness.

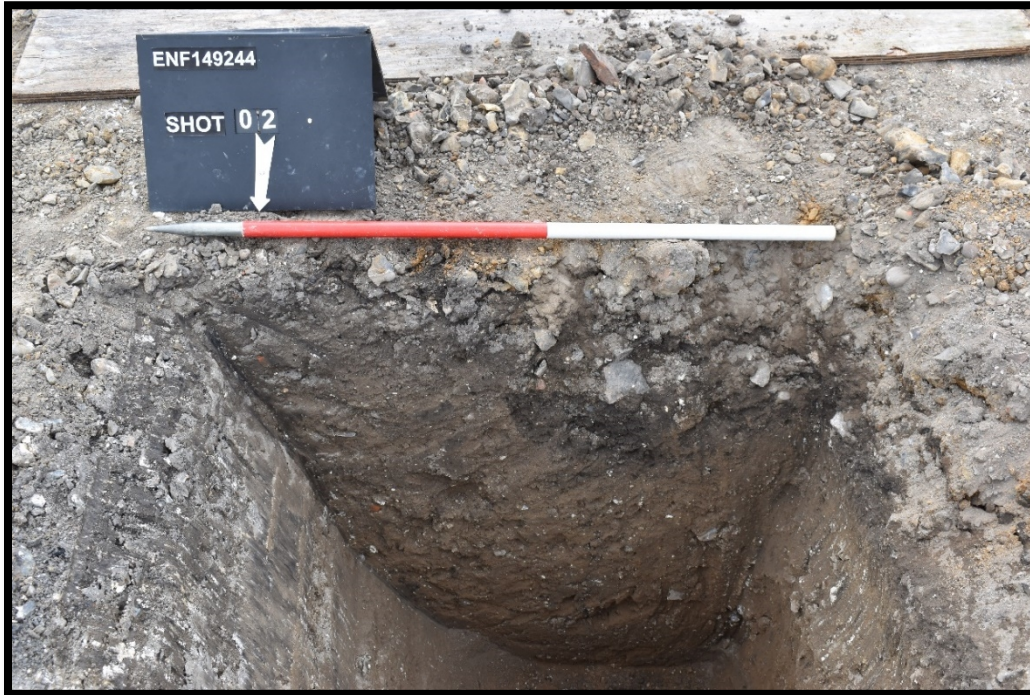
Plate 11: View of probable Chalk Pit [215] in Trench 2 (Sondage 2), scale 1 x 1m

A continuation of probable Chalk Pit [215] was recorded in Sondage 2 which was located 4.70m southwest of Sondage 1 (Fig. 5). The recorded fills of the pit mirrored those recorded in Sondage 1 (Fig. 6, Section 5 & Plate 11). The sondage was excavated to a depth of 1.2m. At this depth, the base of the pit was not reached.

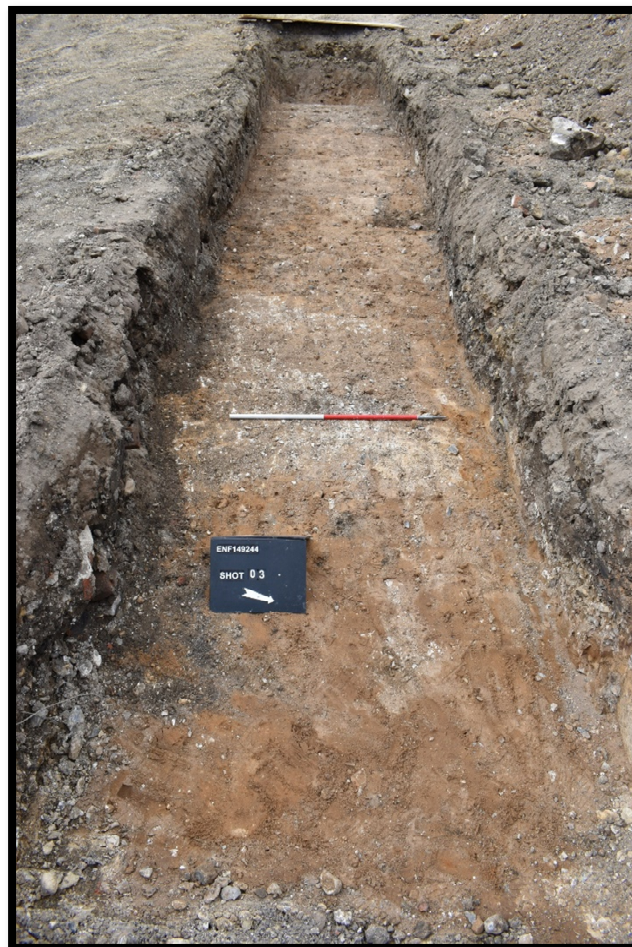
Plate 12: General view of Trench 2 facing southwest, scale 1 x 1m

Trench 2 was located in the southeast part of the site and partially located within the footprint area of the new dwellings to be built in this part of the site (Fig. 2). The trench was excavated in three parts over a distance of 23m (Fig. 5) and aligned east northeast-to-west southwest. The trench was not machine excavated in a continuous strip owing to the discovery of a substantial chalk pit [215] in Sondage 1. The uppermost fill of the chalk pit was located immediately beneath a thin layer of demolition material resulting from the recent demolition of the hospital. Rather than machine a continuous trench across the top of the chalk pit and into its upper fills, it was decided to excavate a series of sondages at intervals until undisturbed natural deposits were located. Sondage 2 placed further west recorded a continuation of the chalk pit but the west edge of the chalk pit was located at the east end of the wider trench excavated 4.15m west of Sondage 2. A further probable chalk pit [216] was located close to the southwest end of the trench (Fig. 5) From this point a machine excavated linear trench was excavated measuring 10.40m in length and 1.80m in width

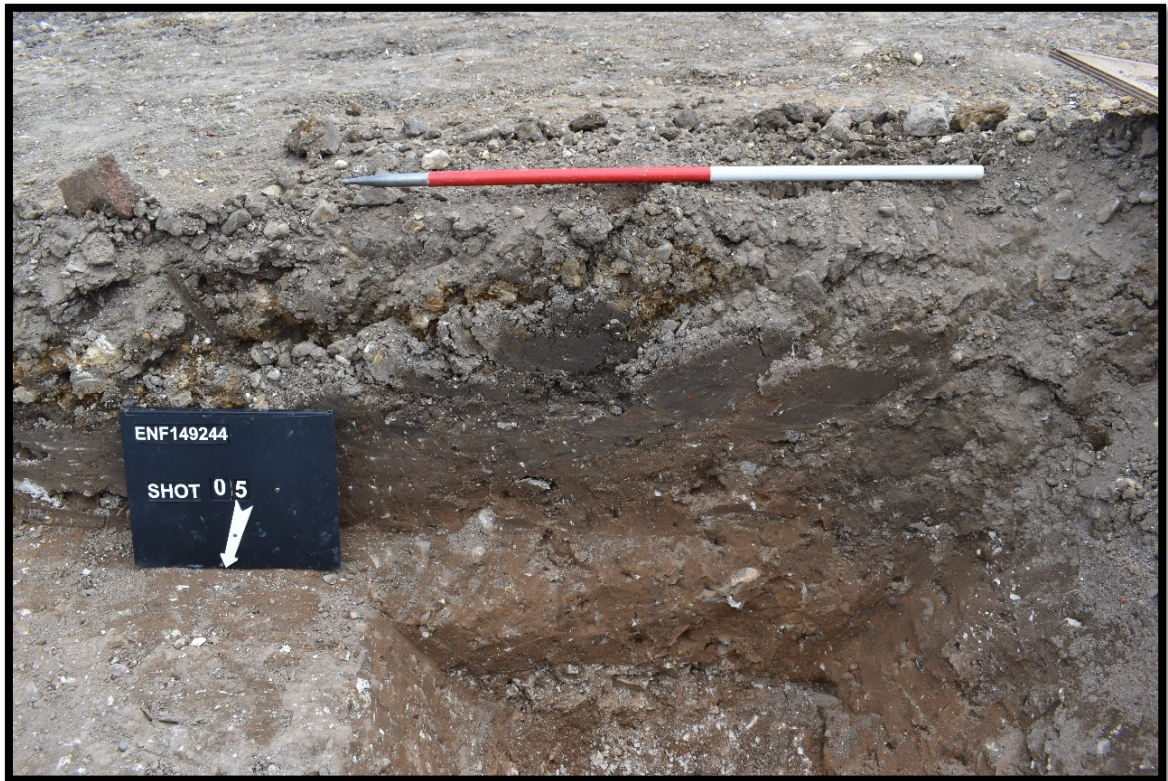
Plate 13: View of probable Chalk Pit [216] in Trench 2 facing south, scale 1 x 1m

The east edge of another probable chalk pit [216] was identified close to the southwest end of the linear trench and could feasibly represent the east edge of Chalk Pit [103] recorded in the south part of Trench 1. The cut curved across the line of the trench. In section (Fig. 6, Section 7 & Plate 13), the cut was seen to be gently sloped and measured 0.44m in maximum depth. Presumably, as the cut progressed westwards, it would have become progressively deeper. The cut was filled by a single deposit of light-to-mid brown sand (213).

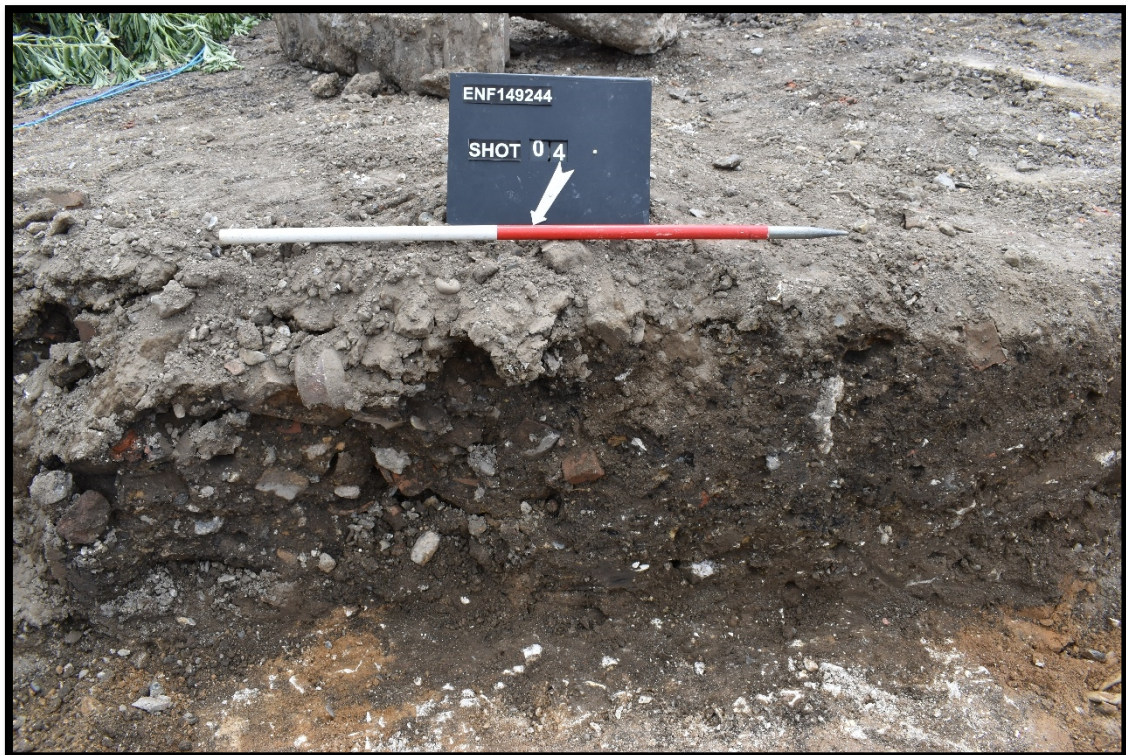
Plate 14: View of Demolition material in Trench 2 facing east, scale 1 x 1m

In the linear trench, the cuts for chalk pits [215] and [216] were sealed by a 0.70m depth of demolition rubble (212) composed of dark grey silty sand which included frequent quantities of modern brick, flint cobbles, concrete fragments and mortar lumps (Fig. 6, Section 6 & Plate 14). This material is derived from the recent demolition of the Thetford Cottage Hospital and shows that the site in this area has been truncated to the current level of the natural material (214).
