## NEW SEWER TO NO. 9 NELSON STREET, KING'S LYNN, NORFOLK

**Archaeological Watching brief**

Historic Environment Service Event No.: ENF129698

## Archaeological Watching Brief

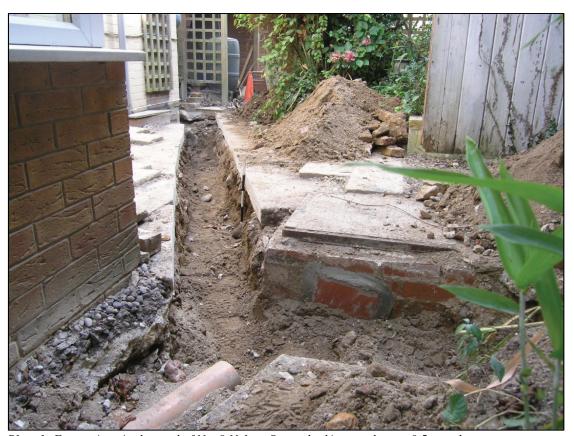
The trench excavated in the yard was 0.45m wide by 0.45m deep (*Plate 1*), and was contained within clearly modern deposits of mid grey brown silty sand, overlain by makeup material for the existing patio.

Plate 1- Excavations in the yard of No. 9 Nelson Street, looking northwest; 0.5m scale

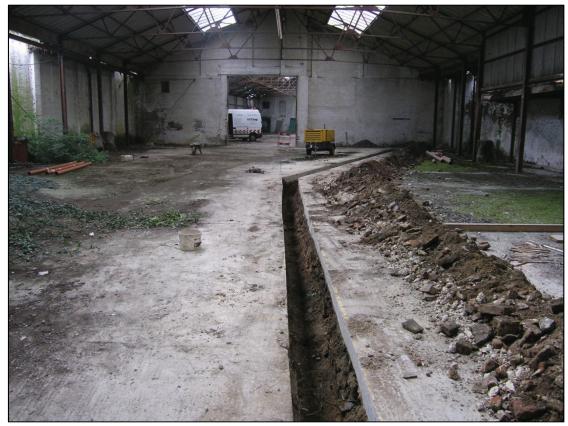
Within the warehouse (*Plate 2*), the trench was 0.45m wide by an average 0.65m deep. A dark grey sandy silt (003) was encountered at an average depth of around 0.45m below the top of the concrete floor slab. The deposit appeared to predate the construction of two sections of brick wall, together forming a NE-SW alignment

Plate 2 – Excavations in the warehouse, looking southwest

The existing warehouse west of No. 9 Nelson Street and south of Hampton Court incorporates elements from several earlier structures including the Grade II listed Sommerfeld and Thomas warehouse (List No. 1195401) located on South Quay. The mid 18<sup>th</sup> century building of seven bays on three storeys forms the western end of the modern warehouse. The north wall of the modern warehouse is formed by the north wall of a building shown on the 1886 Ordnance Survey map (a section forming the southern boundary of gardens west of Hampton Court has been dated as 16<sup>th</sup> century and is included in the designation with the 18<sup>th</sup> century warehouse on South Quay) and the south wall of Hampton Court. The south wall of the existing warehouse is mostly modern, but the building is divided internally by east walls surviving from the warehouse mentioned above and a malthouse located further to the south (also shown on the Ordnance Survey map of 1886). The large opening in the internal wall appears to coincide with a gap between the original structures (see *Plate 2* – top, centre).

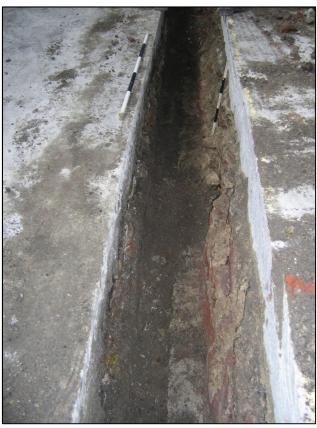
The north-eastern length of wall [006] was located at c. 0.35m below the top of existing floor level ( $Plate\ 3$ ). Only the southeast side of the feature was revealed in the trench, extending over a distance of c. 6.50m. The wall was 0.30m high by at least 0.20m wide and was bonded by light greyish brown mortar. Continuing the alignment to the southwest, [007] was encountered at c. 0.30m below existing floor level ( $Plate\ 4$ ). Measuring at least 4.25m long by 0.60m wide and at least 0.35m high, it was more solidly constructed than [006] with a bonding of bluish grey mortar. Taken together, the walls appear to represent the southeast side of a structure shown on the 1886 OS (see Fig. 5).

Plate 3 - Wall [006], looking southwest; 1.0m and 0.5m scales

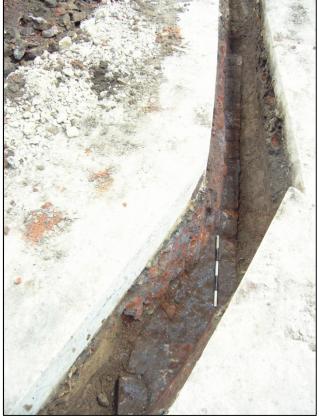
Plate 4 - Wall [007], looking northeast; 0.5m scale

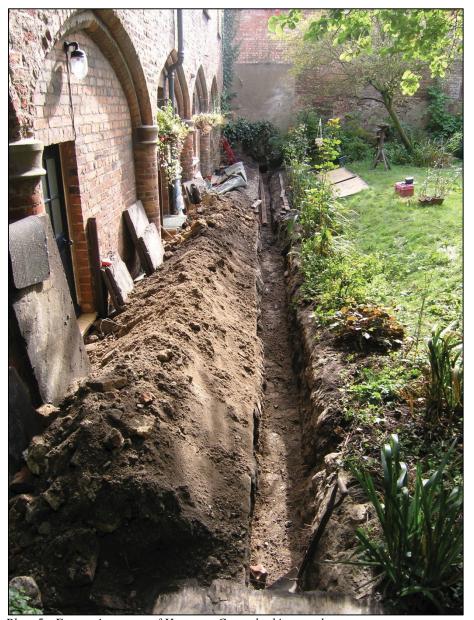
Plate 5 - Excavations west of Hampton Court, looking southeast

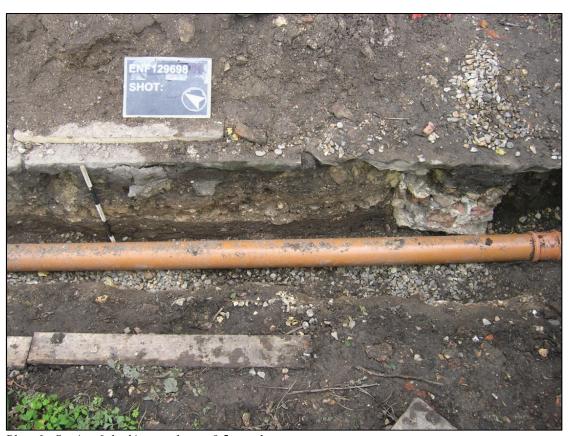
The structural remains included wall [010]. The wall – aligned at right angles to Hampton Court and located near the southern end of the path - was constructed in limestone and brick with a bonding of hard mortar (Section 5 and *Plate 6*). The position of the feature coincides with the north wall of a building shown as abutting Hampton Court on the 1886 Ordnance Survey map. A possible return to the south (aligning with the west side of the structure recorded on the 1886 OS map) is represented by fragmentary structural remains comprising brick wall [020] and stone wall [018], running along the western edge of the trench (*Plate 7*). The latter incorporates a small area of brickwork, [019].

Plate 6 - Section 6, looking northeast; 0.5m scale

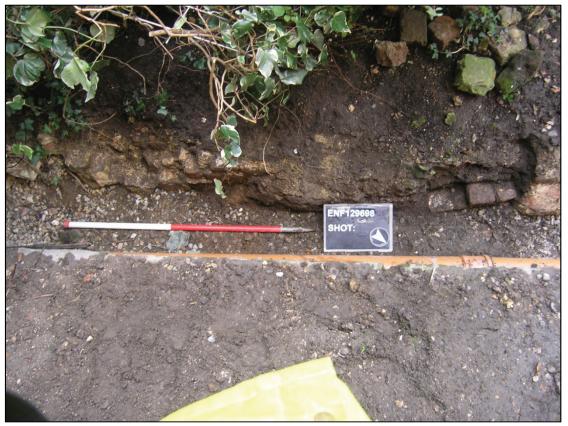
Plate 7 - Walls [018], [019] and [020], looking southwest; 1.0m scale

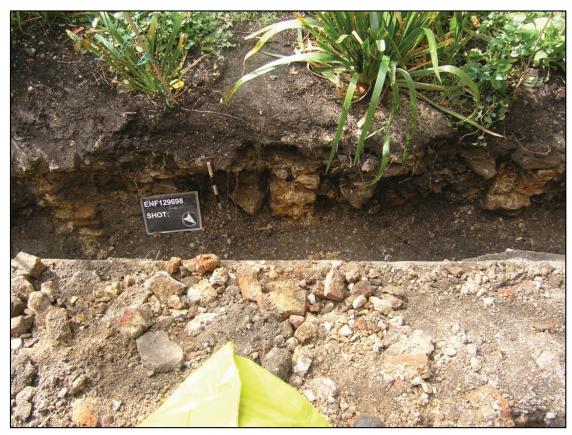
Three more walls - [022], [023] and [024] – were recorded mid way along the path (*Plate 8*), aligned at right angles to Hampton Court (Section 6). The walls were identical to one another in composition (brick bonded by light yellowish brown mortar) and in width (around 0.24m). They were evenly spaced, leaving gaps of 0.90m between the central and flanking walls. The spaces between the walls contained mixed deposits of mortar, silty sand and limestone – (025) and (026) – indicating deliberate backfilling or an accumulation of demolition debris. The central wall, [023], may correspond to a dividing wall between two properties shown as abutting Hampton Court on the 1886 Ordnance Survey map.

Plate 8 - Section 6, looking southwest; 0.5m scale

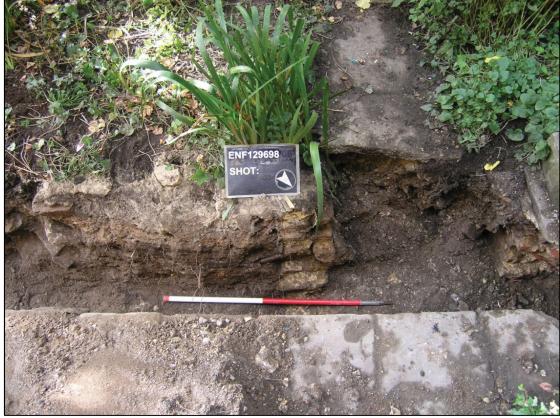
Walls - [040] and [041] - located at the northern end of the trench (Section 7, *Plate 9*), were identical in construction to [022], [023] and [024] and displayed the same spacing (0.9m apart). The space between the walls contained an identical deposit of backfill or demolition material (032). The more northerly of the two walls, [041], aligns closely with the north wall of a structure depicted on the 1886 Ordnance Survey map.

The stratigraphic position of a sequence of layers recorded at the northern end of the trench (Section 7, *Plate 9*, left of view) is uncertain (the deposits could not be correlated with remains to the south and were truncated on their north side). The earliest deposit in the sequence was a greyish brown silty sand (038), which was overlain by orange brown sandy silt (037). The latter was sealed by a shallow layer of chalk fragments (036), interpreted as a possible surface, which was in turn overlain by brownish grey silty sand (035), followed by orange brown silty sand (034) and mid brown silty sand (033). Cut [039] had a steeply sloping southern edge and was filled by mid brown silty sand (029), mid to dark greyish brown silty sand (030), and mid brown silty sand (031). The stratigraphic relationship between the cut and wall [040] could be determined.

Plate 9 - Section 7, looking southwest; 0.5m scale
