August 2013

### MAGNOLIA COTTAGE, KIRKGATE, TYDD ST GILES, CAMBRIDGESHIRE

**Archaeological Trial Trench Evaluation**

Event No.: ECB4002

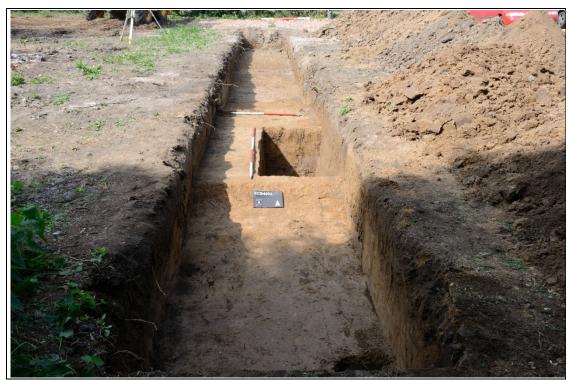
Plate 1: General view of Trench 2 looking north; 2m and 1m scale

The earliest deposit recorded on the site was light yellowish brown silt alluvium (016) revealed in the southern part of Trench 2 at around 0.40m below existing ground level.

The alluvium (016) was overlain in the northern part of Trench 2 by light to mid grey silt (015) and greyish/yellowish brown silty clay (013), apparently contained with a large cut [014]. The deposits were partially removed by machine, to provide a section through the upper levels of the southern edge of [014]. The section (see *Plate 2*) revealed a gradually sloping edge consistent with interpretation as an ancient roddon (silted up salt water creek). Deeper explorations in Trench 1 revealed a sequence of deposits at least 1.20m deep comprising mid greyish brown clayey silt (006) overlain by mid grey silt (005), in turn sealed by yellowish grey silt (004). The sequence of silts was sealed by a thick deposit of silty clay (003) identical to (013) in Trench 2. The upper horizons of the silt layers rose in level towards Kirkgate while the overlying clay (003) thickened to the south.

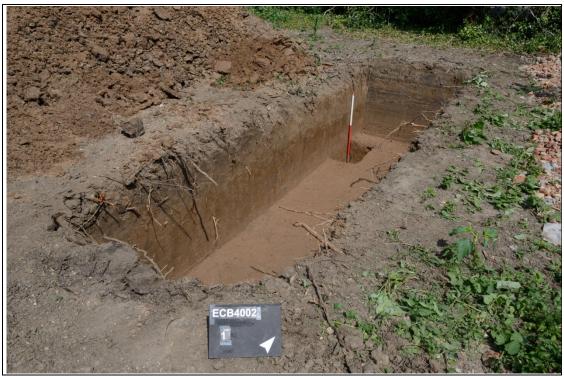
Plate 3: General view of Trench 1, Section 1 looking northwest; 1m scale

Topsoil averaging around 0.25m thick extended throughout Trenches 1 and 2.

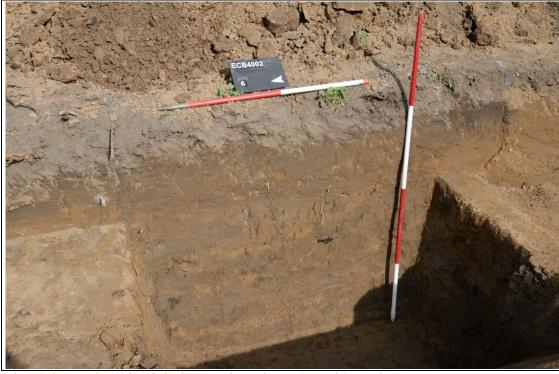
Plate 1: Section 2, cut [012], looking south-southeast; 1m and 2m scales

The alluvial deposit was cut in Trench 2 by a large linear cut, [012], aligned east-west. The cut, measuring c. 1.95m wide by 1.00m deep, had steep near vertical sides and a flattish base. The lower levels of the feature were filled by light to mid grey and orange-yellow silt (011), with sand striations indicative of varying phases of sedimentation. The overlying deposit of mottled light to mid grey and orange-yellow silt (010) yielded several fragments of post medieval brick and pottery.

Laminated silts and sands (011) in the base of the linear cut [012] indicate a process of natural sedimentation consistent with interpretation as a boundary or drainage ditch. However, the profile of the feature (steep sides and flat base) may indicate a relatively short period of use (before erosion of the sides to a more typical v shape), the former presence of a form of revetment, or rapid backfill suggestive of a pit (possibly elongated/rectilinear in form). The only datable artefacts, occurring in the higher levels of the secondary fill, indicate that the feature was visible as an earthwork or was backfilled at a comparatively late date. However, the feature does not appear to have been depicted on the Ordnance Survey maps of 1888 or 1902.
