HIGHWAY IMPROVEMENT AT DODWELLS ROUNDABOUT, HINCKLEY, LEICESTERSHIRE

Archaeological Monitoring and Recording

Site Code: HIDR14
Museum Accession No.: X.A143.2014
Planning Application No.: N/A
NGR: SP 39961 93090
OASIS ID: withamar1-251421

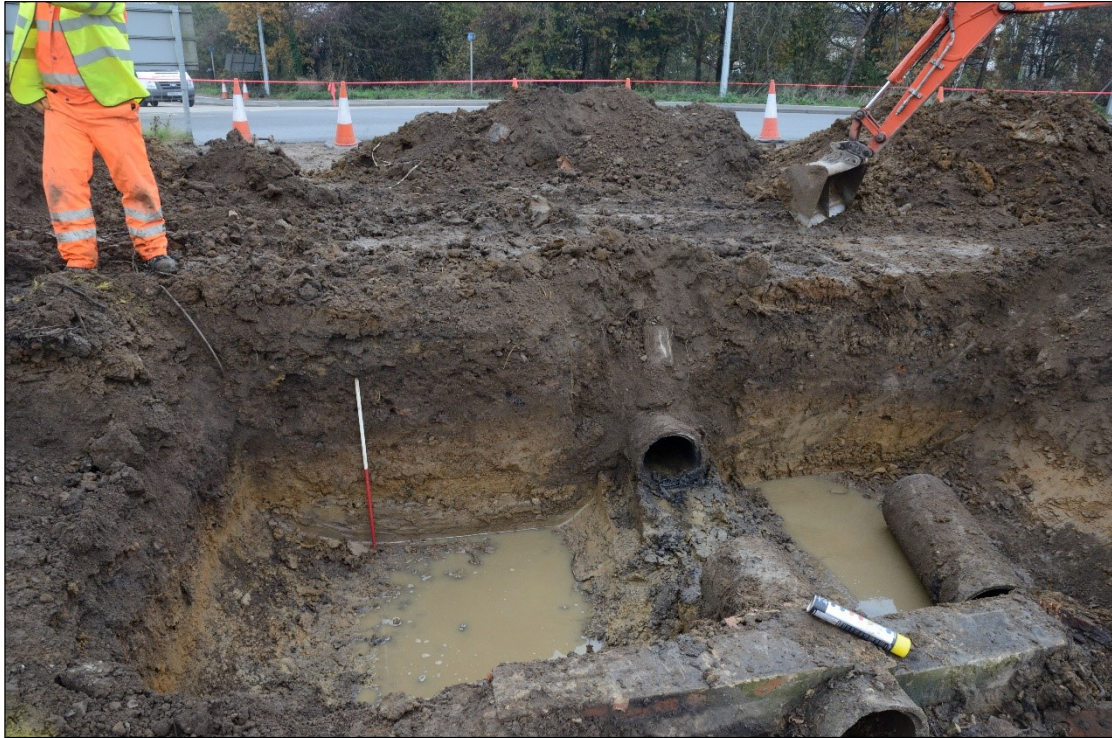
Plate 3: Area C, Section 1, looking northwest; 1m scale

Stratigraphic sequences of deposits in Area B were recorded during excavations to form new headwalls to culverts at either end of an existing drainage ditch on the roundabout. The lower part of the sequence at both ends comprised light brown clay, probably the natural, (126), at 1.1 - 1.15m below existing ground, overlain by light yellowish brown clayey silt, (125), 0.4 – 0.6m thick. The latter deposit may be interpreted as a relict plough-soil.

At the western end of the ditch (125) was sealed by recently disturbed ground 0.75m thick (124). The same type of material, numbered (127) and 0.40m thick, was encountered at the eastern end, separated from (125) by a layer of topsoil 0.10m thick, (128).

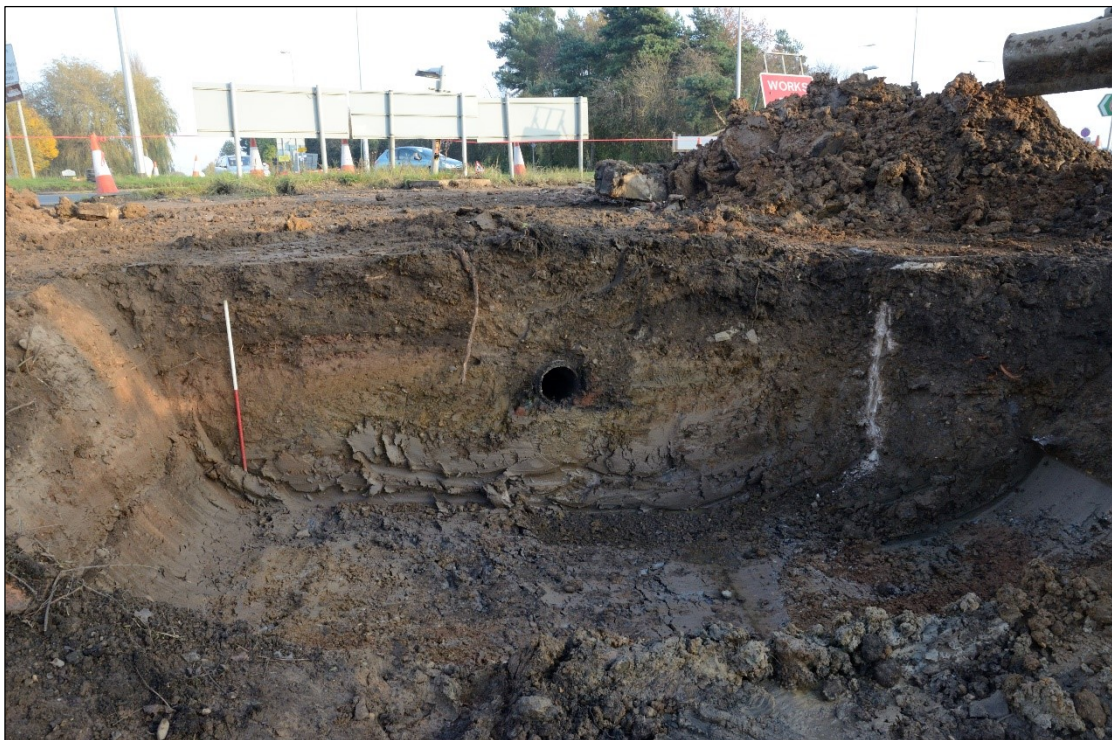
Plate 4: Area C, Section 2, looking southeast; 1m scale

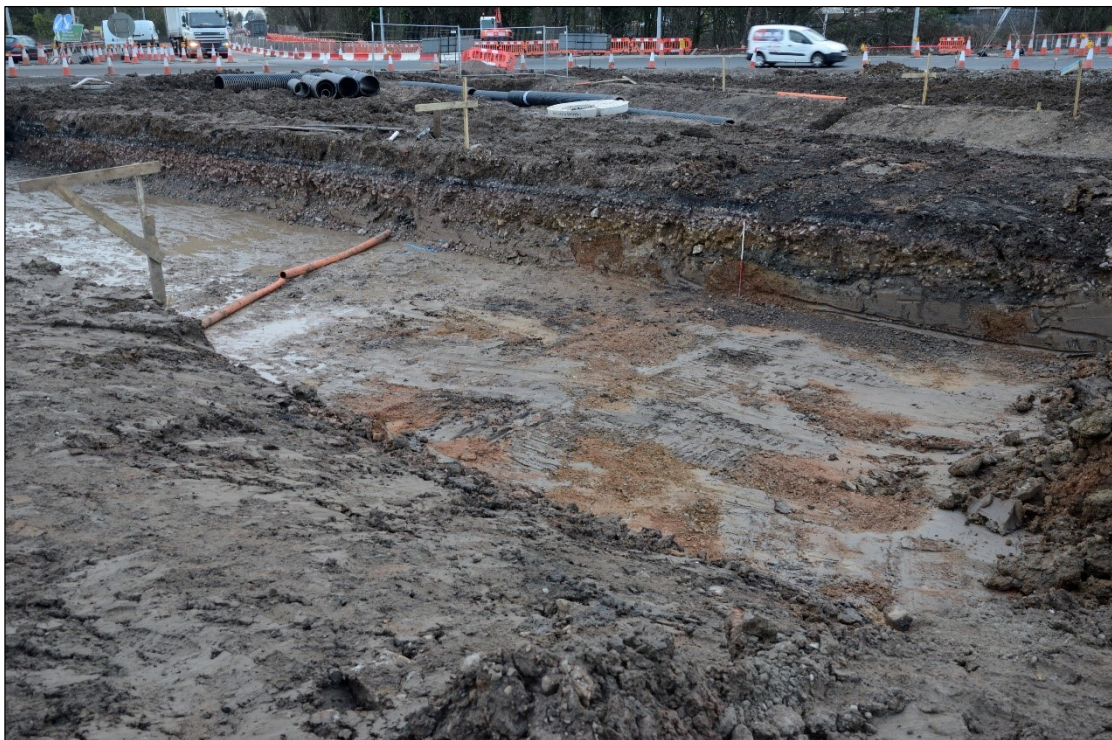
Plate 6: Excavation for water storage feature (Area A), looking northwest; 1m scale

The geology of light to mid reddish brown clay (107) was revealed in the lowest levels of Area A. It was overlain by a layer of small stone mixed with clay (106) interpreted as a possible metallated surface. The surface, revealed intermittently on the north side of the trench, was around 0.20 to 0.22m thick where recorded.

The probable metallating was sealed by a sequence of deposits interpreted as makeup for comparatively late phases of road construction. The lowest of the layers, (105), was 0.22 – 0.30m thick, comprising large fragments of angular stone (80%) mixed with light yellowish brown silty sand (20%). It was overlain by a layer, (104), of smaller stone (70%) mixed with reddish brown silty sand (30%), which was

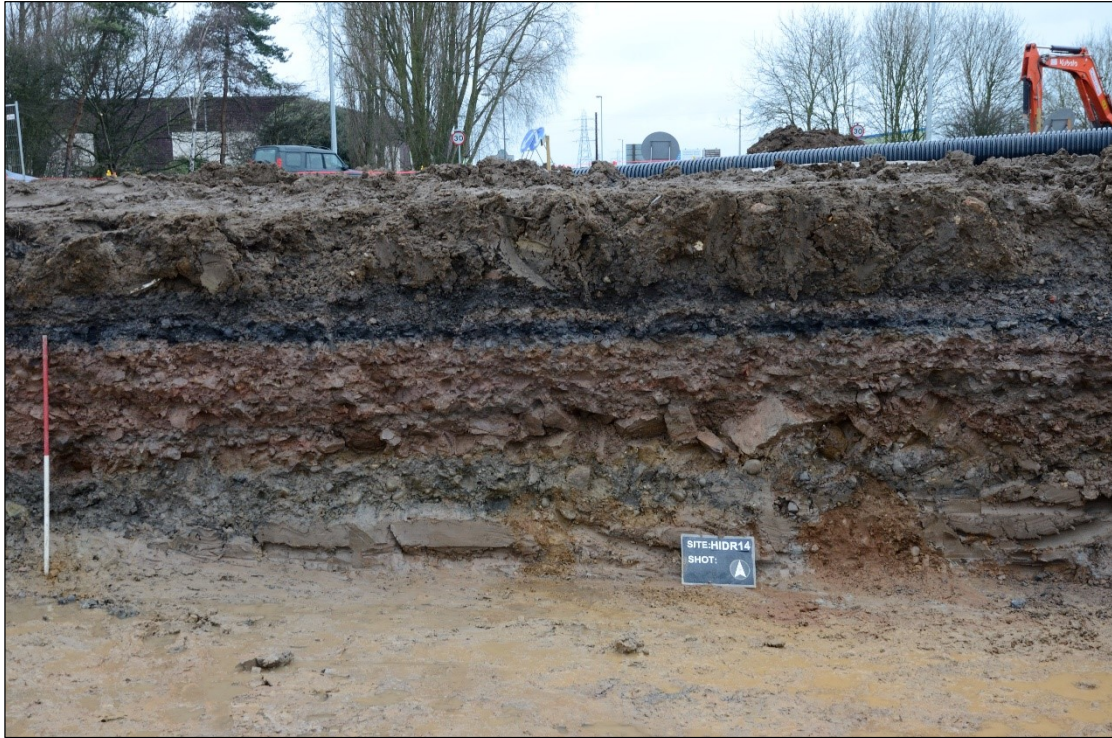
Plate 7: Section 3 in the water storage feature (Area A), looking north; 1m scale

in turn sealed by a layer, (103), of small angular stone (70%) mixed with dark grey/black silty sand (30%).

The upper part of the recorded sequence comprised a shallow layer, (102), of small stone (80%) mixed with light yellowish brown silty sand (20%), followed by a layer, (101), of dark reddish brown silty sand (50%) and small stone (50%), and finally, material redeposited as part of the ongoing roadworks (100). The latter deposit was 0.35m thick.

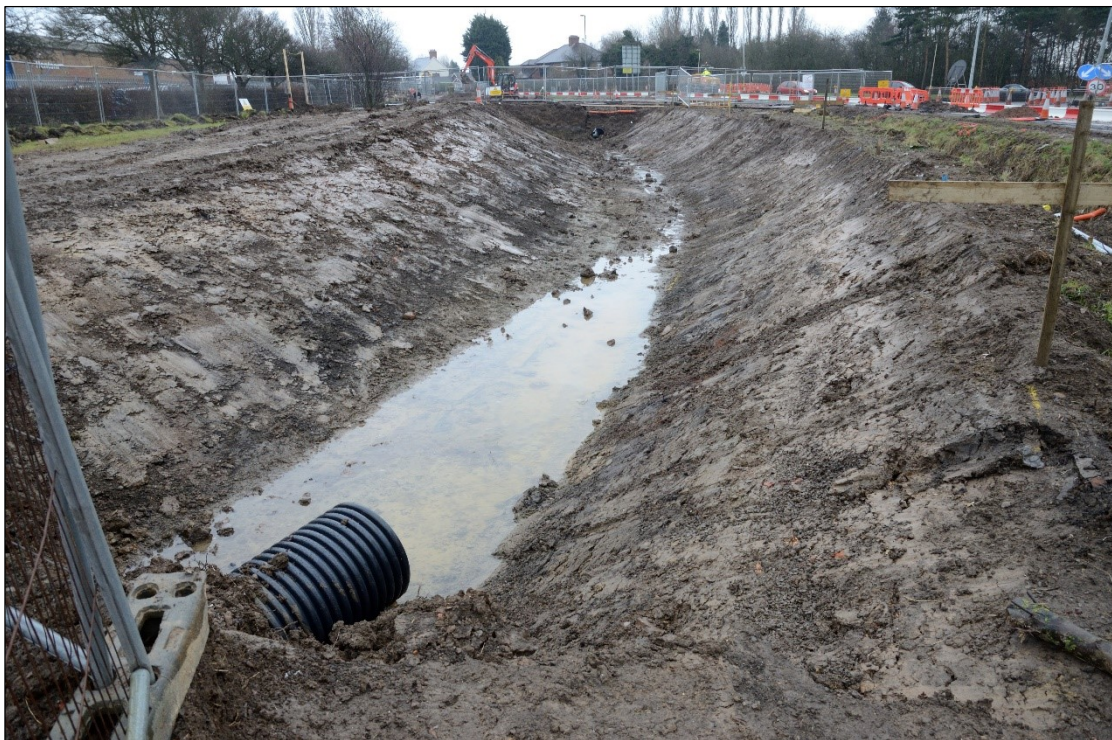
Plate 8: New drain northeast of the roundabout (Area D), looking southeast

Area D designates a new ditch excavated on the north side of the roundabout, between Dodwells Road (the A47) and Coventry Road (the B4666). The feature replaces an original ditch located closer to the roundabout.

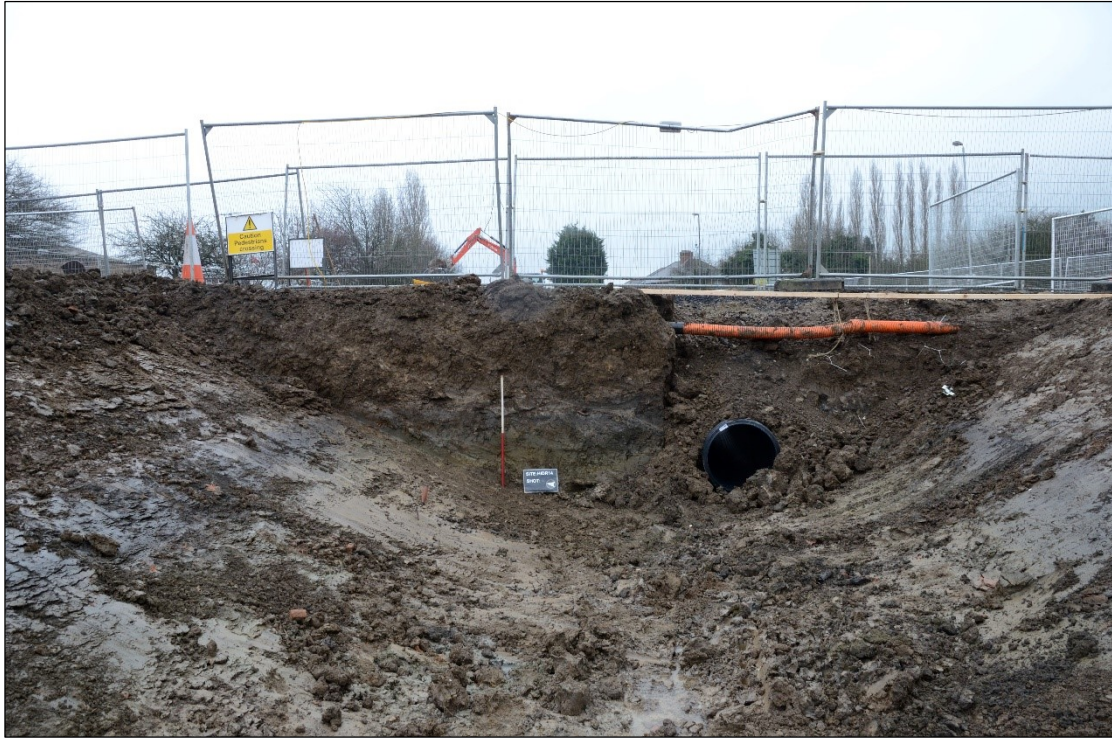
Plate 9: Section 5 in Area D, looking southeast; 1m scale

At a point mid way along the length of the ditch, the top of natural clay, (120), was encountered at a depth of 1.6m below existing ground level. It was sealed by light to mid greyish brown clay 0.15m thick, (119), which was in turn sealed by dark grey silty clay 0.15m thick. The latter had the appearance of a topsoil, while a small quantity of pottery recovered from the deposit indicated a 19th century date of deposition. The assemblage included one sherd dated as 17th – 18th century (see Appendix B).

The topsoil was sealed by a deposit of mixed clayey silt and clay 1.3m thick. Modern materials in the layer, including wire and plastic, indicate deposition at some time in the late 20th century, presumably as part of previous roadworks or associated drainage works.

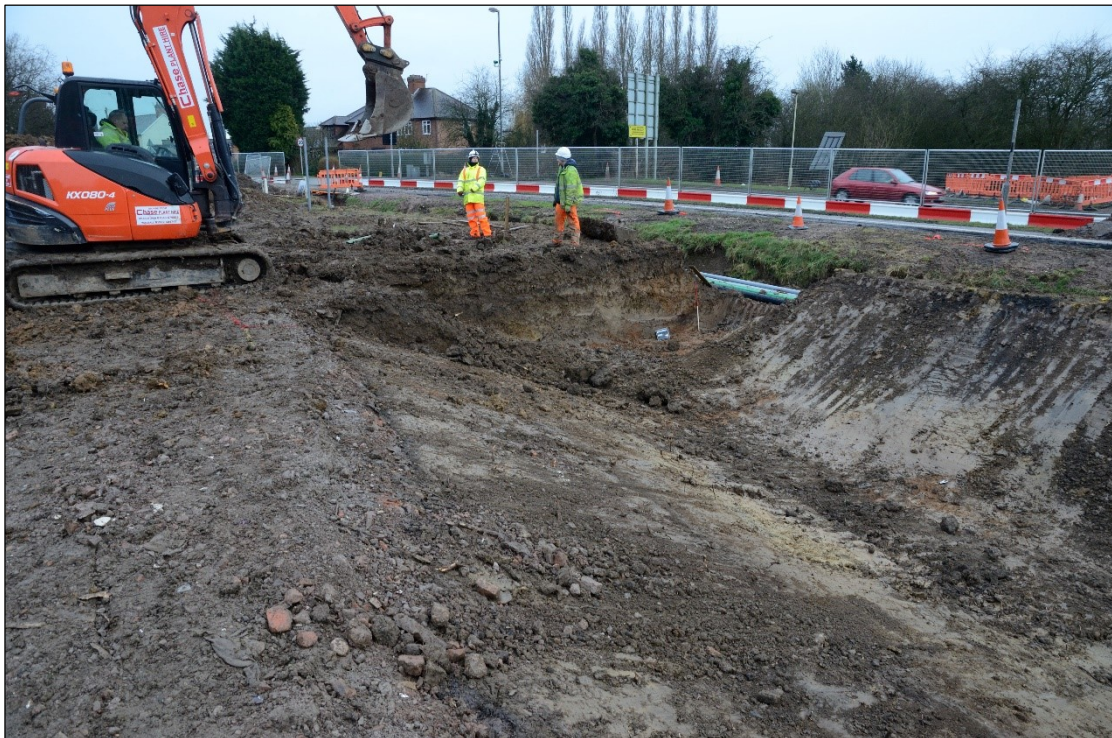
Plate 10: Eastern end of Area D including Section 6, looking c. southeast; 1m scale

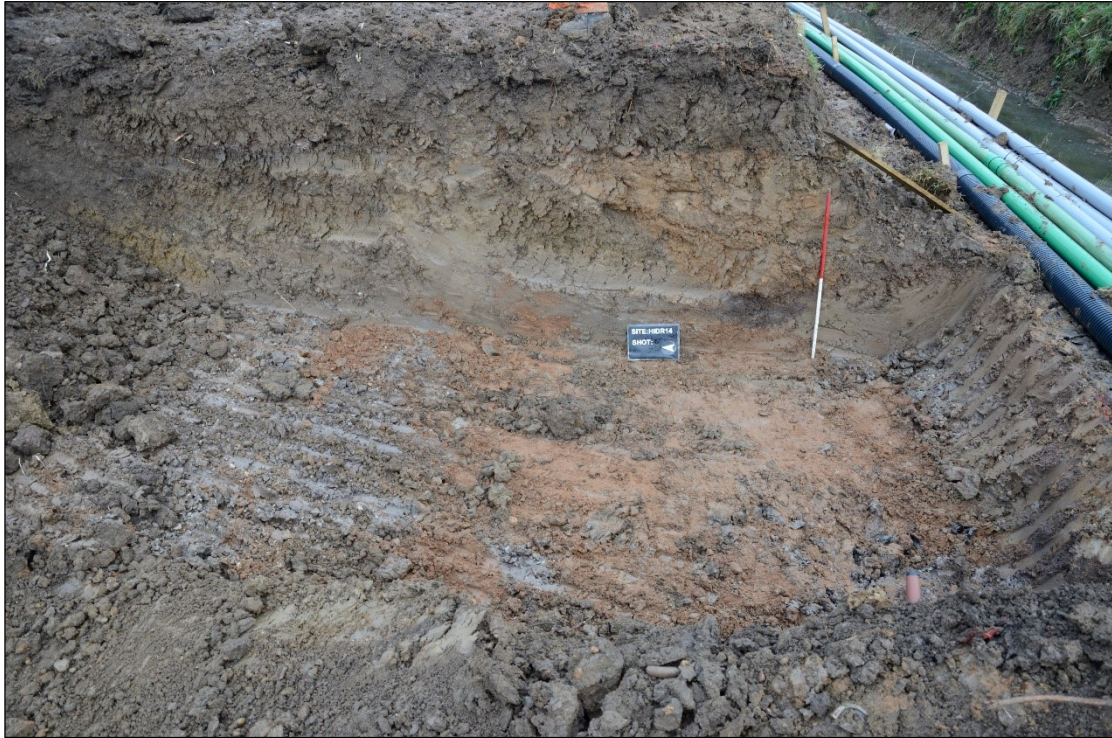
Plate 11: Section 6 (Area D), looking east; 1m scale

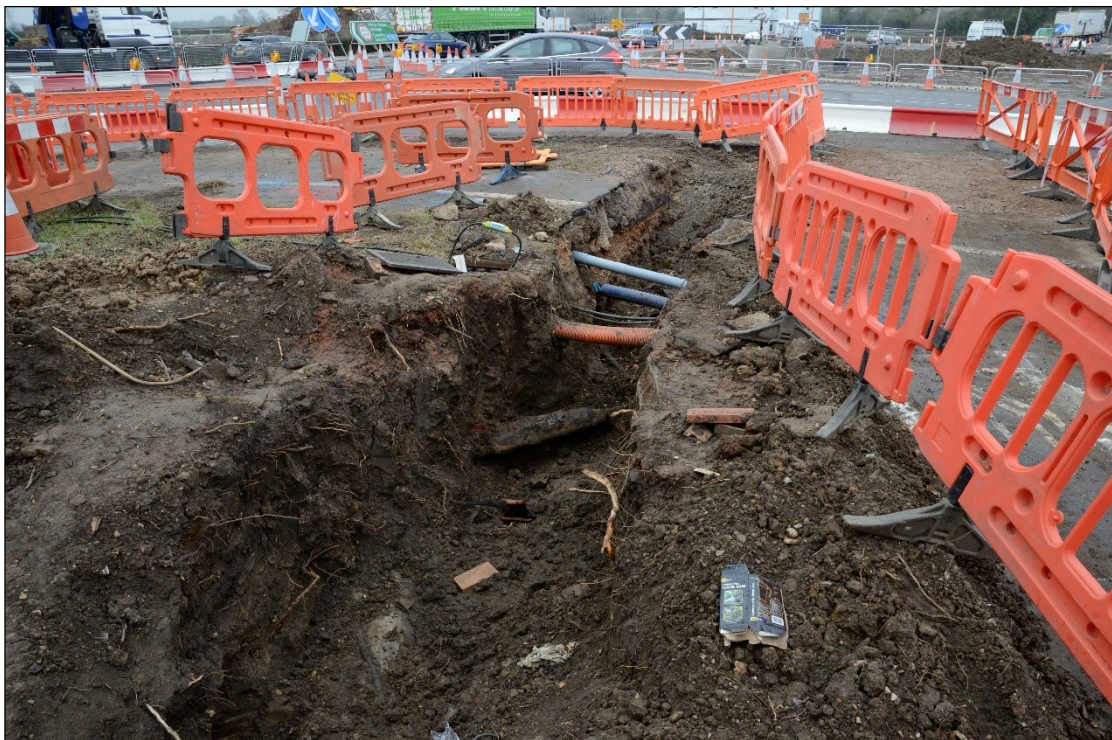
Plate 12: Work in progress, east of the roundabout, looking c. west

Excavations carried out as part of road widening on the east side of the roundabout, in the angle between the A5 and Coventry Road, were closely monitored for evidence of early road construction. The works revealed high levels of previous disturbance from services and earlier phases of modern road construction, to a depth of at least 800mm, obscuring or truncating any evidence for the continuation of the areas of metalling recorded in Areas A and B.

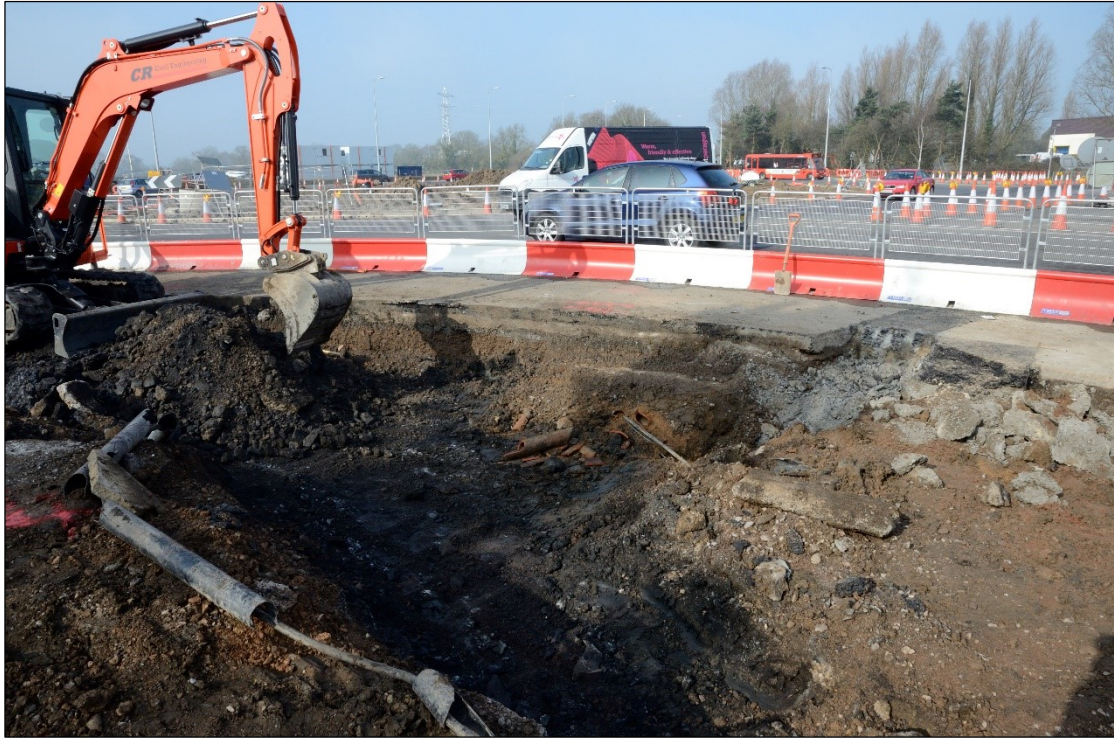
Plate 13: Work in progress, east side of the roundabout, looking c. west
